NISTIR 7841

Study of Early-Age Bridge Deck Cracking in Nevada and Wyoming

Prepared for Federal Highway Administration Central Federal Lands Highway Division

January 2012

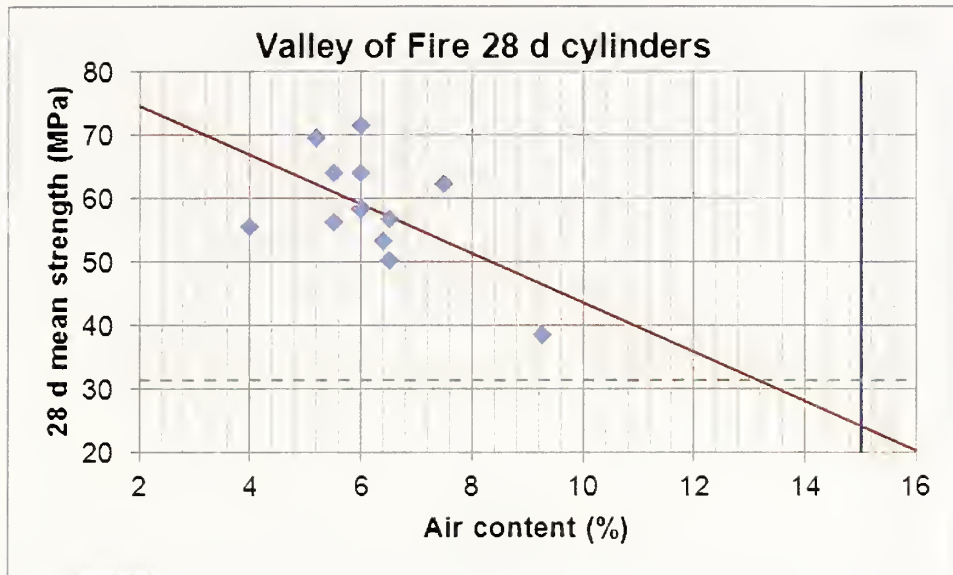
Figure 1. Measured 28 d mean compressive strength vs. air content for Valley of Fire bridge deck concrete [10]. The solid red line indicates the best fit linear equation. The dashed green horizontal line indicates the strength level measured for drilled cores taken in June 2010 [10]. The solid blue vertical line indicates the air content measured in the original petrography report [13].

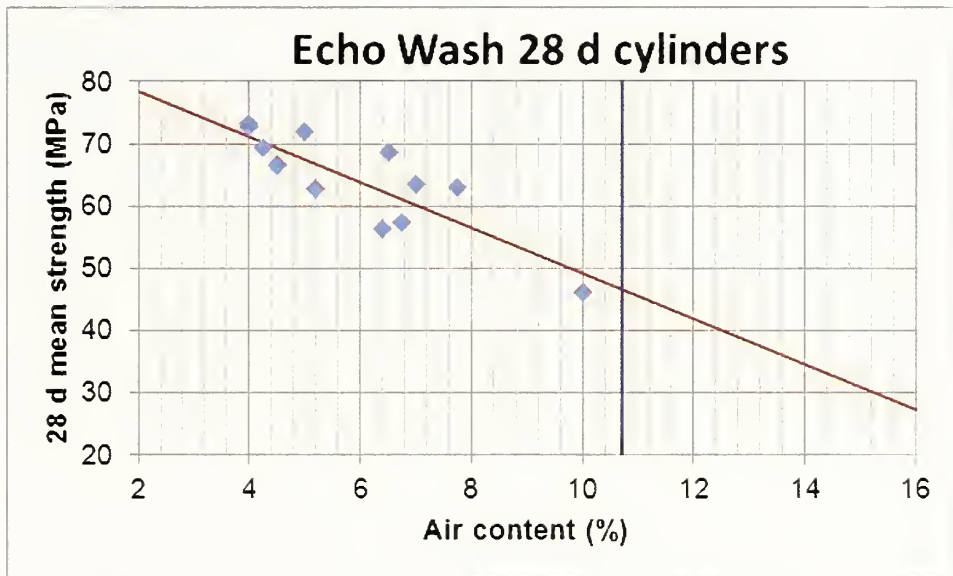
Figure 2. Measured 28 d mean compressive strength vs. air content for Echo Wash bridge deck concrete [10]. The solid red line indicates the best fit linear equation. The solid blue vertical line indicates the air content measured in the original petrography report [13].

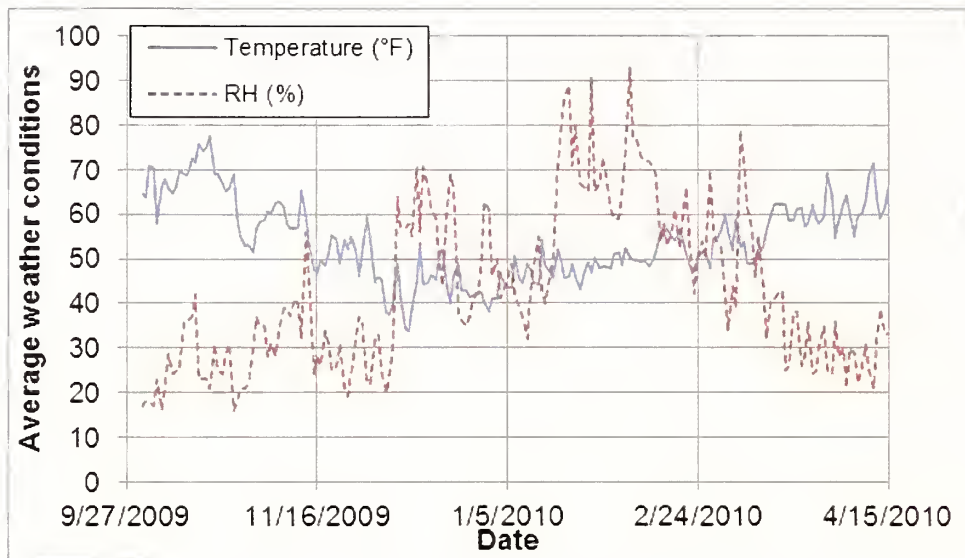
Figure 3. Average daily air temperature and ambient relative humidity in Overton, NV, for the time period from 10/1/2009 until 4/15/2010 [15].

Data from the weather station in Overton, NV for the time period from the casting of the bridge decks (October 2009) until the observation of significant cracking (February to March 2010) are summarized in Figure 3 [15]. It is assumed that the cracking mostly occurred sometime in the months of February and March, as it was not noted in the Olson Engineering reports, whose surveys were conducted on January 28-29, 2010. This would suggest that the cracking likely occurred following a “rainy” season that was characterized by high daily average relative humidities in the range of 70 % to 80 %. Following this, the RH steadily decreases to 20 %. This drying trend may have introduced additional stresses that could have initiated the cracking observed in these concretes.

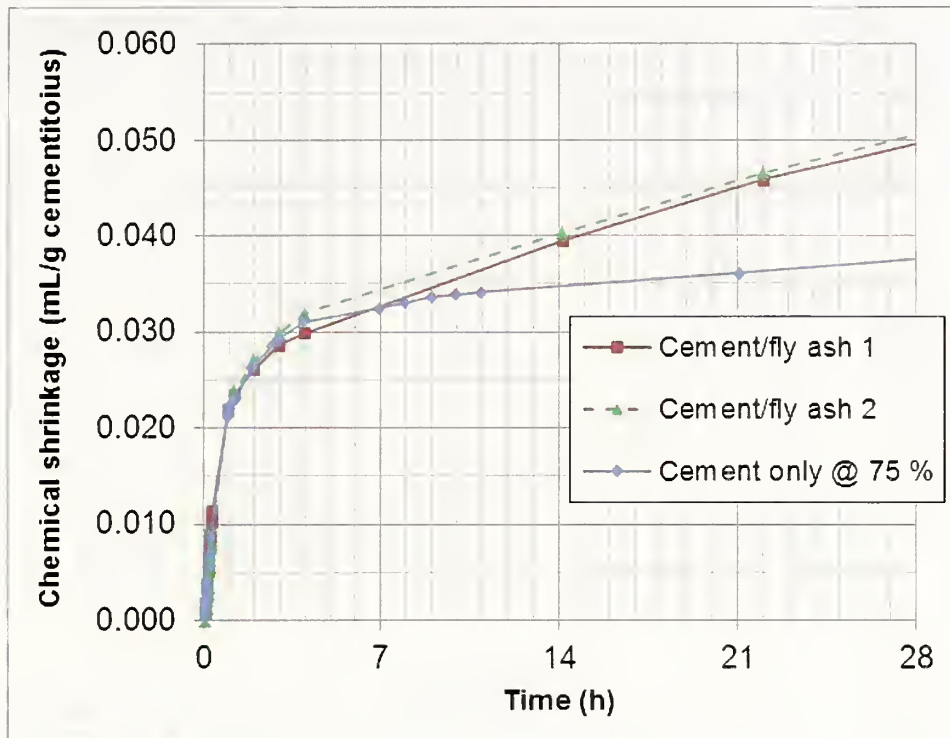
Figure 5. Measured chemical shrinkage for two replicate pastes prepared with cement/fly ash and the scaled (75 %) chemical shrinkage measured for paste prepared with cement only.

Chemical shrinkage measurements were conducted on paste specimens prepared with only the cement ($w/c = 0.40$) and prepared with the cement/fly ash proportions ($w/cm = 0.40$) used in the bridge deck concretes. The plot in Figure 5 indicates that in the cement/fly ash blend, the cement has the dominant effect on the chemical shrinkage until an age of about 7 d, as the measured chemical shrinkage is basically equivalent to that measured for a pure cement paste scaled to its 75 % mass content in the cement/fly ash blend. Beyond that age, a substantial contribution to the reactions is provided by the (pozzolanic) reaction of the fly ash with the cement hydration products, as the curves for the cement/fly ash blends begin to greatly exceed that of the pure cement paste scaled at 75 % at about 7 d. This reaction continues at a fairly high rate out through 28 d, the end of the chemical shrinkage measurement. This enhanced overall reactivity and increased chemical shrinkage at intermediate ages could contribute to additional autogenous shrinkage within the same time period [18].

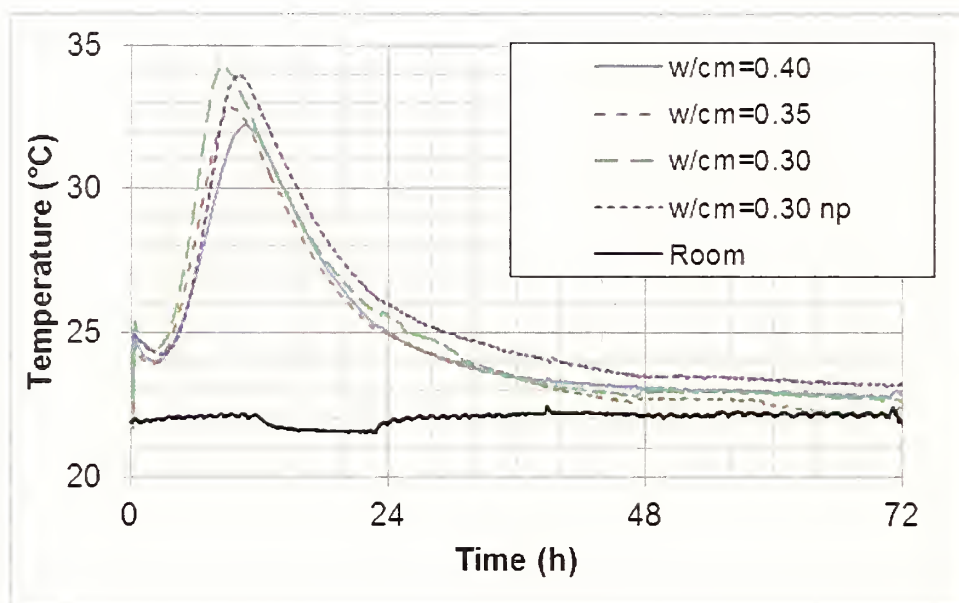
Figure 6. Measured semi-adiabatic temperature rise for the four mortar mixtures.

Figure 6 shows the measured temperature for individual specimens from the four mortar mixtures during their first three days of hydration under semi-adiabatic conditions. As would be expected, due to their higher cement content and lower heat capacity (since water has a much higher heat capacity than cement or sand), the lower w/cm systems produce a slightly higher temperature rise. A slight retardation is seen in the $w/cm = 0.30$ mortar without pigment relative to its pigment-containing counterpart, most likely due to a slight overdosage of the high range water reducer (HRWRA) in the former mixture. For the fairest comparison of performance, the

For plain Portland cement systems, temperature rise is usually highest for an intermediate w/c (~ 0.35), as lower w/c may not provide sufficient water to maximize hydration and temperature rise [19]. However, for these blended cements with about 25 % fly ash by mass, the w/cm of 0.30, 0.35, and 0.40, correspond to equivalent w/c of about 0.40, 0.47, and 0.53, respectively. Since the fly ash is fairly inert at early ages, none of these mixtures should be water limited and therefore, the semi-adiabatic temperature response is dominated by the increasing cement content of the lower w/cm mixtures. Based on the 25 % fly ash content and the prevailing environmental conditions (temperature) recorded during the casting of the concrete bridge decks, the impact of a potential slightly increased temperature rise, due to the potentially lower w/cm of the field concrete mixture, on any likelihood for thermal cracking is deemed minimal. Additionally, such thermal cracking would normally manifest itself much sooner than the approximately four month delay from casting to the observation of considerable cracking for the bridge decks in question.

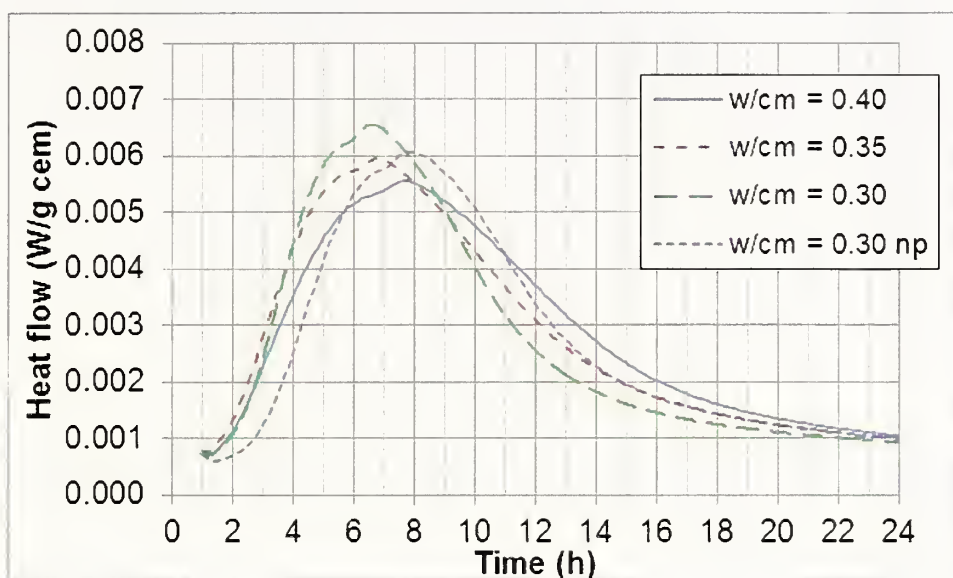
Figure 7. Heat flow normalized per mass of cement for the first 24 h of hydration for the four mortar mixtures.

The isothermal calorimetry results for the four mortars are provided in Figures 7 to 9. Figure 7 shows the heat flow results for the first 24 h of hydration. The four curves are quite similar, with a slight retardation observed for the $w/cm = 0.30$ mortar without pigment, once again due to a slight overdosage of the HRWRA. Figure 8 shows the cumulative heat release curves, with the expected effect that higher w/cm mortars produce greater heat release at later ages, due to the self-desiccation that occurs and somewhat limits further hydration in the lower w/cm mortars. The curves for the four mortars begin to diverge after approximately 18 h of hydration. The cumulative heat release curves for the $w/cm = 0.30$ mortars, with or without pigment, are basically identical, indicating that the initial hydration retardation occurring in the

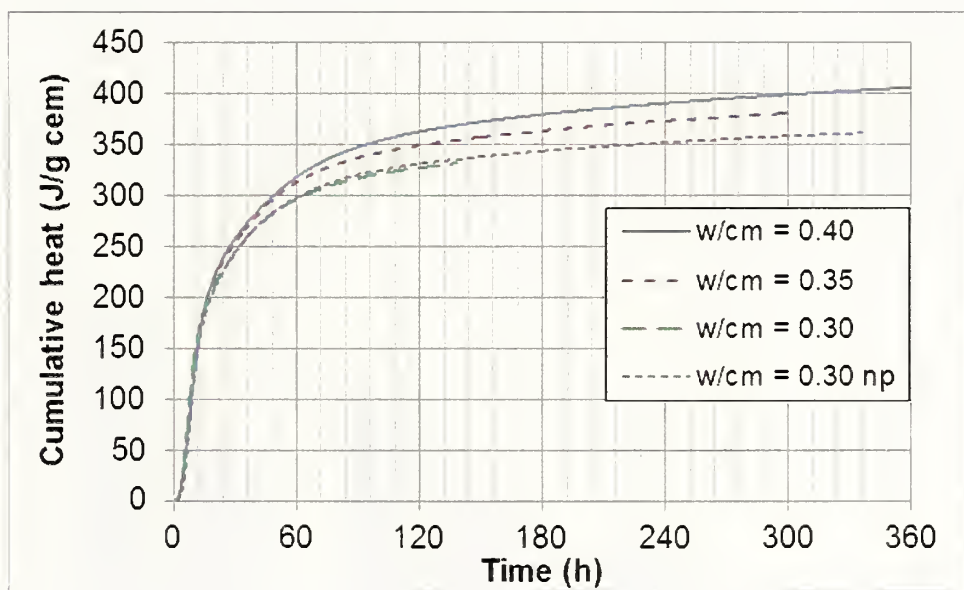
Figure 8. Cumulative heat release per mass of cement for the first 14 d of hydration for the four mortar mixtures.

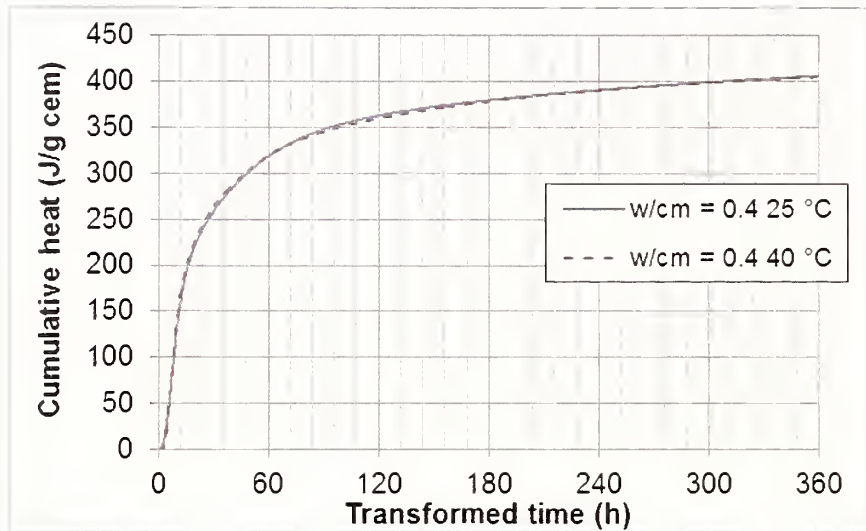
Figure 9. Example of time-temperature transformation, using an apparent activation energy of 30.4 kJ/mol, for $w/cm = 0.40$ mortar under isothermal conditions at either 25 °C or 40 °C.

Figure 9 shows results for mortars hydrated at two different temperatures (25 °C and 40 °C), to illustrate that the hydration of this blended cement can be accurately described using a commonly applied maturity-based approach, with a calculated apparent activation energy of 30.4 kJ/mol. The time-temperature transformed curves in Figure 9 nearly overlap one another, indicating the adequacy of the applied Arrhenius model.

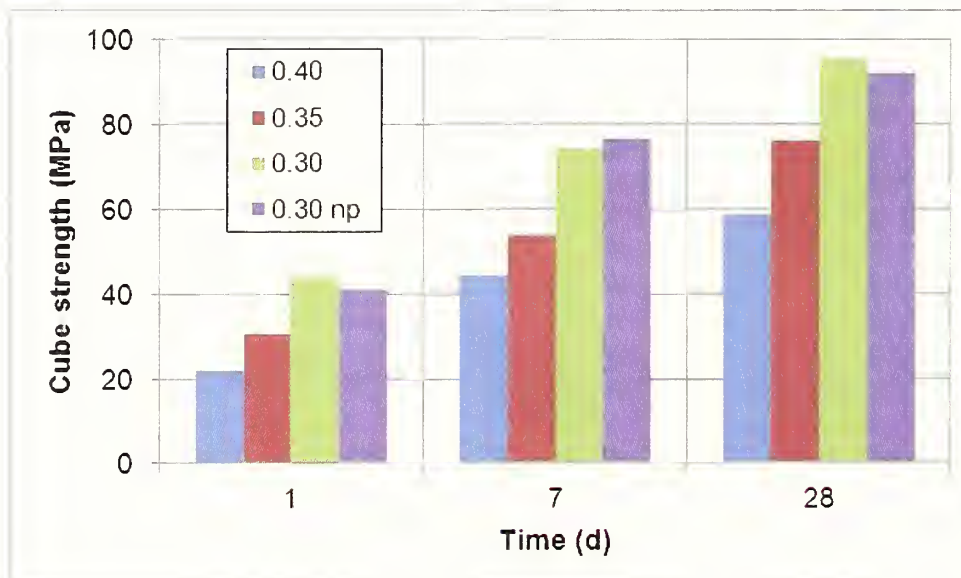
Figure 10. Measured mortar cube compressive strengths for the four mortar mixtures at ages of 1 d, 7 d, and 28 d. Mean coefficients of variation were 1.4 %, 1.7 %, 4.2 %, and 5.3 % for the 0.40, 0.35, 0.30, and 0.30 np mortars, respectively.

The measured mortar cube compressive strengths (average of three specimens) at ages of 1 d, 7 d, and 28 d are shown in the Figure 10. The trends are as would be expected with the lower w/cm mortars providing higher strengths. Relatively little difference is seen between the two $w/cm = 0.30$ mortars with and without pigment. The increase in compressive strength with decreasing w/cm implies that for the equivalent concretes, the potential reduction in w/cm between the batched and the specified concrete could produce higher compressive strengths, which could effectively mask the expected decrease in compressive strength due to any abnormally high air contents in the delivered product.

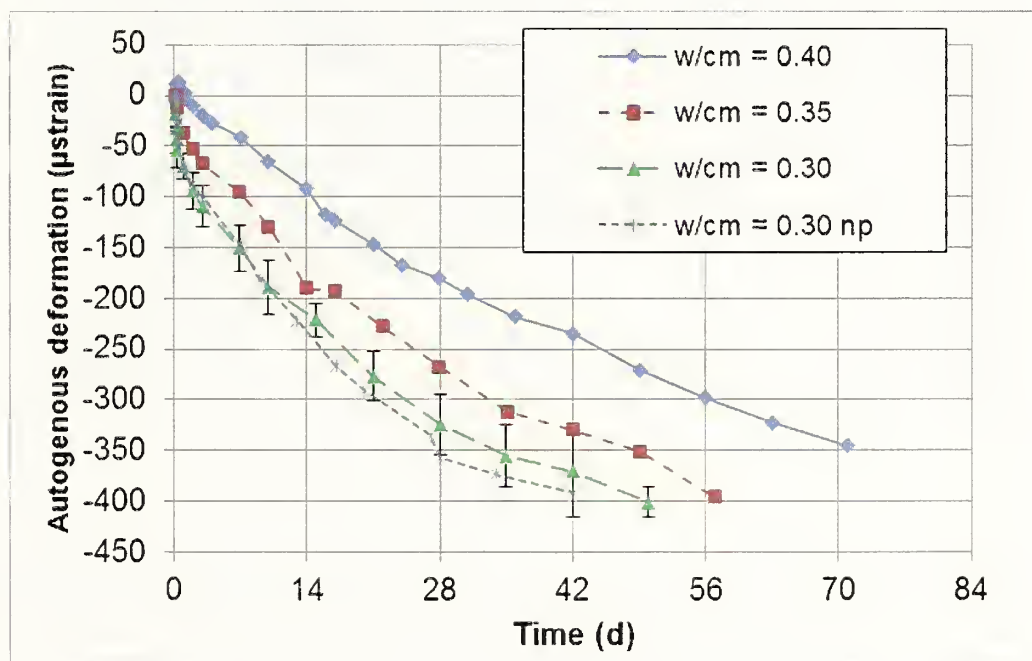
Figure 11. Measured autogenous deformation vs. time for the four mortar mixtures under sealed curing conditions. To provide an indication of measurement variability, error bars are shown for the $w/cm = 0.30$ mortar without pigment that represent \pm one standard deviation based on the evaluation of three replicate specimens.

Autogenous shrinkage, as seen in Figure 11, is fairly linear over the entire measurement time scale of 56 d. Normally, for an ordinary Portland cement, the autogenous shrinkage increases rapidly and then levels off, following more of an exponential-shaped curve. For this particular blend of cement, as evidenced by the chemical shrinkage results, the pozzolanic reactions become very active at ages of about 7 d and beyond. It is thought that this pozzolanic reaction is responsible for maintaining a significant rate of autogenous shrinkage at ages beyond 7 d, and likely even beyond 56 d.

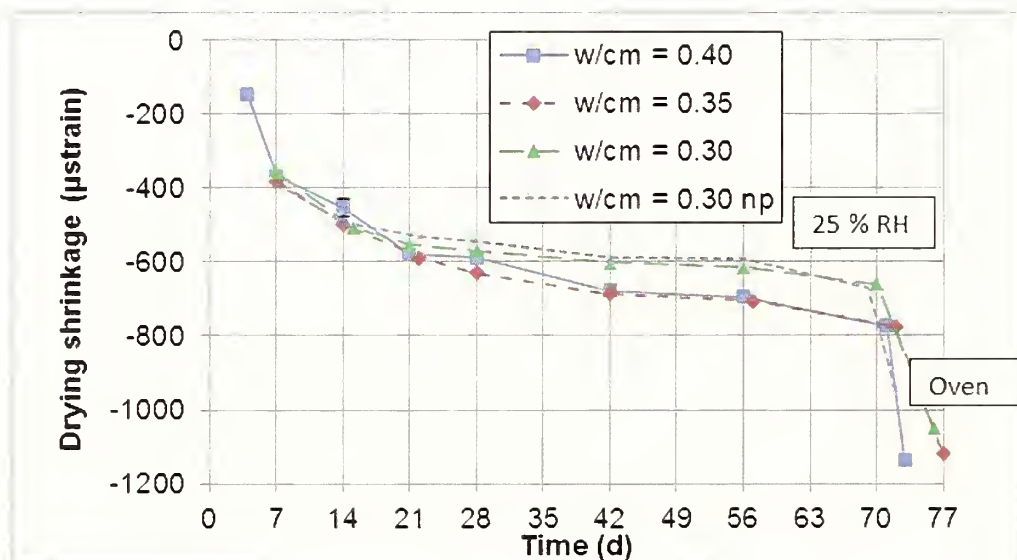
Figure 12. Drying shrinkage vs. time for the four mortar mixtures upon curing for 3 d and subsequent exposure to a 23 °C, 50 % RH controlled environment. Error bars for the $w/cm=0.40$ mortar indicate \pm one standard deviation for measurements for six replicate specimens and generally fall within the size of the data points.

The same four mortar mixtures were evaluated for drying shrinkage based on the ASTM C596 standard test method [16]. The shrinkage tests were initially carried out in a controlled environment of 23 °C and 50 % RH for 56 d (environmental chamber). At that time, the specimens were moved to a second environmental chamber that was set at 23 °C and 25 % RH to evaluate further shrinkage. This was deemed prudent as the daily average relative humidity reported by the Overton, NV weather station in February and March of 2010 reached 25 % and even lower (Figure 3). Finally, the specimens were oven dried at 100 °C to determine the evaporable moisture content of each mixture. At each measurement time, both the mass and length of each of the six specimens per mixture were assessed. In addition, at ages out to 28 d, the resistivity of the specimens was also measured, using a commercially available 4-probe resistivity meter. The results are presented in Figures 12 to 16. Figure 12 simply shows the measured drying shrinkage (in microstrain) vs. time for the four different mortar mixtures. Unlike the autogenous shrinkage results, the measured drying shrinkage results for these four different w/cm mortars are quite similar. At later ages, about 10 % less drying shrinkage is observed in the $w/cm = 0.30$ mortars. Considering these drying shrinkage results along with the autogenous shrinkage results presented above (although the two cannot be simply added due to the 2 d of water curing applied in the ASTM C596 standard test procedure [16]), the total shrinkage should be generally greater in the mortars with the lower w/cm , likely increasing their propensity for early-age (total shrinkage) cracking.

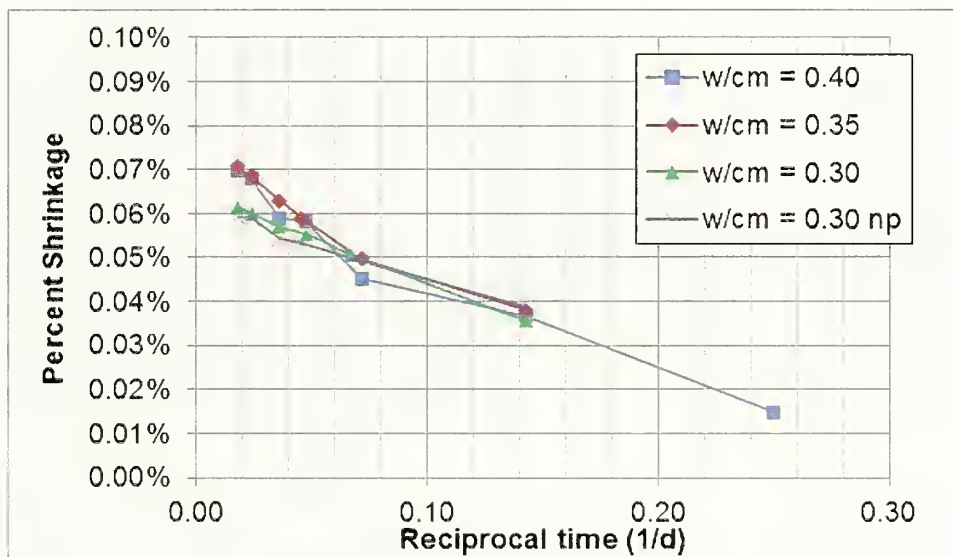
Figure 13. Measured percent shrinkage plotted vs. reciprocal time for the drying shrinkage data for the four mortar mixtures.

The ASTM C596 standard [16] suggests that the percent drying shrinkage be plotted against the reciprocal of the exposure time. These results are provided in Figure 13, which indicates the linearity expected when the data are plotted in this manner, with some minor deviations at early and late ages. Figure 14 plots measured shrinkage vs. measured mass loss (normalized by the initial demolded specimen mass) and a generally linear relationship is

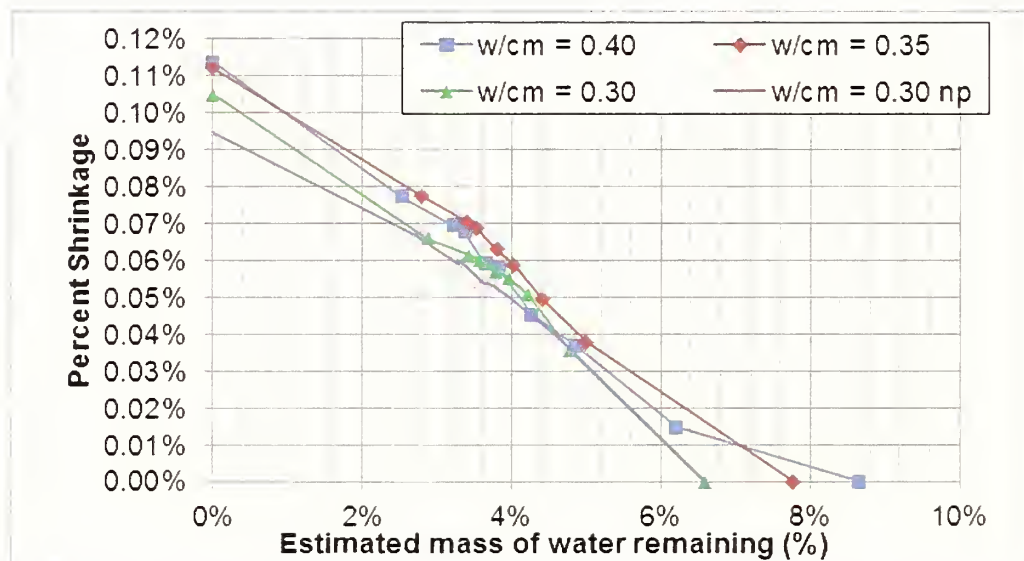
Figure 15. Measured percent shrinkage vs. estimated mass of water remaining for the four mortar mixtures.

obtained for each individual mixture. Figure 15 provides a plot of shrinkage vs. estimated mass of water remaining (using the final oven dry mass of the specimen and normalizing by the initial demolded specimen mass). The plot indicates that the data for the four different mortar mixtures converges towards a single line. This suggests that for these mortars prepared with the same starting materials, the measured shrinkage is controlled by the mass fraction (or volume fraction) of water remaining within the prisms as they are exposed to drying conditions.

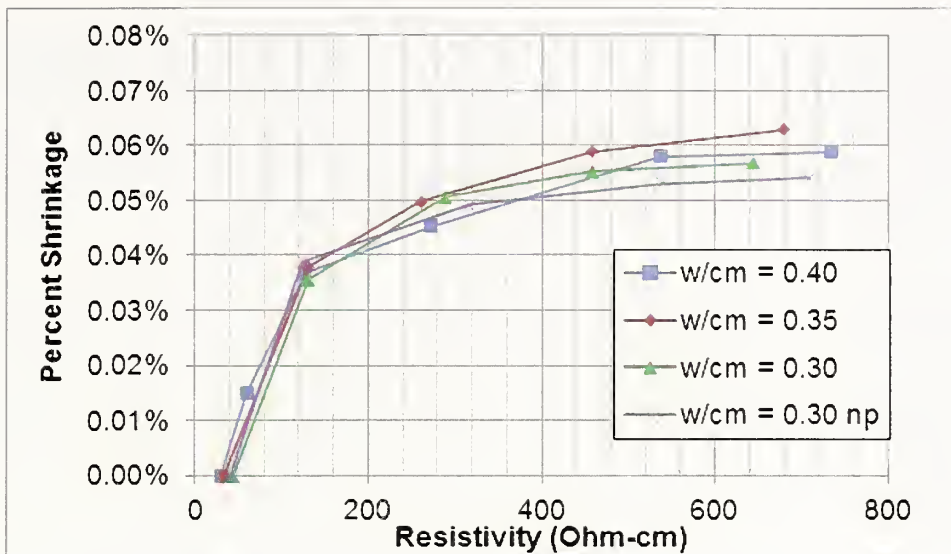
Figure 16. Measured percent drying shrinkage vs. measured specimen resistivity.

Figure 16 contrasts the measured specimen resistivity to the measured drying shrinkage. The resistivity was measured by first dampening the four pins of the resistivity meter (spaced at an interval of 37 mm) and then centering them on the face of the drying specimen prism that was opposite to its top finished surface. Although there is some scatter, the plot indicates a potential master curve for the relationship between these two variables, perhaps suggesting that both are equally sensitive to the volume percentage and spatial arrangement of (liquid) water within the drying cement paste microstructure. The average coefficient of variation for the resistivity measurements for a single mortar mixture ranged between 3 % and 7.5 % for measurements performed between 3 d and 28 d. Conversely, for the shrinkage measurements, these coefficients of variation ranged between 1.5 % and 3.7 %.

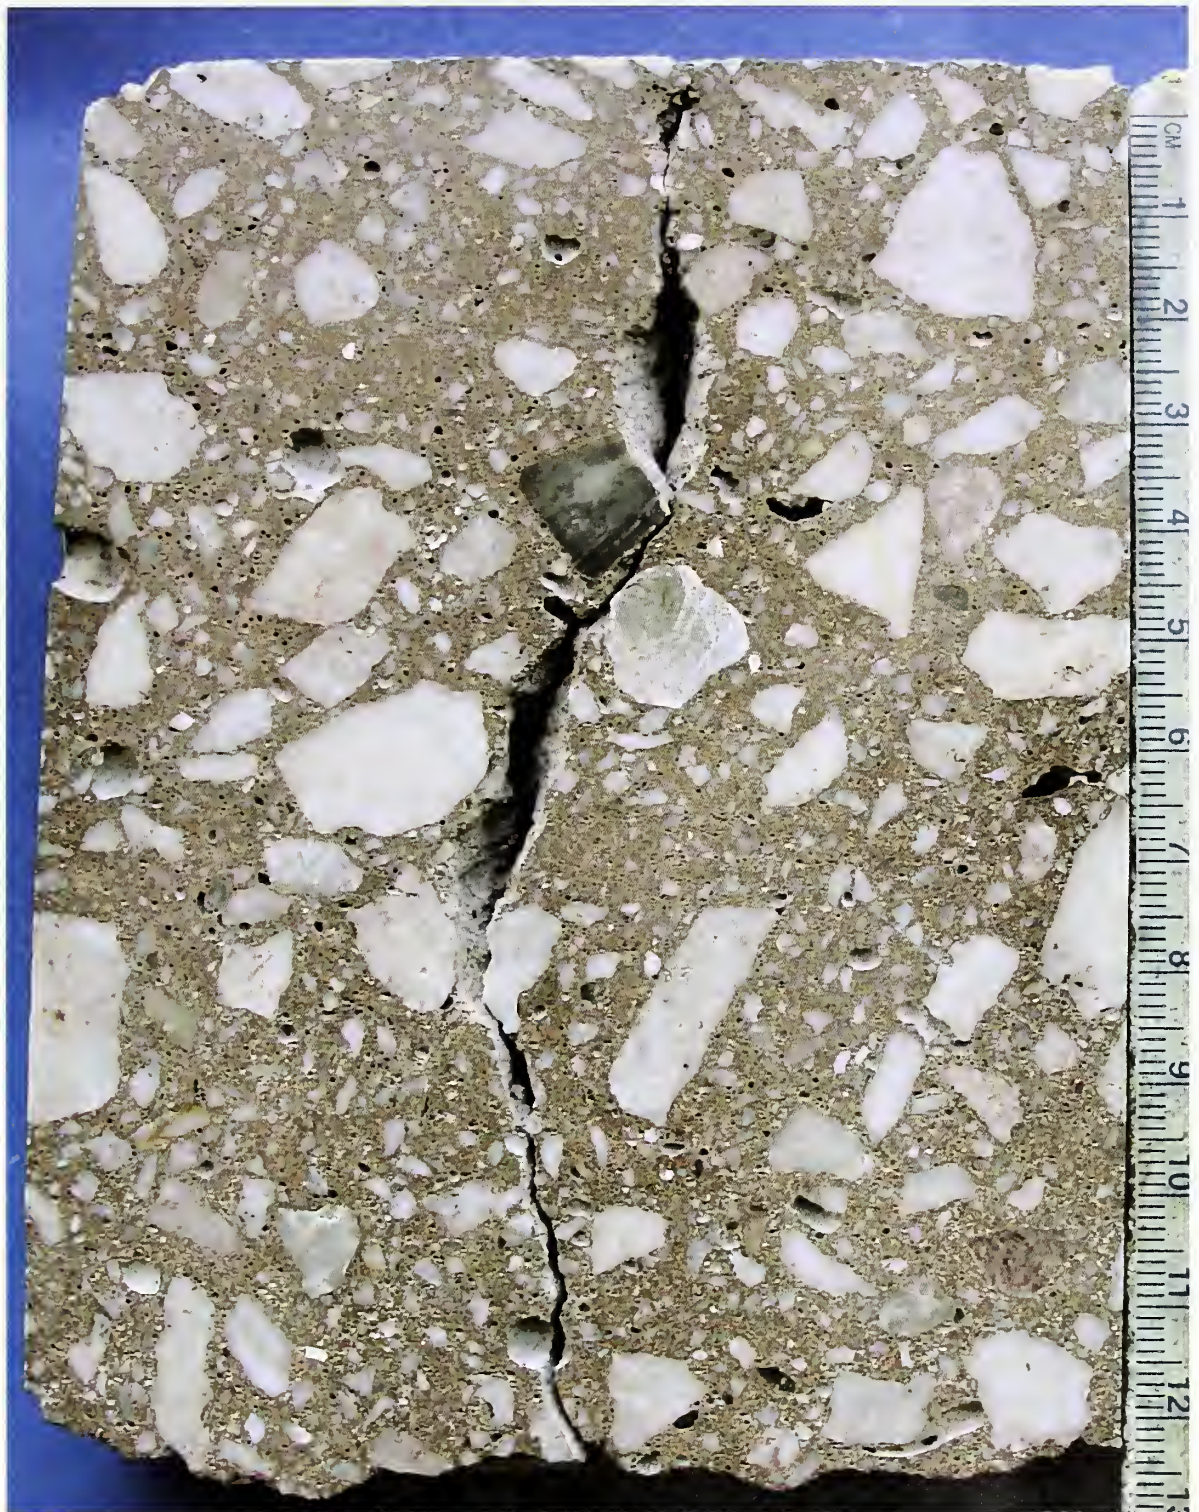
Echo Wash core #1 was drilled on a crack that travels the length of the 135 mm section. The surface of the pavement is ground to produce grooves a few millimeters deep. The concrete appears strong, cutting and polishing well. The hardened cement paste bond to both the coarse and fine aggregate is strong as seen by a clean polish across the boundary and lack of aggregate plucking. The coarse aggregate was a crushed, angular dolostone and limestone to 20 mm size, and the fine aggregate was an angular crushed sand. The aggregate and paste distribution appears irregular, with numerous mortar-rich regions and coarse aggregate-rich regions. The coarse sand fraction appears to be minimal, leading to a gap-graded appearance. The cement paste appears strong and is subtranslucent, and tinted a pink-tan color with some of the pigment appearing to be partially absorbed into the coarse aggregate. Some evidence of retempering is apparent

against coarse aggregate, as a more dense, lower-air paste that appears darker. The entrained air void system appears to be abundant to excessive and entrapped air voids are also common. The crack in EW #1 fits together (unlike a plastic shrinkage crack that is of variable width), is roughly vertical through the core section and generally travels through the mortar. A few coarse aggregate were plucked out in the process of sectioning the slab.

Figure 17. Echo Wash #1 core exhibiting heterogeneous aggregate distribution, abundant entrapped air and a crack extending the length of the core section.

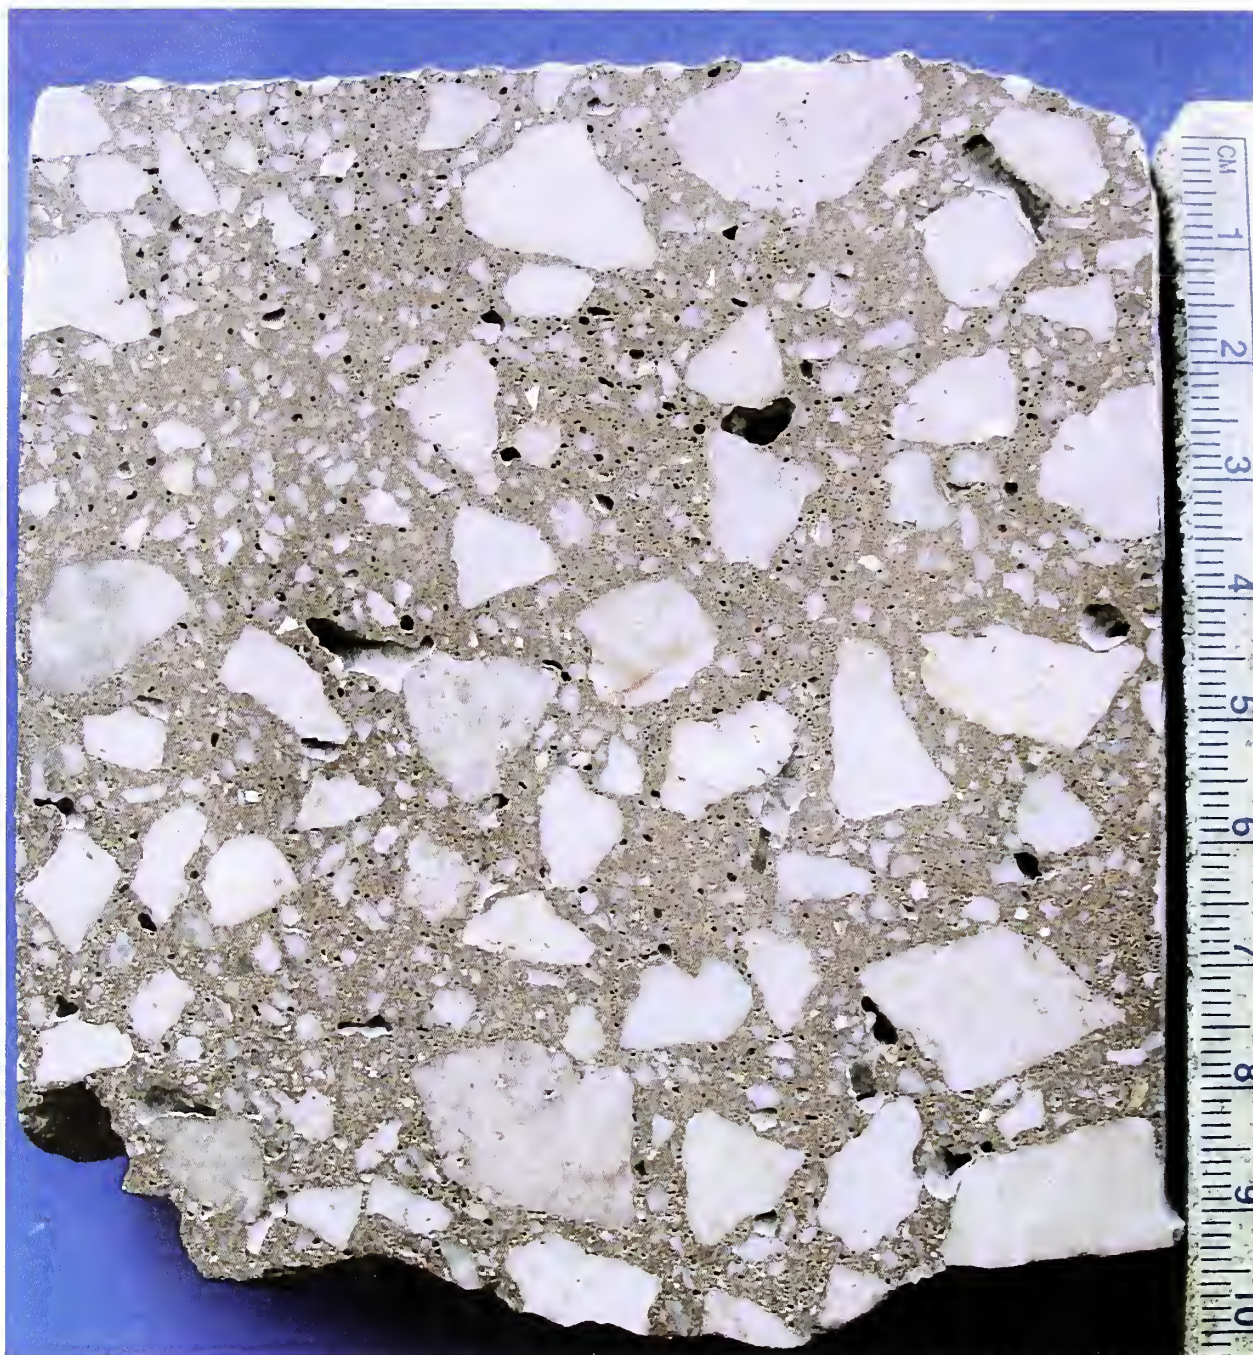
Figure 18. Echo Wash #2 core exhibits abundant entrapped air and some heterogeneous aggregate distribution. The grooves from the surface cutting operation are visible at the top of the core.

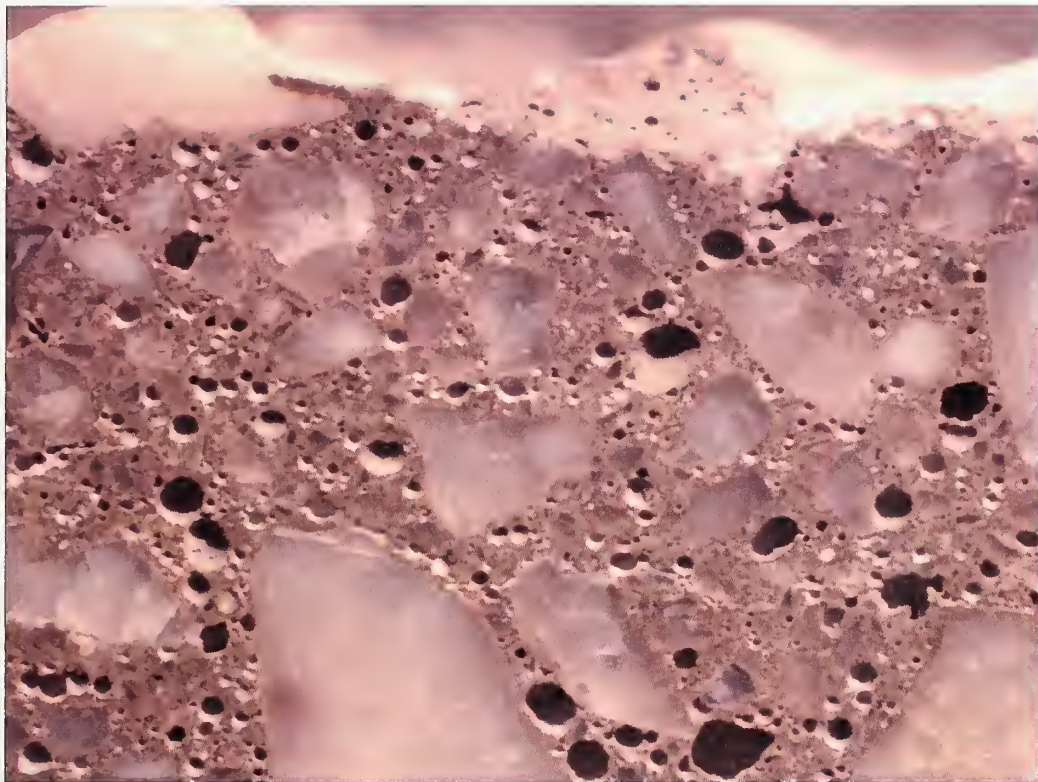
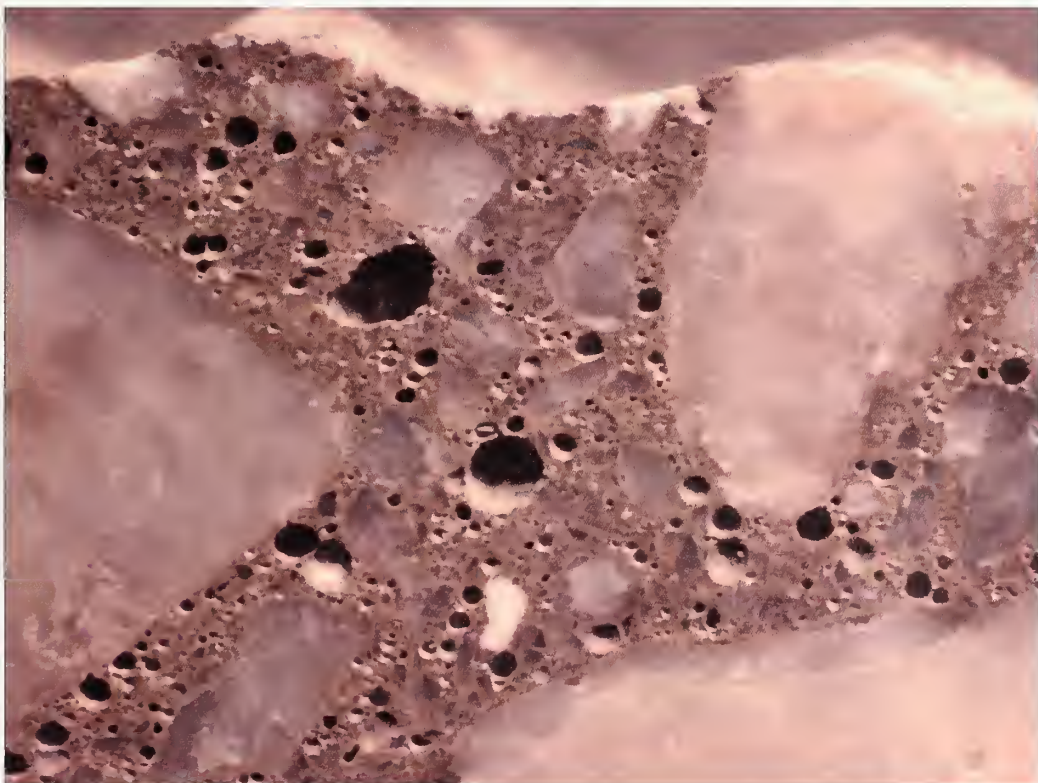
Figure 19. Surface microstructure of the Echo Wash #2 core with a field width of 10 mm shows the strong hardened cement paste by well-defined surfaces and air void edges, smooth cement paste, and the abundance of air.

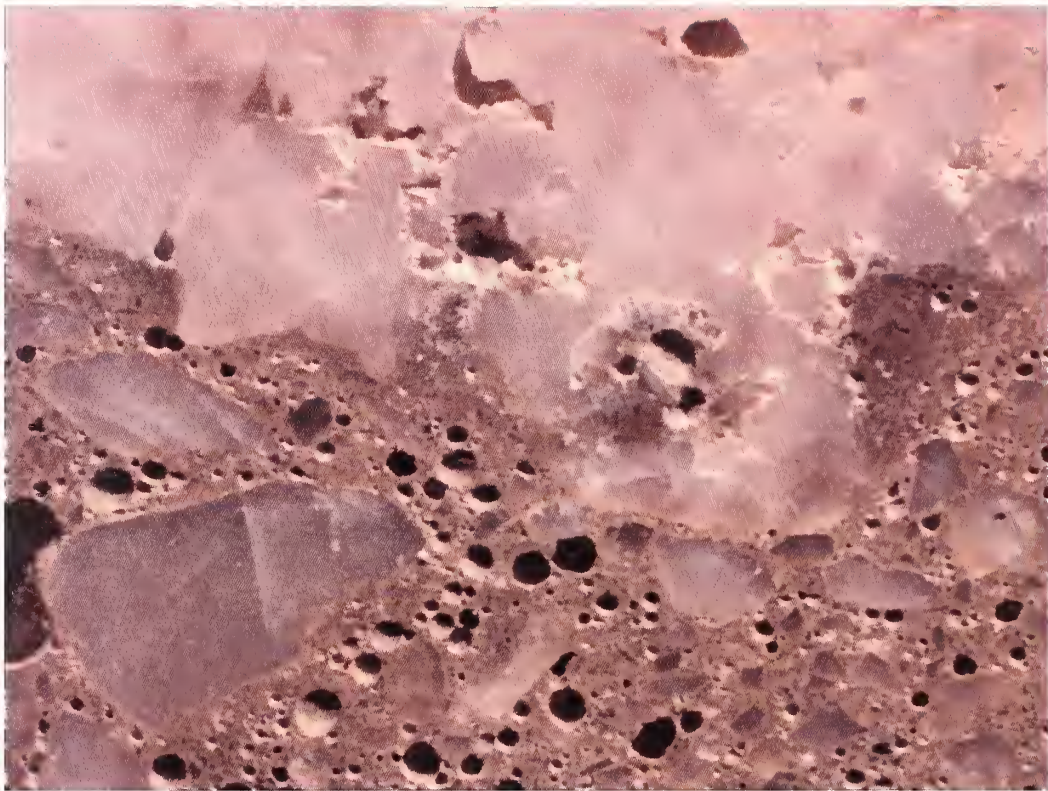
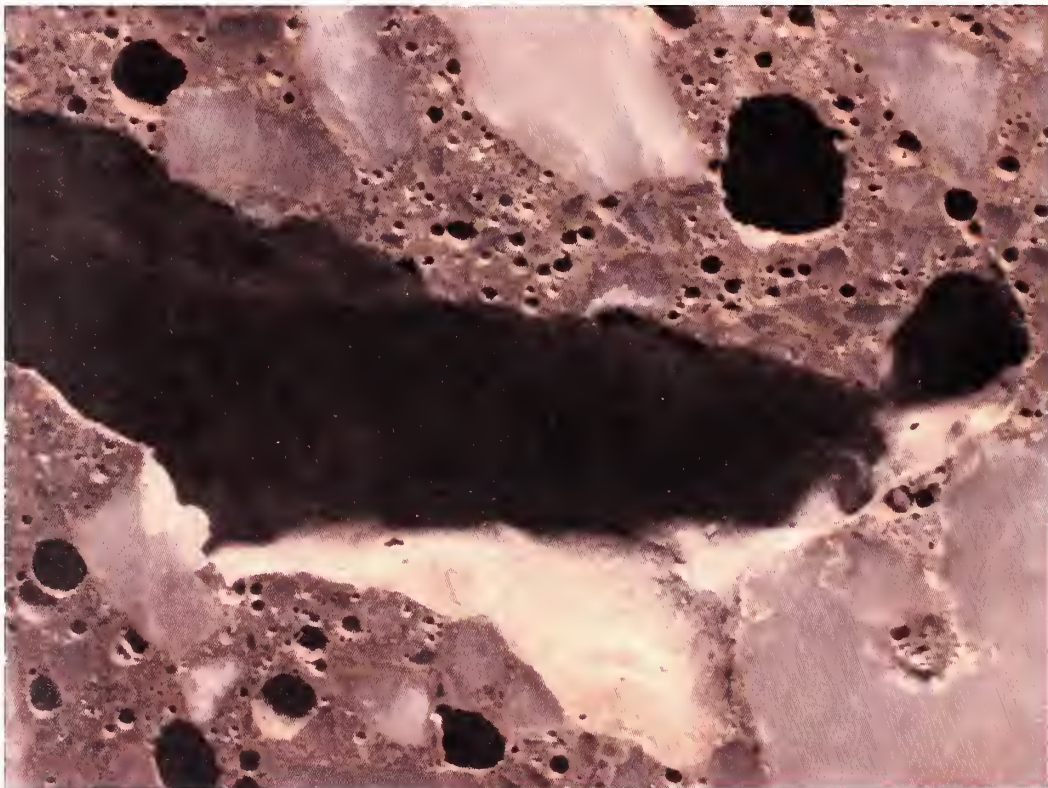
Figure 20. Darker, relatively air-free paste adjacent to the coarse aggregate is present in some cases, suggesting retempering (upper image, 10 mm field width) while large entrapped air voids (lower image) are common throughout the core.

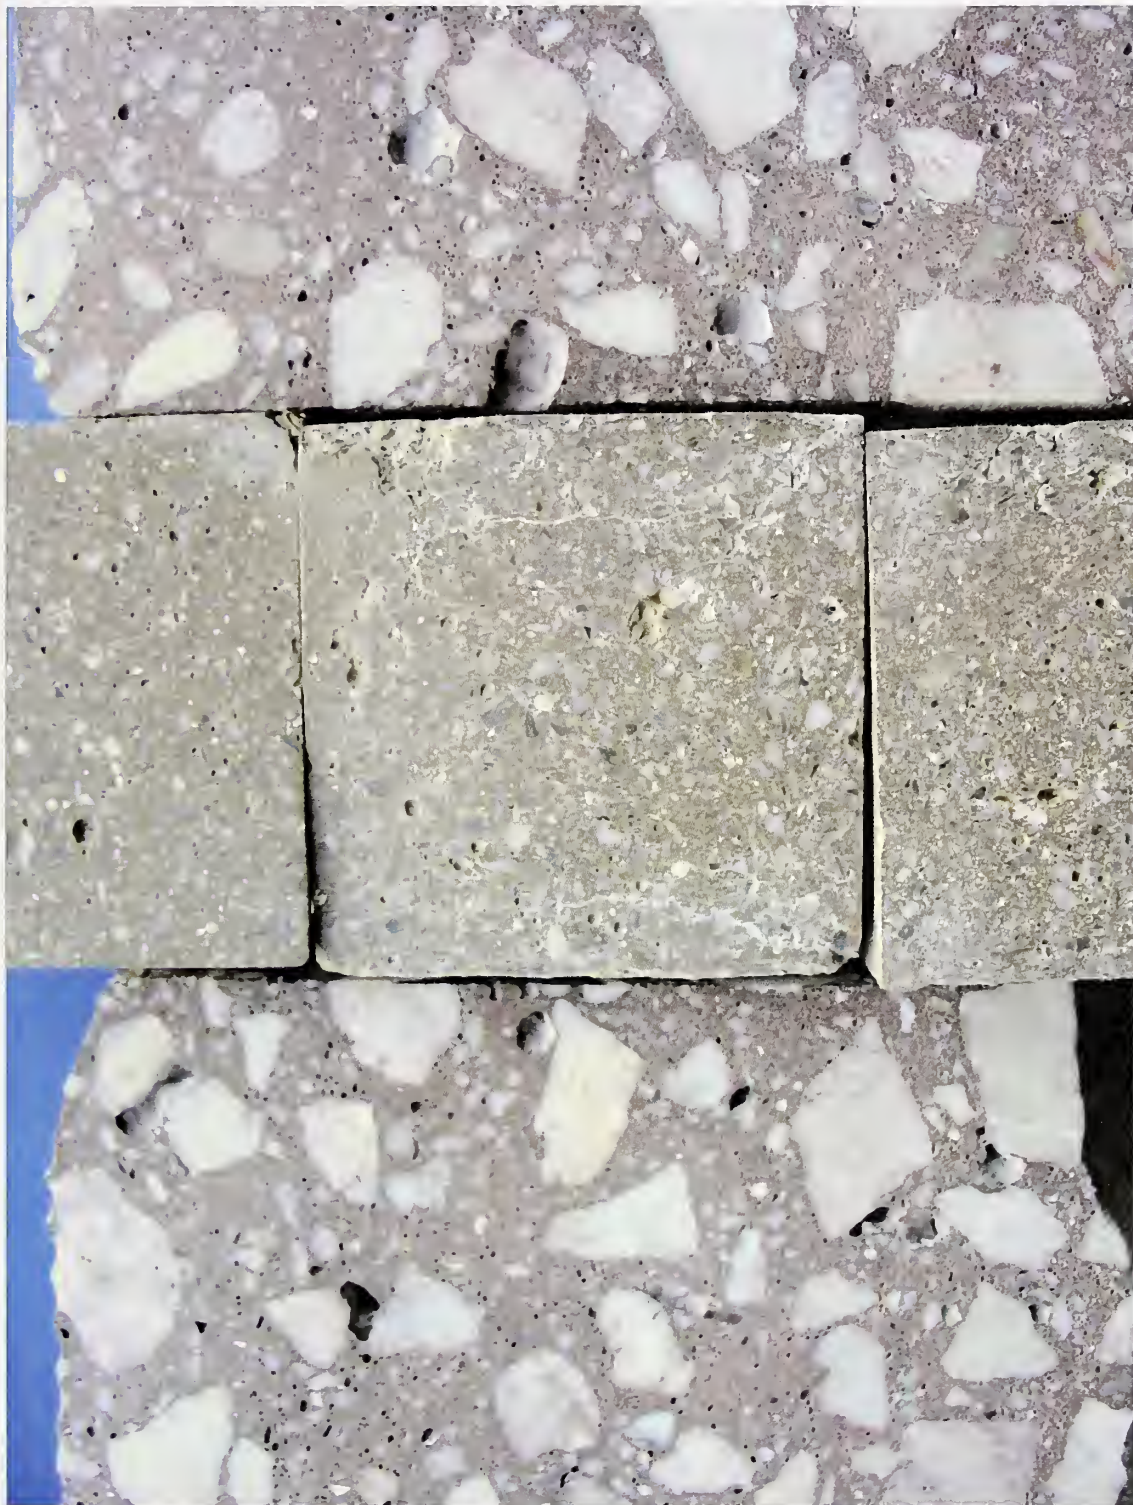
Figure 21. Comparison of the Echo Wash cores #1 (upper) and #2 (lower) against 0.30 (left) 0.35 (center) and 0.40 (right) w/cm 50 mm cubes of lab mortar shows that the deck cores are redder in appearance, suggesting a lower w/cm ratio or possibly an increased dosage of pigment.
