NISTIR 7841

Study of Early-Age Bridge Deck Cracking in Nevada and Wyoming

Prepared for Federal Highway Administration Central Federal Lands Highway Division

January 2012

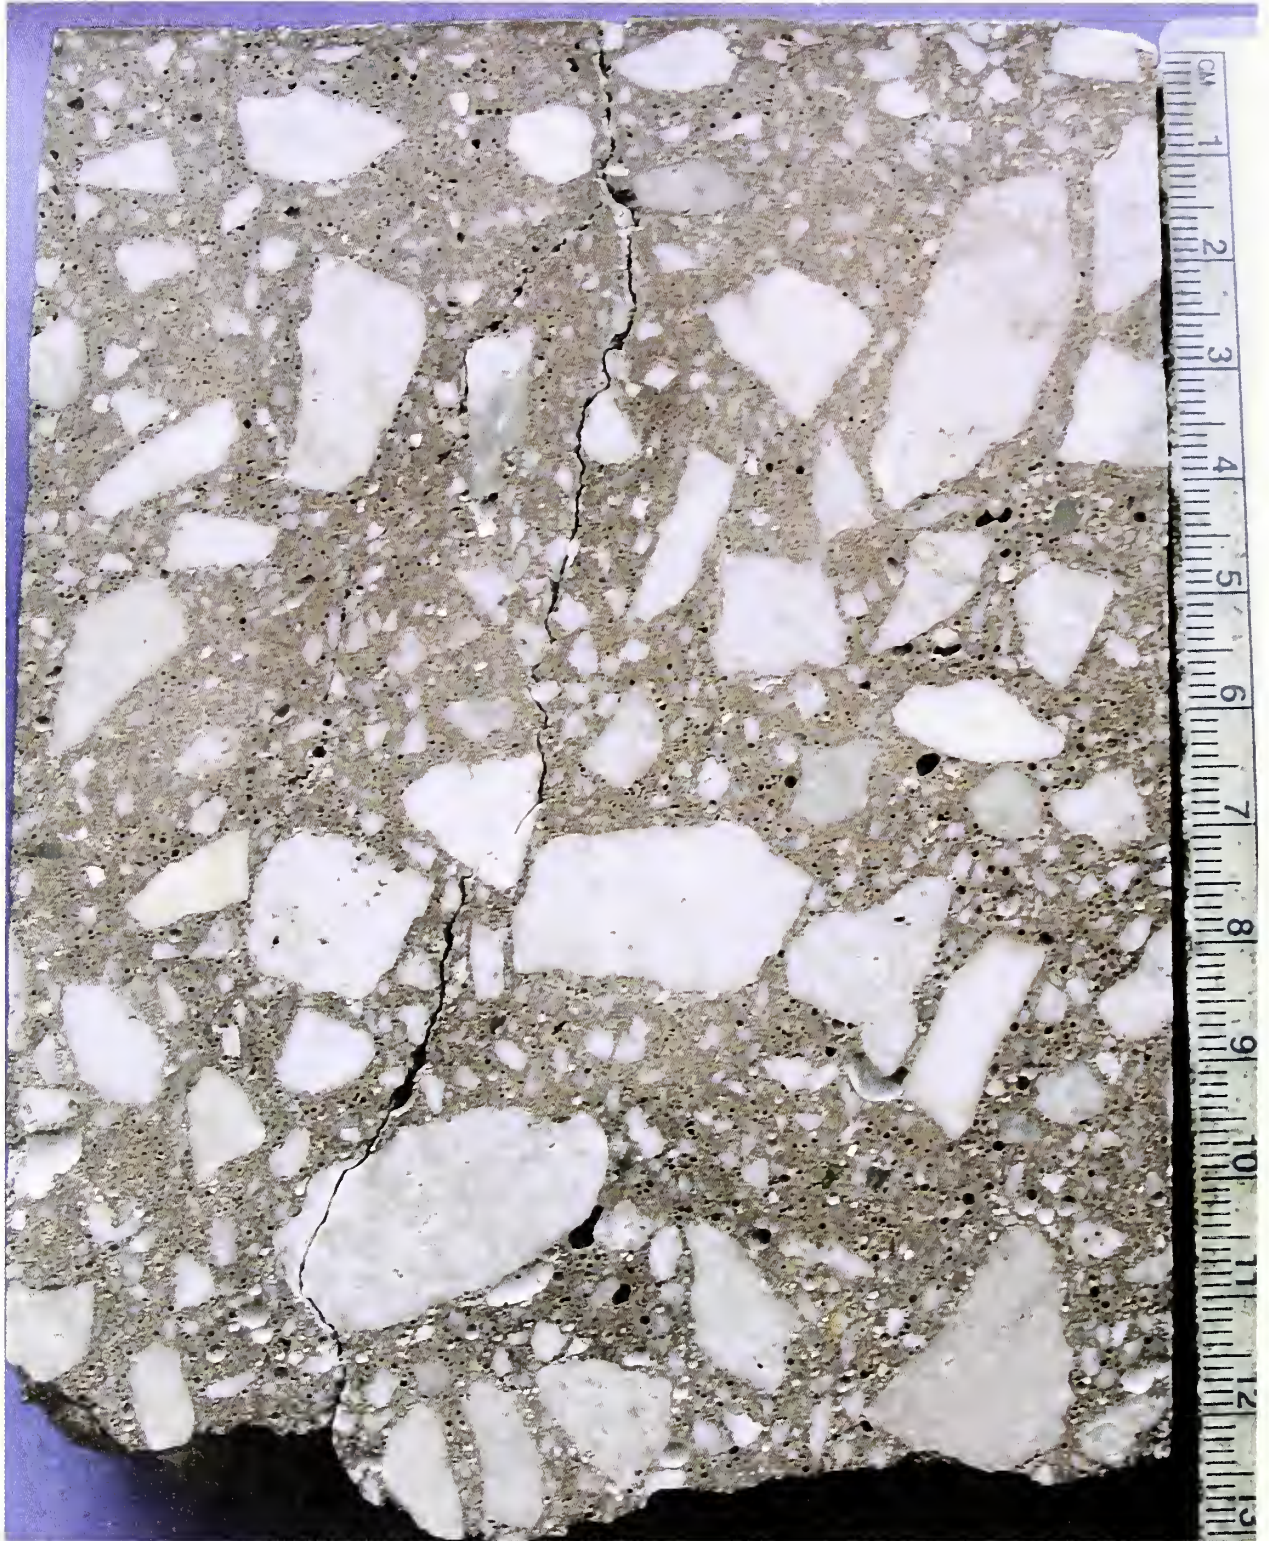
The Valley of Fire cores are partial-depth cores of about 135 mm in depth and 100 mm in diameter and are from a pavement that has a brushed finish. Core #1 was drilled on a crack that extends the depth of the core. The concrete appears strong, cutting and polishing well. The hardened cement paste bond to both the coarse and fine aggregate is strong. The coarse aggregate is predominantly a crushed angular dolostone with some limestone, and the fine aggregate is also a crushed dolostone and limestone. The mortar and coarse aggregate is heterogeneously distributed with mortar-rich regions being common. The aggregate gradation also appears to be non-uniform with the coarse sand fraction missing. Abundant air is seen in these cores and some indication of a heterogeneous air distribution is seen with regions of abundant fine-sized bubbles, while other regions contain fewer, but larger air voids. Entrapped air is present, but appears less common than with the Echo Wash concrete. The hardened cement paste is subtranslucent and tinted a pink-tan color with some of the pigment absorbed into the coarse aggregate. The paste appears strong and polishes well. VOF #2 does have a crack that is parallel to the surface about 3 mm to 4 mm beneath the surface that intersects some entrapped air voids. The cracks in VOF #1 generally travel around the aggregate, with the exception of two large fractured aggregates.

Figure 22. Valley of Fire core #1 with crack extending the length of the section passing mostly through the mortar with a heterogeneous aggregate distribution, common entrapped air, and heterogeneous entrained air void distribution.

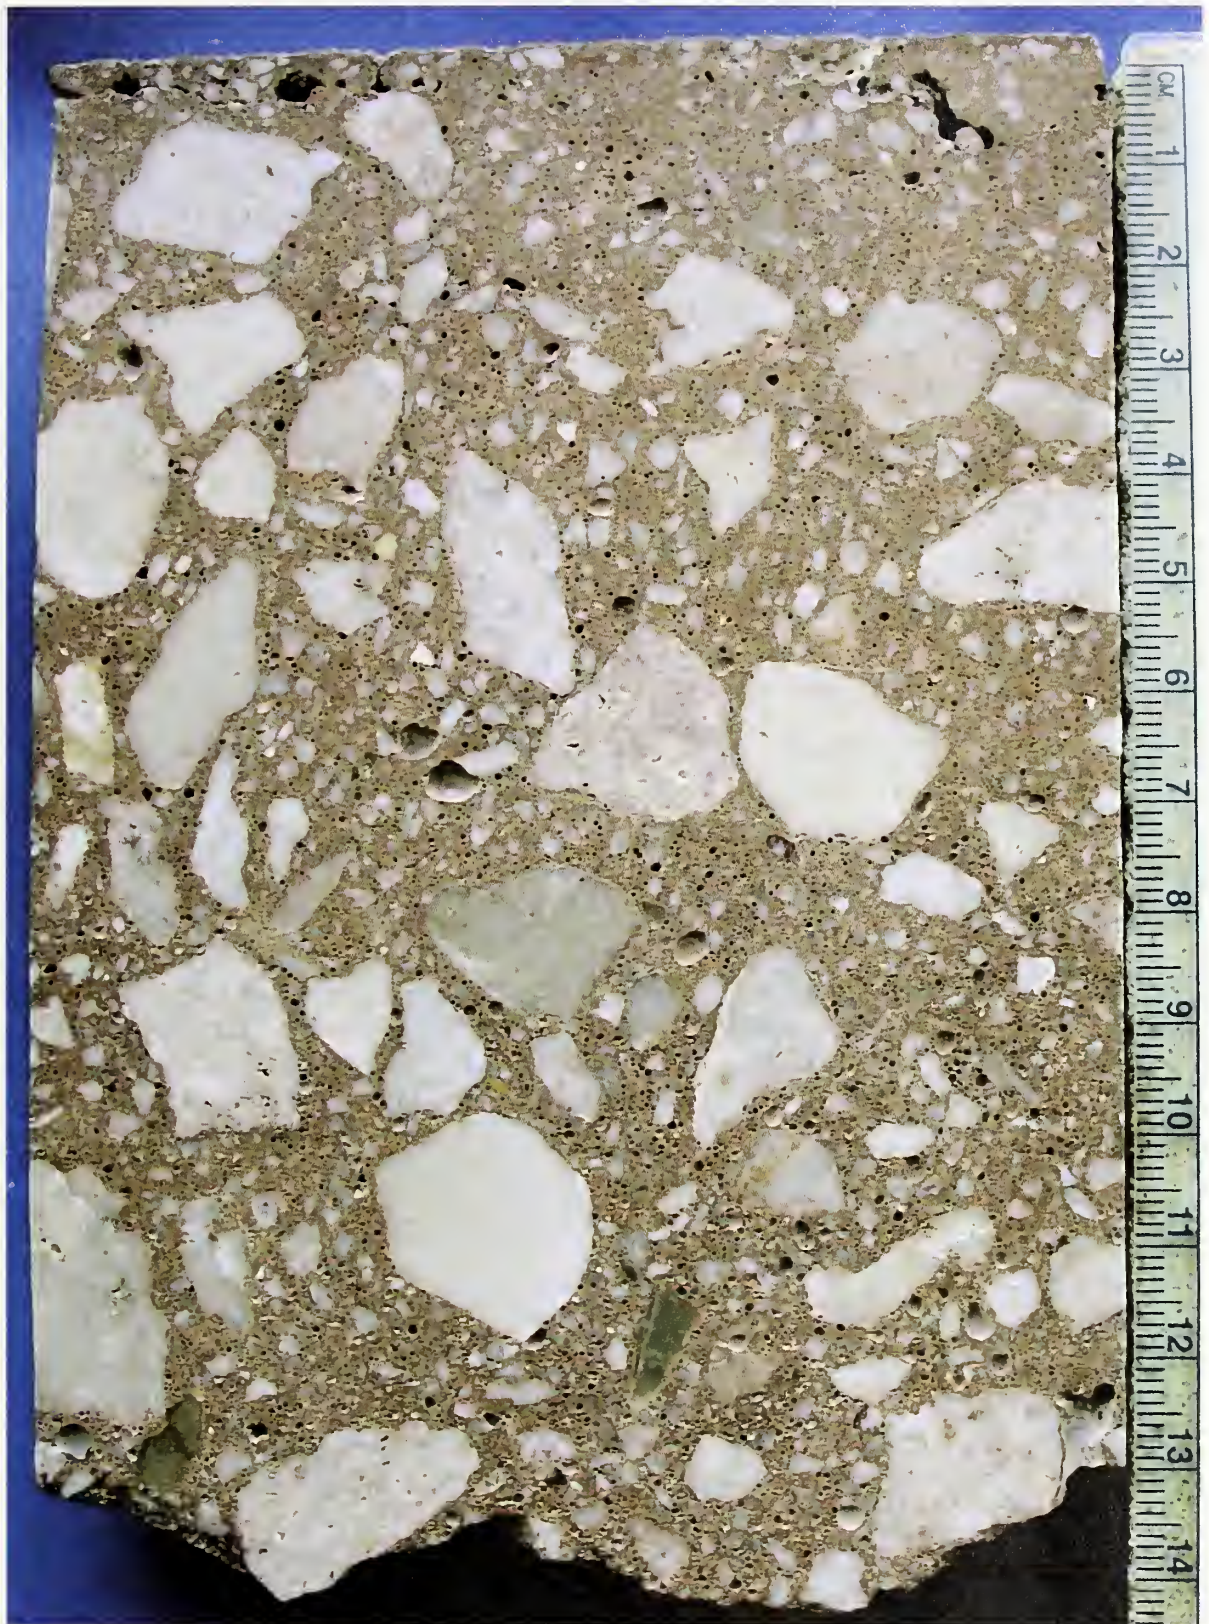
Figure 23. Valley of Fire core #2 with heterogeneous aggregate distribution, abundant entrapped air and crack parallel to the surface on the upper-left that transects entrapped air voids.

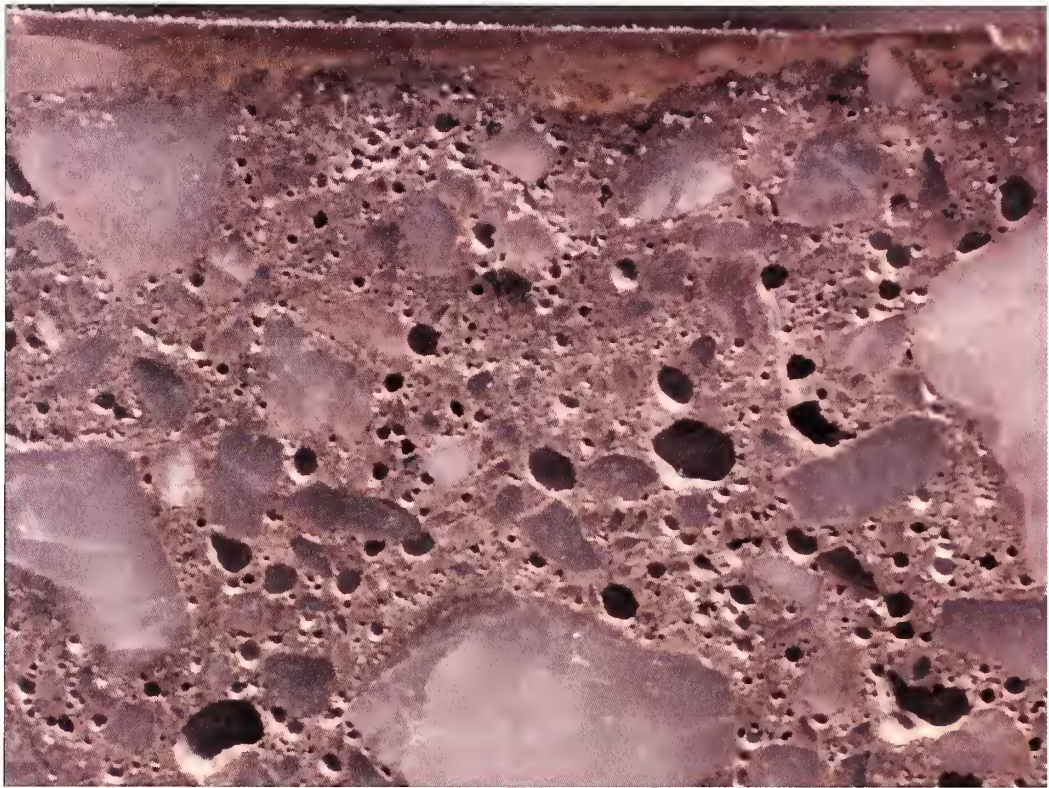
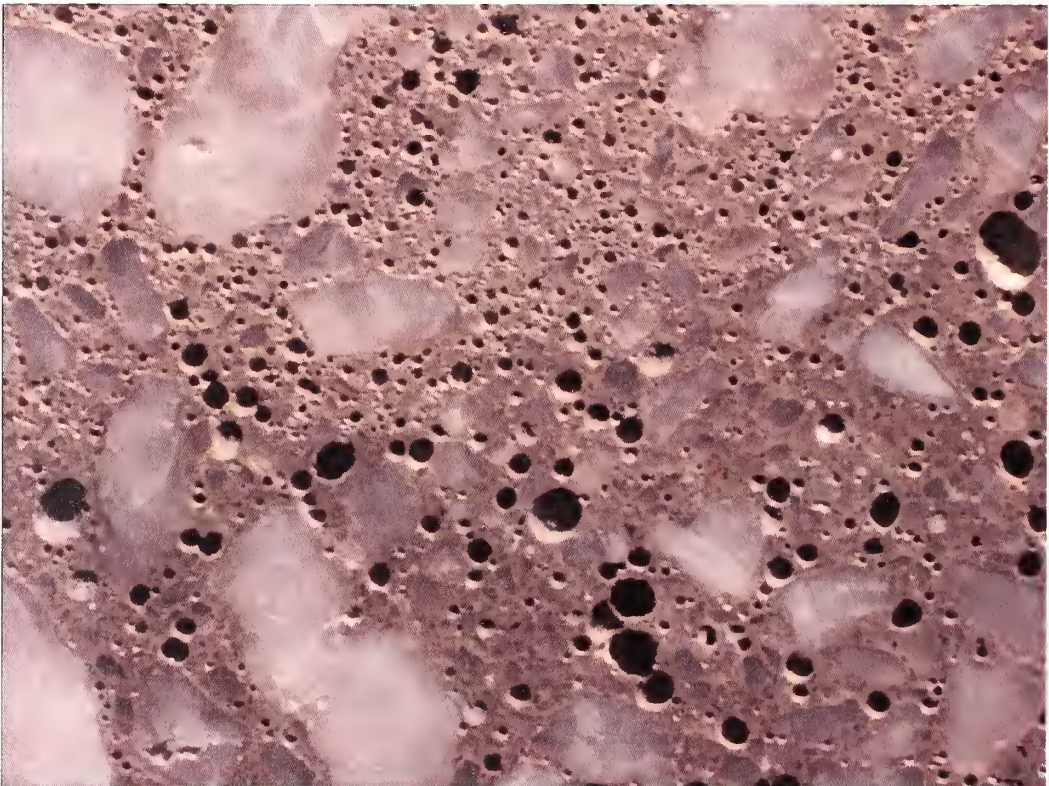
Figure 24. Valley of Fire core #1 surface (upper, 8 mm field width) showing the epoxy layer and permeation of a few mm into the core, abundant but variable air, and (bottom, 14 mm field width) image of numerous fine-sized (upper left of image) and fewer large-sized air voids.

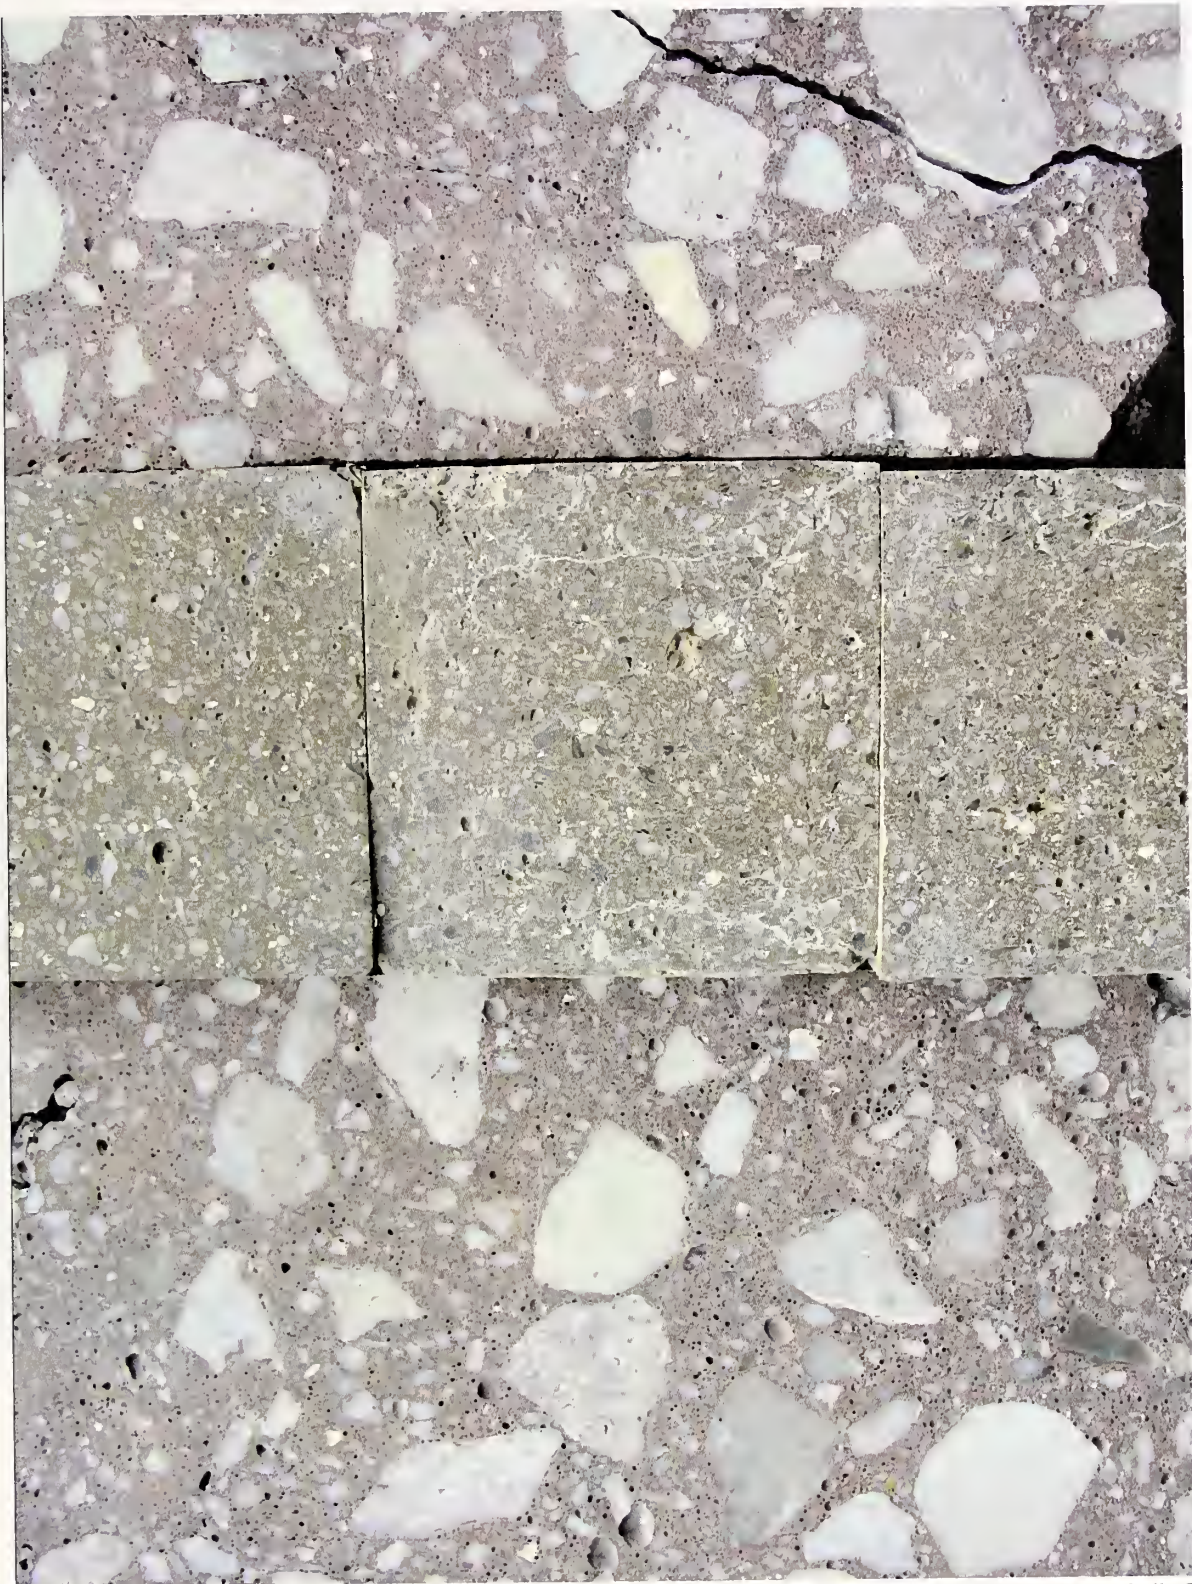
Figure 25. Comparison of the Valley of Fire cores #1 (upper) and #2 (lower) against 0.30 (left) 0.35 (center) and 0.40 (right) *w/cm* 50 mm cubes of lab mortar shows that the deck cores are redder in appearance, suggesting a lower *w/cm* ratio or possibly an increased dosage of pigment.

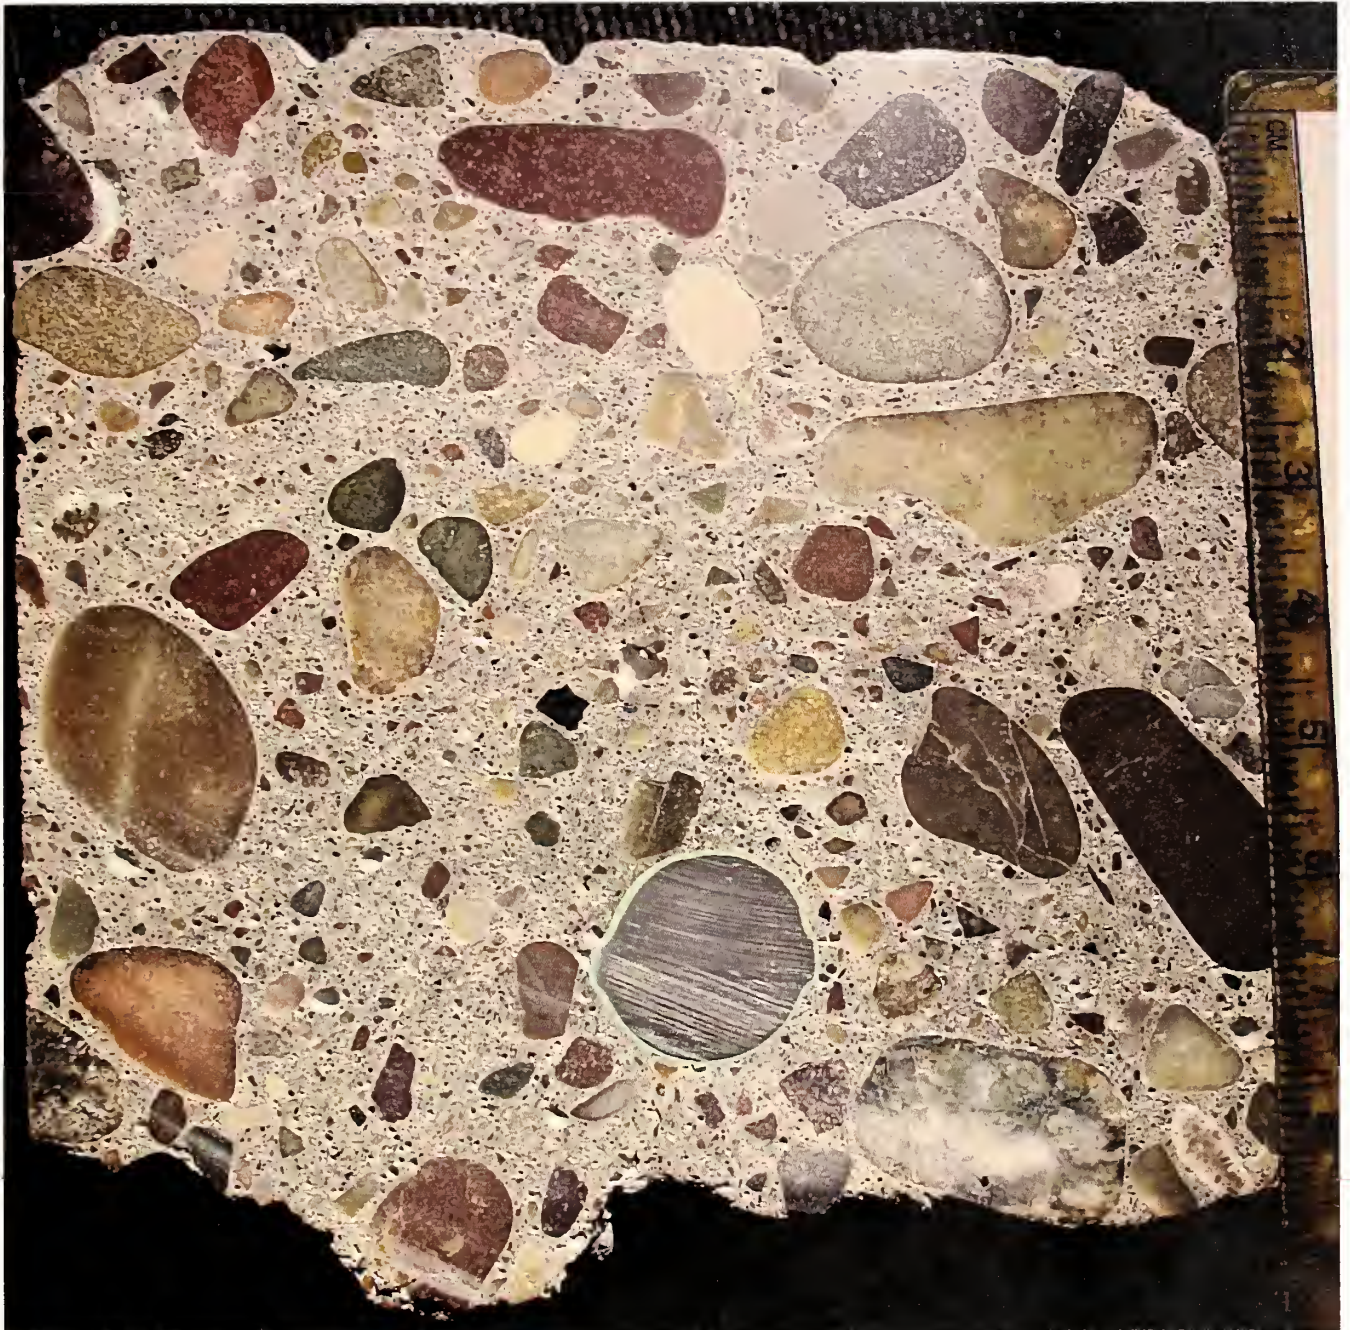
Figure 26. Snake River large-diameter core cross section has a crack extending from one of the surface grooves to the top of the epoxy-coated rebar. Some entrapped air voids are visible.

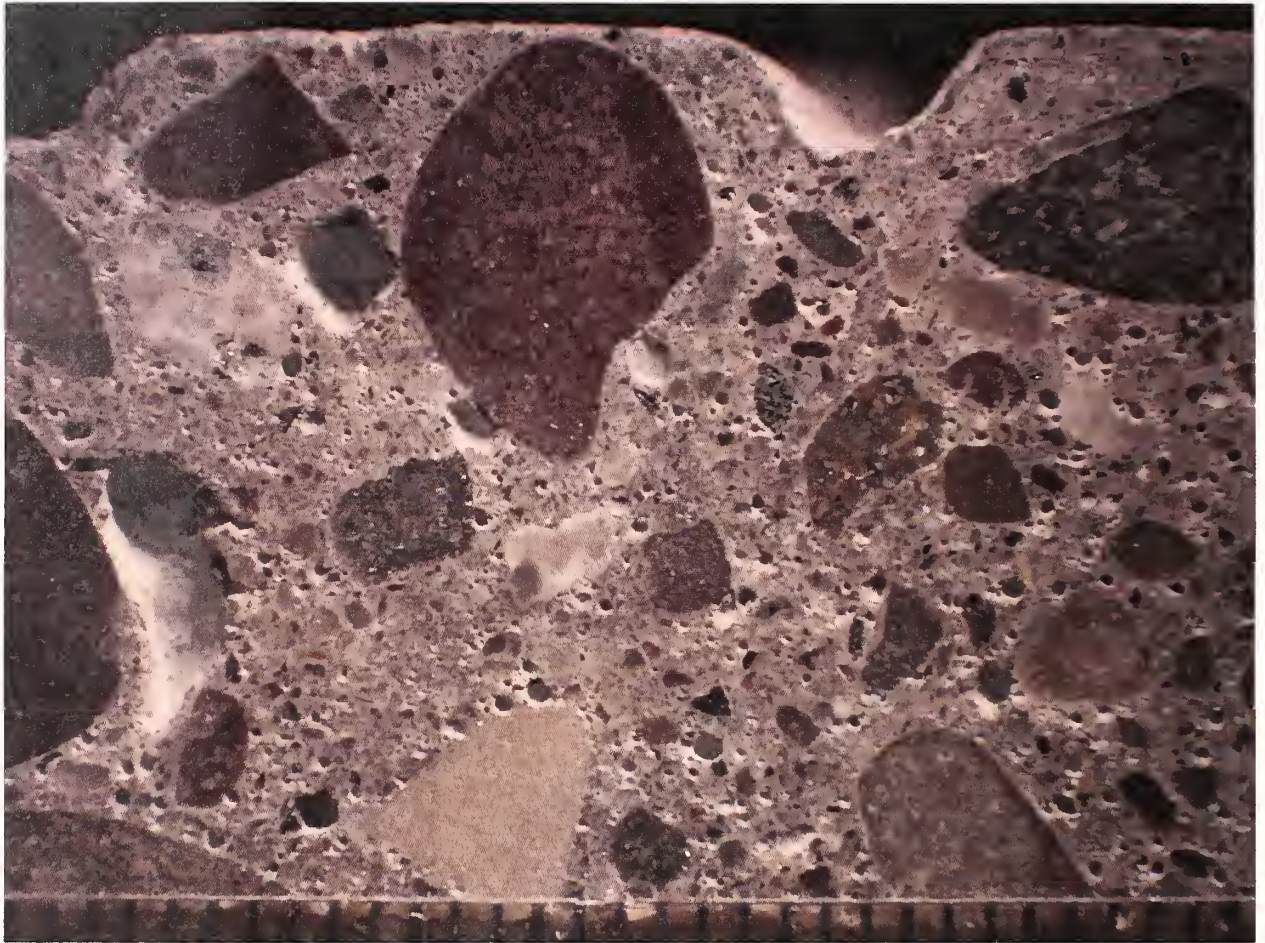
Figure 27. Snake River large core surface showing cut grooves, uniform aggregate distribution, entrained and some large entrapped air voids. Field width = 31 mm.

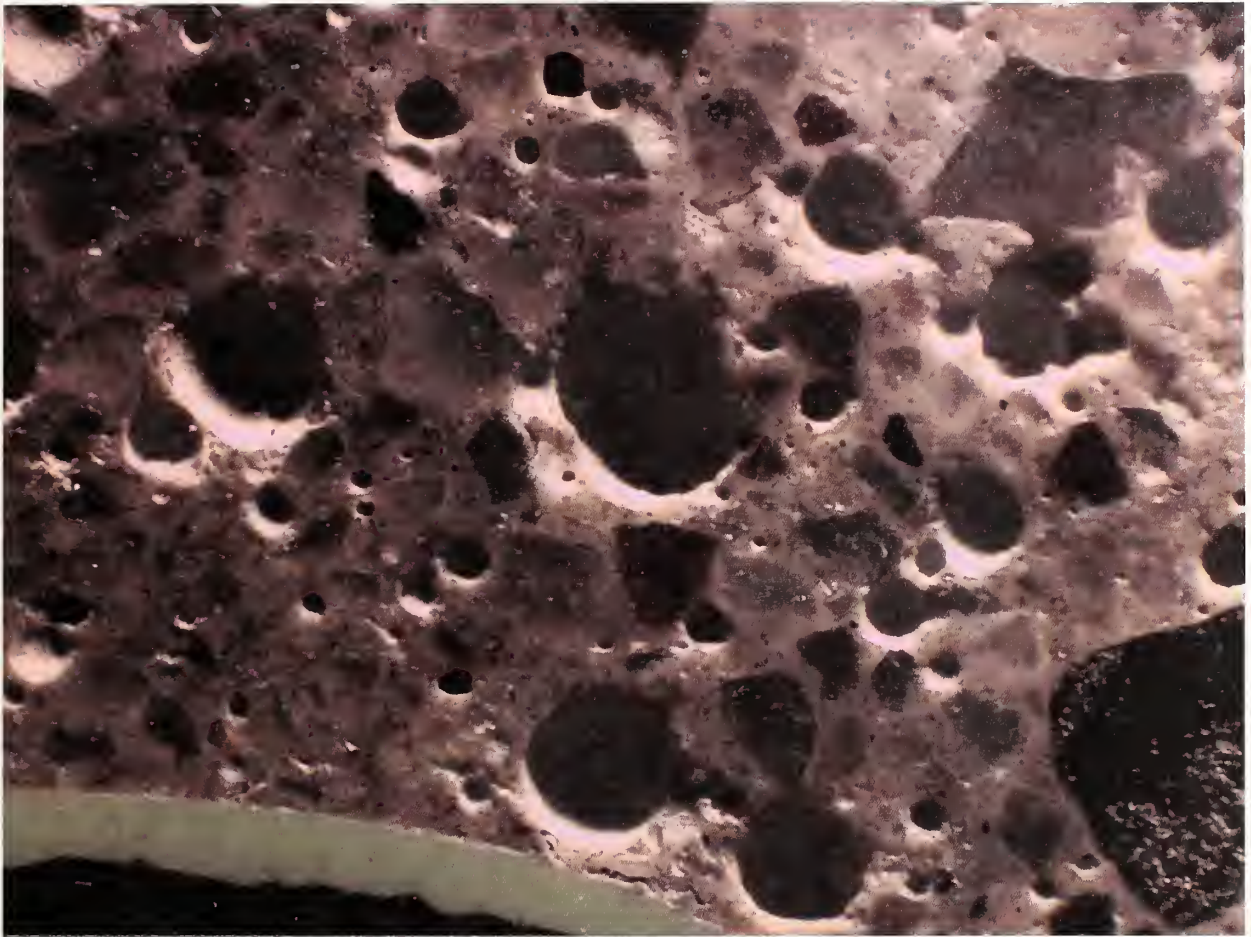
Figure 28. Snake River large core about -75 mm depth showing the paste bond to the epoxy-coated rebar and the entrained air void system.

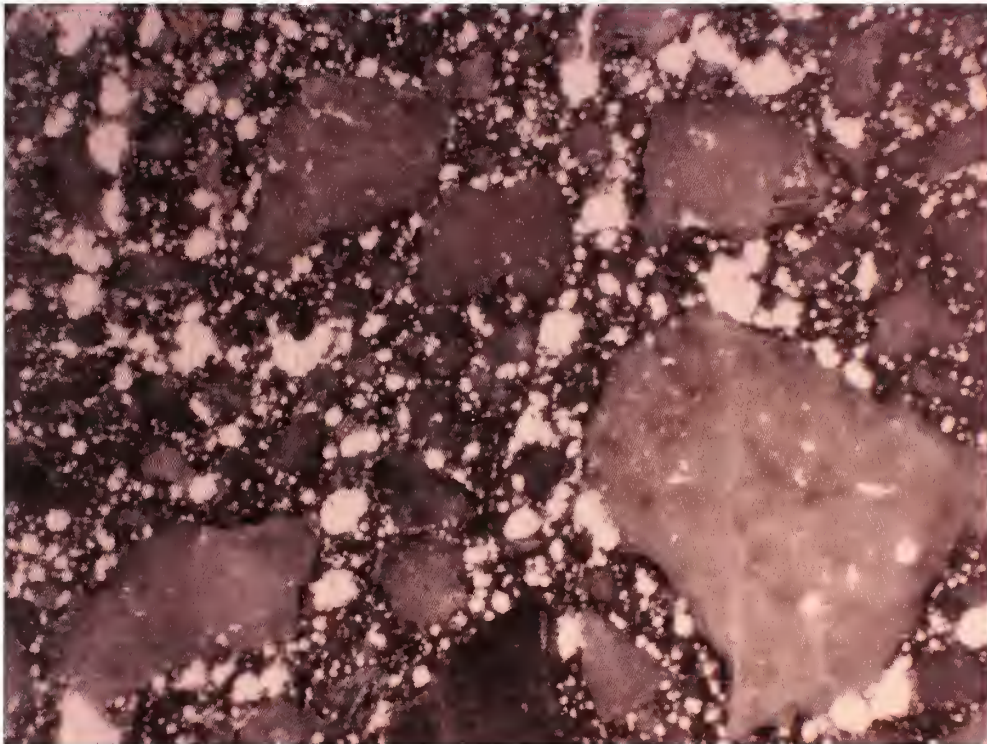
Figure 29. Calcium hydroxide powder filling air voids provides contrast necessary for quantitative video imaging. Field width: 25 mm.

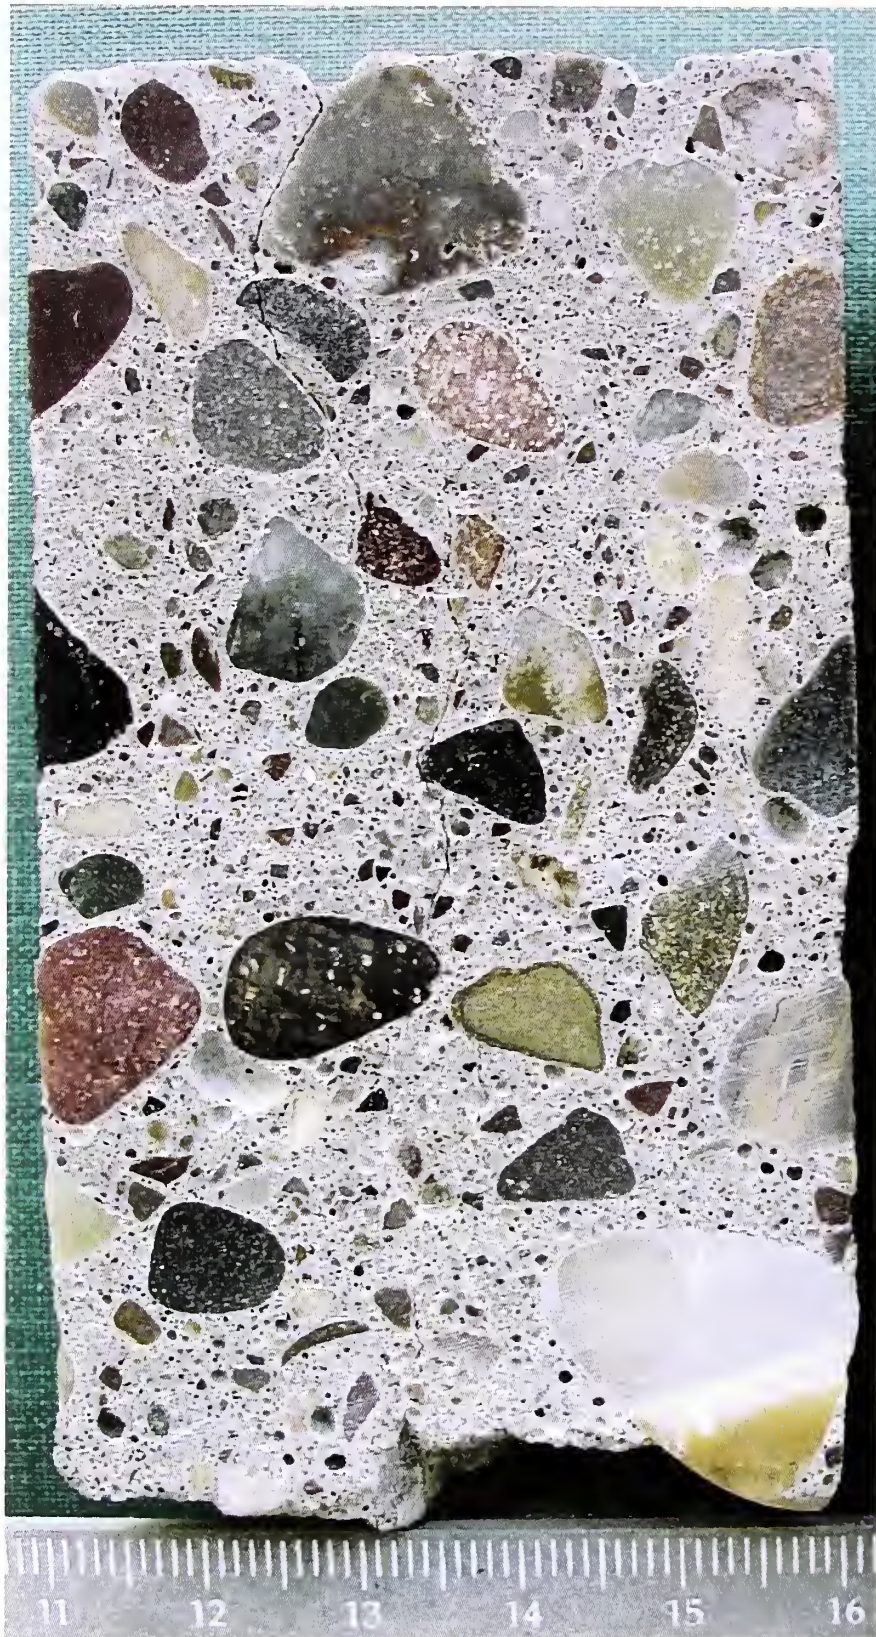
Figure 30. Snake River bridge core #3 showing a full-core depth crack, and high air content.

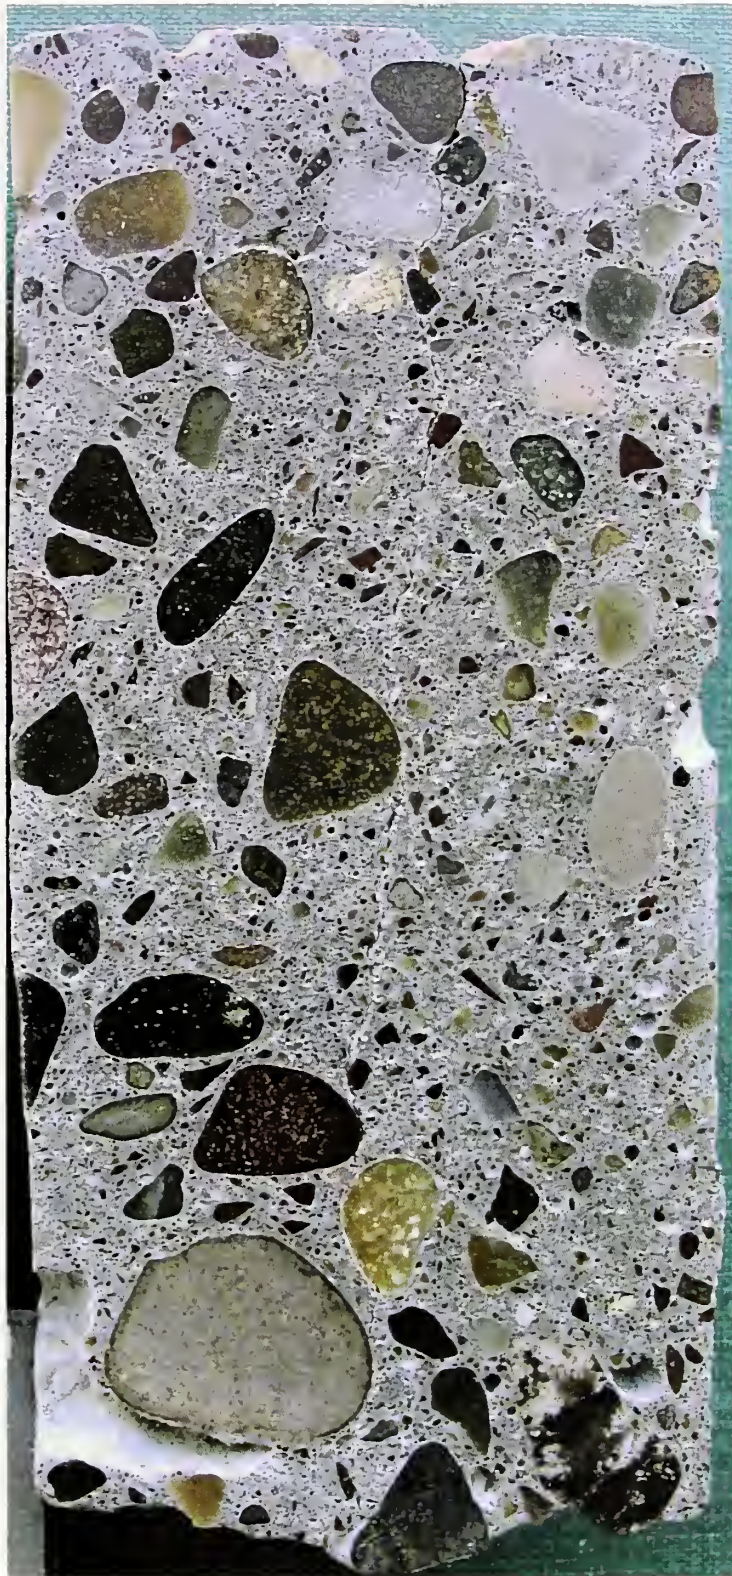
Figure 31. Snake River bridge core #4 (50 mm width) contains a full-core depth crack and some large entrapped air voids, mortar-rich regions and abundant entrained air.

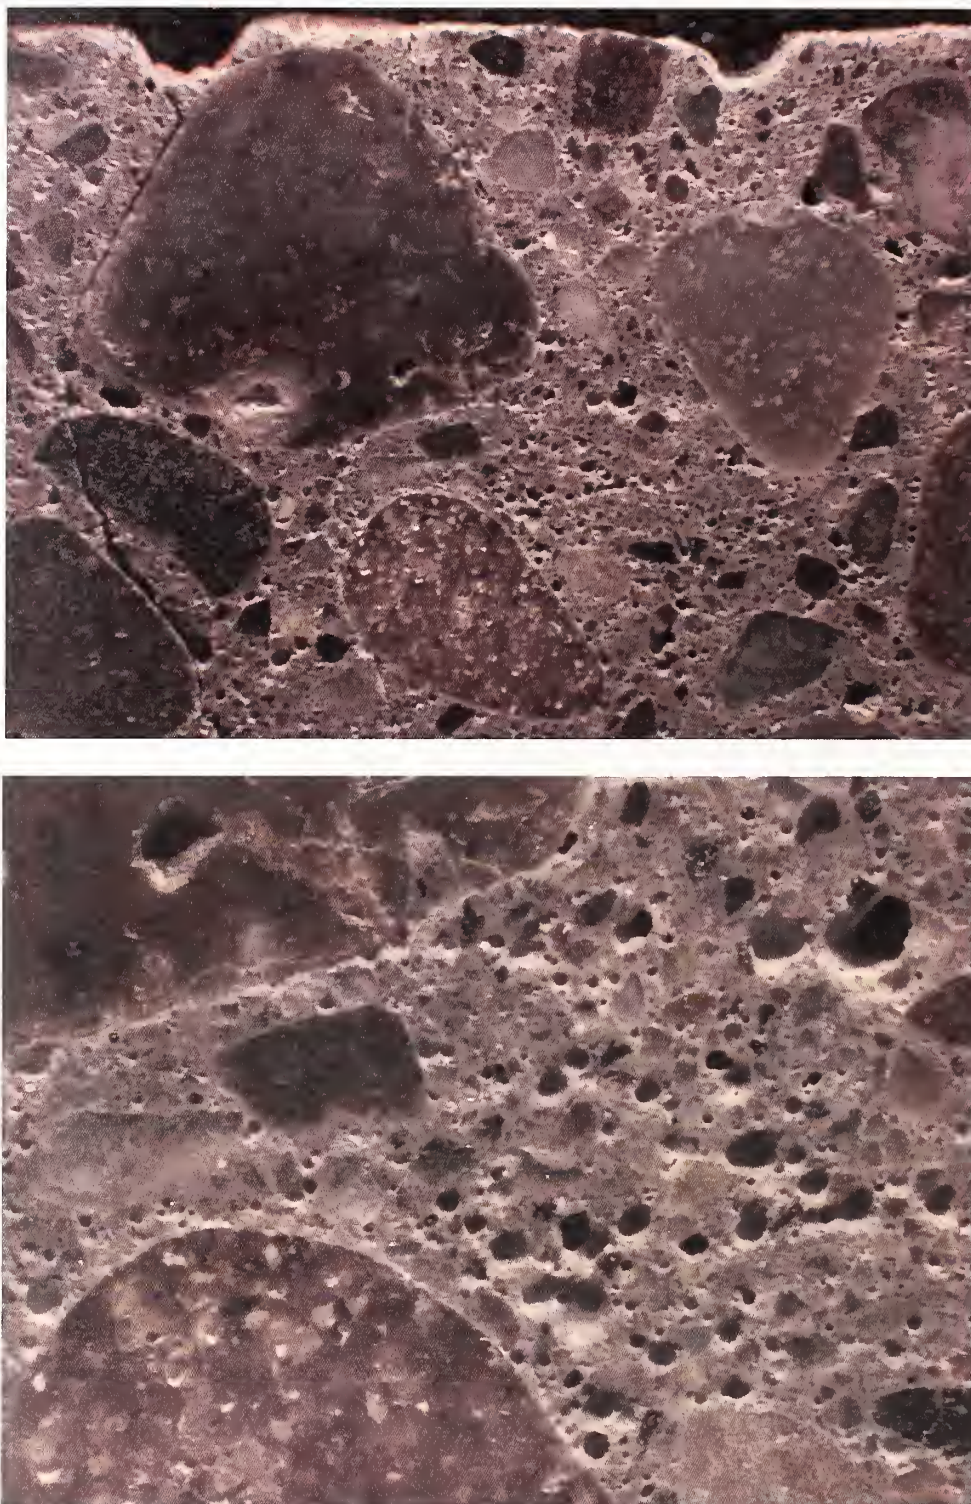
Figure 32. Snake River bridge core #3 showing the surface (32 mm field width) and crack traveling into the core (upper image) and a closer view (10 mm field width) of the hardened cement paste showing some air void clustering and high air content.

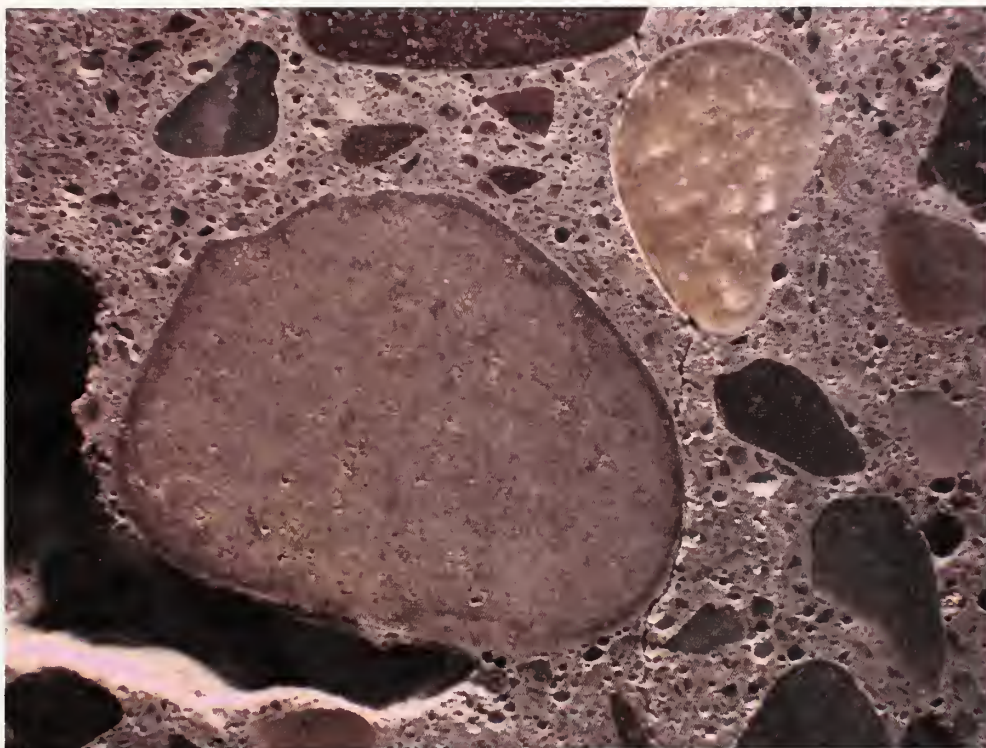
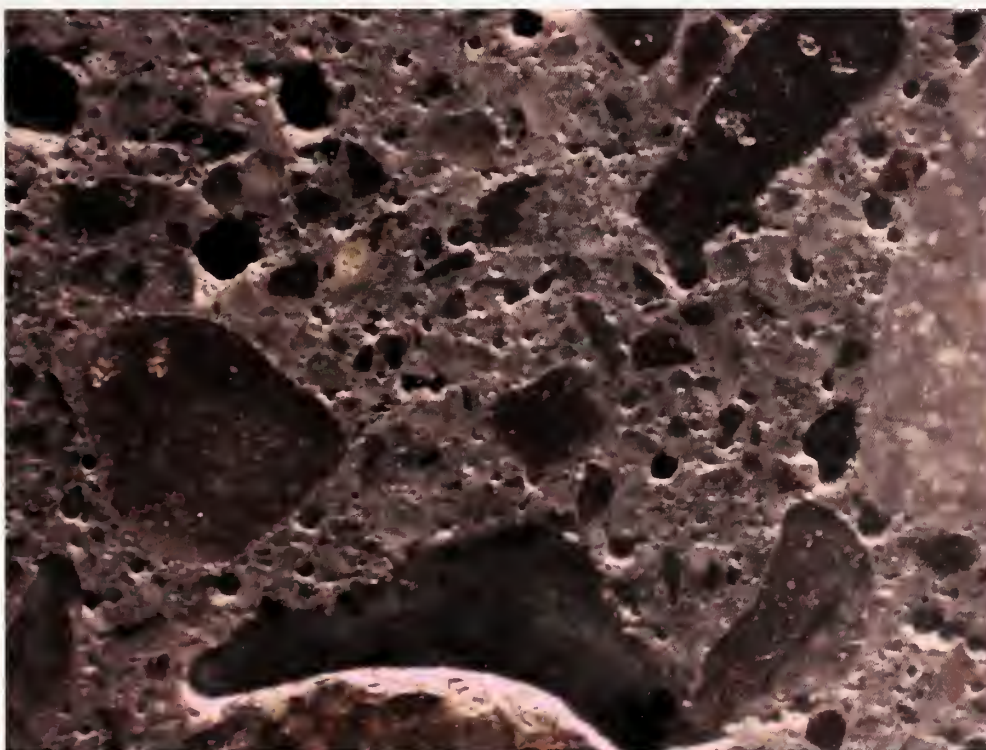
Figure 33. Snake River core #4 at (upper) 32 mm field width and (lower) 10 mm field width showing large entrapped air voids and high air content.

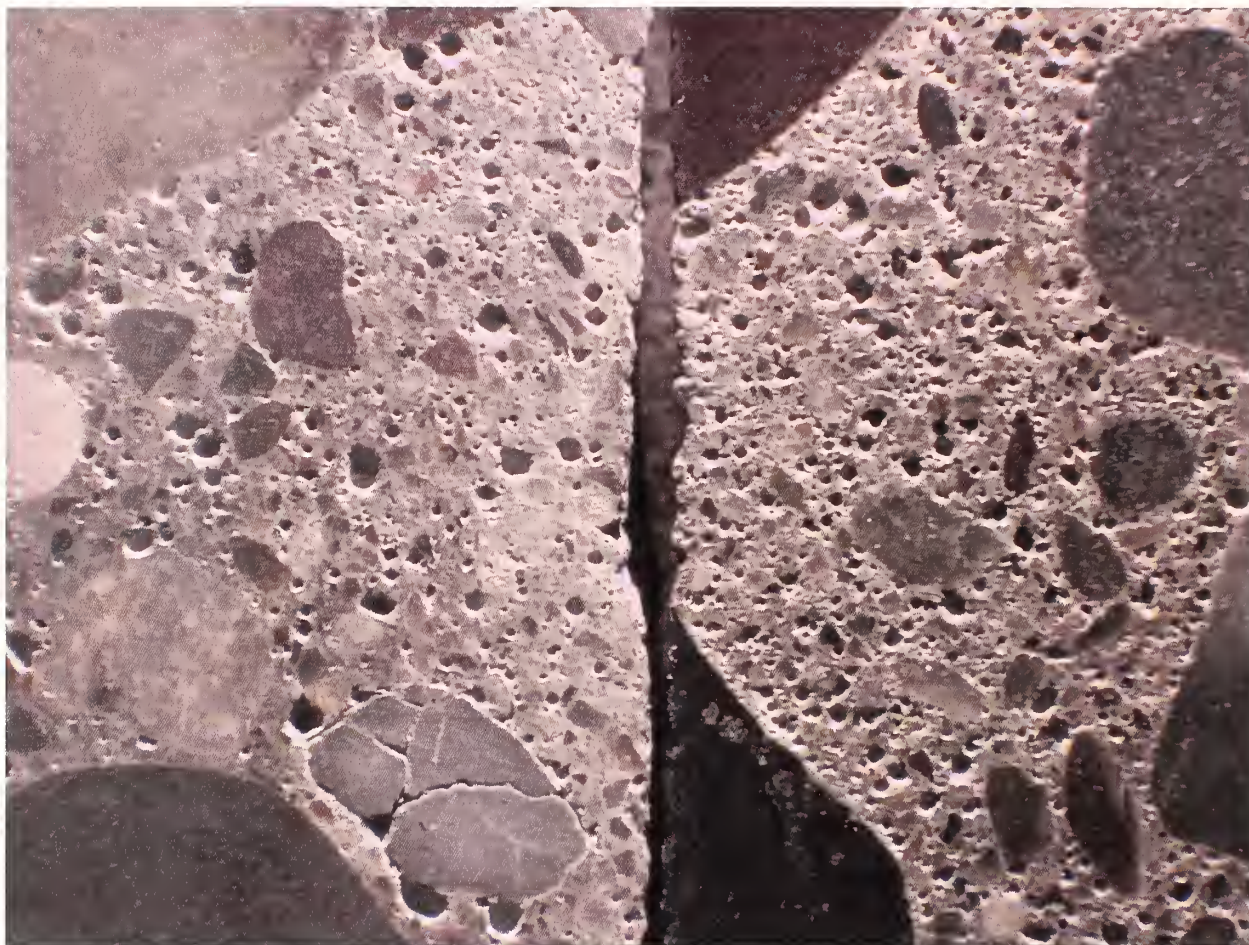
Figure 34. Comparison of the large (8.6 % air) on the left and core #3 (13.1 % air) on the right clearly shows the difference in air void volume and possibly a larger overall air void size for the large core (field width 32 mm).

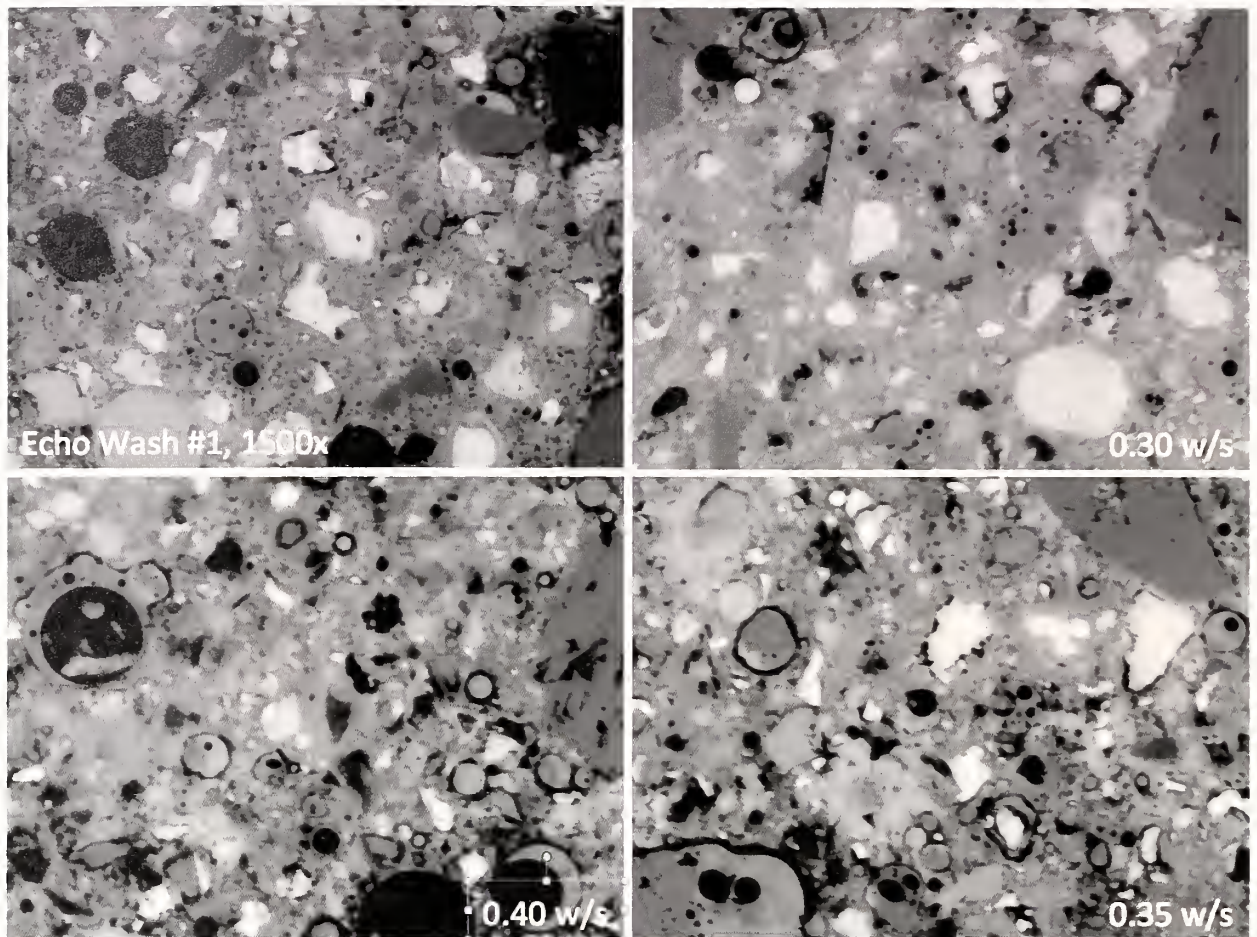
Figure 35. Echo Wash cement paste microstructure and comparison to mortars prepared at w/cm (or water-to-solids ratio, w/s) of 0.30, 0.35, and 0.40.

Visual estimation of w/cm based upon the cement paste microstructure may also provide insights on the w/cm ratio. A difficulty with this approach is the inherently heterogeneous nature of the microstructure, so a number of regions were selected. Like the Danish procedure using fluorescent epoxy to estimate w/cm ratio, the SEM image porosity appears in contrast to the surrounding cement paste. In this case, we have three lab-produced mortars based upon the mix design of the deck concretes but prepared at w/cm of 0.30, 0.35, and 0.40 and cured for about 45 d. An example of this approach for the Echo Wash core and the three laboratory mortars is provided in Figure 35. Based on these images, it is difficult to assess the likely w/cm of the in-place concrete and thus, the point counting procedure presented above is the preferred method for estimating this value.
