NISTIR 89-4064

THE MECHANISM, MEASUREMENT, AND INFLUENCE OF PROPERTIES ON THE GALLING OF METALS

December 1989

Final Report

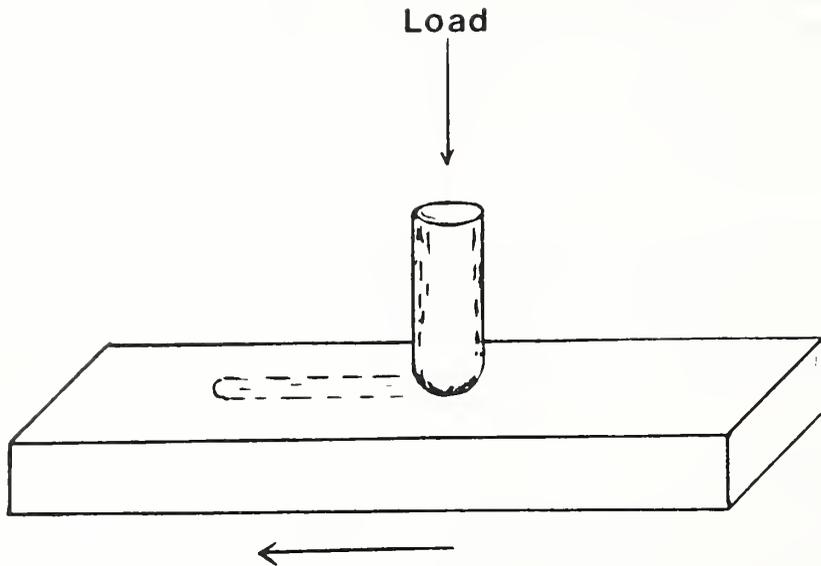
The pin-on-flat specimen configuration employed for the majority of the galling tests carried out in this investigation is shown in Fig. 1. The pin with a spherically shaped tip is loaded against the flat.

Fig. 1. Pin-on-flat test configuration.

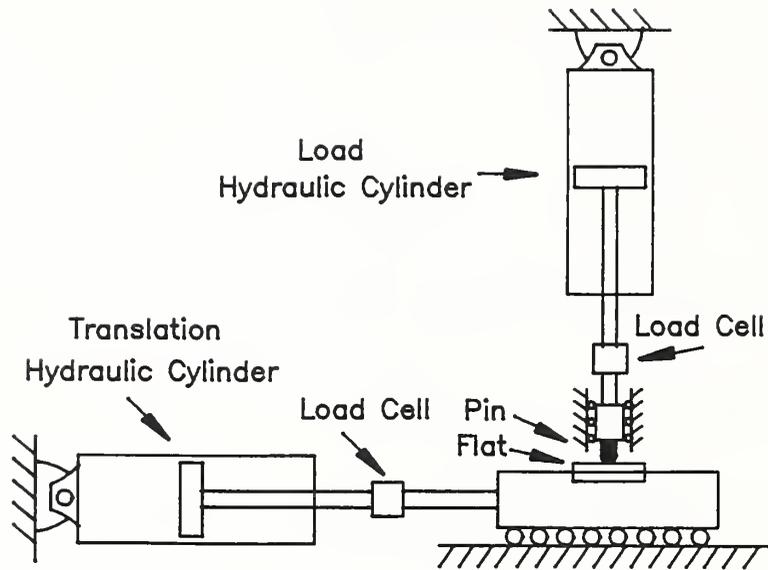
Fig. 2. Schematic drawing of hydraulically operated galling test machine.

Both machines were equipped for measurement of displacement and friction force. Values of these quantities were recorded simultaneously during each test. It was therefore possible to plot friction force, or the derived friction coefficient values, as a function of sliding

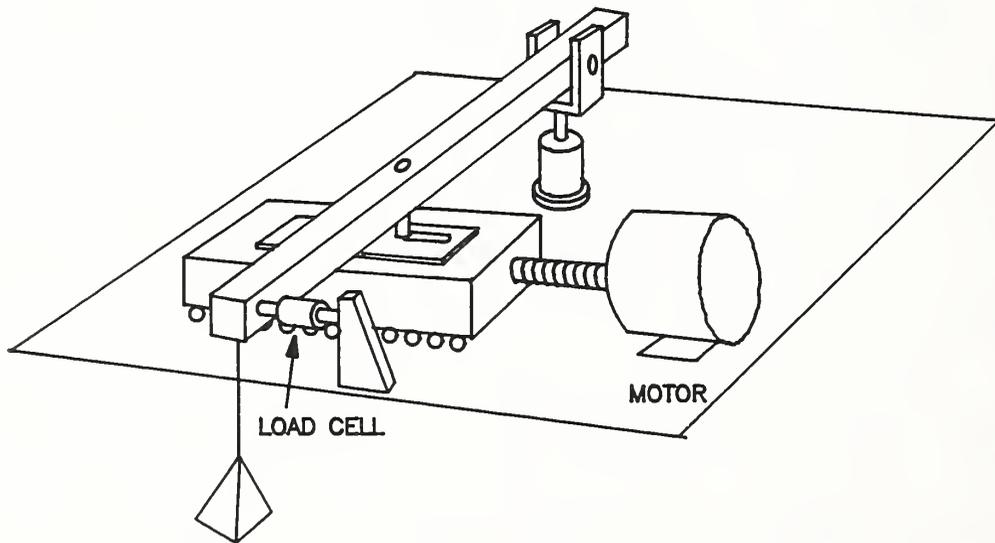
Fig. 3. Schematic drawing of screw-driven test machine with dead-weight loading.

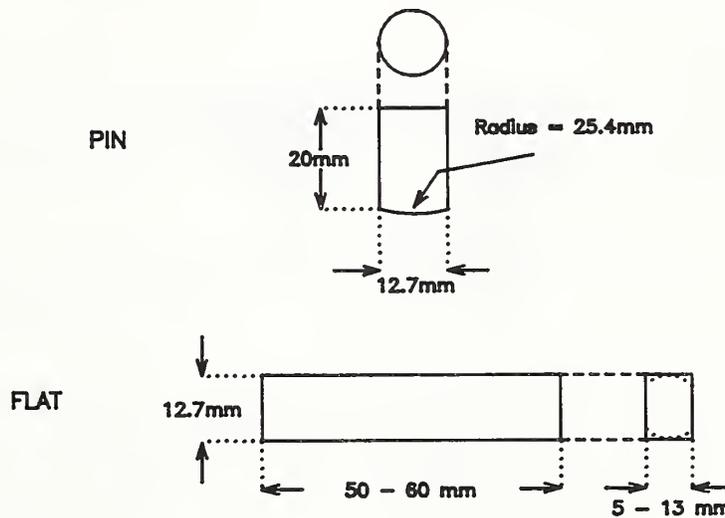
Typical specimen dimensions are indicated in Fig. 4. A wide tolerance on the length and thickness of the flat was allowed; the actual dimensions within the prescribed size limits were determined by available stock material. When possible, stock material was acquired in the form of 12.7 mm (0.5 inch) diameter rod. Most commercial alloys are readily available in this form and machining of both flats and pins is easily accomplished.

Fig. 4. Test specimens dimensions.

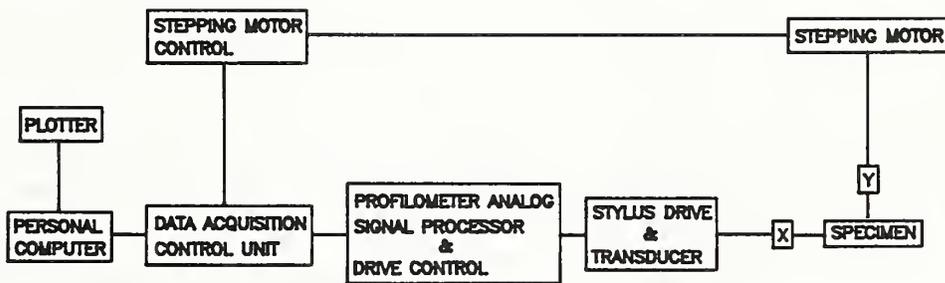
Fig. 5. Diagram of automated profilometer system.

As has already been pointed out, a major effort was mounted in this program to develop a suitable method for the quantitative characterization of galling damage. As was indicated, the approach involved the measurement of surface topography by means of stylus profilometry and the calculation of appropriate parameters to indicate the amount and nature of the damage. Measurement of the surface topography was done by means of an automated, computer-controlled profilometer system. A schematic diagram of the system is shown in Fig. 5. Details of the stylus and specimen translation arrangement are shown in Fig. 6.

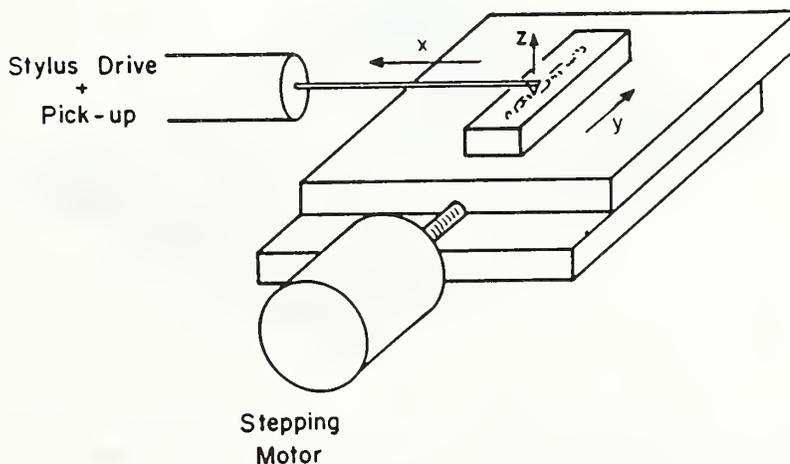
Fig. 6. Schematic drawing of profilometer stylus drive and specimen translation stage.

With reference to Fig. 6, the x-coordinate is assigned to the tracing direction of the stylus, y to the direction of specimen translation (parallel to the track on the flat), and z to the vertical direction indicating the height of topographic features. In conducting a measurement, the trace length, number of points per trace, and the spacing between traces are selected. Computer memory and software limitations restricted the total number of points that could be handled to about 27k. A typical track on a specimen-flat has a length of about 40 mm and width of <3 mm. Approximately 150 parallel traces at a spacing of 300 μm are taken perpendicular to the track. The traces are allowed to extend beyond the edges of the track on both sides. The extra length is employed to establish the location of the original surface which acts as a reference plane in various computations. The spacing between points within a trace is normally set to 20 μm . An example of a traced track with the surface presented in an oblique projection, is shown in Fig. 7. Because of the relatively large spacing between traces the resolution along the length of the track is low. A small section of the track could, of course, be traced at much higher resolution. An example of a high resolution tracing is shown in Fig. 8.

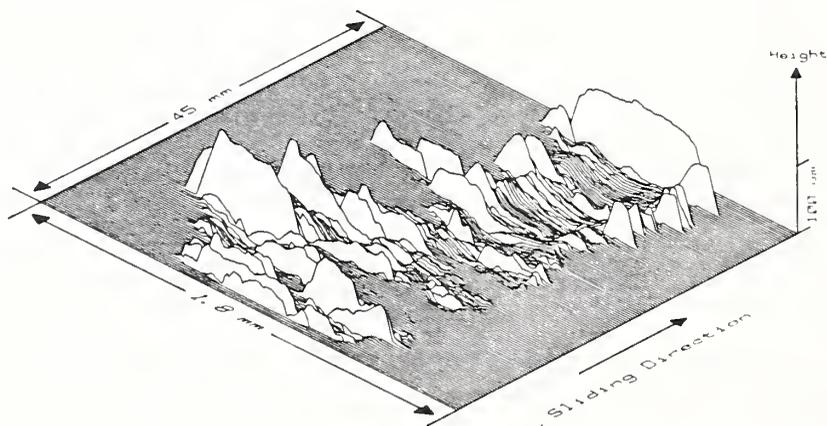
Fig. 7. Stylus profilometer traces showing topography of track on flat in oblique projection.

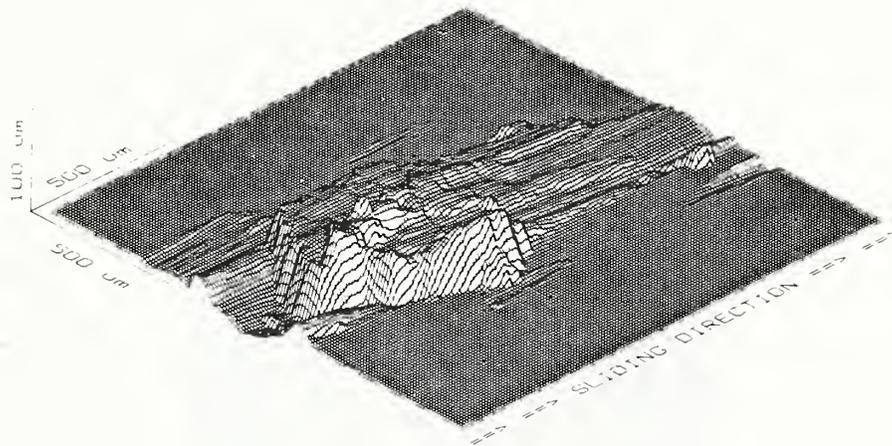
Fig. 8. High resolution tracing of damage on flat.

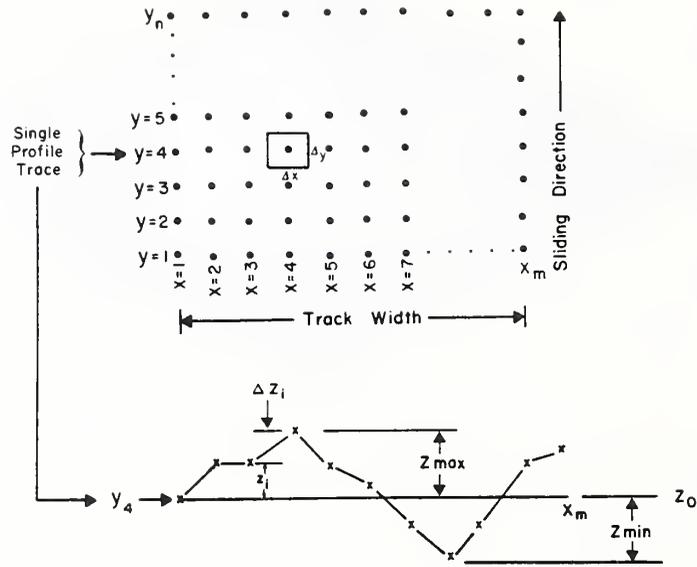
Topographic data were recorded in the form of a matrix of z -values as illustrated in Fig. 9. These values together with the constant incremental spacings Δx and Δy between points in the x - and y -directions were the raw data describing the surface topography. In practice the surface plane of the flat was never precisely parallel to the xy -tracing plane. Once the data was collected, however, it was a relatively simple procedure to transform the original data so that the undamaged surface of the flat was coincident with the plane, $z = 0$. Recalling that each trace across the wear track in the x -direction consists of points on either side of the track, a straight line was fitted to these bounding points. Subtracting this line from the original traced curve left z -values that indicated elevations above and below a $z = 0$ plane. Calculations of the various damage parameters were based on these data. Errors will of course result if the original surface is not perfectly flat and smooth, as was always the case. For such surfaces z -values would represent original topography as well as changes due to sliding damage. For severely damaged, i.e., galled surfaces, the errors were not significant. However, when the damage was small, the errors could be relatively large, with some parameters being more sensitive than

Fig. 9. Arrangement of profile data matrix used in the calculation of damage parameters.

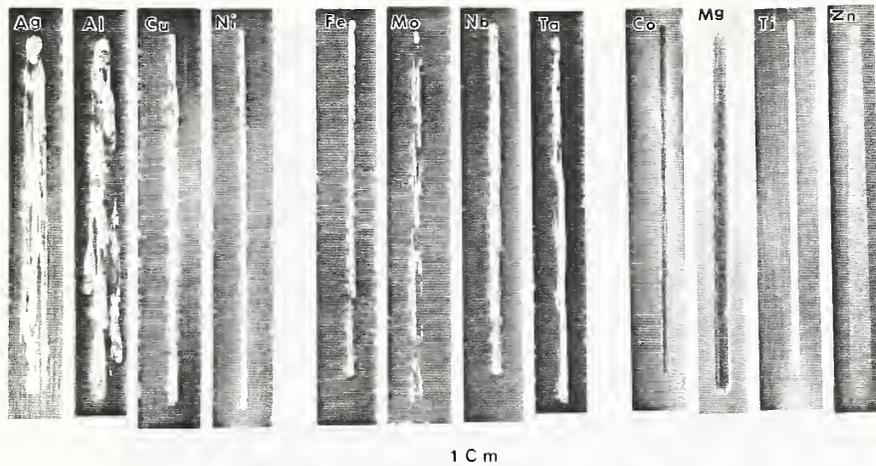
Fig. 11. Flats of 12 different pure metals after self-mated tests at 130 N.

Although the pattern of damage differs in detail among the various fcc and bcc metals, all exhibit features that are characteristic of galling and are consistent with the wedge formation process described

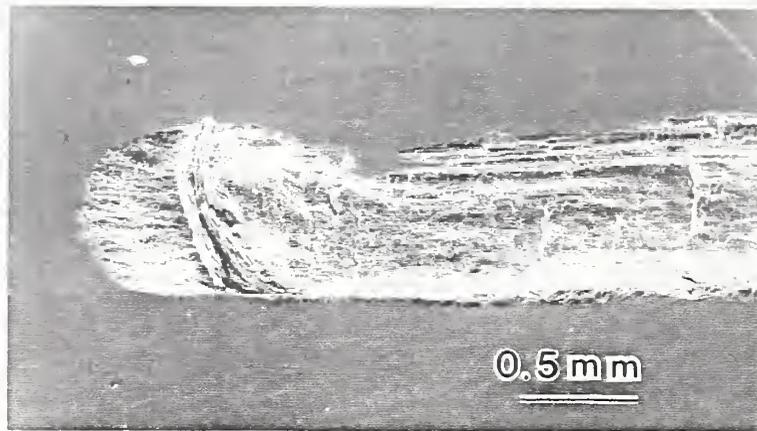
Figure 12 shows the initial part of the track on the Fe flat. The damage can be accounted for as follows: As sliding commenced, a volume of material within the flat lying beneath the pin was plastically deformed and displaced to form a prow. Sliding took place by a shear-fracture process, accumulating material into the prow. With continued sliding the prow grew in size, both forward of the pin and perpendicular to the surface. This increase in size, together with strain hardening, resulted in the eventual, partial failure of the prow, leaving the raised lip seen in Fig. 12. The remaining part of the prow was still attached to the pin. The prow growth and failure process was then repeated as the pin moved along the flat. Figure 13 shows three lips approximately one-half centimeter from the beginning of the track occurring as a result of three repetitions of prow growth and failure. In some cases nearly the entire prow was left in the track. This is

Fig. 12. SEM micrograph of initial section of galled track on Fe flat.
130 N load.

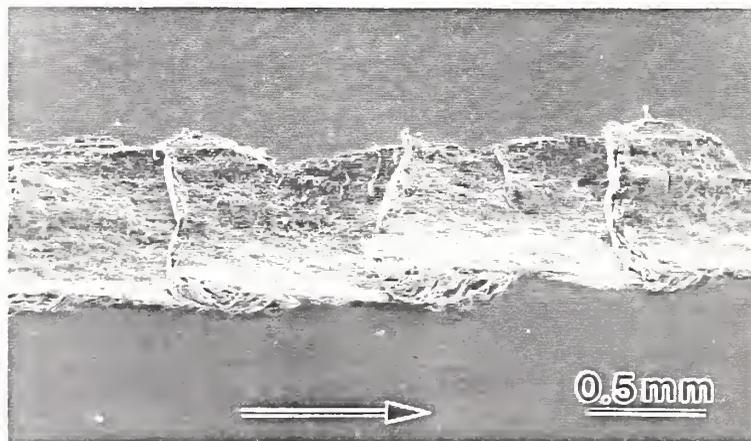
Fig. 13. Damage at approximately one-half centimeter from beginning of
track on Fe flat.

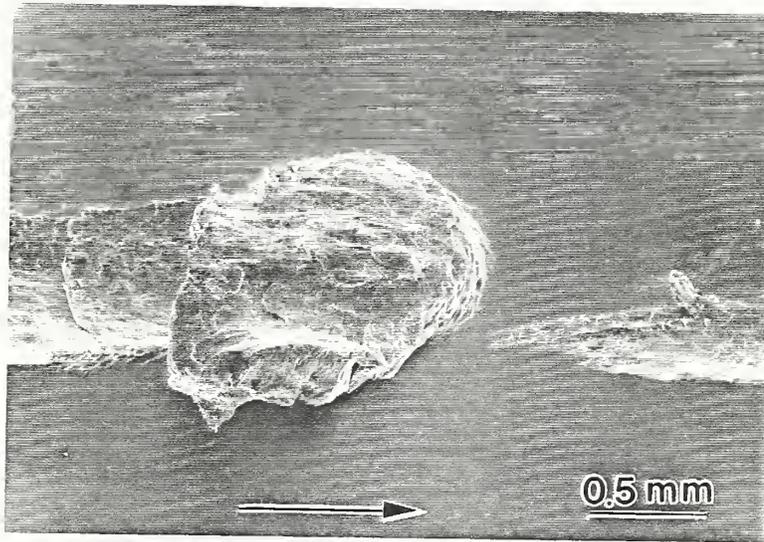
Fig. 14. Prow located 3 cm from start of track on Fe flat.

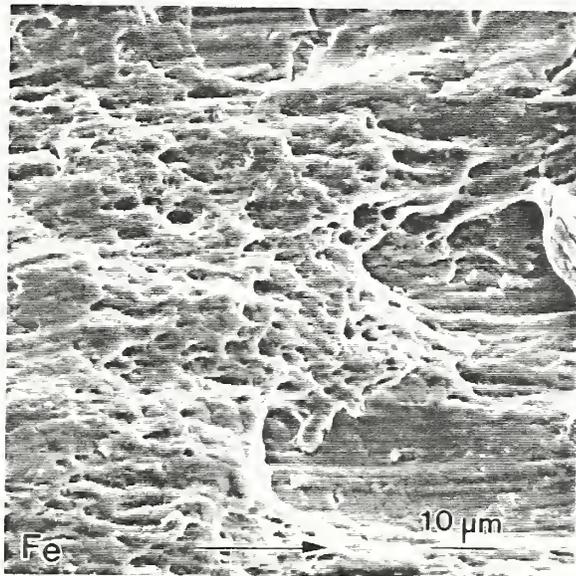
Fig. 16. Dimple structure in track on Fe flat.

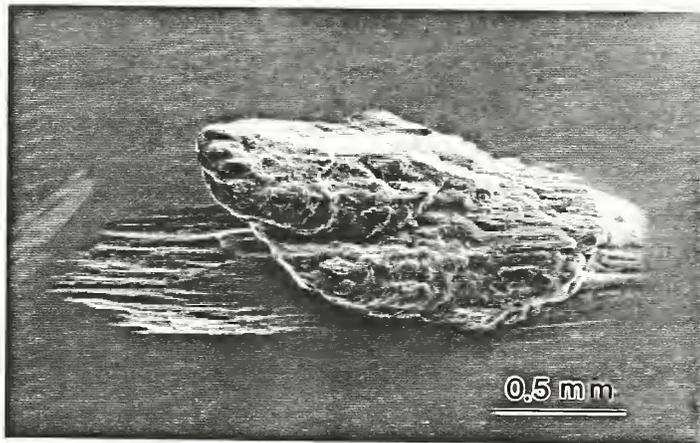
Fig. 17. Initial damage on Mo flat.

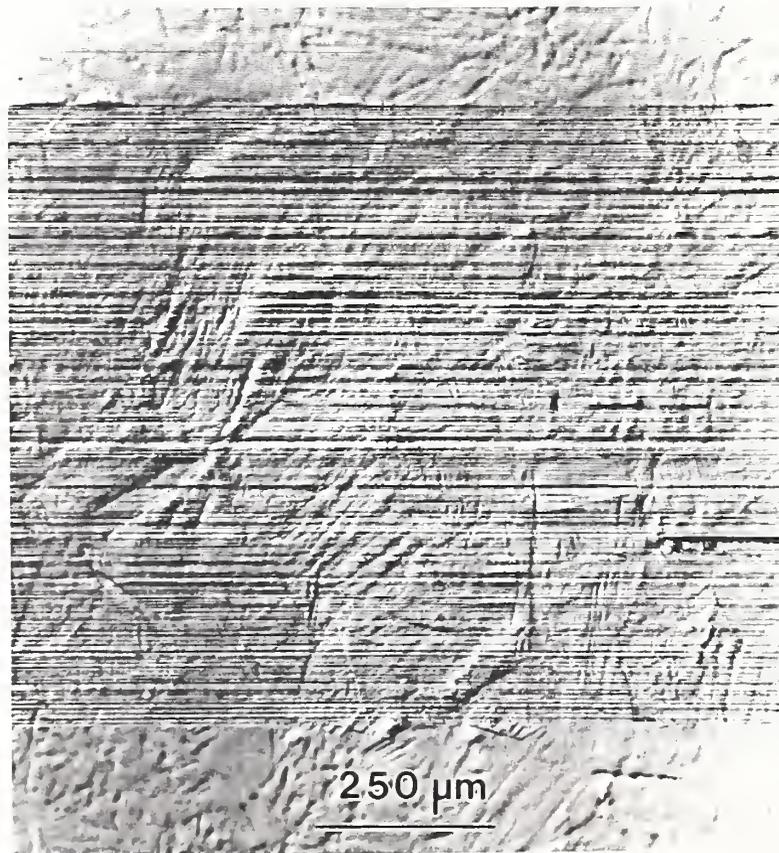
Fig. 18. Optical micrograph of part of track on Co flat. Nomarski interference contrast.

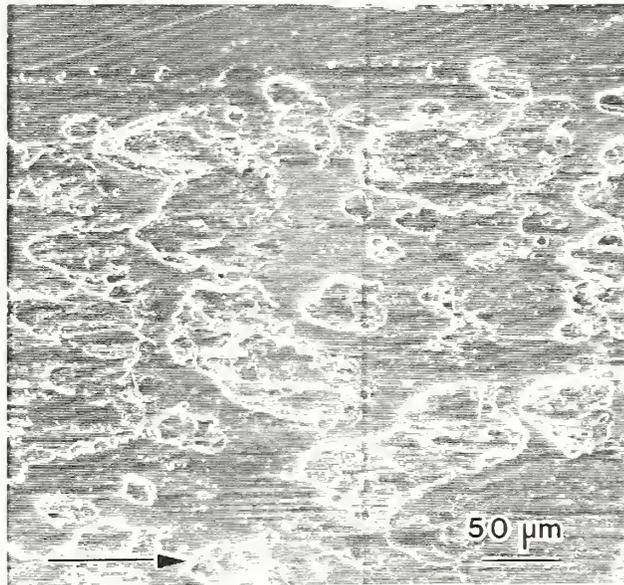
Fig. 19. SEM micrograph of section of track on Zn flat.

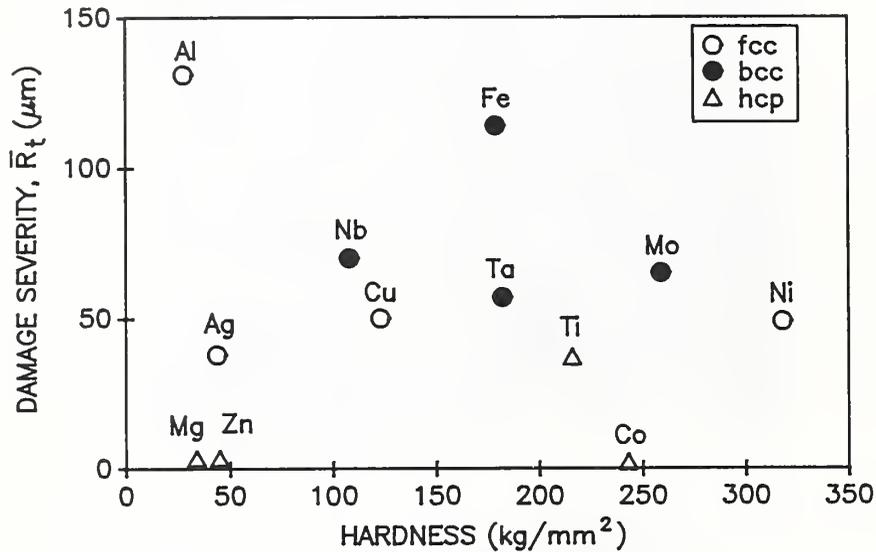
Fig. 20. Damage severity measured in terms of \bar{R}_t plotted as a function of hardness for pure metal specimens.

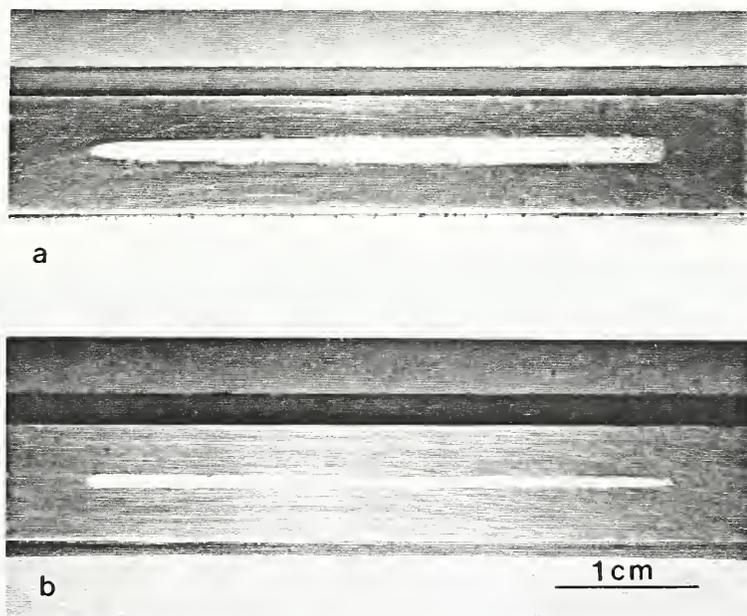
Fig. 21. Optical photographs of (a) Ni flat against which Cu pin was slid and (b) Cu flat against which a Ni pin was slid. Sliding was initiated at the left.

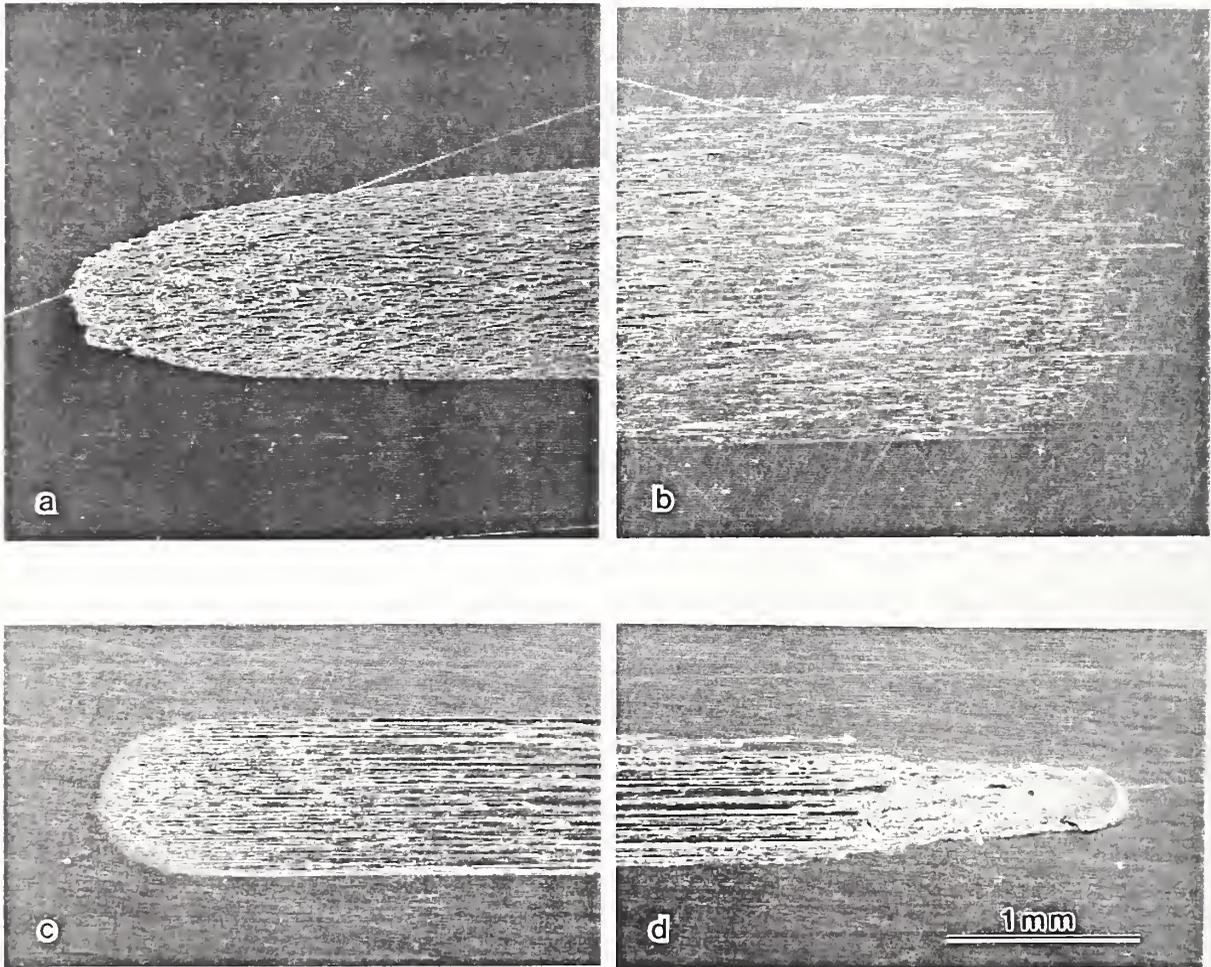
When a Ni pin was slid against a Cu flat, initially, damage to the Cu flat, Fig. 22c, appears to consist of a series of relatively small, parallel grooves. Examination at higher magnifications indicated that the grooves were produced by the motion of small prows. Several of the prows are shown in Fig. 25. At the end of the track on the Cu flat, Fig. 22d, a single rather large prow is present. No such prow was formed at the end of the track on the Ni flat, Fig. 22b. With the Ni pin vs. Cu flat arrangement, Cu is transferred to the pin. Thus, the damage to the Ni pin seen in Fig. 23b is actually a layer of transferred Cu. In this case, shortly after sliding is initiated, contact is mainly Cu against Cu. During the course of sliding, Cu is both accumulated

Fig. 22. SEM micrographs showing (a) start and (b) end sections of track on Ni flat against which Cu pin was slid and (c) start and (d) end of track on Cu flat against which Ni pin was slid.

SEM micrographs of the beginning and end sections of the tracks on the Ni and Cu flats are shown in Fig. 22. Figure 23 shows micrographs of the mating pin tips. For the Ni flat, Figs. 22a and b, the visible damage is due entirely to transfer from the Cu pin. In the optical microscope the copper color of the transferred metal is quite apparent. Transfer from the pin, of course, explains why the width of the track on the Ni flat increases with increasing sliding distance. As the spherical tip on the pin is worn away, the contact diameter becomes

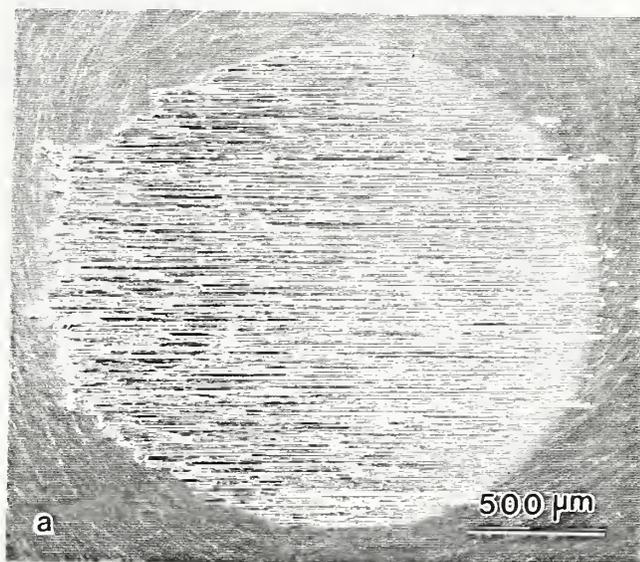
Fig. 23. SEM micrograph of scar on (a) Cu pin after sliding against Ni flat and (b) Ni pin after sliding against Cu flat. Leading edge is at right.

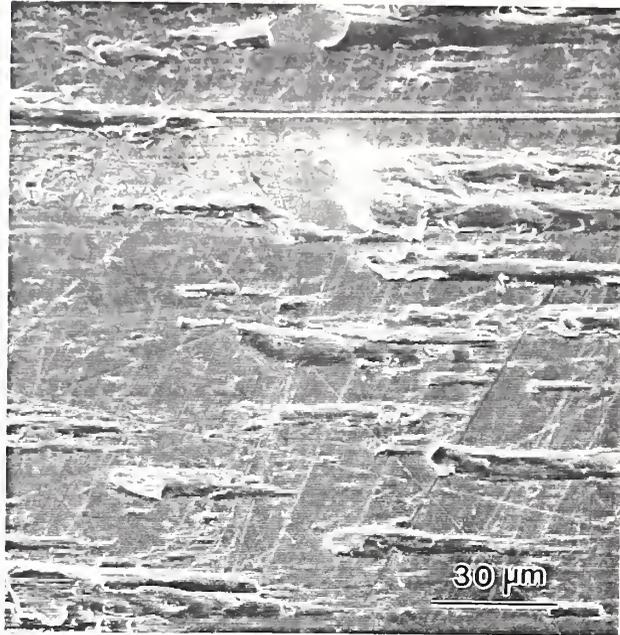
Fig. 24. SEM micrograph of damage on Ni flat. Direction of motion of Cu pin was from left to right.

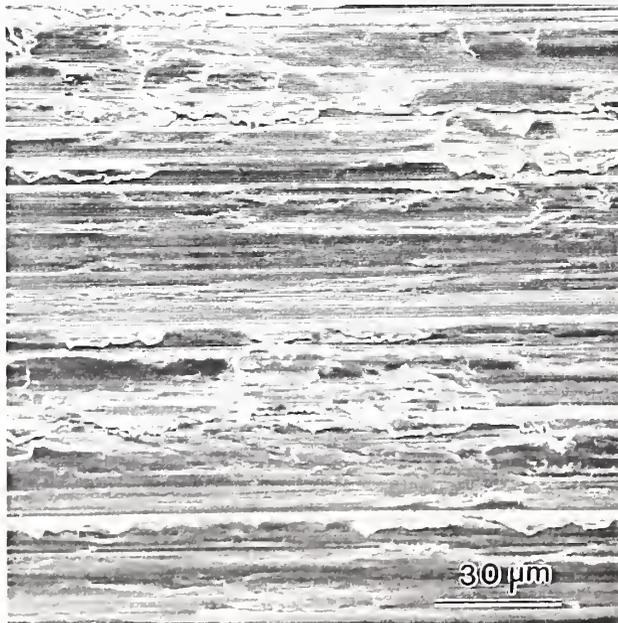
Fig. 25. SEM micrograph of damage on Cu flat. Direction of motion of Ni pin was from left to right.

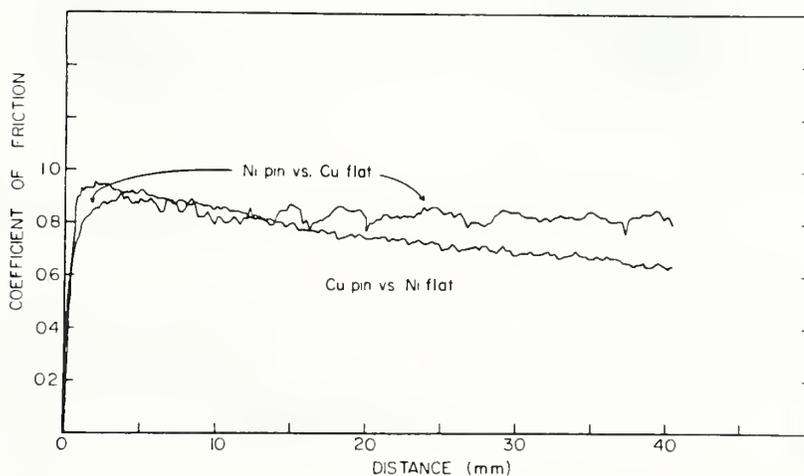
Fig. 26. Coefficient of friction plotted as a function of sliding distance for Ni vs. Cu pin and flat combinations.

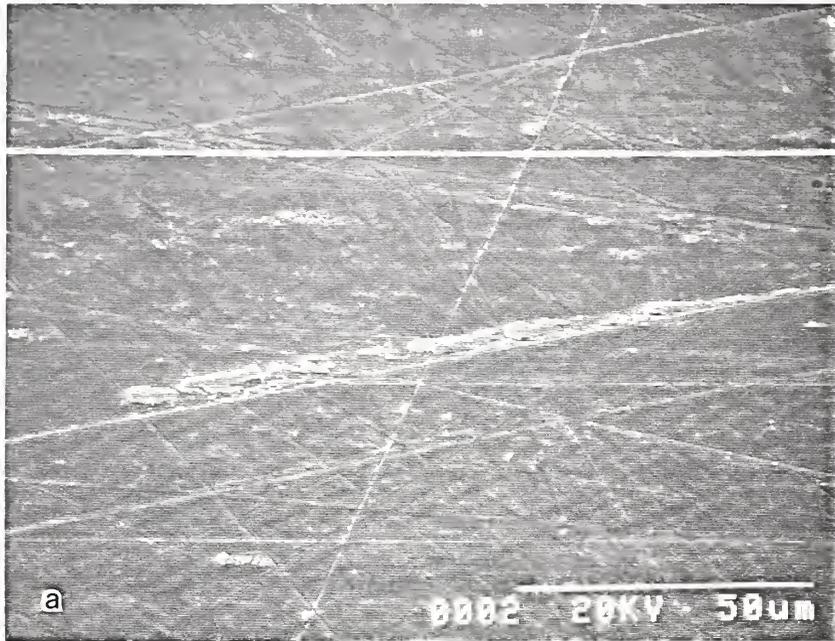
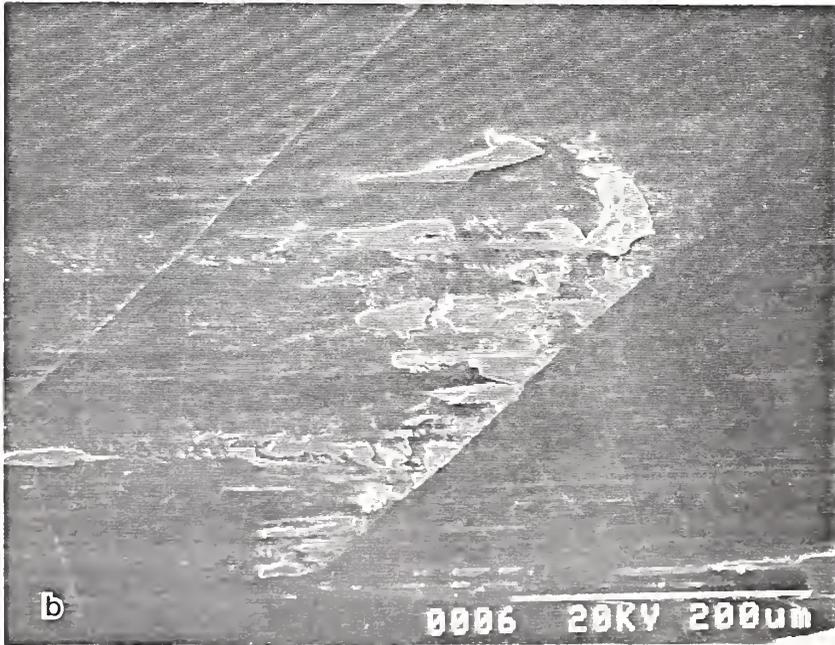
Figure 29a shows some small patches of transferred silver near the beginning of the track on the Ni flat. Polishing scratches in the Ni surface appear to have a significant influence on the incidence of transfer, an effect that was also noticed in the case of Cu on Ni. A much larger patch of transferred Ag near the end of the track is shown in Fig. 29b. The influence of scratches in the Ni surface is also quite evident here.

Fig. 29. Patches of transferred Ag on Ni flat (a) near beginning of track and (b) near end of track.

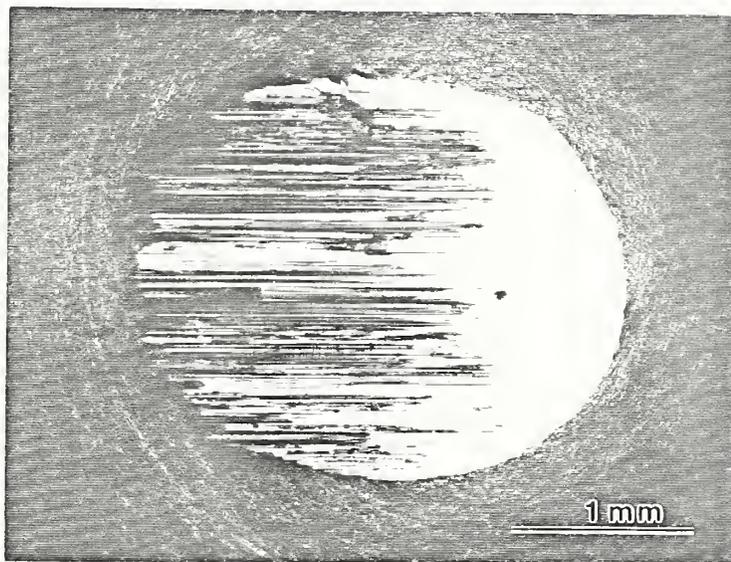
Fig. 30. Optical micrograph of scar on Ag pin after sliding against Ni flat. Leading edge of scar is at right.

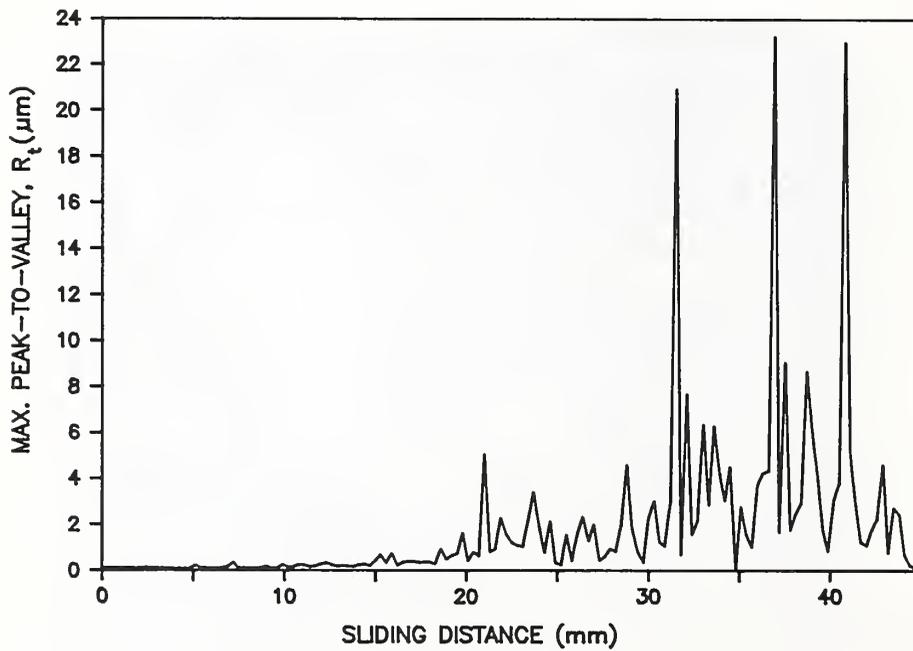
Fig. 32. Maximum peak to valley height, R_t , plotted as a function of sliding distance for track on Ni flat after sliding against a Ag pin.

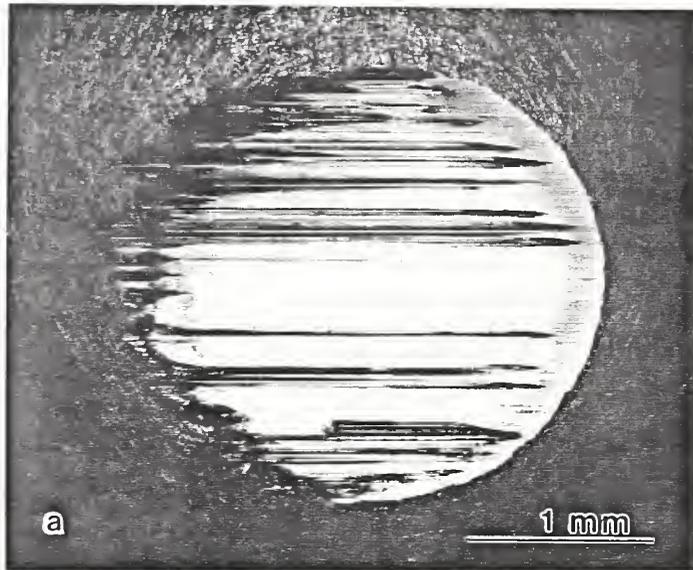
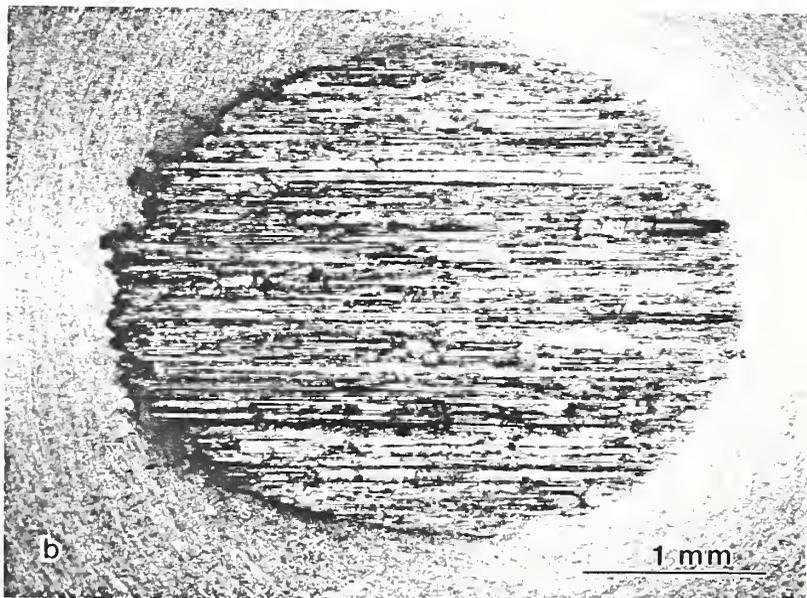
Fig. 33. Photographs of scars on (a) Ag and (b) Cu pins after sliding against Co flats. Leading edge is at right.

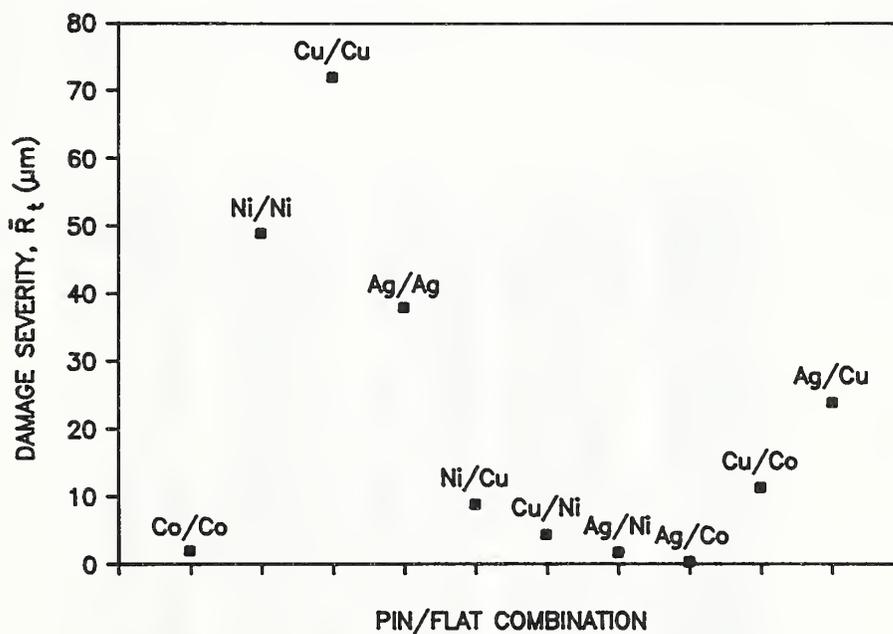
Fig. 35. Average maximum peak to valley damage parameter, \bar{R}_t , for different pin and flat specimen combinations. The metal identified at the left refers to the pin and the metal at the right refers to the flat.

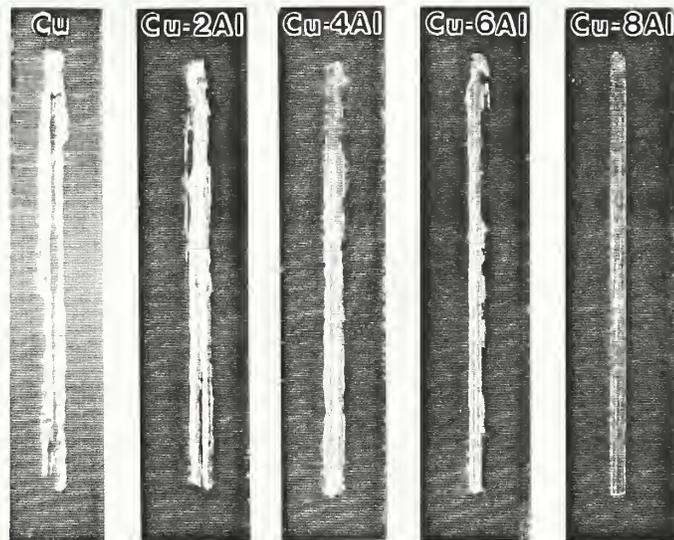
Fig. 36. Optical photographs of sliding tracks on Cu-Al flats. Sliding was initiated at the top.

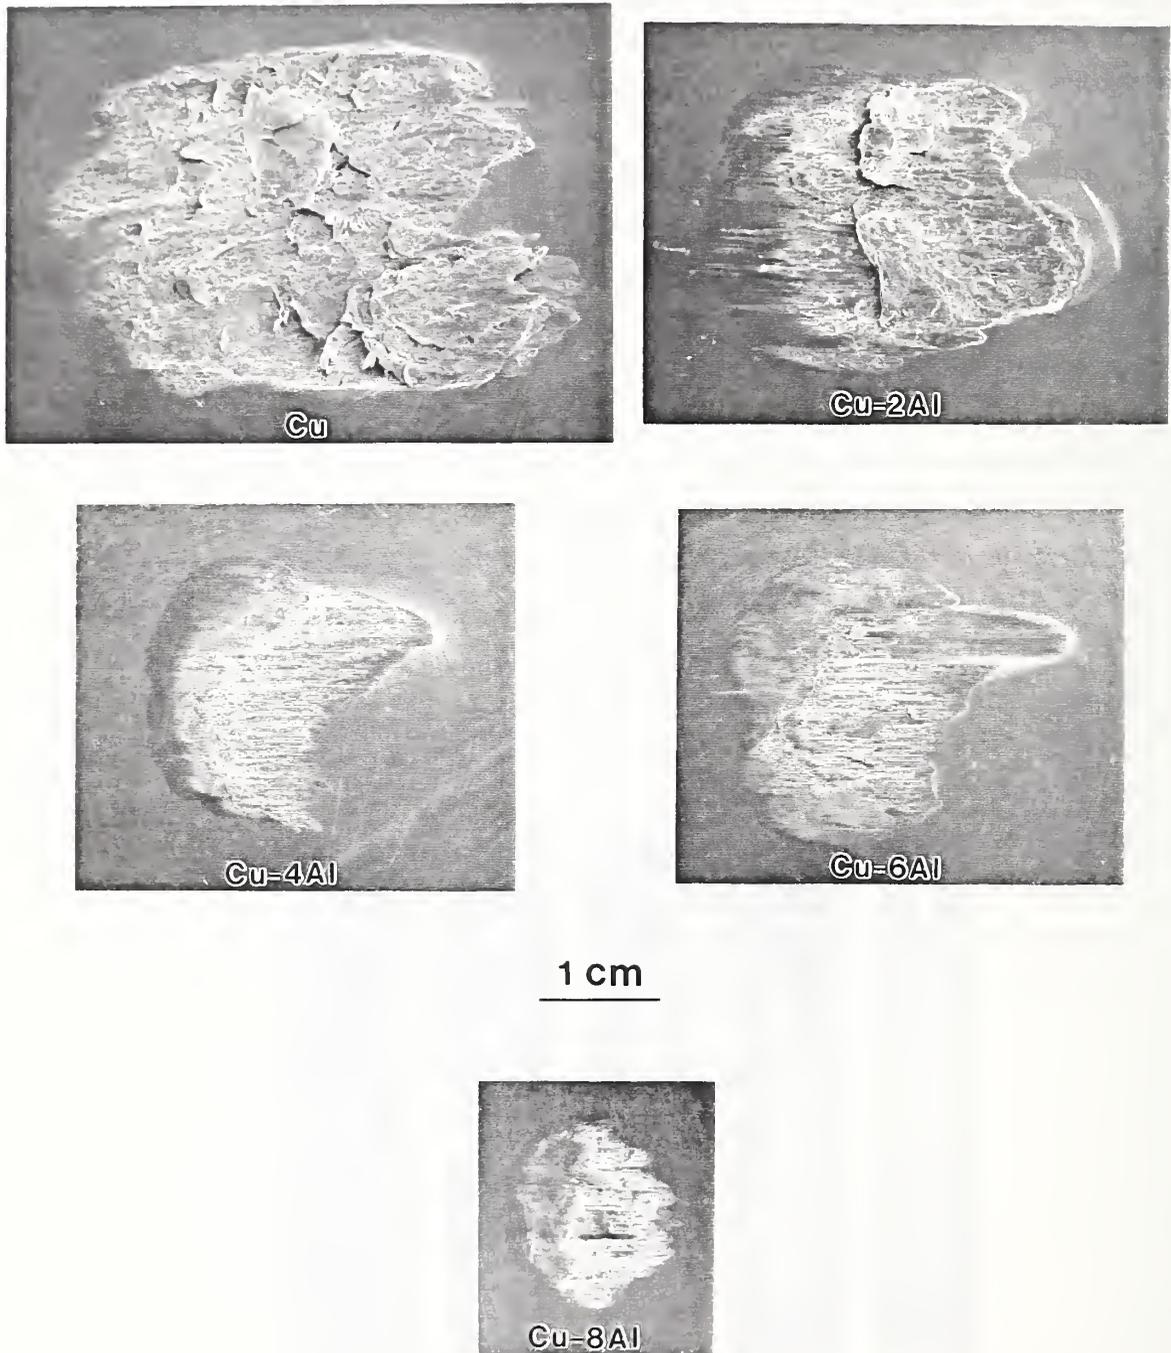
Fig. 37. SEM micrographs of wear scars on pins slid against flats shown in Fig. 36. The leading edge of each scar is at the left.

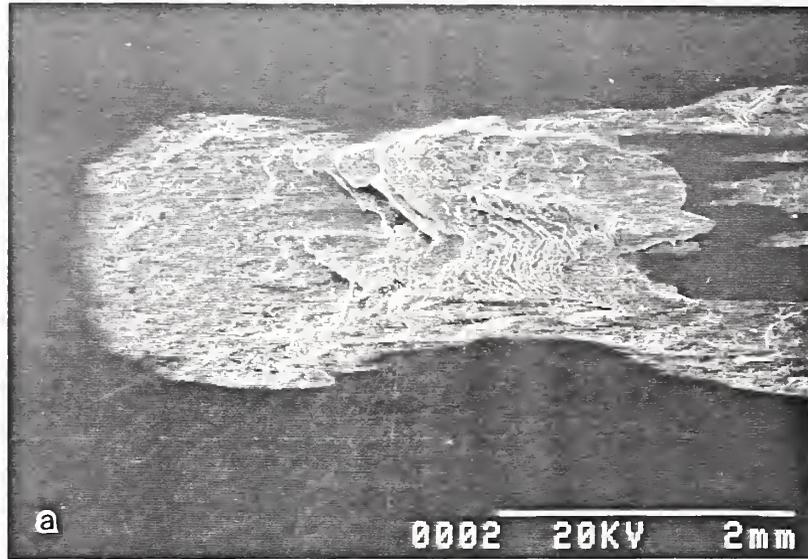
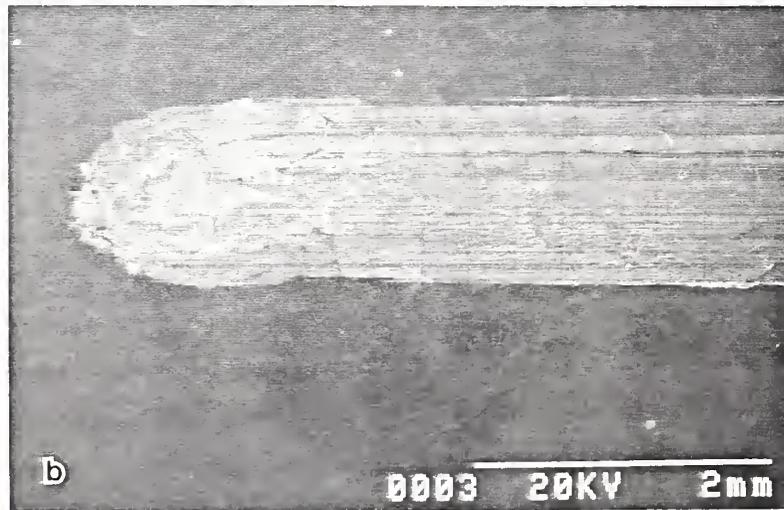
Fig. 38. SEM micrographs of initial section of tracks on (a) Cu and (b) Cu-8Al flats.

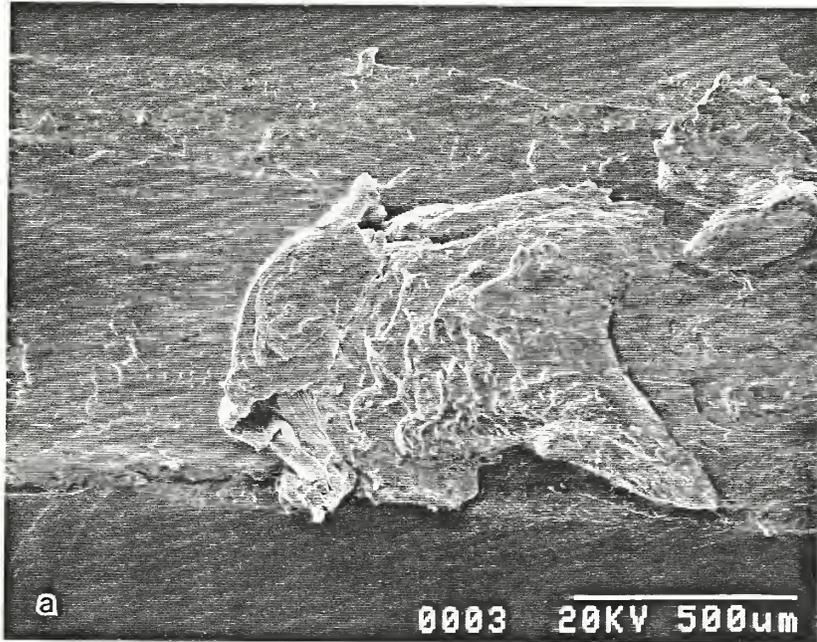
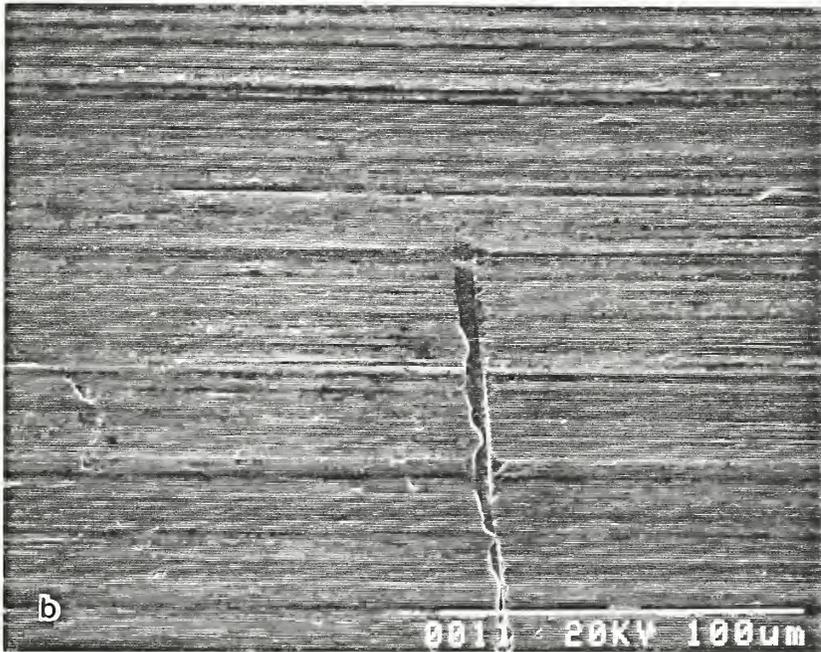
Fig. 39. SEM micrographs of damage on (a) Cu and (b) Cu-8Al flats near midsection of tracks. Motion of pin was from left to right.

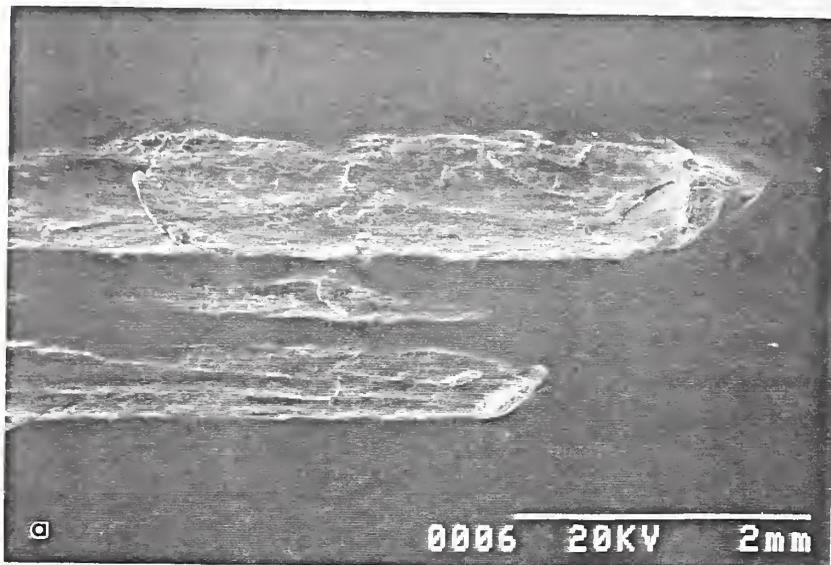
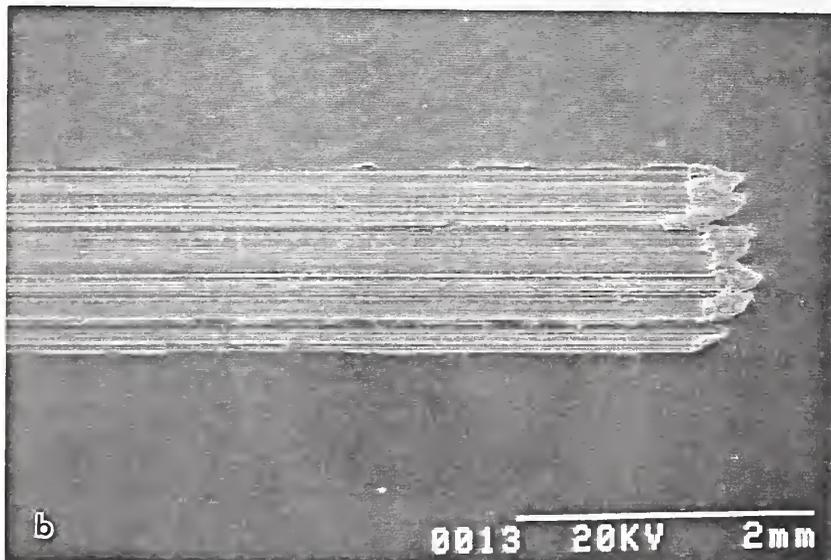
Fig. 40. SEM micrographs of the ends of the tracks on (a) Cu and (b) Cu-8Al flats.

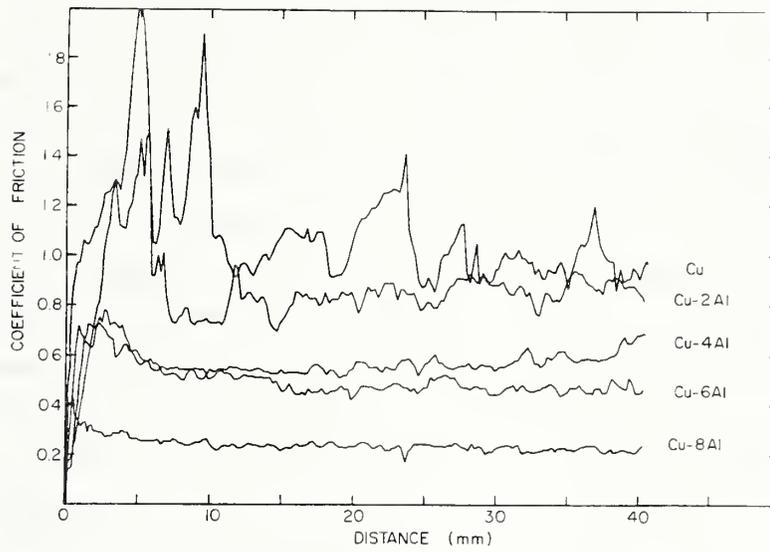
Fig. 41. Coefficient of friction traces for specimens in Cu-Al series.

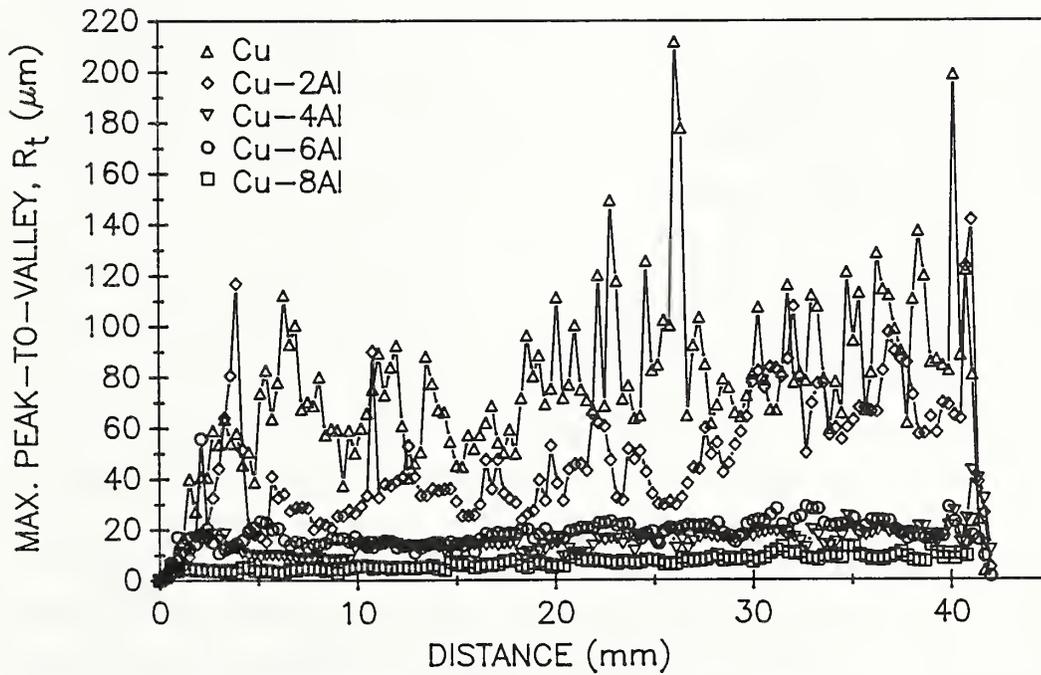
Fig. 42. Maximum peak to valley height, R_t , of damage on flats in Cu-Al series plotted as function of sliding distance.
