NISTIR 89-4064

THE MECHANISM, MEASUREMENT, AND INFLUENCE OF PROPERTIES ON THE GALLING OF METALS

December 1989

Final Report

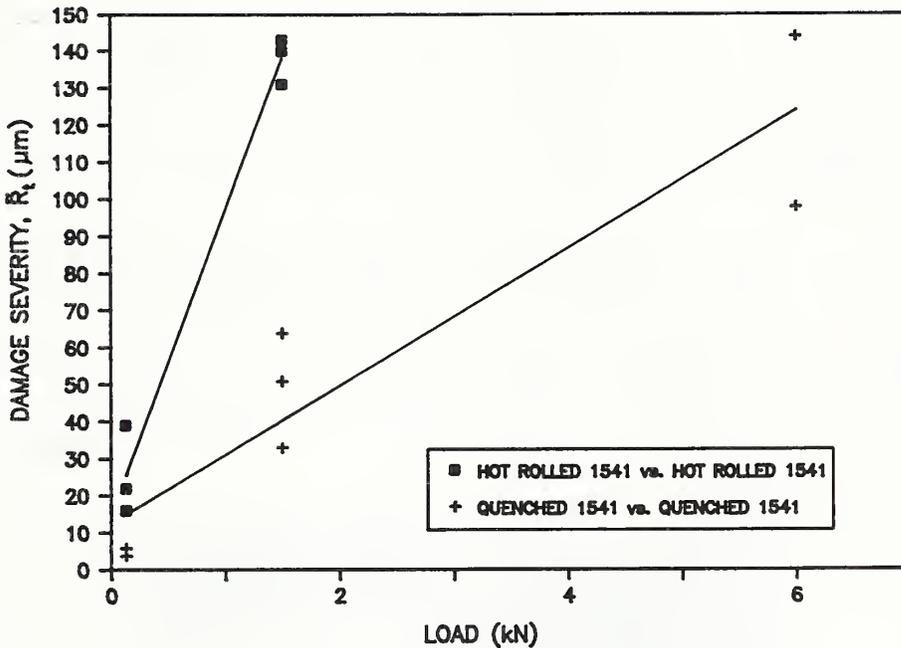
Fig. 44. Damage parameter, \bar{R}_t , plotted as a function of load comparing hot rolled and quenched 1541 steel.

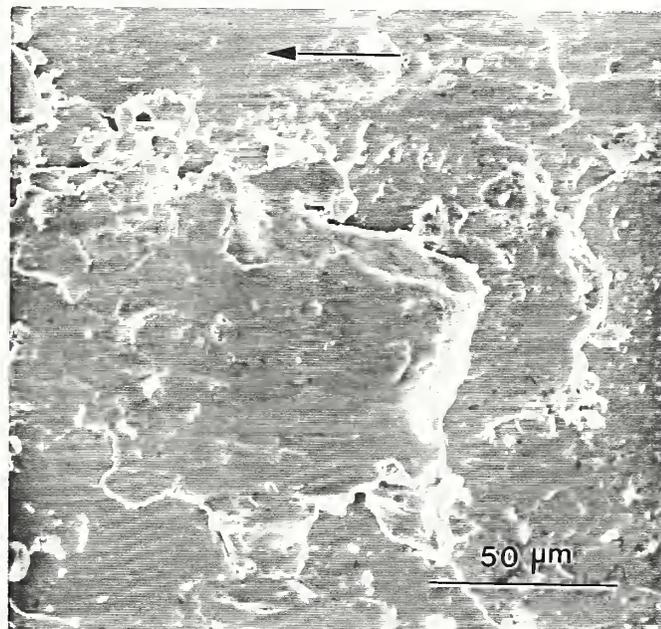
Fig. 45. Damage on quenched 1541 steel flat in self-mated test at 1500 N. Arrow indicates direction of pin motion.

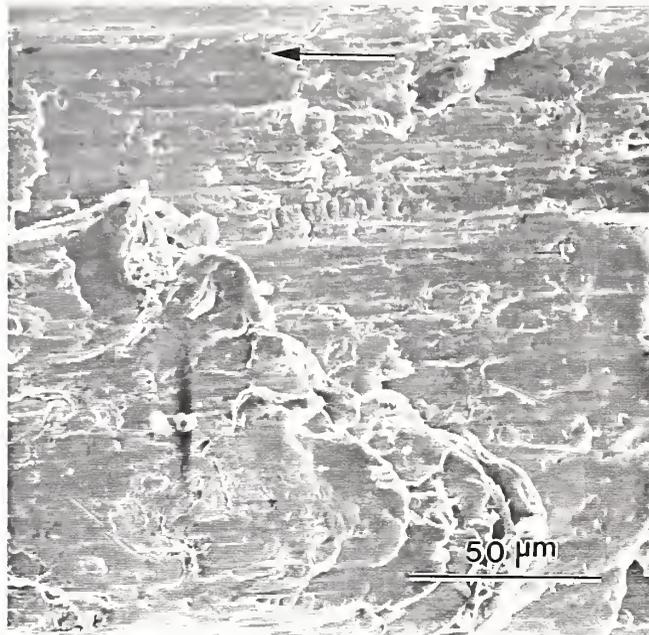
Fig. 46. Damage on hot rolled 1541 steel flat after self-mated test at 1500 N load. Arrow indicates direction of pin motion. Fig. 47. Hardness profile across carburized case on 8620 steel.

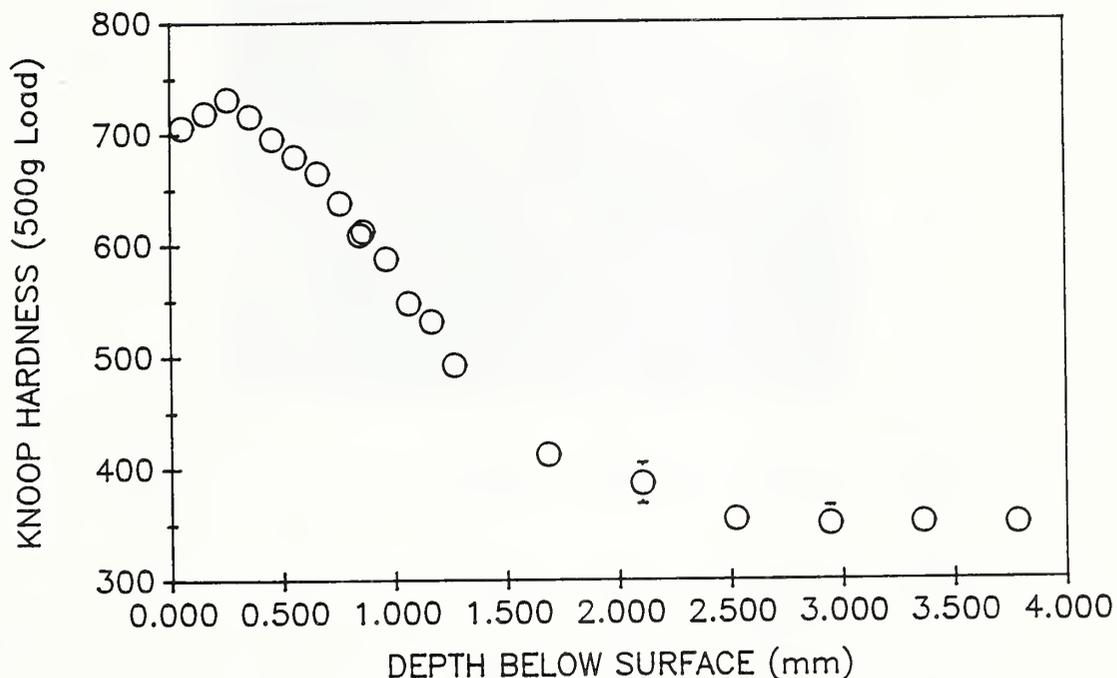
Fig. 47. Hardness profile across carburized case on 8620 steel.

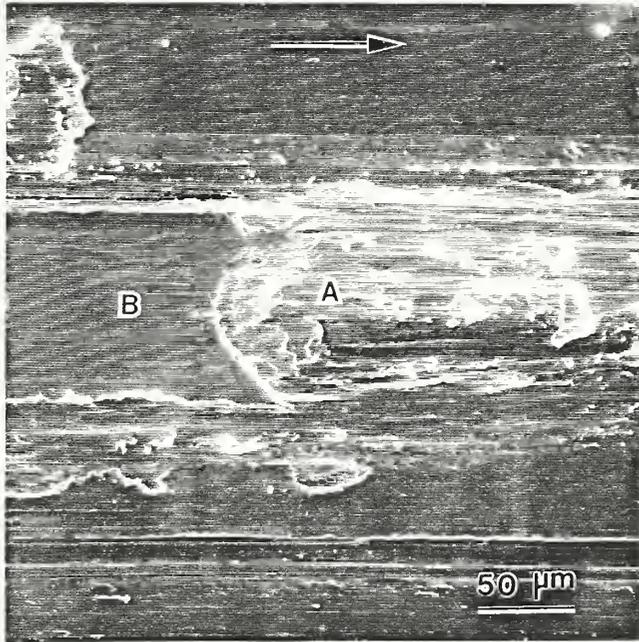
Fig. 48. Prow on 8620 steel flat produced by sliding against a quenched 1541 steel pin at 1500 N. A and B identify locations analyzed by EDS. Arrow indicates direction of pin motion.

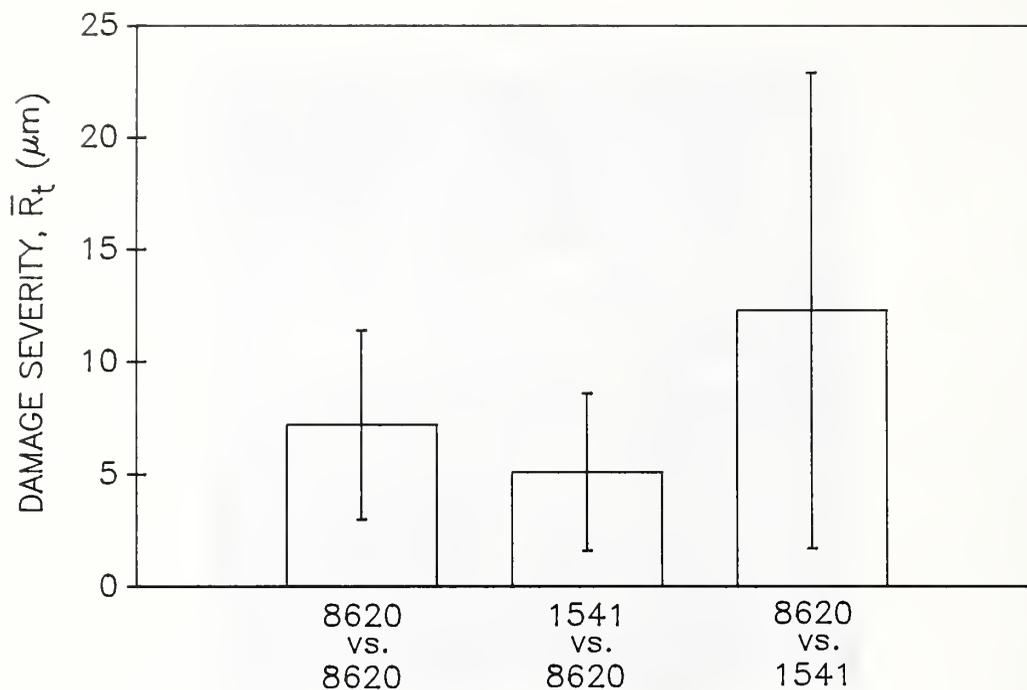
Fig. 49. Comparison of damage results for different steel combinations in tests at 1500 N.

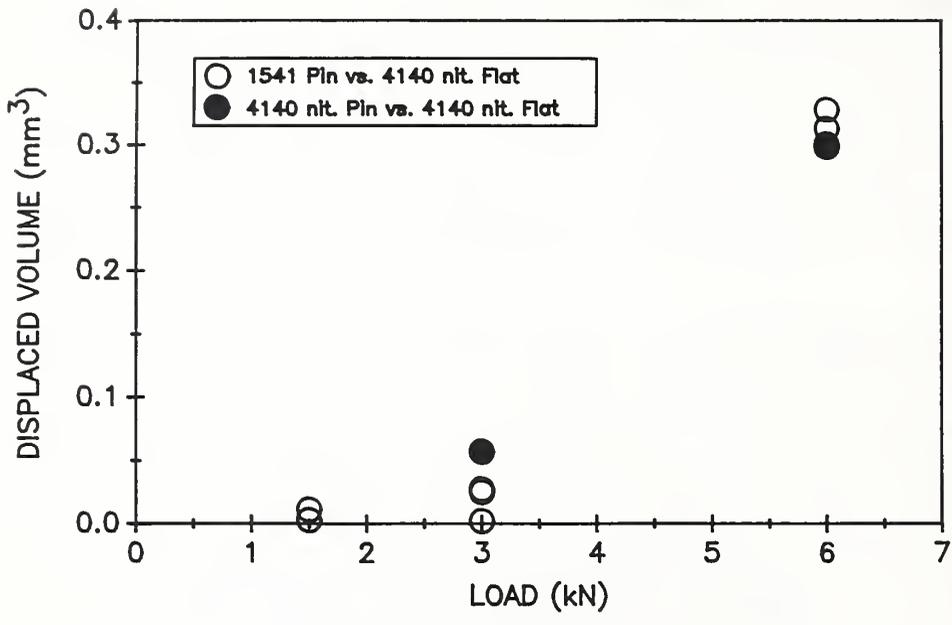
Fig. 50. Variation in displaced volume parameter, DV, with applied load on flats for different sliding combinations.

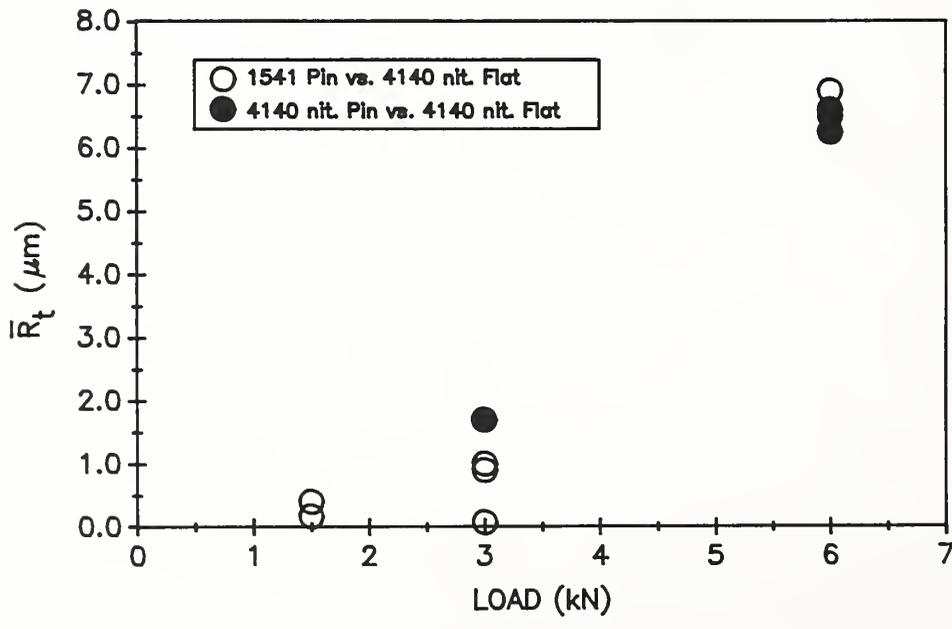
Fig. 51. Variation in average maximum peak to valley parameter, \bar{R}_t , with applied load for different sliding combinations.

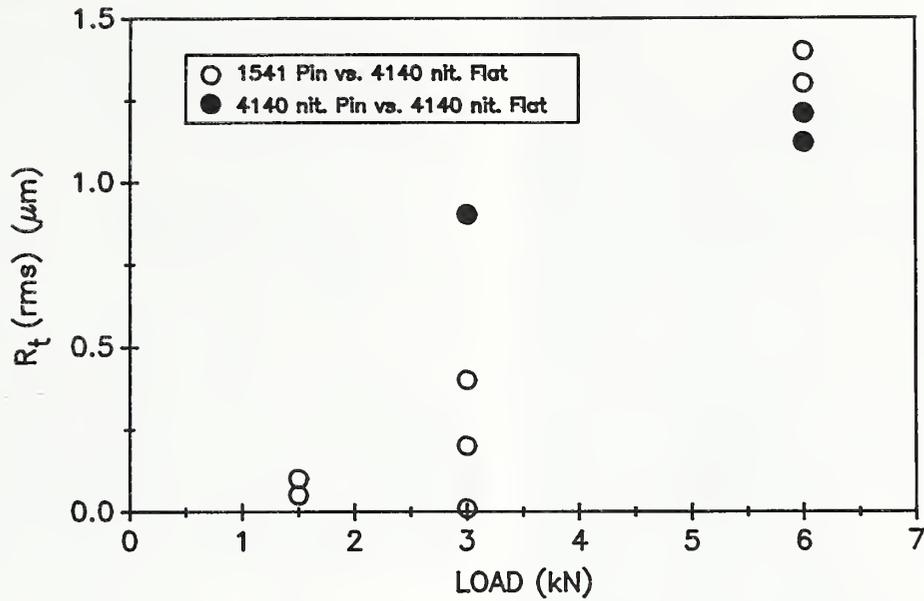
Fig. 52. Variation R_t (rms) as a function of applied load for different sliding combinations.

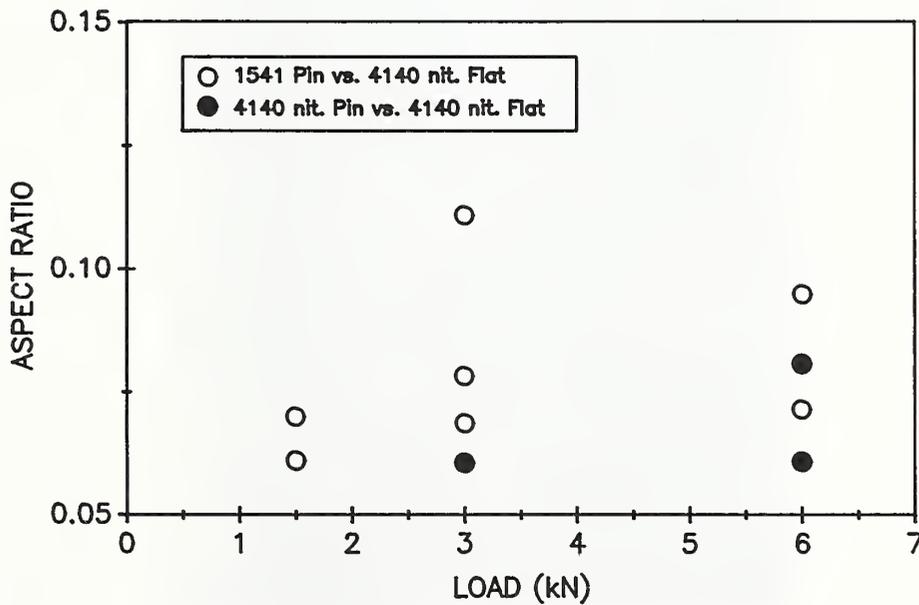
Fig. 53. Variation in aspect ratio parameter, AR, as a function of applied load for specimen flats. The low values, all $\ll 1$, indicate damage is primarily in the form of long grooves and ridges parallel to the direction of sliding.

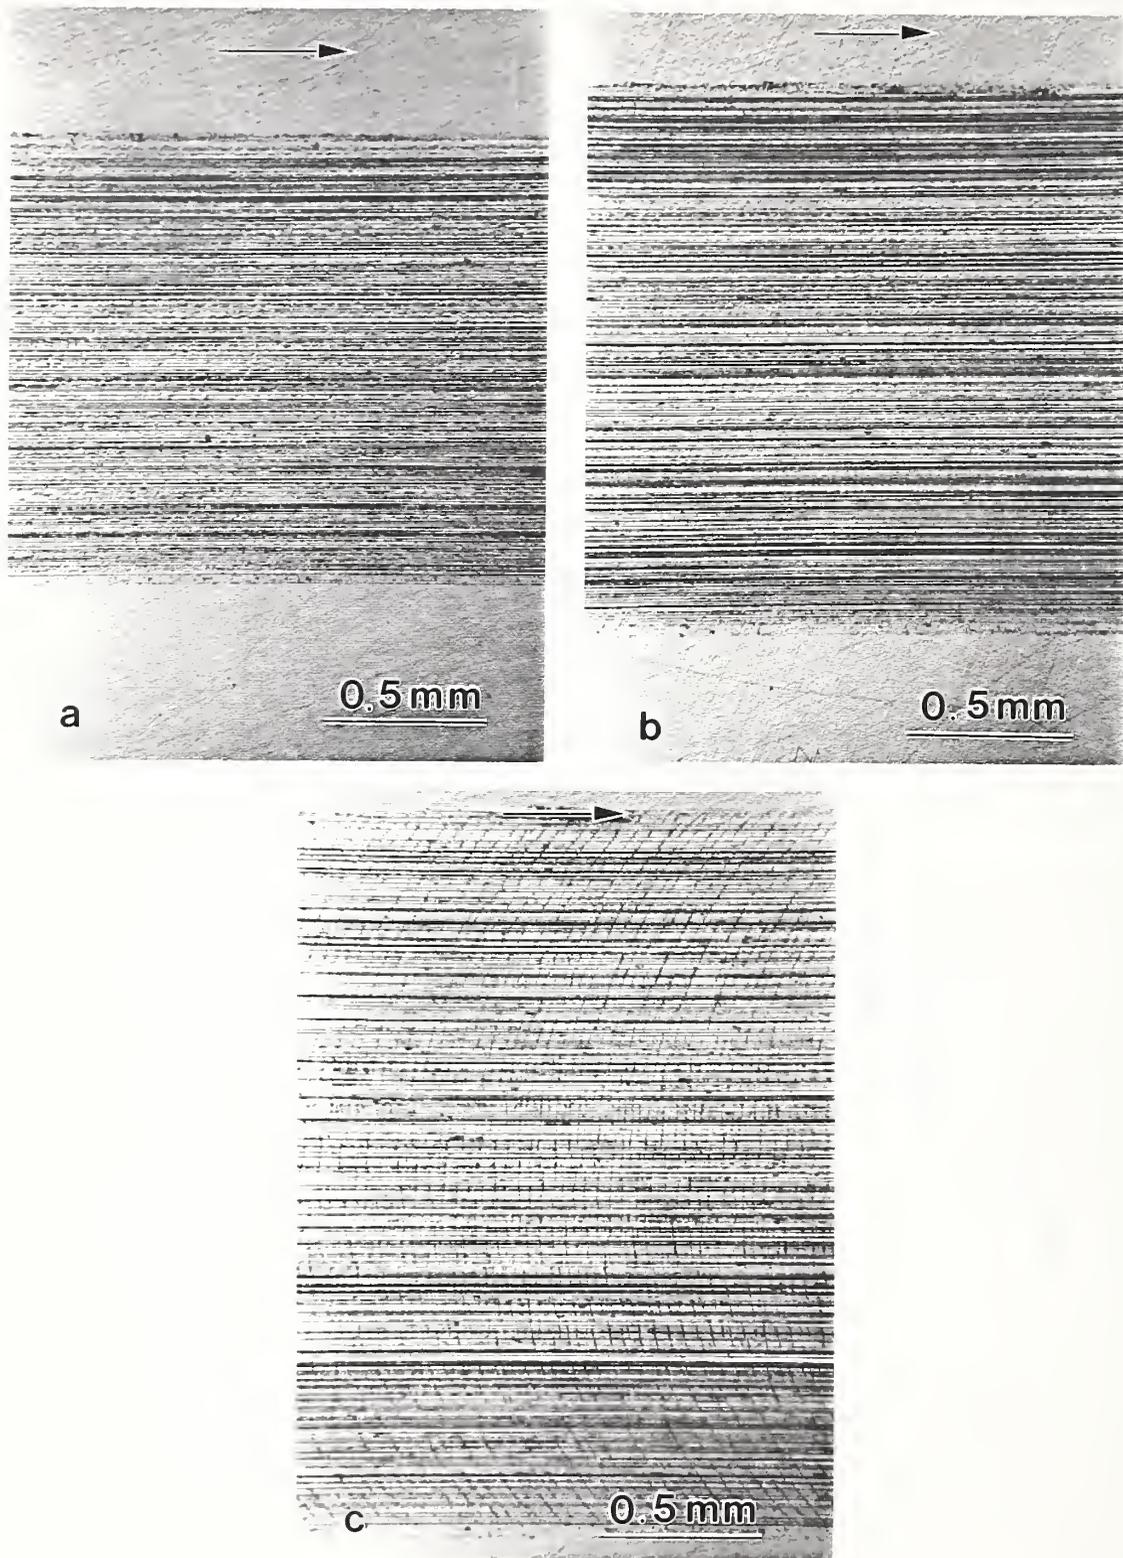
Fig. 54. Optical micrographs (Nomarski contrast) showing section of track on nitrided 4140 specimen flat after sliding against 1541 pin. (a) 1500 N load. (b) 3000 N load. (c) 6000 N load.

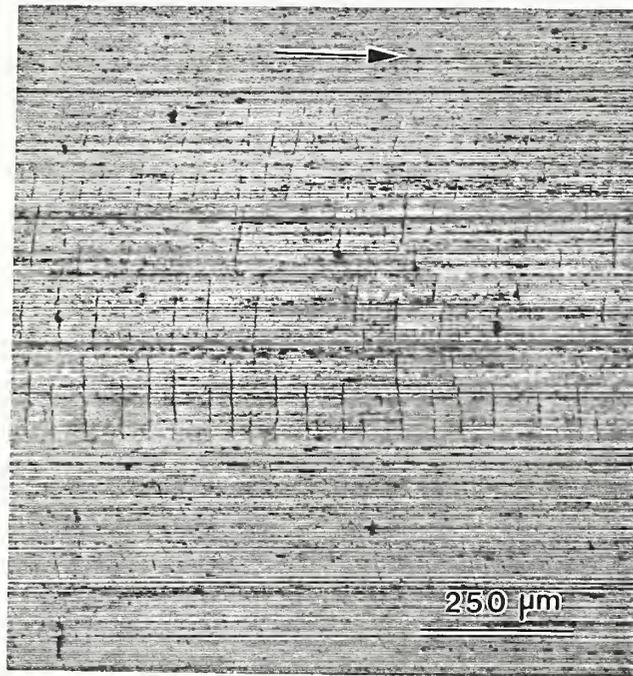
Fig. 55. Transverse cracks in wear track on nitrided 4140 specimen flat after sliding against 1541 steel pin at 1500 N. Nomarski contrast. Arrow indicates direction of pin motion.

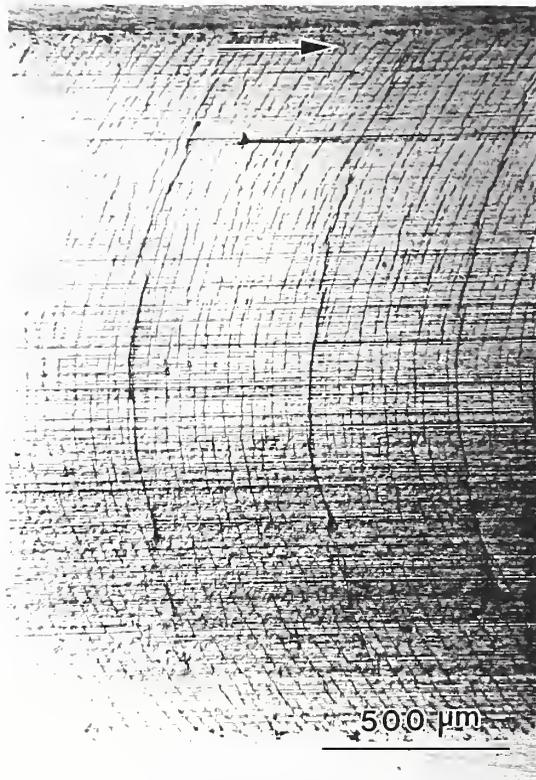
Fig. 56. Optical micrograph (Nomarski contrast) showing section of track on nitrided 4140 specimen flat after sliding against nitrided 4140 pin at 6000 N load. Arrow indicates direction of pin motion.

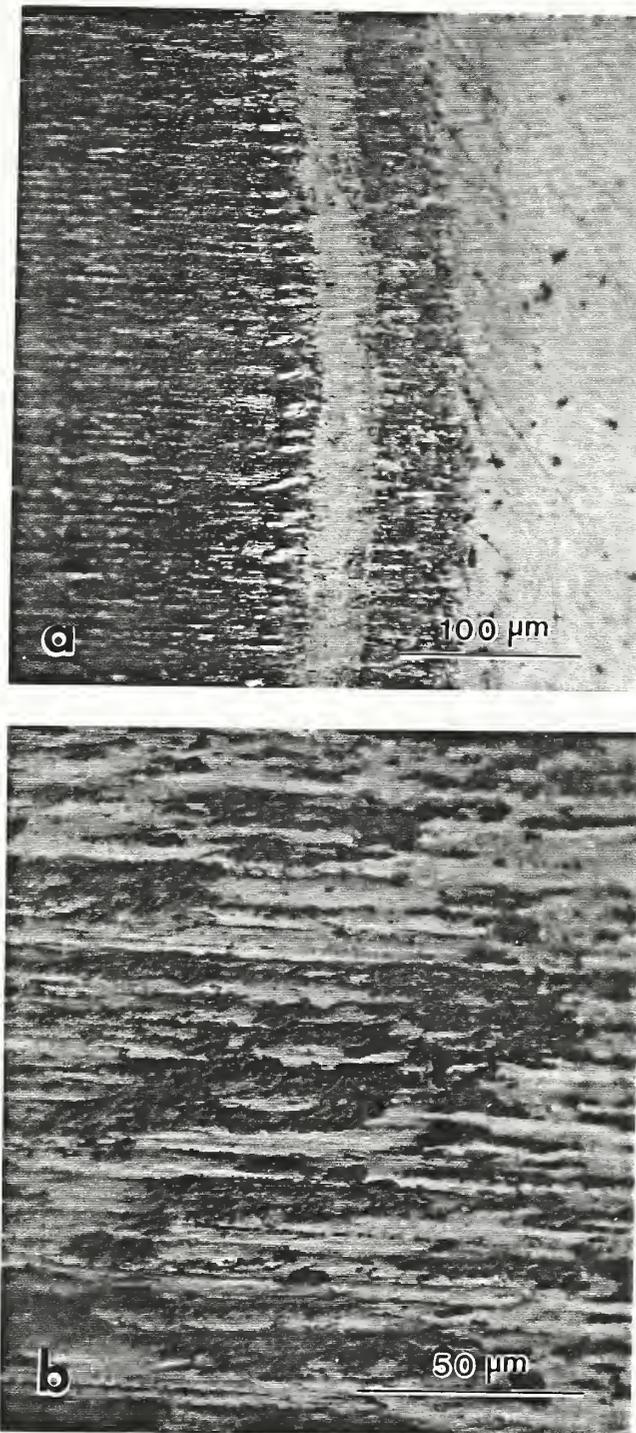
Fig. 57. Optical micrographs of scar on 1541 pin after sliding on nitrided 4140 flat. (a) Front part of contact showing transferred lumps and oxide. (b) Oxide near center of contact area on pin.

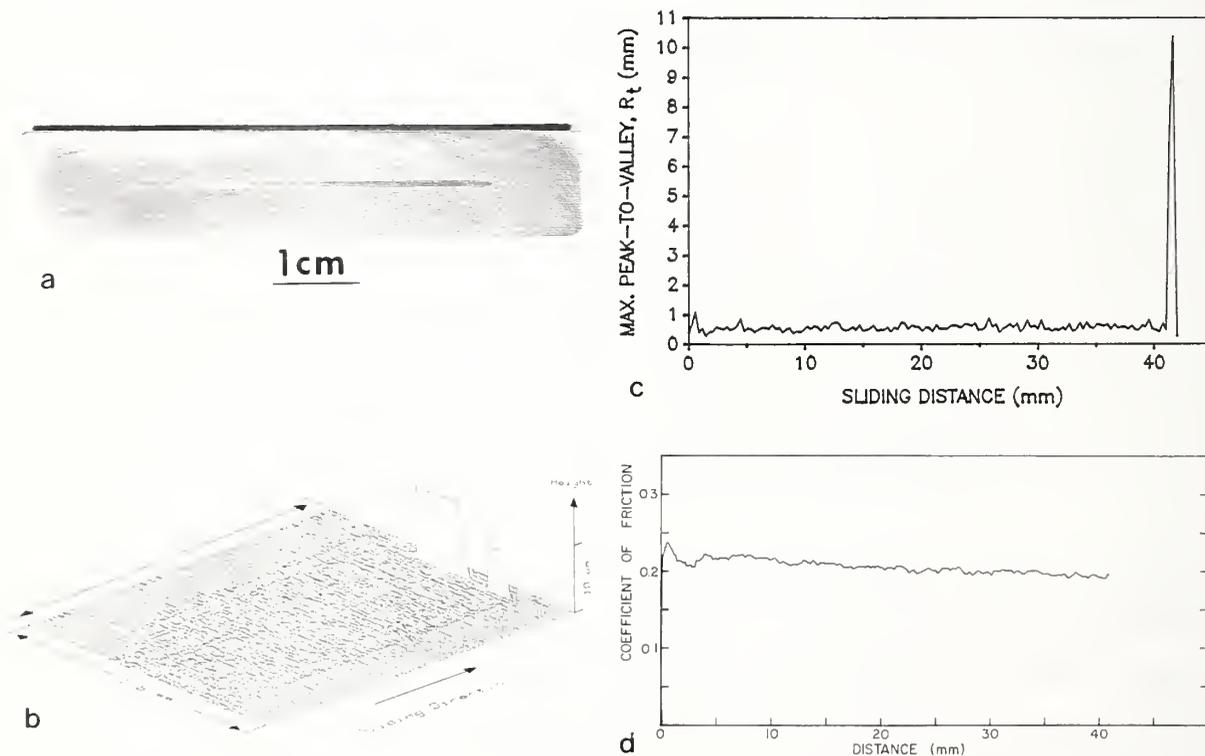
Fig. 58. (a) Optical photograph of track on an aluminum bronze flat. (b) Profilometer tracing of damage. (c) Plot of the maximum peak-to-valley heights as a function of distance along the track. (d) Coefficient of friction plotted as a function of sliding distance.

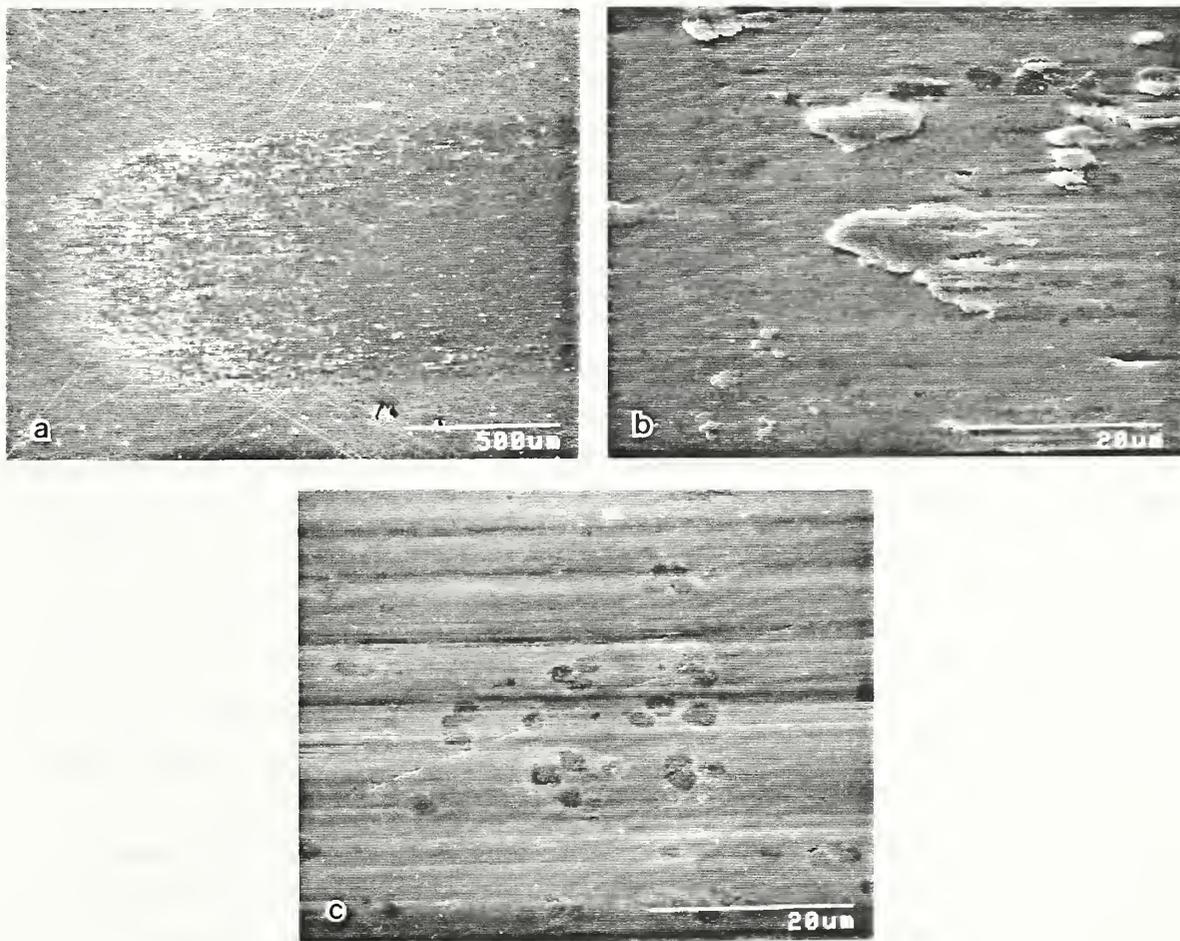
Fig. 59. (a) SEM micrograph of initial part of track on aluminum bronze flat. (b) Small prows present at beginning of track. (c) Typical appearance of track past initiation point.

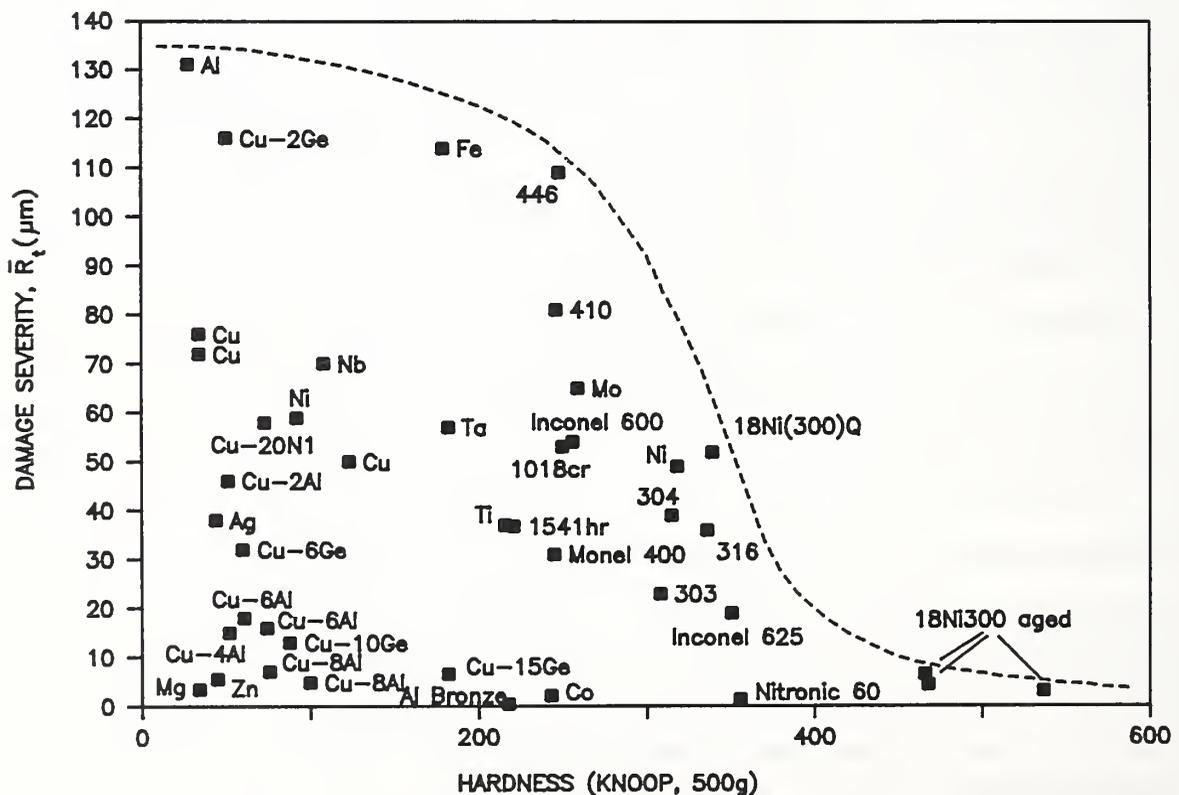
Fig. 60. Damage severity, \bar{R}_t , plotted against pretest hardness for self-mated metals at 130 N.

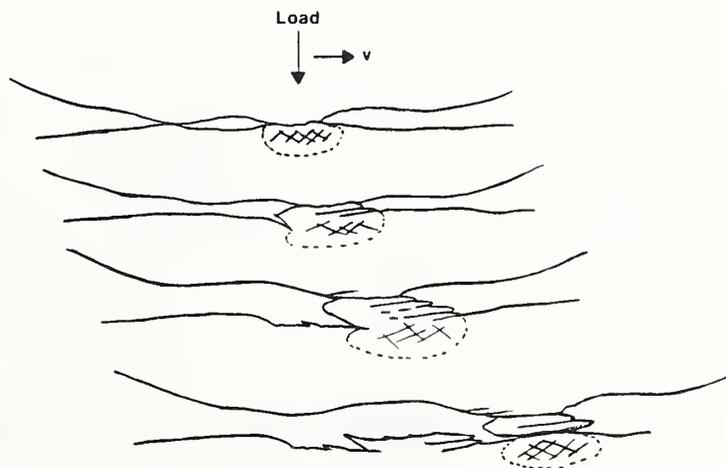
Fig. 61. Schematic drawing illustrating basic wedge formation process responsible for galling.

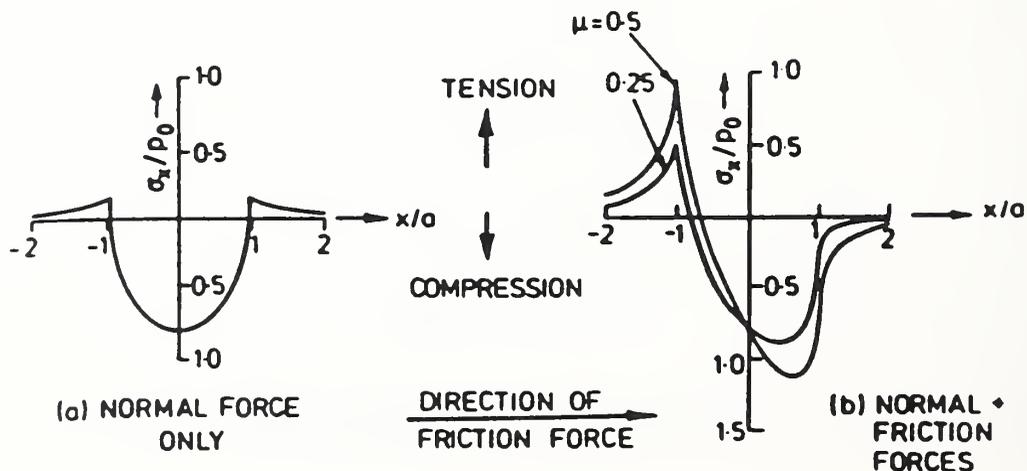
Fig. 62. Variation in normal component of stress σ_x in contact plane for spherical indenter: (a) with out tangential force and (b) with tangential force.

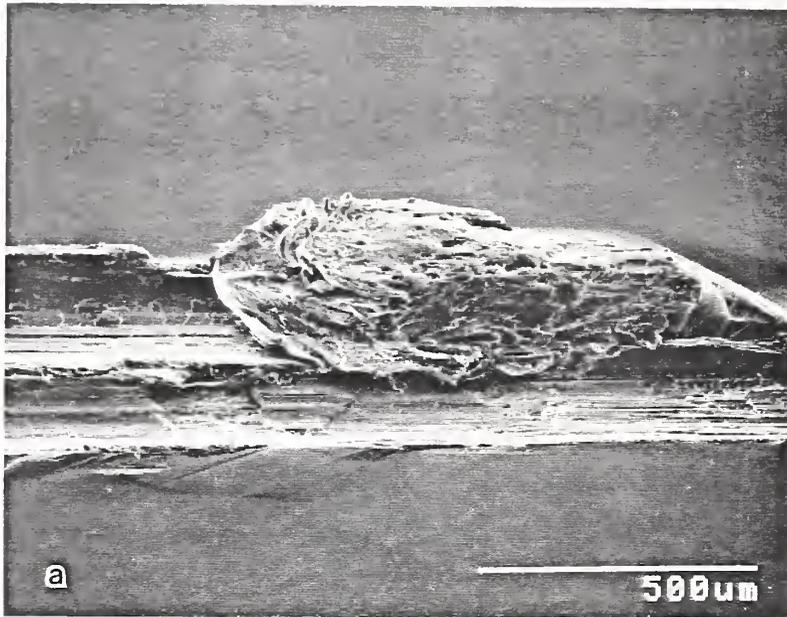
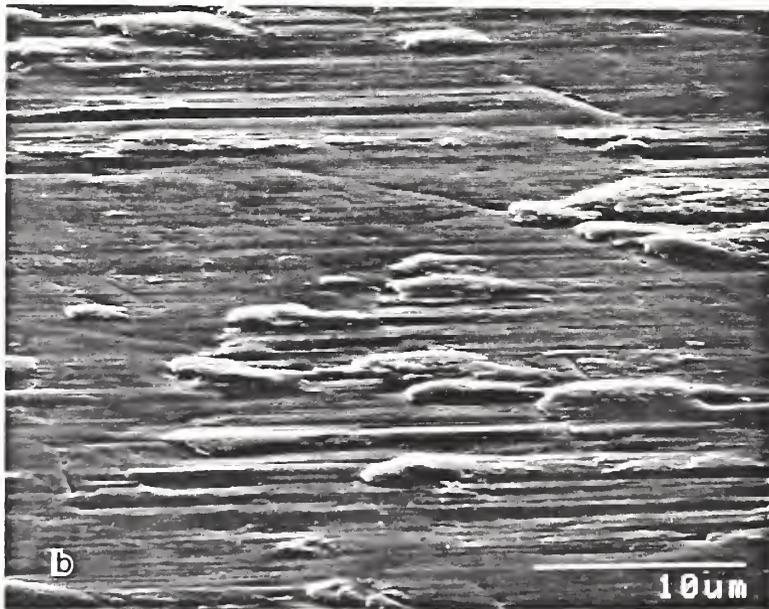
Fig. 63. Similar appearance of damage at different scales: (a) Ni flat and (b) aluminum-bronze flat. 130 N load.

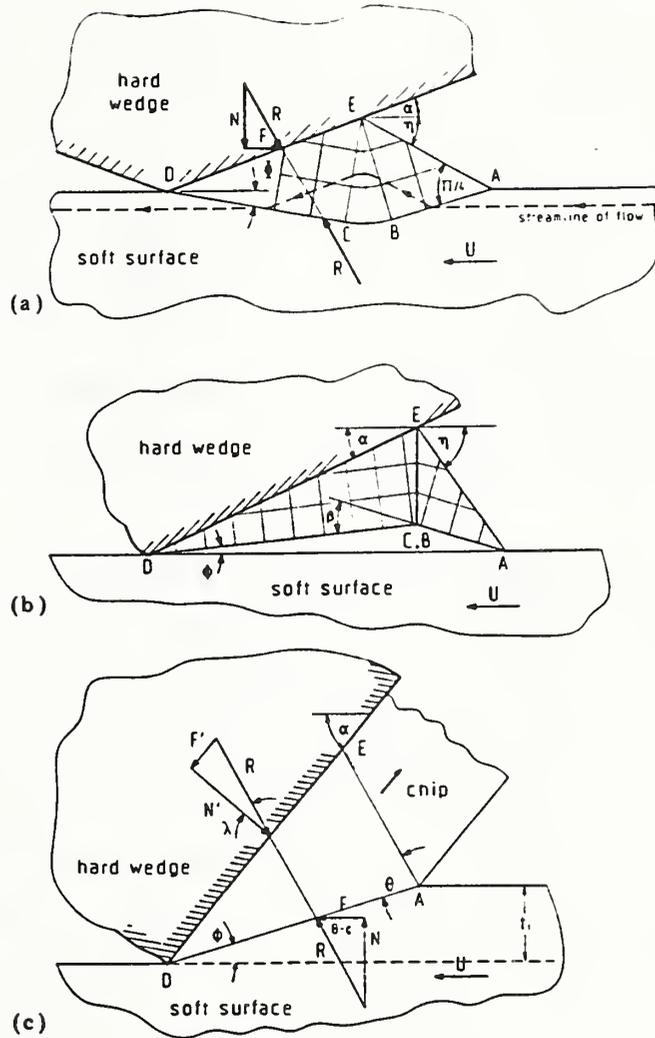
Fig. 64. Slip-line field models used by Black, Koplansky and Oxley [20] to study the different regimes of sliding deformation: (a) plastic wave formation, (b) wave removal, and (c) chip formation.
