NIST NCSTAR 1-2

# Baseline Structural Performance and Aircraft Impact Damage Analysis of the World Trade Center Towers

Fahim Sadek  
*Building and Fire Research Laboratory*  
*National Institute of Standards and Technology*

September 2005

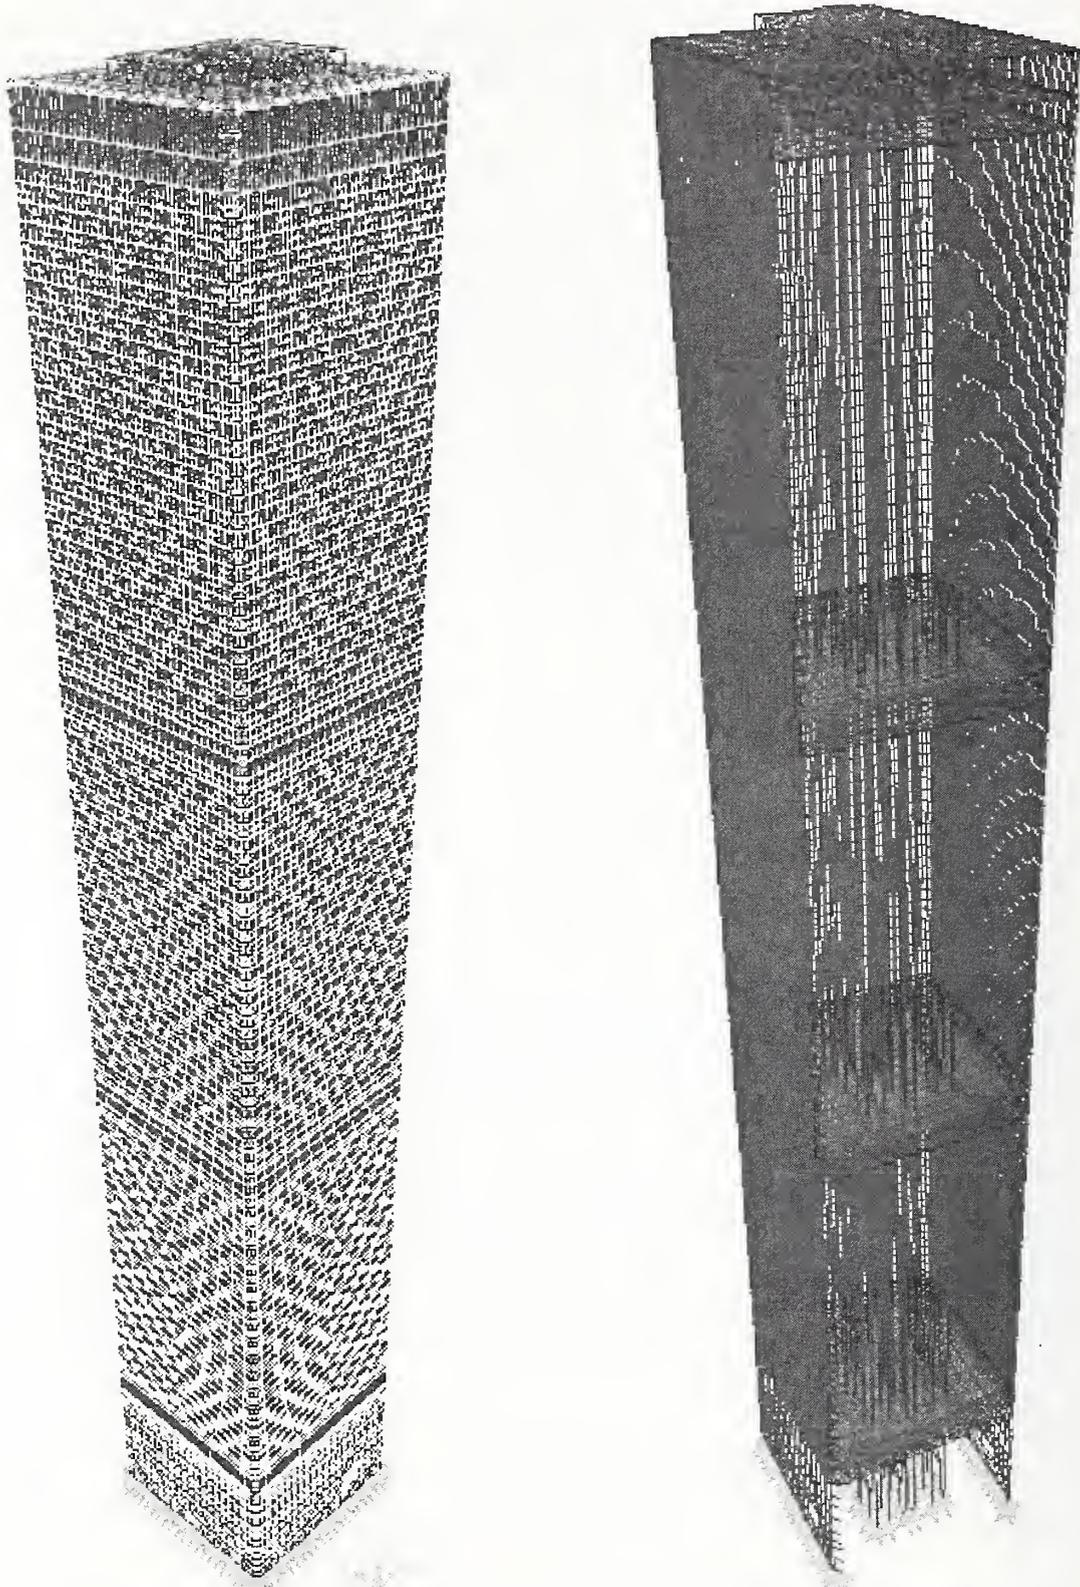
**Figure E-1. Rendered isometric views of the WTC 1 global model.**

The global models were developed primarily using prismatic and non-prismatic frame (beam) elements. Shell elements were used only to represent the flexible floor diaphragms. For the development of beam element representations of the exterior wall panels, detailed shell element models of the panels were developed and used to calibrate the behavior of the beam element model under gravity and lateral loads (Figure E-2). Similarly, the detailed floor models were used to calibrate the response of a simplified shell element representation of the floor systems for use as flexible diaphragms in the global models.

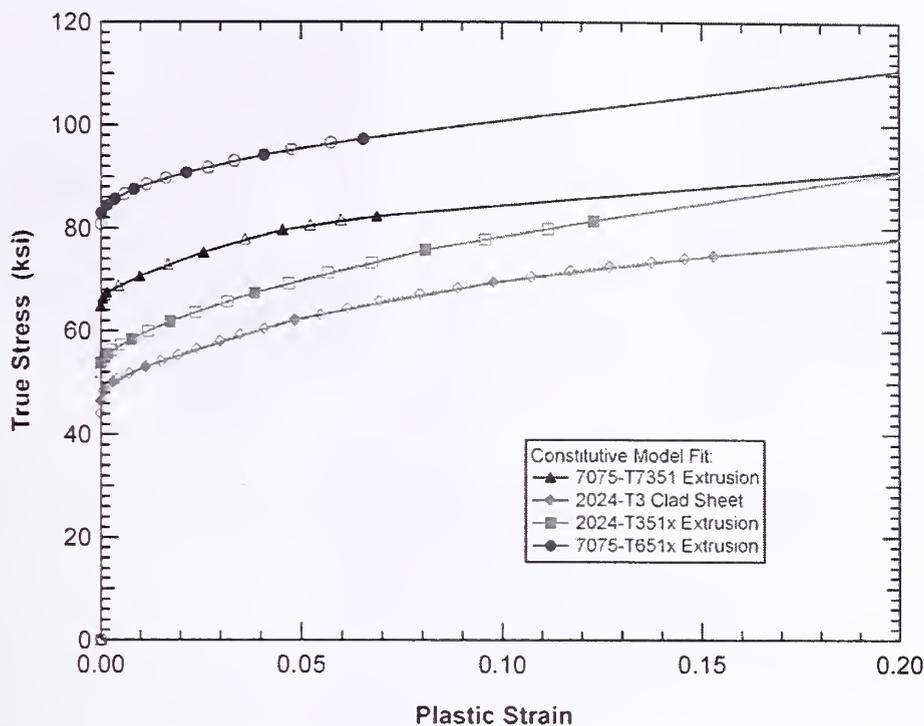
Figure E-19. True stress-strain curves developed for various aircraft aluminum alloys.

The constitutive and failure properties for the aircraft materials were developed from data available in the open literature. Complete engineering stress-strain curves were obtained for various 2024 and 7075 aluminum alloys that are commonly used in the construction of the Boeing 767 airframe structures. These curves were digitized for the various aluminum alloys. Representative stress-strain curves were then converted into true stress and true strain and used to develop tabular curves for constitutive models. The tabular constitutive model fits are shown in Figure E-19. No rate sensitivity of the aircraft materials was considered.

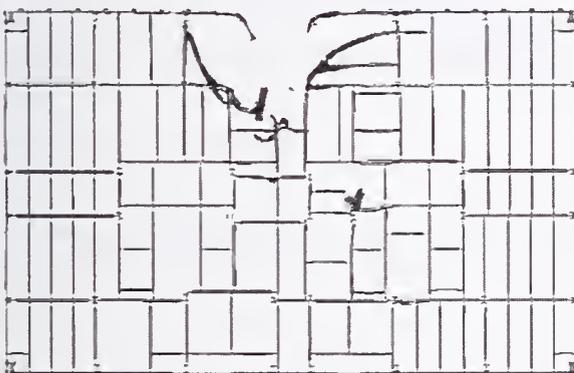
(a) Floor 95 core framing damage

Figure E-30. Base case impact damage to the core beams of floors 95 and 96 of WTC 1.

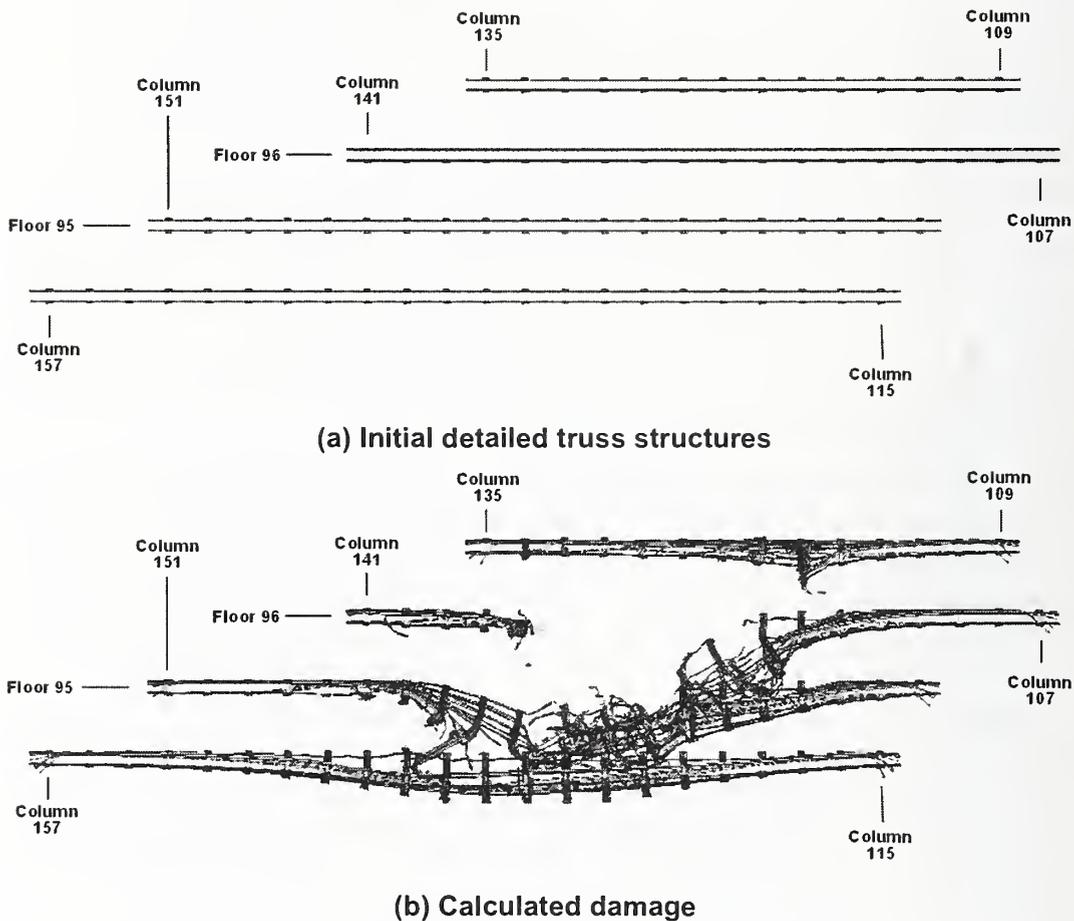
Figure E-31. Base case impact damage to the WTC 1 floor trusses (front view).

An overall frontal view of the floor trusses in the impact zone, along with the calculated impact damage to the floor trusses, is shown in Figure E-31. The figure shows that the trusses experienced significant damage and sagging in the impact zone. A plan view of the calculated damage to the trusses on floors 95 and 96 is shown in Figure E-32. The calculated impact response produced severe damage to the truss structures in the primary impact path of the fuselage from the exterior wall to the core. The truss floor system on floors 94 through 96 were damaged and sagged downward as a result of the impact loading. The calculated damage to the WTC 1 floor slab for floors 95 and 96 are shown in Figure E-33, where a similar pattern of response to that observed in the trusses can be seen for the floor slabs.

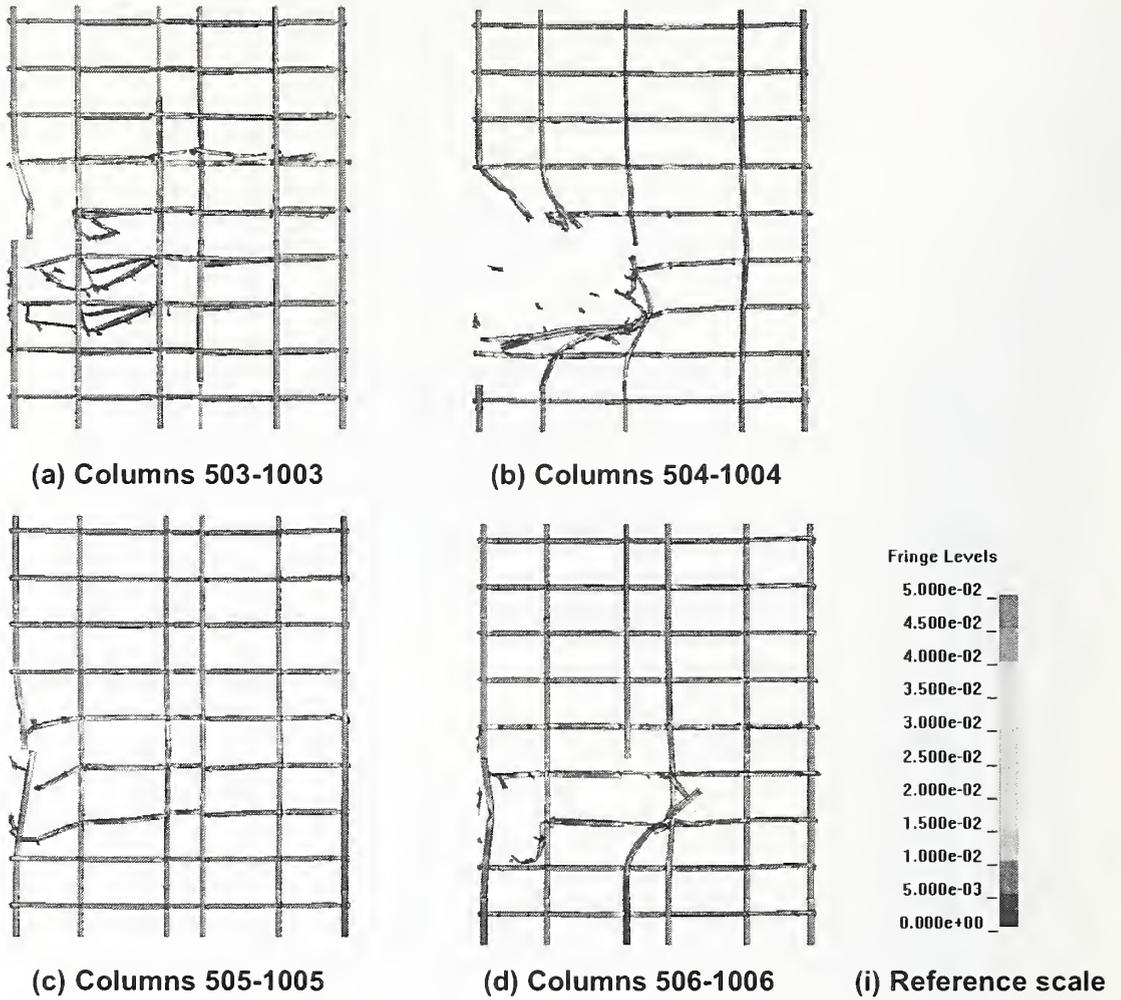
Figure E-37. More severe impact response of the WTC 1 core columns.

The calculated damage to the core columns by row is shown in Figure E-37, and the damage to the core framing for floors 95 and 96 is shown in Figure E-38. A total of six columns were severed, and three columns were heavily damaged in the more severe case, compared to three columns severed and four columns heavily damaged in the base case WTC 1 impact analysis. This shows a clear correlation between damage magnitude and impact severity.

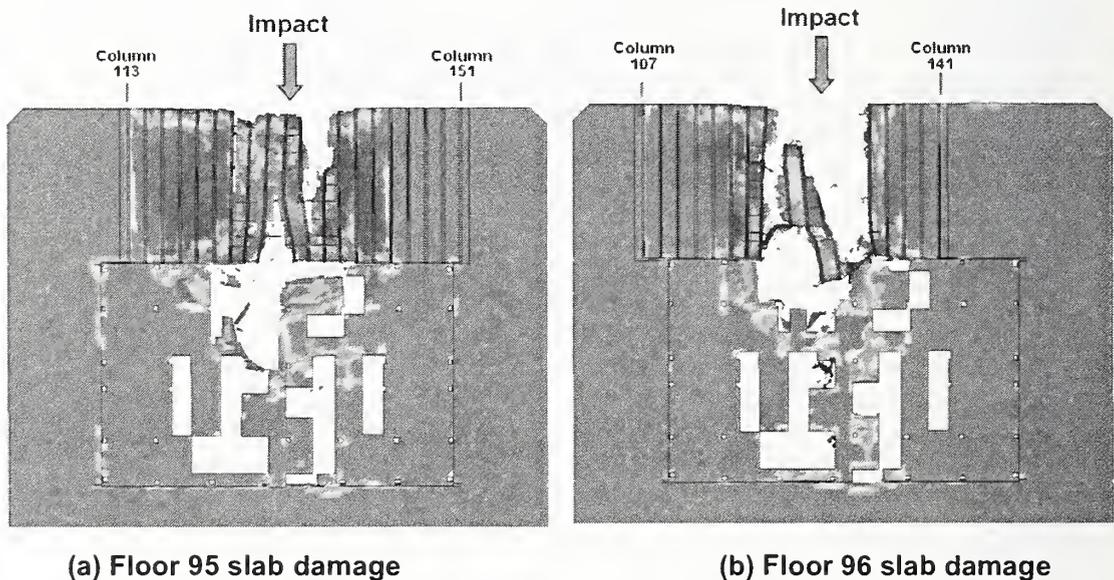
**Figure E-41. More severe impact damage to the slabs on 1 floors 95 and 96 of WTC 1 (plan view).**

The calculated more severe impact damage to the floor slabs for floors 95 and 96 of WTC 1 is shown in Figure E-41. The magnitude of floor slab damage was, in general, very similar for the base case and more severe global impact analyses. When the floor-by-floor damage was compared for the two analyses, the damage appeared to be slightly less for the more severe impact analysis. Similar to the truss damage, the reduced damage in the floor slabs is believed to be the result of the reduction in the downward impact trajectory angle from 10.6 to 7.6 degrees in the more severe impact analysis, reducing the normal downward force on the floor structures.

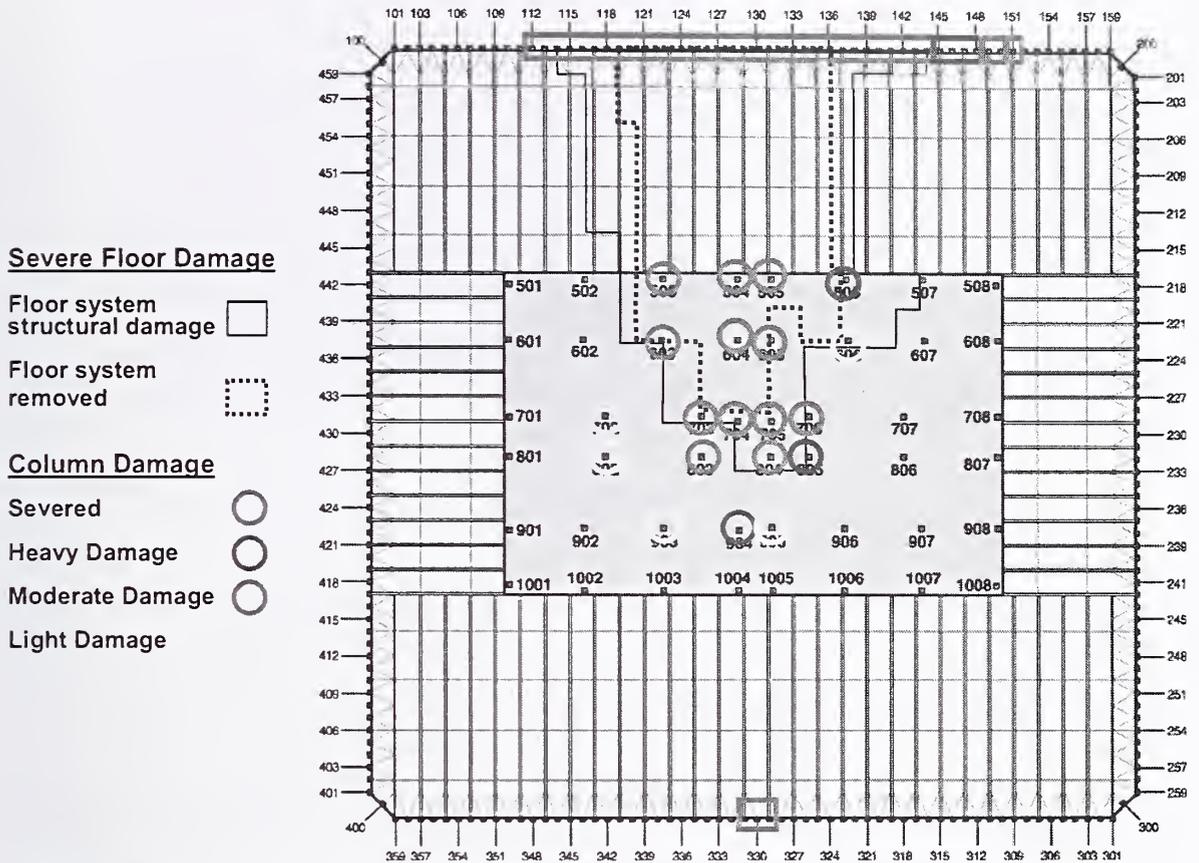
Figure E-42. Cumulative structural damage to the floors and columns of WTC 1 (more severe case).

Figure E-42 presents the cumulative damage to WTC 1 on all affected floors and columns for the more severe case.

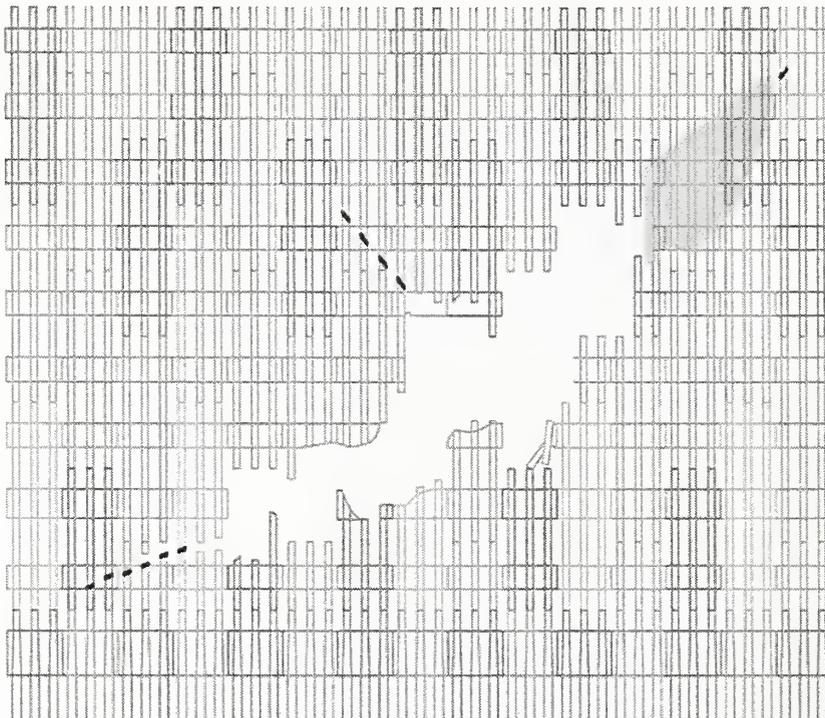
(a) Schematic of observed damage

A comparison of the south exterior wall observed and calculated damage from the base case WTC 2 global impact analysis is shown in Figure E-46. The exterior wall completely failed in the regions of the fuselage, engine, and fuel-filled wing section impacts. Damage to the exterior wall extended to the wing tips, but the exterior columns were not completely failed in the outer wing and vertical stabilizer impact regions. Failure of the exterior columns occurred both at the bolted connections between column ends and at various locations in the column depending on the local severity of the impact load and the proximity of the bolted connection to the impact.

The comparison of the calculated and observed damage indicated that the geometry and location of the impact damage zone were in good agreement. This agreement served to validate the geometry of the aircraft model, including the aircraft orientation, trajectory, and flight distortions of the wings. The agreement of both the mode and magnitude of the impact damage served to partially validate the constitutive and damage modeling of the aircraft and exterior wall of the tower.

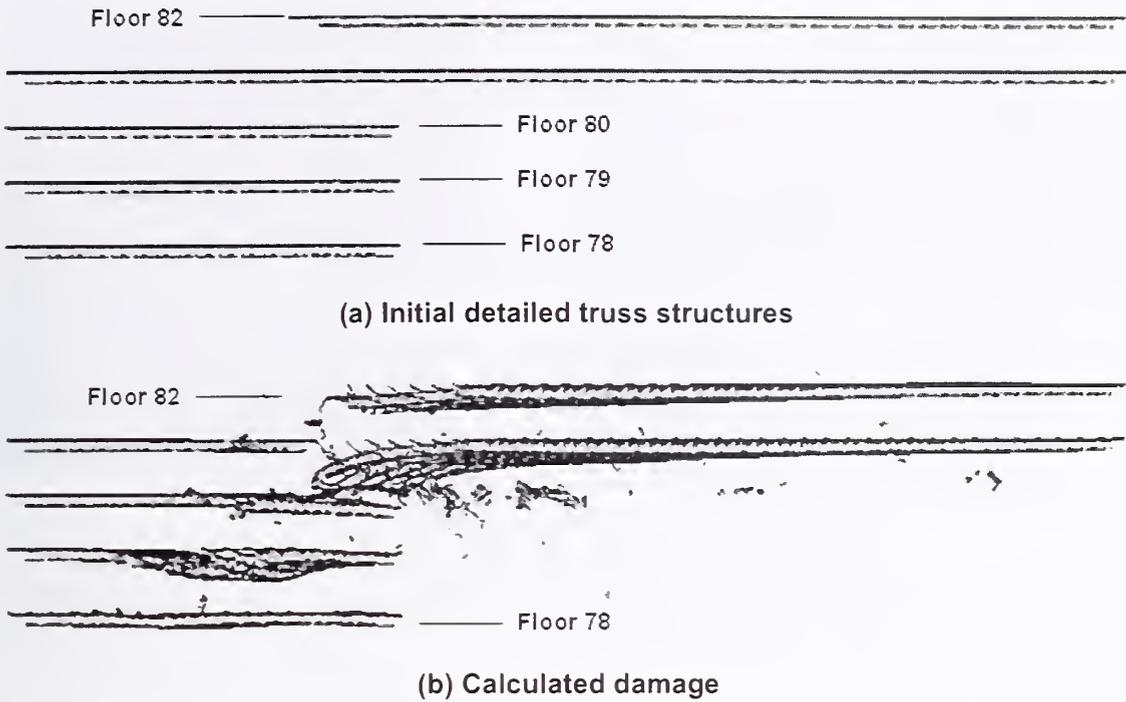
Figure E-49. Base case impact damage to the WTC 2 floor trusses (front view).

An overall frontal view for the floor truss structure in the WTC 2 impact zone, along with the calculated base case impact damage to the trusses, is shown in Figure E-49. The figure shows that the trusses experienced significant damage in the impact zone, with the largest damage on floor 81. A plan view of the calculated damage to the trusses on floors 80 and 81 is shown in Figure E-50. The calculated impact response produced severe damage to the truss structures in the primary impact path of the fuselage. The truss structures were severely damaged from the exterior wall to the core. The truss floor system on floors 79 and 81 had sufficient damage from the impact that truss floor sections sagged downward. The calculated damage to the WTC 2 floor slabs for floors 80 and 81 is shown in Figure E-51, where a similar pattern of response to that observed in the trusses can be seen for the floor slabs.

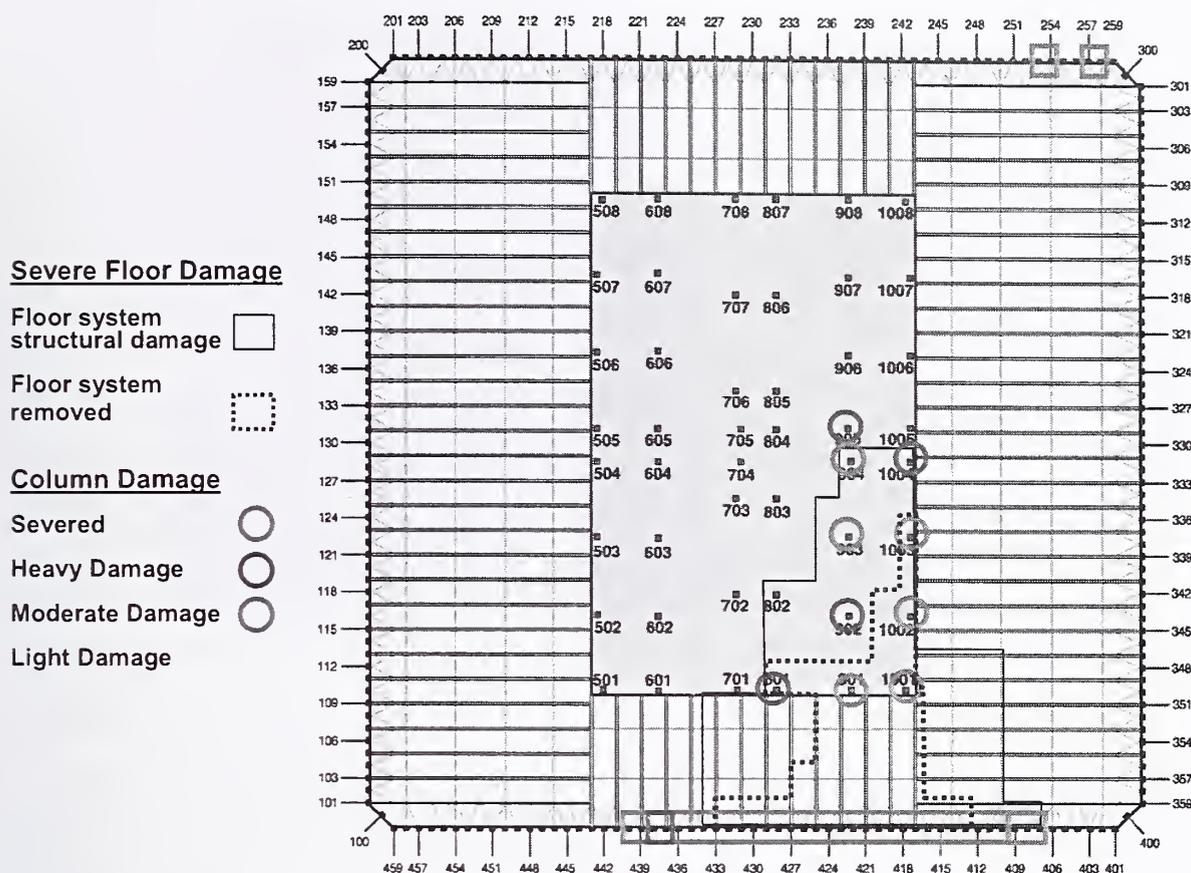
Figure E-52. Cumulative structural damage to the floors and columns of WTC 2 (base case).

The impact-induced structural damage described above provided the initial conditions for the post-impact fire-structural analyses. Figure E-52 presents the cumulative damage on all affected floors and columns. The damage to the columns at the various levels is identified by the color of the circles, where red, blue, green, and yellow signify severed, heavily damaged, moderately damaged, and lightly damaged columns, respectively. The dotted boxes on the figures indicate areas where the impact created an opening in the floor. These were used to identify slab openings in the fire dynamics simulations. The solid boxes indicate areas in the floor system that had severe structural damage. These areas were removed from the subsequent structural analyses. Figure E-52 also shows the damage to columns on the north perimeter wall, which the analysis did not capture due to the coarse mesh on the north wall. This damage was observed in photographs. As a result, this damage was accounted for in the subsequent structural analyses.

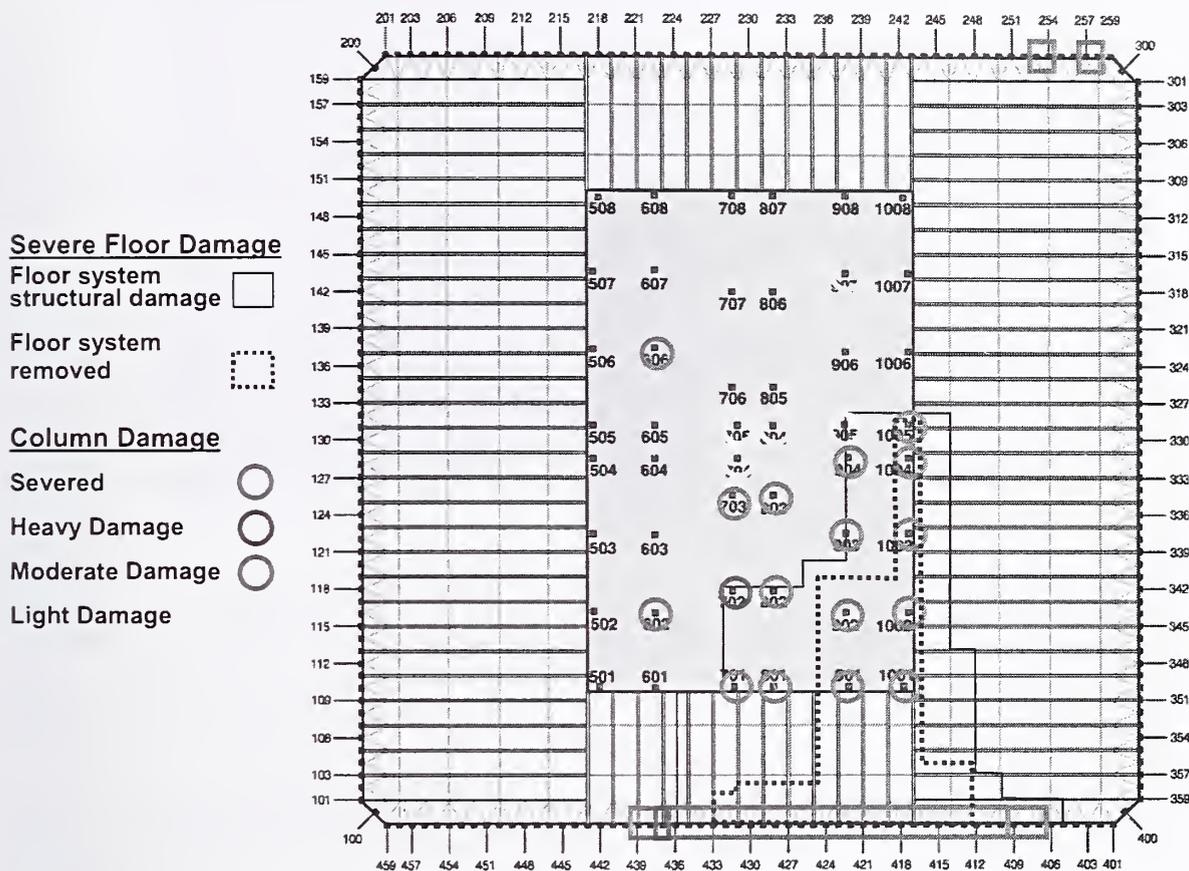
Figure E-60. Cumulative structural damage to the floors and columns of WTC 2 (more severe case).

Figure E-60 presents the cumulative damage to WTC 2 on all affected floors and columns for the more severe case.

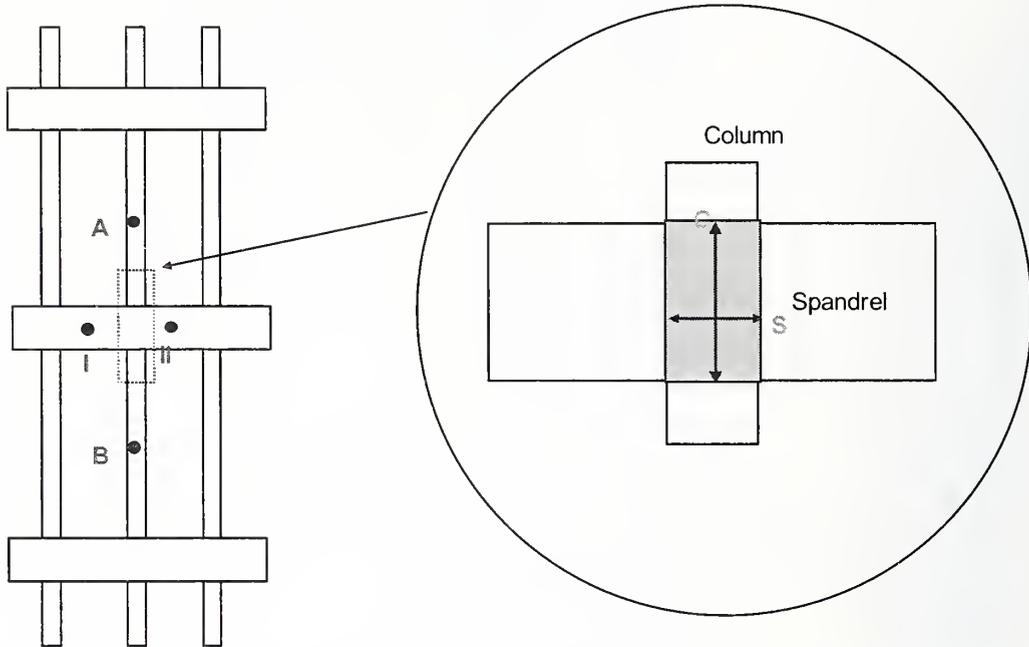
**Figure 2-8. Selection of column and spandrel rigidity of typical exterior wall panel.**

For studying the lateral deformation of the exterior panels, panel properties were taken from three different areas of the building at floors 79 to 82, 53 to 56, and 23 to 26. The deformations at points A, B, I, and II (Fig. 2-8) were studied for the three different panels. The top most columns were connected via a rigid link and loaded in the plane of the panel and perpendicular to the columns with a lateral load of 100 kip. The boundary conditions included roller supports at the spandrel ends and pin supports at the bottom of the columns as seen in Fig. 2-7.

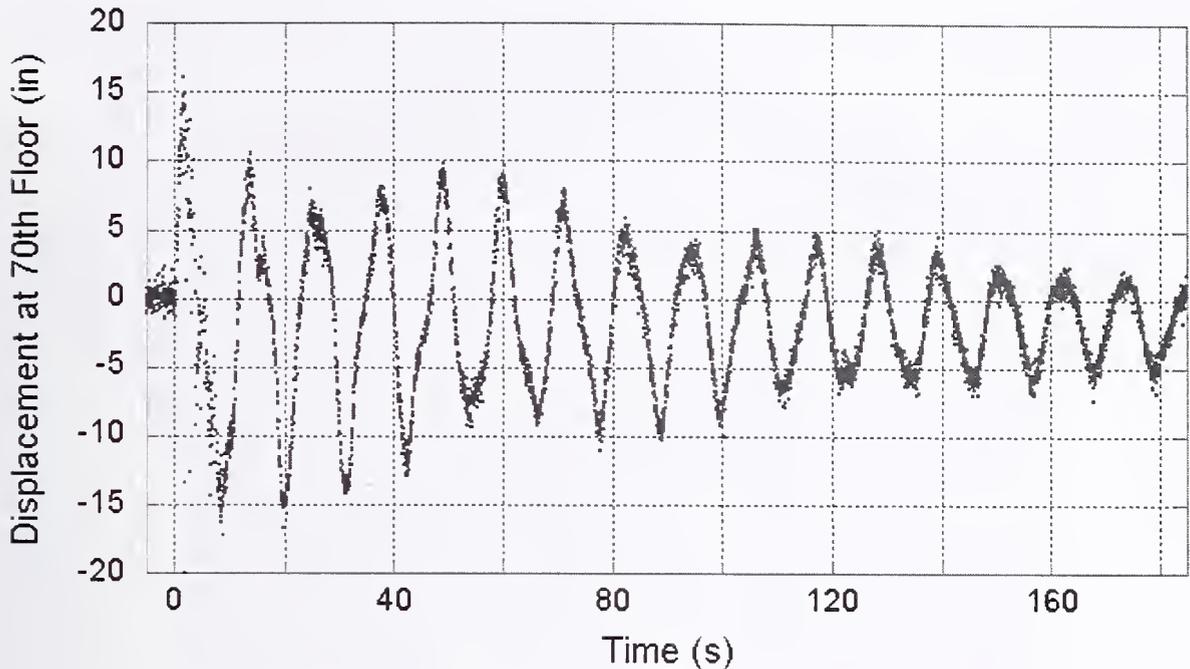
**Figure 2-15. Displacement of floor 70 of WTC 2 after impact based on video analysis (NIST NCSTAR 1-5A).**

The maximum displacement of the WTC 2 tower at floor 70 was measured to be about 12 in., while the maximum sway of the tower at the top was approximately 27 in. (NIST NCSTAR 1-5A).

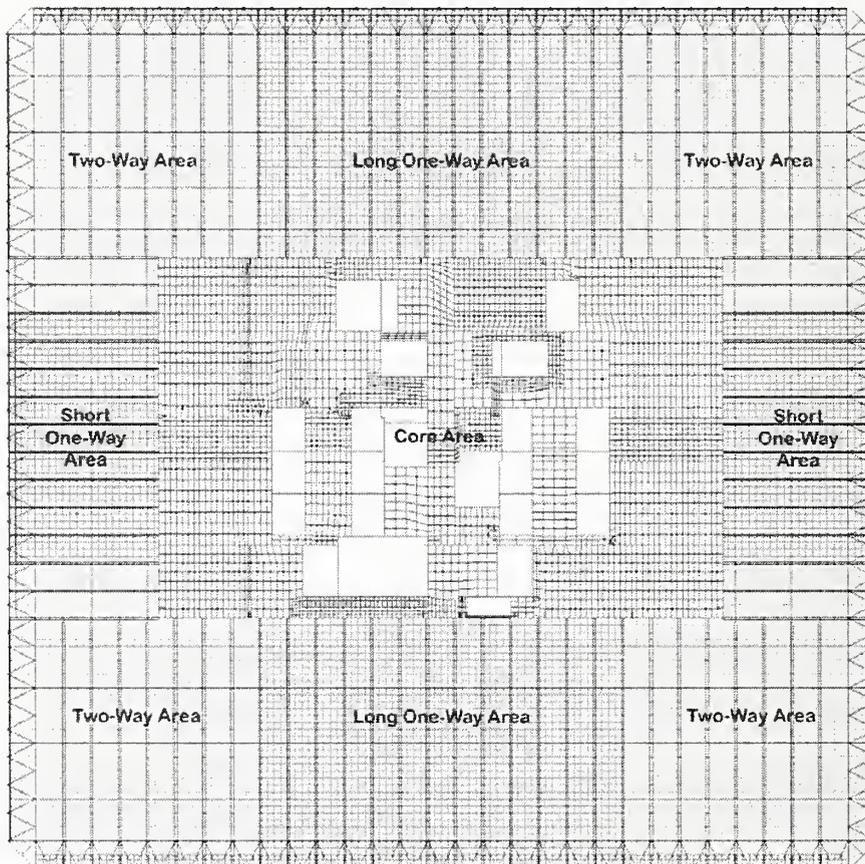
**Figure 2-16. Typical floor truss framing zones.**

trusses) normally found elsewhere. The secondary trusses had additional strength and connectivity to enable them to act in tandem with the long spanning trusses to form a two-way spanning truss grid. The floor trusses were pre-assembled into floor panels as defined in the contract drawings. The floor panels included primary trusses, bridging trusses, deck support angles, metal deck, and strap anchors. A typical composite beam and slab construction was used for the floors inside the core.

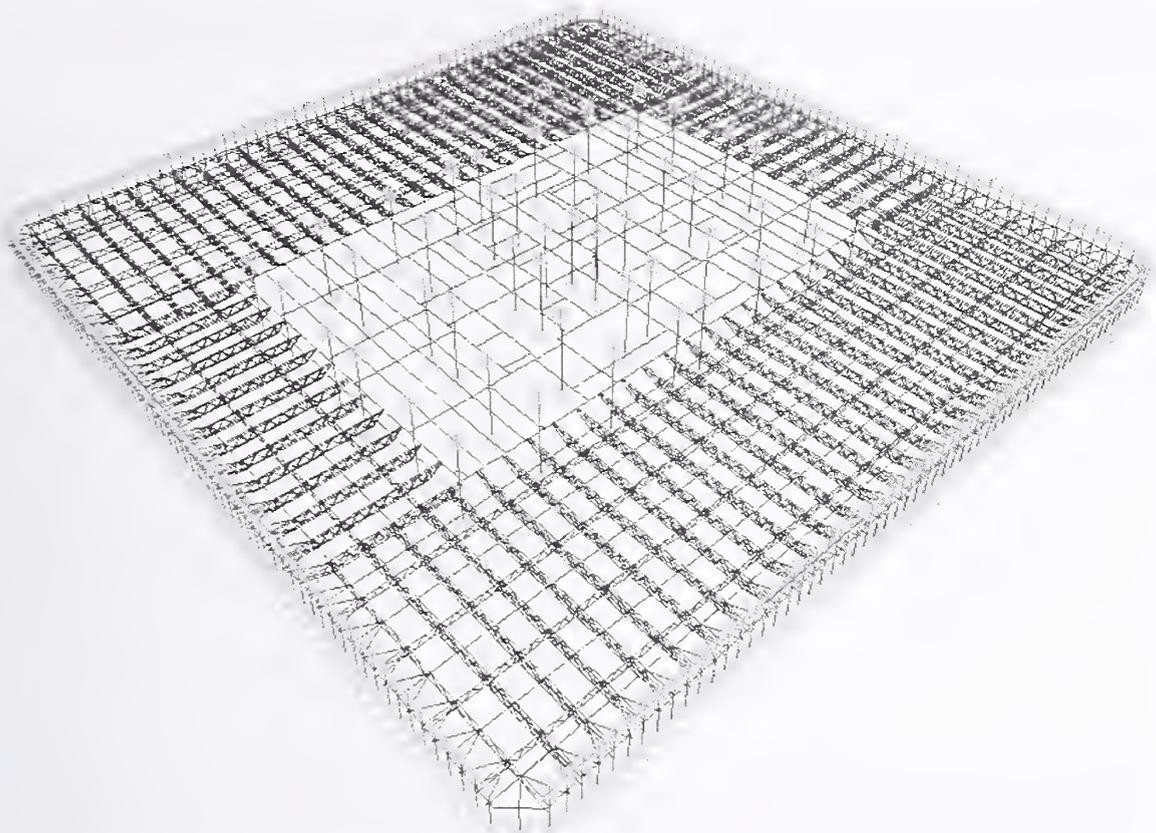
Figure 2–17. Typical truss-framed floor model (floor 96 of WTC 1), slab not shown.

In order to select the typical truss-framed floor within the expanded impact and fire zones of both towers, the drawings for floors 80 to 100 were reviewed to identify structural similarities. Appendix G of NIST NCSTAR 1-2A provides the details of this study. It was found that floor 96 of WTC 1 (96A) represented the typical truss-framed floor in the expanded impact and fire region for WTC 1 and WTC 2. An isometric view of the typical truss-framed floor model is shown in Fig. 2-17. Table 2-1 includes a summary of the size of the 96A floor model. The floor model consisted primarily of frame elements with the exception of the floor slabs, which were modeled using shell elements. The following summarizes the major components of the typical truss-framed floor model.

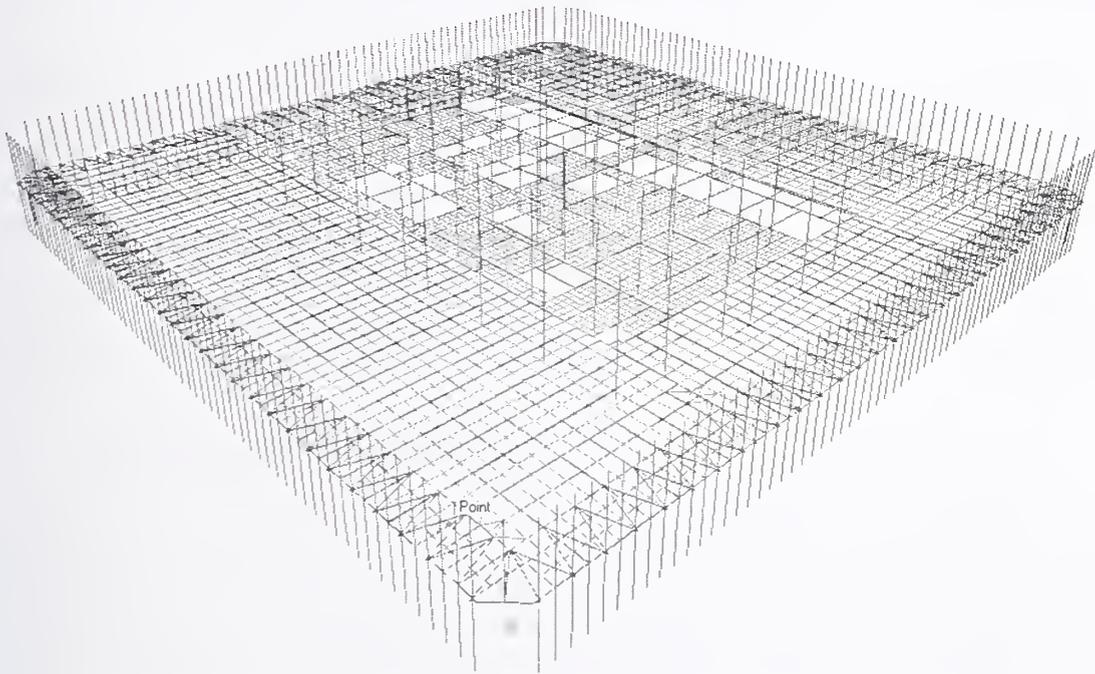
Figure 2-21. Typical beam-framed floor model (floor 75 of WTC 2).

As described in Section 2.4 for truss-framed floors, the structural drawings were reviewed to identify structural similarities between the beam-framed floors within the expanded impact and fire zones of both towers (see Appendix G of NIST NCSTAR 1-2A). It was found that floor 75 of WTC 2 (75B) represented the typical beam-framed floor in the expanded impact zone for WTC 2 (floors 74B to 88B). There were no beam-framed floors within the expanded impact zone of WTC 1. An isometric view of the typical beam-framed floor model is presented in Fig. 2-21. Table 2-1 includes a summary of the size of the 75B floor model. The following presents the major structural systems and components of the beam-framed floor model.

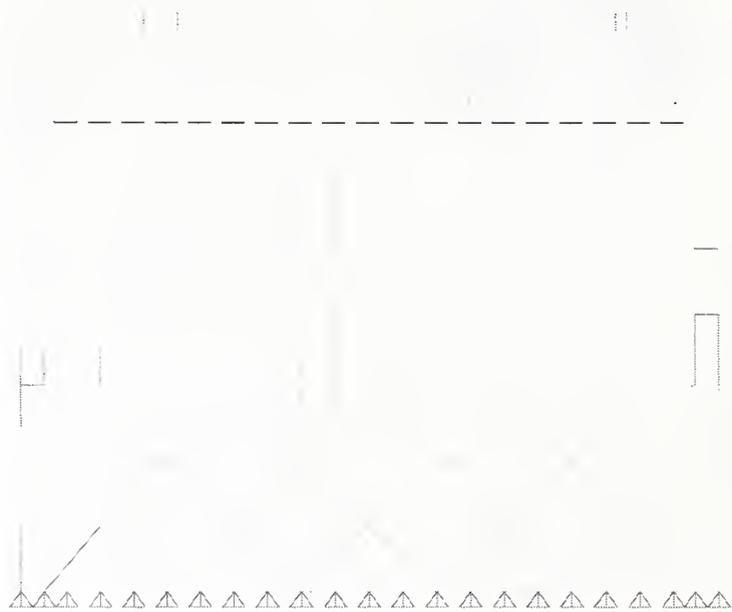
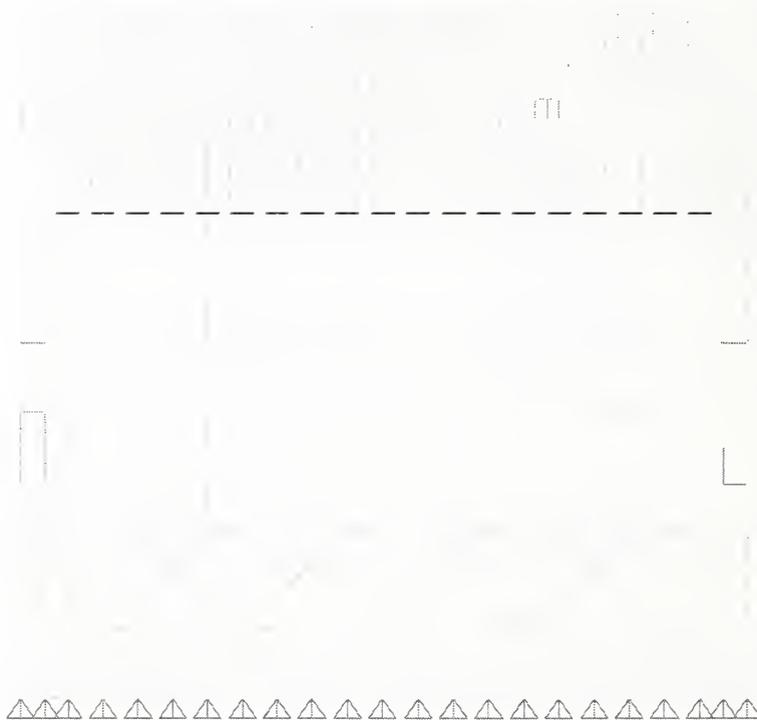
Figure 4-4. RCRs for WTC 1 under original design loads below floor 9, (a) north elevation, and (b) east elevation.

Fig. 4-3 shows the distribution of DCRs for the four exterior walls of WTC 1 under the original design load case. Close-up views are shown for the exterior walls below floor 9 in Fig. 4-4. DCRs for the WTC 1 core columns are provided in Fig. 4-5. Similar plots for WTC 2 DCRs can be found in Chapter 5 of NIST NCSTAR 1-2A.

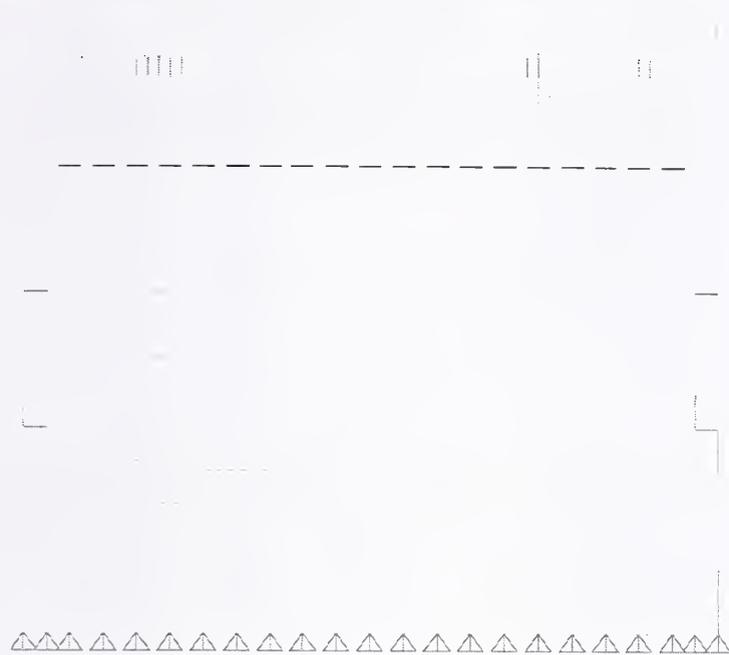
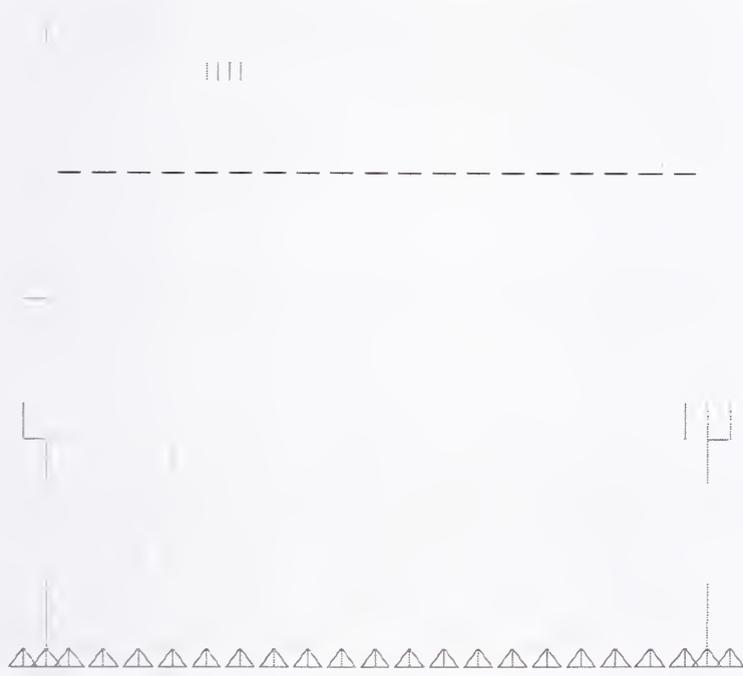
Figure 4-4. (c) south elevation, and (d) west elevation (continued).

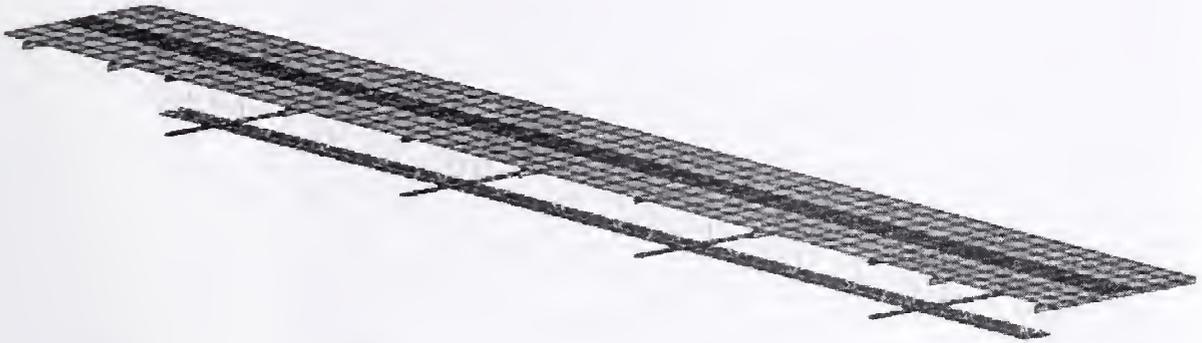
**Figure 5–12. Model of a truss floor segment.**

individual truss floor segments spanned the distance from the exterior wall to the core. An example of a truss floor segment used in the global model is shown in Figure 5–12. In the double truss sections, the two trusses were modeled explicitly with the proper dimensions.

The floor truss model was developed using a uniform layer of Belytschko-Tsay shell elements for the combined floor slab and metal decking, Belytschko-Tsay shell elements for the truss upper and lower chord components, and Hughes-Liu beam elements for the round bar truss diagonals. The upper chord was attached to the floor slab using a tied interface. This approach, using shell elements as opposed to solid brick elements for the floor slab, was adapted to reduce the model size requirements. Development of a model with matching mesh density in the slab and truss structures (nodal alignment for a merged connection) resulted in a much larger model size. Bridging trusses were modeled in a similar fashion to the primary trusses.

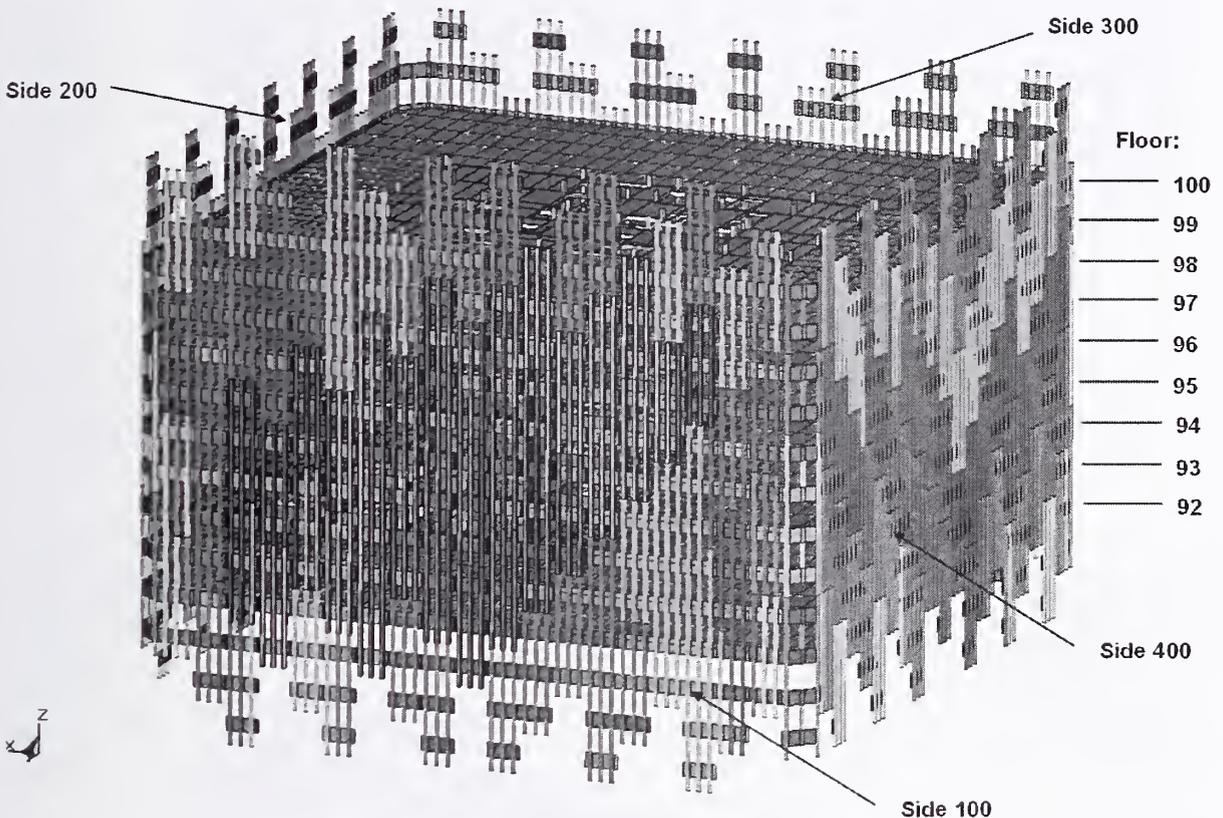
Figure 5–18. Global impact model of the WTC 1 tower.

The multiple floor global model of the impact zone in WTC 1 is shown in Figure 5–18. The model included the complete floors inside and outside the core, the exterior walls, and core structures for floors 92 through 100. The boundary conditions at the top and bottom of the exterior and core columns were constrained vertical displacements. This allowed for free translations of the tower structure in the longitudinal and lateral directions and rotation about the vertical axis. The higher resolution exterior wall panels in the impact zone can be seen on the impact face of the tower model (side 100).

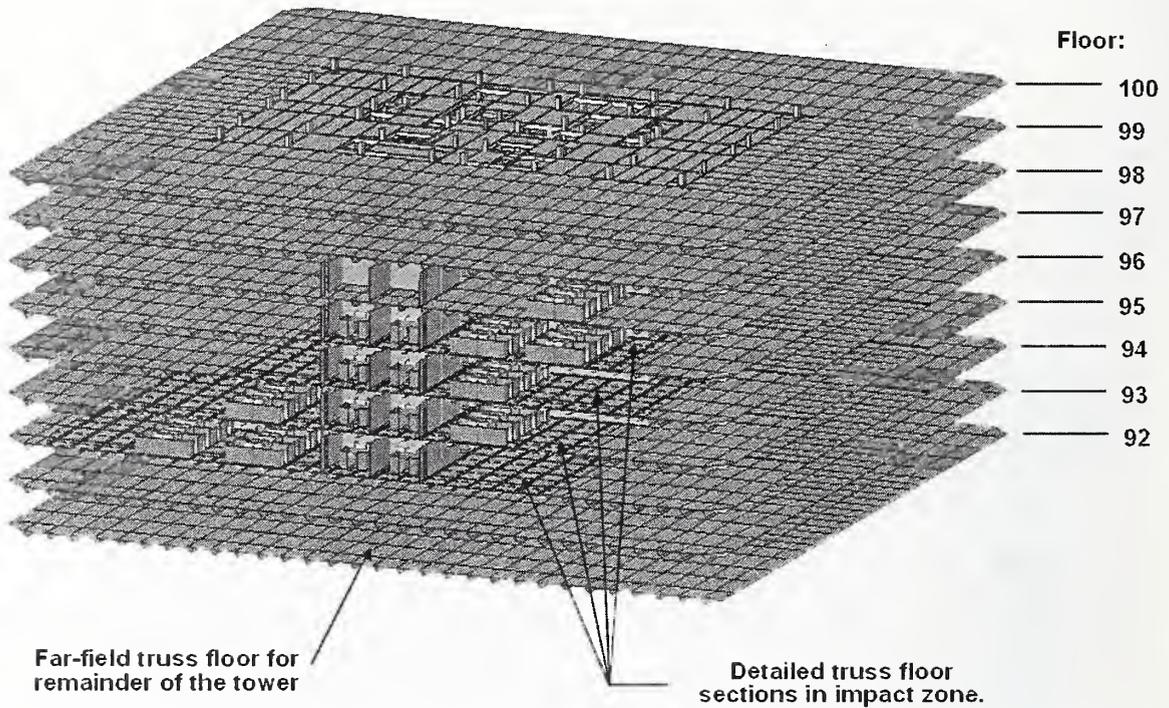
Figure 5-19. Interior structures and contents of the WTC 1 global impact model.

In the assembled global model, the core columns for floors 93 through 98 of WTC 1 were modeled with higher resolution than that in the floors above and below the direct impact zone. This higher mesh resolution was needed to capture the local damage that occurred from direct impact of aircraft structures and debris.

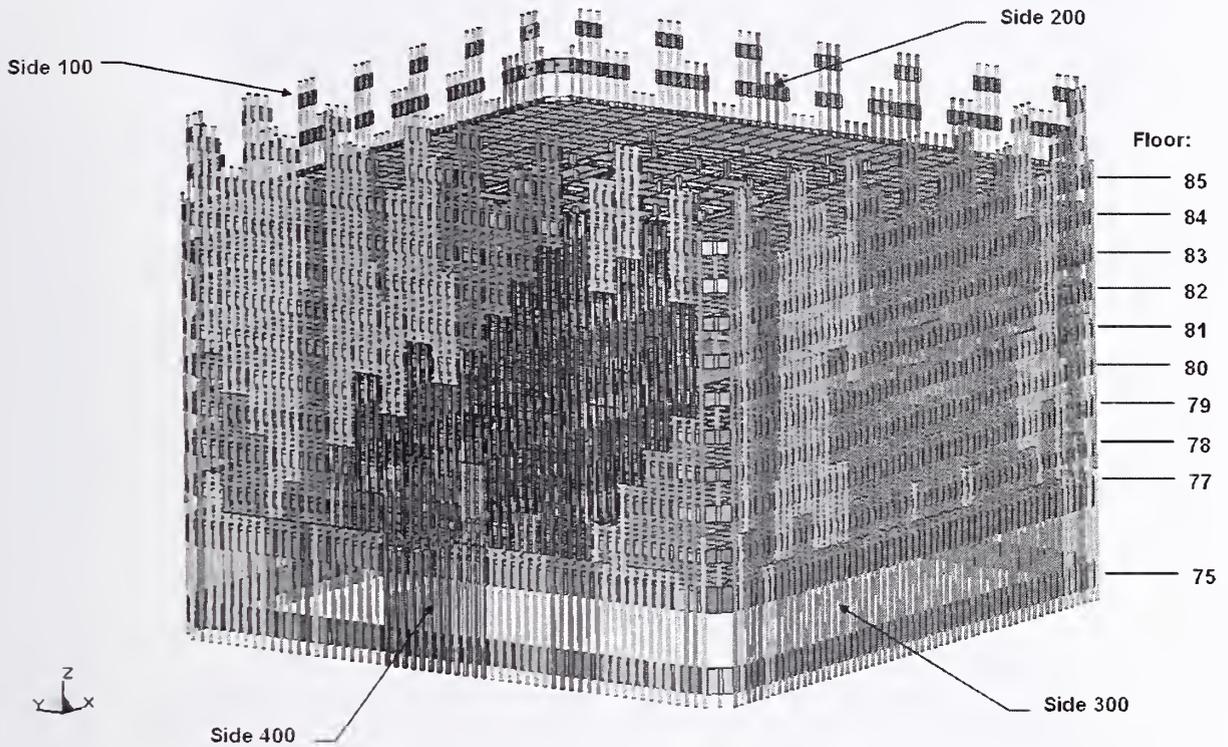
**Figure 5–21. Global impact model of the WTC 2 tower.**

The WTC 2 global impact model is shown in Figure 5–21. The model included the complete floor inside and outside the core for floors 77 through 85. The exterior wall panels at the bottom end of the model extended downward below floor 75. The boundary conditions at the top and bottom of the exterior and core columns were the same as those for the WTC 1 model. The higher resolution exterior wall panels in the impact zone can be seen on the impact face of the WTC 2 tower model (Side 400).
