NIST NCSTAR 1-2

# Baseline Structural Performance and Aircraft Impact Damage Analysis of the World Trade Center Towers

Fahim Sadek  
*Building and Fire Research Laboratory*  
*National Institute of Standards and Technology*

September 2005

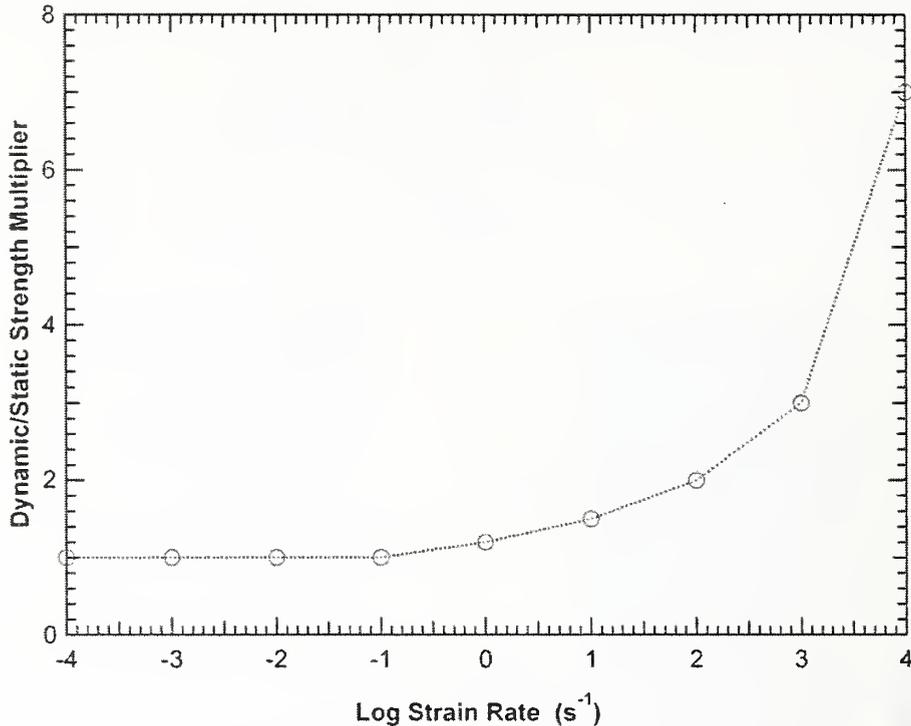
Figure 5-29. Tabular concrete strain rate effects curve.

Experimental characterization of the strain rate effects on concrete is difficult, and there is a wide scatter in data that is influenced by concrete type, strength, and the testing methods applied. In general, elevated strain rate loading has a greater influence on the tensile strength than on the compressive strength. However, in the aircraft impact response of the WTC towers, the majority of the high-rate damage occurs with impact and penetration of the floor slab by hard components such as the aircraft engine. As a result, the strain rate effects for compressive loading were used for the constitutive model. The strain rate effects were added to the model in tabular form. The rate effects curve used in the model is shown in Figure 5-29, based on the work of Bischoff and Perry (1991) and Ross et al. (1992). The curve was selected to provide a relatively smooth fit to the available compressive rate effects data on compressive strength.

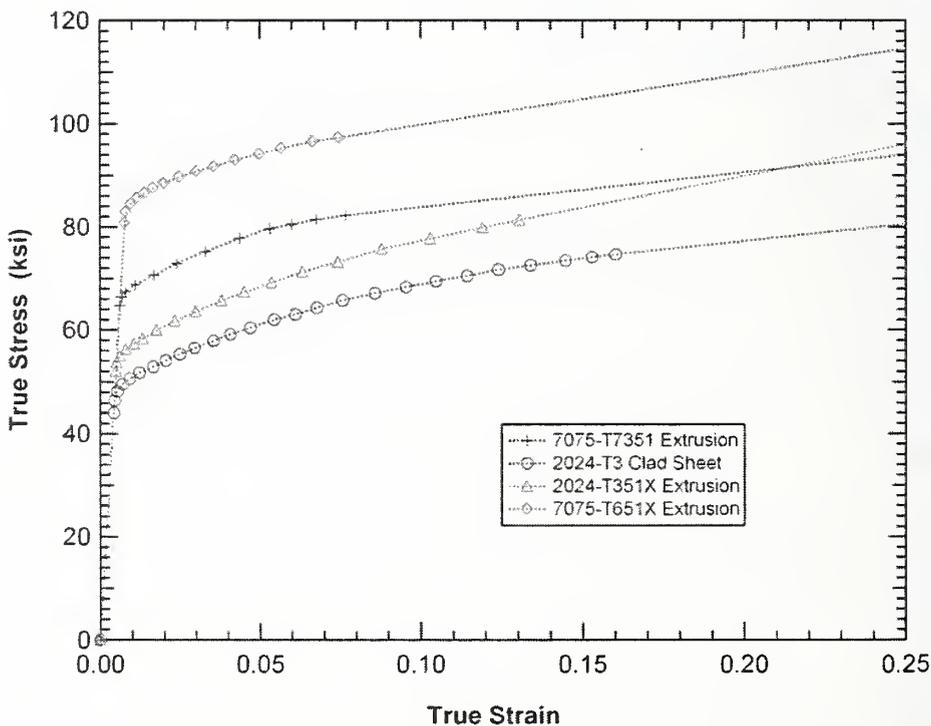
Figure 5–43. True stress-strain curves developed for various aircraft aluminum alloys.

Complete engineering stress-strain curves were provided in the MIL-HDBK-5F for various 2024 and 7075 aluminum alloys that are commonly used in the construction of the Boeing 767 airframe. These curves were digitized for the various 2024 and 7075 alloys. Representative stress-strain curves were then converted into true stress and true strain and used to develop tabular curves for constitutive models. The calculated true stress-strain curves and tabular constitutive model fits are shown in Figure 5–43 and Figure 5–44, respectively. Appropriate failure criteria for the aircraft materials were developed using the fine and coarse wing component models, see NIST NCSTAR 1-2B. No rate sensitivity of the aircraft materials was considered.

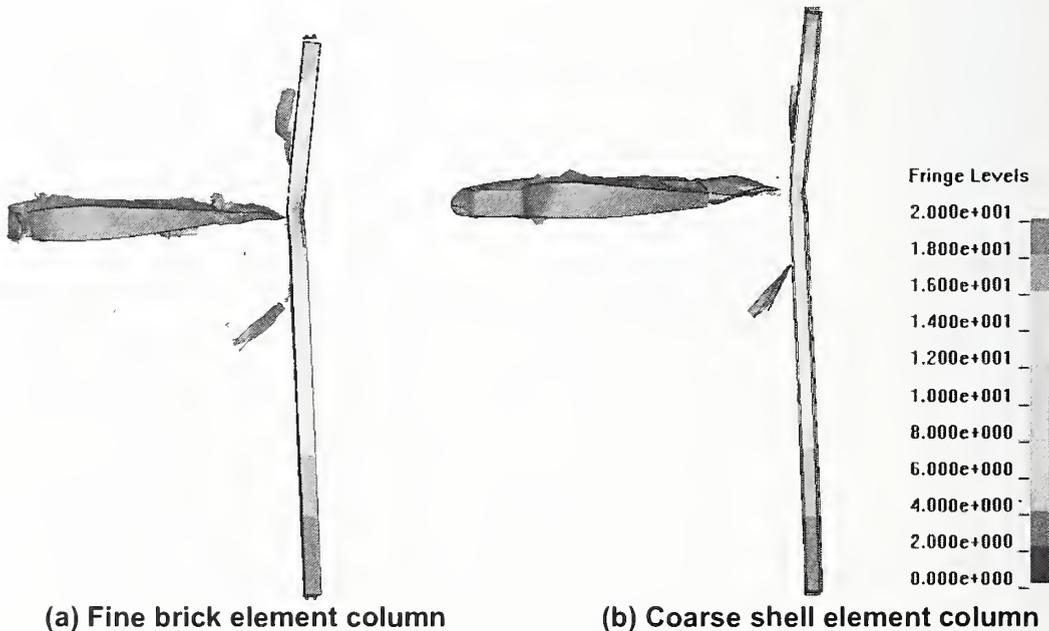
Figure 5–45. Exterior column response comparison, showing contours of the displacement magnitude (in.).

The calculated impact response is shown in Figure 5–45. The column model on the left has the fine mesh of brick elements, and the column model on the right has the coarse mesh of shell elements. Contours of resultant displacements are shown on the column components. The figure indicates that the overall response was similar in both magnitude and damage mode. The reduction in model refinement resulted in a significant reduction in run time from over 600 min to 9 min. This comparison demonstrated the significance of the mesh refinement on capturing local stress and strain concentrations and the resulting effect on the impact response.

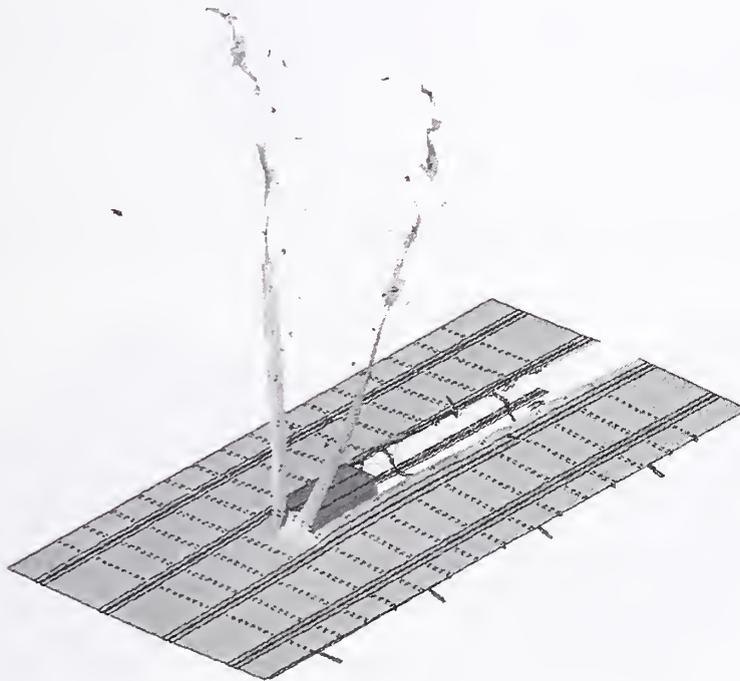
Figure 5-52. Floor assembly impact response with shell element concrete slab.

The impactor used in the component modeling was a simplified plow type impactor, which produced repeatable damage, not complicated by all the debris and randomness associated with an engine-floor impact. The weight of the plow impactor was comparable to an engine, and the impact speed was 500 mph, applied horizontally. An example analysis with a plow impactor and the fine mesh floor model is shown in Figure 5-51. The calculated impact damage with the coarser shell element floor system model is shown in Figure 5-52. This component impact configuration was useful for comparing the differences in response with changes in the modeling methods or refinement.

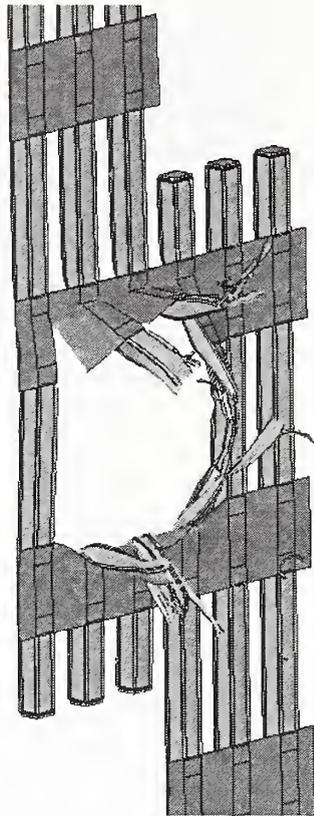
(a) With SPH approach

Figure 5-56. Impact response of a wing section laden with fuel modeled using SPH approach.

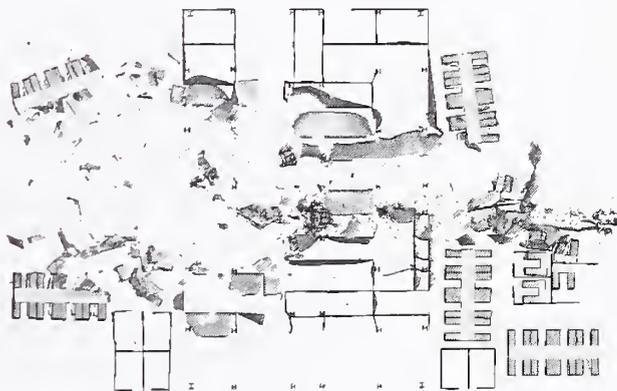
(c) Calculated impact response (fuel removed)

Figure 7-30. Calculated more severe WTC 1 impact response of floor 95 contents.

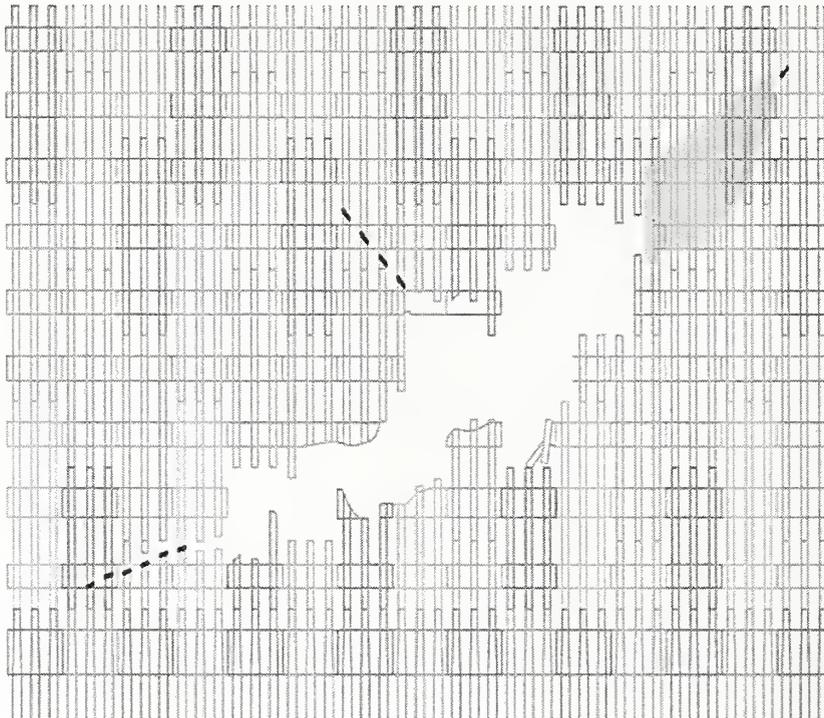
(a) Schematic of observed damage

Figure 7-36. Base case impact damage to the WTC 2 exterior wall.

As was the case for WTC 1, there were small differences in the damage estimates for the south wall of WTC 2 from the base case and the more severe case scenarios (compare Figure 7-36 and Figure 7-50). Overall, the agreement with the observed damage from photographs was very good for both cases. The most obvious differences were largely due to portions of panels that may have severed columns in one case or have been removed at the connections in another.

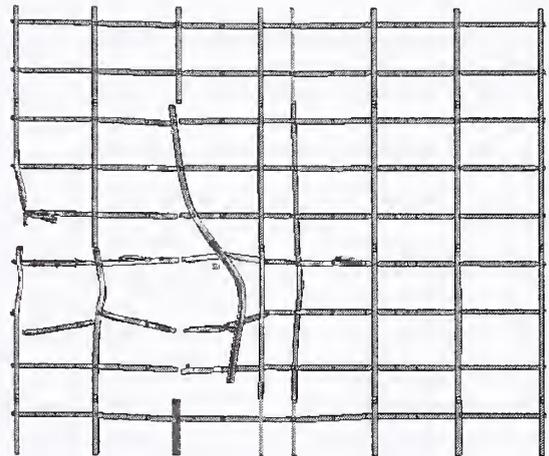
(b) Columns 901-908

The calculated damage to the core columns by row is shown in Figure 7-37. The columns are shown with color fringes representing plastic strain magnitude, with undamaged sections in blue and strains at or above 5 percent shown in red. A summary of the column damage is listed in Table 7-6. The qualitative classification of the column damage levels were provided previously in Figure 7-7. The damage to the core beams for floors 80 and 81 is shown in Figure 7-38.

Figure 7-37. Base case impact damage to the WTC 2 core columns.

The core had significant damage in the region close to the impact point, in particular the southeast corner of the core. The columns in line with the aircraft fuselage failed on the impact side, and several of the core beams were also severely damaged or failed in the impact zone. In some cases, failure of the column splices located on floors 77, 80, and 83 contributed significantly to the failure of the core columns. This was particularly true for the heavy column number 1001 at the southeast corner of the core that failed at the three splice locations.

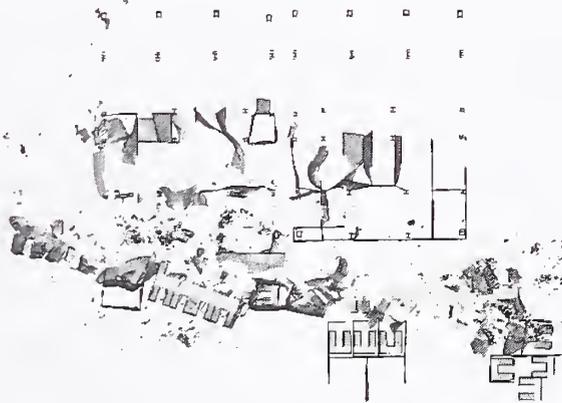
(c) Calculated impact response (fuel removed)

Figure 7-46. Calculated floor 80 contents, and fuel distribution (base case).

Plots of debris distribution and damage to tower contents at the end of the impact simulation similar to those in Figure 7-46(c) and Figure 7-47(c), were used to estimate the damage to fireproofing. The extent of dislodged fireproofing was estimated by considering fireproofing damage only to structural components in the direct path of debris. For details of the methodology and the extent of fireproofing damage, see NIST NCSTAR 1-6.

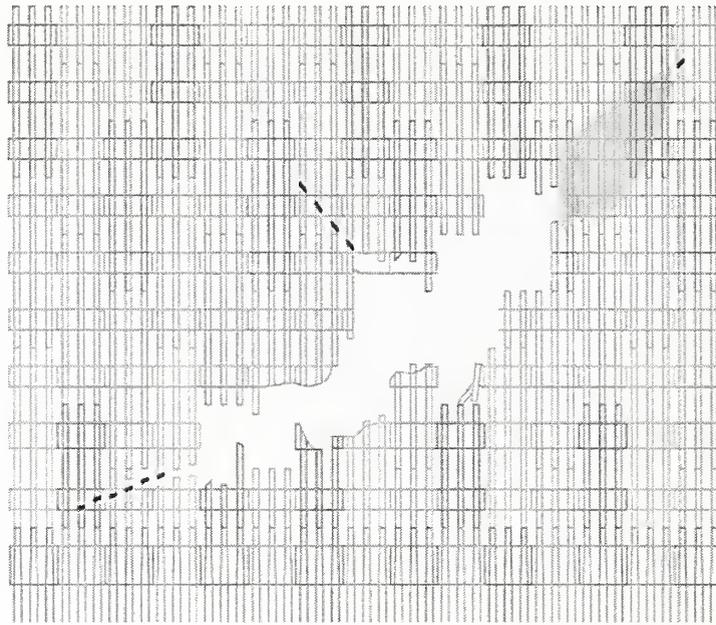
(a) Schematic of observed damage

A comparison of the south exterior wall observed and calculated damage from the more severe WTC 2 global impact analysis is shown in Figure 7-50. The calculated impact damage to the exterior wall is shown with color fringes representing plastic strain magnitude, with undamaged sections in blue and strains at or above 5 percent shown in red. The mode and magnitude of the calculated and observed impact damage on the exterior wall were still in good agreement in this more severe impact analysis.

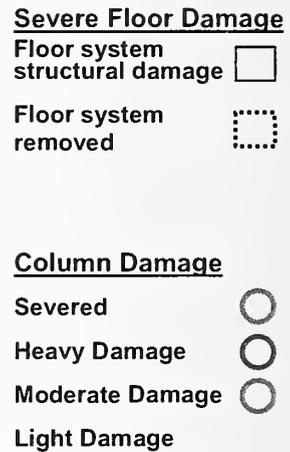
Figure 7-56. Summary of the floor-by-floor structural damage to the floors and columns of WTC 2 (more severe case) (continued).

Figure 7-56 shows a summary of the structural damage to the core columns and floor systems at floors 77 through 83 of WTC 2 for the more severe case (Case D). Figure 7-57 presents the cumulative damage to WTC 2 on all affected floors and columns.

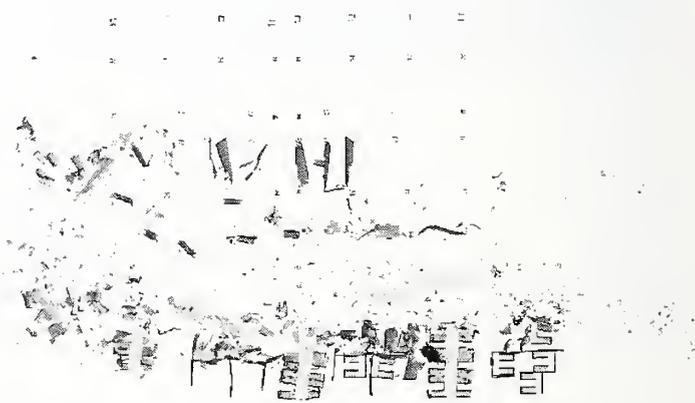
(c) Calculated impact response (fuel removed)

Figure 7–61. Calculated floor 81 contents and fuel distribution (more severe case).

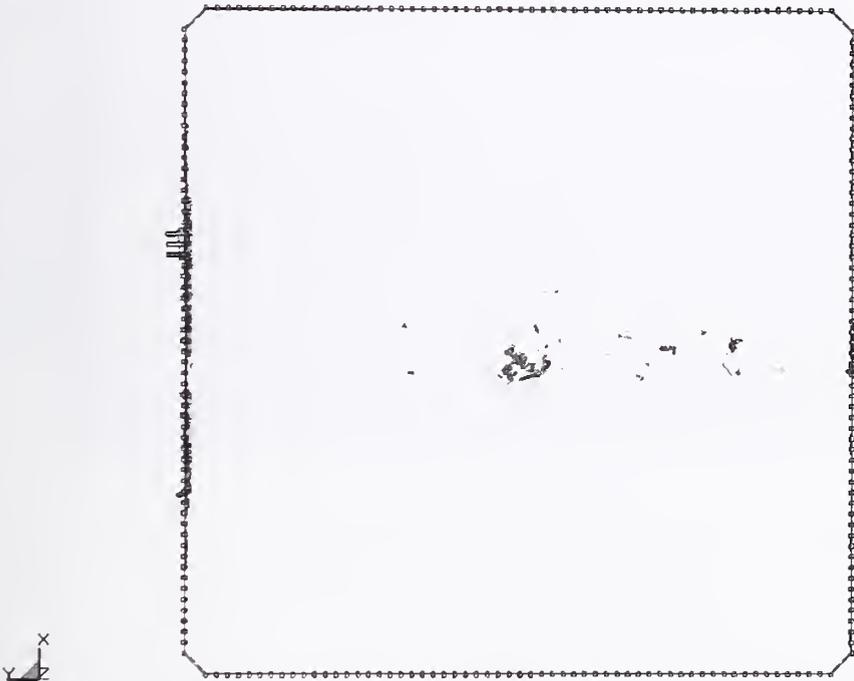
(b) Calculated landing gear debris (t = 0.685 s)

Figure 7-67. More severe damage aircraft debris distribution in WTC 1.

The amount of aircraft debris found to exit WTC 1 in the global impact analyses varied, as shown in Figure 7-67 and Figure 7-68. However, no portion of the landing gear was observed to exit the tower in the simulations, but rather was stopped inside, or just outside, of the core. In order to simulate the trajectory of specific pieces of aircraft debris, a fairly precise knowledge of the internal configuration of the building was needed. This is especially true with components passing through the core of the building, where some of the most massive building contents and partition walls were present. Uncertainties regarding the internal layout of each floor, such as the location of hallways or walls, could make the difference between debris from a specific component passing through or being stopped inside the tower. In addition, modeling uncertainties and assumptions might play a role in not matching the observable.

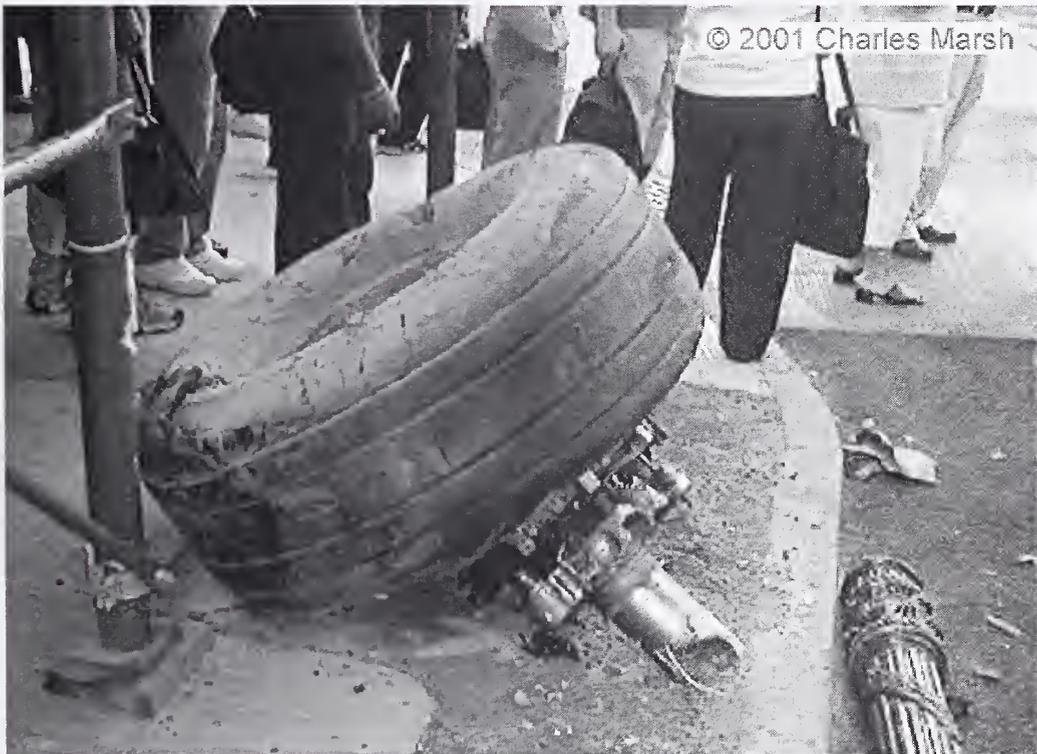
Figure 7-69. Landing gear found at the corner of West and Rector Streets.

A portion of the main landing gear of AA 11 exited WTC 1 at the 94th or 95th floor and landed at the corner of Rector St. and West St. The debris consisted of a tire, wheel, brake assembly and hub of a main landing gear, as shown in Figure 7-69. Based on the final position of the landing gear and assuming the landing gear to be a projectile with a horizontal initial velocity, the exit speed of the landing gear from the south wall of WTC 1 can be estimated to be about 105 mph. Note that there is a significant uncertainty in this estimate associated with the exit trajectory, aerodynamic effects, landing position rather than final resting position of debris, etc. Another piece of landing gear debris, shown in Figure 7-70, was found embedded in what is postulated to be the panel containing columns 329, 330, 331, running from the 93rd to the 96th floors. This panel was dislodged from the building and found at Cedar Street near its intersection with West Street. As little other damage had been documented on the south face of WTC 1,

it is postulated that the landing gear debris that landed at the corner of Rector St. and West St. also exited through this panel location.

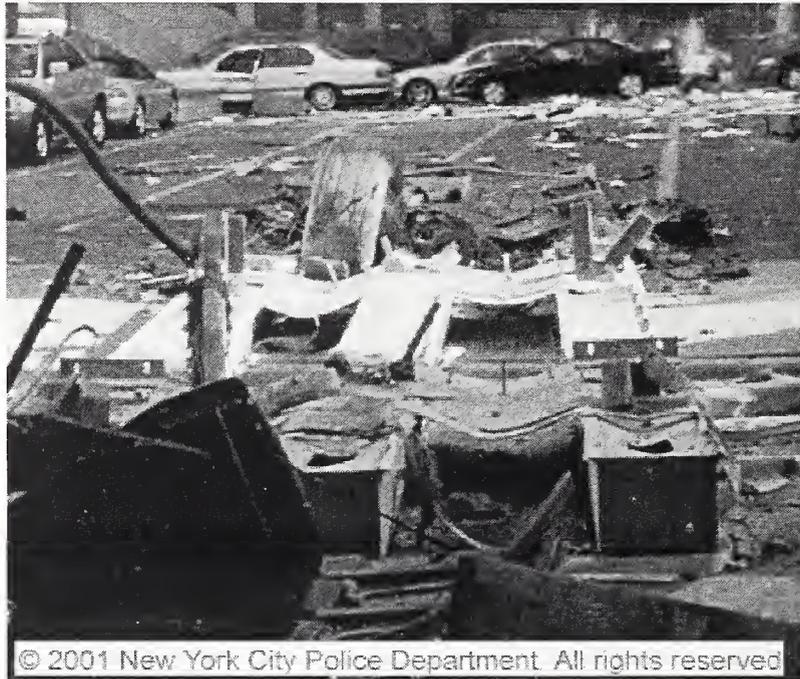
**Figure 7–70. Landing gear found embedded in exterior panel knocked free from WTC 1.**

The exterior panel from column 329 to 331 between floors 94 through 96 on the south face of WTC 1 was knocked free by landing gear and possibly other debris (see NIST NCSTAR 1-5A). These columns were located in the center of the south wall of the WTC 1. In both the base case and more severe damage global analyses, aircraft debris impacted the south face of the tower, as shown in Figure 7-66 and Figure 7-67, and exited the building. The figures also show the calculated landing gear debris for both simulations. None of the debris impacting the south wall happened to contain landing gear fragments. In the base case analysis, the debris impacted columns 328 to 330 at floor 96. In the more severe impact analysis, debris impacted columns 328 to 333 on both floors 95 and 96. In the base case analysis, very little damage was done to the exterior panels on the south wall. However, damage was heavy in the more severe damage analysis, as shown in Figure 7-68.

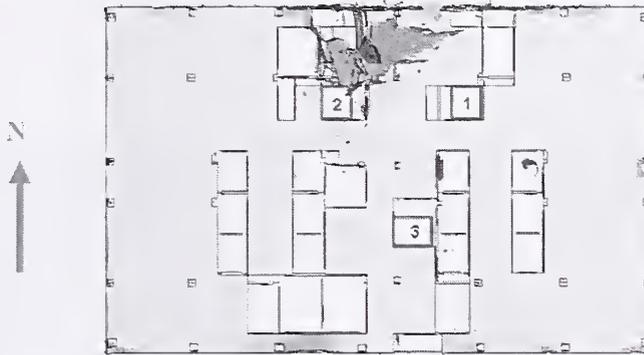
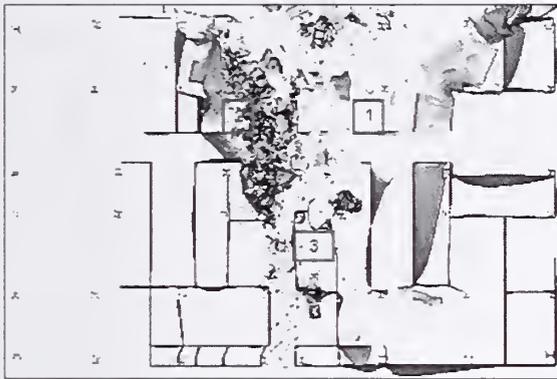
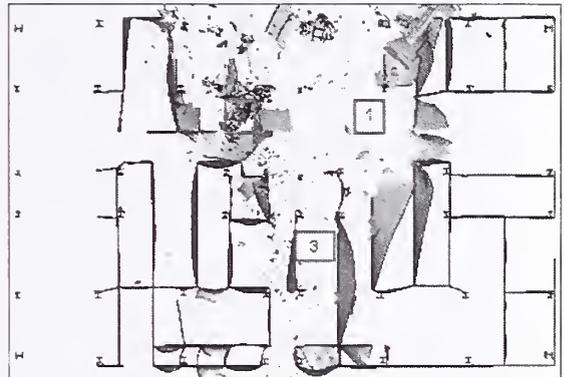
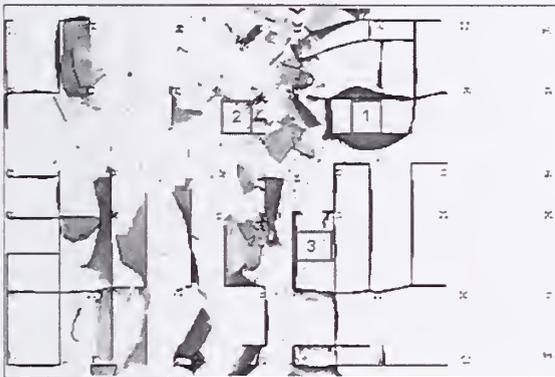
According to eyewitness interviews, stairwells 1 (referred to also as stairwell A), 2 (stairwell C), and 3 (stairwell B) inside the core were impassable at floor 92 and possibly above after the impact of AA 11 (see NIST NCSTAR 1-7). The calculated base case stairwell disruption is shown in Figure 7–71 for floors 93 through 97. Stairwell positions are outlined with red boxes in the figure. No debris or disruption was observed to the core on floor 92 in the calculation, therefore, it is not shown in the figure. Recall that the global model for WTC 1 only contained partition walls in the core on floors 94 through 97. Therefore, the ability to ascertain damage and/or debris in the stairwell on floors 92 and 93 was limited. The floor slab was removed from the view on floors 94 through 97 so that debris is more visible.

Based on the calculated damage to, or debris in, the stairwells on floors 94 to 96, all three stairwells appear impassable. Given that falling debris in these areas would cause further subsequent damage to the floors below, as well as block passage on these floors, this result was reasonably consistent with the eyewitness accounts.

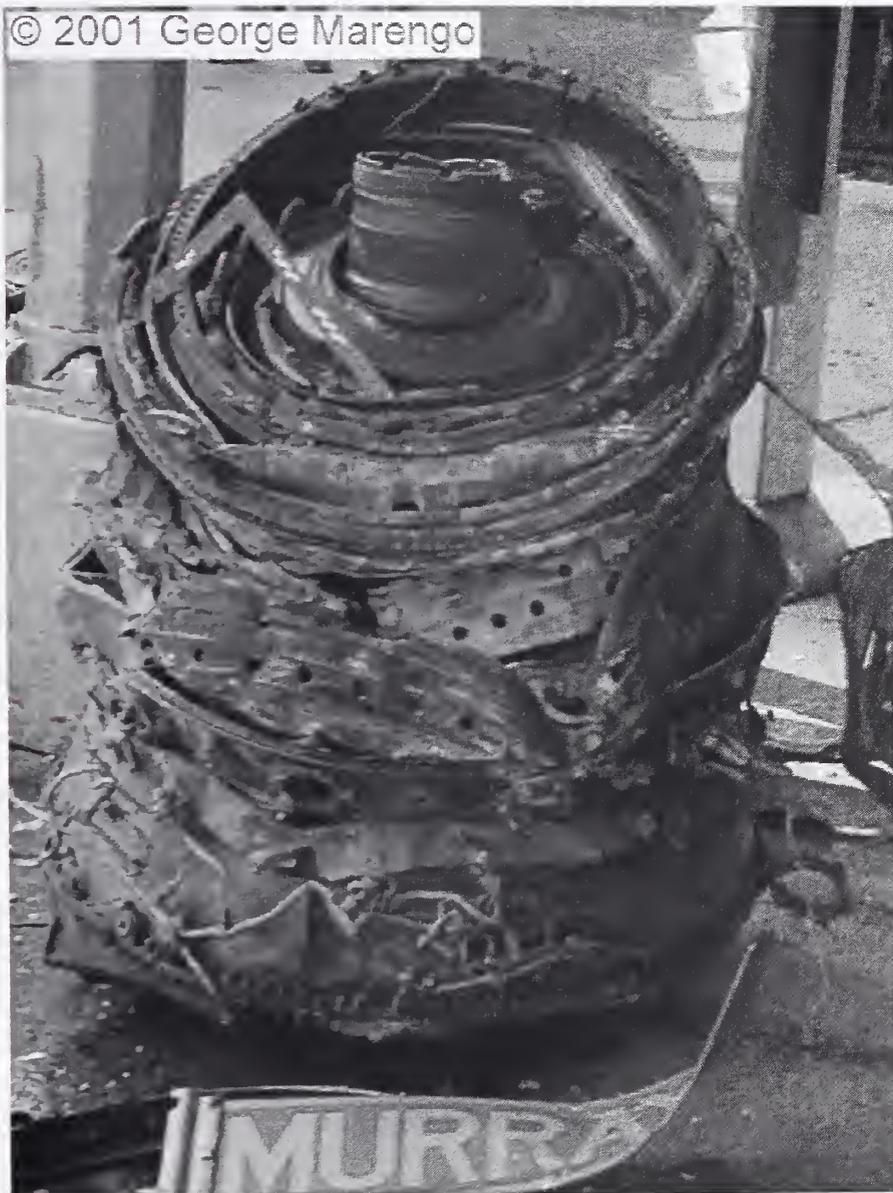
(c) Engine fragment found at Murray and Church St.

Figure 7-82. Calculated and observed engine damage.

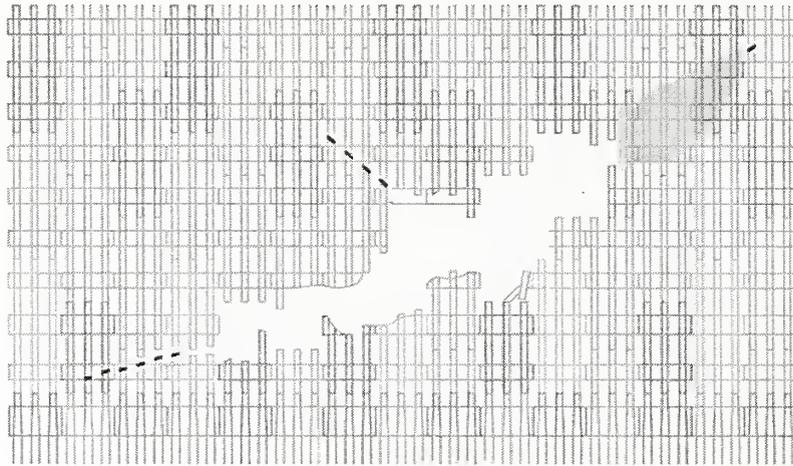
(a) Schematic of observed damage

The calculated base case impact damage to the exterior north wall of WTC 1 from this study is compared to the impact damage calculated by WAI in Figure 7-86. The figure also shows a schematic of the damage observed in photographic evidence. Figure 7-87 shows a similar comparison for the south wall of WTC 2. In both towers, the base case impact damage estimated in this study closely matched the observed damage. The damage profiles in the WAI impact simulations had some noticeable differences. The first was that the damage profile included complete failure of the exterior columns over the entire length of the wings and to the top of the vertical stabilizer. The second difference was that the failure mode of the exterior walls was dominated more by local rupture of the columns adjacent to the impact point with less influence of the bolted connections on panel failure and removal.
