NIST NCSTAR 1-3B

**Federal Building and Fire Safety Investigation of the
World Trade Center Disaster**

Steel Inventory and Identification

Stephen W. Banovic

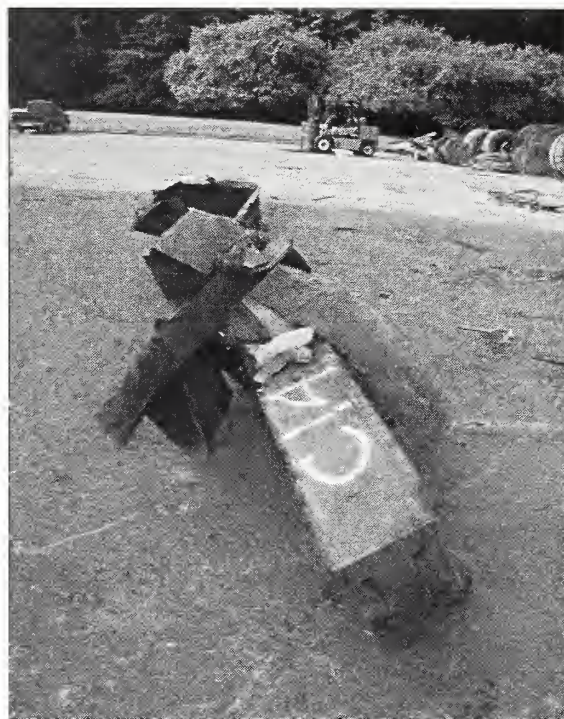
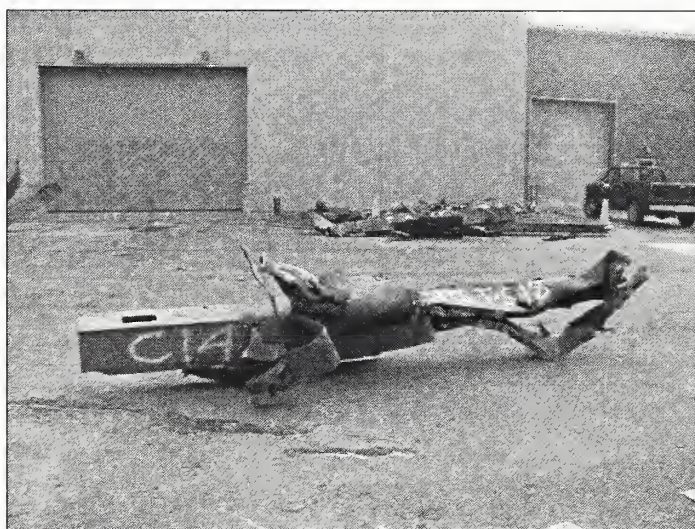
**Figure 3–1. Characteristic “overall” view of the samples taken for each piece received.
Sample shown here is C-14.**

As samples were delivered, overall images of the pieces were taken for record-keeping purposes. An example is shown in Fig. 3-1. Samples are identified by their original alphanumeric identification codes assigned by Structural Engineers Association of New York to be consistent with the Federal Emergency Management Agency report. However, there were cases in which two different codes were found on one piece. In these instances, if the pieces were already undergoing documentation procedures, the first code noted was used. Samples that arrived lacking a code were labeled as part of the U series. Additionally, samples brought from Hanger 17 at John F. Kennedy International Airport maintained their "B"-series labels provided in the Voorsanger report.²

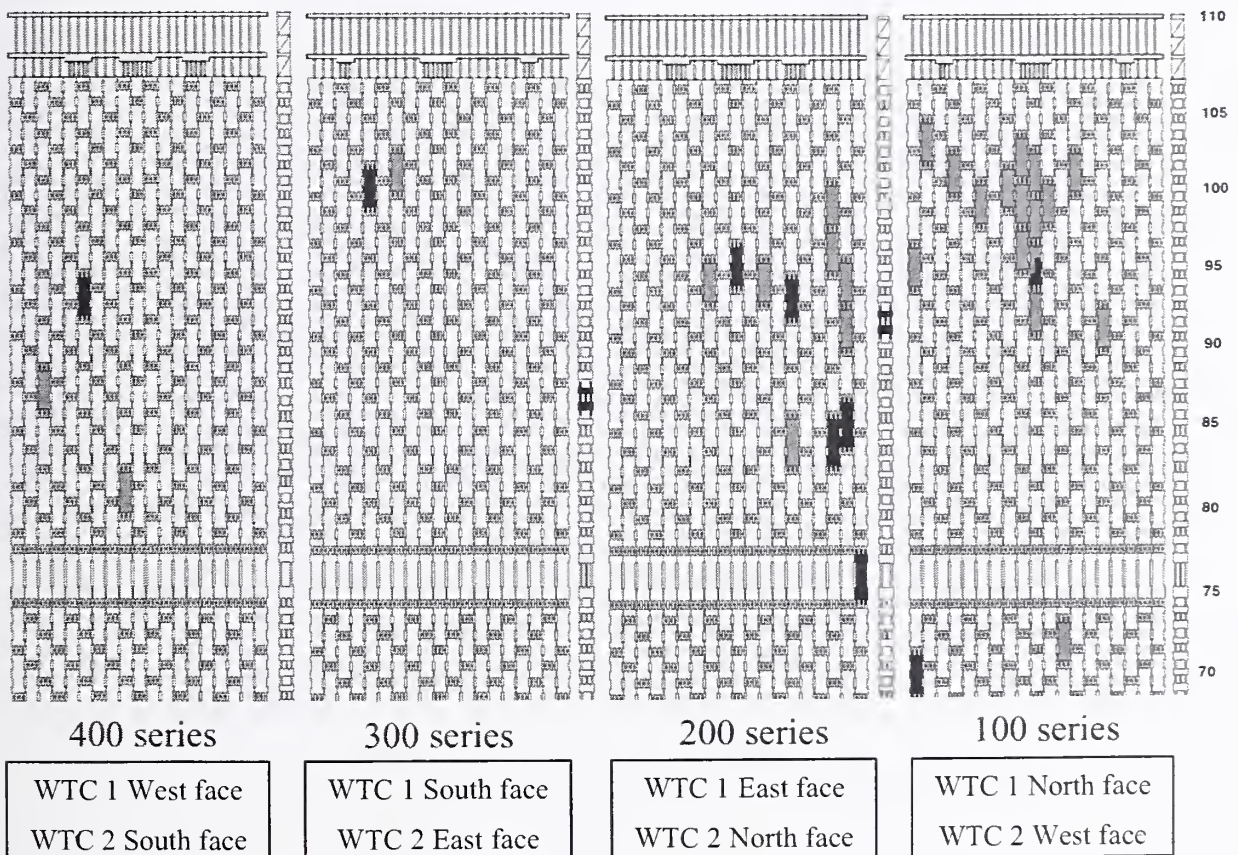
Note: WTC 1 panels are shown in green and WTC 2 panels are in blue.

Figure 3–2. Location of the exterior panels recovered from the top third of WTC 1 and WTC 2.

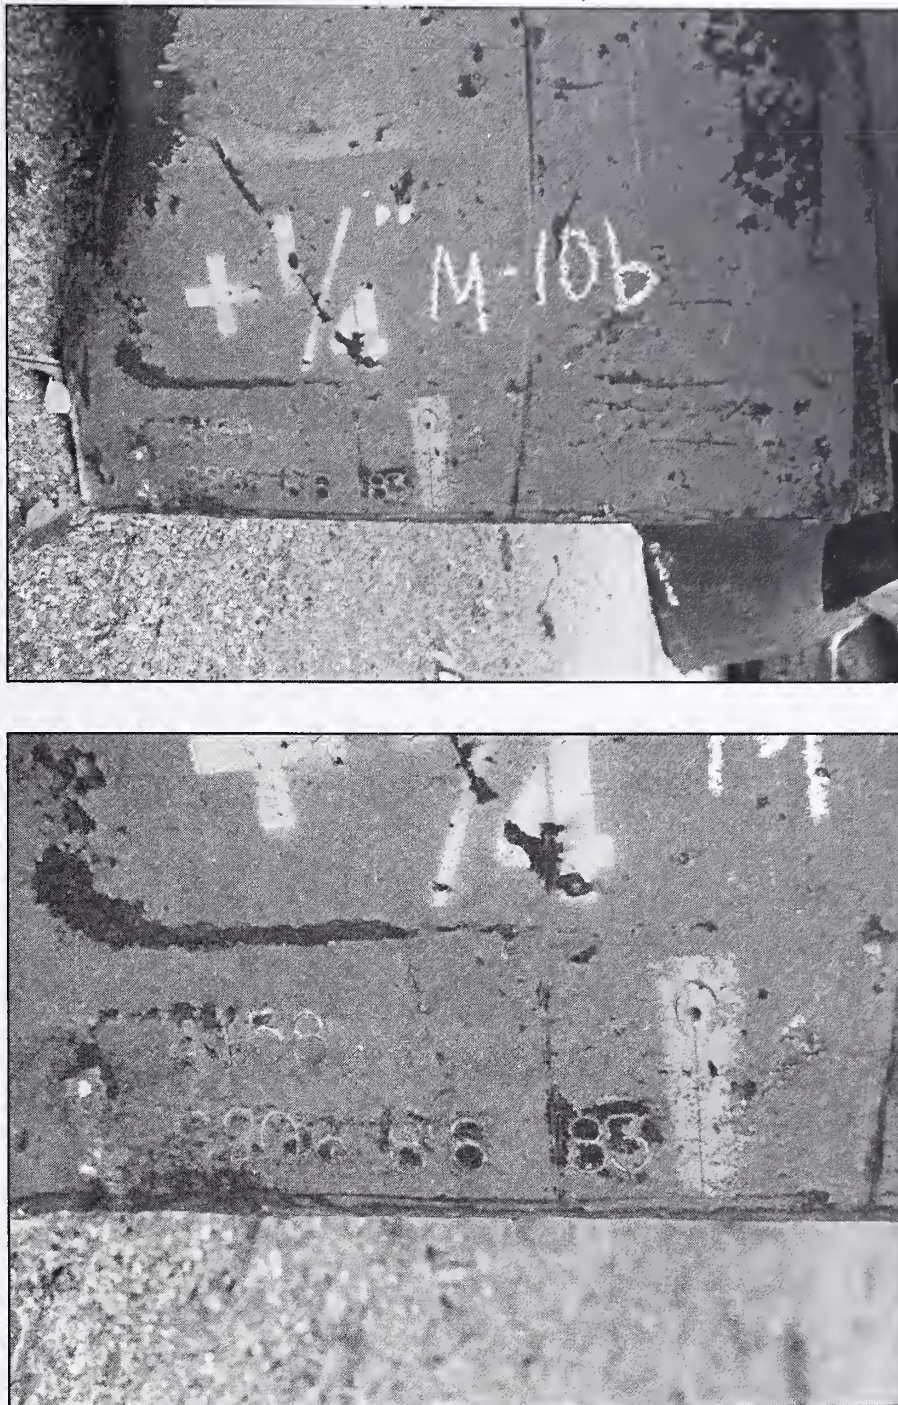
Figure 3–3. Example of stampings on the interior base of the middle column for each panel.

The positive identification of the structural elements was made possible by deciphering the stampings and/or stencils found on them. During the fabrication process, the exterior panel sections were stamped at the bottom of the center column on the inside face. These stampings indicated the building, center column line number, and floors spanned by the columns. The core columns had stampings placed at the lower end of the component near the connector. The building was typically represented as "A" for WTC 1 and "B" for WTC 2. An example of a stamping found on an exterior column is shown in Fig. 3-3, where the stamping indicates that the piece was from WTC 2, with center column line number 206, spanning floors 83 through 86. Core column material was found to have similar markings (Fig. 3-4). Other stampings have also been found on the flanges of the perimeter columns that indicated the column type (Fig. 3-5 and Table 3-5) as well as the specified minimum yield strength of the column. All of these stampings typically reside within 1 m from the bottom of the column.

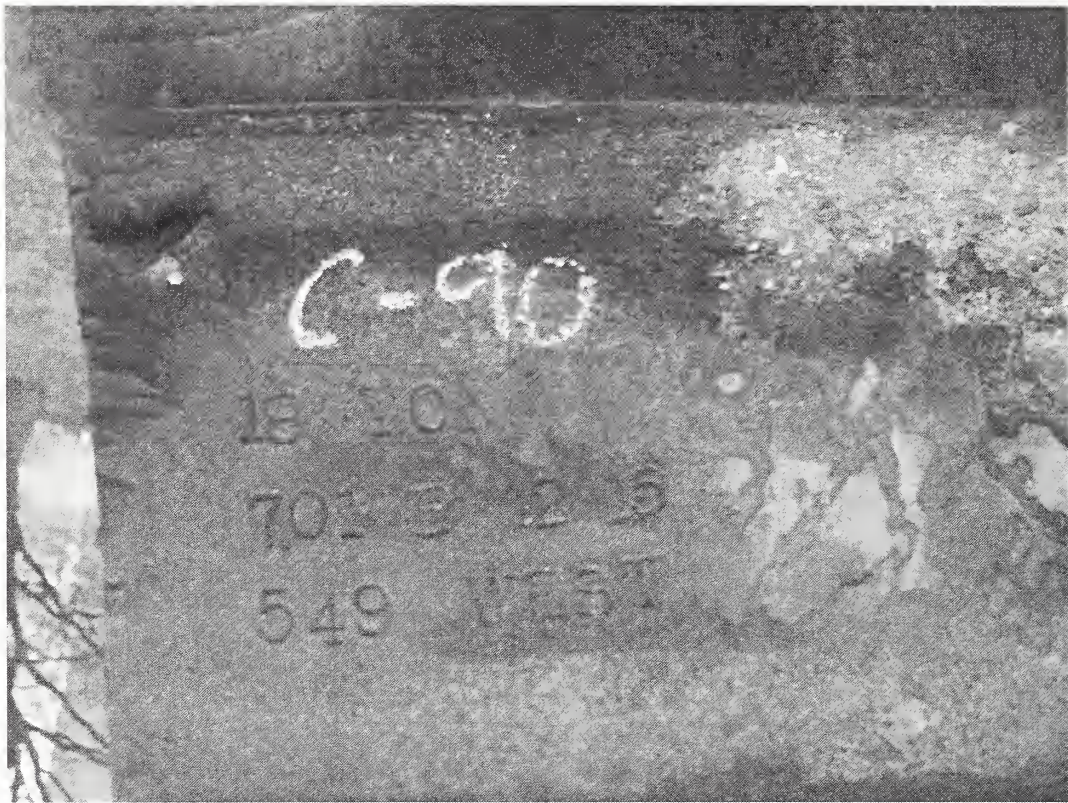
Figure 3–4. Example of stampings placed on one end of a core column.

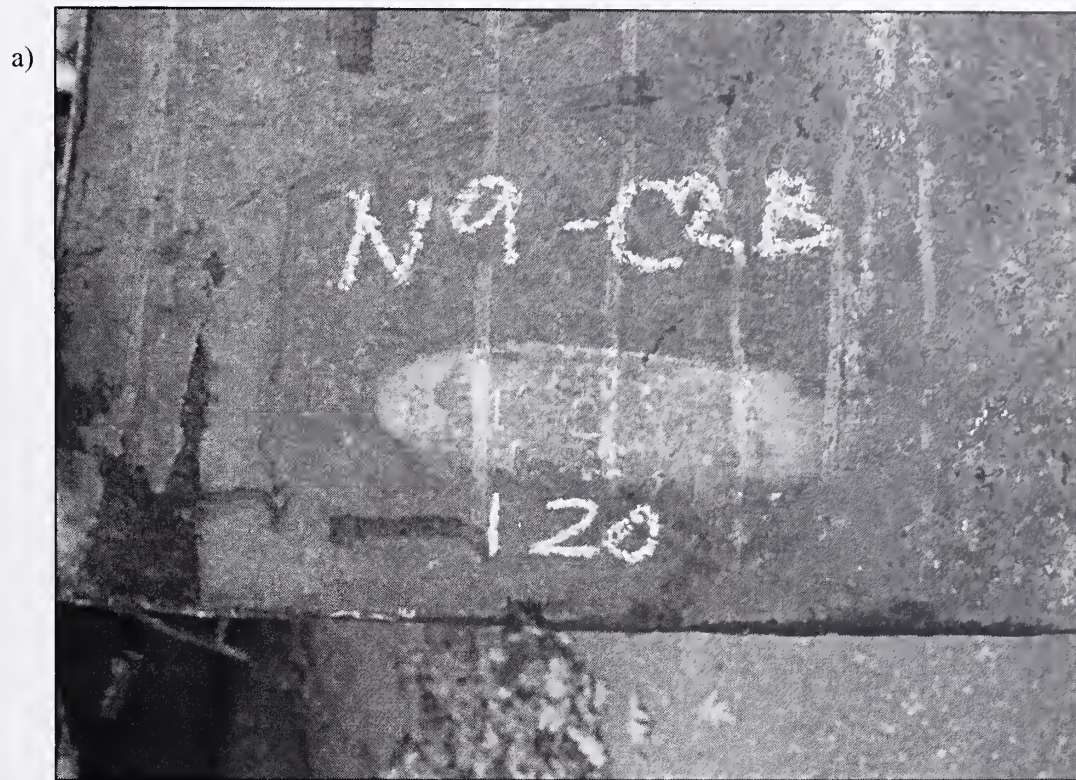
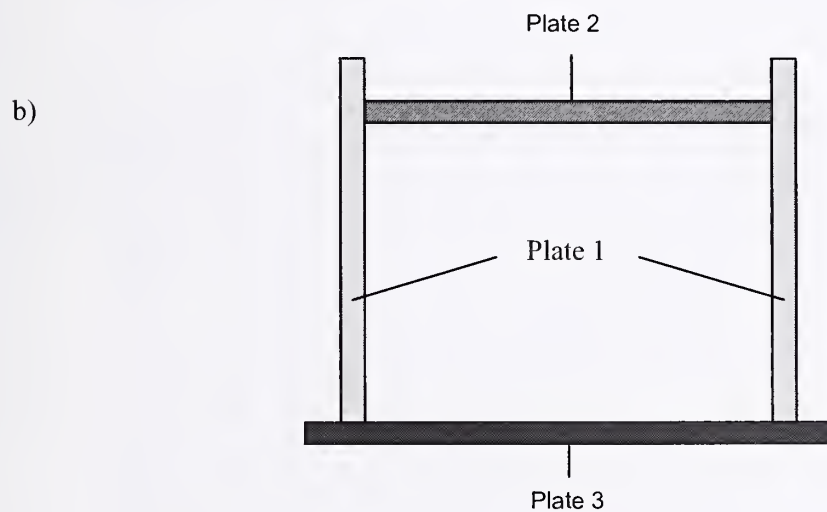
Figure 3–5. (a) Example of stamping placed on flange indicating the column type (120), and (b) schematic indicating the various plates corresponding to Table 3–5.

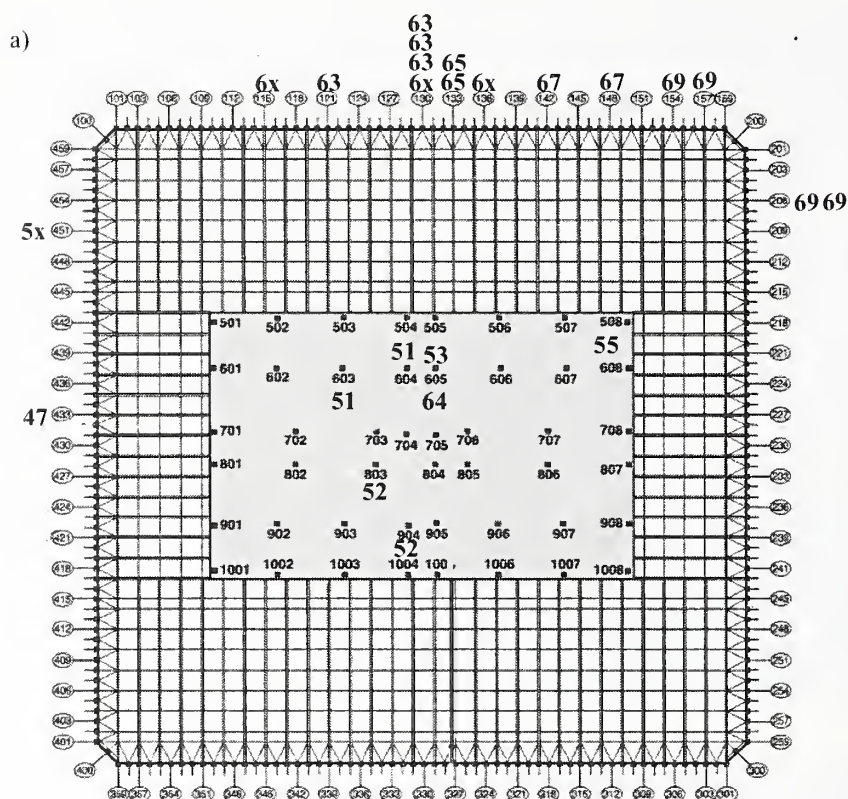
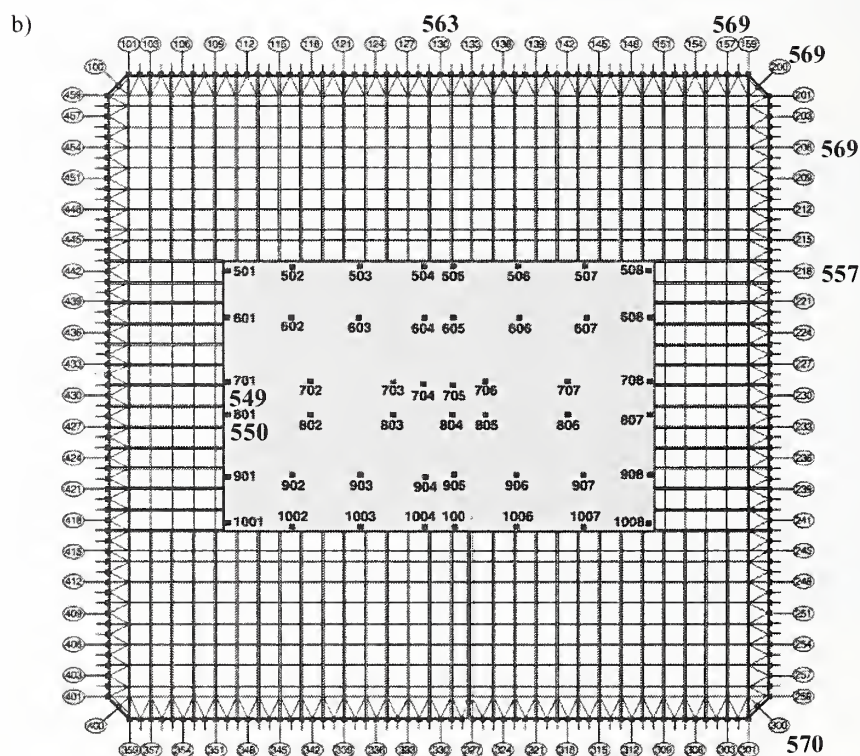
Figure 3–7. Schematic showing derrick divisions that hoisted the specific columns for (a) WTC 1 and (b) WTC 2. The “x” signifies the information that was not readable.

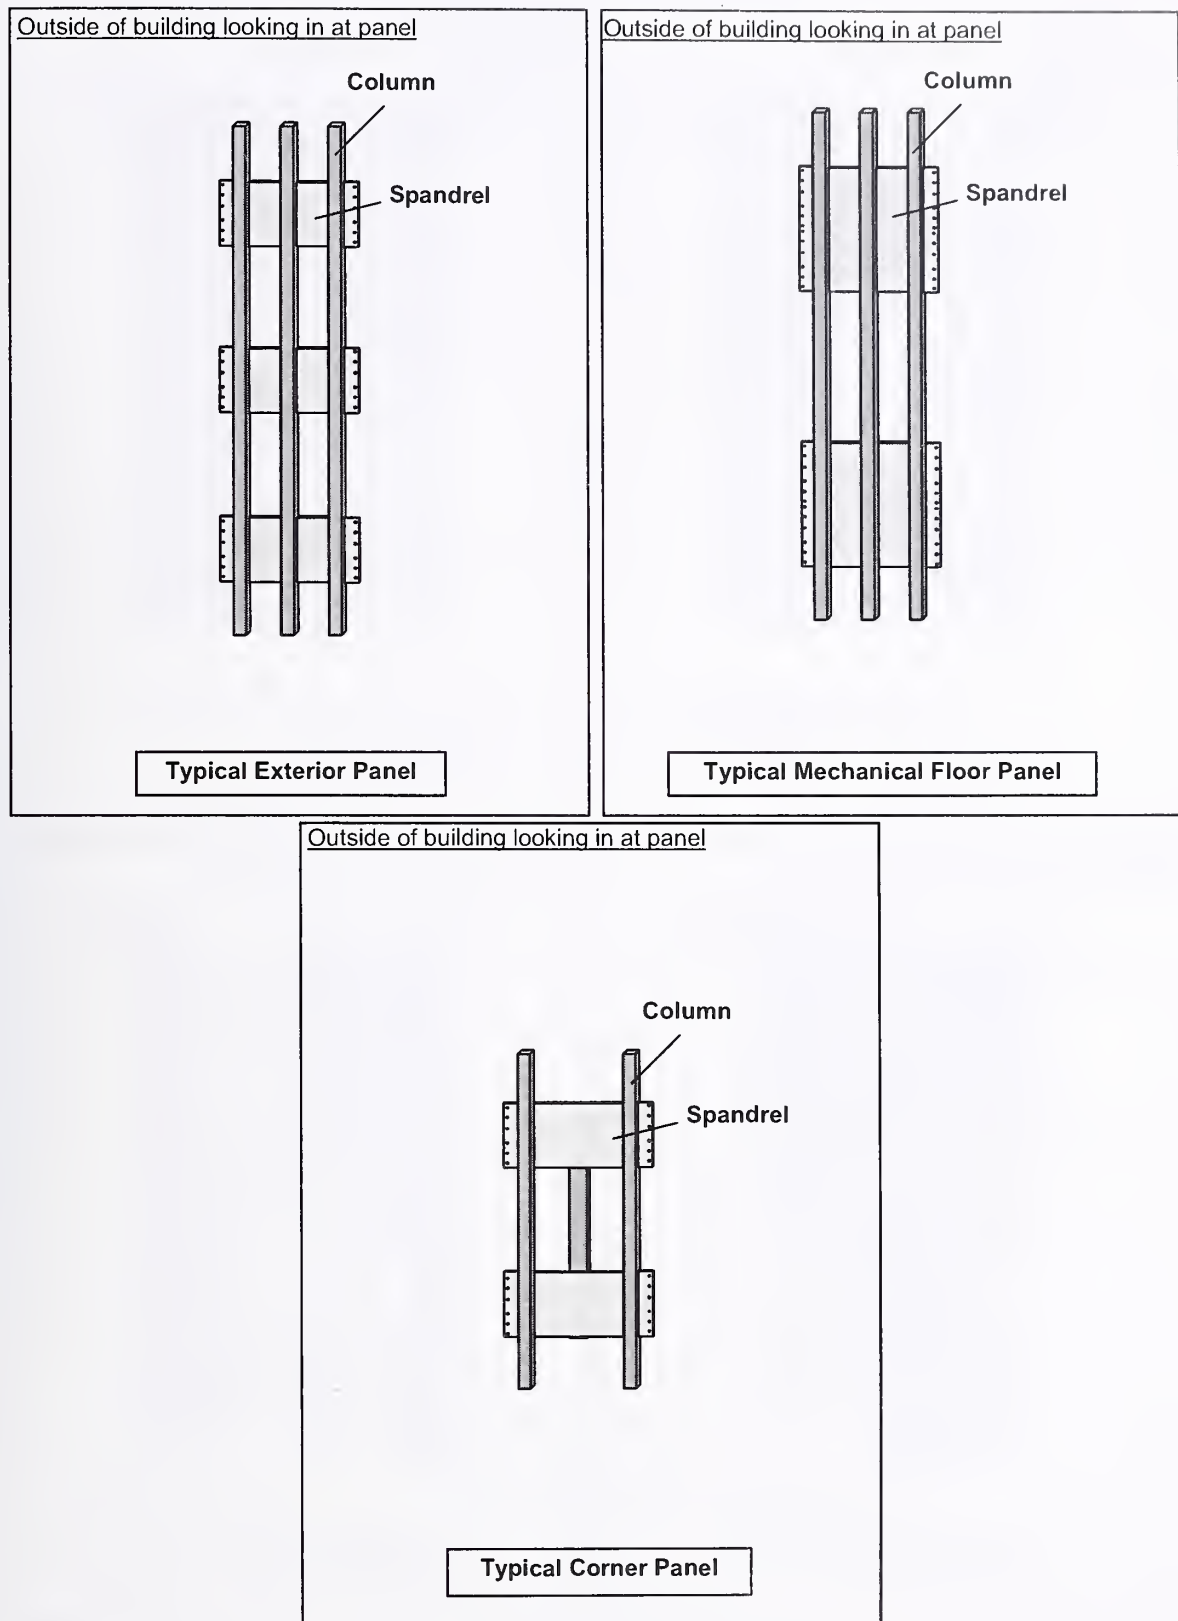
Figure 3–9. Schematics displaying the various types of exterior column panels.

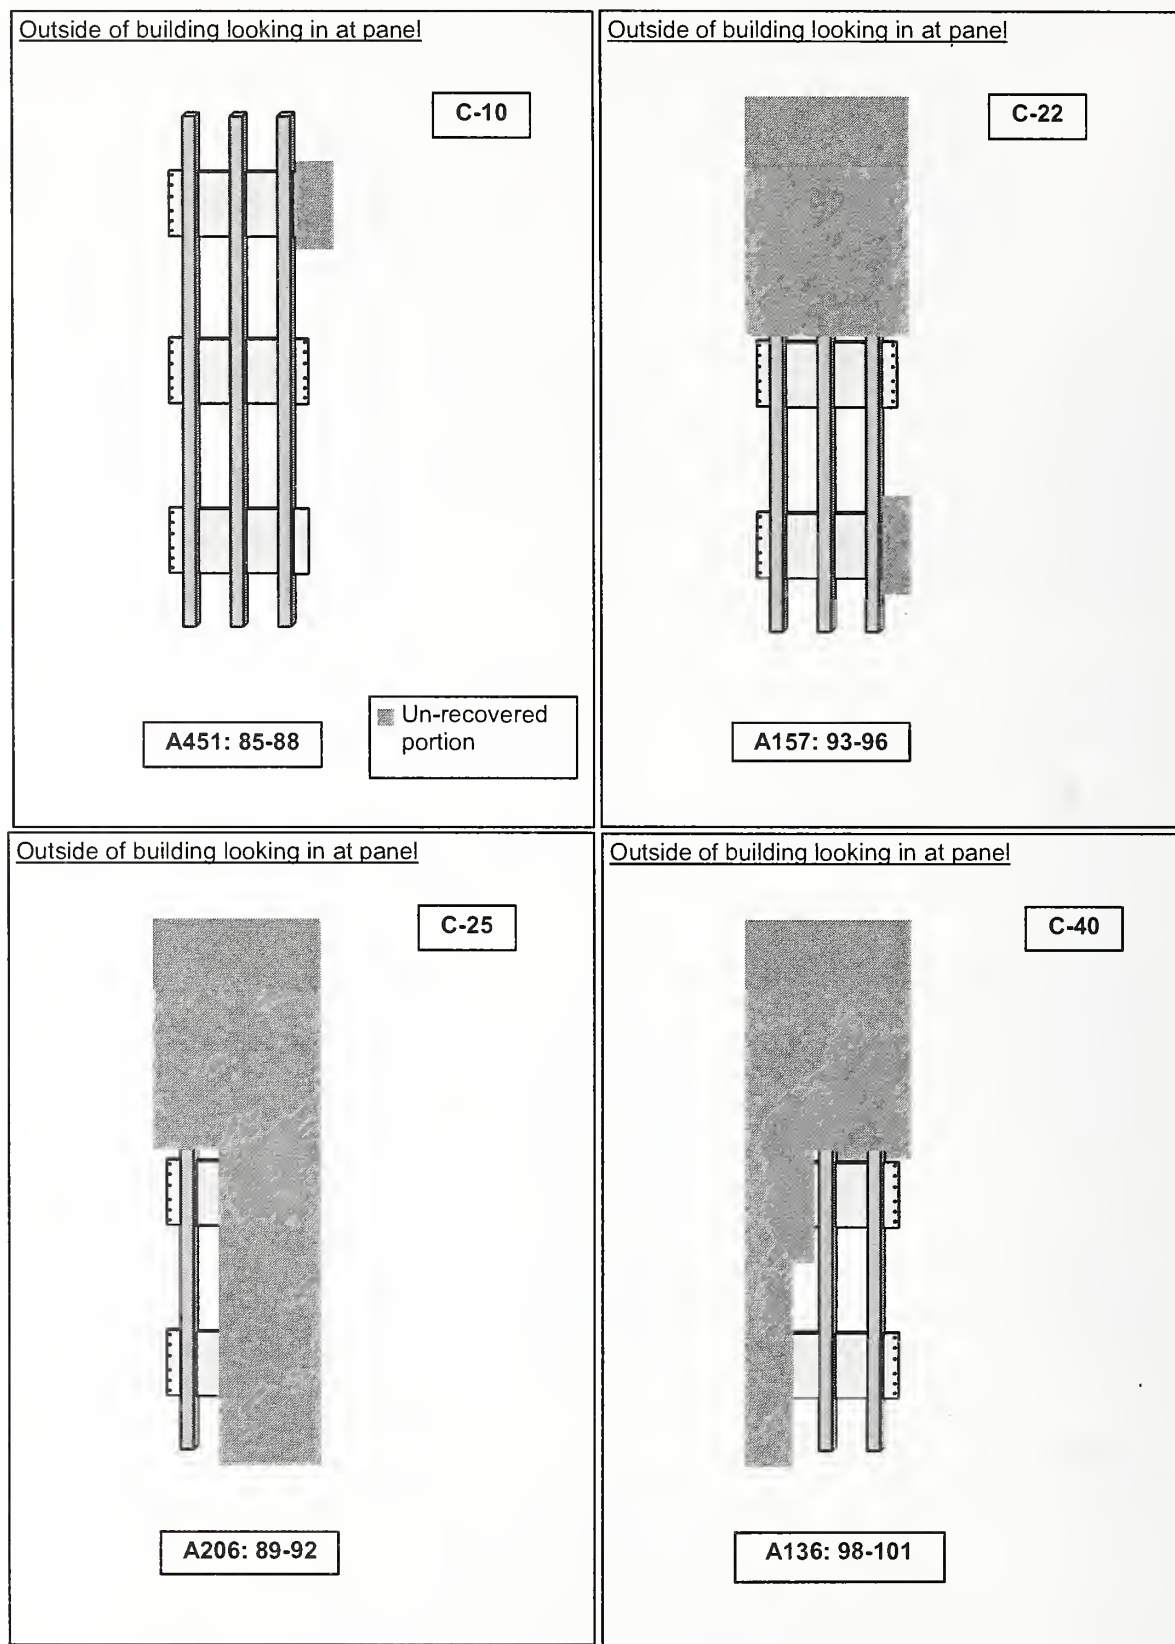
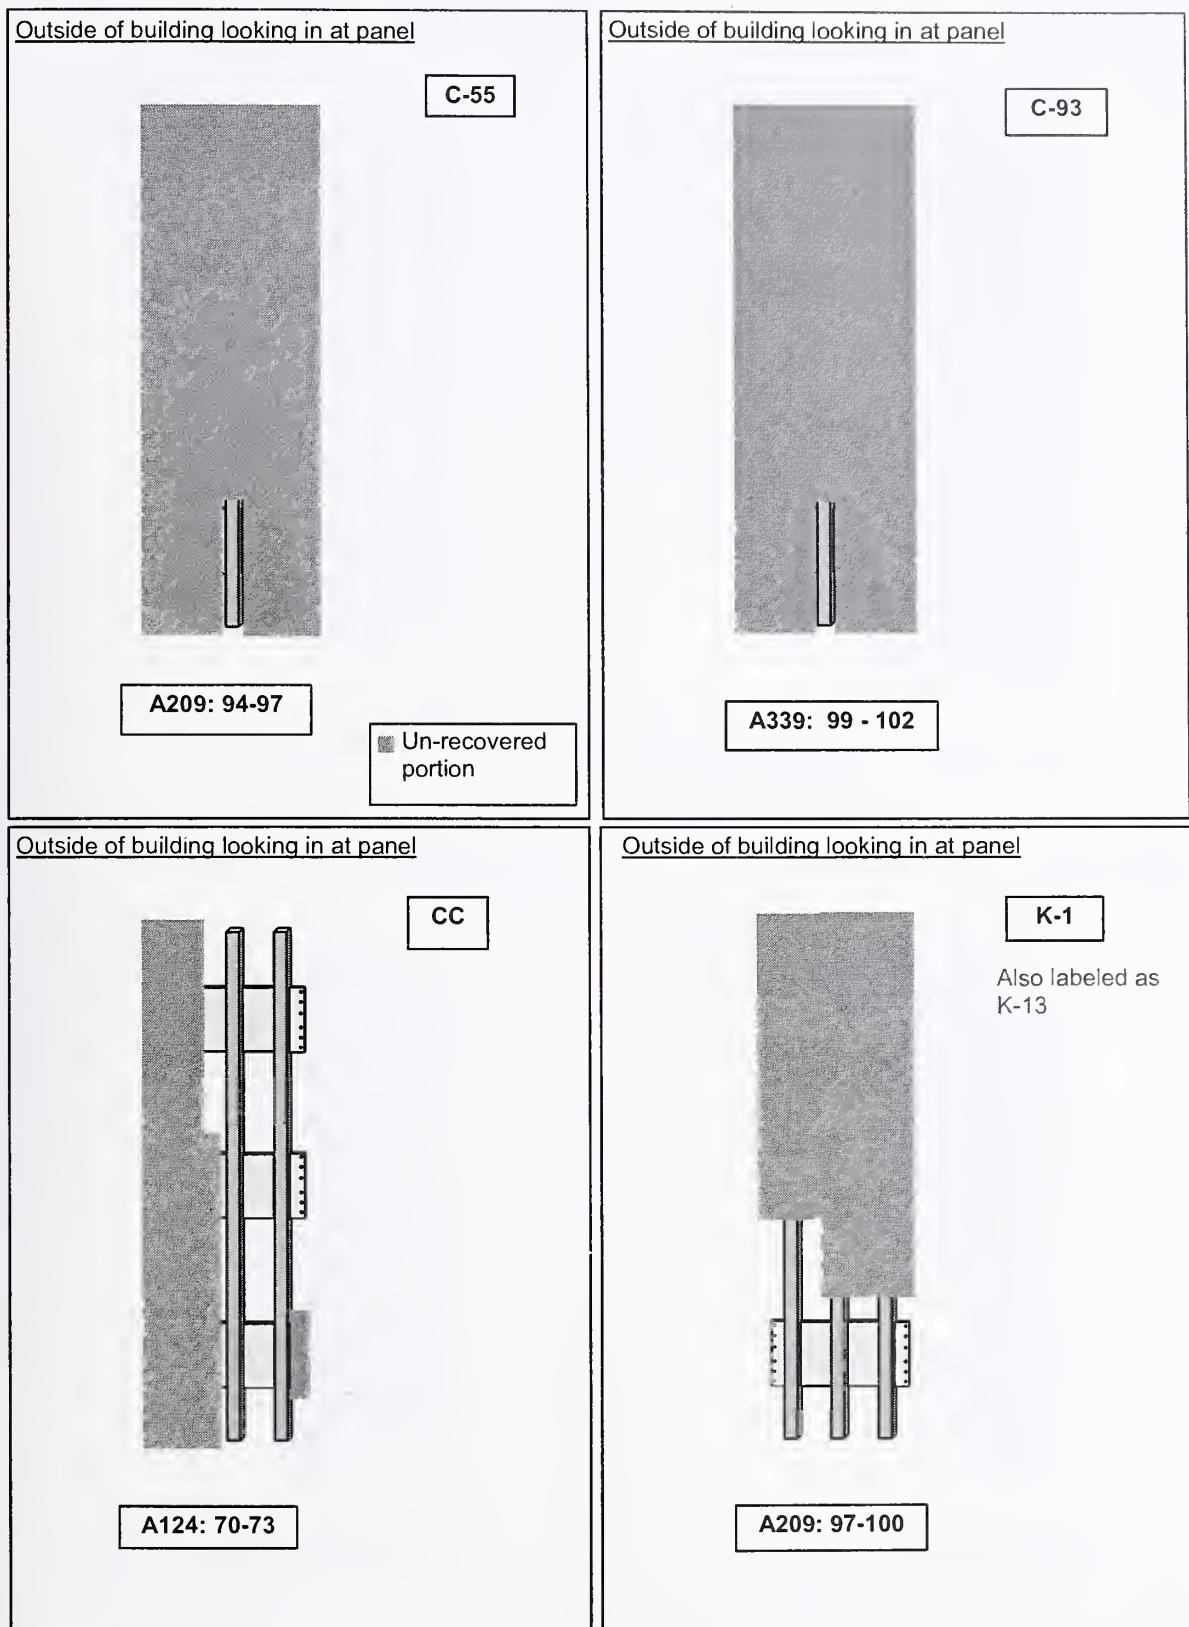
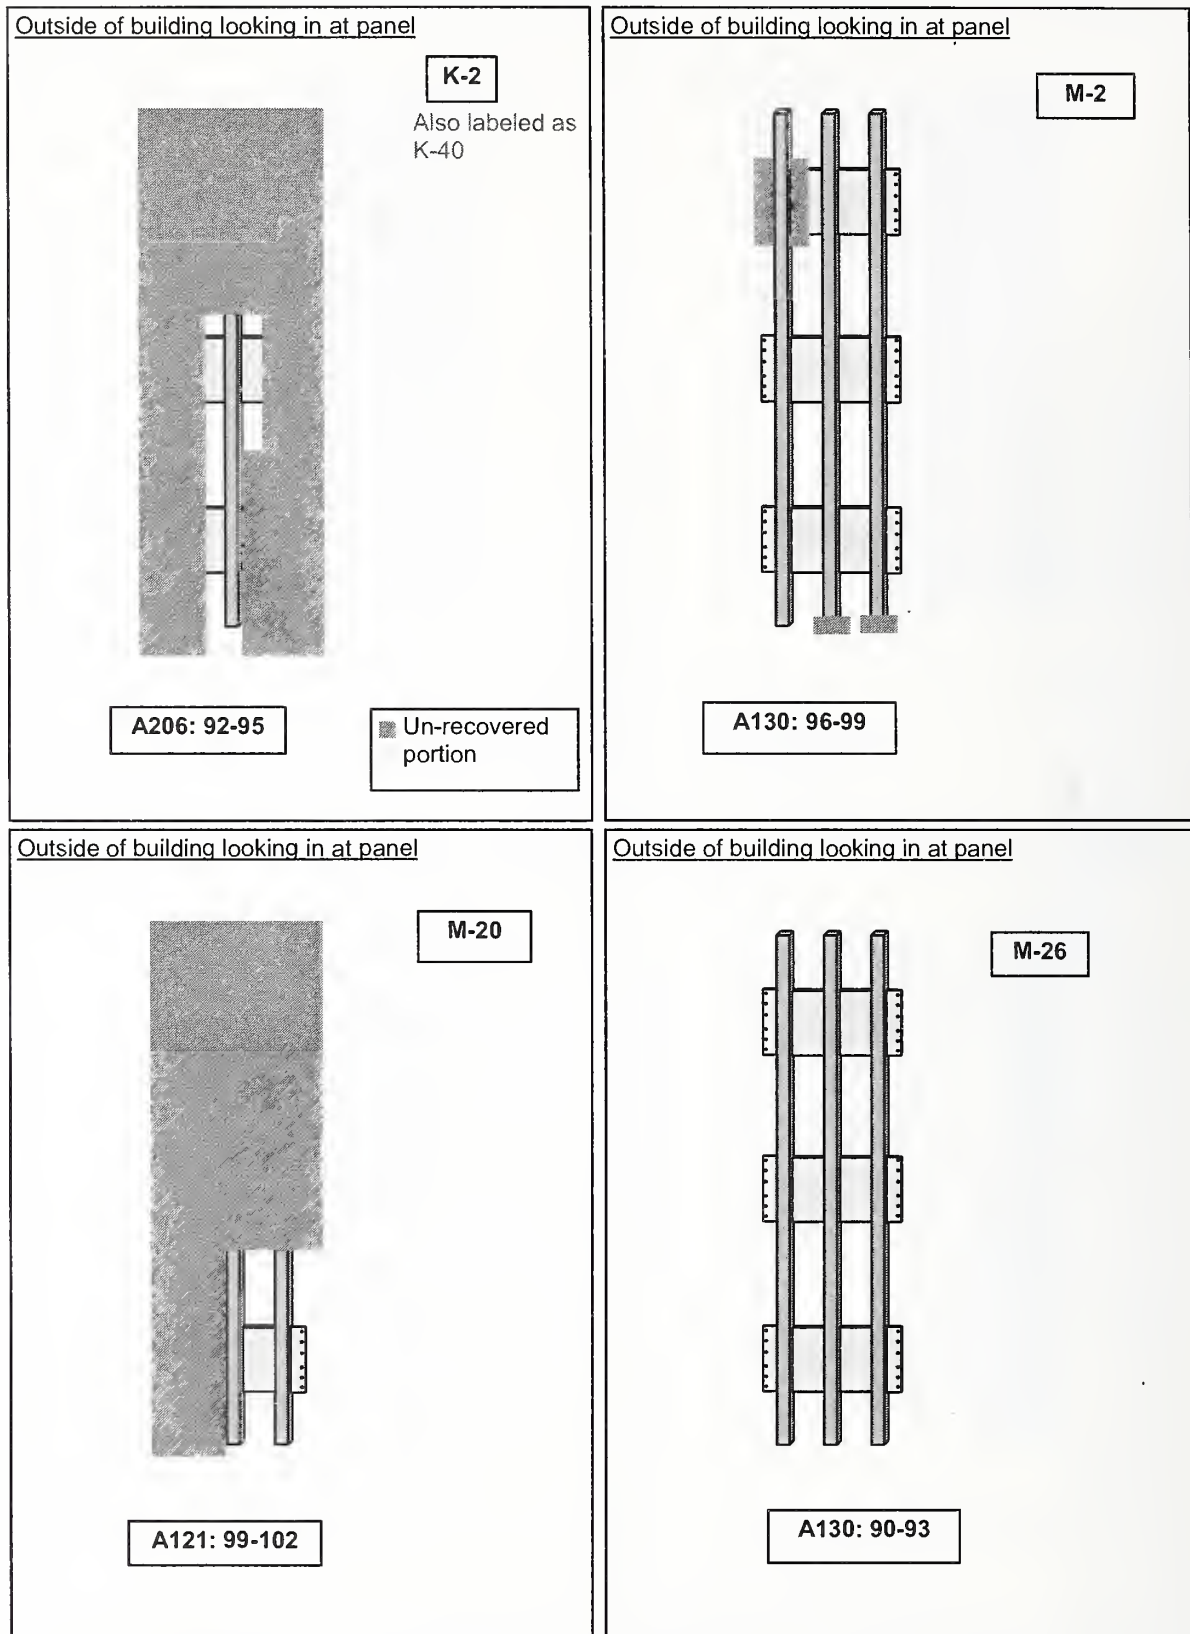
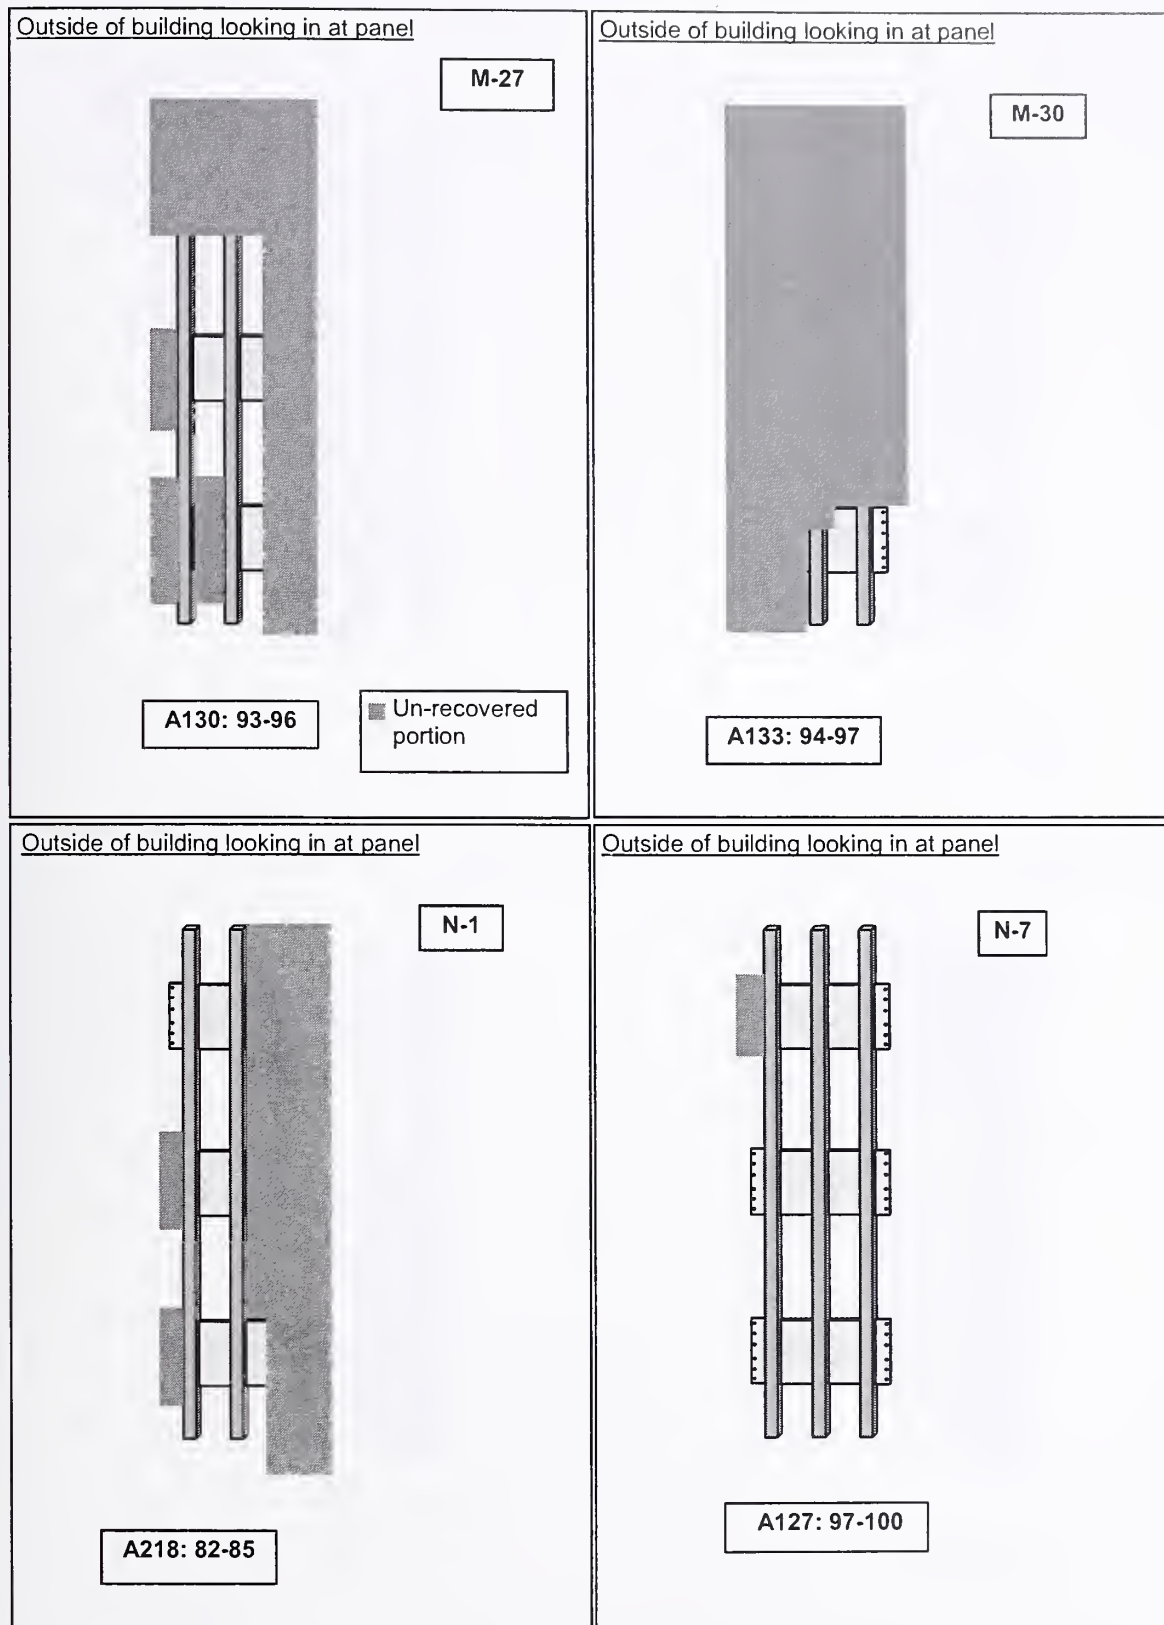
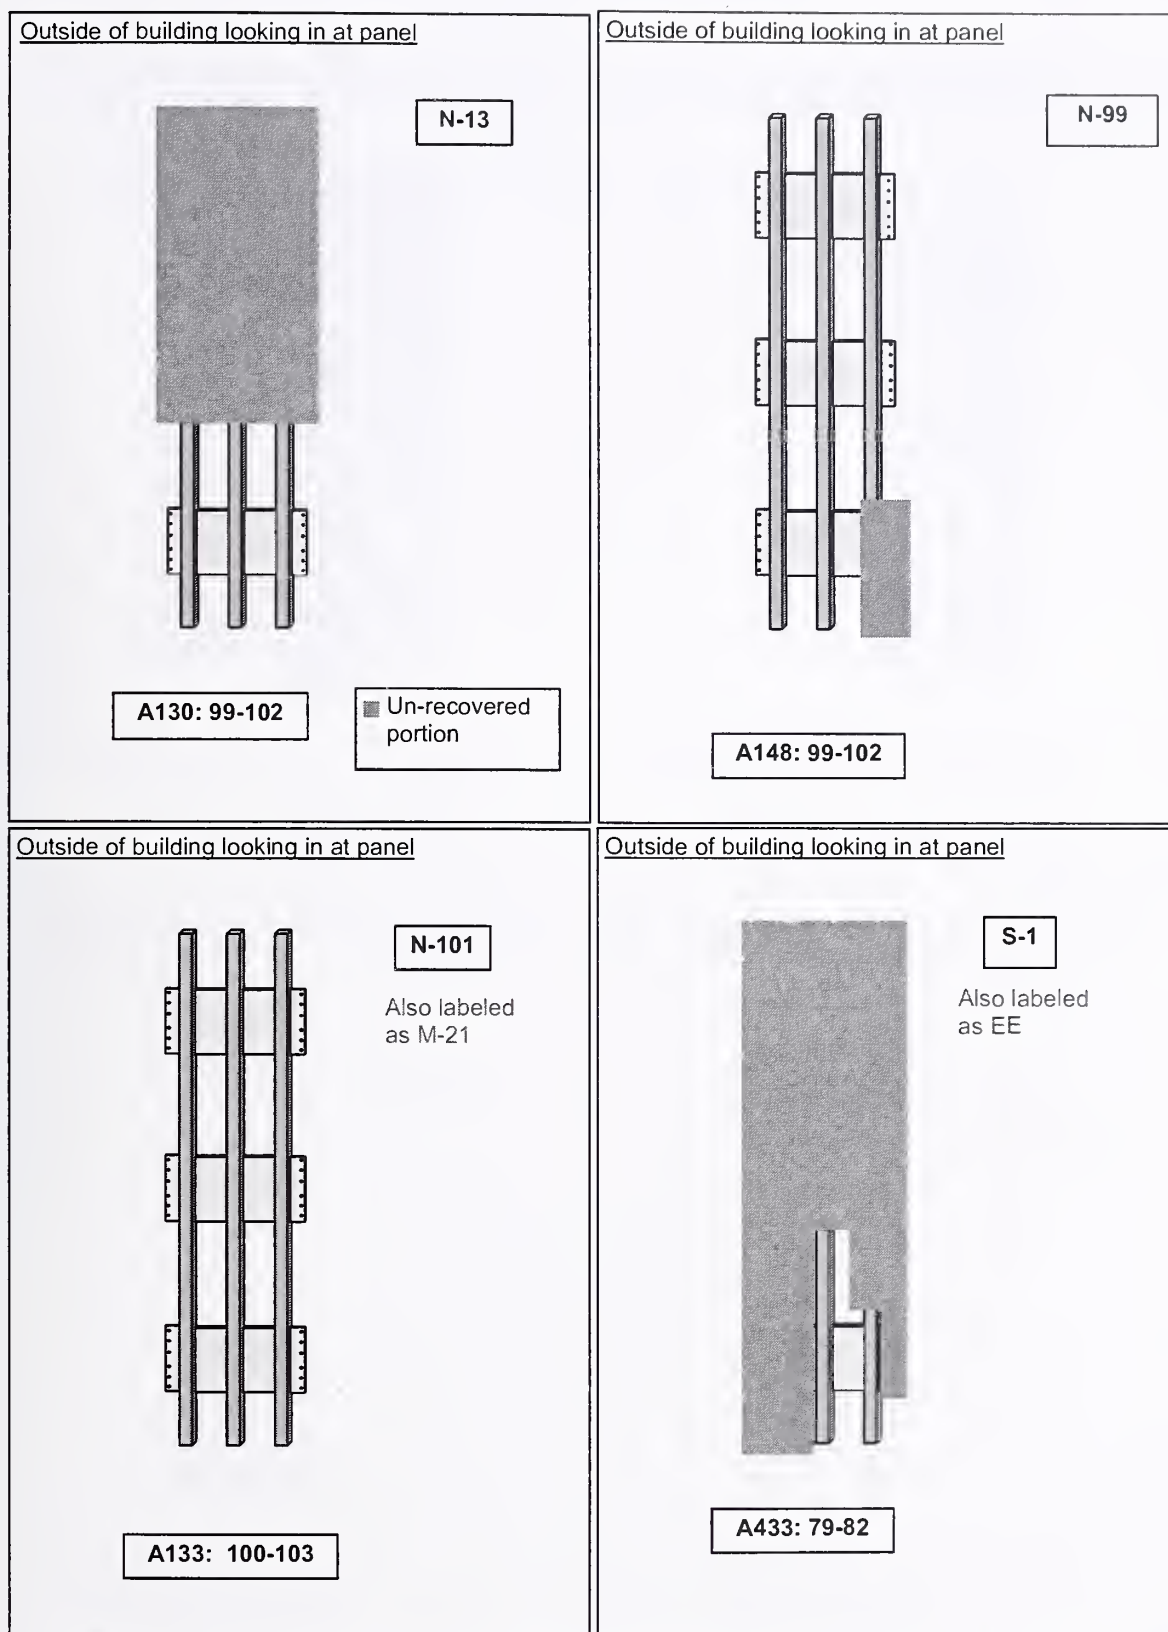
Figure 3-10. Exterior column panel maps indicating the portion of the specific exterior column panel section recovered from WTC 1.
