NIST NCSTAR 1-3B

**Federal Building and Fire Safety Investigation of the
World Trade Center Disaster**

Steel Inventory and Identification

Stephen W. Banovic

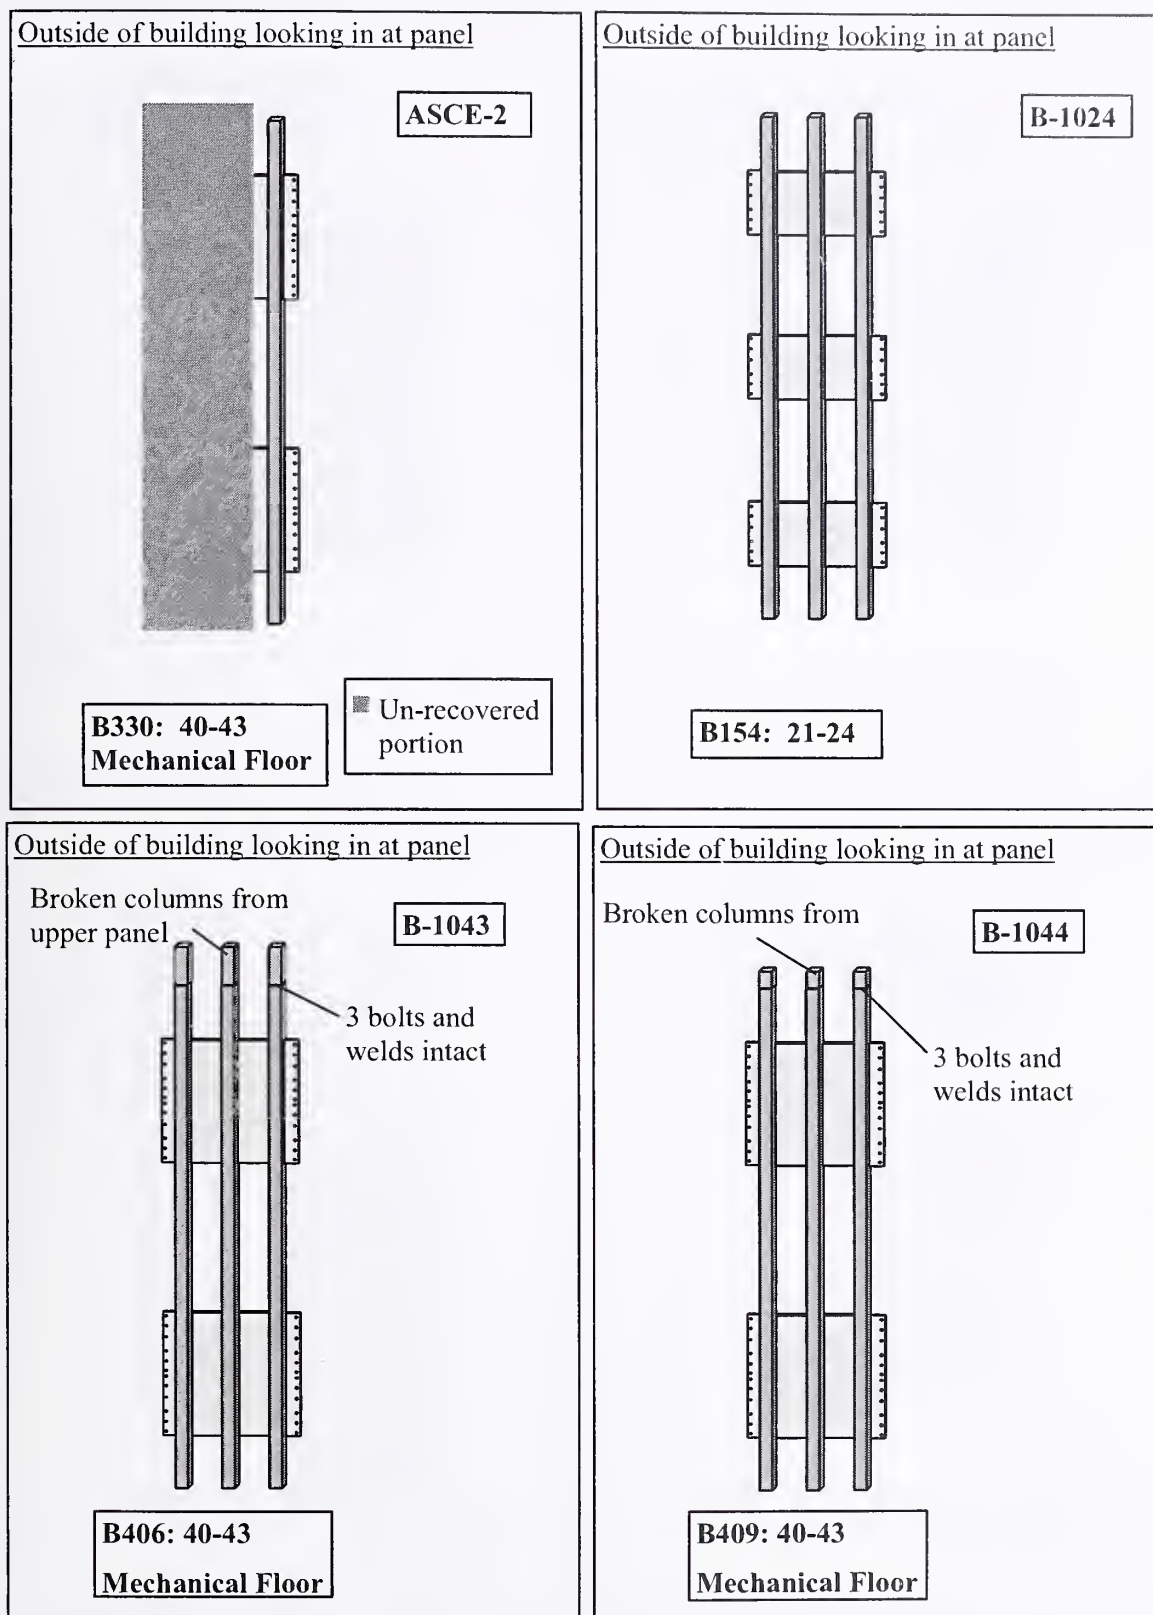
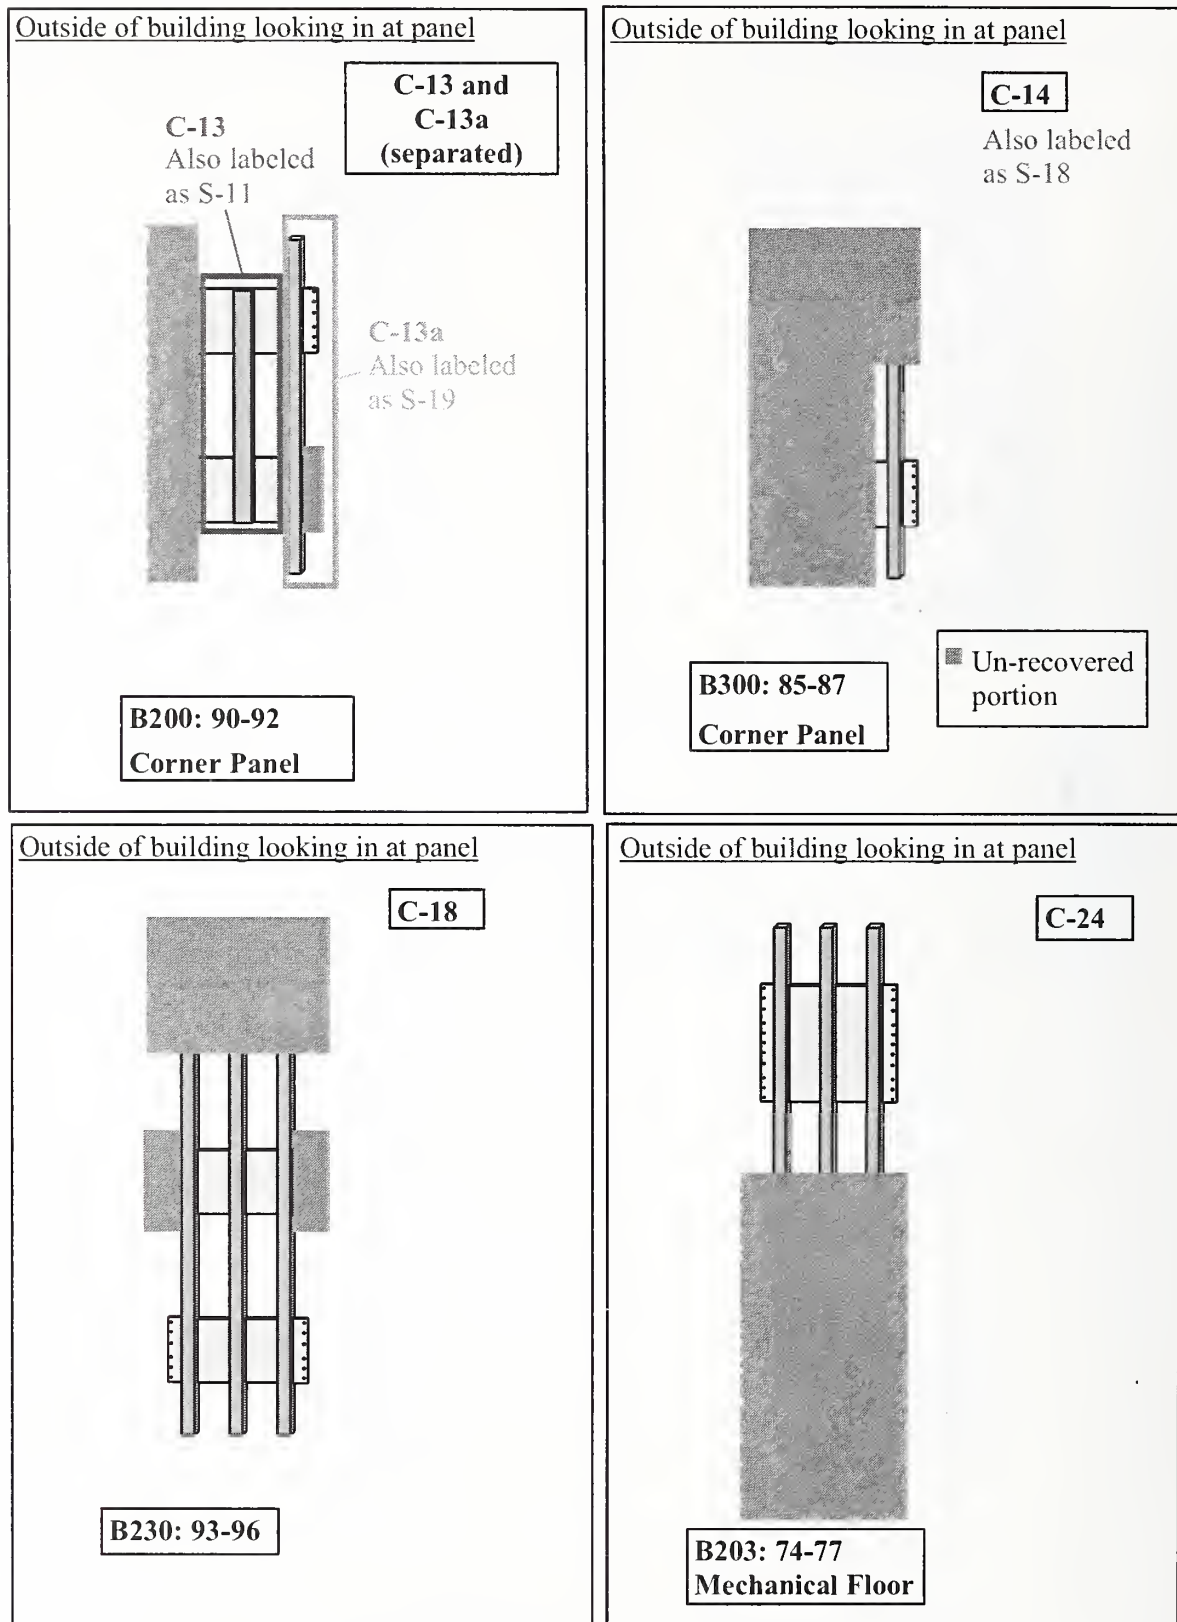
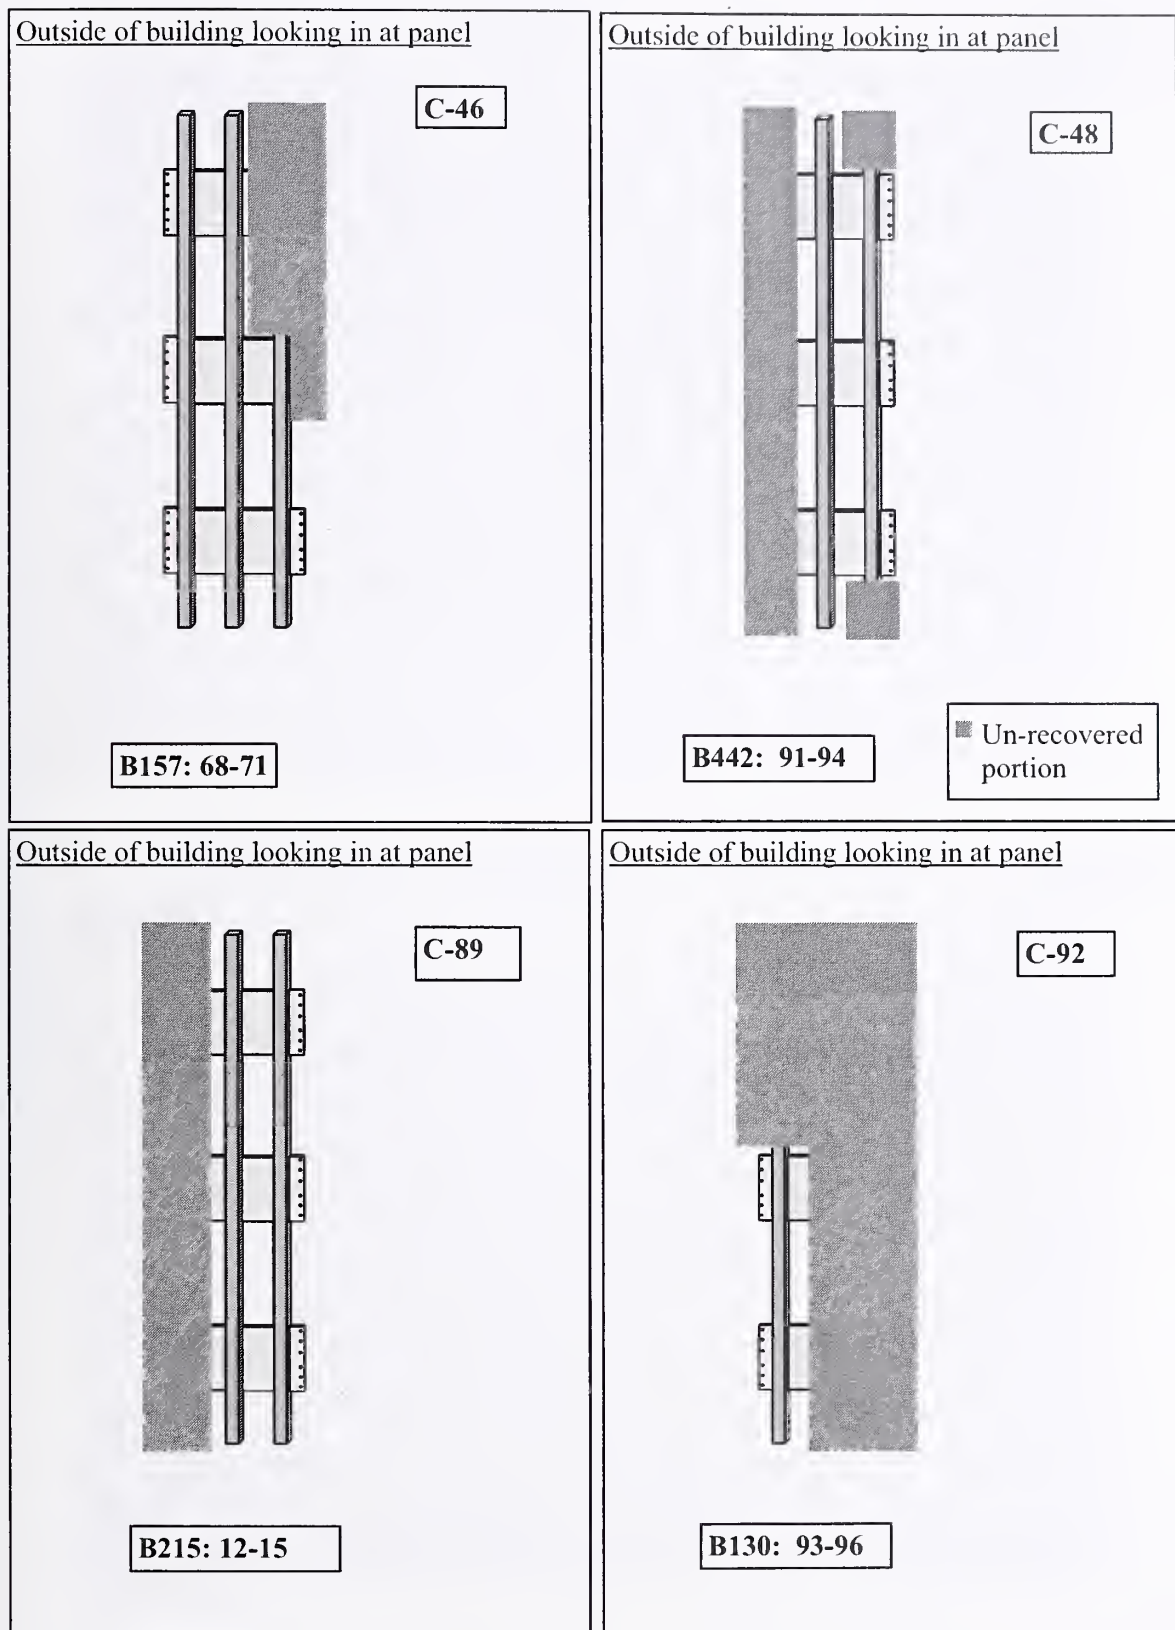
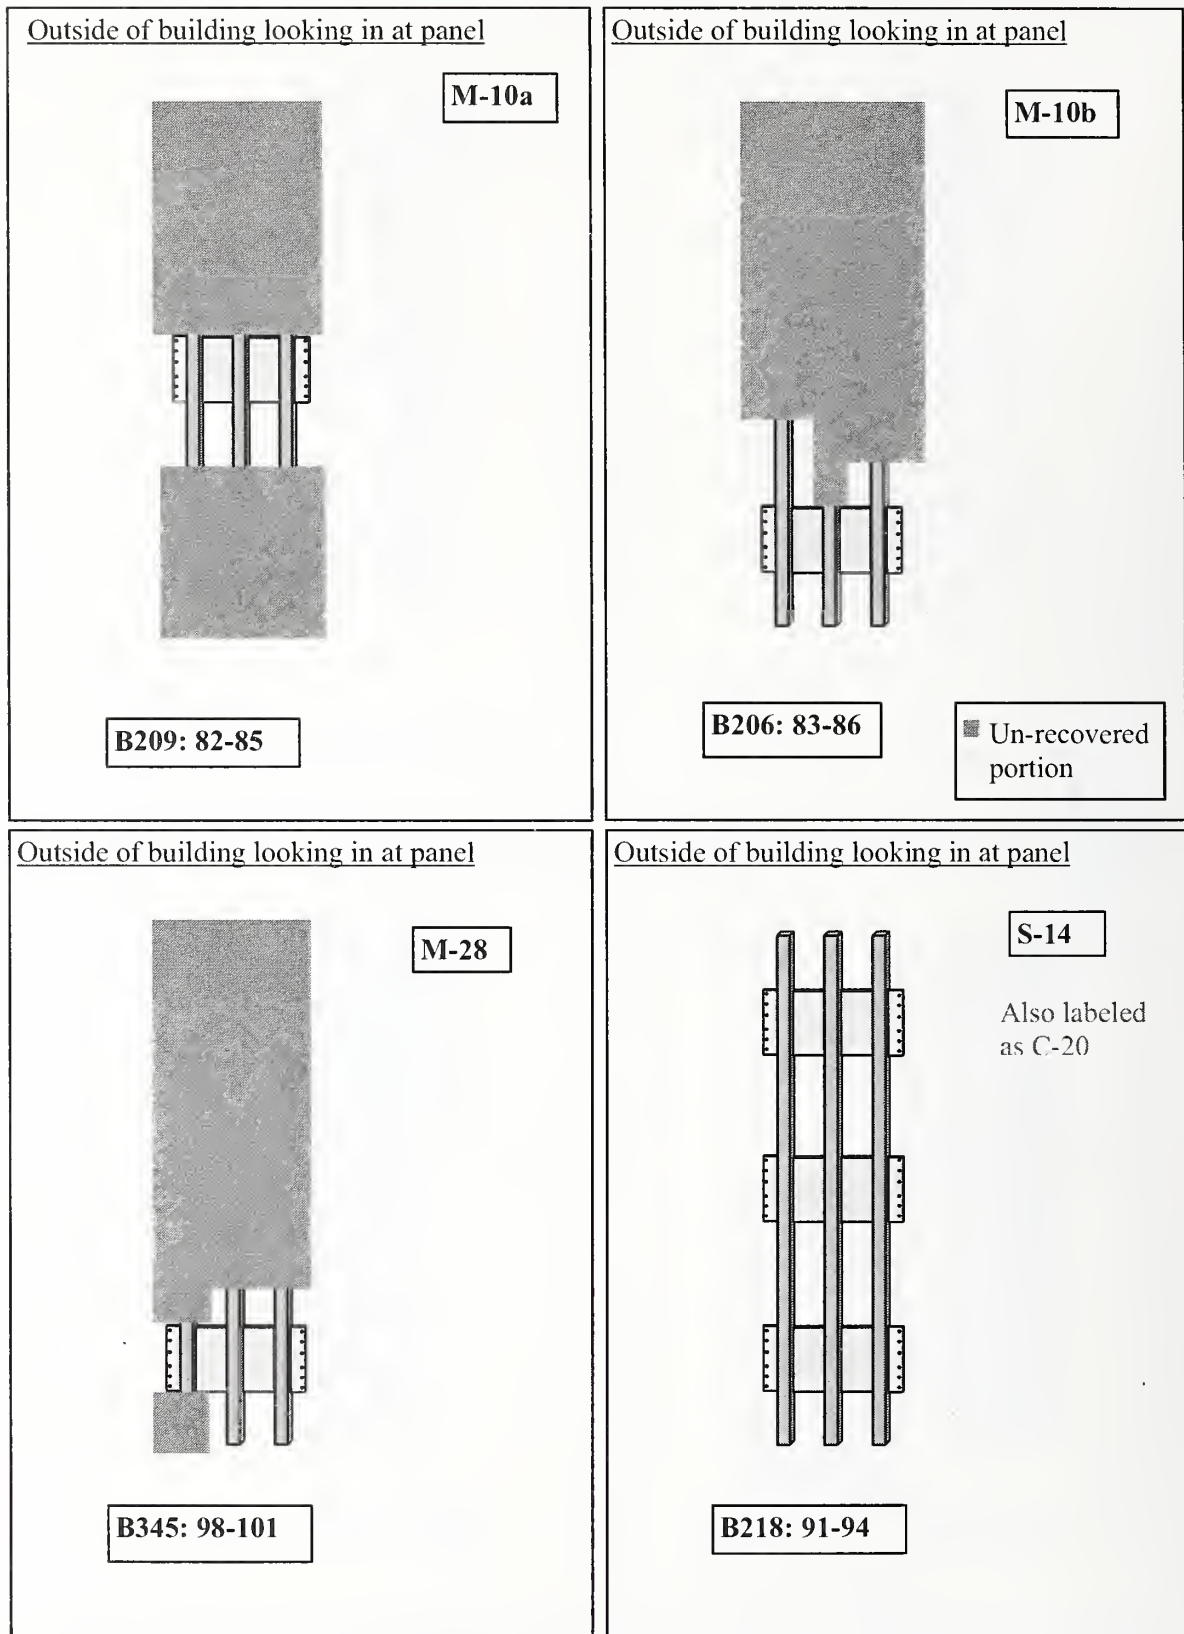
Figure 3-11. Exterior column panel maps indicating the portion of the specific exterior column panel section recovered from WTC 2.

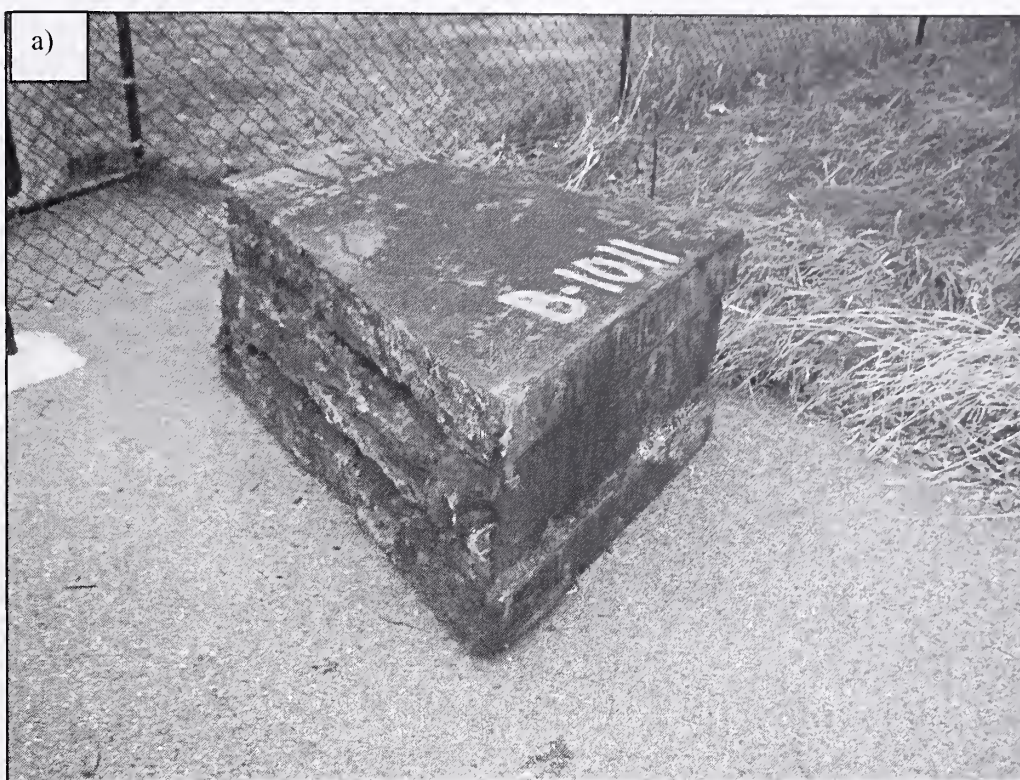
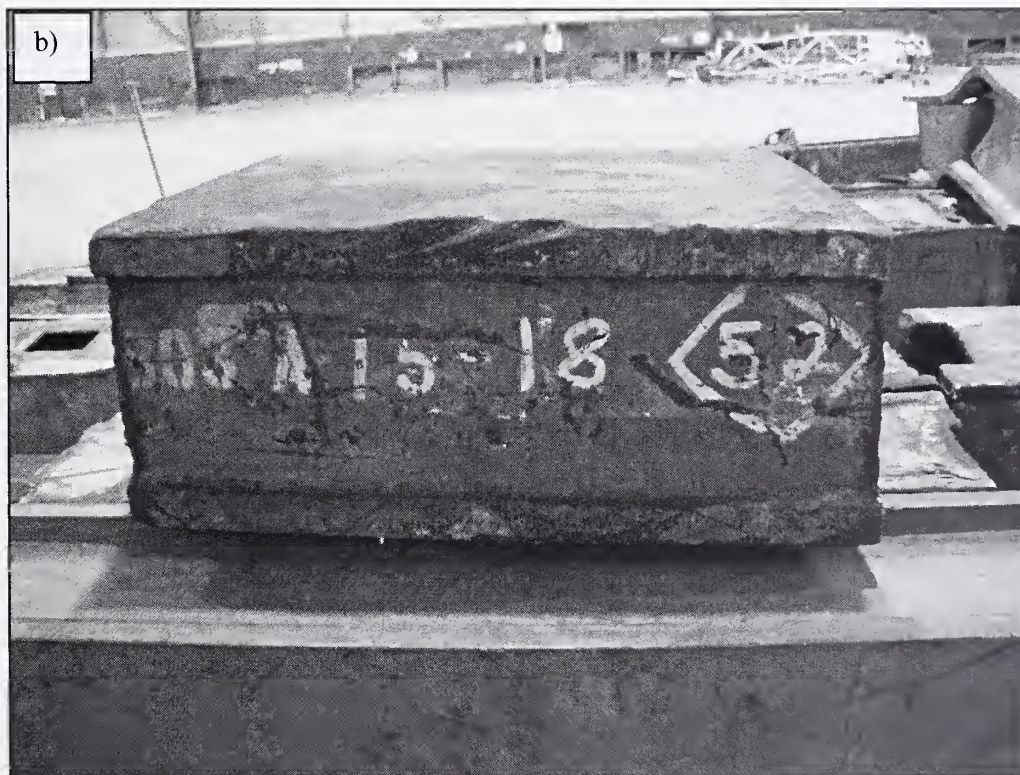
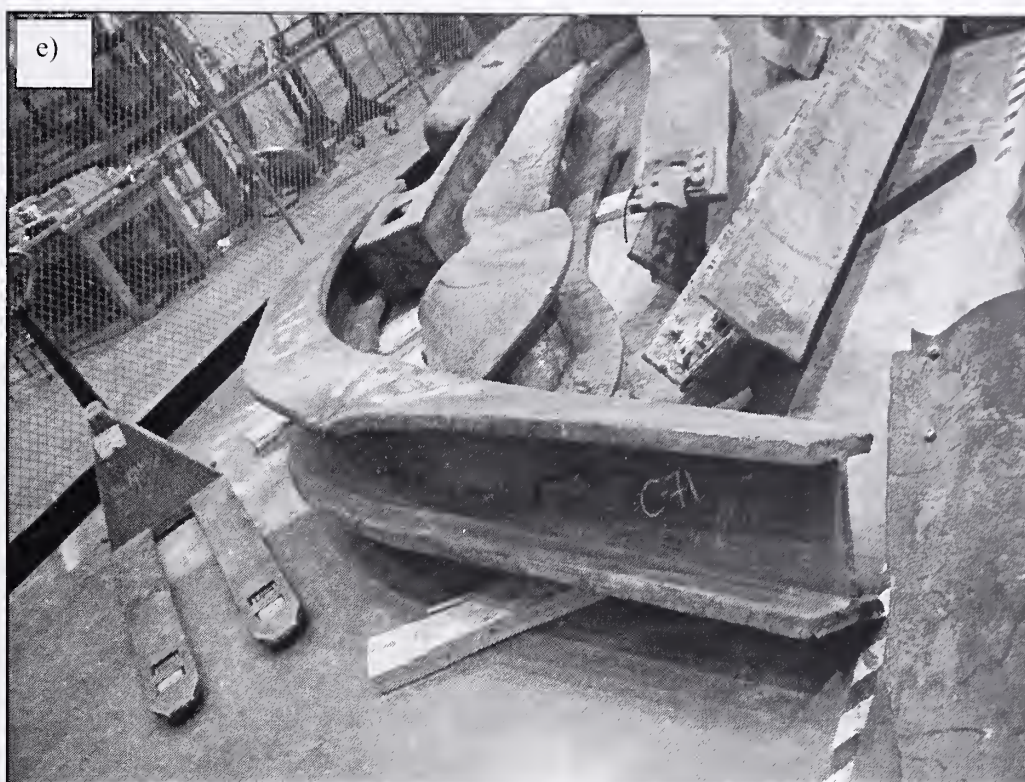
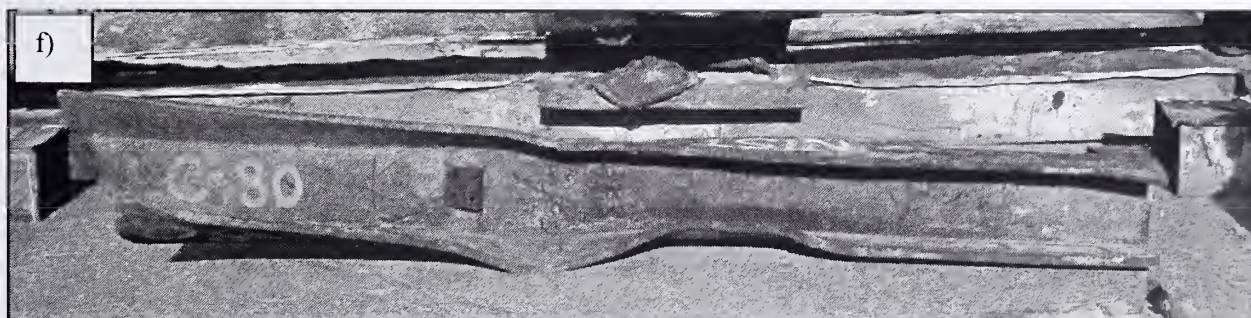
Figure 3–12. Core columns recovered from WTC 1. a) B-1011 (508A: 51–54), lower 2 ft to 3 ft of built-up box column, b) B-6152-1 (803A: 15–18), lower 3 ft of built-up box column.

Figure 3–12. Core columns recovered from WTC 1. c) B-6152-2 (504A: 33–36), lower 2 ft of built-up box column, d) C-65 (904A: 86–89), lower 24 ft of wide flange section (continued).

Figure 3–12. Core columns recovered from WTC 1. e) C-71 (904A: 77–80), lower 16 ft of wide flange section, f) C-80 (603A: 92–95), lower 13 ft of wide flange section (continued).

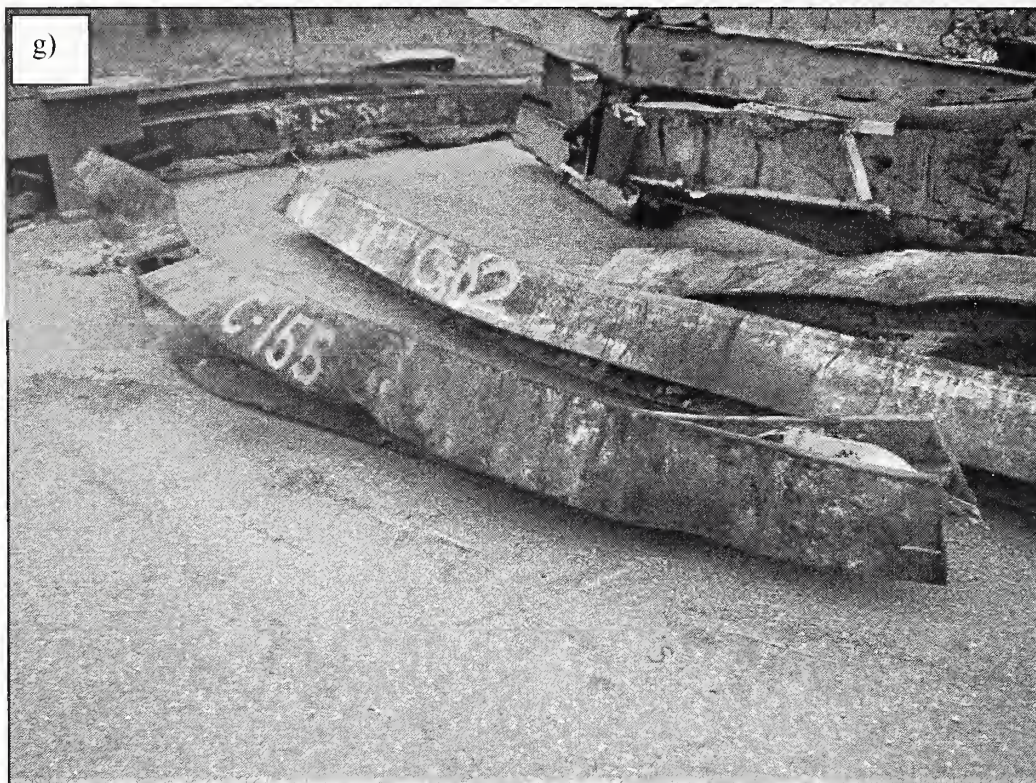
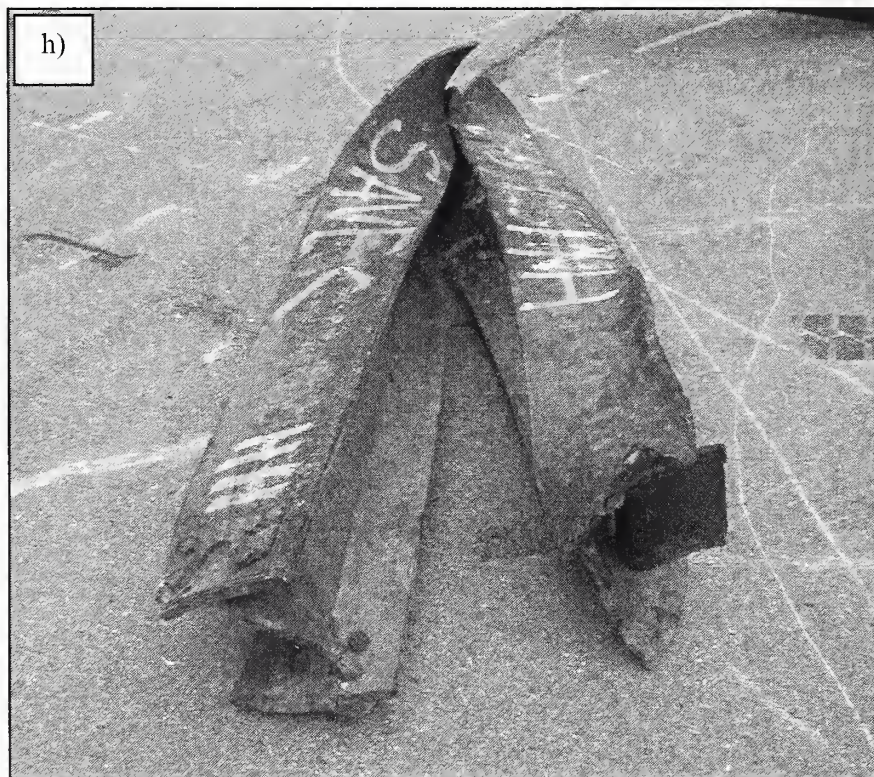
Figure 3–12. Core columns recovered from WTC 1. g) C-155 (904A: 83–86), lower 33 ft of wide flange section, and h) HH (605A: 98–101), lower 16 ft of wide flange section (continued).

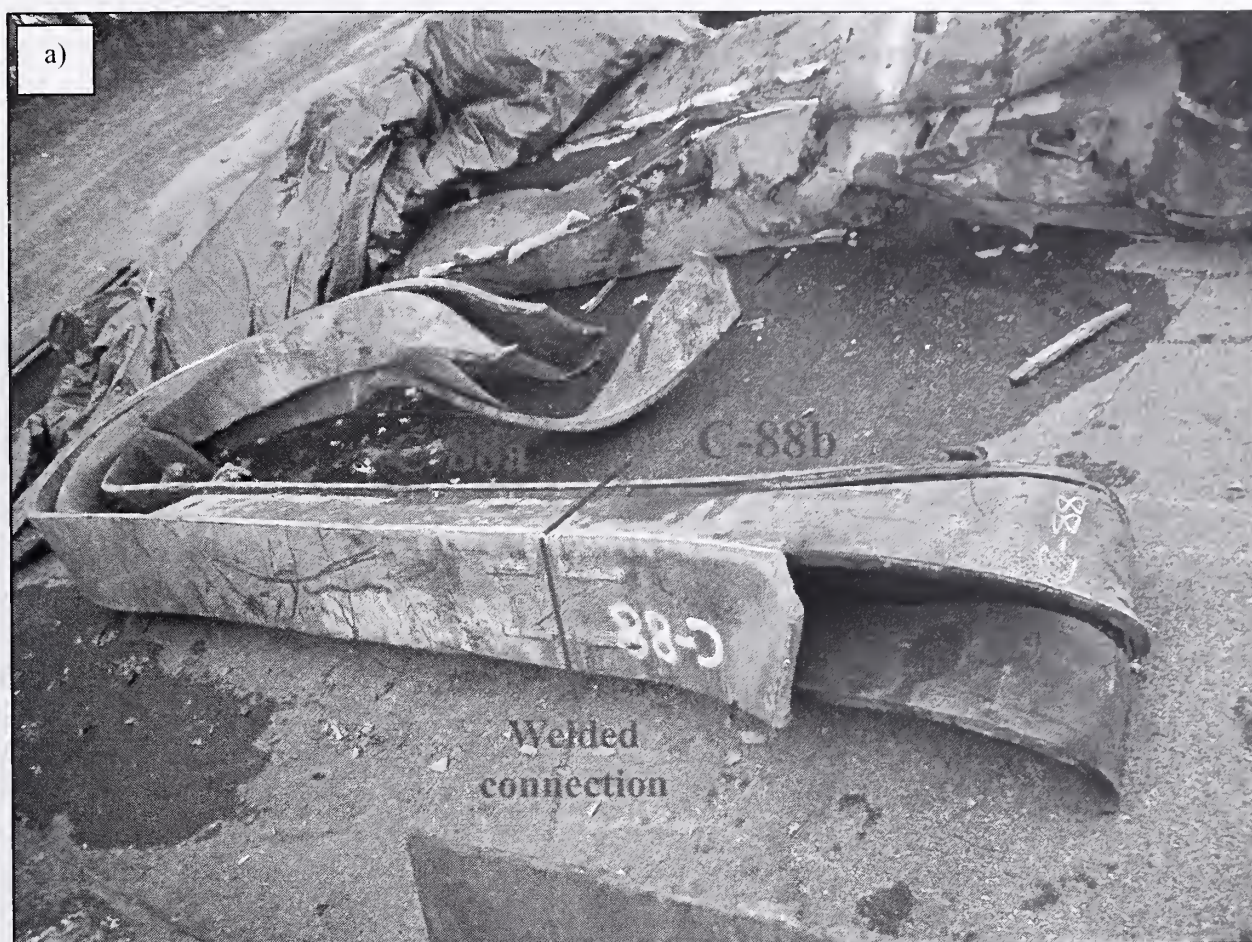
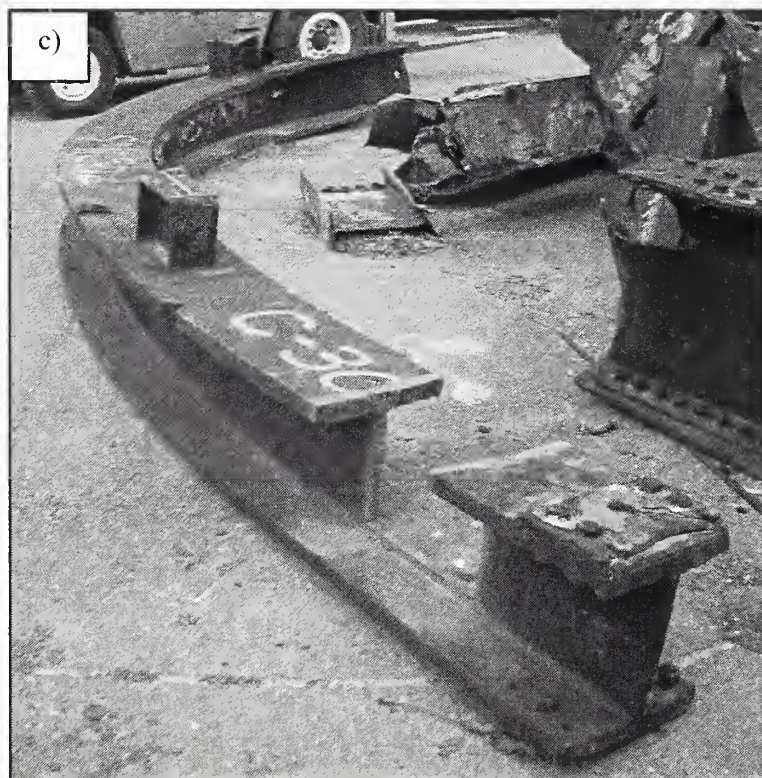
Figure 3–13. Core columns recovered from WTC 2. a) C-88a (801B: 80–83), lower 16 ft of built-up box column and C-88b (801B: 77–80), upper 8 ft of built-up box column.

Figure 3–13. Core columns recovered from WTC 2. b) C-90 (701B: 12–15), entire length of built-up box column, and c) C-30 (1008B: 104–106) entire length of wide flange section (continued).

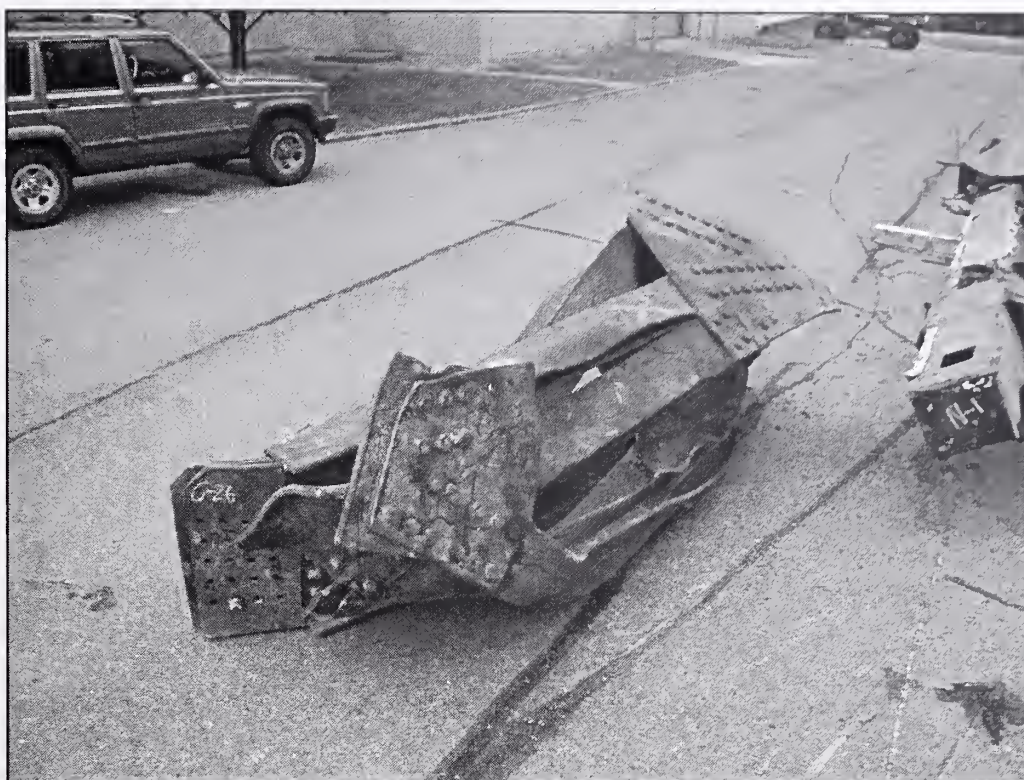
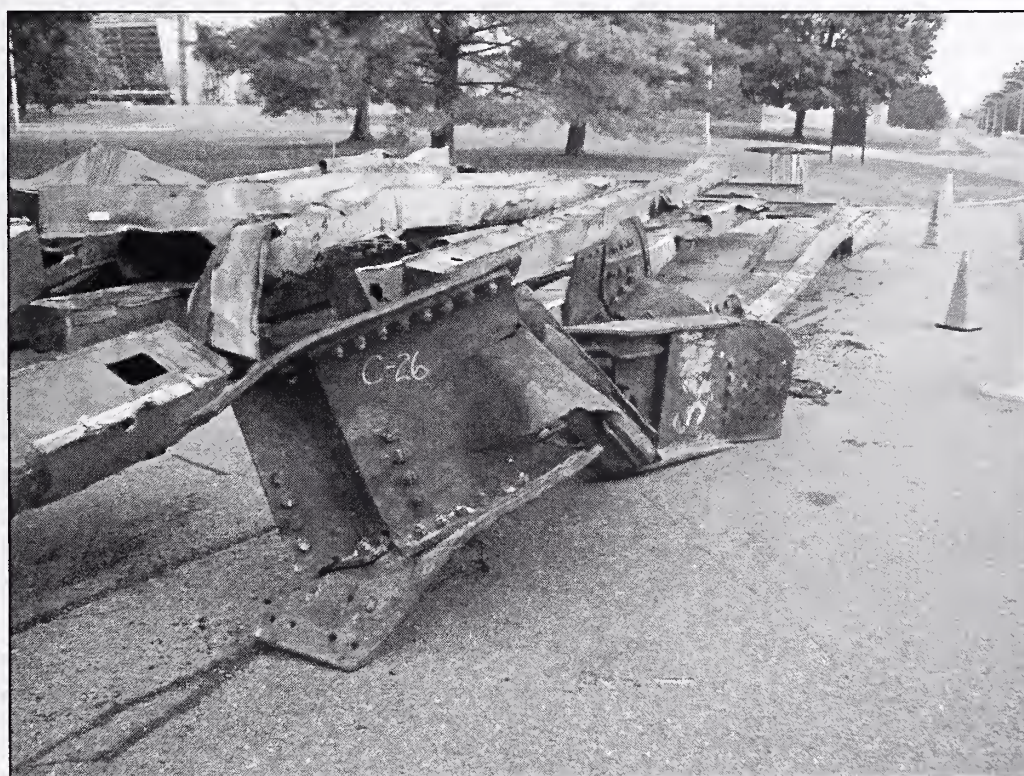
Figure 3–14. Structural element composed of three wide flange sections bolted together. The component was found to be from the framed floor area outside of the core on the 107th floor of WTC 1 (sample was C-26).

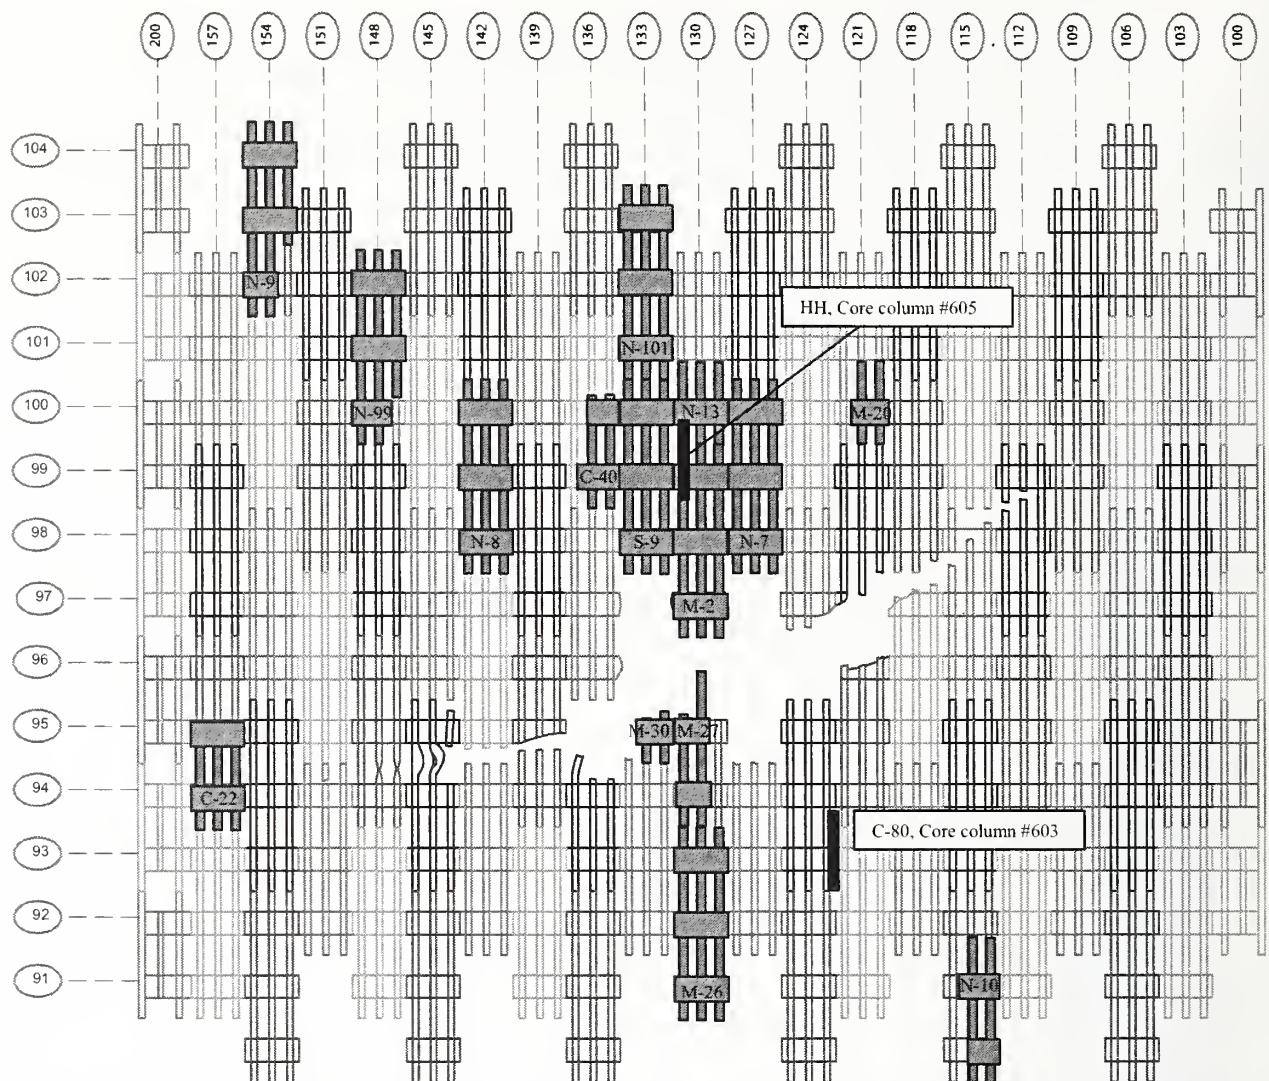
Figure 4–1. Interpreted column damage, from photographic evidence, to WTC 1, with overlay of samples in NIST’s possession. Samples shown represent recovered portions. Core columns 603 and 605 are in the second row from the north face of WTC 1.

Interpretation of the photographic evidence revealed that damage to World Trade Center (WTC) 1 due to aircraft impact occurred from floor 94 to floor 99 and was bounded by columns 111 through 152. For WTC 2, the impact area was lower with damage found from floor 77 to floor 85. While the damage appears to be bordered by column lines 411 and 440, columns closer to the southeast corner of the building may also have been affected. However, few images were obtained where smoke is not obscuring this portion of the south face of WTC 2 to complete the analysis. From this information, NIST was able to determine which perimeter panels and core columns could be used to comment on damage and possible failure mechanisms in this area. Figure 4-1 shows the sample overlay of the exterior panels in NIST's possession in and around the impact zone of WTC 1. Samples C-80 and HH, both core columns, were also identified as residing near the impact zone. The recovered portion of each column is approximately represented in this image. Unfortunately, there were no similar corresponding exterior panels for WTC 2, but two core columns were recovered (Fig. 4-2).

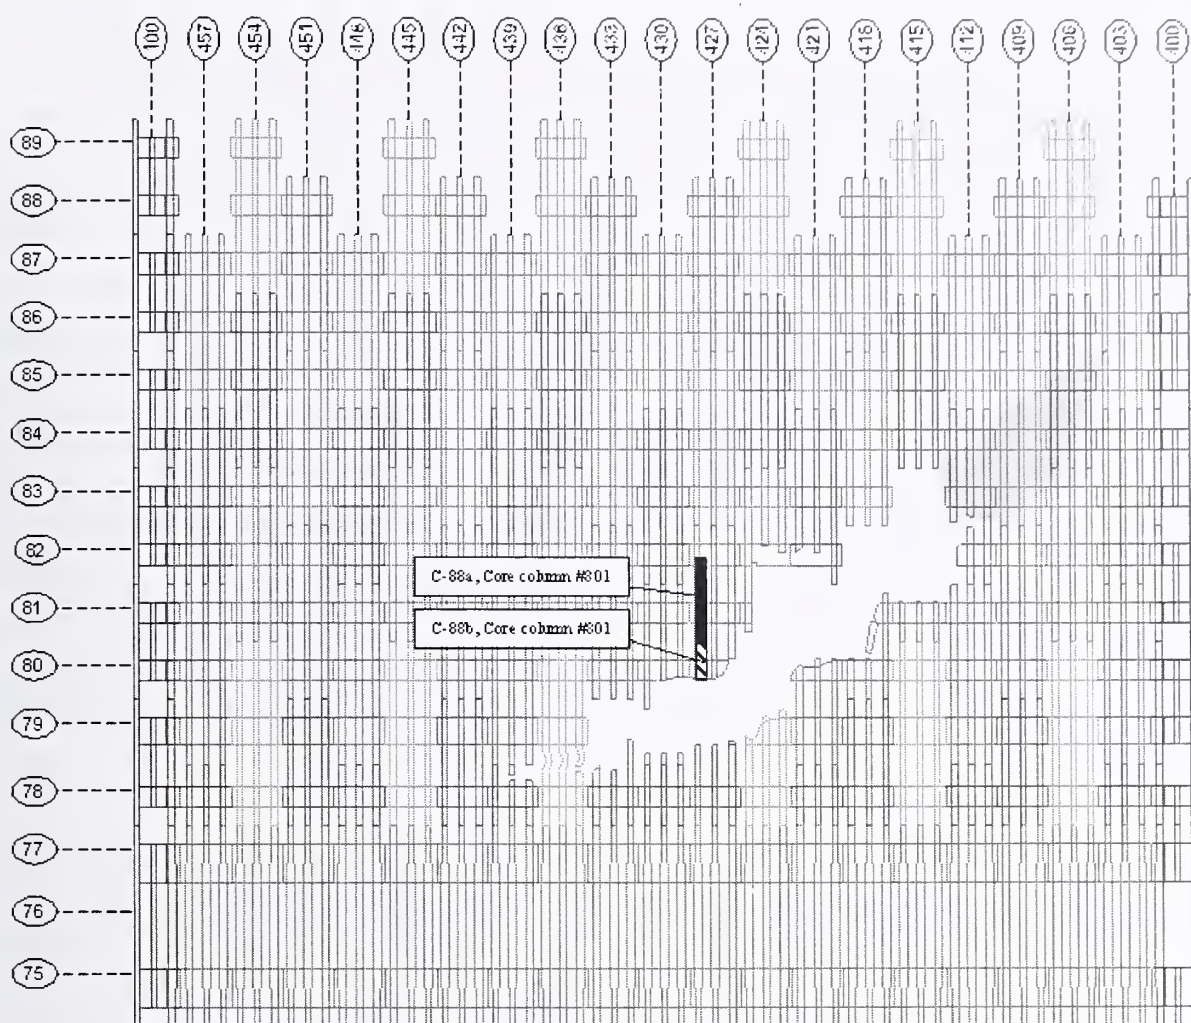
Damage in shaded area cannot be accurately determined.

Note: Core column 801 is in the closest row to the south face of WTC 2.

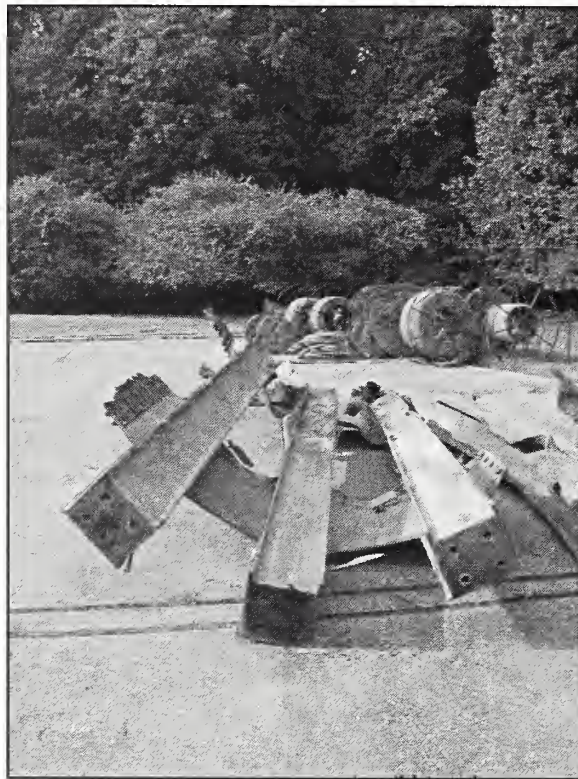
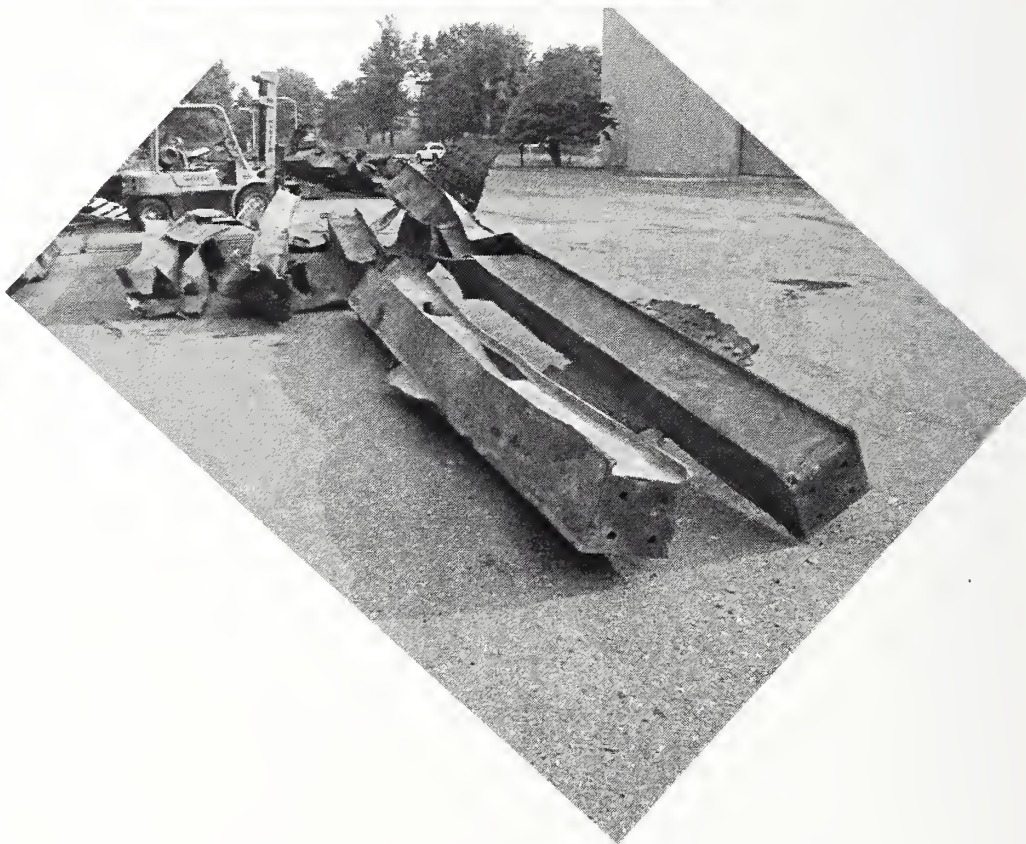
Figure A-1. Exterior column panel, sample C-46 shown.

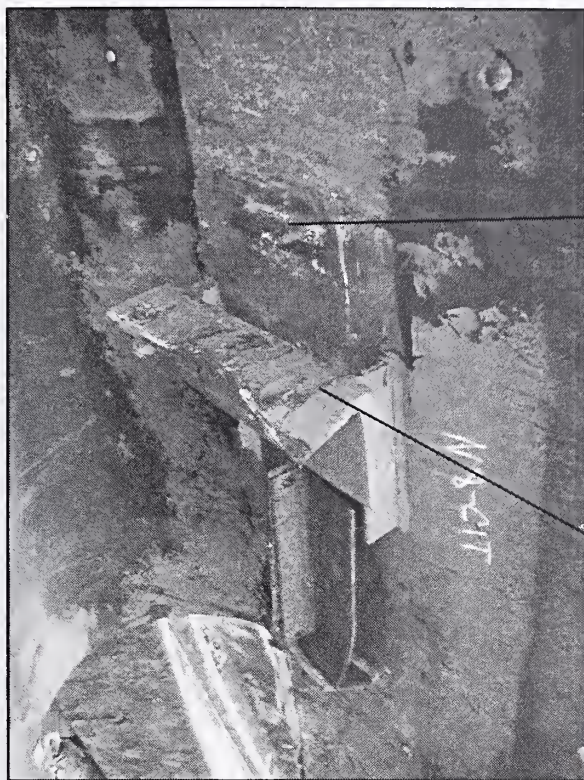
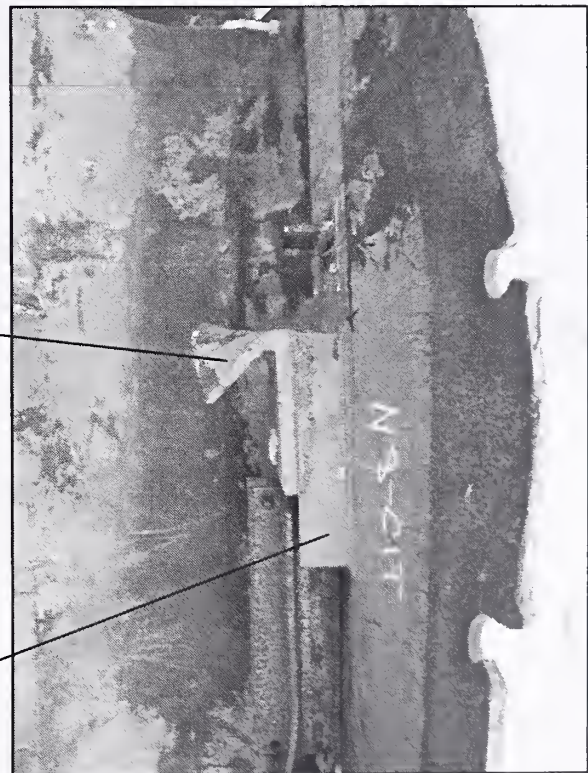
Welded gusset plate

Seat with 2 intact bolt holes for floor truss attachment. Intact bolt remains in far hole.

Seat

Stand off plates used to attach seat to column interior

Figure A-2. Floor truss seats shown from sample N-8.

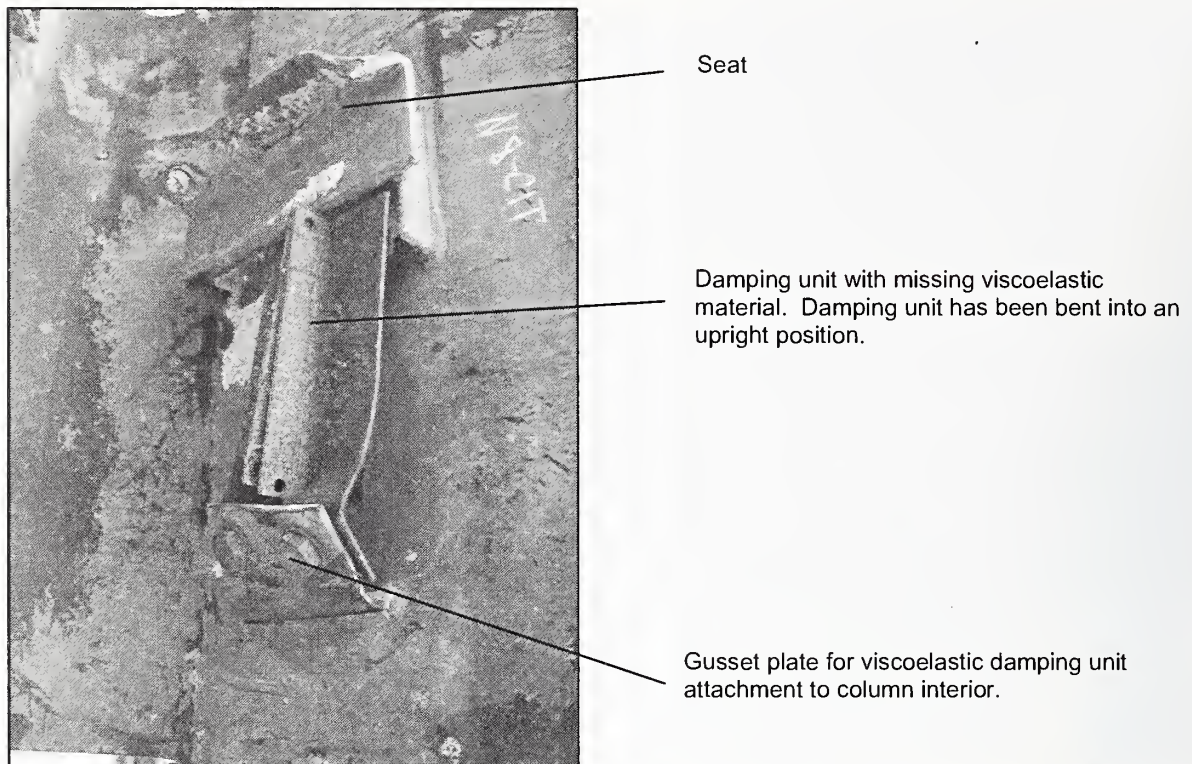
Figure A-3. Damping Unit shown from sample N-8.

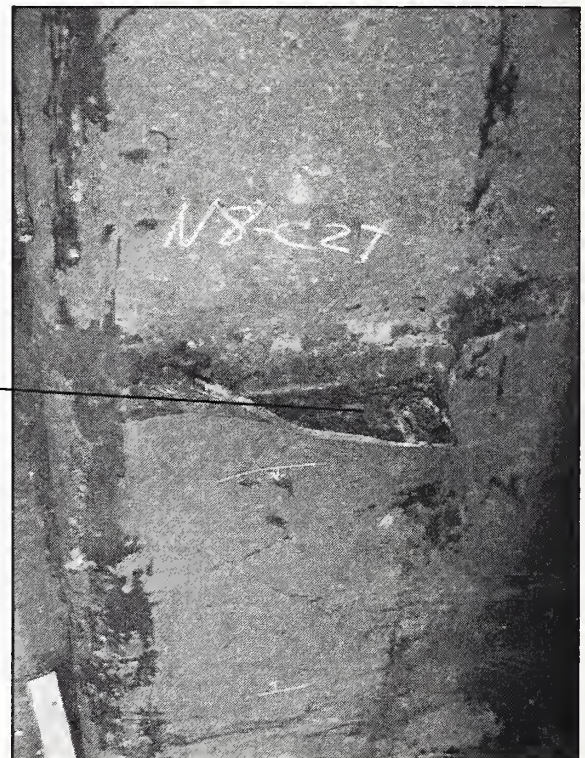
Welded gusset plate used in place of seat on alternate column/spandrel intersections. One method used to attach diagonal bracing strap to exterior wall

Figure A-4. Gusset plate shown from sample N-8.

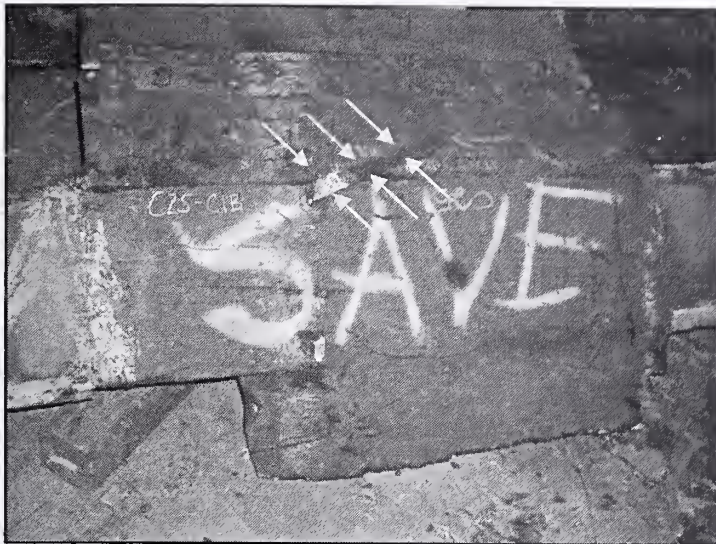
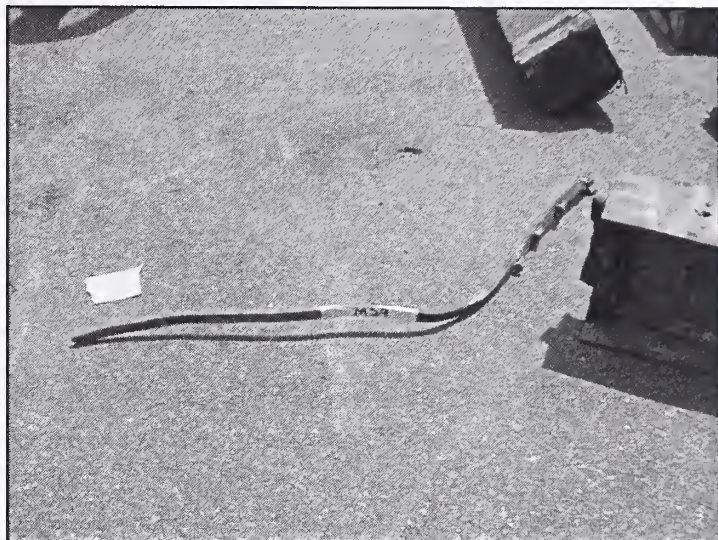
Diagonal bracing strap attached directly to exterior column

Figure A-5. Diagonal bracing strap shown on sample C-25 (top), and single strap labeled M-29 (bottom).
