NIST NCSTAR 1-3B

**Federal Building and Fire Safety Investigation of the
World Trade Center Disaster**

Steel Inventory and Identification

Stephen W. Banovic

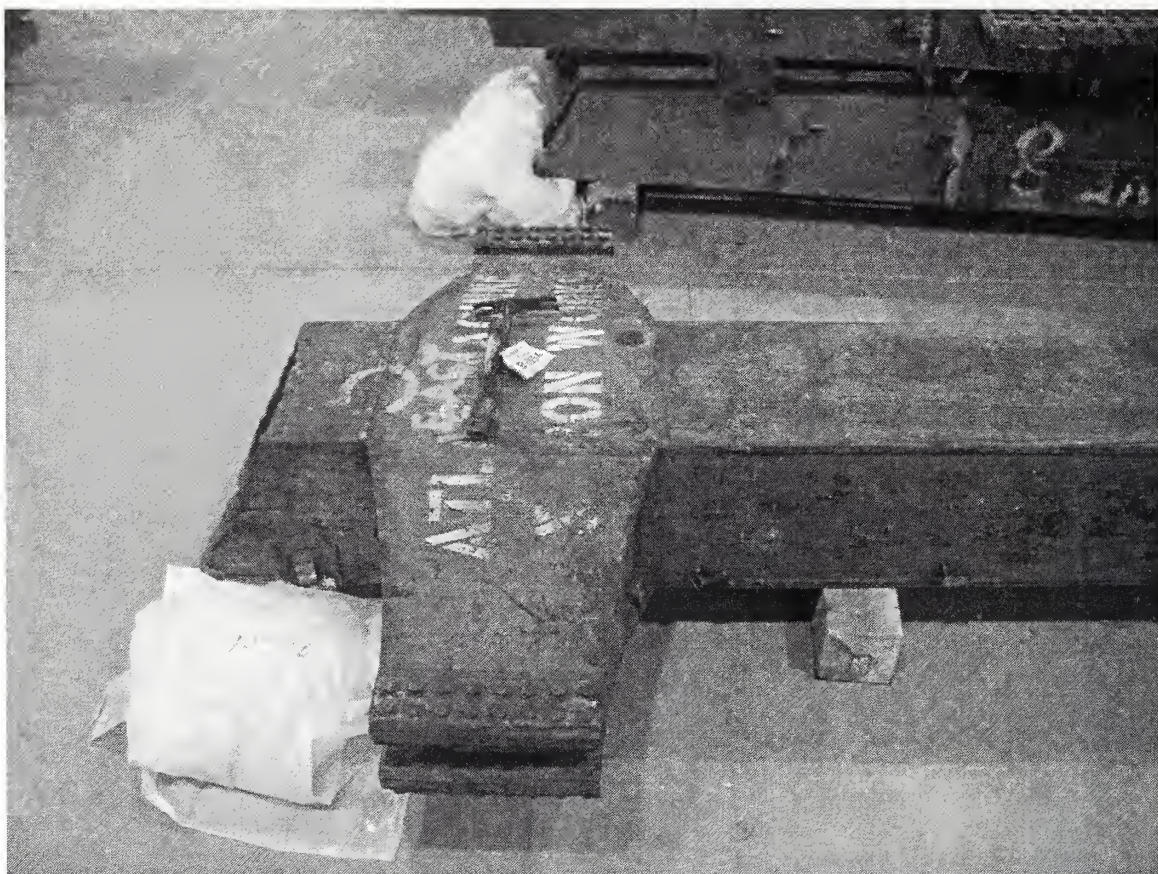
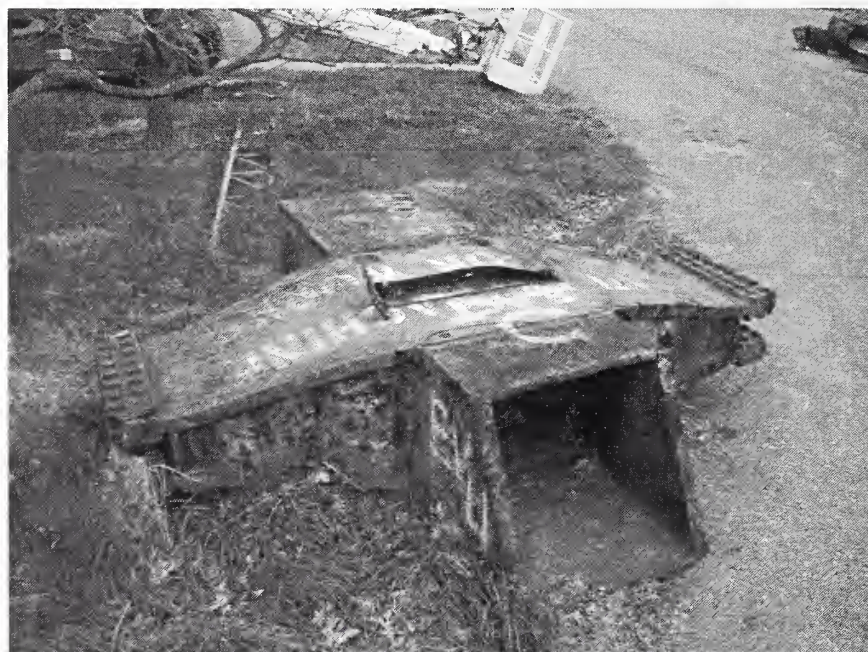
B-5004 at JFK

B-5004 portion cut and moved to NIST campus

Figure A-6. Bowtie section of exterior wall.

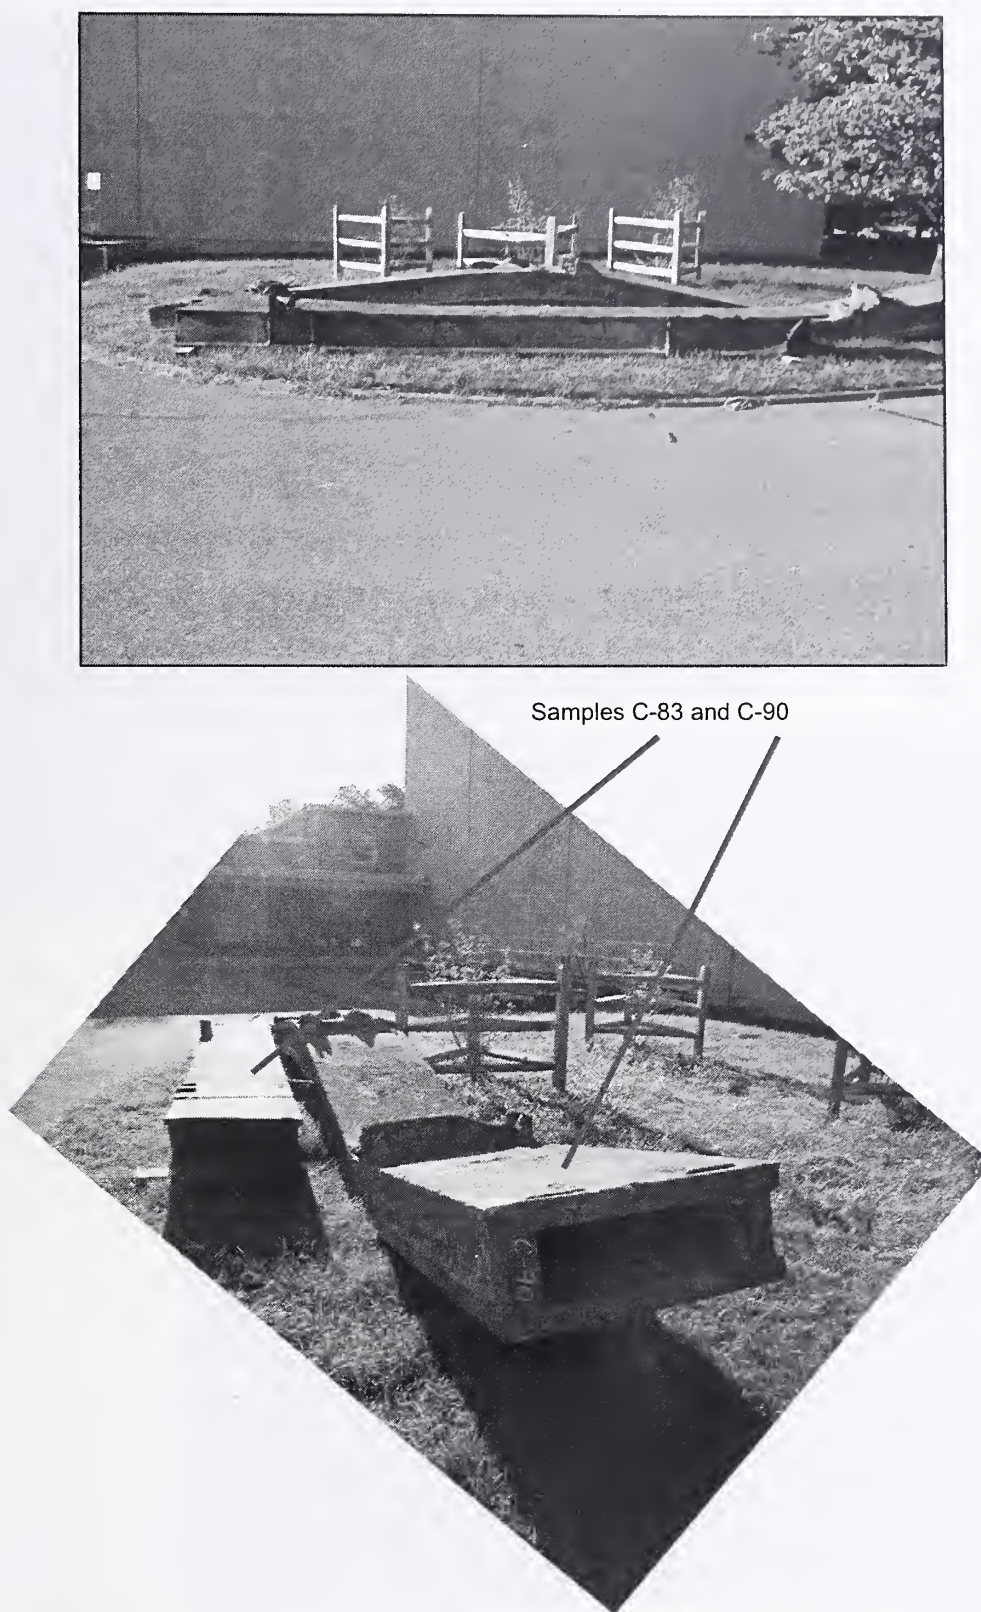
Figure A-7. Recovered rectangular built up box sections used as core columns.

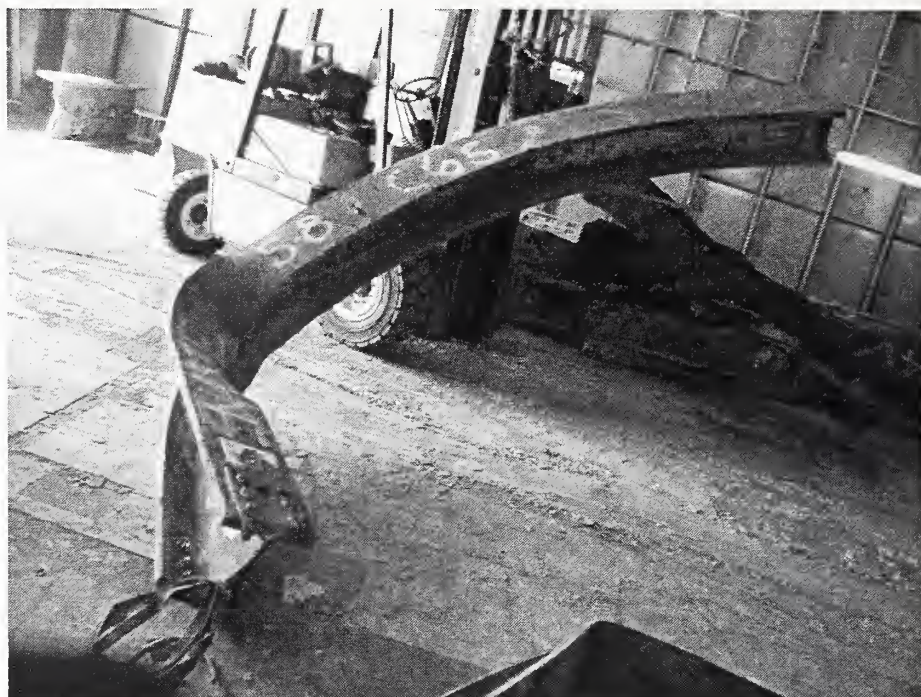
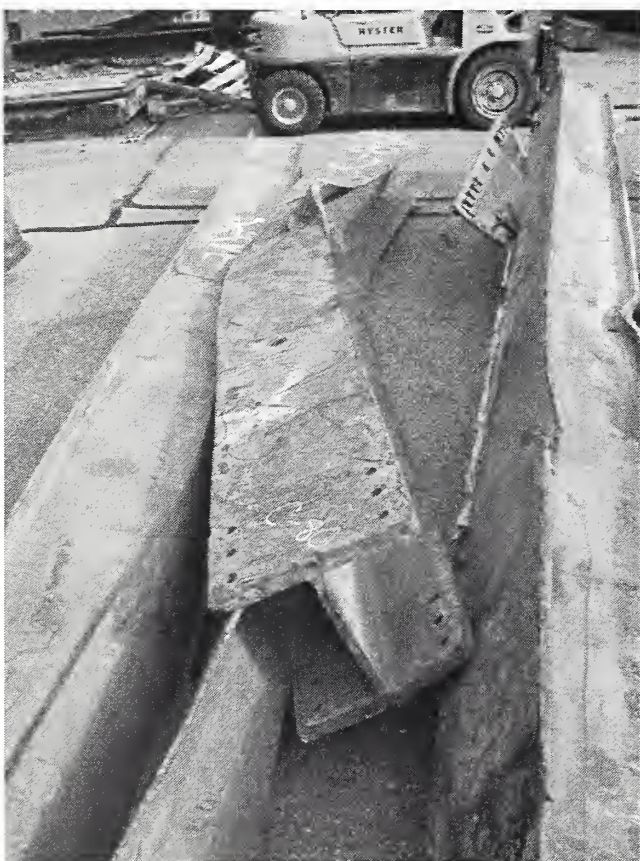
Figure A–8. Recovered wide flange sections used as core columns.

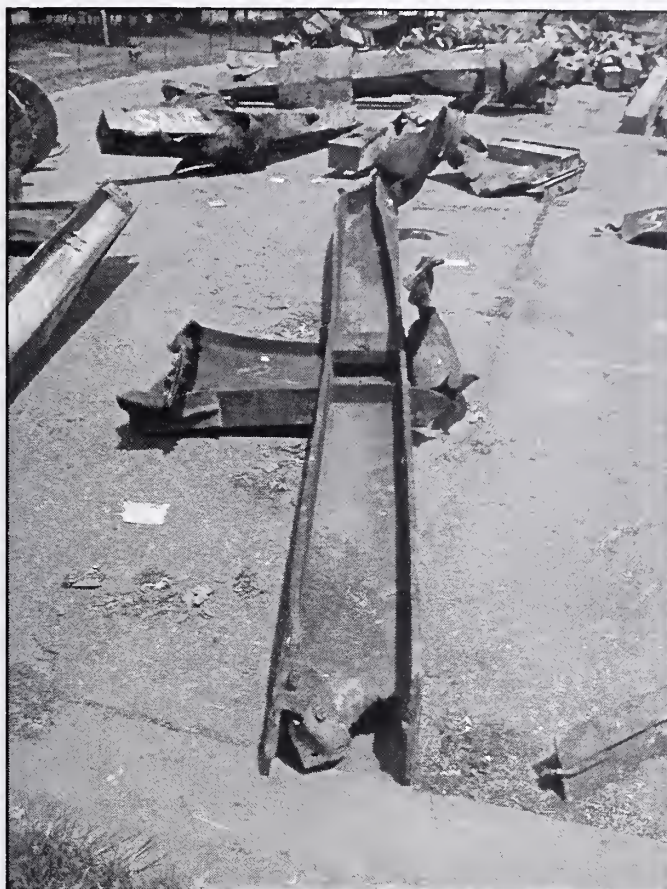
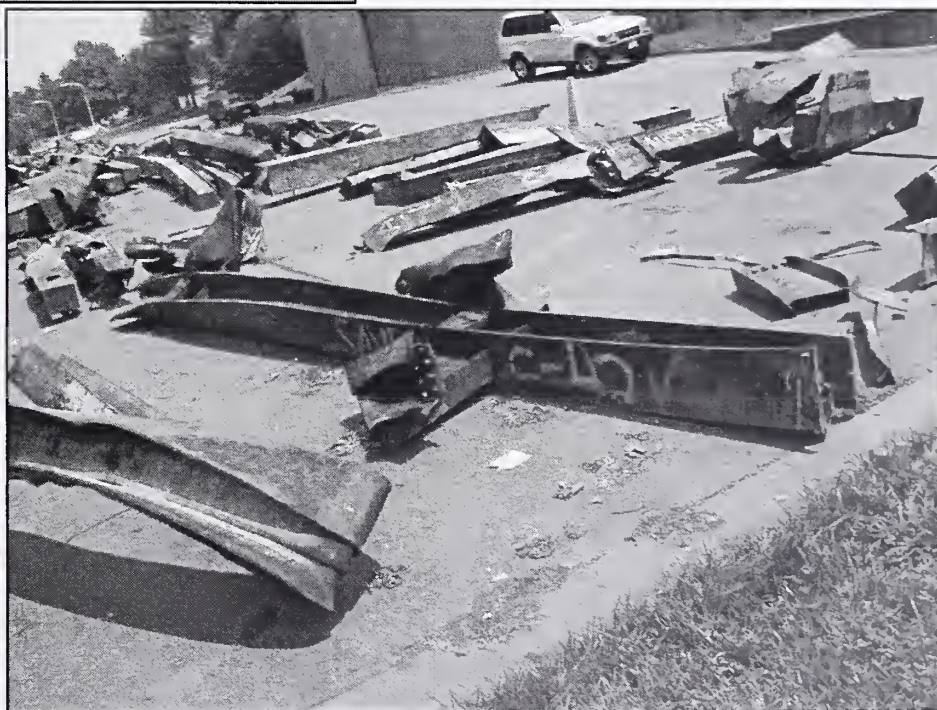
Figure A-9. Other recovered wide flange sections, shown is sample C-42.

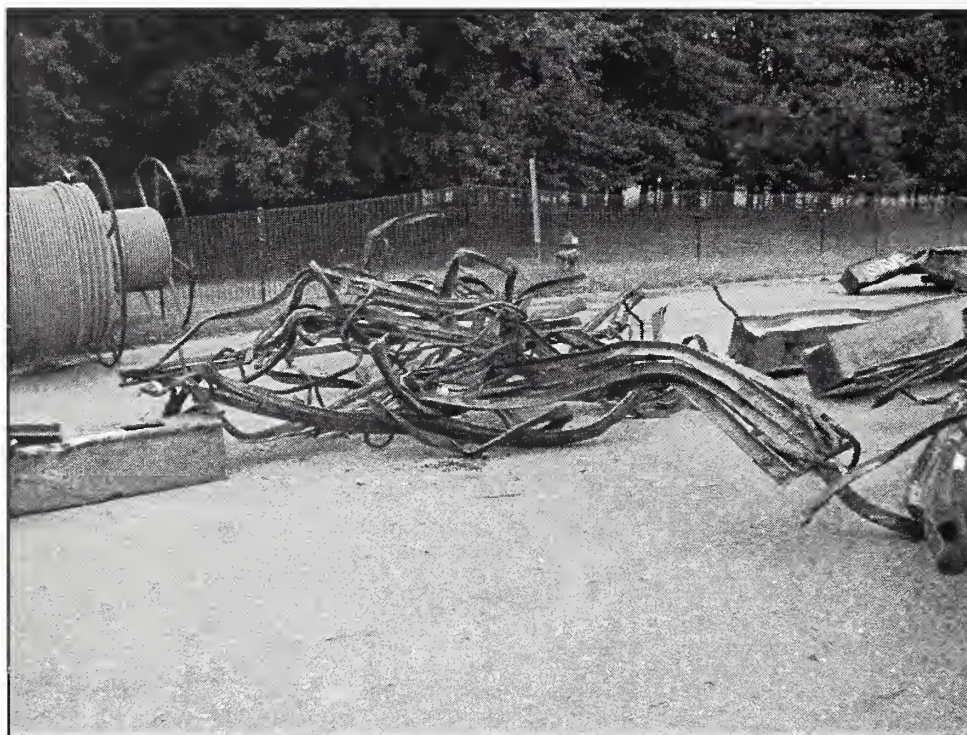
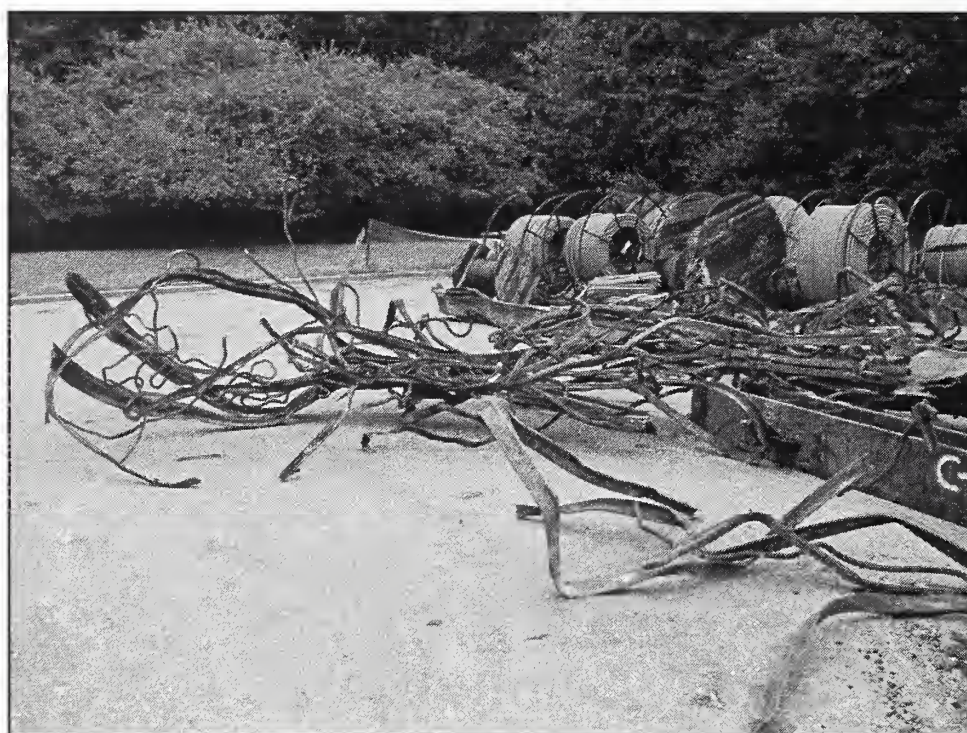
Figure A-10. Recovered floor truss material; shown are portions of sample C-53.

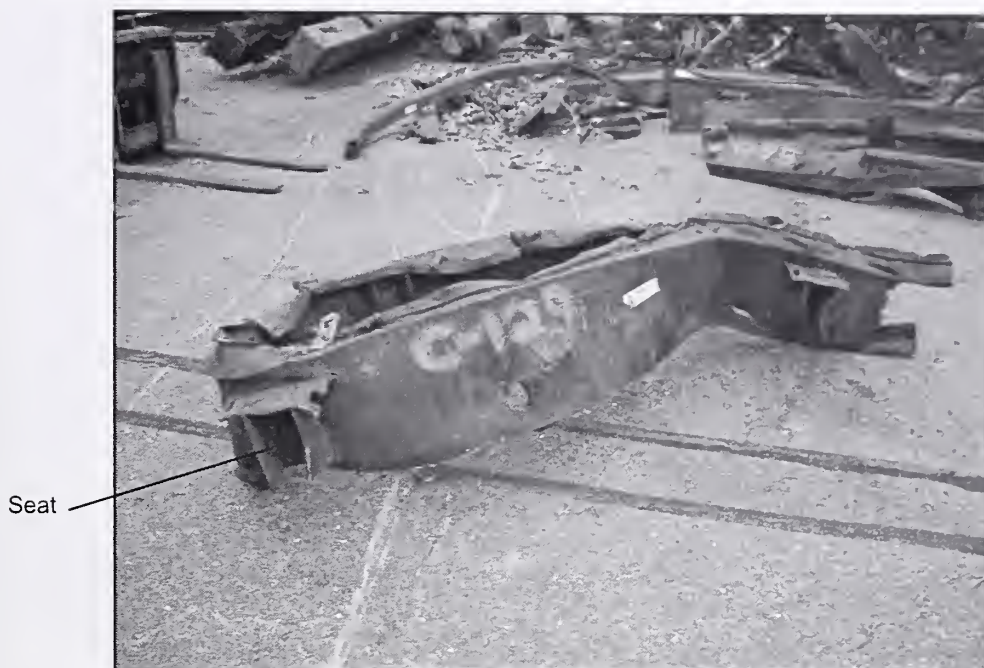
Figure A-11. Recovered inner channel material used to connect floor trusses to core columns; shown is sample C-129.

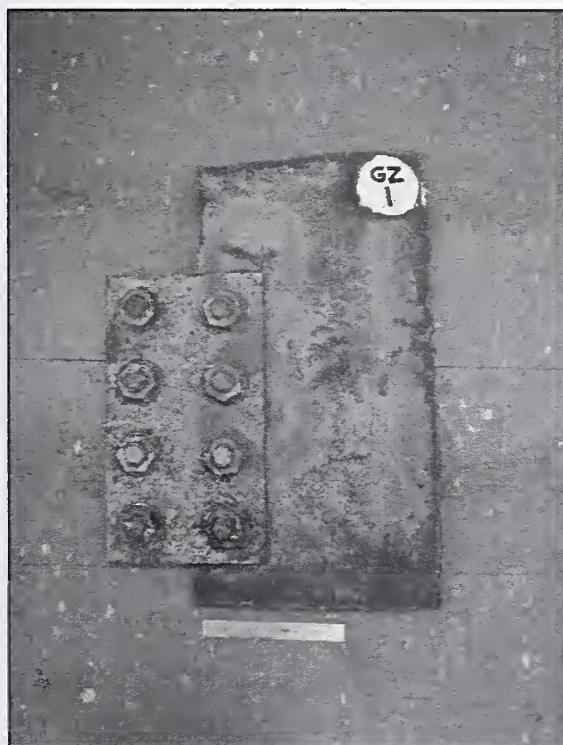
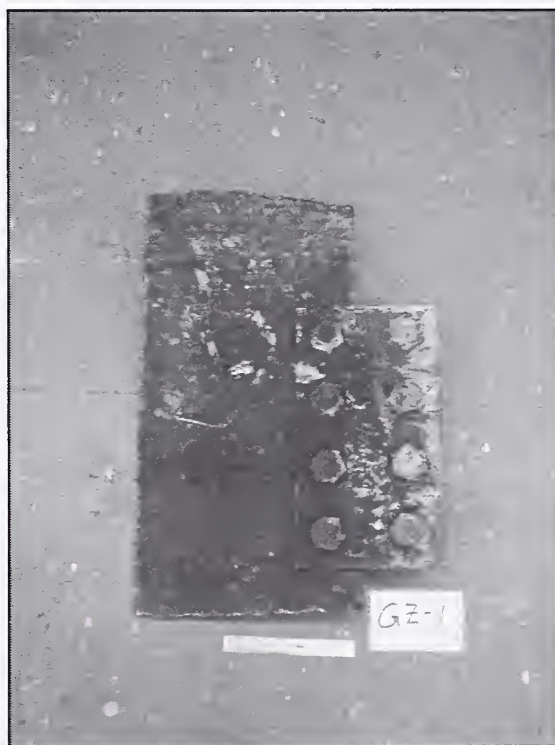
Figure A-12. Coupons removed in the field from WTC 5; shown is sample GZ-1.

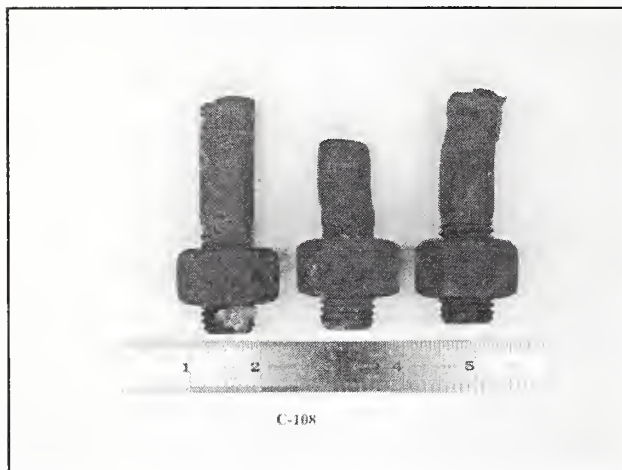
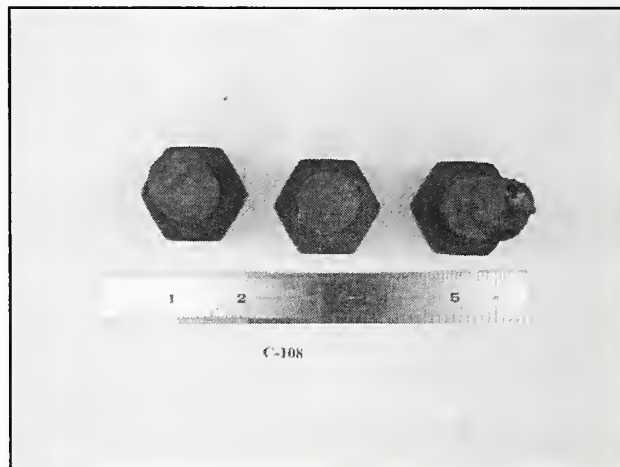
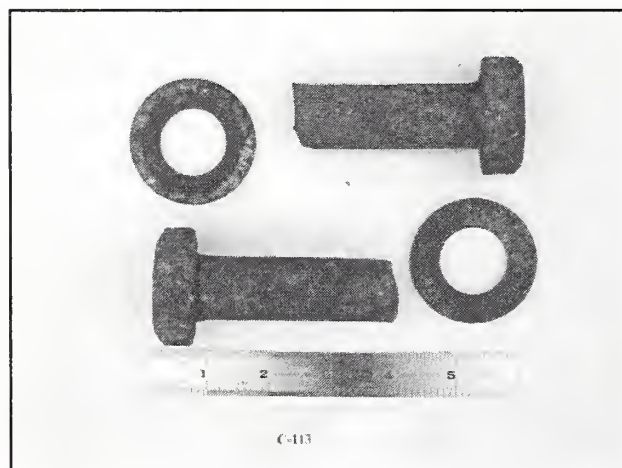
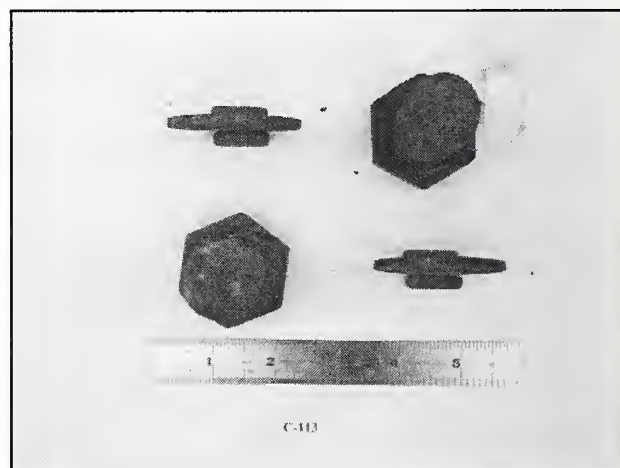
Figure A-13. Examples of recovered bolts from various samples.

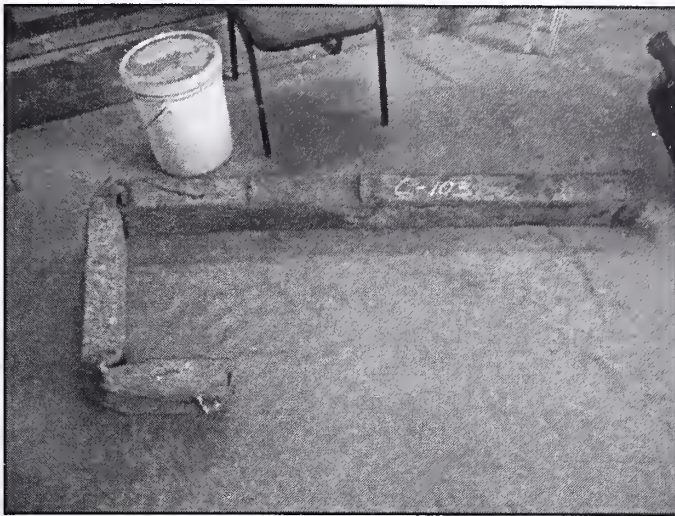
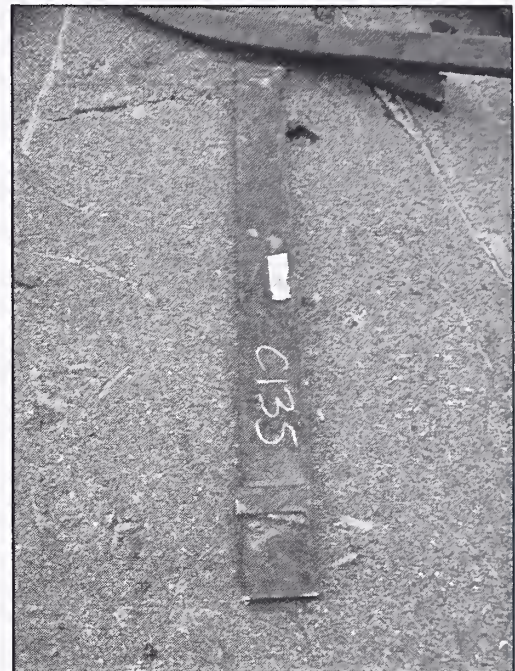
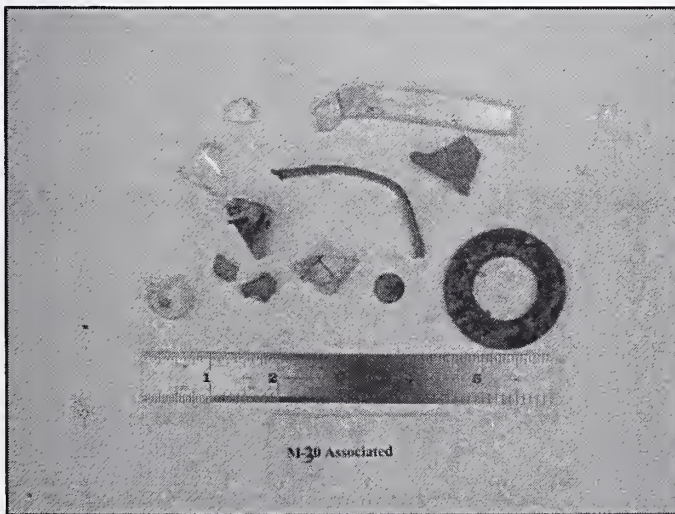
Square tubular piece
Sample C-103

Rectangular tubular piece
Sample C-135

Assorted pieces from within column
Sample M-30 Associated
