NIST NCSTAR 1-6A

Federal Building and Fire Safety Investigation of the World Trade Center Disaster

Passive Fire Protection

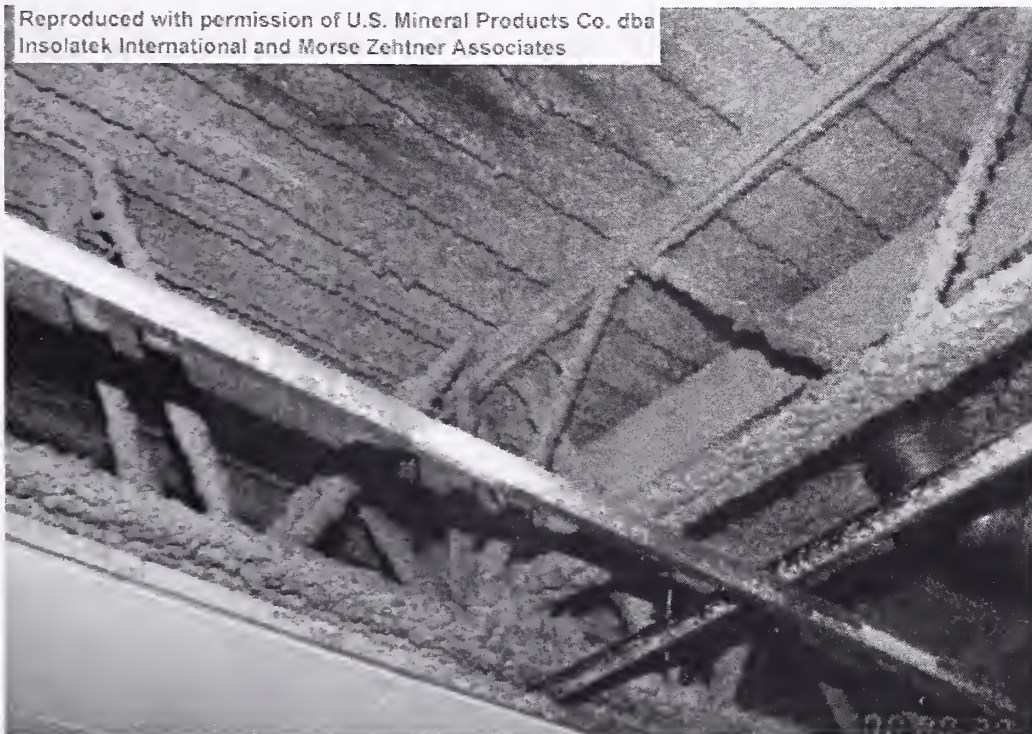
Figure 3–5. Intersection of main truss and bridging truss showing general good coverage of SFRM on truss members but thickness varies on web bars.

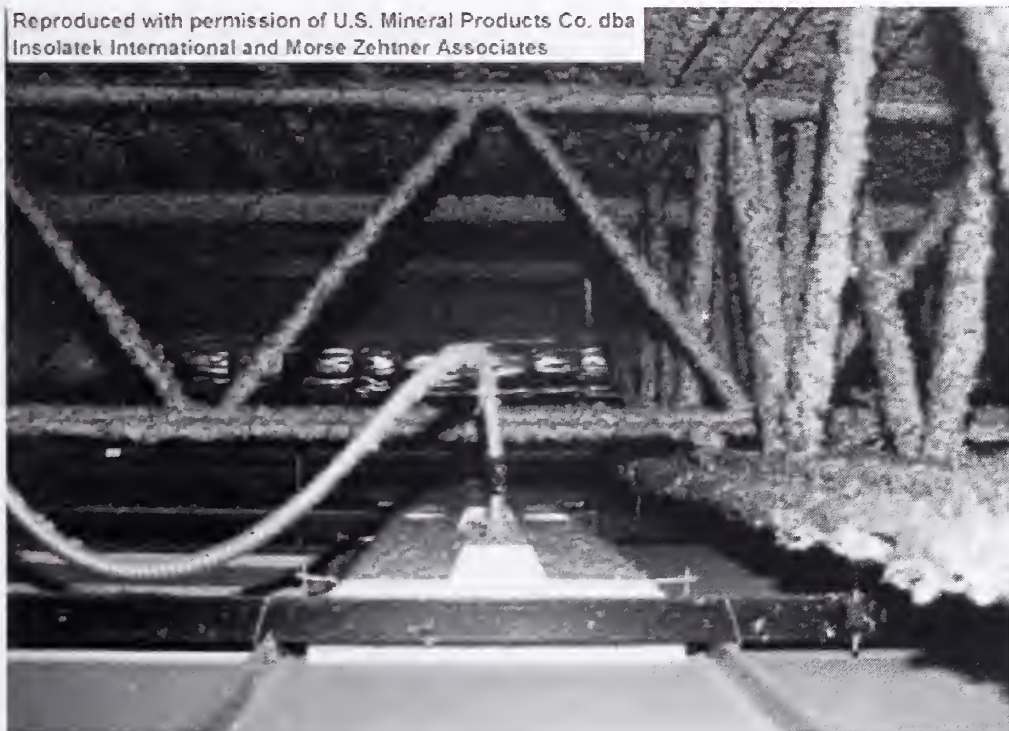
Figure 3–6. Intersection of main truss and bridging truss showing thinner SFRM on members of bridging truss.

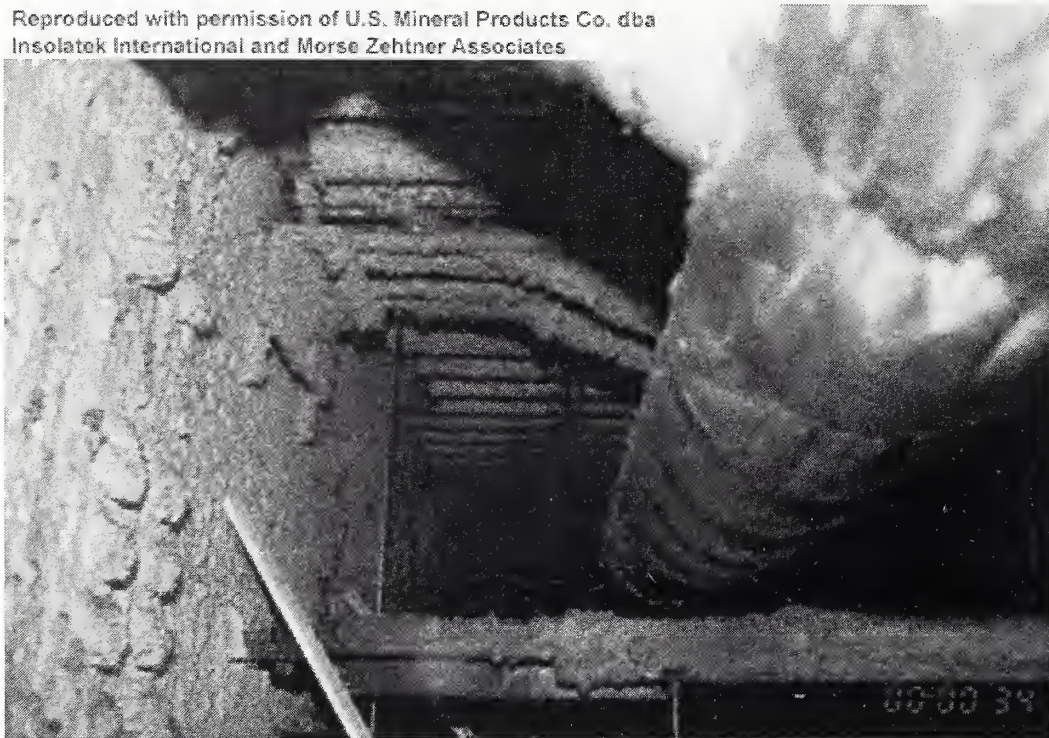
Figure 3-7. Connection of main truss to spandrel beam showing relatively thin SFRM on truss seat and no SFRM on damper.

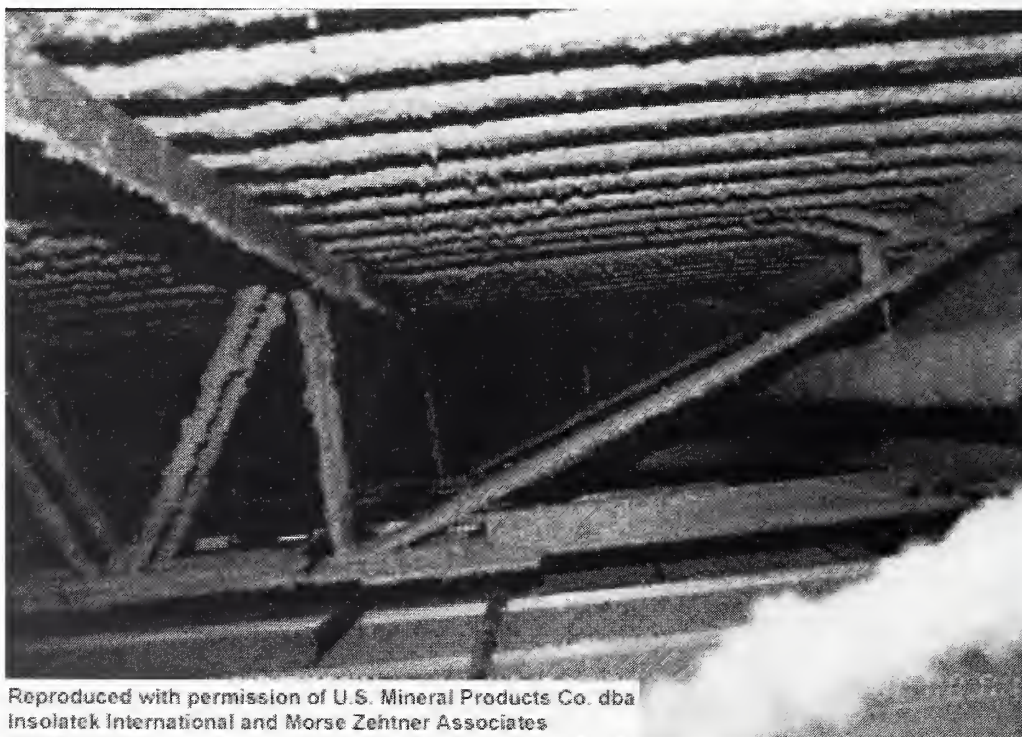
Figure 3-8. End of main truss showing low thickness of SFRM on truss members and no SFRM on damper saddle.

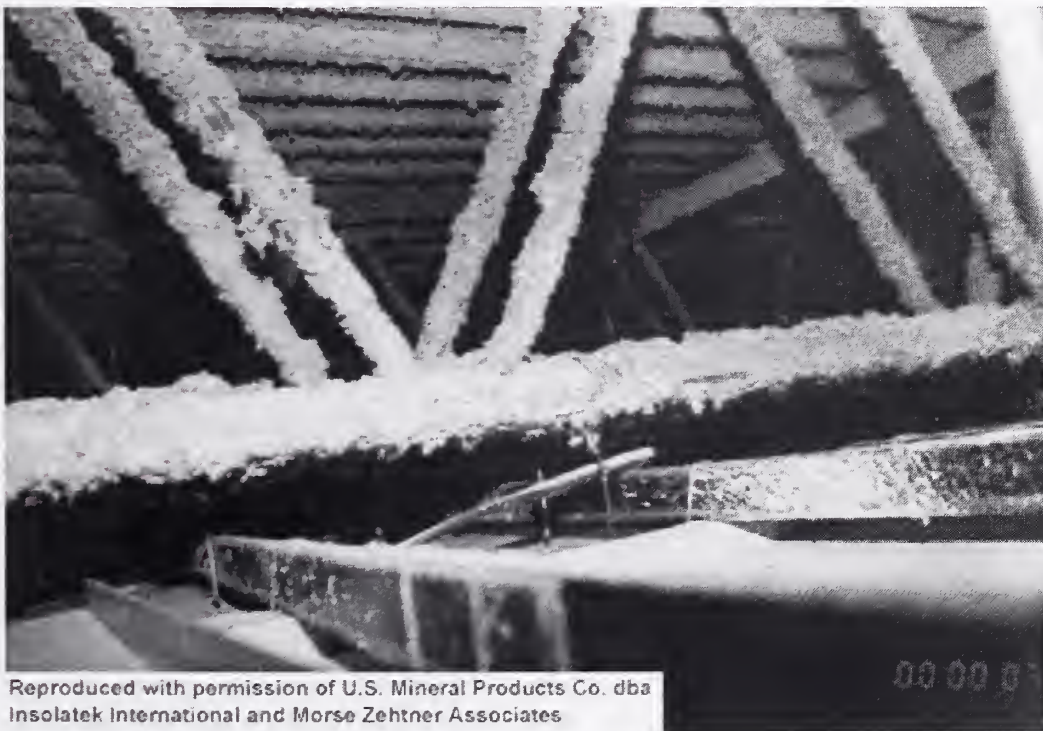
Figure 3-10. Example of damage to SFRM during installation of utilities.

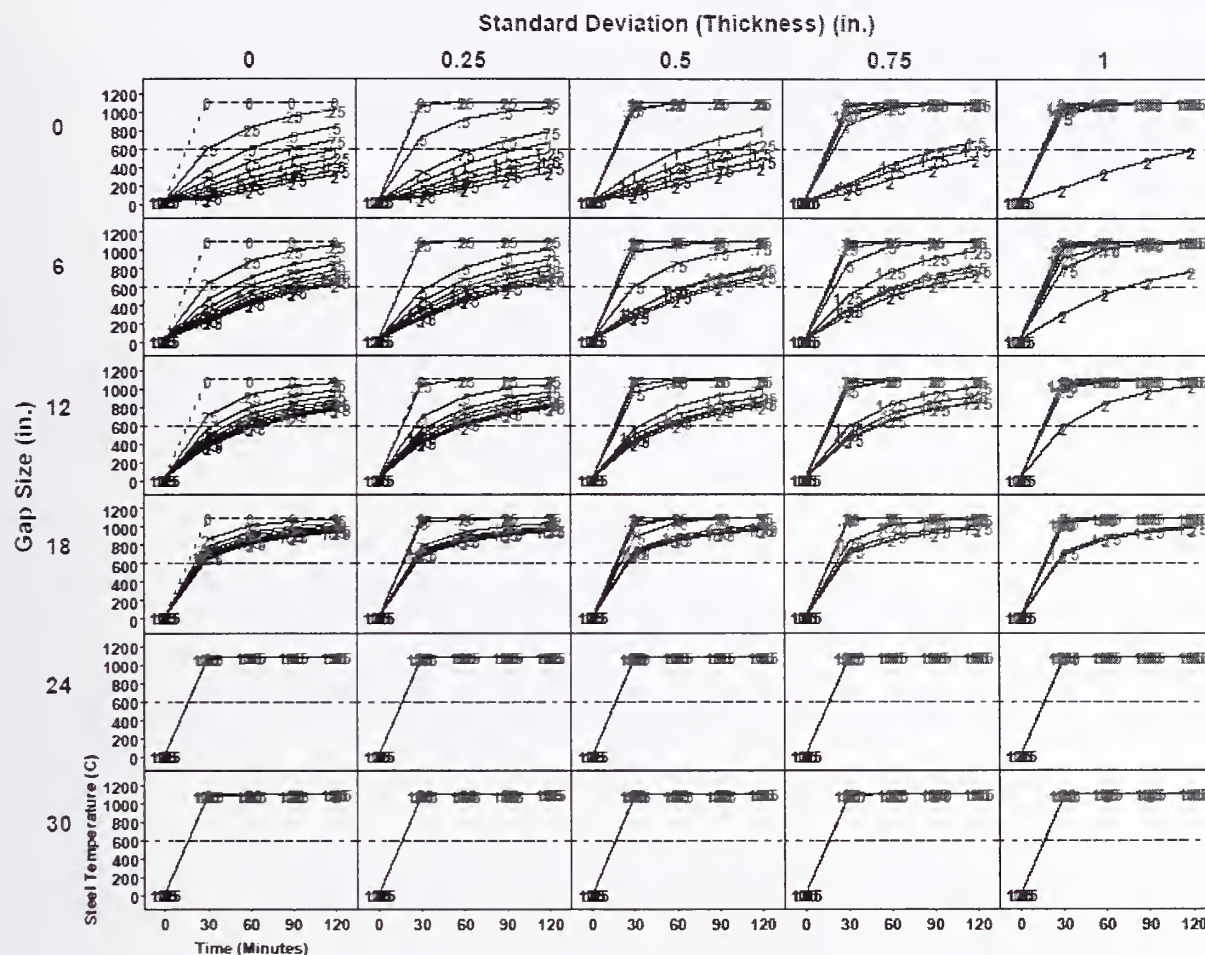
Figure 5–6. Example of plot matrix from sensitivity study of the effects of missing SFRM and variability of SFRM thickness on steel temperature. Each graph is a temperature history of the steel at point #2 (see Fig. 5-5 for location) for different thicknesses of SFRM.

trend of the curves in going downward from the top of a column in Fig. 5-6. The National Institute of Standards and Technology (NIST) does not have sufficient information to determine the frequency of occurrence of these gaps or their typical locations within the fire-affected floors. Therefore, gaps in insulation were not considered in the thermal modeling.

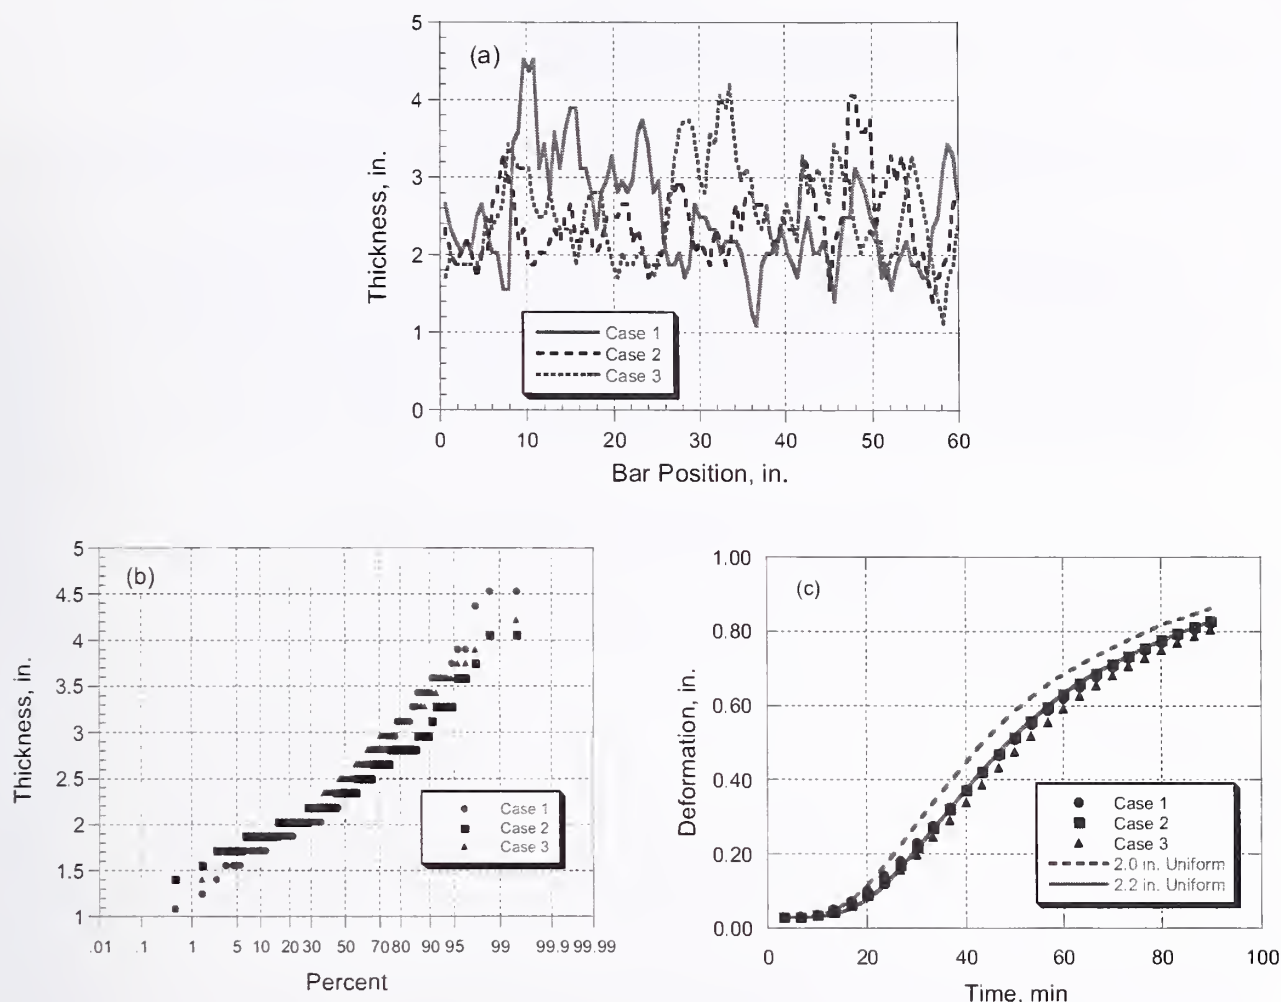
Figure 5–8. (a) Randomly generated thickness profiles with average thickness of 2.5 in. and standard deviation of 0.6 in., (b) normal probability plots of thickness values, and (c) deformation of 1 in. bar compared with deformation for uniform thickness of thermal insulation.

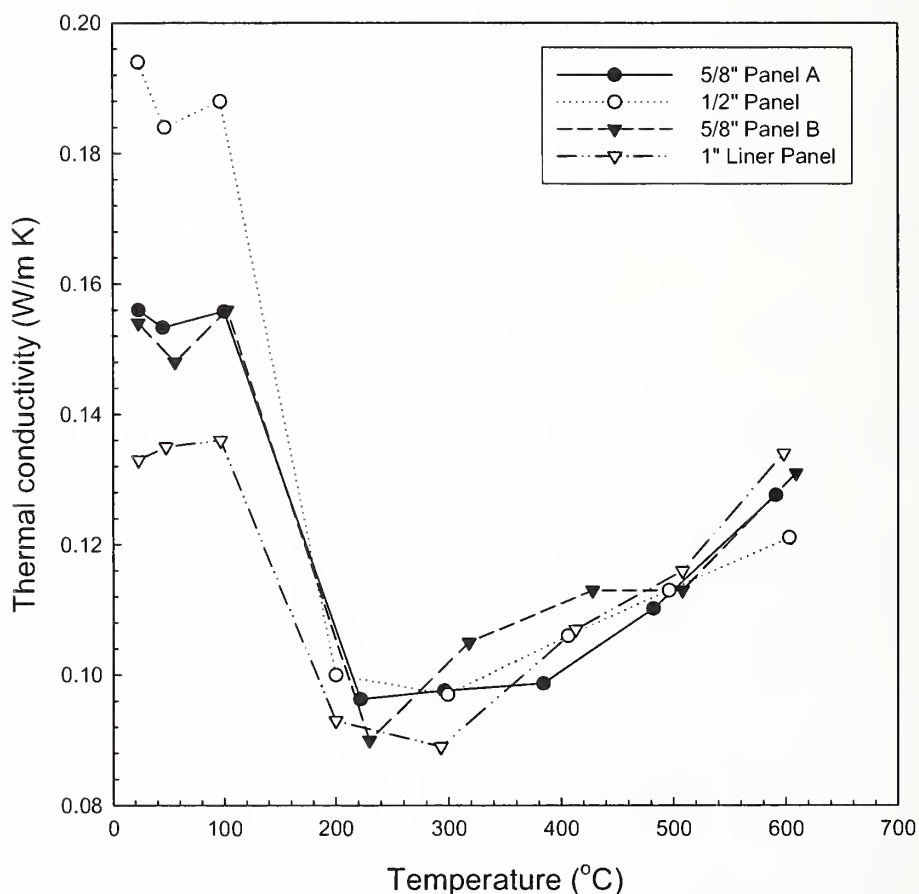
**Figure 6–9. Thermal conductivities of the four gypsum materials as a function of temperature.**

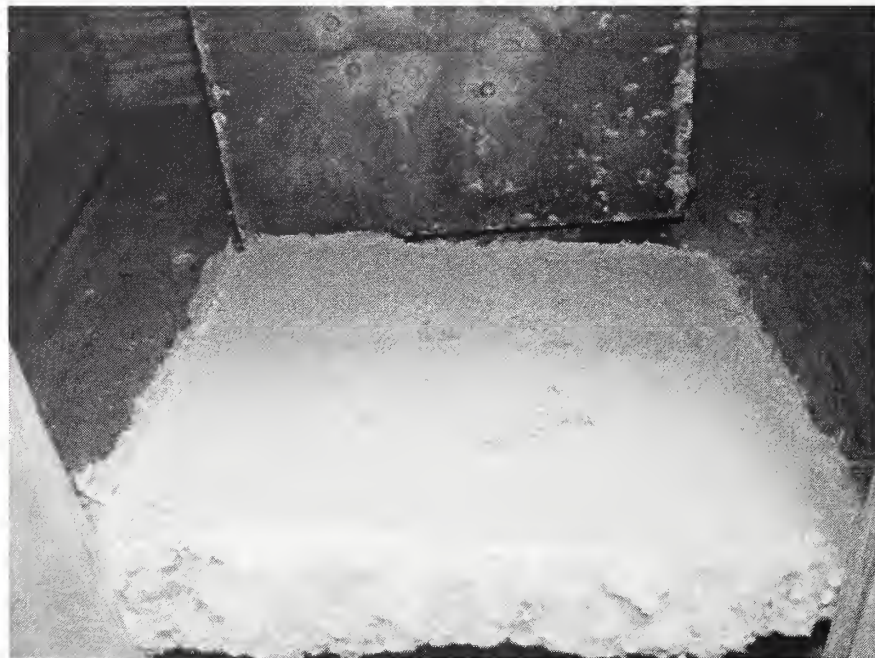
Figure C-4. Photograph showing damage to the SFRM after a ballistic impact at 0 degree. The SFRM layer completely separated from the steel plate.

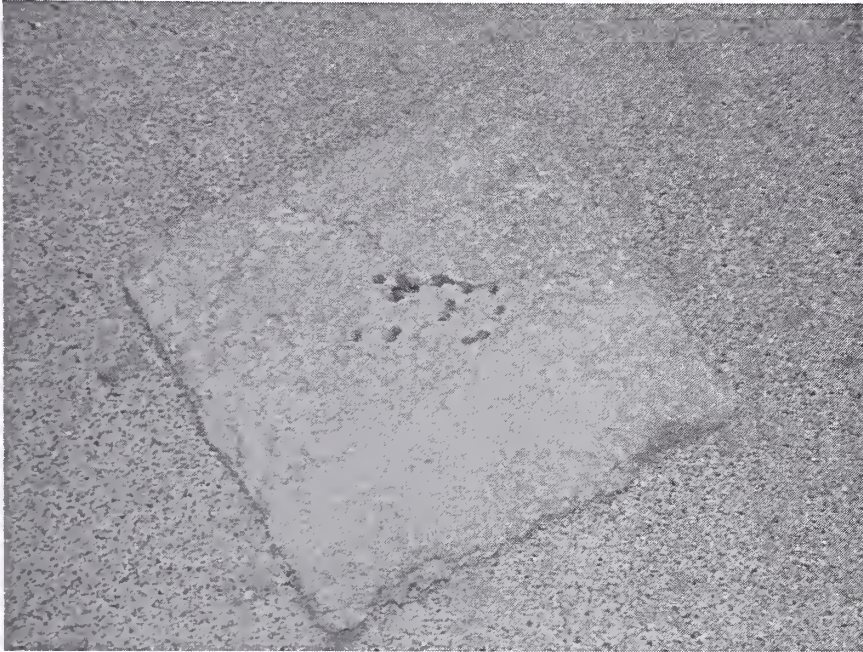
Figure C-5. Photograph showing damage to the SFRM after a ballistic impact at 20 degree. The SFRM layer completely separated from the steel plate and landed on the floor.

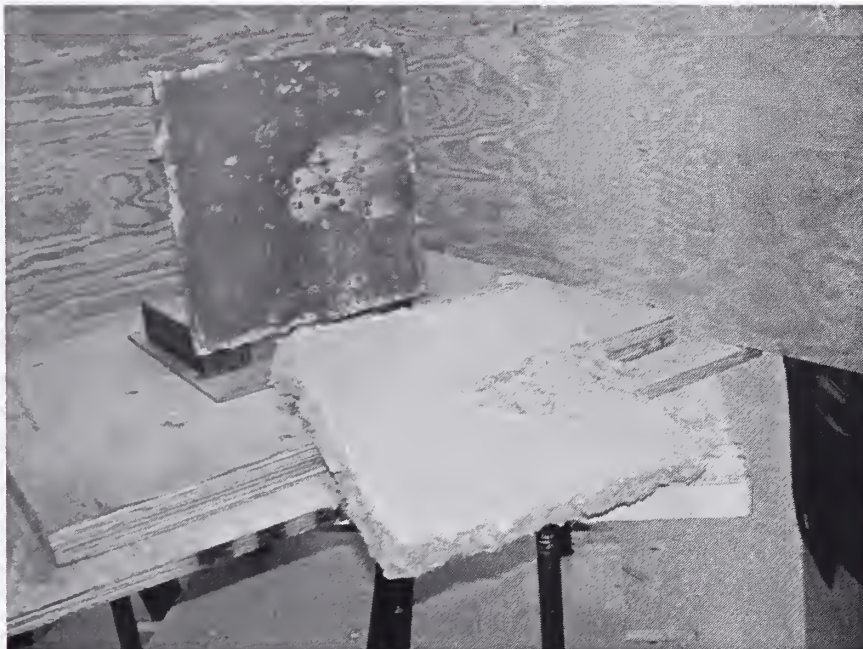
Figure C-6. Photograph showing damage to the SFRM after a ballistic impact at 40 degree. The SFRM layer completely separated from the steel plate.

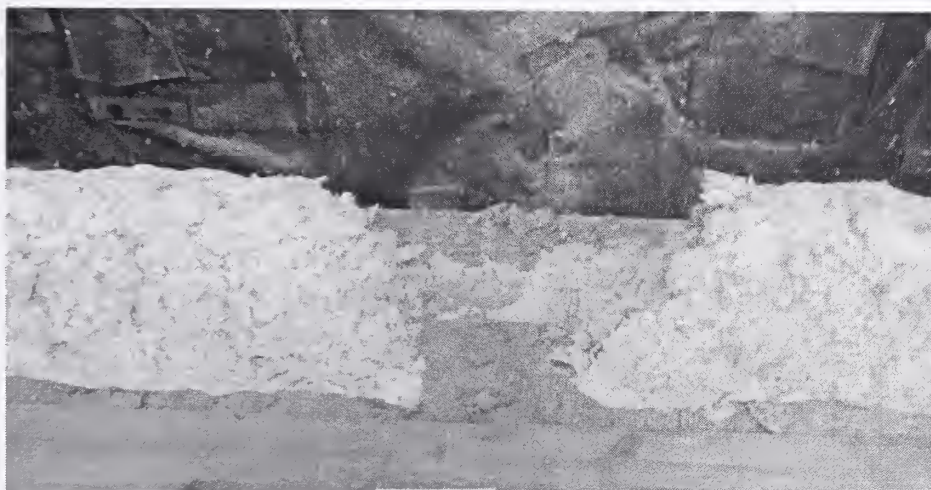
Figure C-11. Photograph showing damage to the SFRM on unprimed steel bar (BAR04) after a debris impact at 0 degree using the large universal receiver.
