**NIST NCSTAR 1-6B**

**Federal Building and Fire Safety Investigation of the  
World Trade Center Disaster**

**Fire Resistance Tests of  
Floor Truss Systems**

September 2005

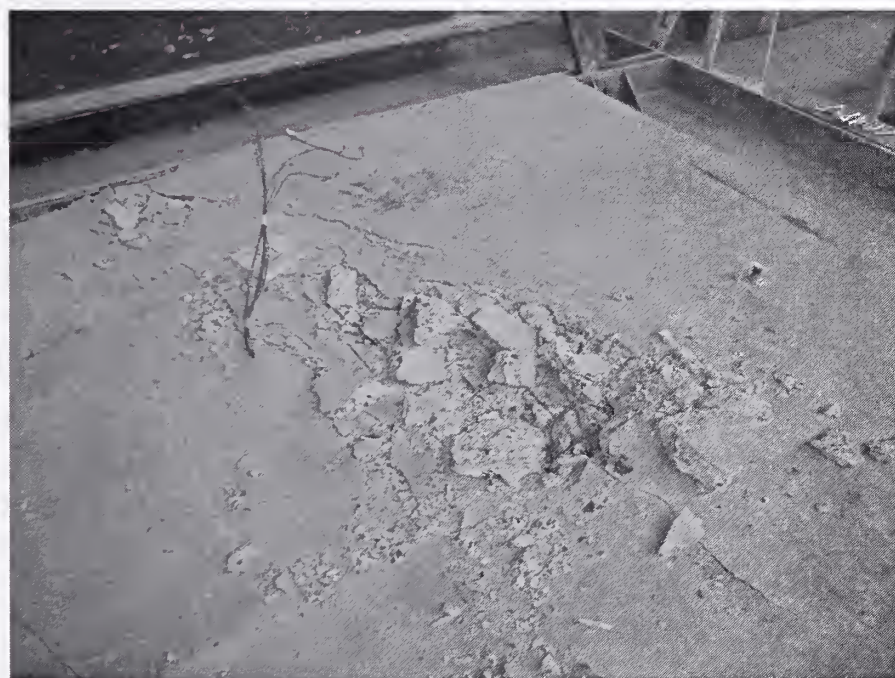
**Figure 5-15. Detail of spalling concrete at east end of Assembly No. 1.**

Figures 5-14 through 5-19 are additional views of the top of the specimen, showing the cracked and spalled concrete, and of the underside, showing bulging of the metal deck and deformations of the steel trusses after the test specimen had cooled and had been removed from the furnace. To confirm the spalling of the bottom side of the concrete slab and to quantify the depth of spalling, sections of the slab were cut using a diamond concrete wet saw (see Fig. 5-20). The depth of the delamination spalling varied but was on the order of 2 in. as seen in Fig. 5-21.

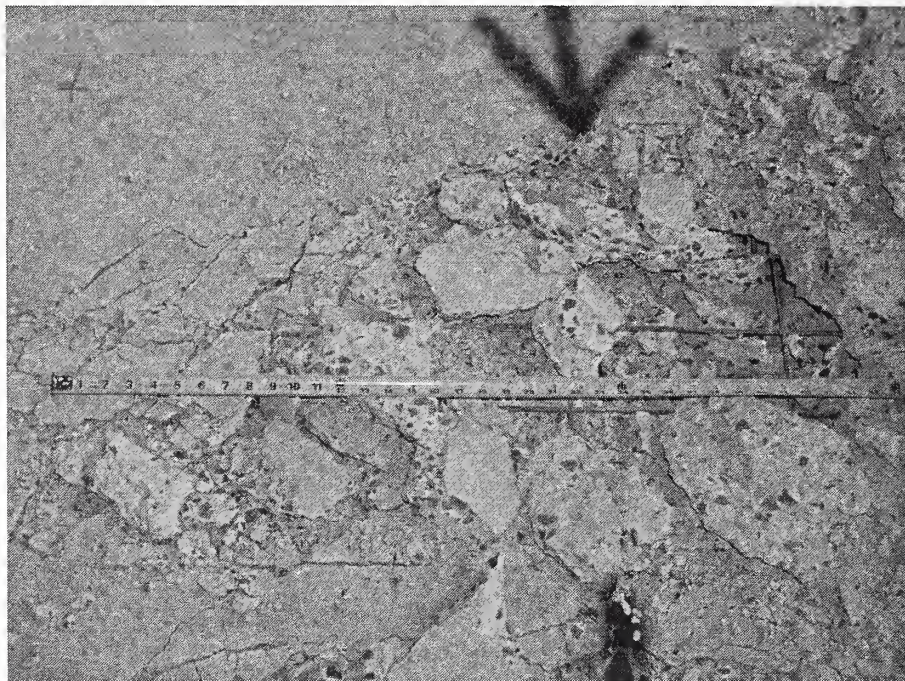
**Figure 5–16. Close-up of spalling concrete at east end of Assembly No. 1.**

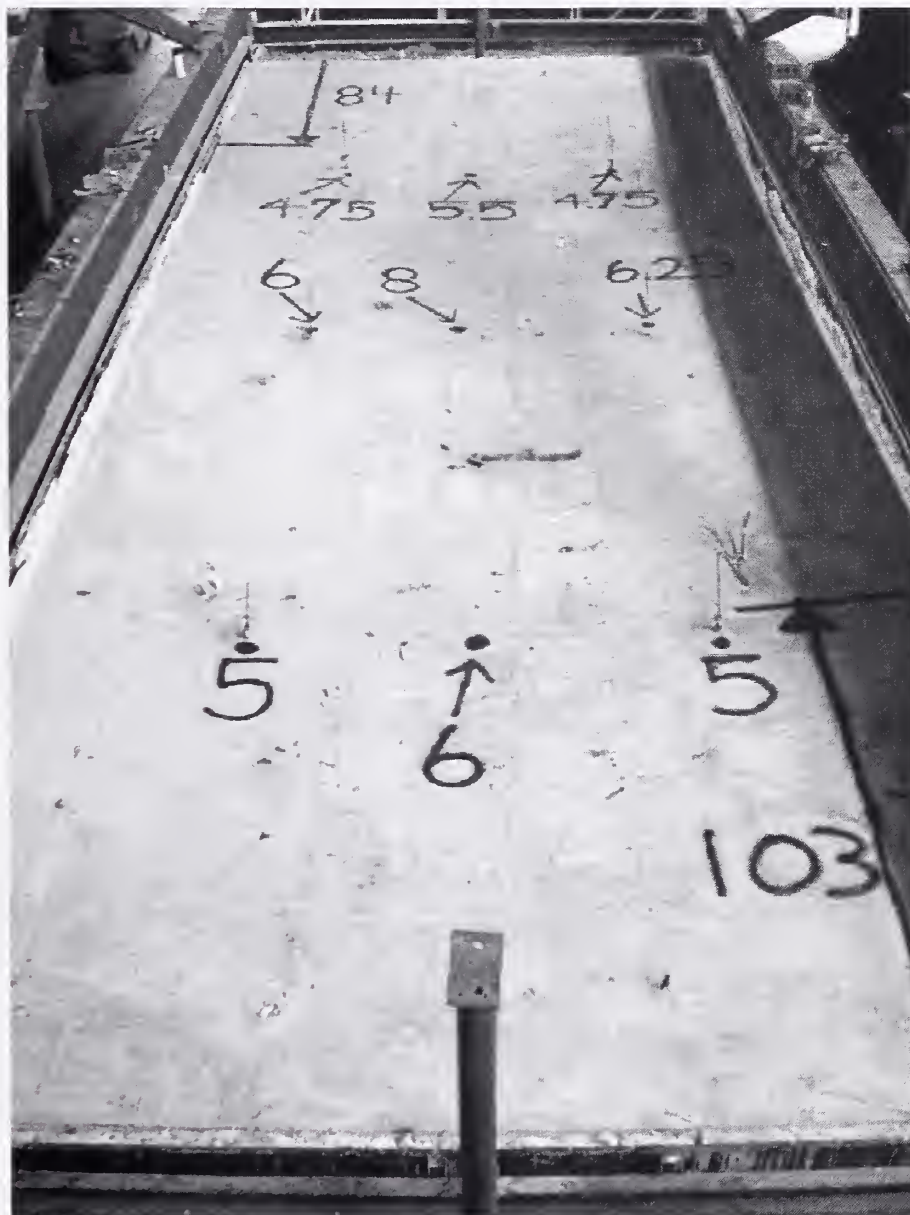
Figure 5–34 shows the unexposed side of the floor assembly after all loading equipment had been removed (view looking east). Numbers shown at the centerline and quarter points are vertical deflections after cooling. All other numbers are reference dimensions as measured from the edge of the slab. Figures 5–35 through 5–37 are views of the underside of the test specimen, showing bulging of the metal deck, and deformations of the steel trusses after the test specimen had cooled and had been removed from the furnace.

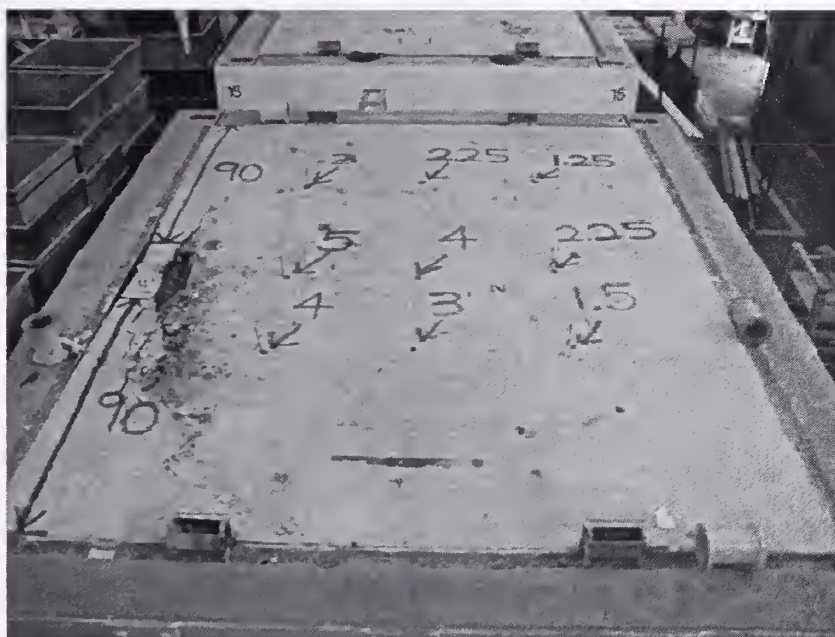
Figure 5-66. Unexposed surface of Assembly No. 4 after loading equipment was removed.

Figure 5-66 shows the unexposed side of the assembly after all loading equipment was removed (view looking north). Numbers shown at the centerline and quarter points are vertical deflections after cooling. All other numbers are reference dimensions as measured from the edge of the slab. Figures 5-67 through 5-70 are additional views of the post-test condition of the test specimen.

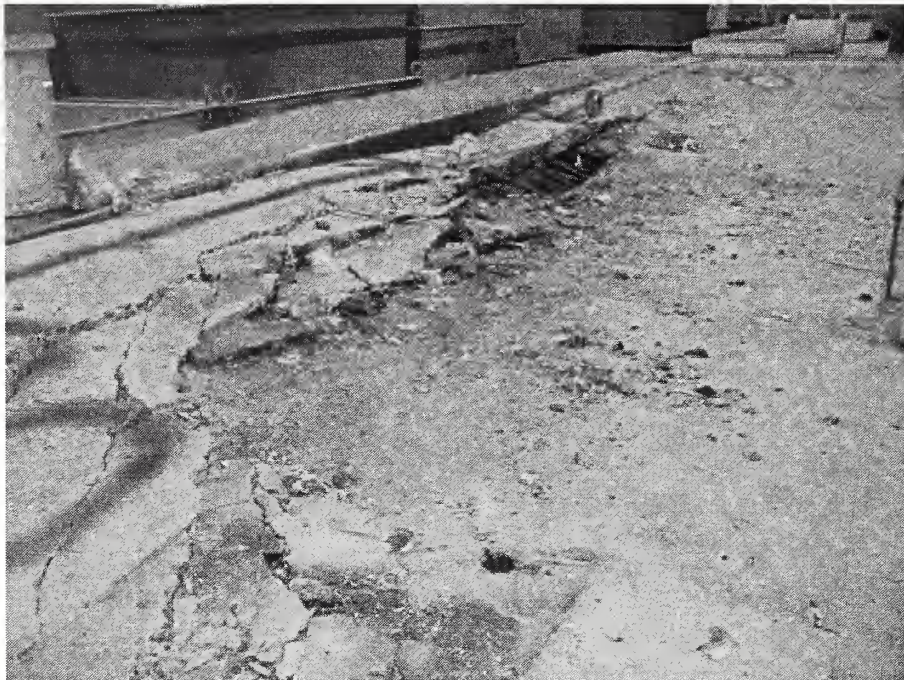
**Figure 5–67. Unexposed surface of Assembly No. 4, view of concrete spalling on west side of assembly.**

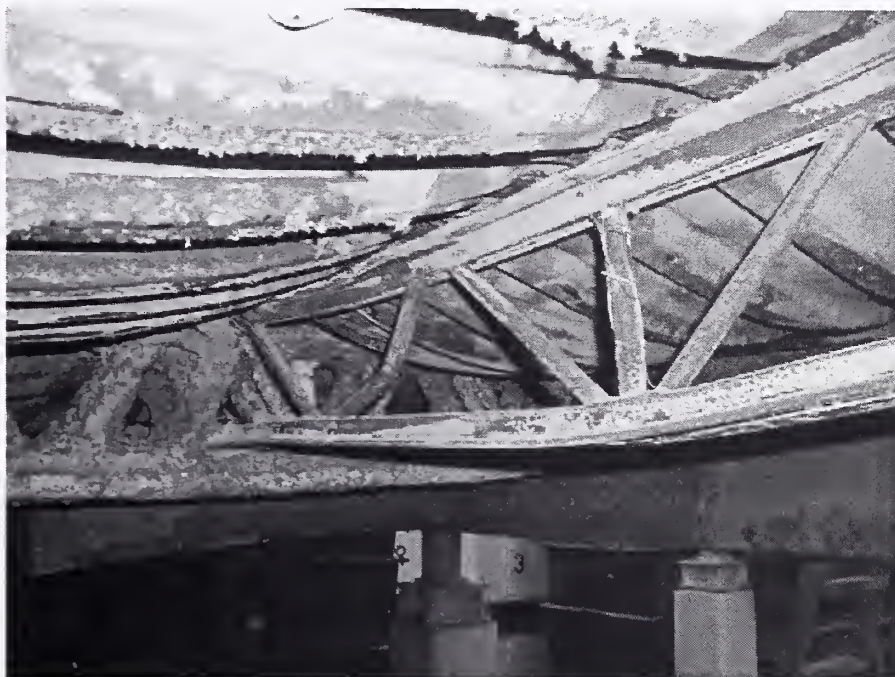
**Figure 5–69. Intersection of north bridging and west main truss on Assembly 4.**
