NIST NCSTAR 1-6D

**Federal Building and Fire Safety Investigation of
the World Trade Center Disaster**

Global Structural Analysis of the Response of the World Trade Center Towers to Impact Damage and Fire

(Chapters 1-3)

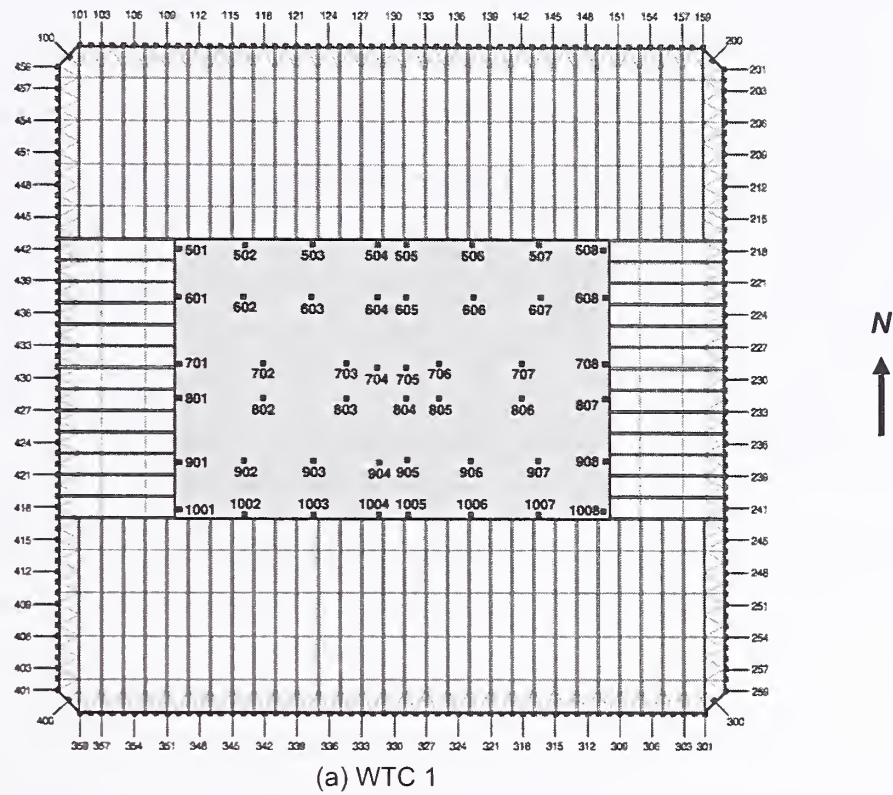
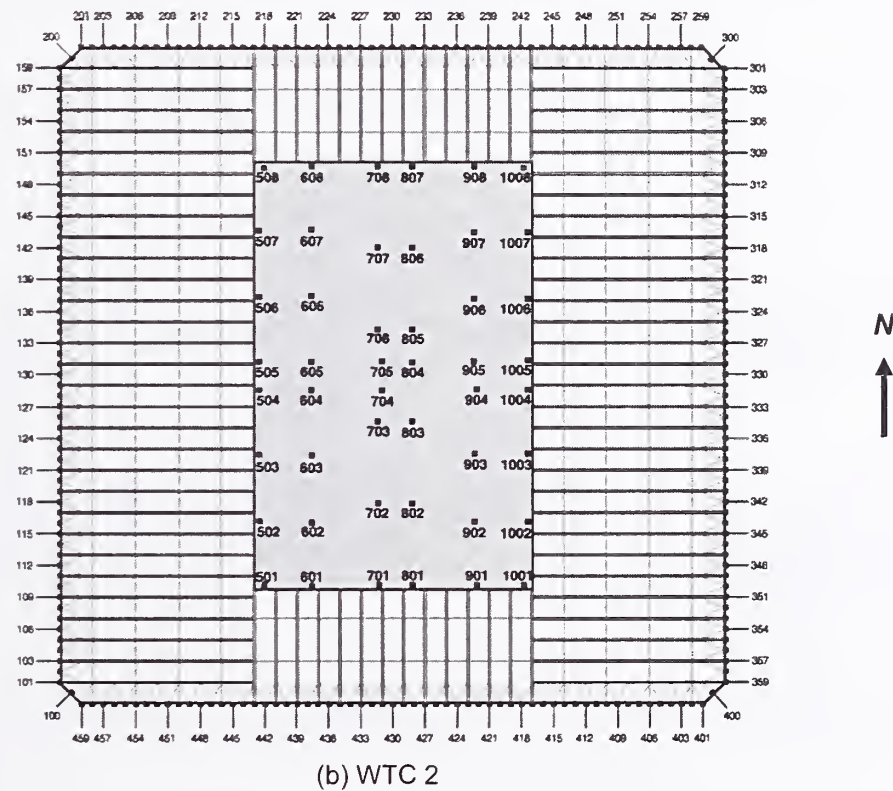
Figure E-1. Column designations.

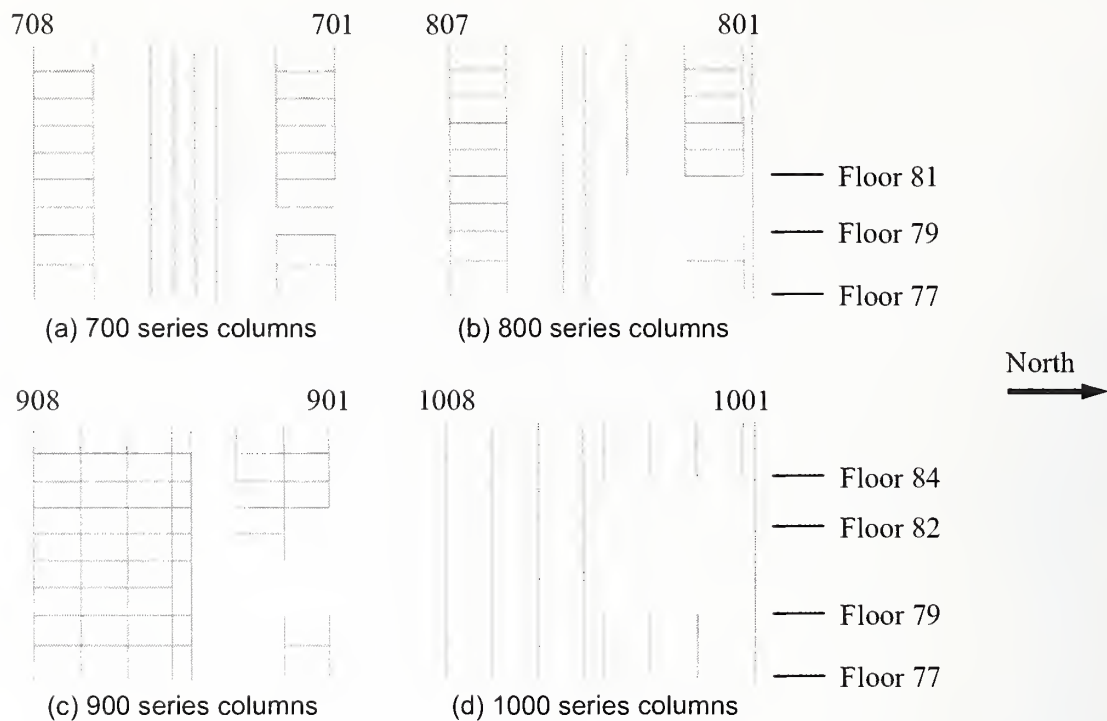
Figure E-5. Case D structural damage condition on the core columns of WTC 2 (including heavily damaged columns).

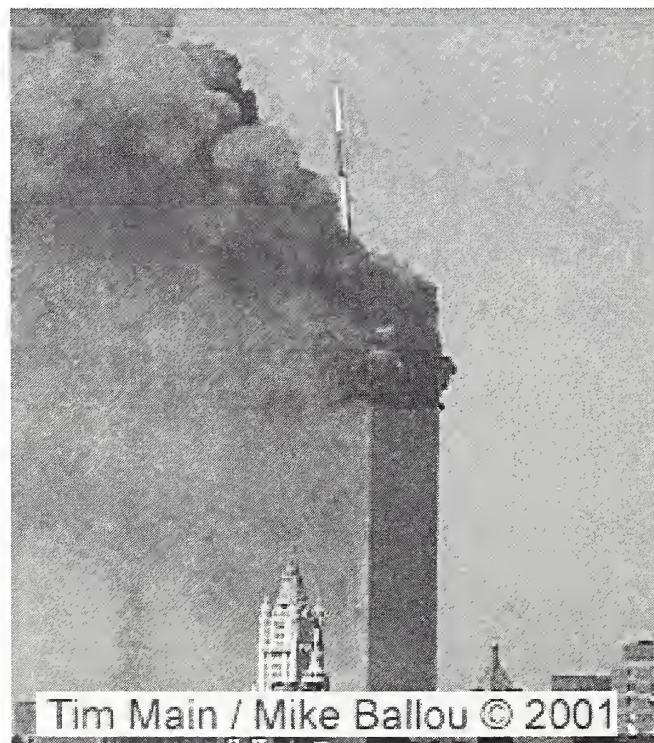
Figure E–11. Collapse initiation and tilting of WTC 1 (view from the northeast).

The section of the building above the impact zone tilted to the east and south (observed at about 7° to 8° to east and about 3° to 4° to south, Fig. E-16) as column instability progressed from the east wall to the adjacent south and north walls. The release of potential energy due to downward movement of the building mass above the buckled columns exceeded the strain energy that could be absorbed by the structure. Global collapse ensued.

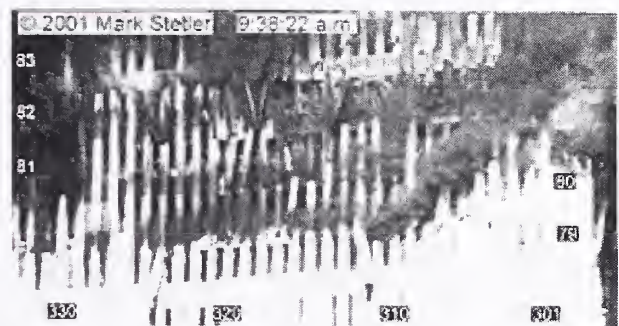
(b) South side at 9:38 a.m.
(35 min after impact)

Figure E-12. Floor sagging observed on the east wall of WTC 2 at different times.

Sagging of Floors and Floor/Wall Disconnections. Aircraft impact and high temperatures due to subsequent fires caused Floors 79 through 83 to sag. The sag was greater at Floor 80 and Floor 81 where the truss seats on the east side of the core failed at aircraft impact. High temperatures weakened the truss

seats on the east exterior wall and caused truss seats to fail at Floor 83 and Floor 82 (see Fig. E-12) which in turn increased the sag in those floors. Floor sagging induced pull-in forces on the east wall columns, beginning approximately 10 min after impact and increasing with time.

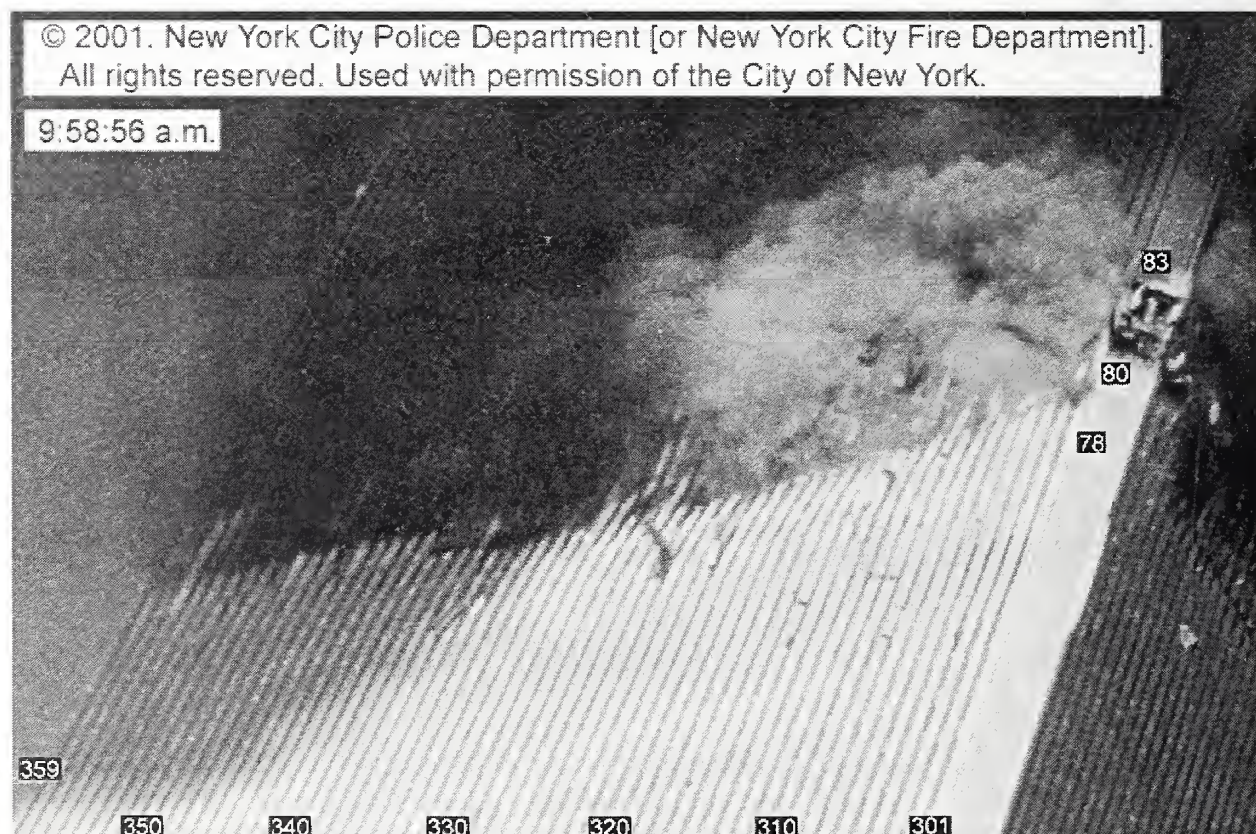
Figure E-14. Inward bowing of exterior columns of the west wall of WTC 2 just before collapse.

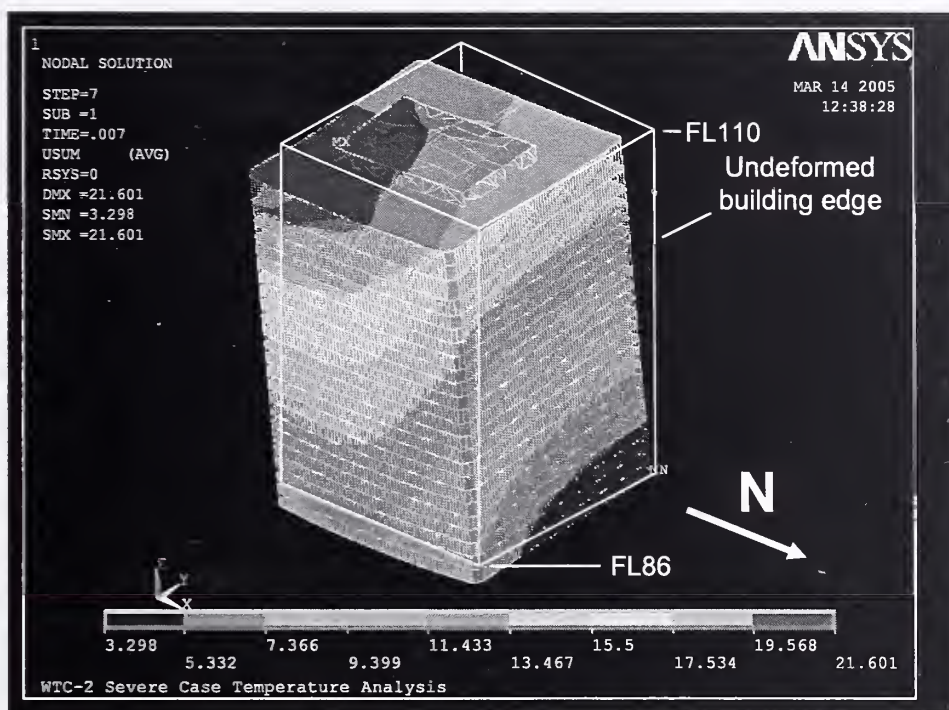
Figure E-15. Total displacements of WTC 2 global model above Floor 86 for Case D conditions at 43 min at collapse initiation (note the tilt toward east and south; deformed shape magnified 20 times).

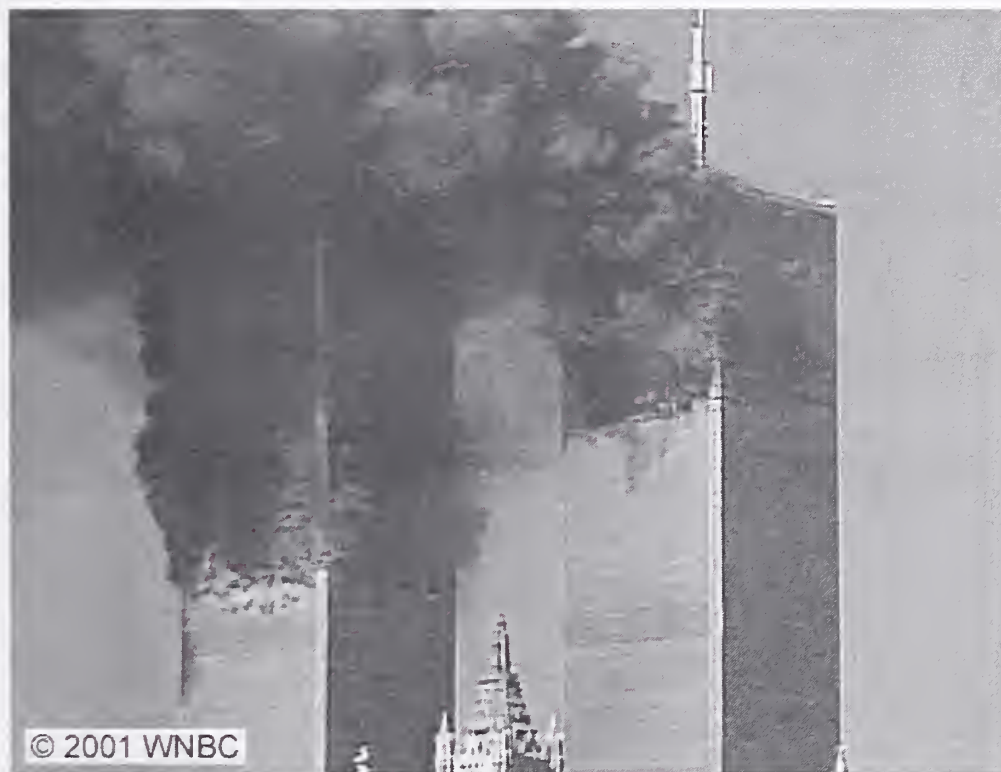
Figure E-16. Initiation of collapse of WTC 2. Note the tilt toward east and south.

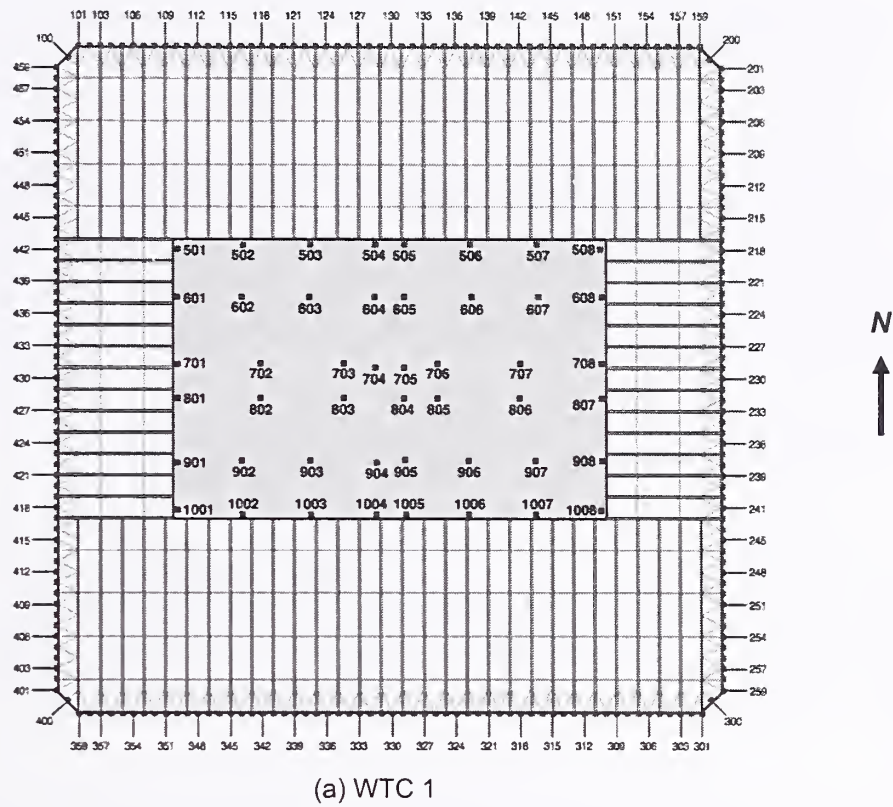
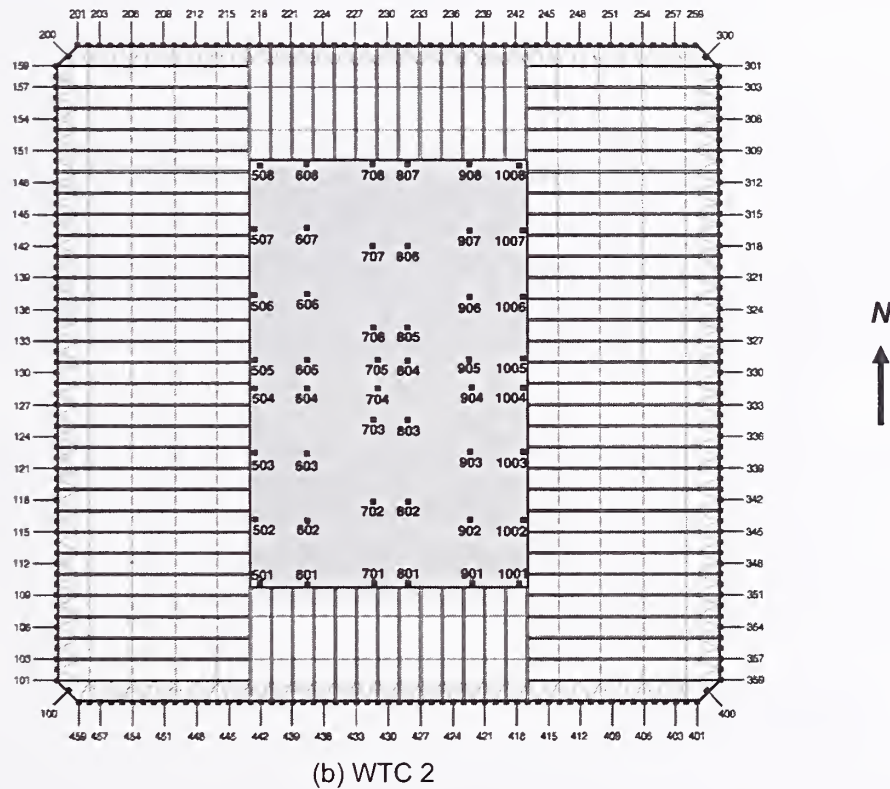
Figure 2-1. Column designations.

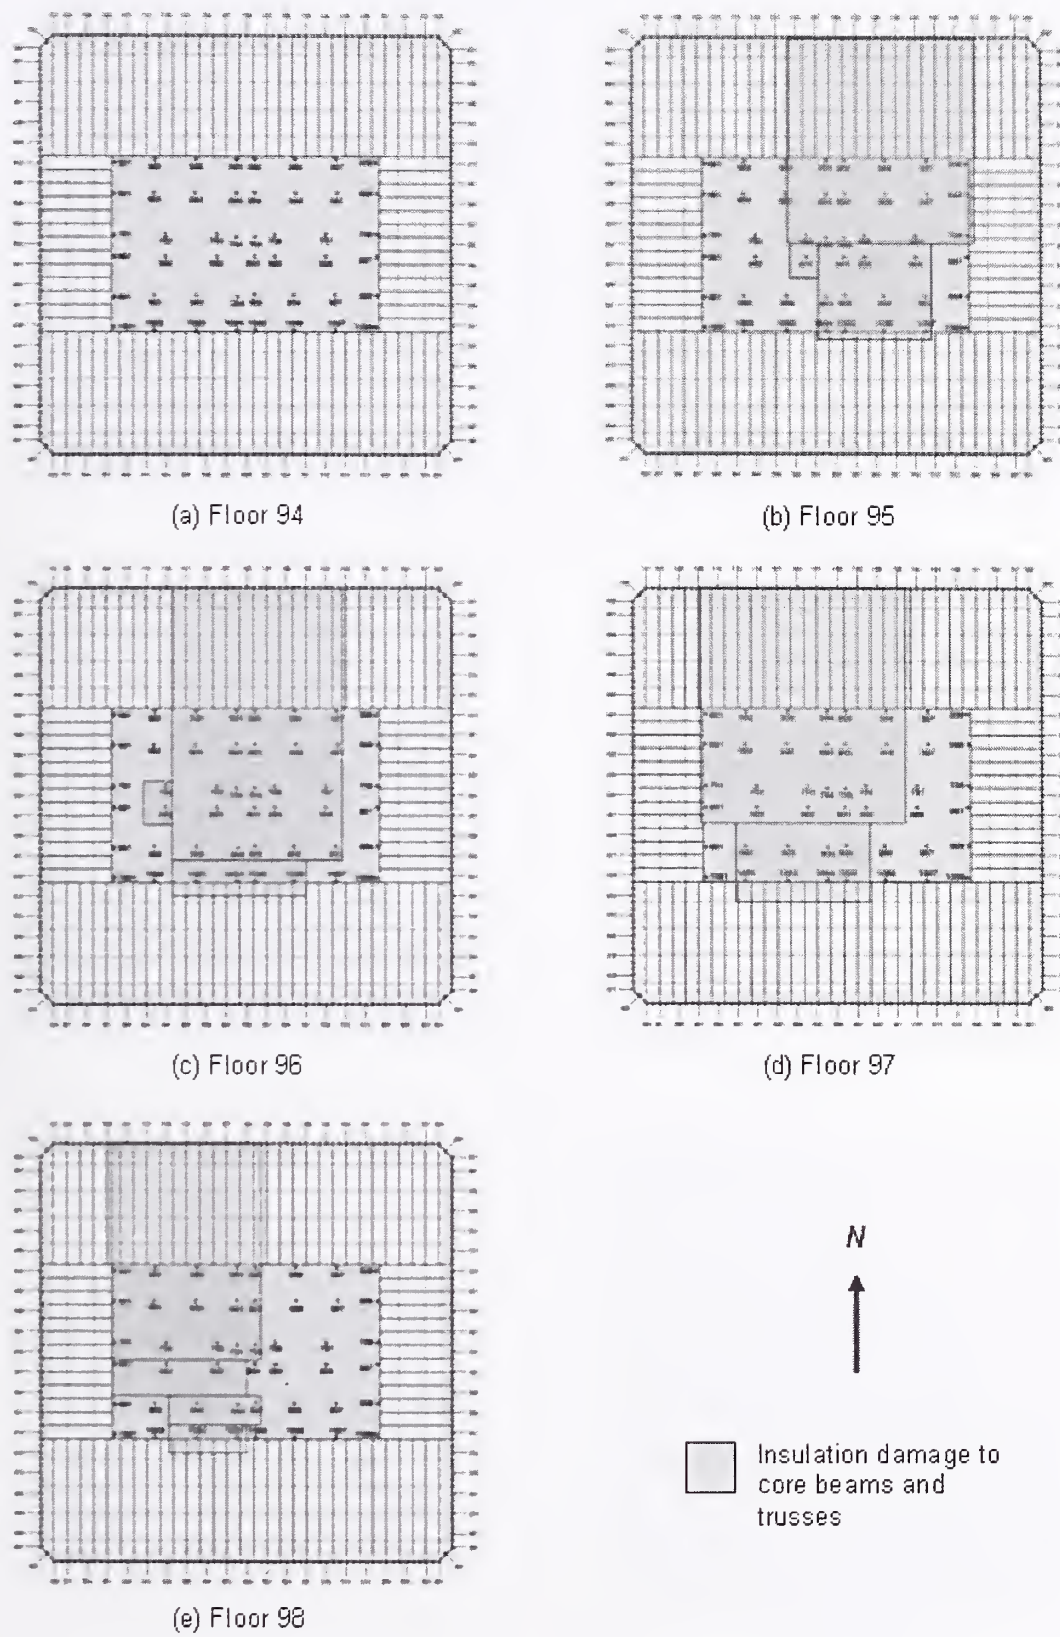
Figure 2-9. Case A₁ insulation damage conditions for WTC 1 floor trusses and beams.

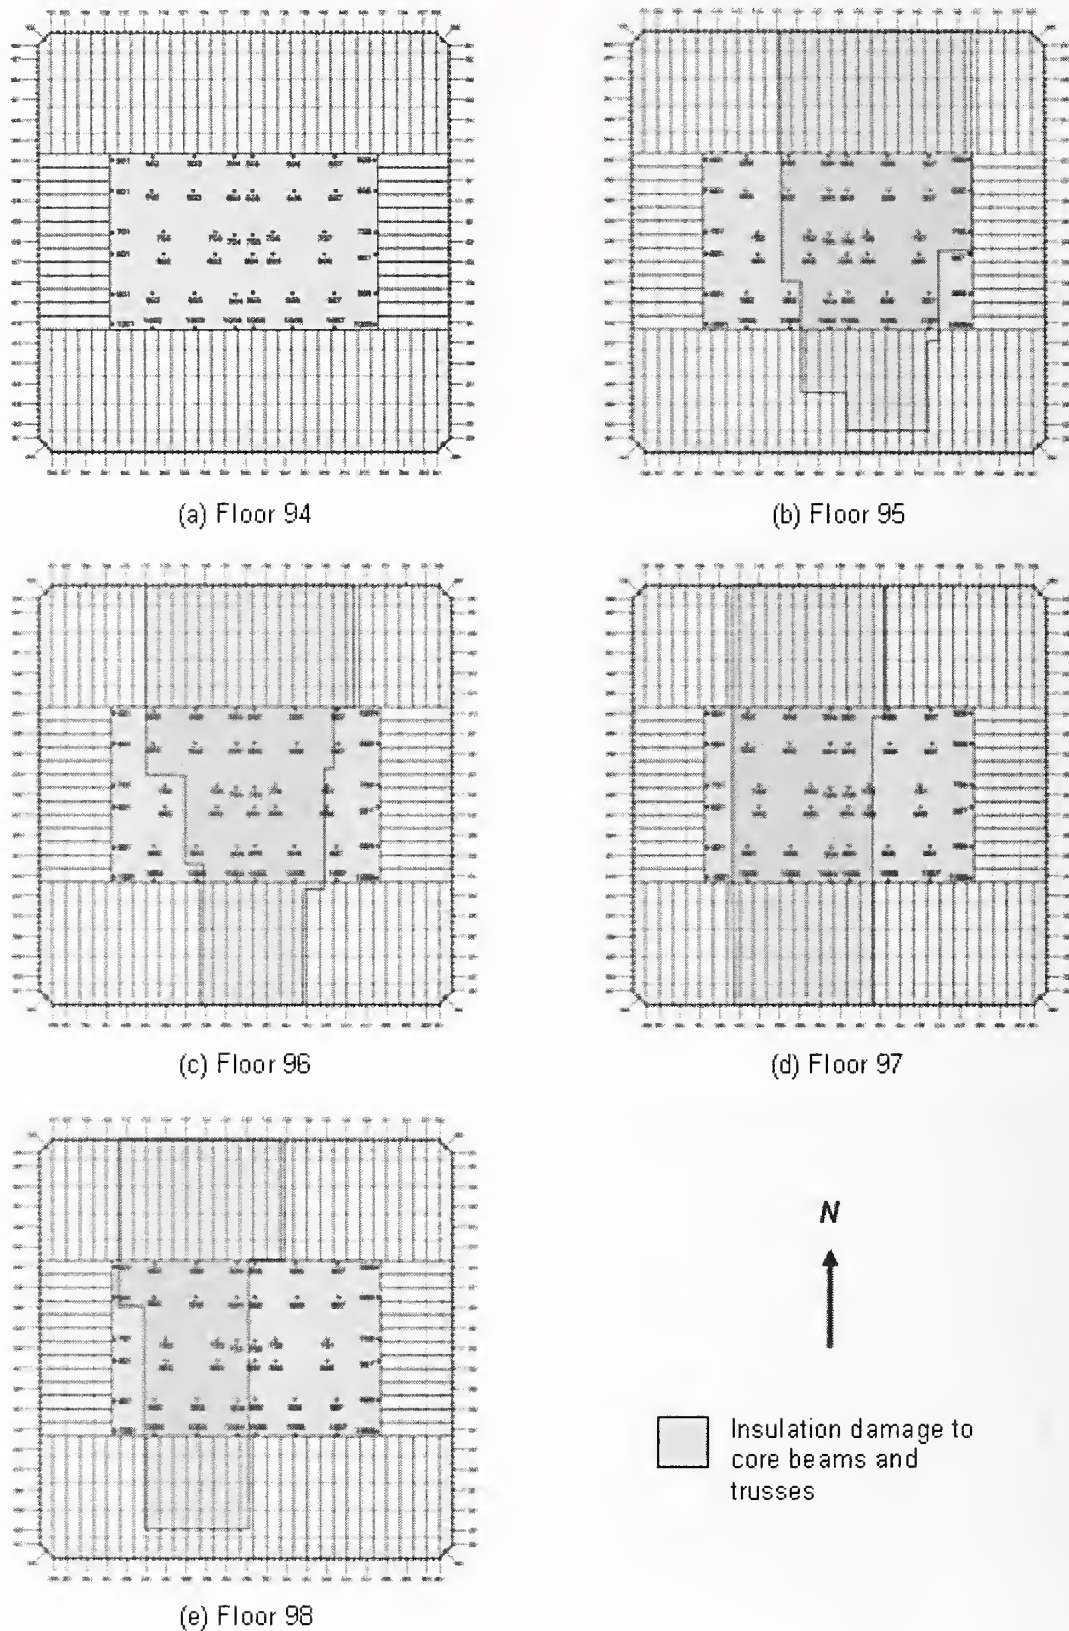
Figure 2–23. Case B insulation damage conditions for WTC 1 floor trusses and beams.

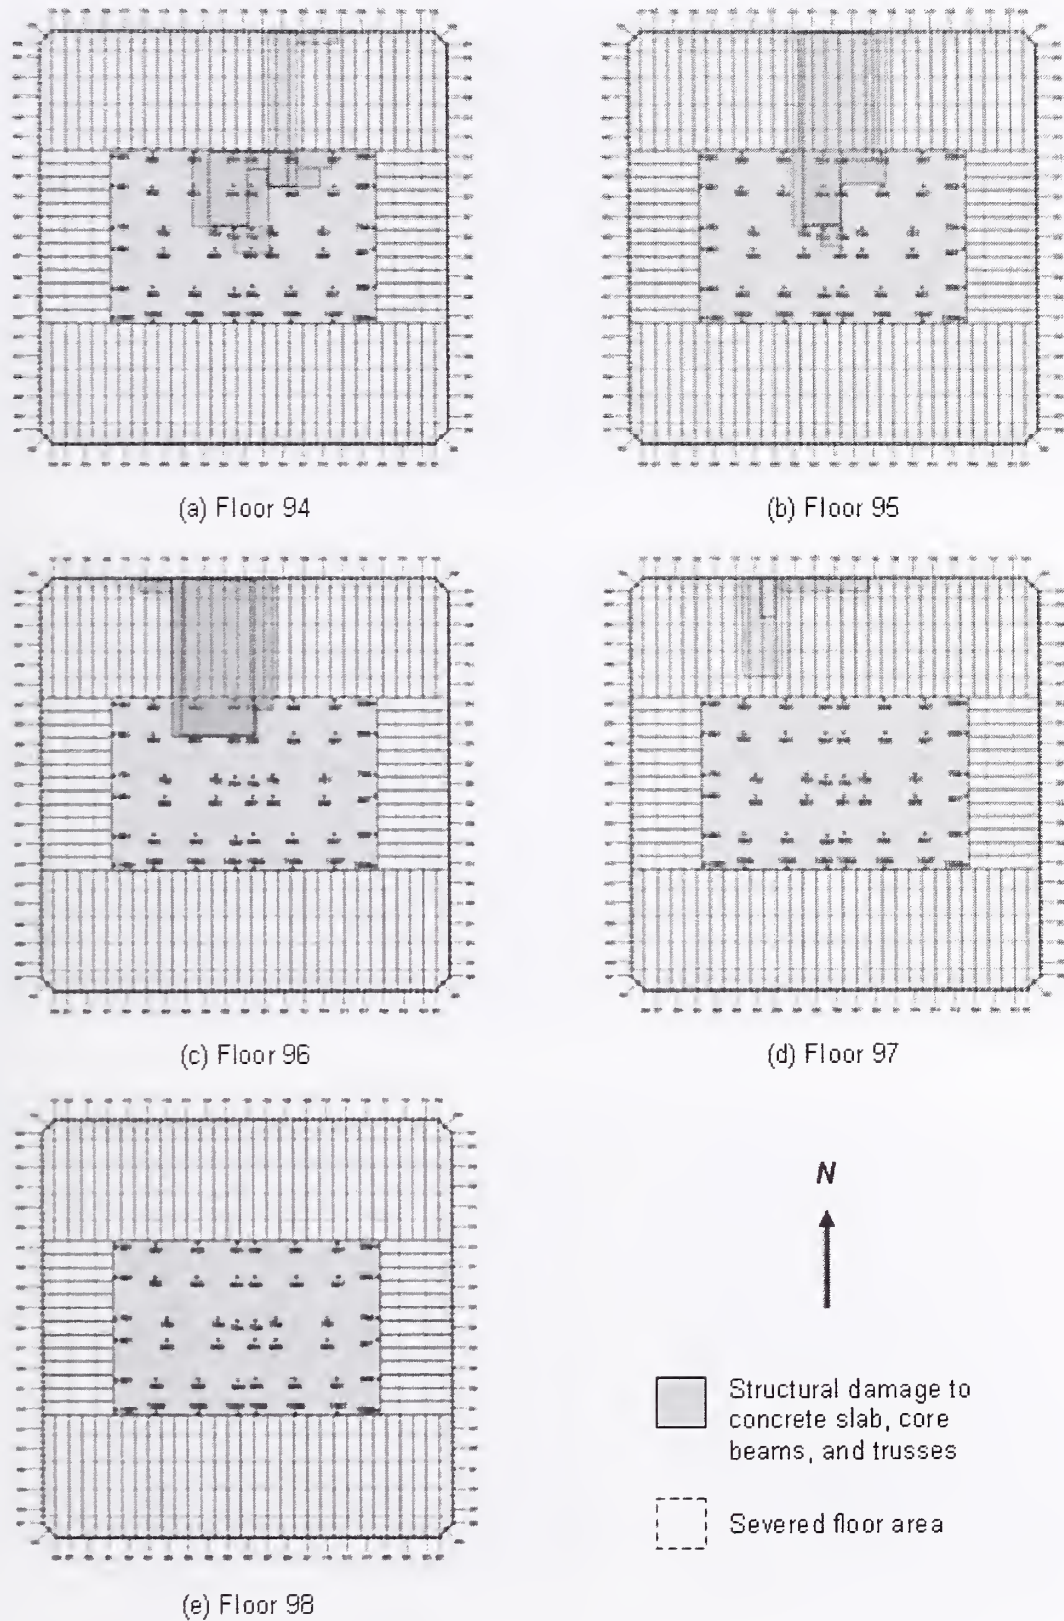
Figure 2-24. Case B structural damage conditions for WTC 1 floors.

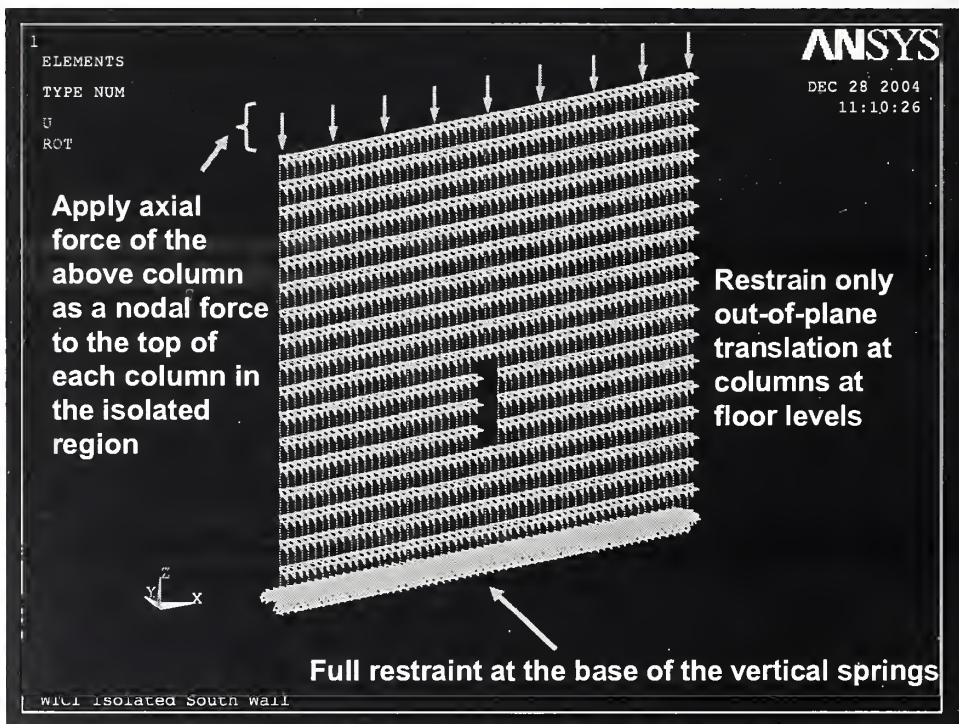
Figure 3–2. Boundary conditions applied on the isolated exterior wall segment on the south wall of WTC 1.

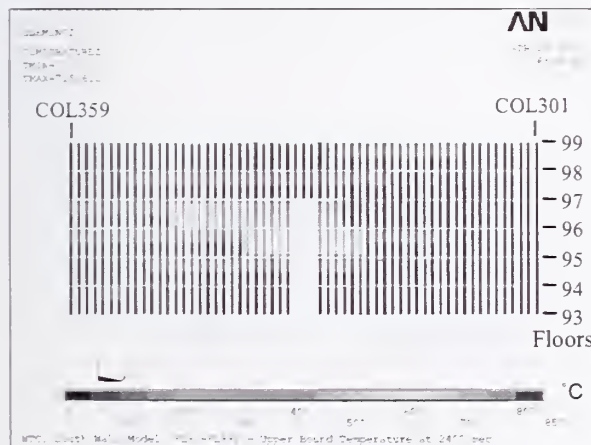
(b) Inside

Figure 3-36. Case B temperature condition of south wall columns of WTC 1 at 30 min.

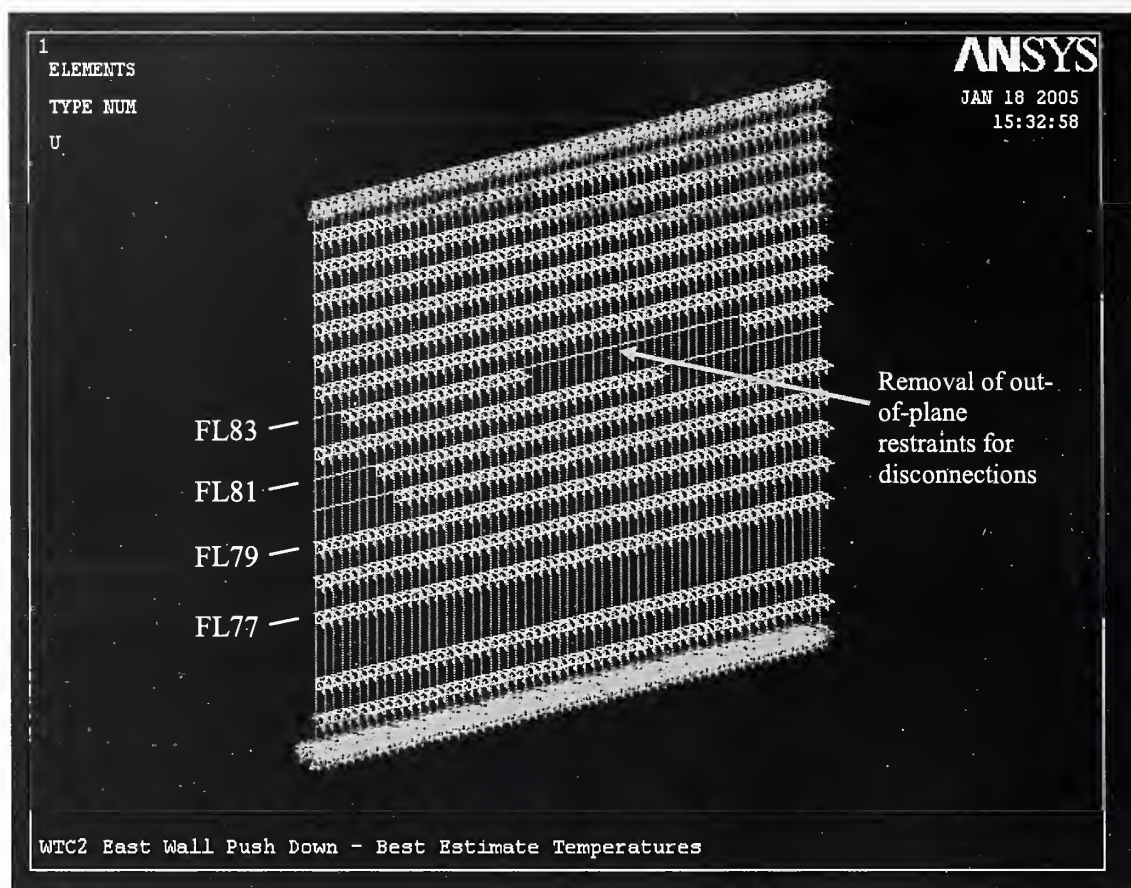
Figure 3-70. Location of the out-of-plane supports and floor/wall disconnections between exterior wall and the floor (WTC 2 east wall for Case C conditions at 60 min).

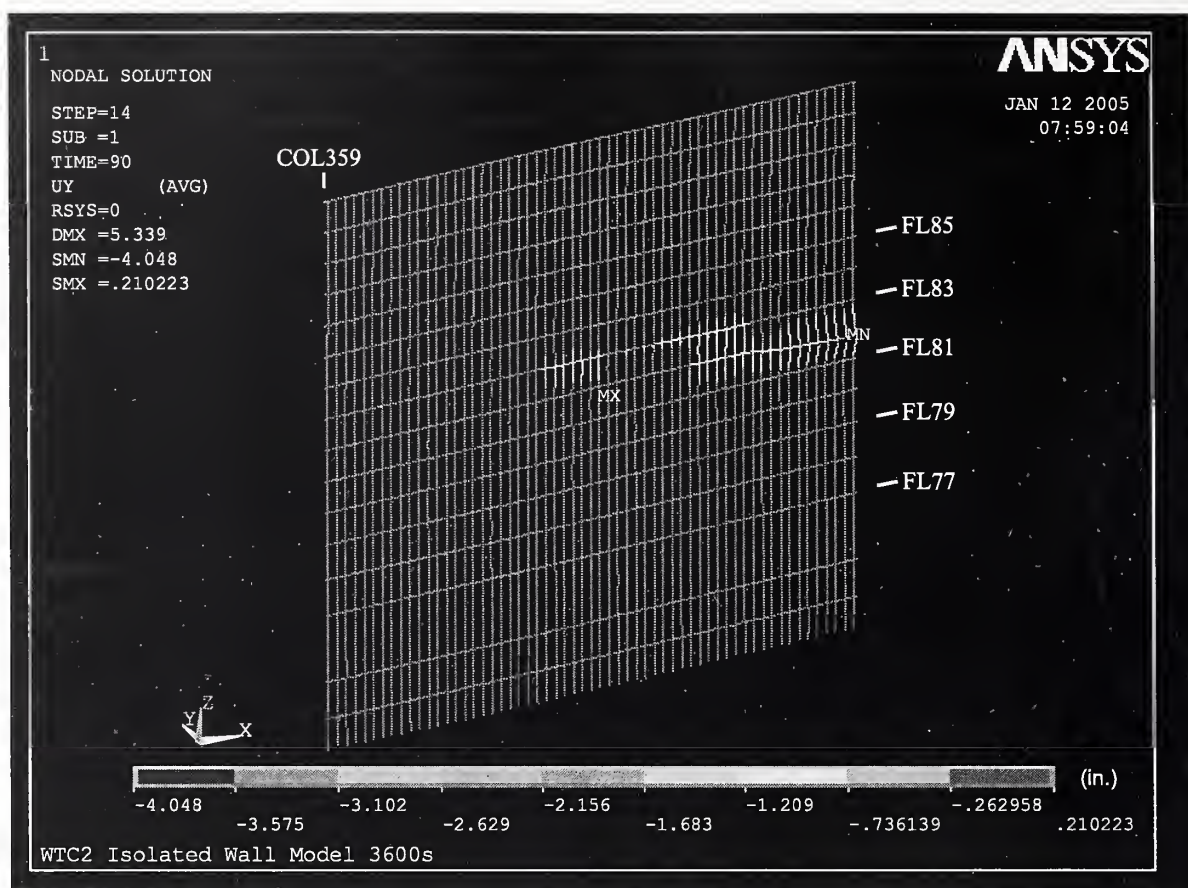
Figure 3–74. Out-of-plane displacement of isolated east wall model of WTC 2 for Case C temperature distribution at 60 min (inward displacement is positive; displacements scaled ten times).

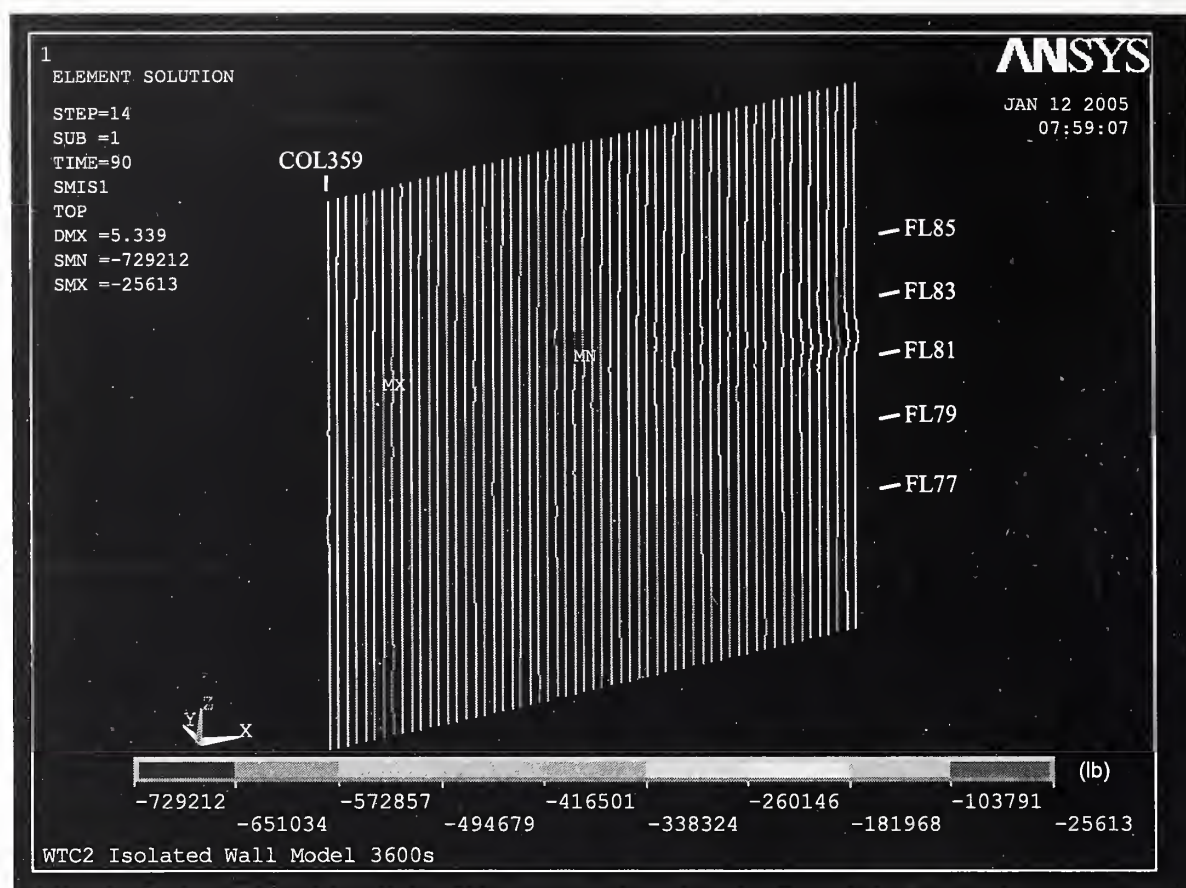
Figure 3-76. Axial load on columns of isolated east wall model of WTC 2 for Case C temperatures distribution at 60 min (compression is negative).

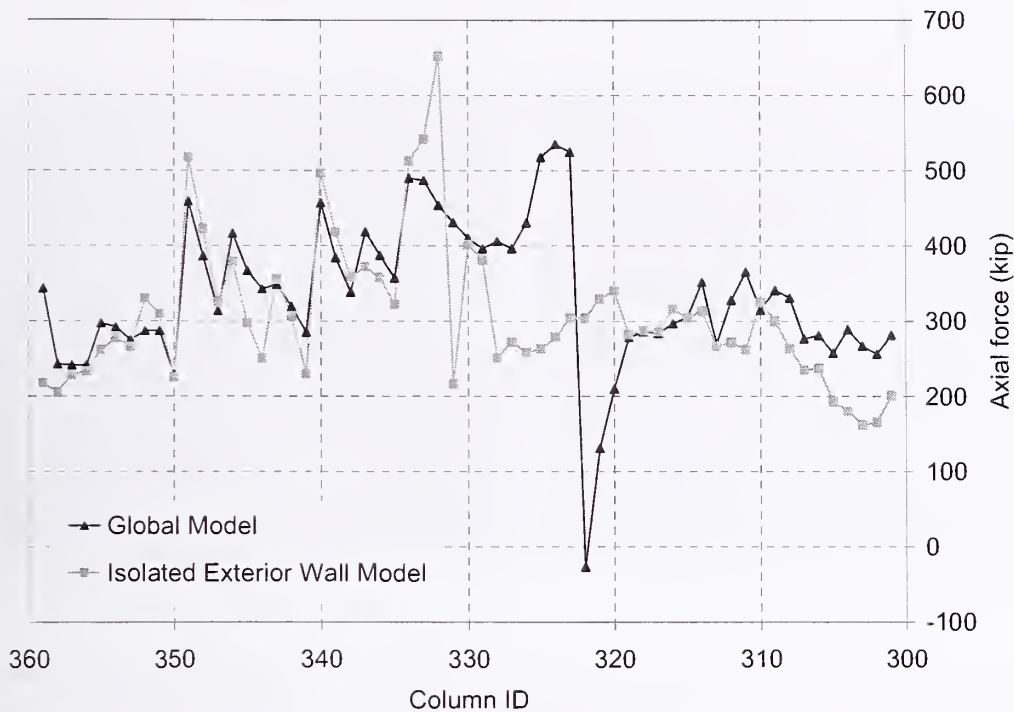
Figure 3-77. Comparison of axial load in columns at Floor 83 of isolated east wall model of WTC 2 at 60 min for Case C temperature conditions and the global model without creep for Case C_i conditions (compression is positive).

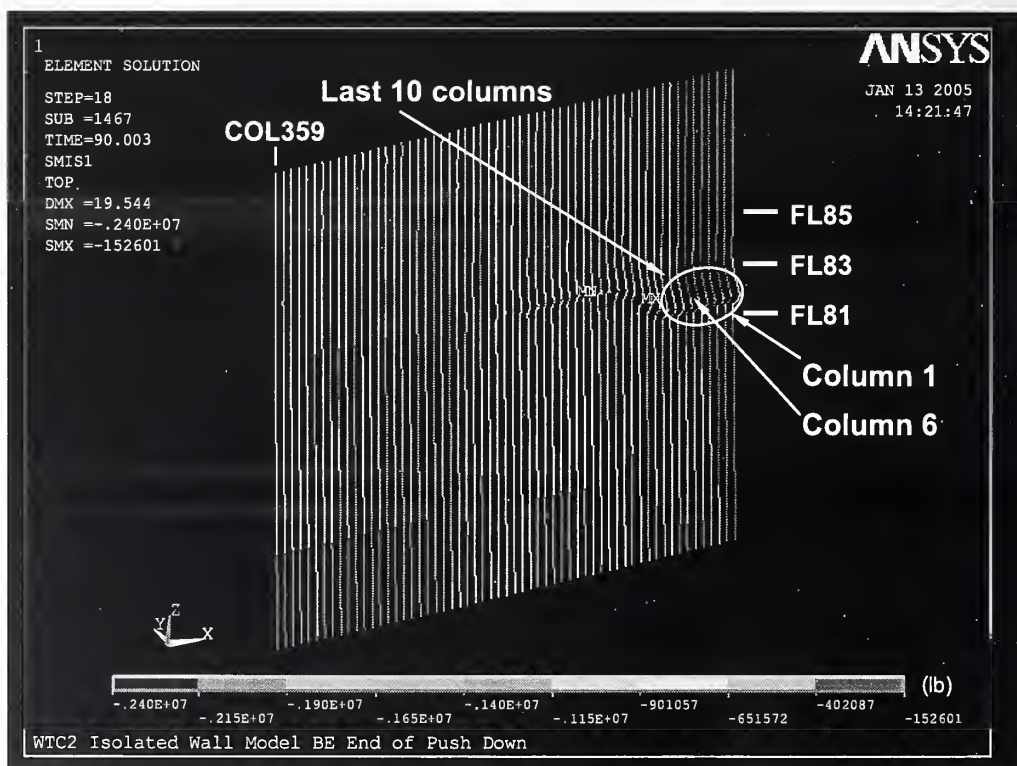
Figure 3–80. Axial load on east wall columns of isolated east wall model of WTC 2 after Case C temperature condition and push-down (compression is negative).

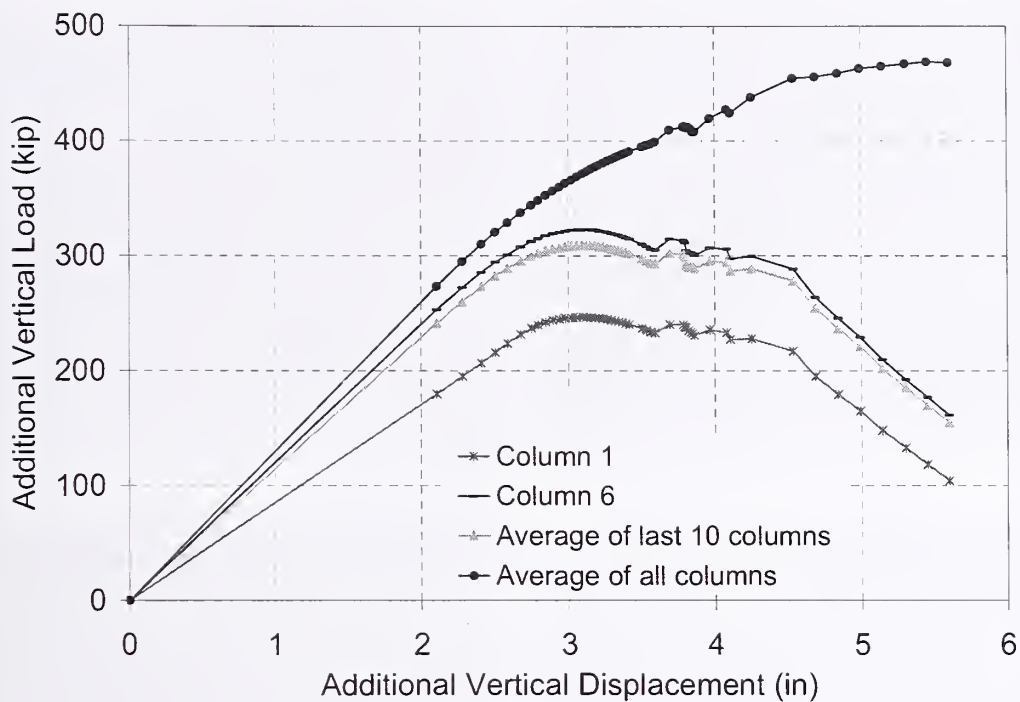
Figure 3-81. Additional vertical load versus additional vertical displacement during push-down analysis of isolated east wall model of WTC 2 for Case C temperature condition (compression is positive; see Fig. 3-80 for column locations).

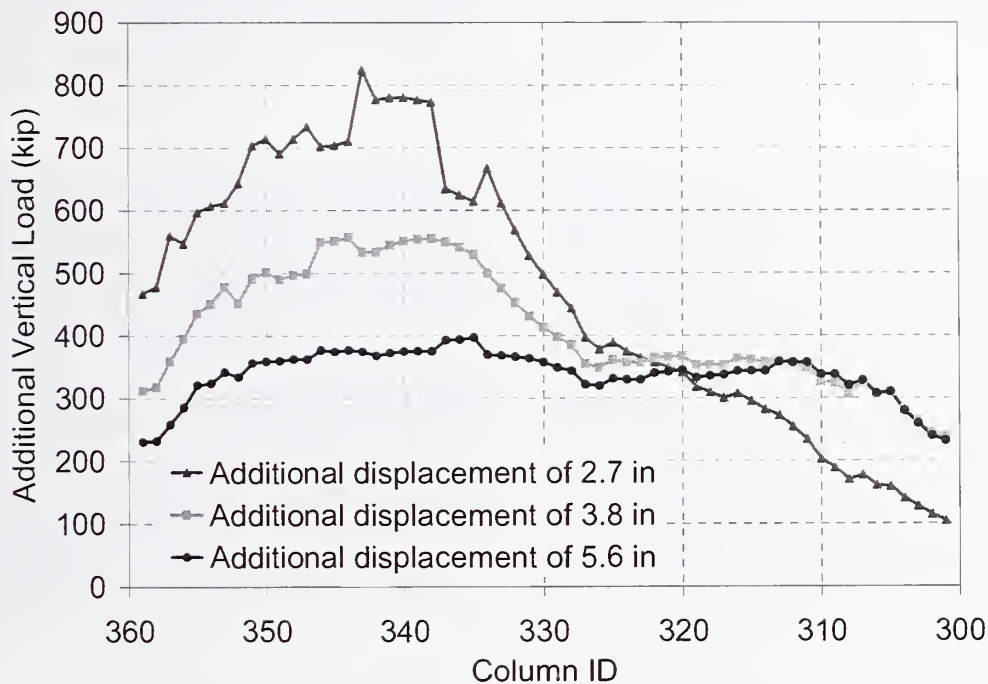
Figure 3-82. Variation of additional vertical load applied to columns of isolated east wall model of WTC 2 at different levels of additional vertical displacements imposed after Case C temperature condition (compression is positive).

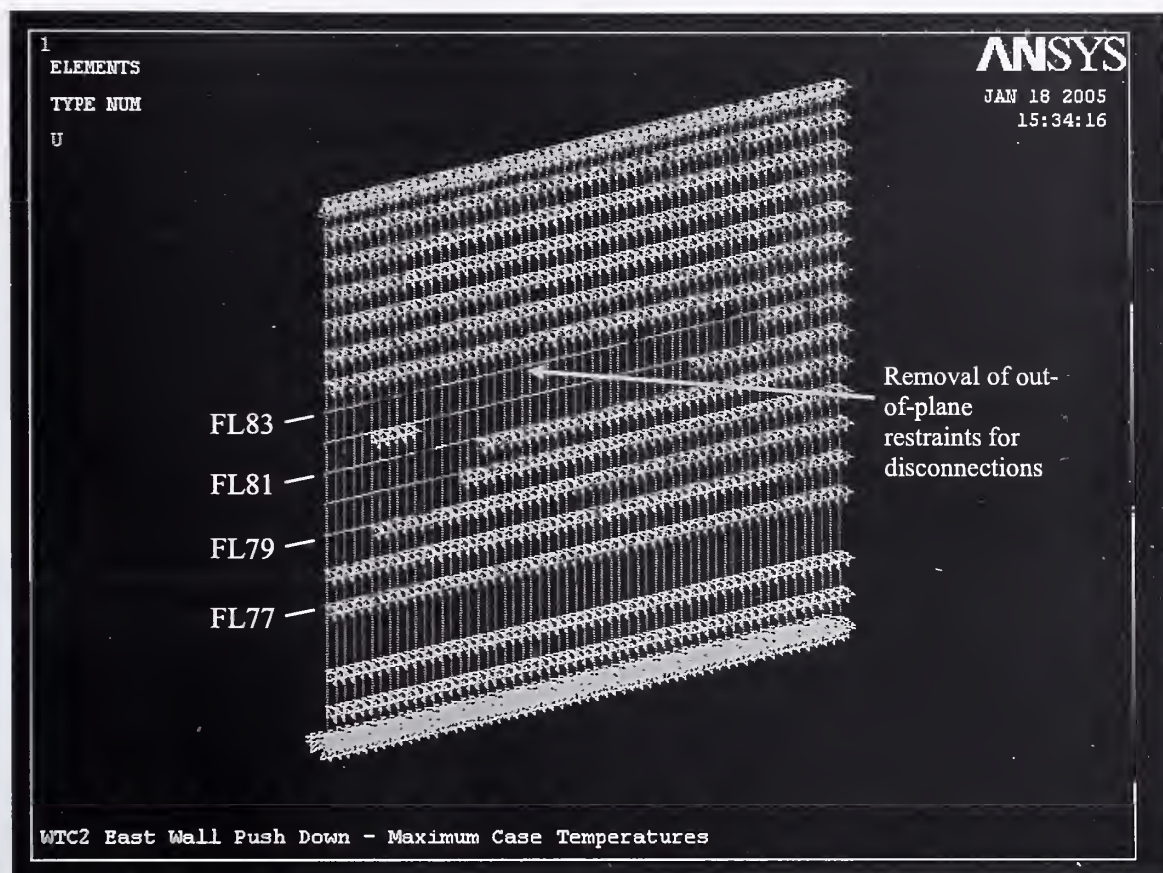
Figure 3–85. Location of the out-of-plane supports and floor/wall disconnections between exterior wall and the floor (WTC 2 east wall for Case D conditions at 60 min).

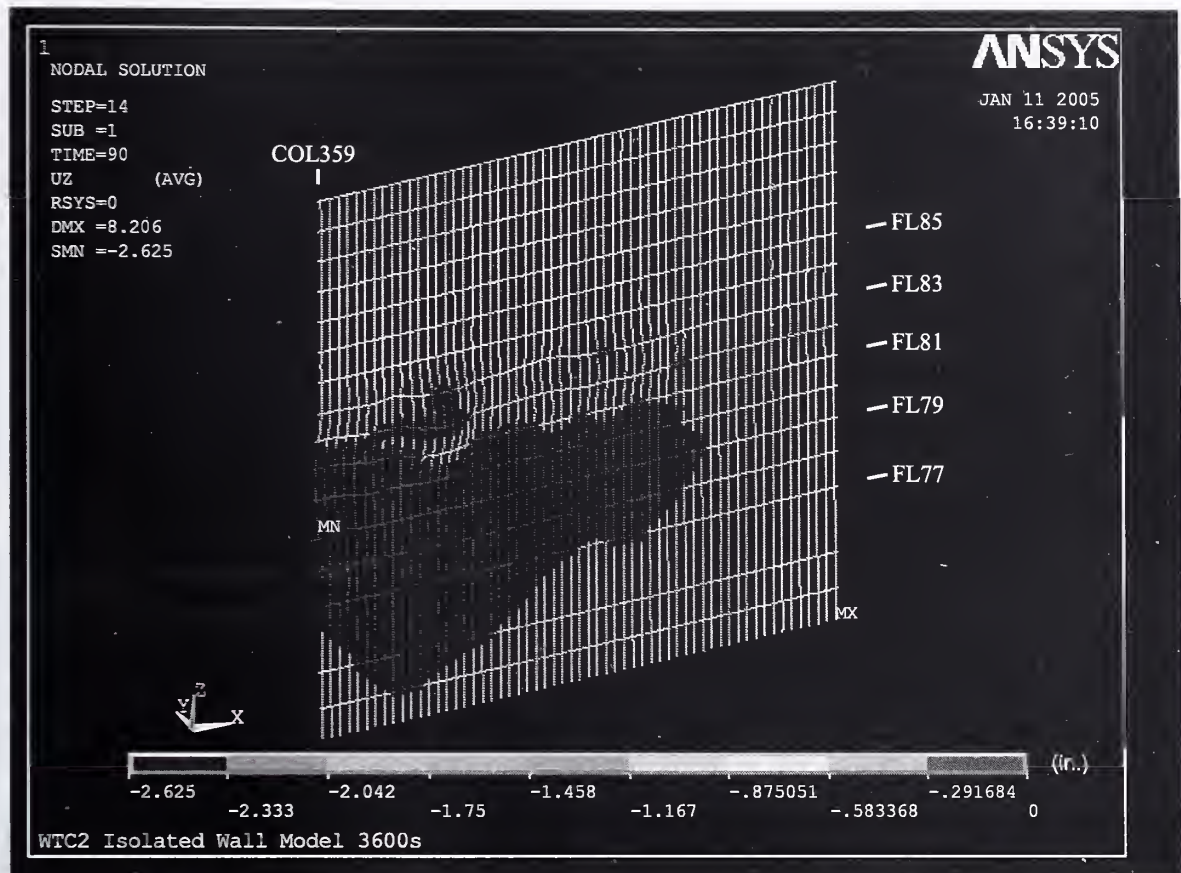
Figure 3-87. Vertical displacement of isolated east wall model of WTC 2 for Case D temperature condition at 60 min (downward displacement is negative; displacements scaled ten times).

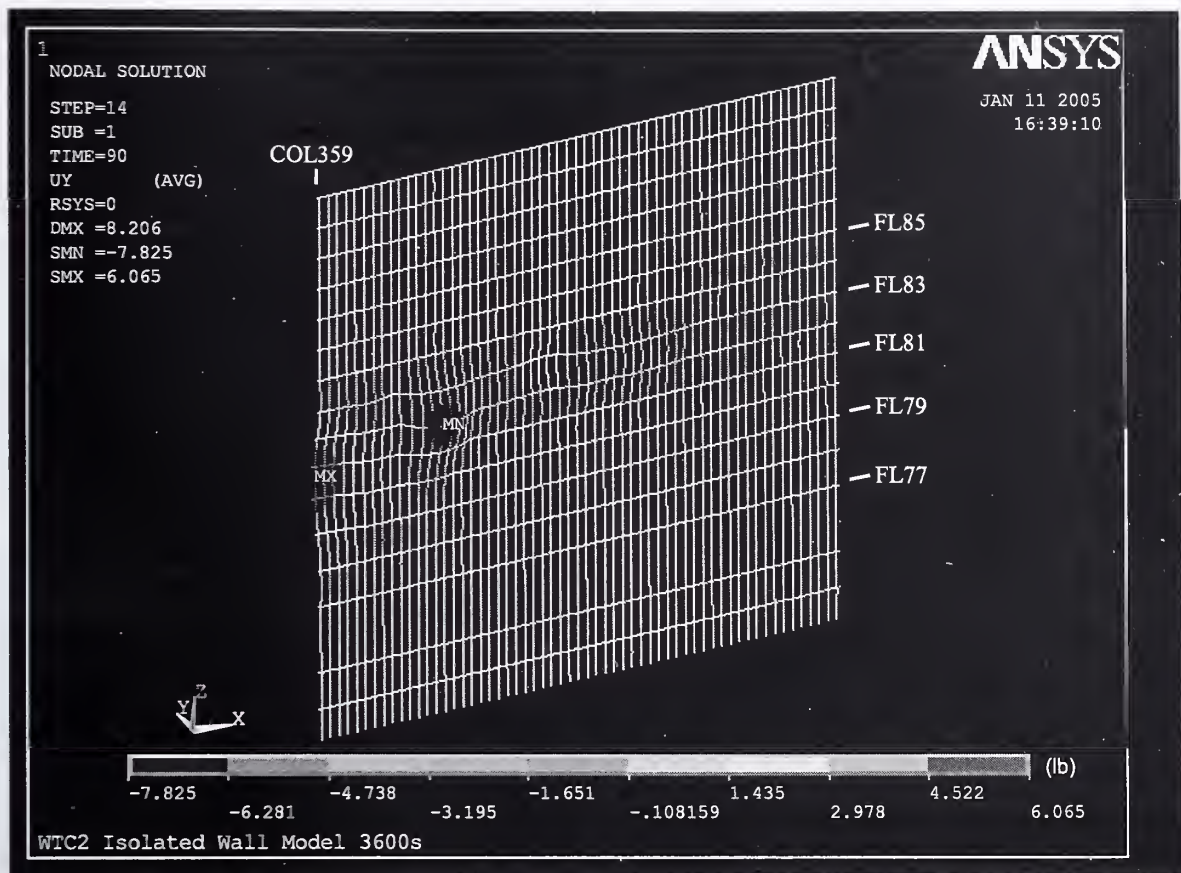
Figure 3-89 Out-of-plane displacement of isolated east wall model of WTC 2 for Case D temperature condition at 60 min (inward displacement is positive; displacements scaled ten times).
