NIST NCSTAR 1-6D

**Federal Building and Fire Safety Investigation of
the World Trade Center Disaster**

Global Structural Analysis of the Response of the World Trade Center Towers to Impact Damage and Fire

(Chapters 1-3)

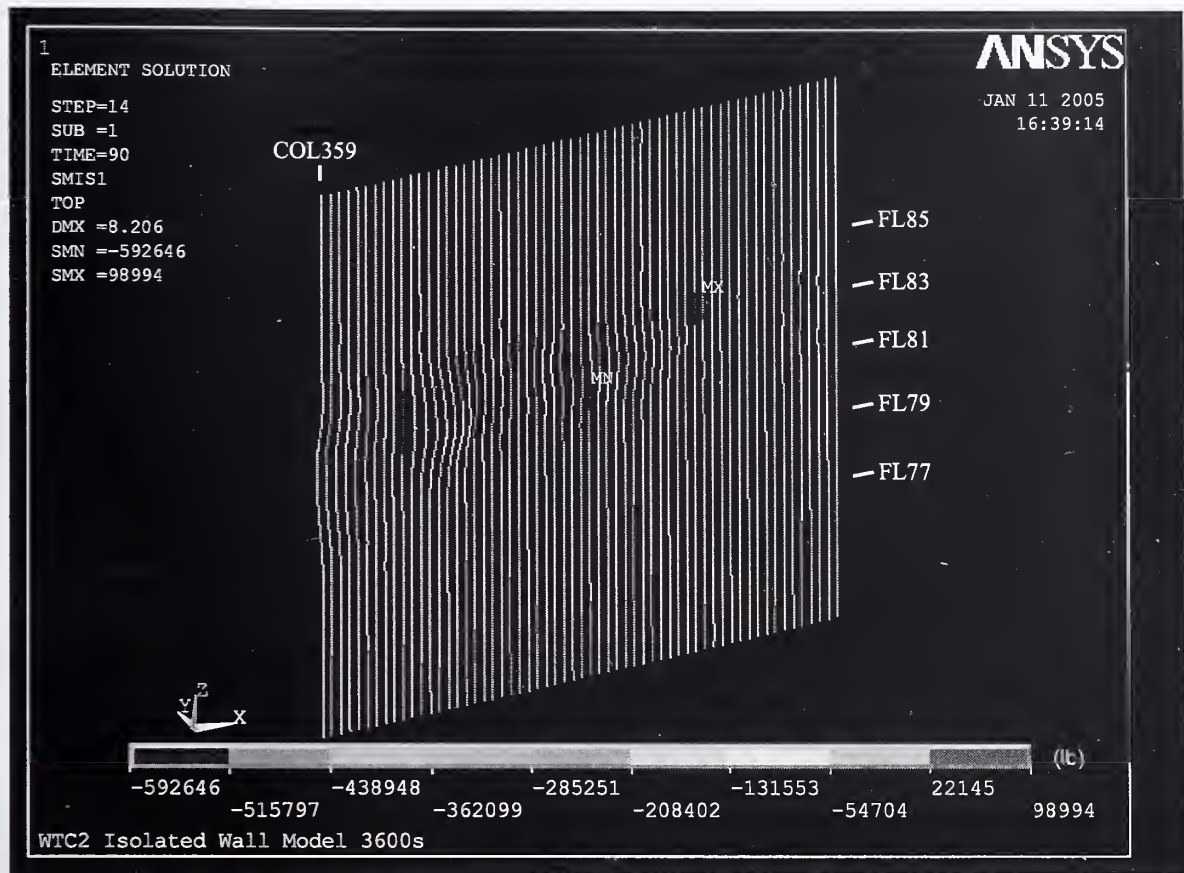
Figure 3-91. Axial load on east wall columns of isolated east wall model of WTC 2 for Case D temperature condition at 60 min (compression is negative).

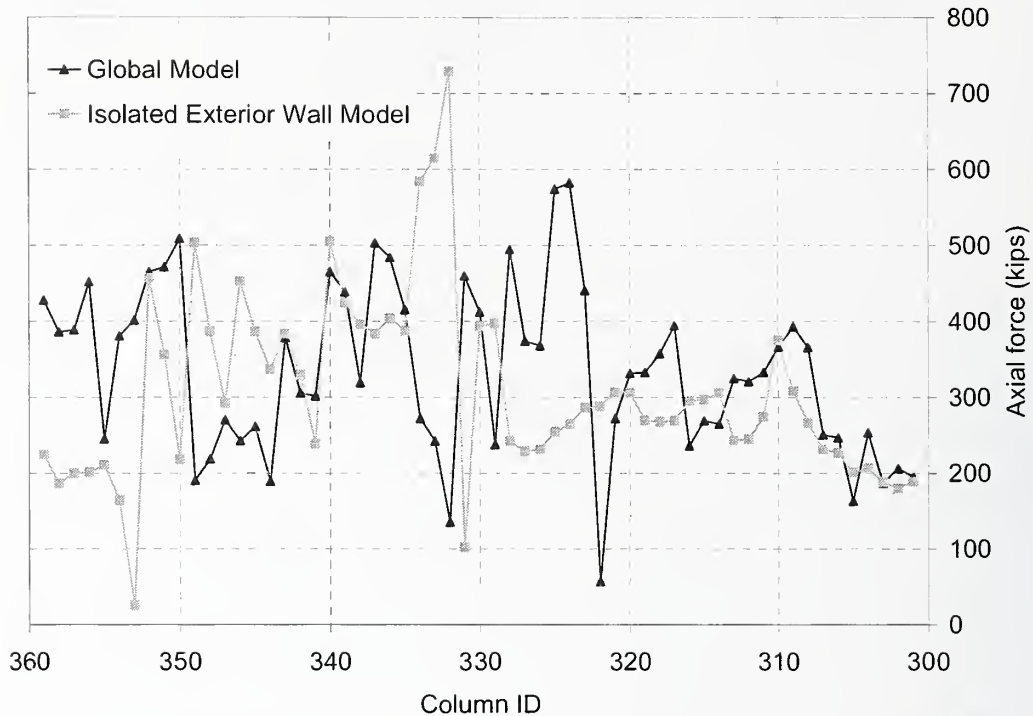
Figure 3-92. Comparison of axial load in columns at Floor 83 of isolated east wall model of WTC 2 at 60 min for Case D temperature conditions and the global model without creep for Case C; structural damage condition and Case D; temperature condition (compression is positive).

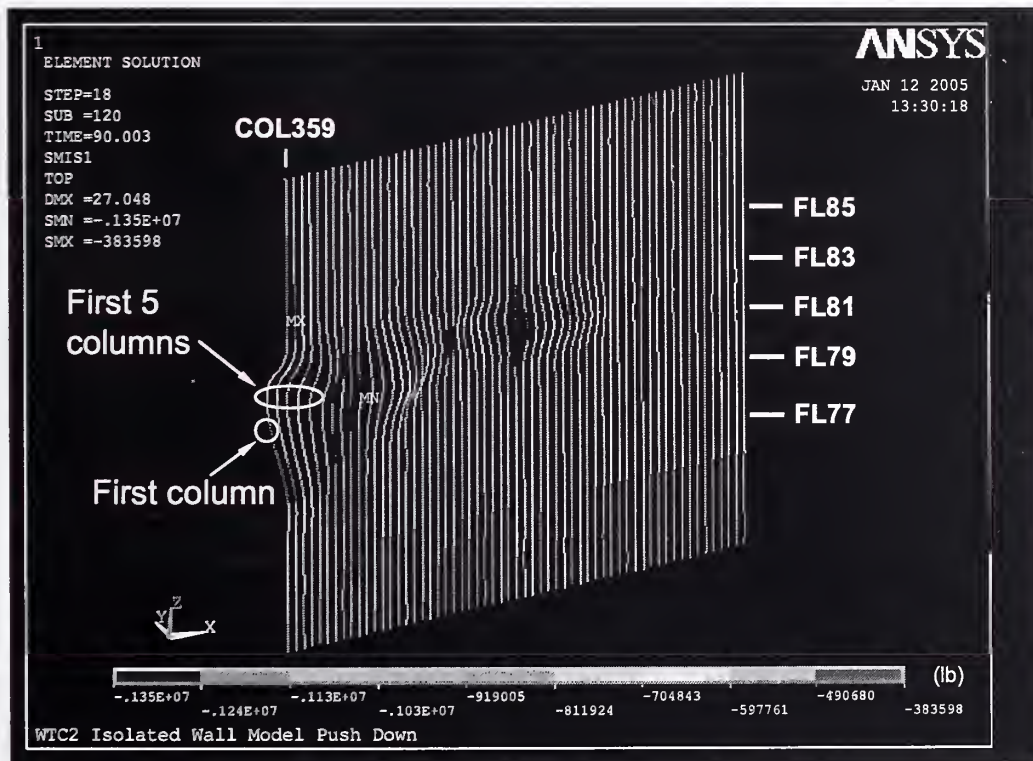
Figure 3–95. Axial load on east wall columns of isolated east wall model of WTC 2 after Case D temperature condition and push down (compression is negative).

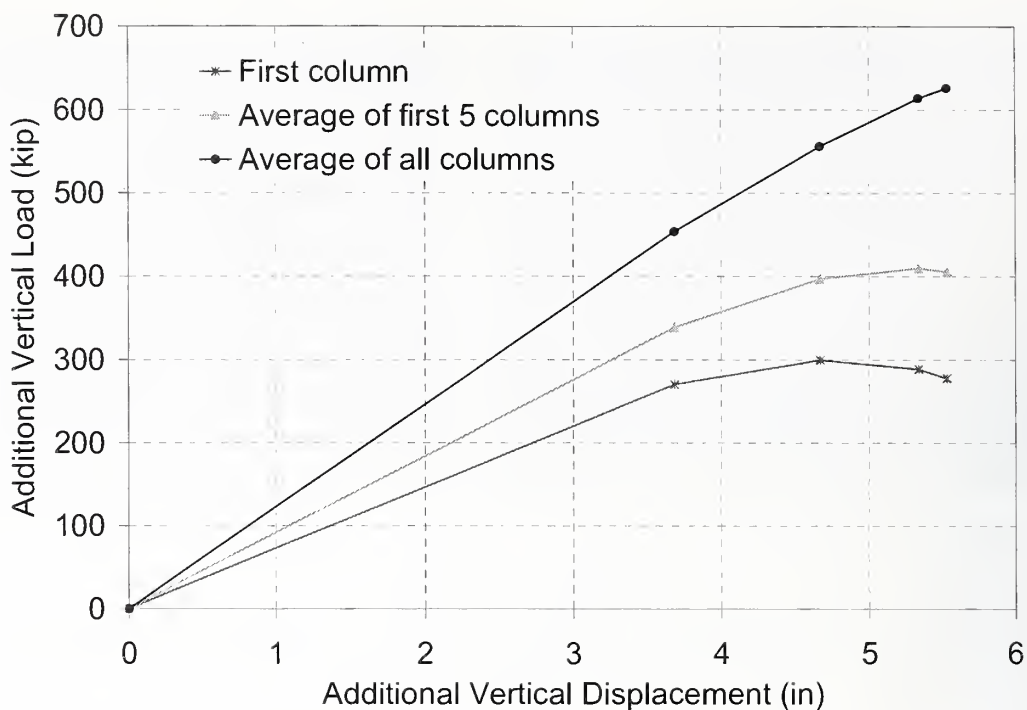
Figure 3-96. Additional vertical load applied to columns versus additional vertical during displacement for push-down analysis of isolated east wall model of WTC 2 for after Case D temperature condition (compression is positive; see Fig. 3-95 for column locations).

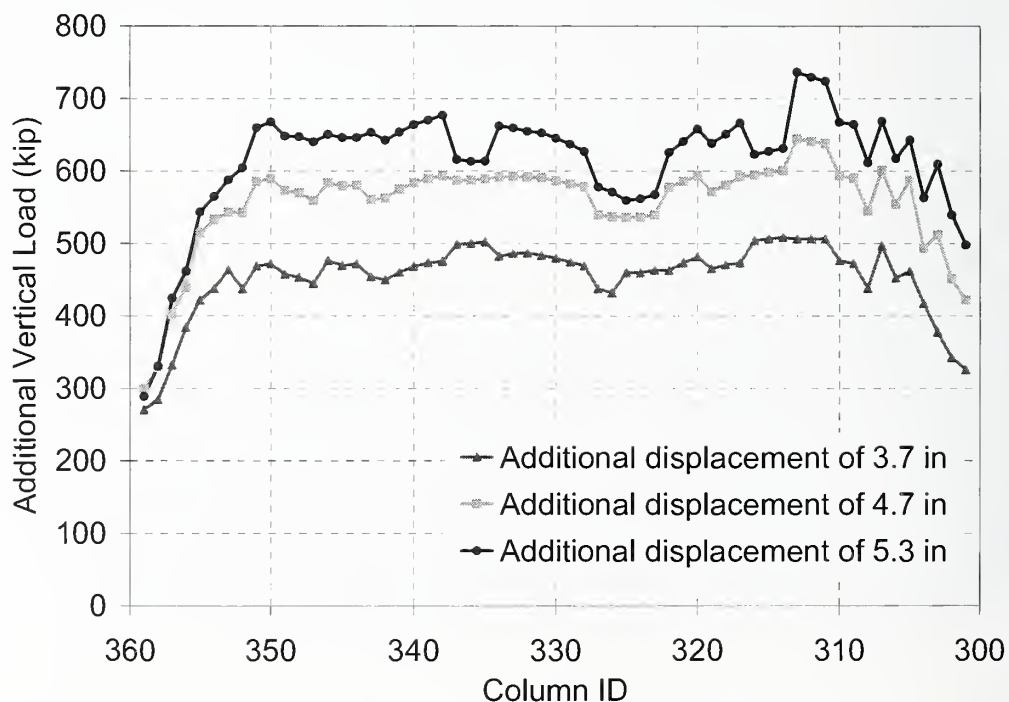
Figure 3-97. Variation of additional vertical load applied to columns of isolated east wall model of WTC 2 at different levels of additional vertical displacements imposed after Case D temperature condition (compression is positive).

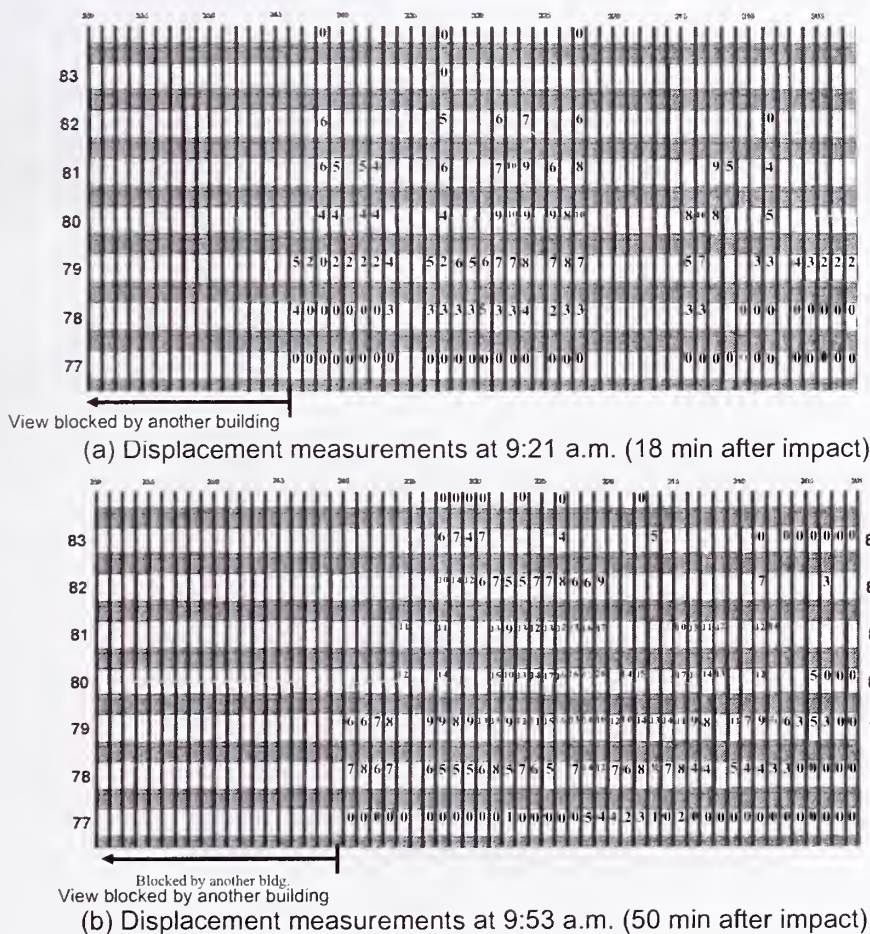
Figure 3–98. Out-of-plane displacements of the east wall of WTC 2 estimated by NIST from photographs (inward displacement is positive; displacements are in in.).

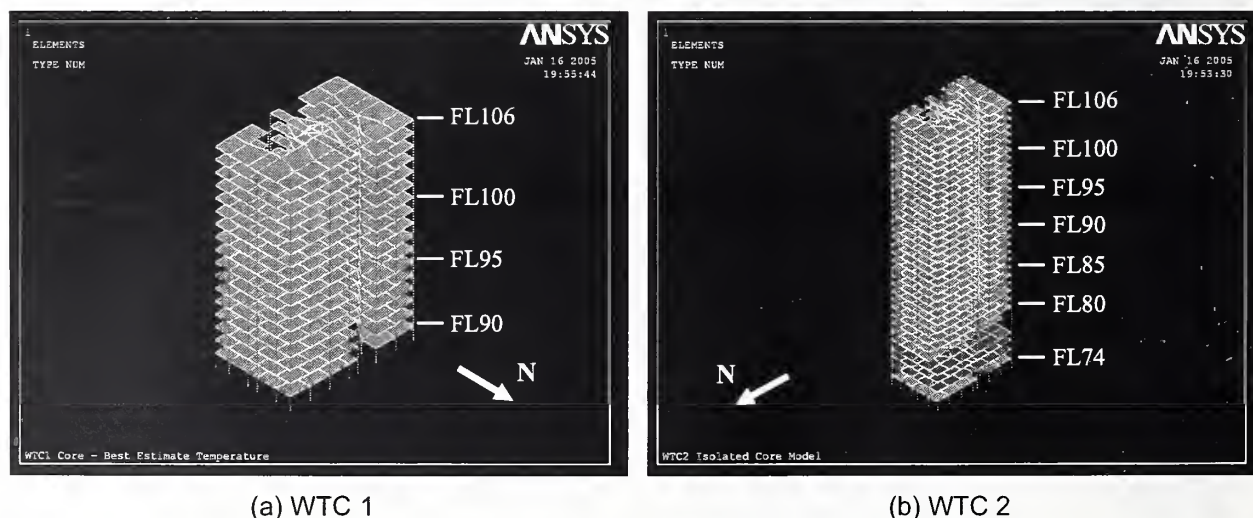
Figure 3-103. Isolated core models.

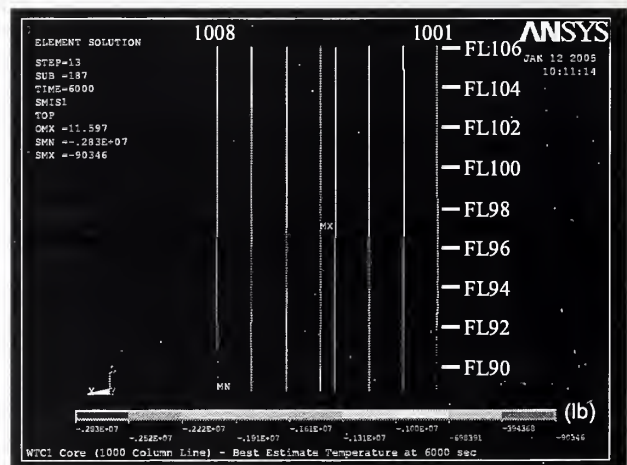
(f) 1000 series columns

Figure 3-114. Axial load in columns of isolated core model of WTC 1 for Case A temperature condition at 100 min (compression is negative).

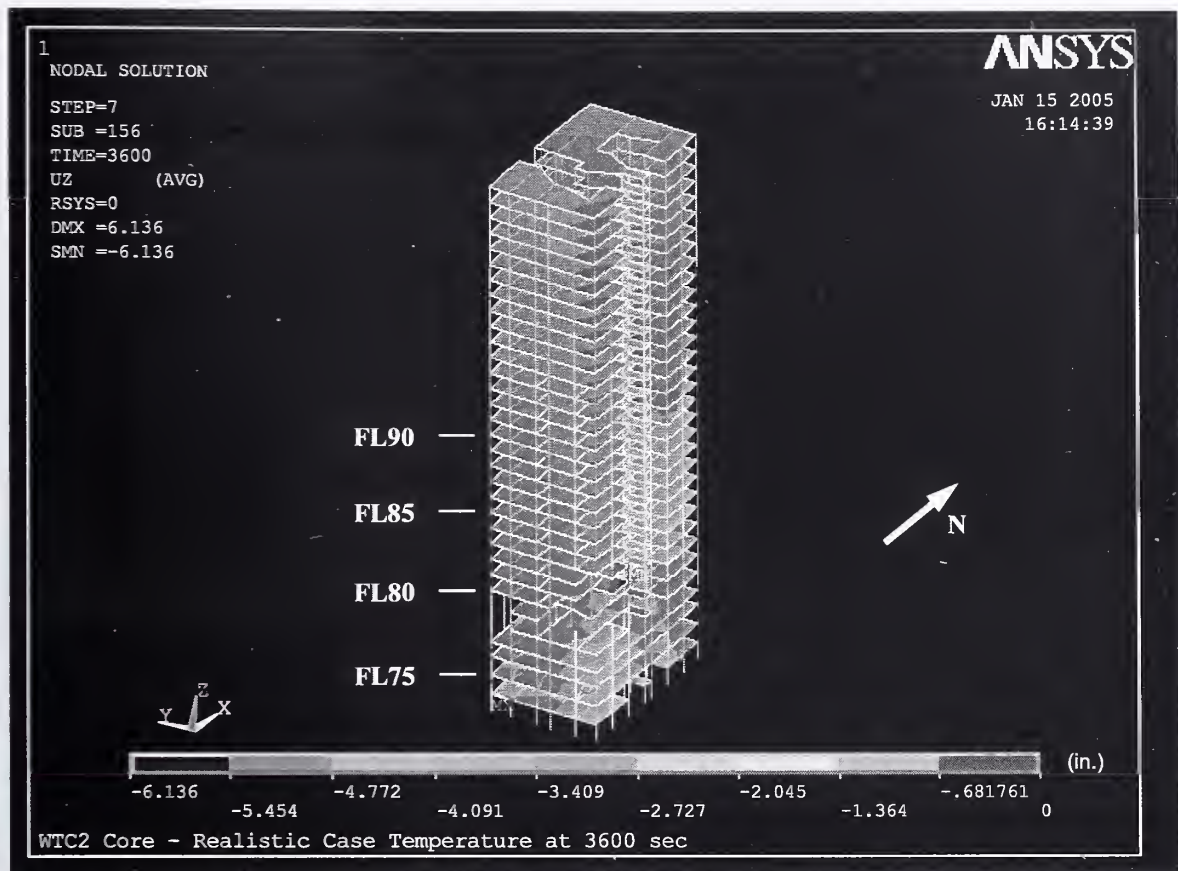
Figure 3-133. Vertical displacement of isolated core model of WTC 2 for Case C temperature condition at 60 min (downward displacement is negative).

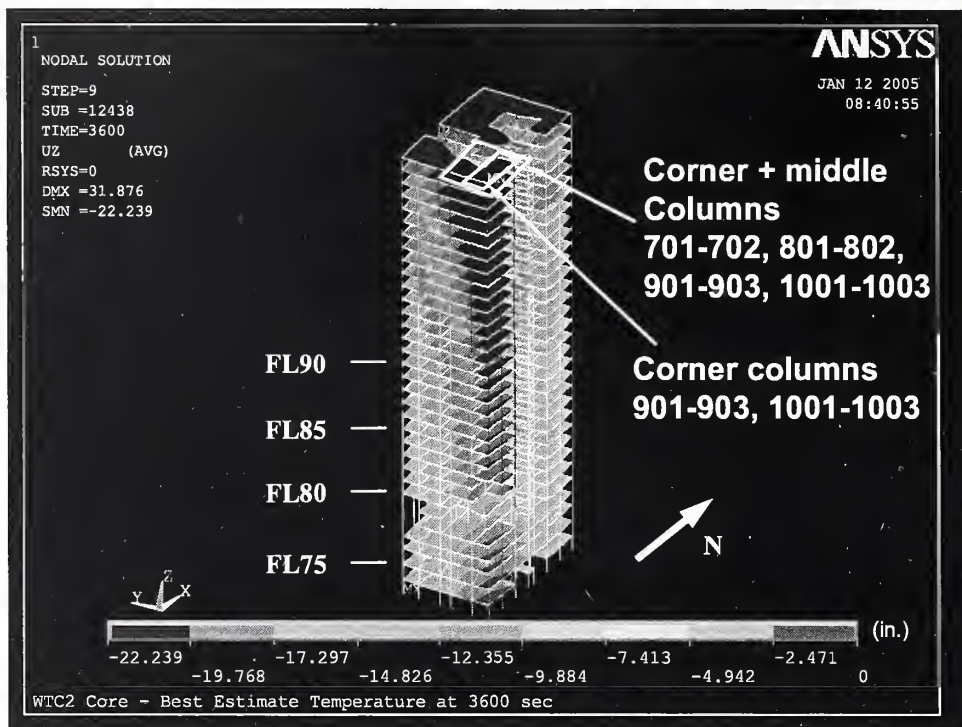
Figure 3-136. Vertical displacement after push down of isolated core model of WTC 2 for Case C temperature condition (downward displacement is negative).

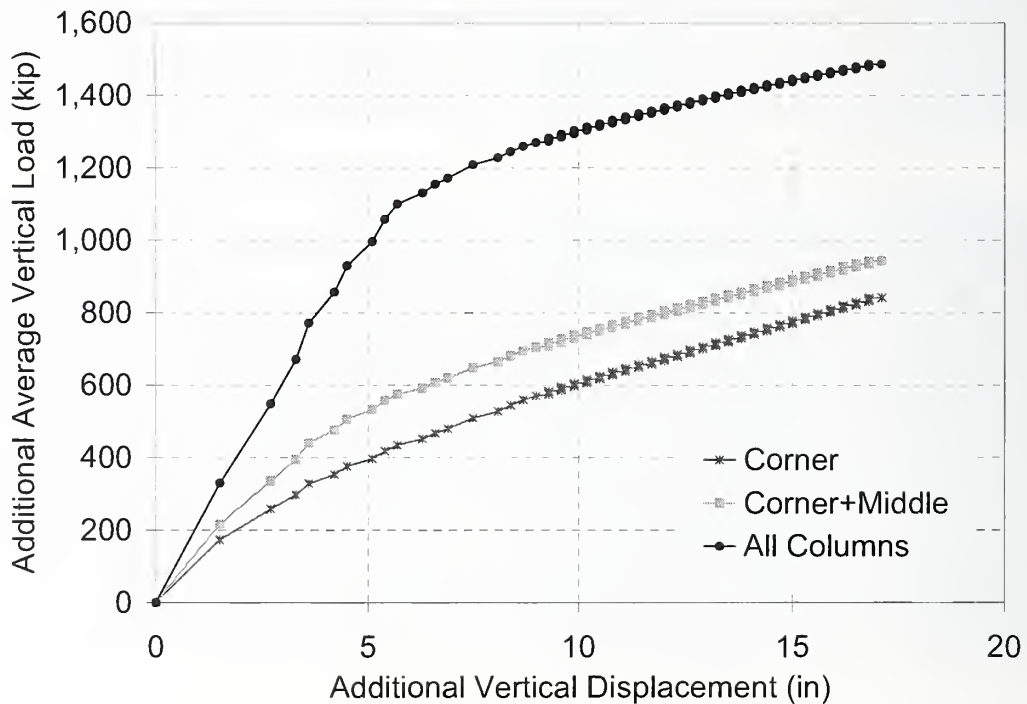
Figure 3-137. Additional average vertical load versus additional vertical displacement during push-down analysis of isolated core model of WTC 2 for Case C temperature condition (compression is positive; core column locations are shown in Fig. 3-136).

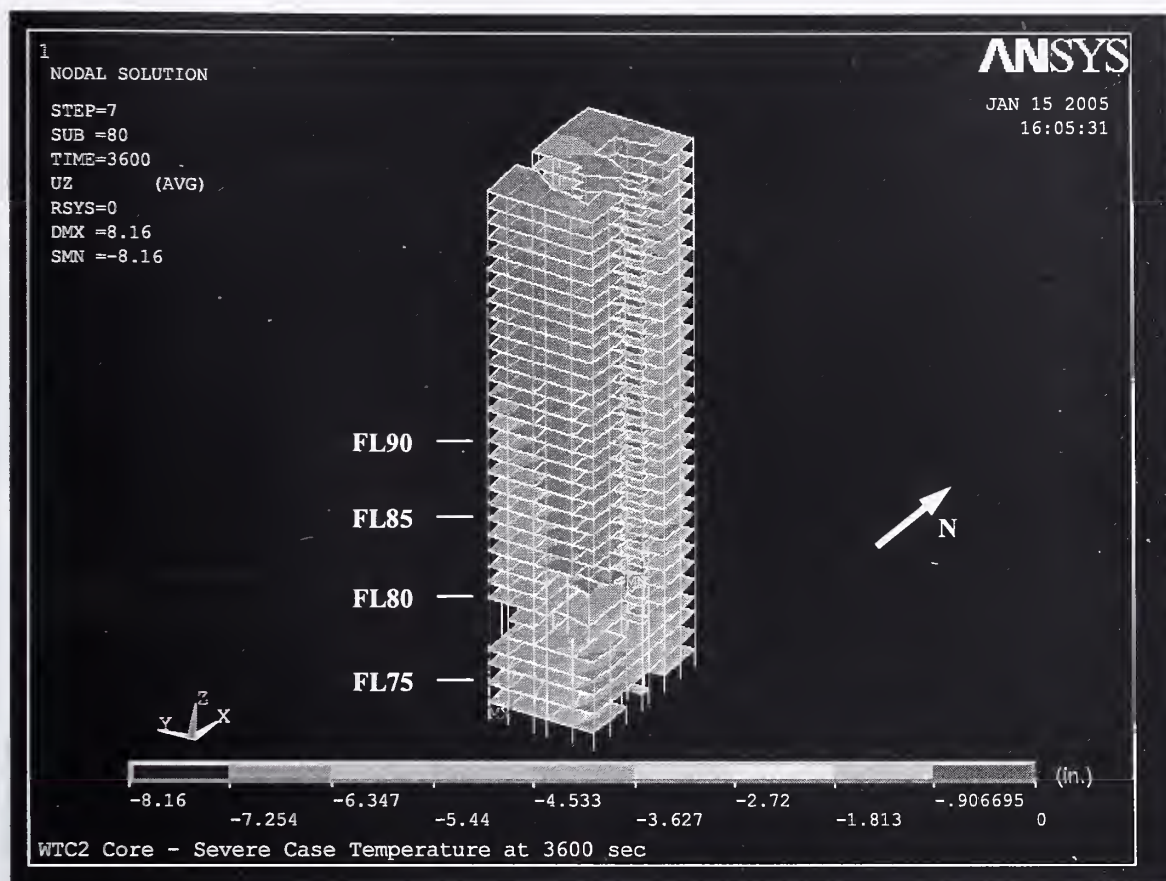
Figure 3-139. Vertical displacement of isolated core model of WTC 2 for Case D temperature condition at 60 min (downward displacement is negative).

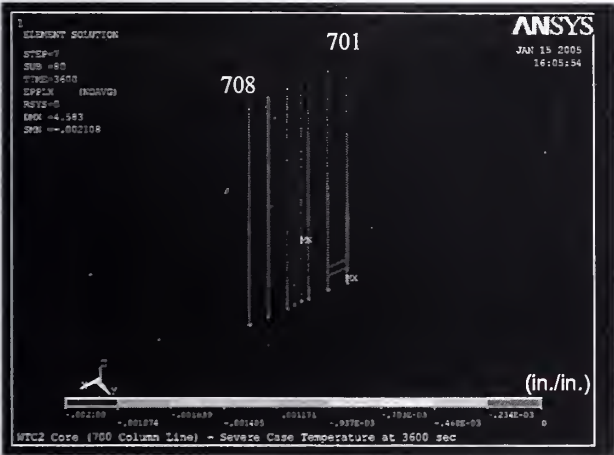
(c) 700 series columns

Figure 3–141. Axial plastic strains in core columns of isolated core model of WTC 2 for Case D temperature condition at 60 min (compressive strain is negative).
