NIST NCSTAR 1-6 Federal Building and Fire Safety Investigation of the World Trade Center Disaster

Structural Fire Response and Probable Collapse Sequence of the World Trade Center Towers

John L. Gross Therese P. McAllister

September 2005

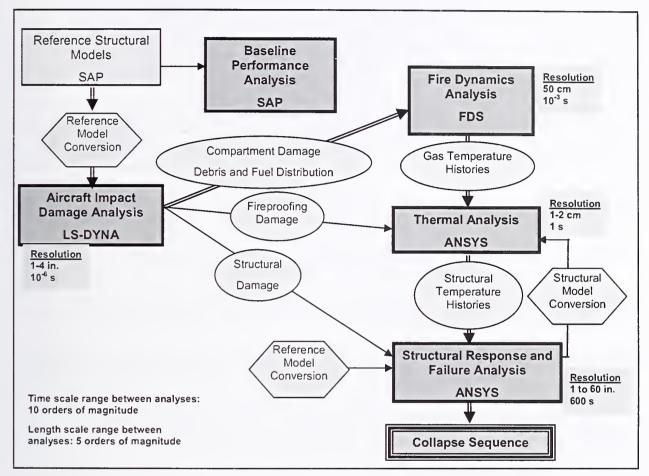
Figure E-1. Critical analysis inter-dependencies.

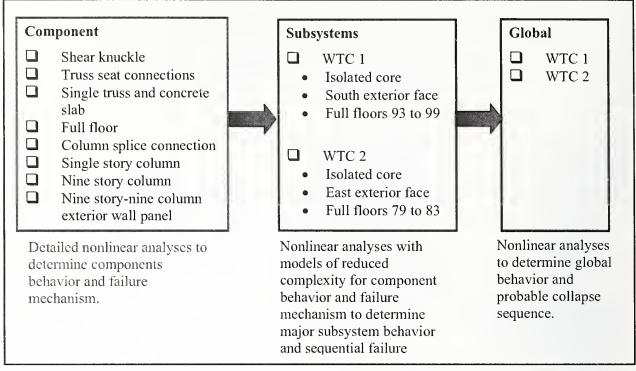
Figure E–2. Structural Analysis Sequence.

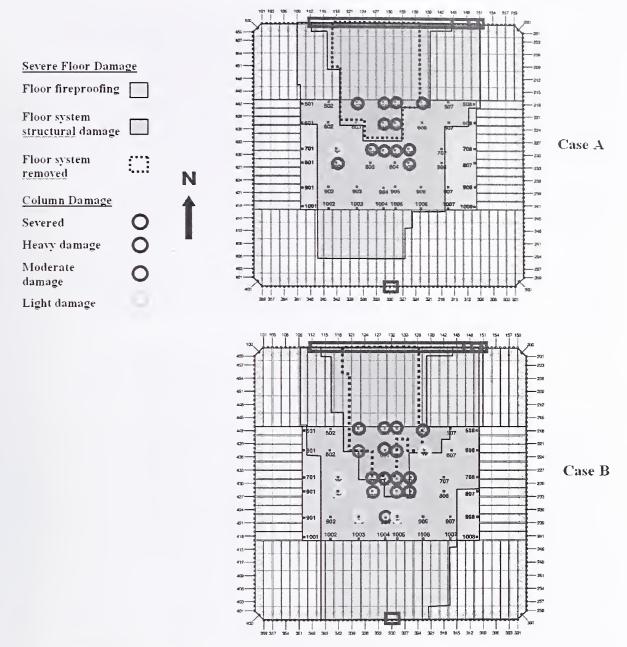
Figure E–3. Plan view of WTC 1 cumulative damage for Floors 93 to 99.

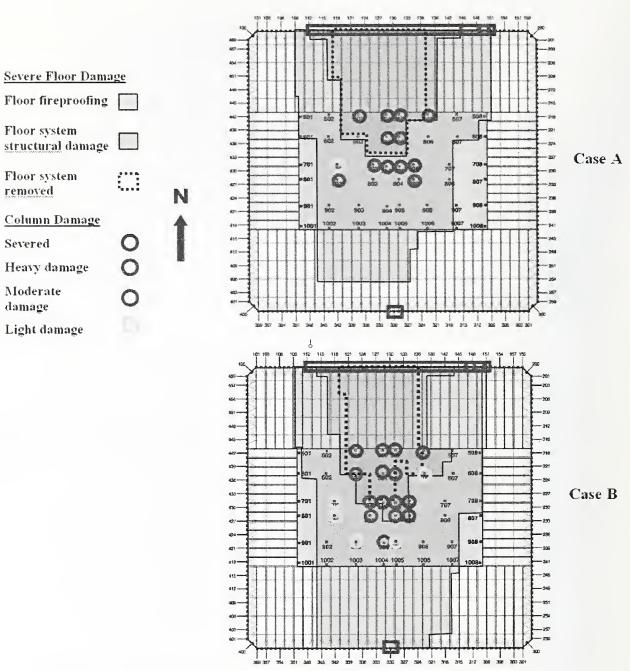
Figure E-4. Plan view of WTC 2 cumulative damage for Floors 78 to 84.

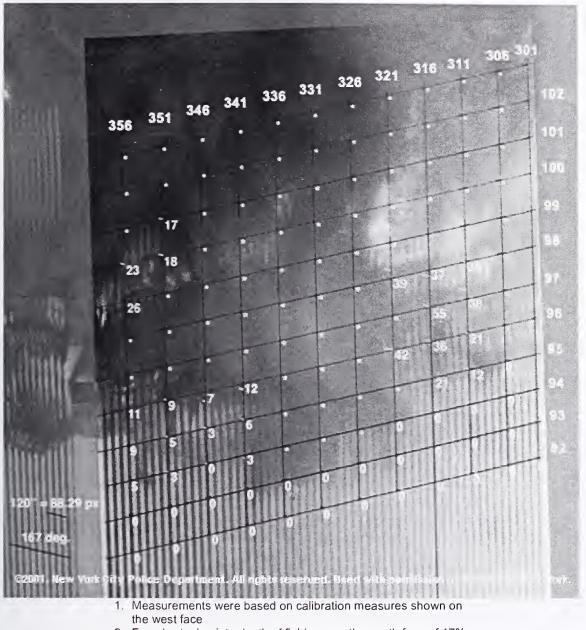
- 2. Foreshortening into depth of field across the south face of 17% was included in the measurements
- 3. Measurement error was at least \pm 6 inches

Figure E--6. WTC 1 building section above impact damage zone tilts to the south.

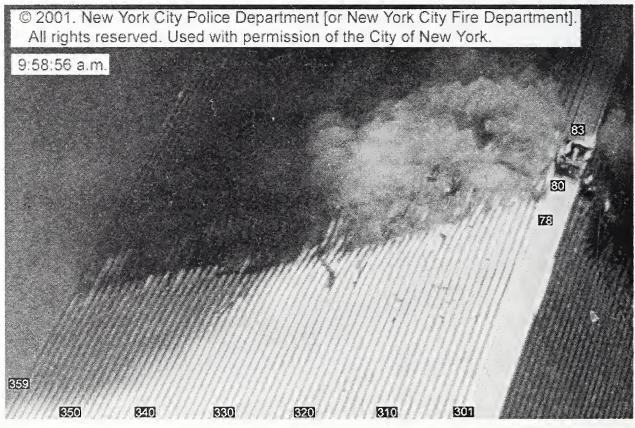
Figure E–7. View of WTC 2 buckling of east wall near northeast corner as collapse initiates from southeast.

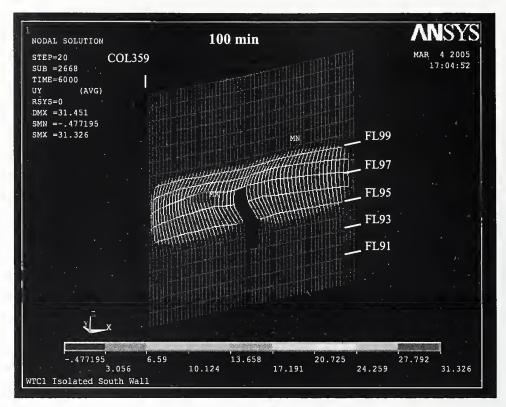
Figure E–9. Inward displacement of the WTC 1 south wall at 100 min of the Case B temperatures with floor disconnections and 6 kip pull-in forces over five floors.

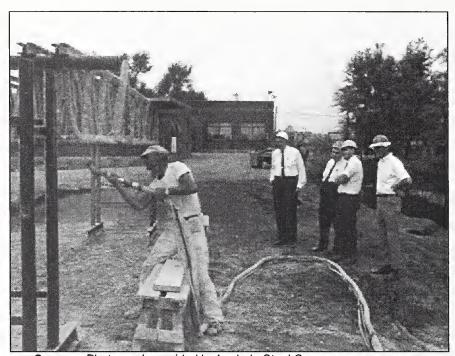
Source: Photograph provided by Laclede Steel Co. Figure 2–2. Demonstration of application of Monokote sprayed fire-resistive material to floor trusses.

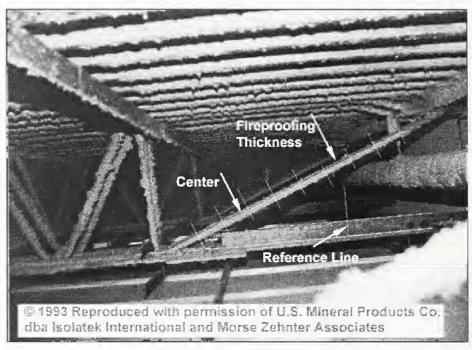
Figure 2–3. Example of measurement procedure used to estimate SFRM thickness from photographs.

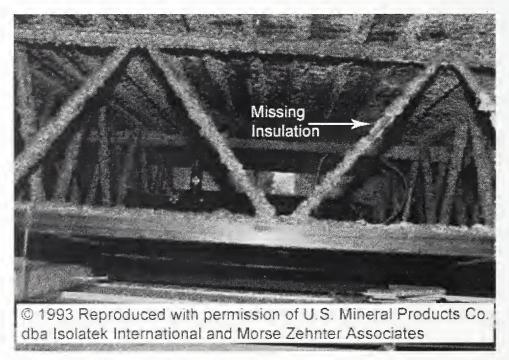
Figure 2–4. Example of "gap" in fire-resistive material on diagonal member of a bridging floor truss.

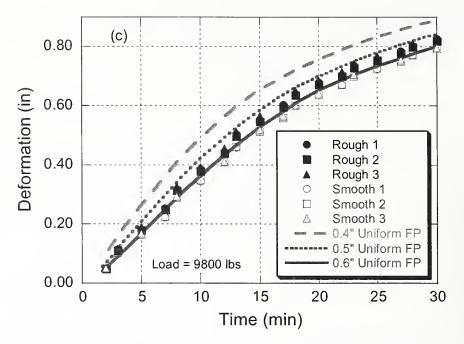
Figure 2–5. Thermo-mechanical response of 1 in. bar compared with uniform thickness SFRM.

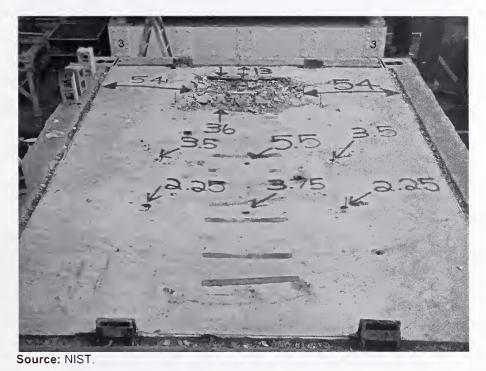
Figure 3–9. Unexposed surface of Assembly No. 3 after loading equipment was removed.

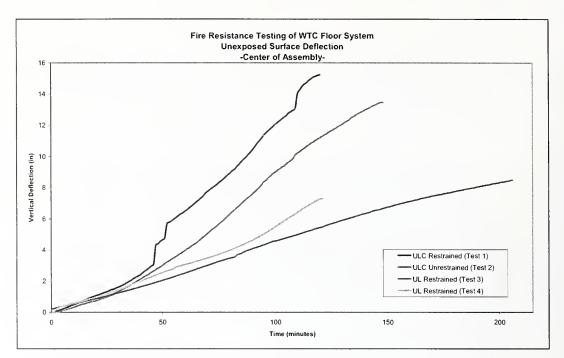
The following plots show the vertical deflection measured at the center of each floor assembly. Figure 3–15 shows the deflection while Fig. 3–16 is a plot of the deflection normalized by the span length. It is seen that Specimen No.1 experienced a significant increase in vertical deflection at 49 min which corresponded directly to a loud report and visible increase in deflection noted during the test. A small increase in vertical deflection for Specimen No. 3 was seen to occur at 82 min, the time when the slab spalled explosively at one end.

Figure 3–15. Deflection measured at the center of each assembly.

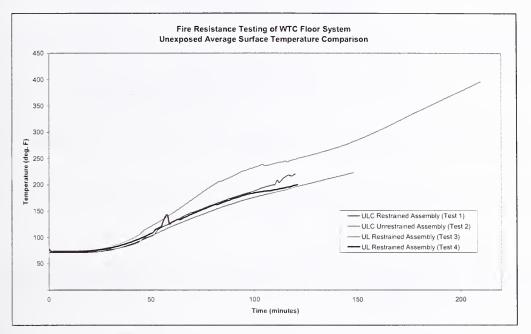
The temperature of the top (unexposed) surface of the floor assemblies is plotted in Fig 3–17. It is observed that the unexposed surface temperatures of all four test assemblies were similar prior to the onset of significant concrete crushing and spalling at around 50 min. In Test 4, the surface-mounted thermocouple on the west edge near the center of the span was affected by the explosive failure of the slab and recorded hot gas temperatures.

Figure 3–17. Average temperature of the unexposed surface for all four tests.

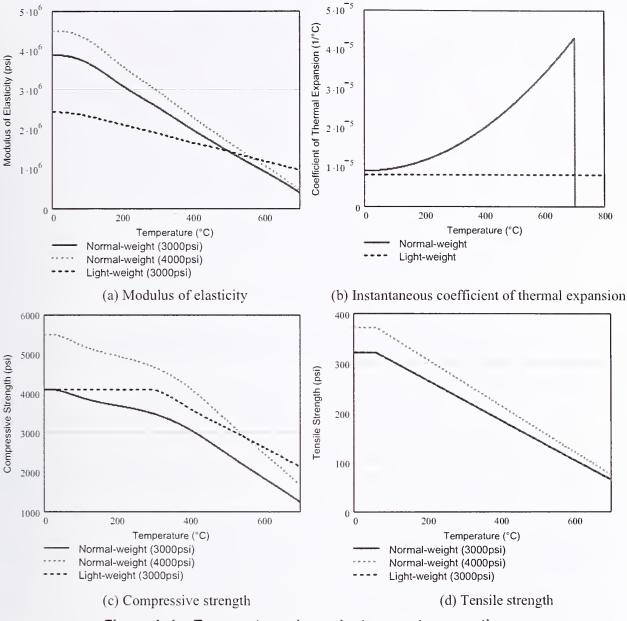
The effects of elevated temperature on concrete mechanical properties, plotted in Fig. 4–1, are based upon Phan (1996) and Phan and Carino (2003). Lightweight concrete shows less degradation in modulus of elasticity and a constant instantaneous coefficient of thermal expansion as temperatures increase. Lightweight concrete heats more slowly than does normal weight concrete. Tensile strength is identical for lightweight and normal weight concretes with the same compressive strength, since tensile strength depends upon the formation of cracks. Compressive strength for lightweight concrete shows no degradation until 300 °C, whereas normal weight concretes begin degrading as temperatures exceed room temperature.

Figure 4–1. Temperature-dependent concrete properties.

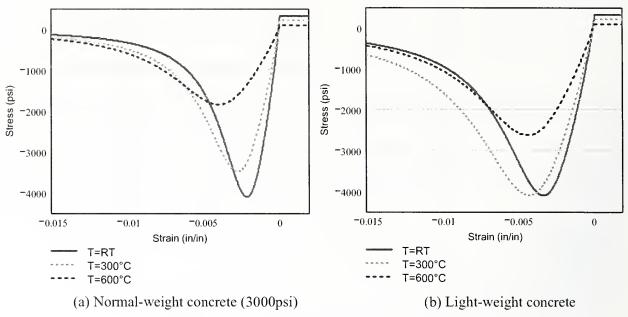
Figure 4–2 shows concrete stress-strain curves at room and elevated temperatures, where compressive stresses and strains are negative and tensile stresses and strains are positive. Tensile stress in concrete increases linearly up to the tensile strength. When strained beyond this point, the concrete begins to crack and the stress across the section will drop. However, this drop in the stress-strain relationship caused significant numerical instability problems during structural analysis. Numerical instabilities were avoided by assuming that the reinforced concrete slab became plastic in tension as the reinforcement carried the tensile load.

Figure 4–2. Concrete stress-strain curves.

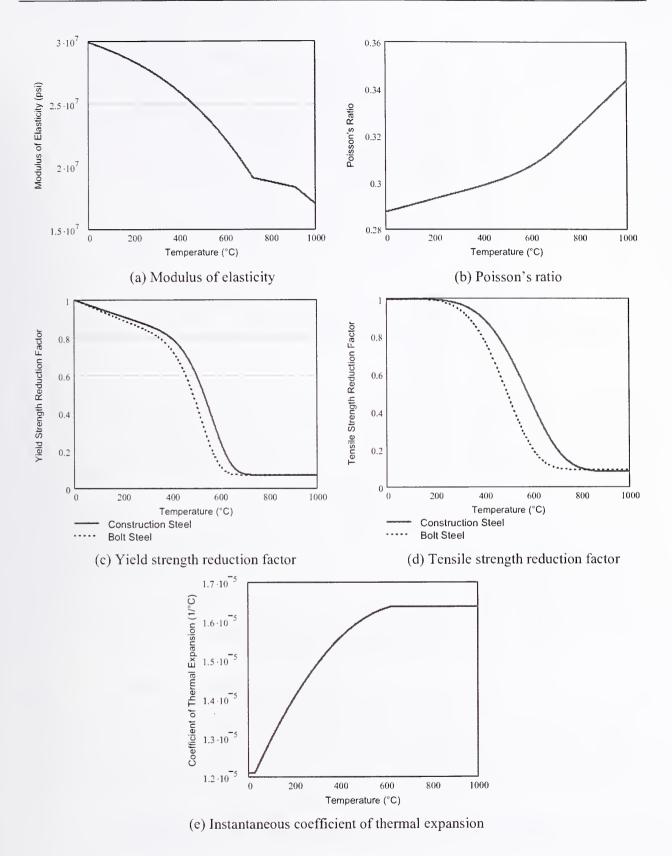
Figure 4–3. Temperature-dependent properties for all steels.

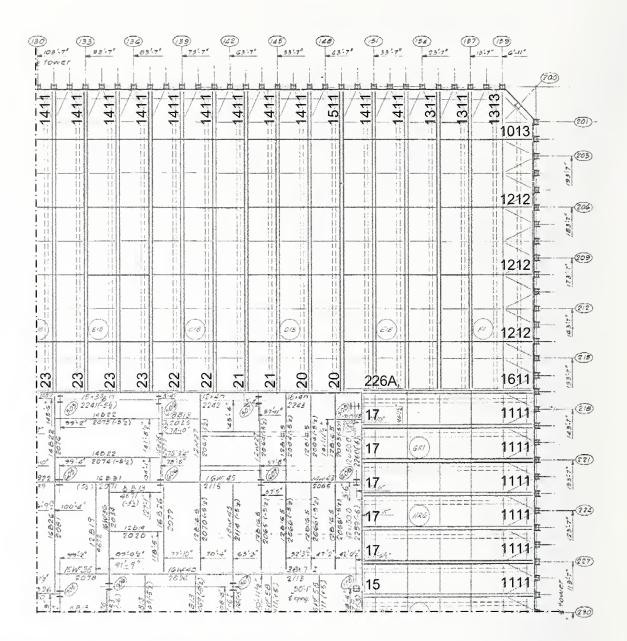
The truss seat connections transferred floor gravity loads to the exterior and core columns and provided lateral bracing for the columns. All seat connections were similar in design, but varied in their dimensions and weld sizes. For Floor 96 of WTC 1, there were seven types of interior truss seats and eight types of exterior truss seats. The different types of interior truss seats were identified with Detail Numbers 15, 17, 20, 21, 22, 23, and 226A; and the exterior truss seats with Detail Numbers 1013, 1111, 1212, 1311, 1313, 1411, 1511, and 1611, as shown in Fig. 4–10.

Figure 4–10. Truss seat detail location on northeast quadrant of Floor 96 of WTC 1. Reproduced with permission of The Port Authority of New York and New Jersey.

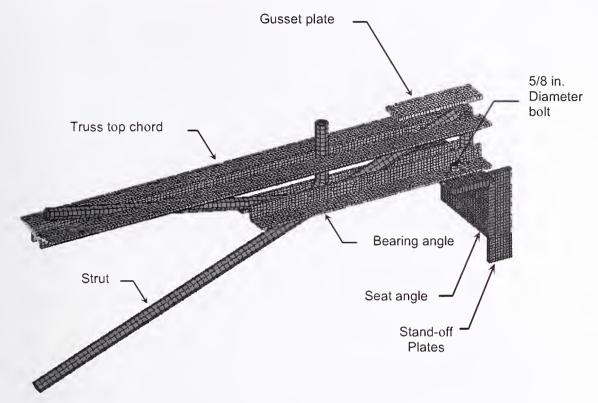
Figure 4–11. Finite element model of exterior seat.

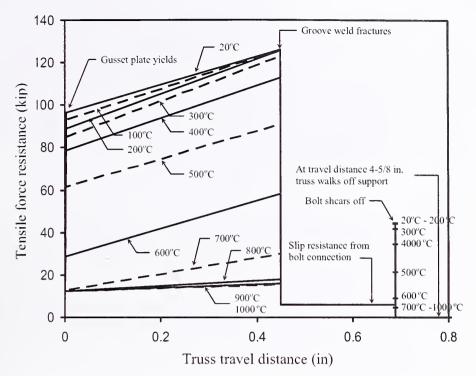
Figure 4–13. Capacity of exterior seat against tensile force (Detail 1411 in Fig. 4–10).

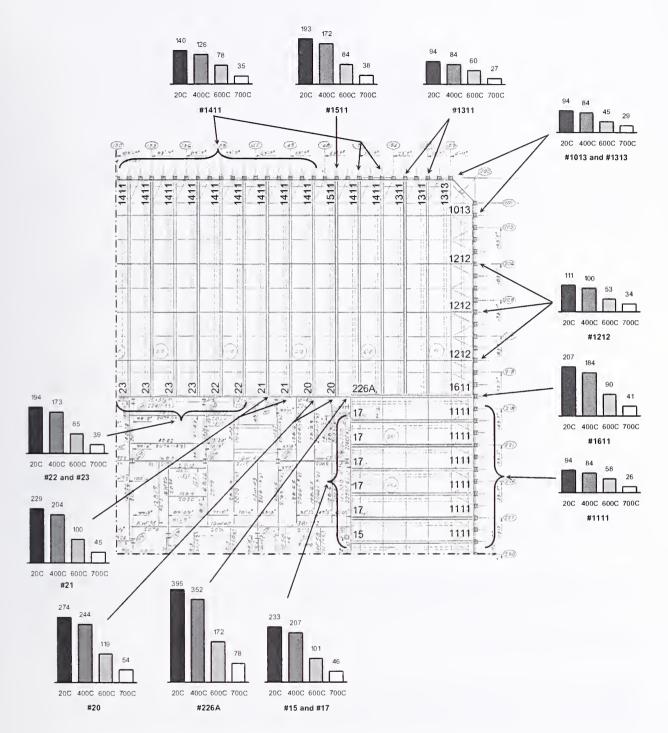
Figure 4–15. Truss seat capacity against vertical force. Reproduced with permission of The Port Authority of New York and New Jersey. Enhancements by NIST.

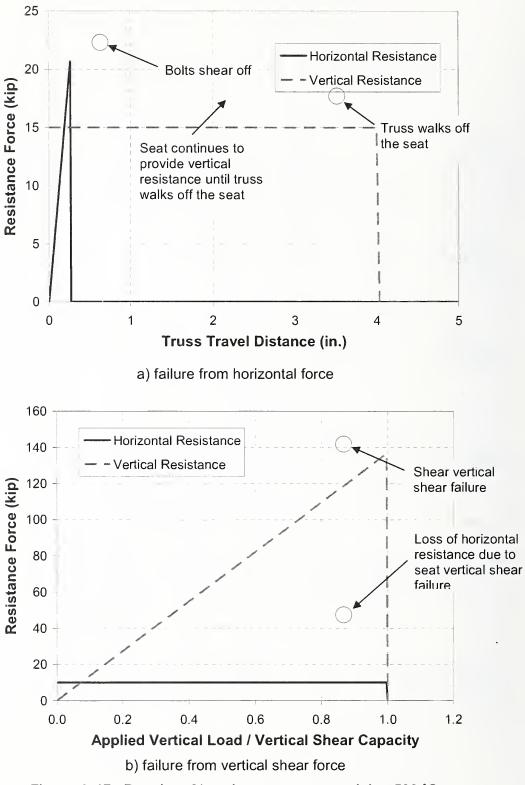
Figure 4–17. Results of interior truss seat model at 500 °C.

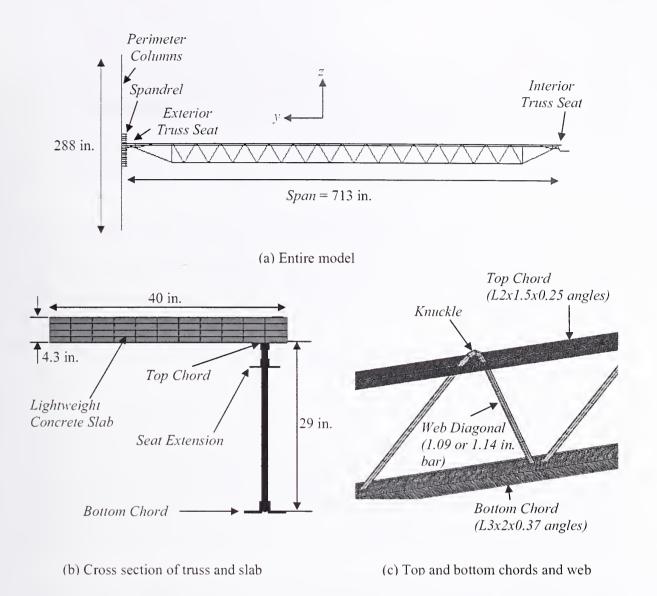
Figure 4–23. Composite truss and concrete slab model.

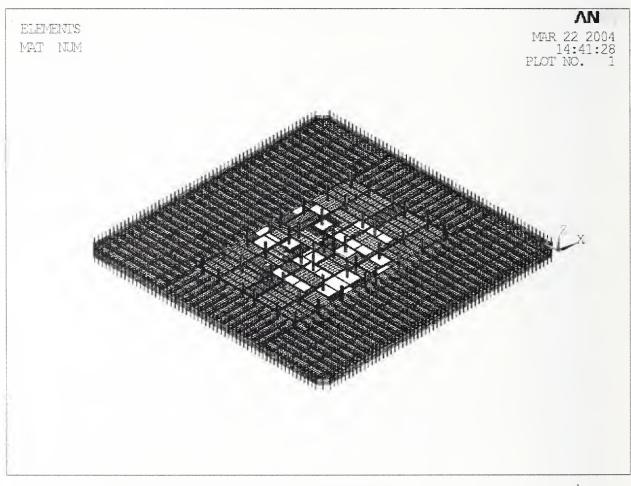
Figure 4–27. Converted ANSYS model for Floor 96 of WTC 1.

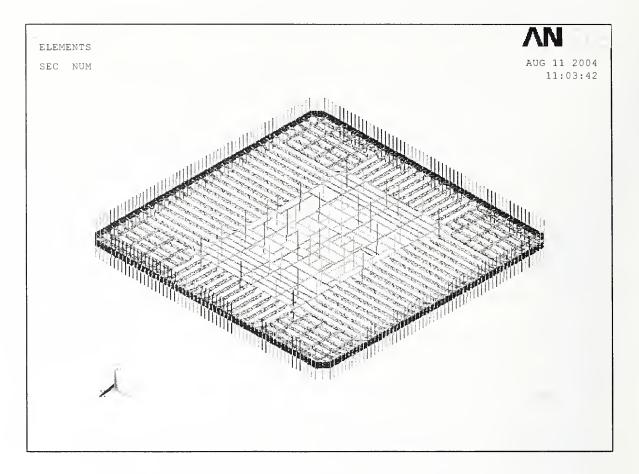
Figure 4–30. Full floor model before impact damage is included (without concrete floor slab).

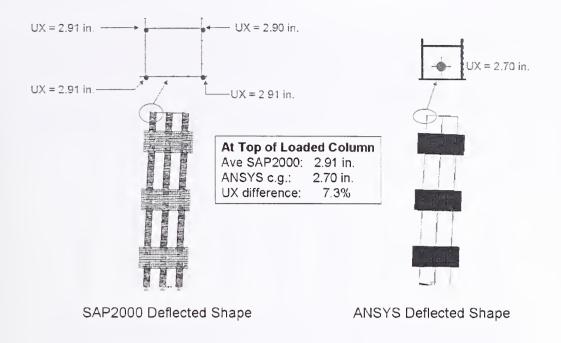
Figure 4–42. Deflection of prefabricated panel under 100 kip lateral load.

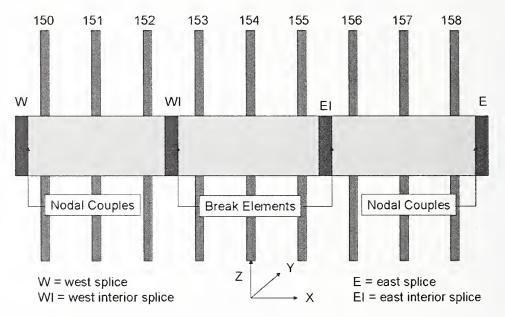
Figure 4–43. Typical spandrel splice layout for exterior wall section model.

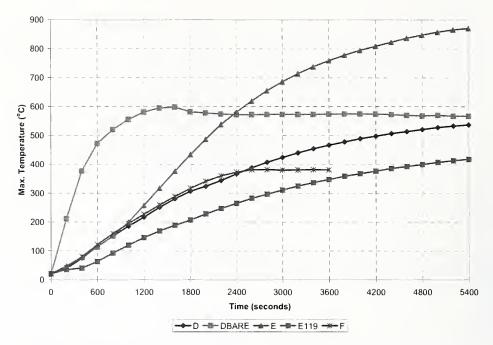
Figure 4–48. Exterior wall model temperature time-histories.

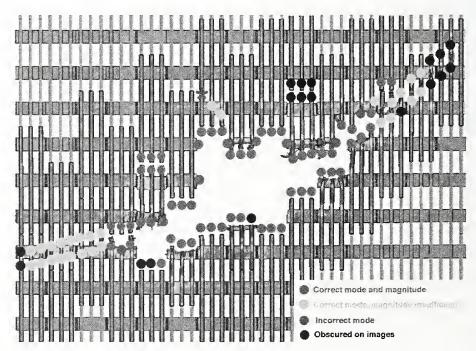
Figure 5–1. Validation of Aircraft Impact Analysis Prediction With Observations for WTC 1 North Exterior Wall Damage.

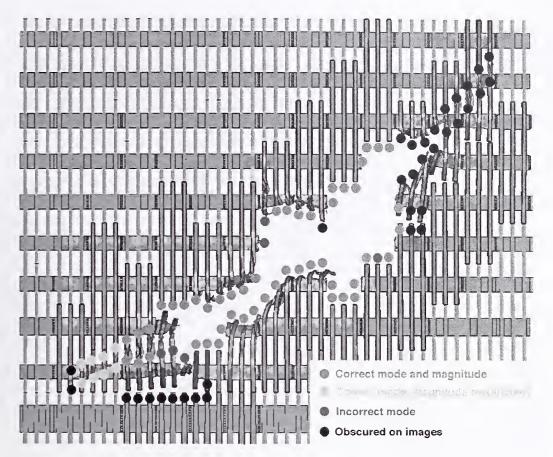
Figure 5–2. Validation of Aircraft Impact Analysis Prediction With Observations for WTC 2 South Exterior Wall Damage.

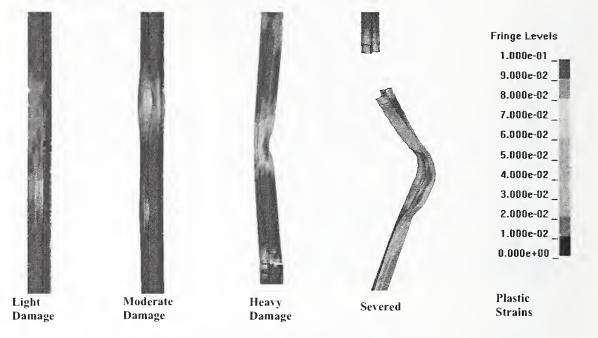
Figure 5–3. Core column damage levels.

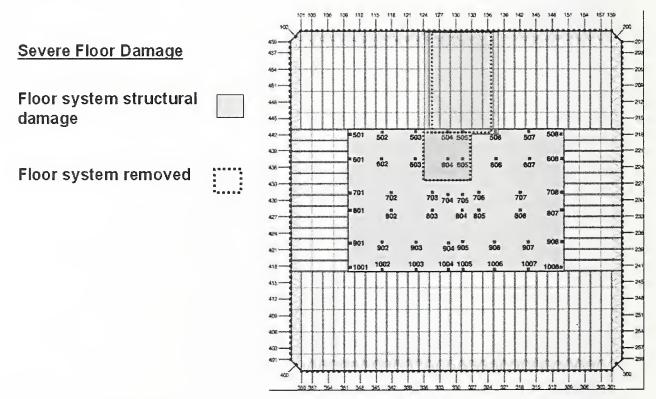
Figure 5–5. Damage to WTC 1 Floor 95 framing and slab for Case A.

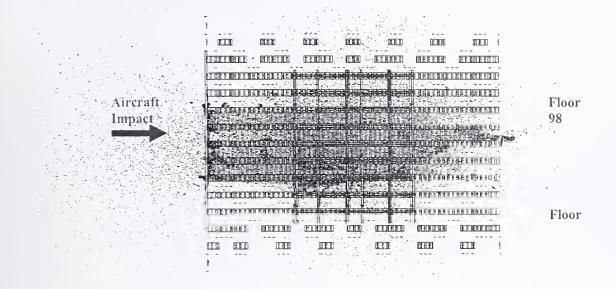
Figure 5–6. Debris and fuel field in WTC 1 Case B analysis of aircraft impact.

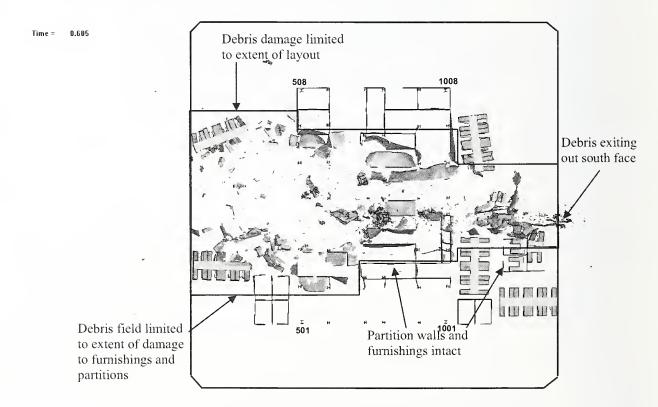
Figure 5–9. WTC 1 Case B Floor 95 partitions and furnishings layout after impact with overlay showing extent of dislodged insulation from direct debris impact.

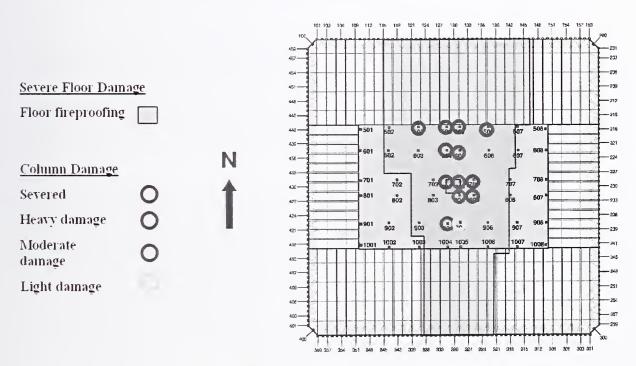
Figure 5-11. Plan view of WTC 1 Case B insulation and column damage for Occupancy Floor 95.

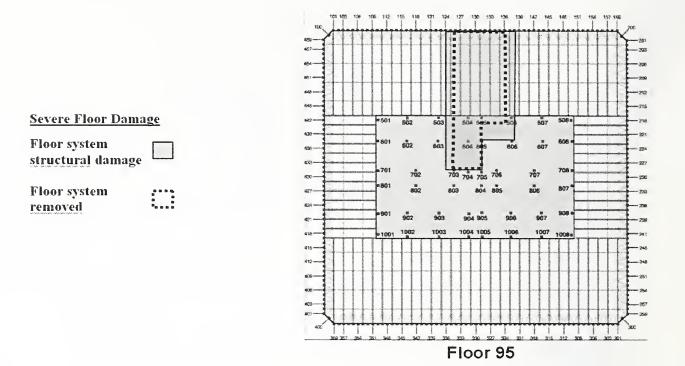
Figure 5-12. Plan view of WTC 1 Case B damage to Structural Floors 95.

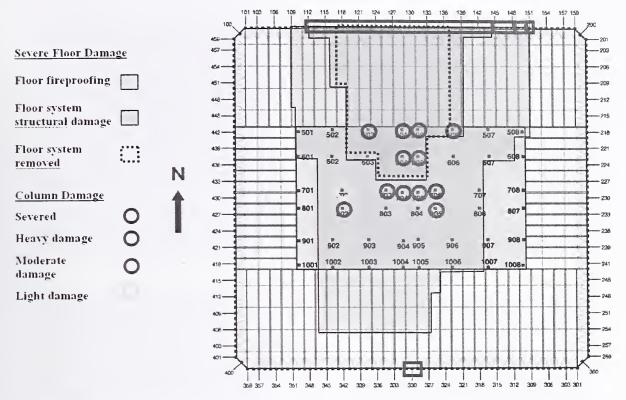
Figure 5–13. Plan view of WTC 1 Case A cumulative damage for Floors 93 to 98.

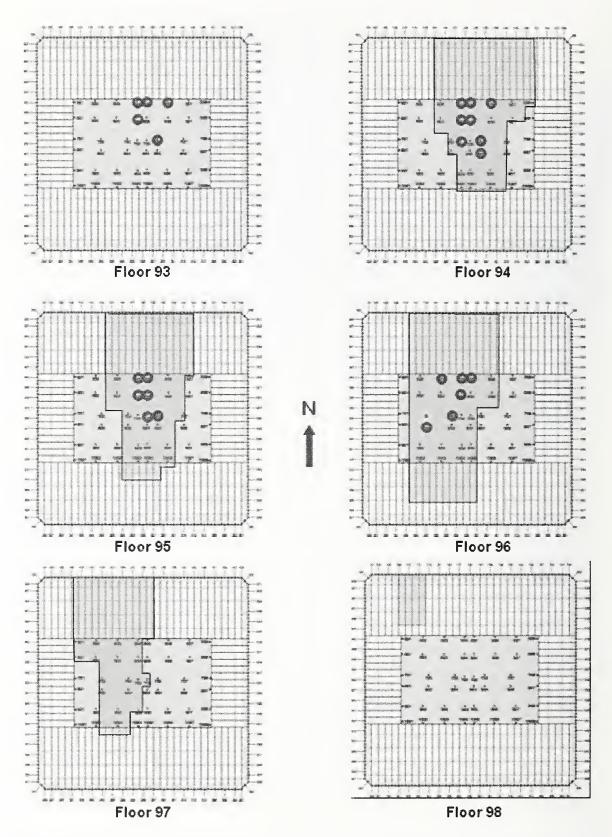
Figure 5–14. Plan view of WTC 1 Case A insulation and column damage to Occupancy Floors 93 to 98.

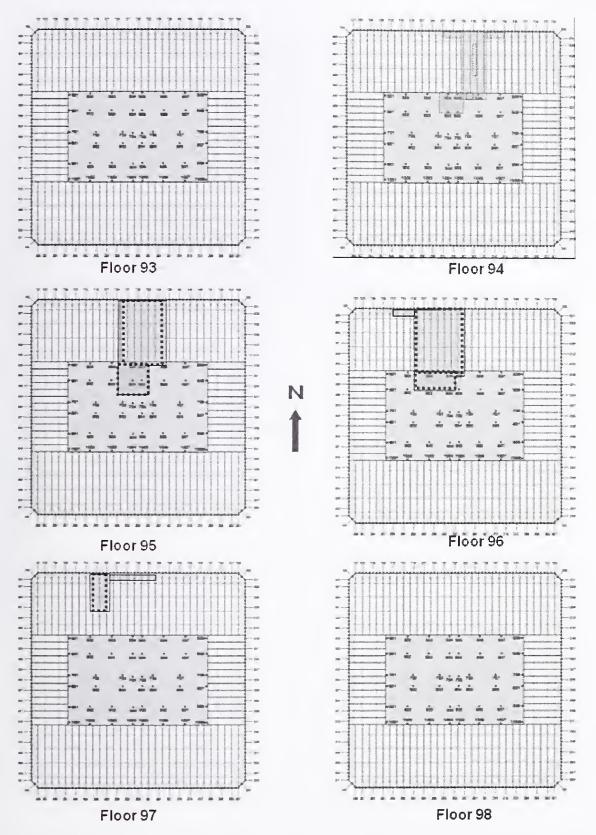
Figure 5–15. Plan view of WTC 1 Case A damage to Structural Floors 93 to 98.

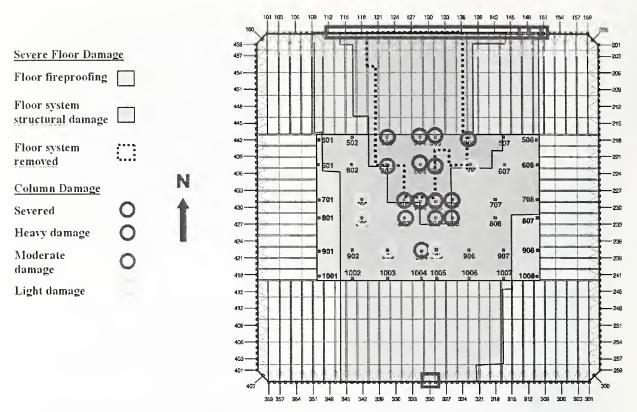
Figure 5–16. Plan view of WTC 1 Case B cumulative damage from Floors 93 to 98.

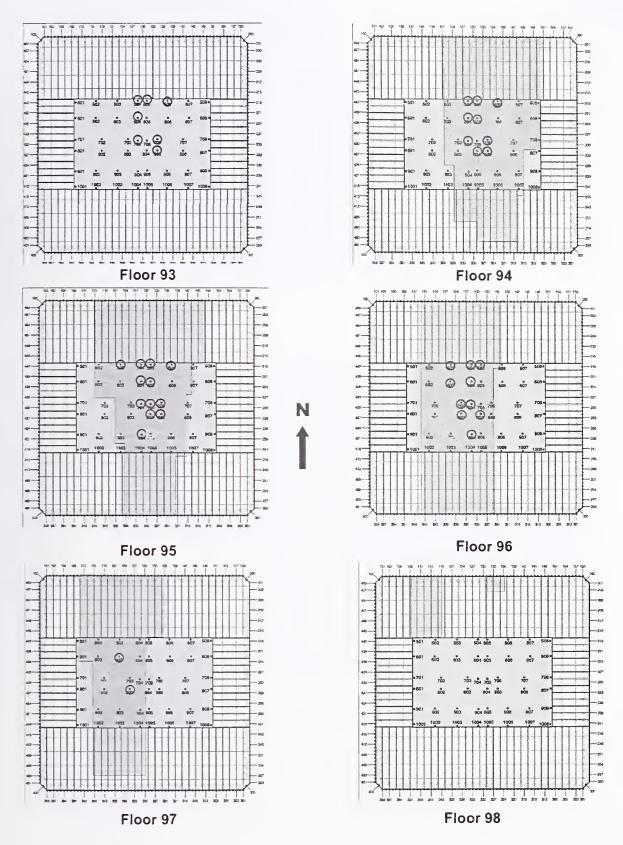
Figure 5–17. Plan view of WTC 1 Case B insulation and column damage to Occupancy Floors 93 to 98.

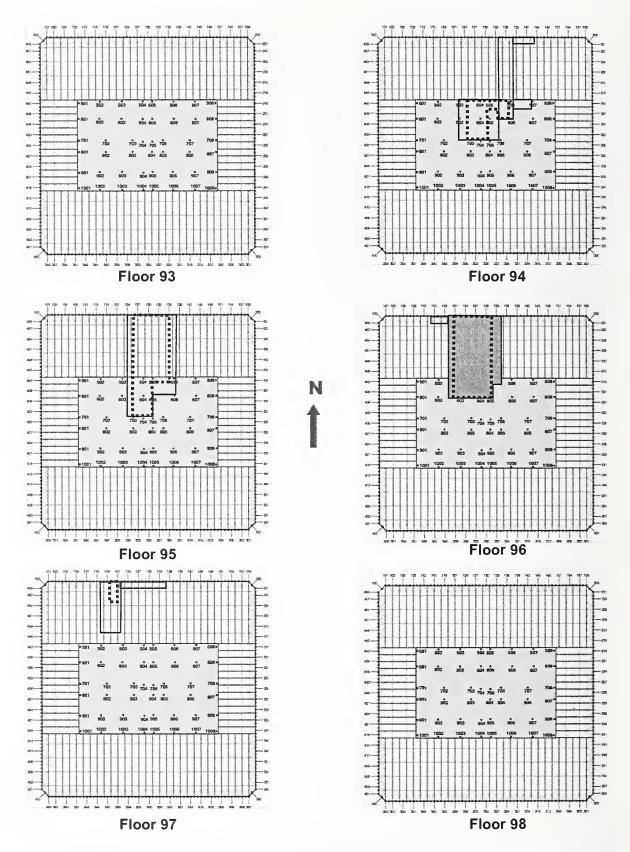
Figure 5–18. Plan view of WTC 1 Case B damage to Structural Floors 93 to 98.

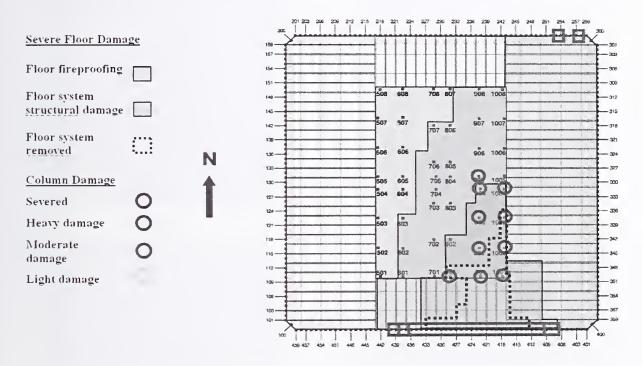
Figure 5–19. Plan view of WTC 2 Case C cumulative damage from Floors 78 to 83.

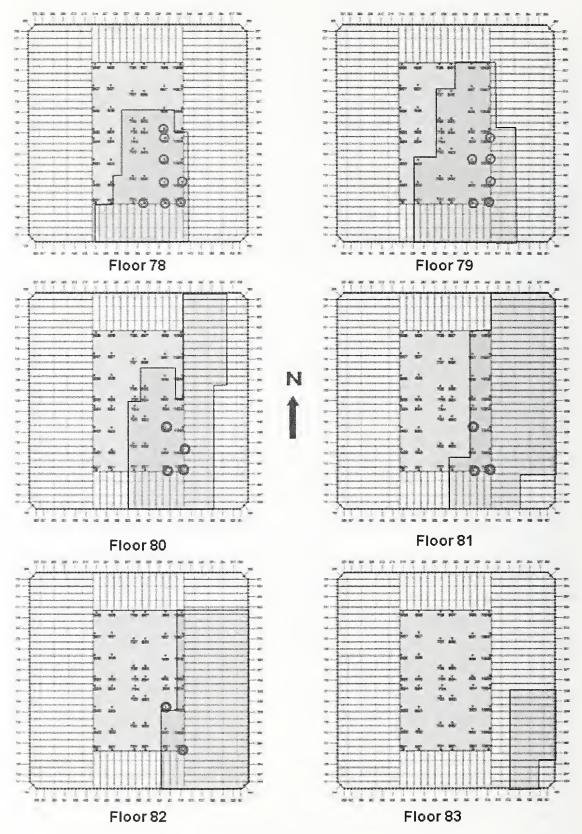
Figure 5–20. Plan view of WTC 2 Case C insulation and column damage to Occupancy Floors 78 to 83.

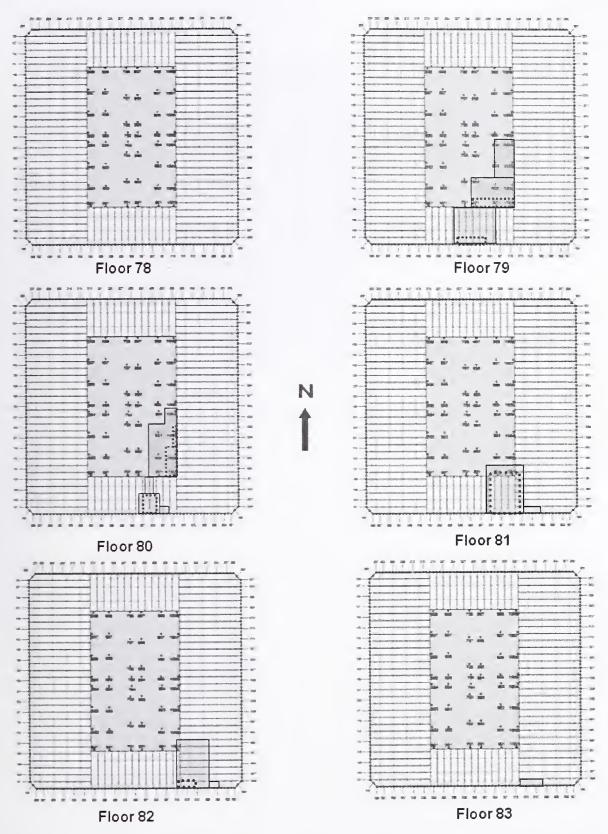
Figure 5–21. Plan view of WTC 2 Case C damage to Structural Floors 78 to 83.

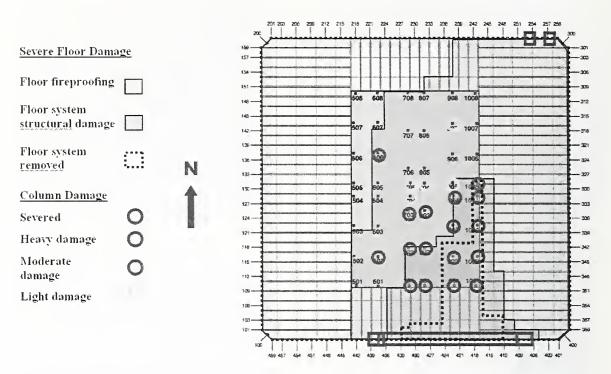
Figure 5–22. Plan view of WTC 2 Case D cumulative damage from Floors 78 to 83.

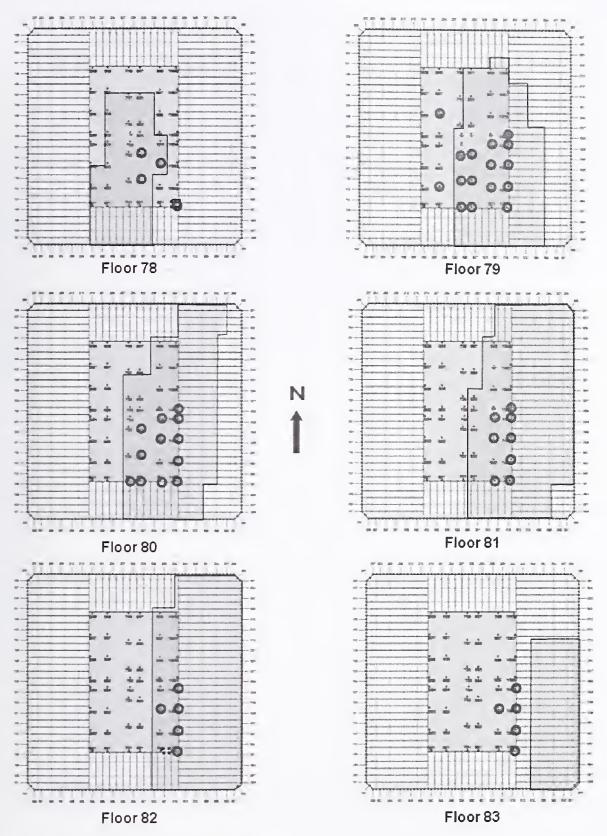
Figure 5–23. Plan view of WTC 2 Case D insulation and column damage to Occupancy Floors 78 to 83.

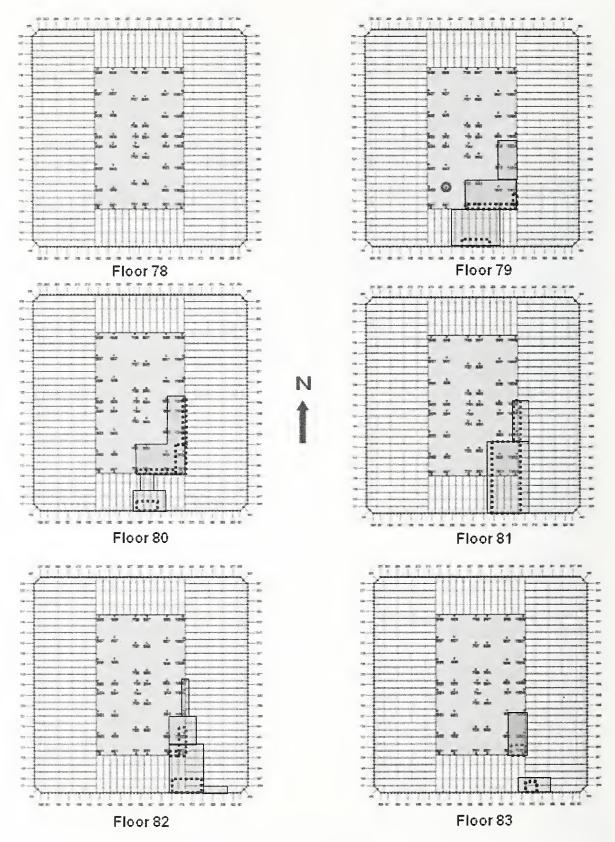
Figure 5–24. Plan view of WTC 2 Case D damage to Structural Floors 78 to 83.

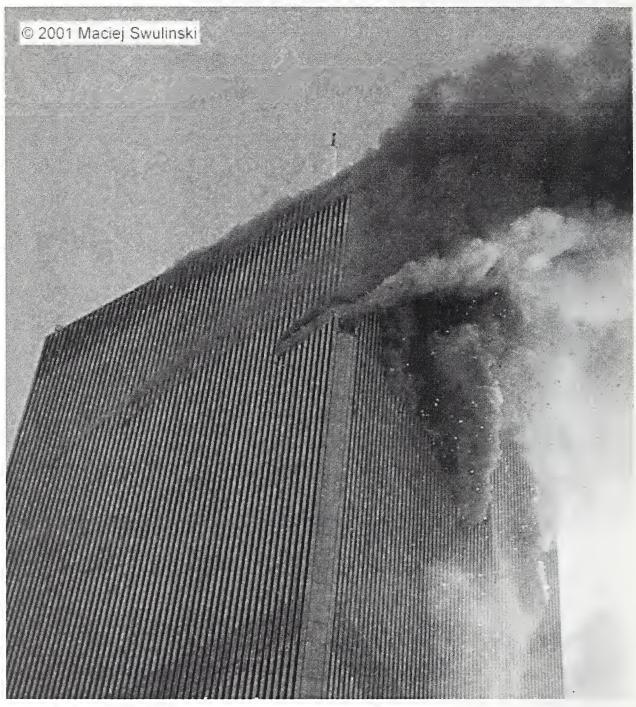
Figure 6–2. Initial aircraft impact damage on WTC 1 west and south faces minutes after impact (exact time of image is unknown).

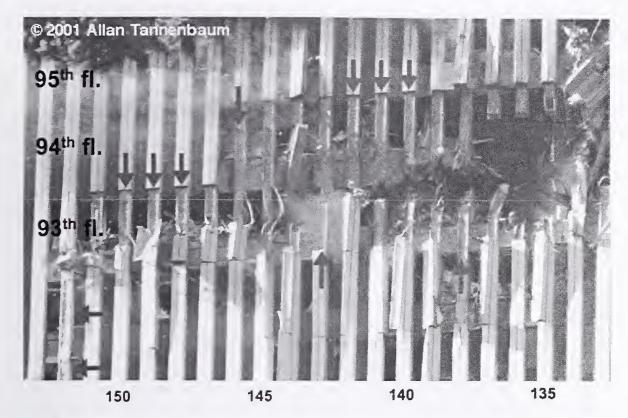
Figure 6–3. SFRM knocked off north exterior columns. Arrows show where fireproofing was damaged or missing.

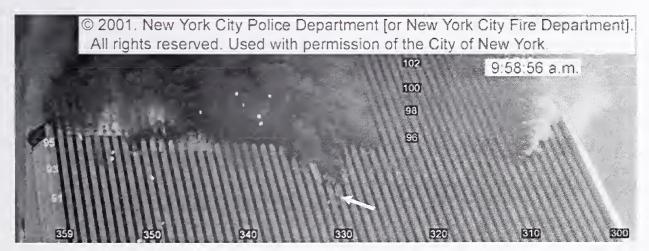
Figure 6–4. South face of WTC 1 with fire visible only on the west side at 9:25. Arrow shows region where debris pile under missing panel was observed.

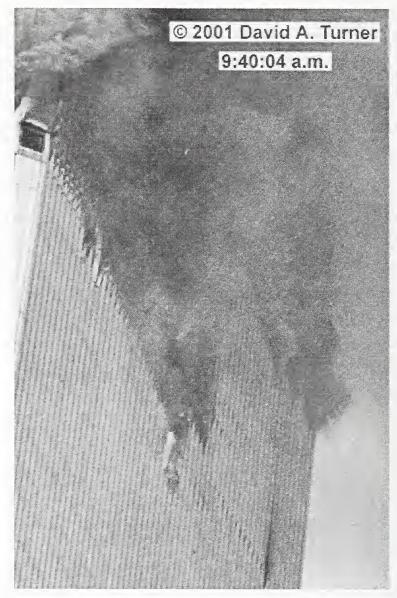
Figure 6–5. Fires on WTC 1 south face at 9:40 a.m. Note lack of inward bowing.

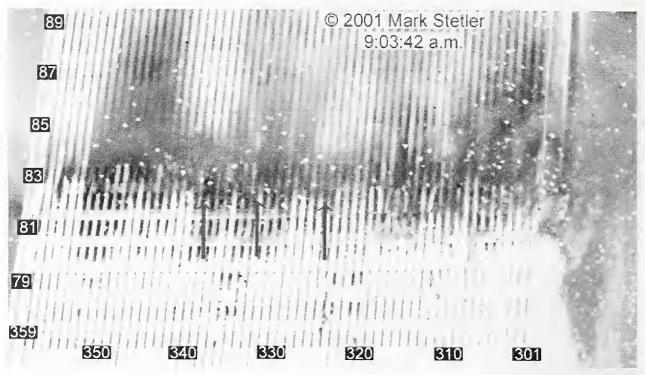
Figure 6–13. Hanging object (noted by arrows) in east windows of Floor 82 appears to be edge of Floor 83.

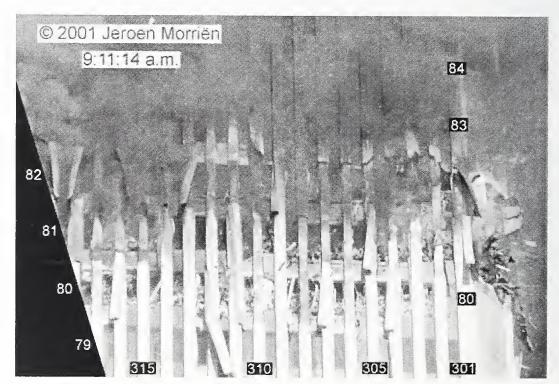
Figure 6–14. Debris piles at windows where fires are burning at the northeast corner.

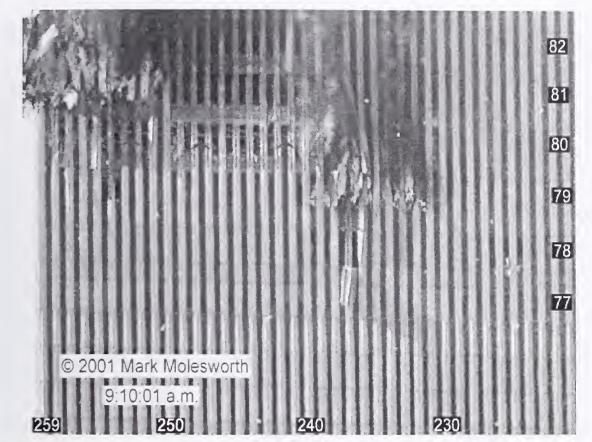
Figure 6–15. Hanging object (noted by arrows) in north windows of Floor 79 appears to be edge of Floor 80.

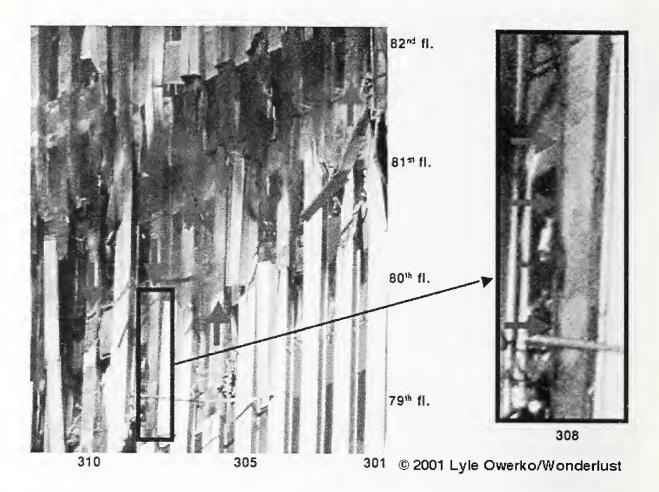
Figure 6–16. Image showing damage to fireproofing on east face of WTC 2 due to internal impact. Red arrows highlight areas where fireproofing has been damaged. The blowup to the right shows a column where red Tnemec primer paint is visible.

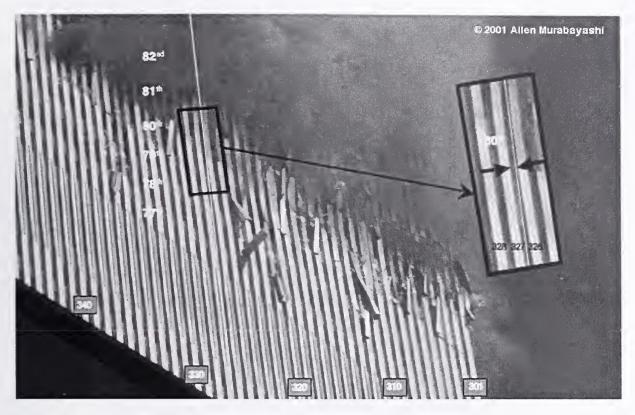
Figure 6–17. WTC 2 exterior columns bowing inward across north side of the east face between Floors 77 and 83 at 9:21 a.m.
