NIST NCSTAR 1-6

Federal Building and Fire Safety Investigation of  
the World Trade Center Disaster

# Structural Fire Response and Probable Collapse Sequence of the World Trade Center Towers

(Chapter 7- Appendix B)

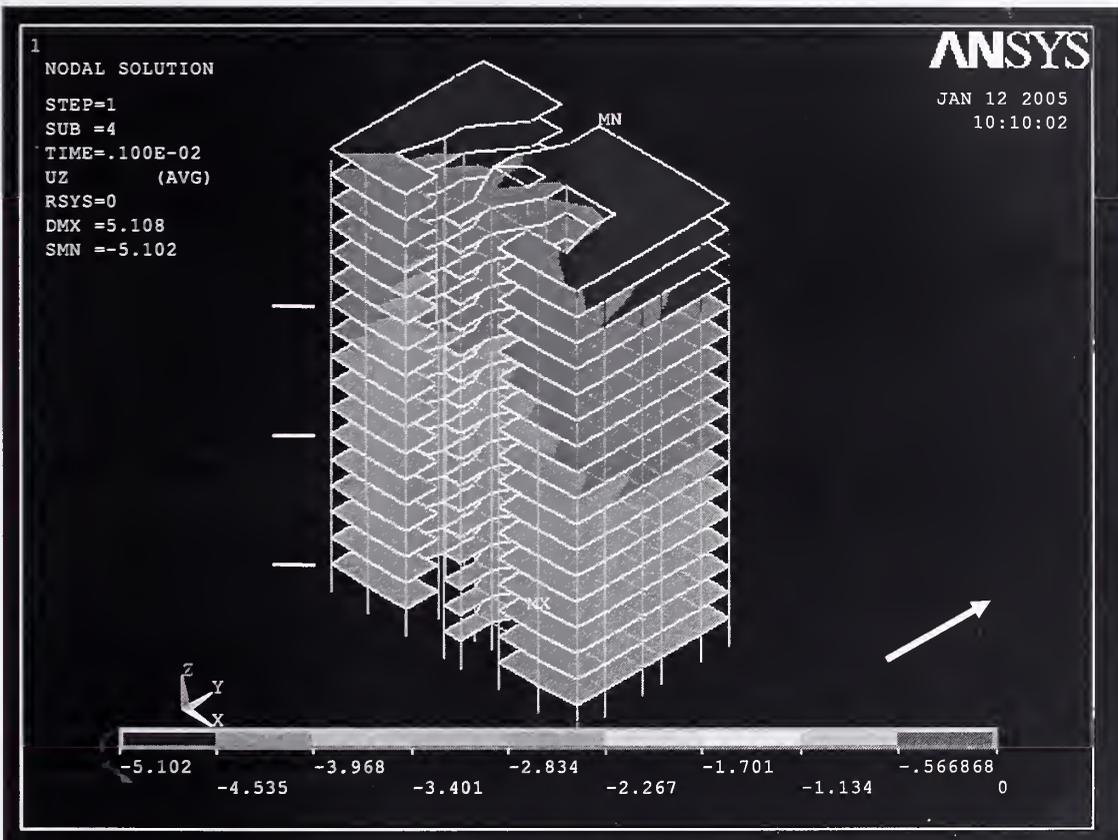
Figure 7-2. Vertical displacement of WTC 1 isolated core model with impact damage and gravity loads.

Figure 7–2 shows the vertical displacement of the WTC 1 isolated core model with impact damage (prior to applying thermal loading) for Case A, where the colors represent the magnitude of vertical displacement. The maximum vertical displacement was approximately 5 in. along the north side of the

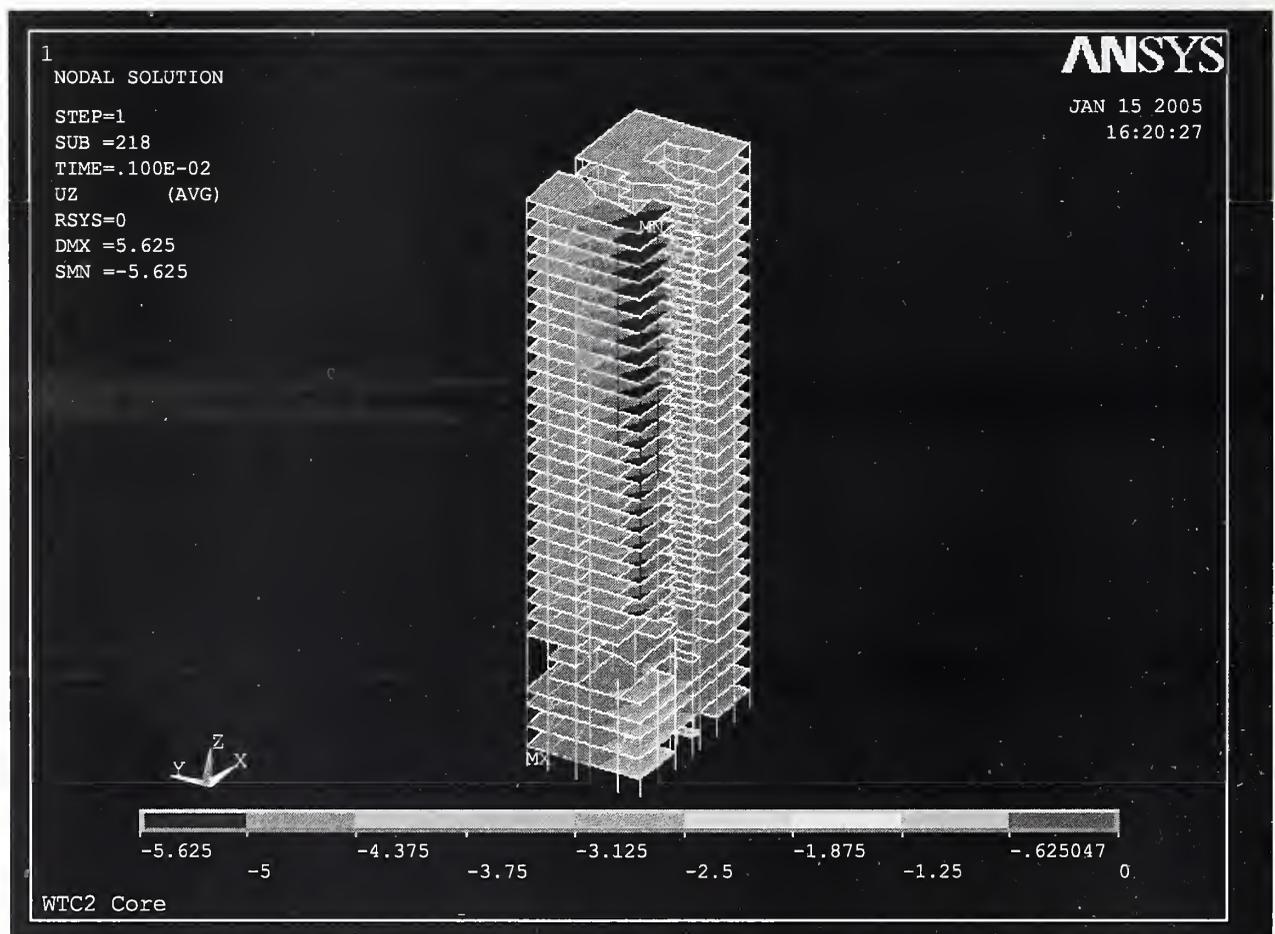
Figure 7–5. Vertical displacement of the WTC 2 isolated core model with impact damage and gravity loads (south and east faces).

Figure 7–5 shows the vertical displacement of the WTC 2 isolated core model with impact damage for Case C. The maximum vertical displacement was approximately 5.6 in. at the southeast corner of the core where core columns were severed. Figures 7–6 and 7–7 show the response (vertical displacement) of the WTC 2 core model to Case C and Case D temperature histories, respectively. Case C resulted in a 6.1 in. vertical displacement at the southeast corner. Case D resulted in an 8.1 in. vertical displacement at the southeast corner. Without horizontal restraints, the core would have tilted more toward the southeast corner, and the vertical displacement would have been larger. No columns buckled in either Case C or Case D.

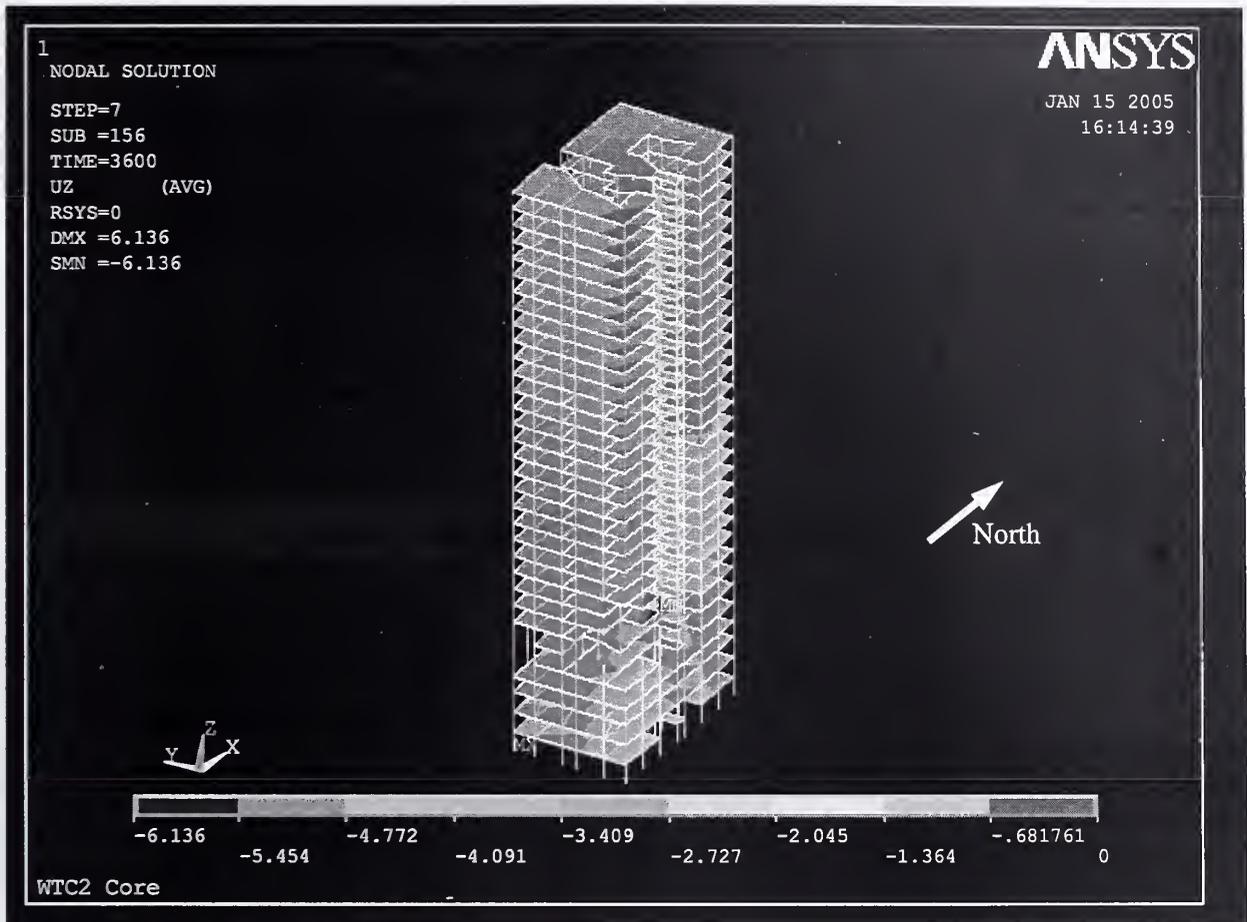
Figure 7-6. Vertical displacement of the WTC 2 core model at 60 min for Case C temperatures (south and east faces).

For both Case C and Case D temperatures, the core structure was weakened at the southeast corner and along the east side of the core. The core structural responses to these two temperature conditions illustrate the slight difference in core weakening by the larger deflection in the southeast corner for Case D, which had more column damage. The WTC 2 response for Case C and Case D temperatures was similar, with a 2 in. increase for Case D. When the results of each isolated core model were compared to the observed behavior of WTC 2, both Cases provided a reasonable match.

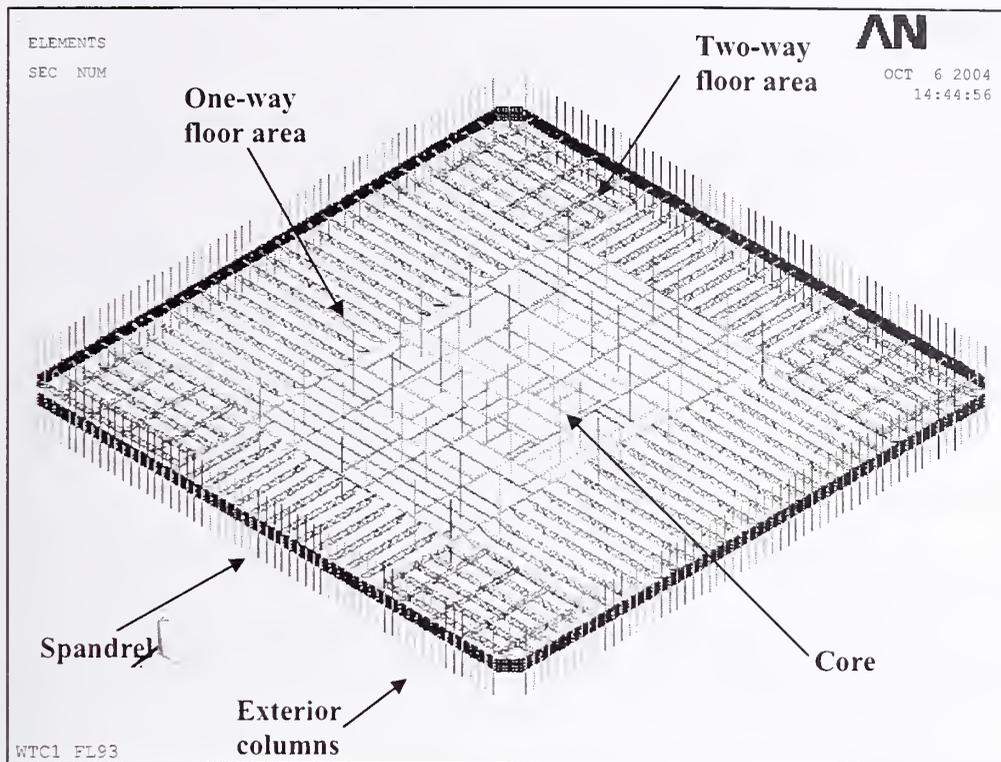
Figure 7-8. Full floor model.

Figure 7–8 shows the full floor model (described in Chapter 4), which included 1) exterior and core columns extending one story below and one story above the floor model, 2) spandrels, 3) floor slab, 4) floor trusses (bridging trusses were retained only in the two-way floor areas), 5) strap anchors, 6) core beams, 7) deck support angles, and 8) break elements to capture failure modes. Both core and exterior columns were fixed against vertical movement at the lower ends and free to displace at the upper ends. Exterior columns were restrained from out of plane displacement and all three components of rotation at the both column ends. The core columns were free to displace horizontally. Note that the two-way zones shown in Fig. 7–8 extended only to the corners of the core rather than beyond the corners as shown in Fig. 4–7. The extent of two-way action shown in Fig. 7–8 was believed to better represent actual structural boundary conditions.

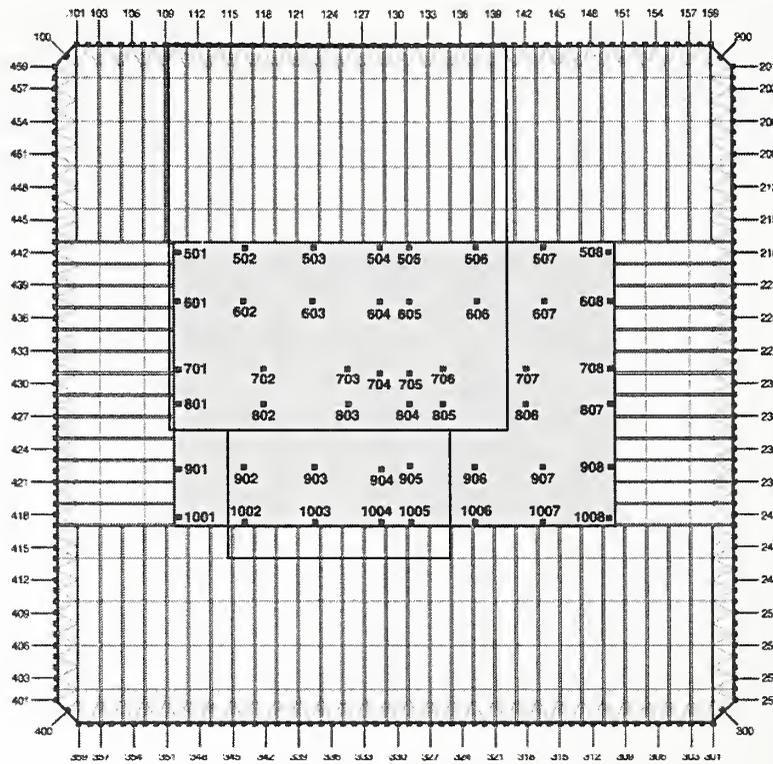
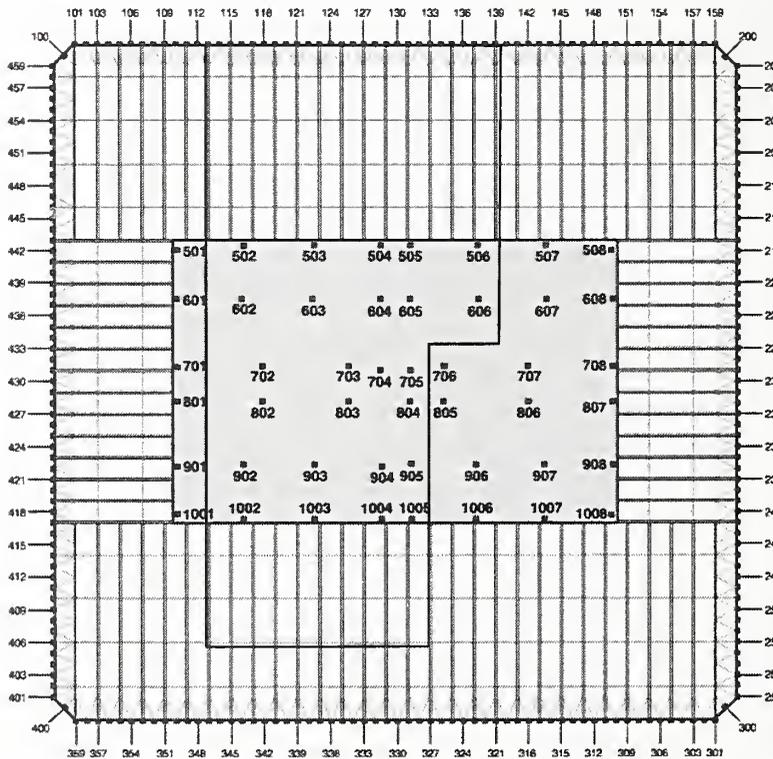
Figure 7-9. Fireproofing damage to WTC 1 Floor 97 for Case A<sub>i</sub> and Case A.

For WTC 1, only Floor 97 showed a significant increase in damage to truss fireproofing on the south side between Case A<sub>i</sub> and Case A, where the fireproofing damage over 11 trusses increased from just beyond the core to two thirds of the floor span, as shown in Fig. 7–9. Figure 7–10 shows the temperature distributions for WTC 1 Floor 97 trusses for Case A<sub>i</sub> and Case A. Analysis of Floor 97 for Case A damage and temperature histories showed little difference in the floor behavior. Case B<sub>i</sub> and Case B structural and fireproofing damage were similar for all floors.

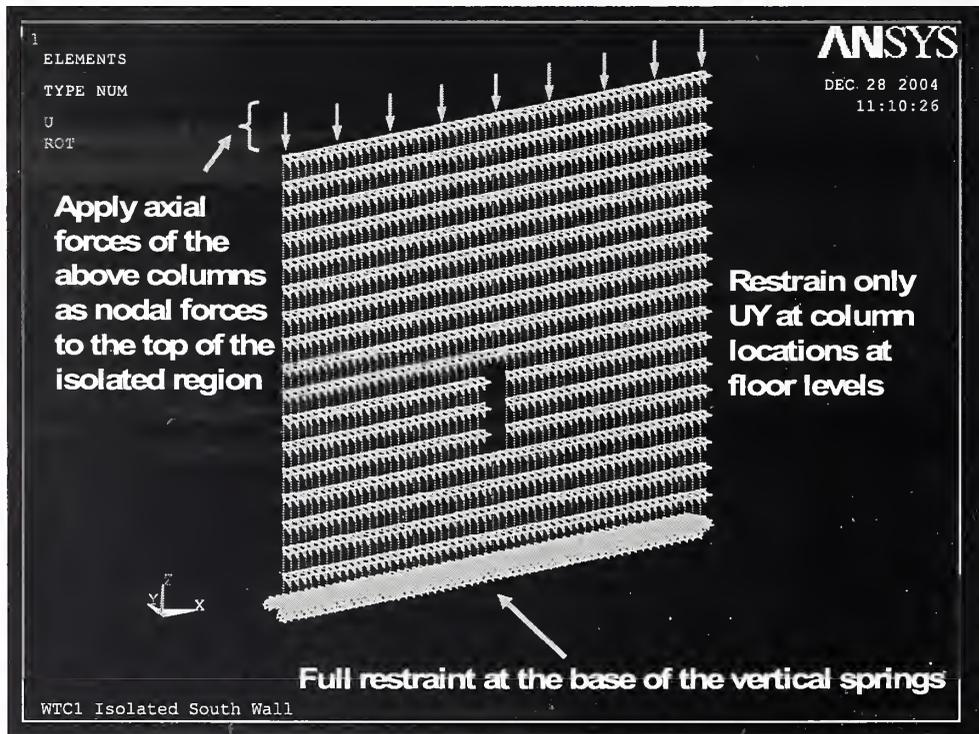
Figure 7–29. Boundary conditions applied on the isolated exterior wall segment.

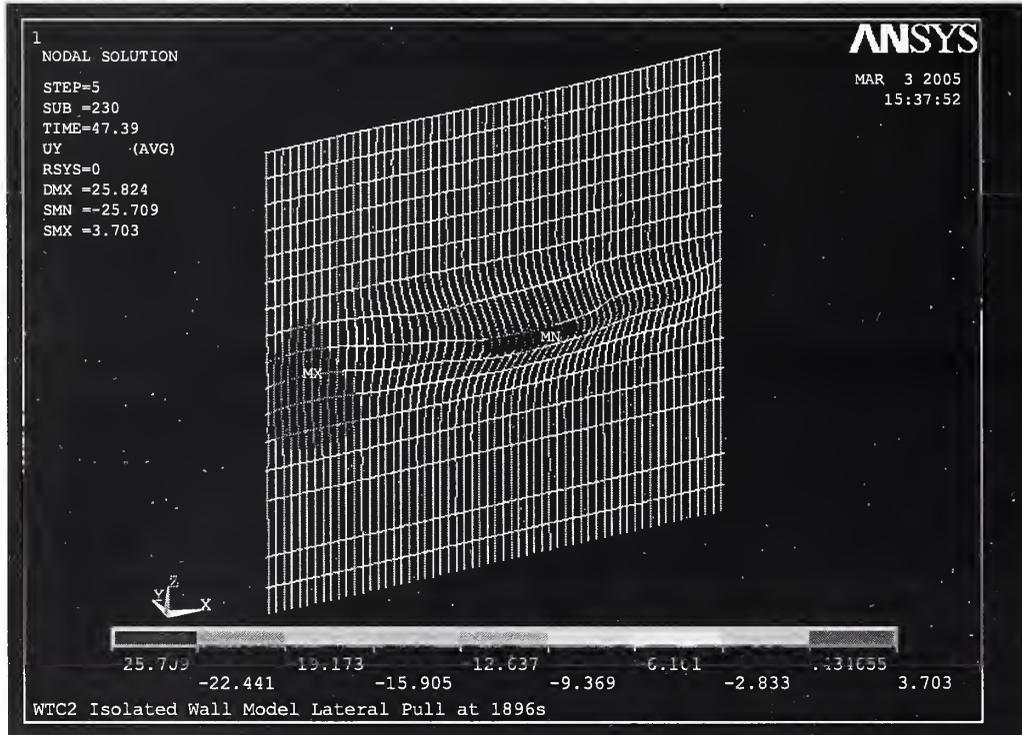
Figure 7–33. Out-of-plane displacements of the WTC 2 east wall calculated with 0.5 kip pull-in force with uniform magnitude distribution at 32 min.

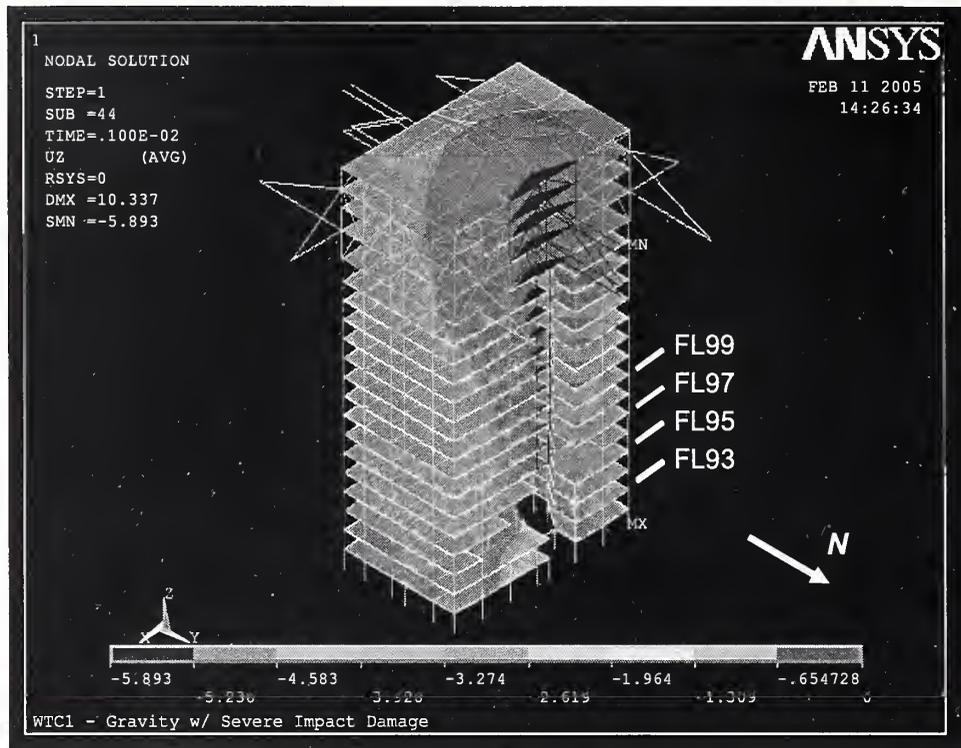
**Figure 8–8. Vertical displacement of the east and north side of the WTC 1 core after aircraft impact for Case B.**

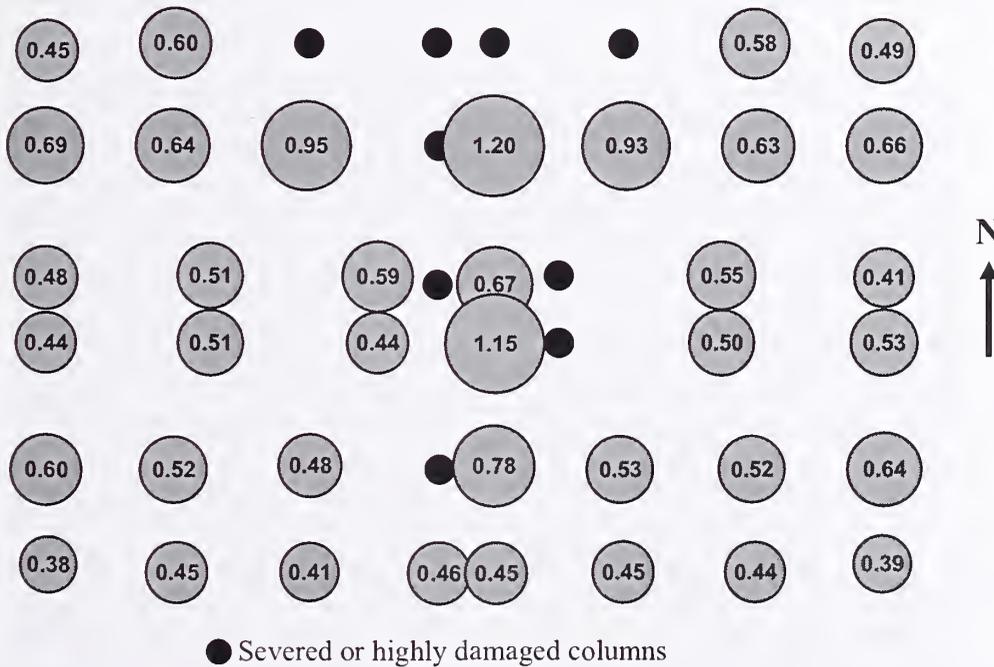
Figure 8-10. Maximum demand-to-capacity ratio for axial force in core columns between Floor 93 and Floor 99 of WTC 1 after aircraft impact for Case B.

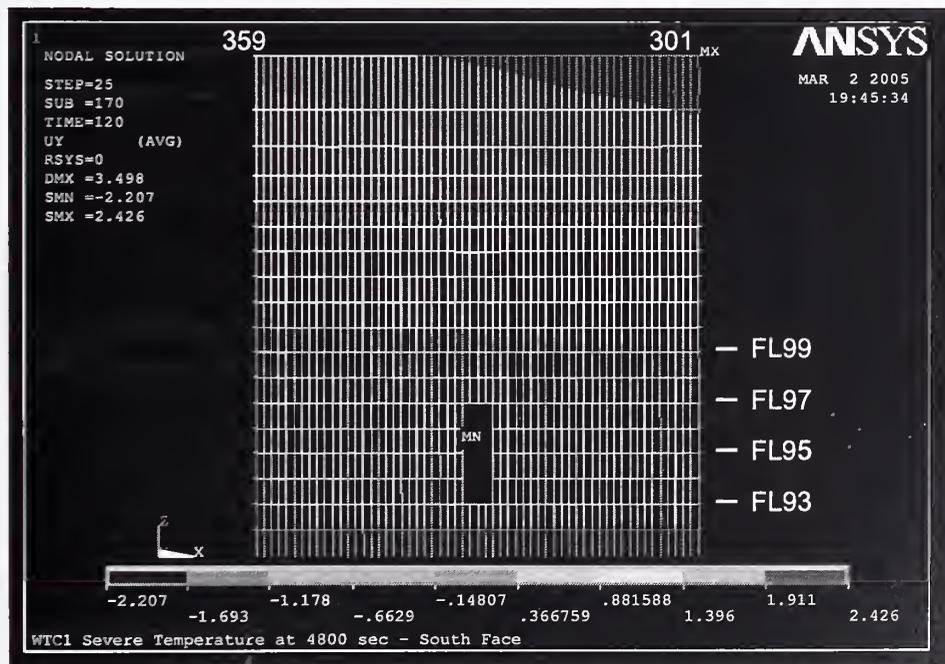
Figure 8–11. Out-of-plane displacement of south wall of WTC 1 at 80 min for Case B.

The full floor analyses for WTC 1 Case B showed that the floors on the south side in the impact zone did not begin to sag and apply a pull-in force at the column connections until approximately 80 min after impact. Based upon the full floor and isolated south wall subsystem analyses, 5 kip of pull-in force was applied to all columns across Floors 95 to 99 beginning at 80 min, as shown in Fig. 7–30. Figures 8–11 and 8–12 show the out-of-plane displacement contours of the south wall at 80 min and 100 min, respectively. Figure 8–13 shows the time history of the inward bowing of the south wall. Until the 5 kip pull-in forces were applied, no inward bowing had occurred. With the application of the 5 kip pull-in force, the maximum inward bow increased to 15.5 in.

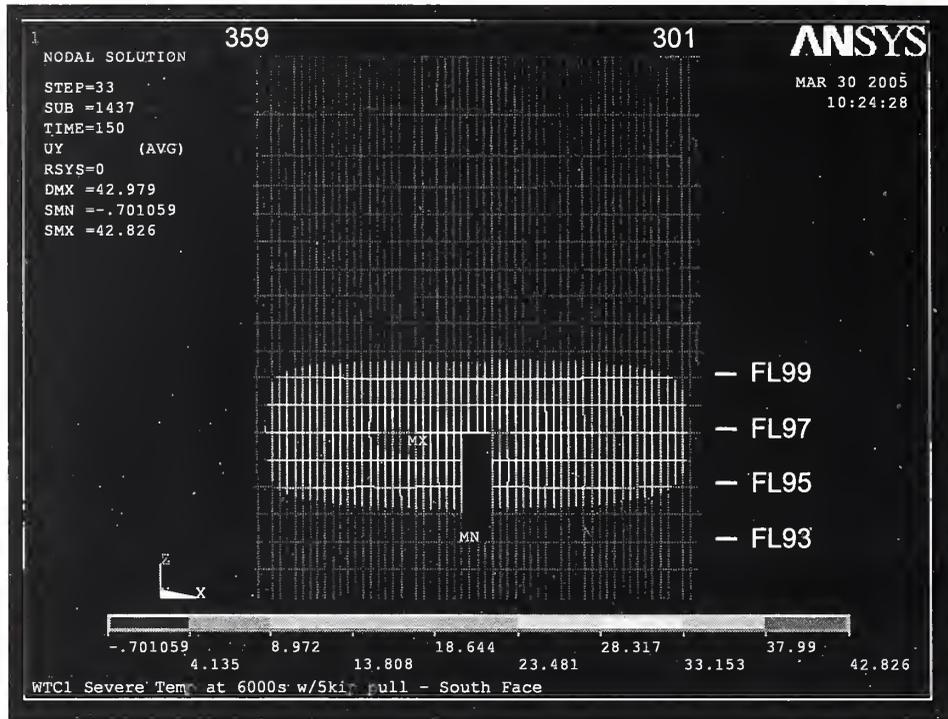
Figure 8–12. Out-of-plane displacement of south wall of WTC 1 at 100 min for Case B conditions with 5 kip pull-in forces.

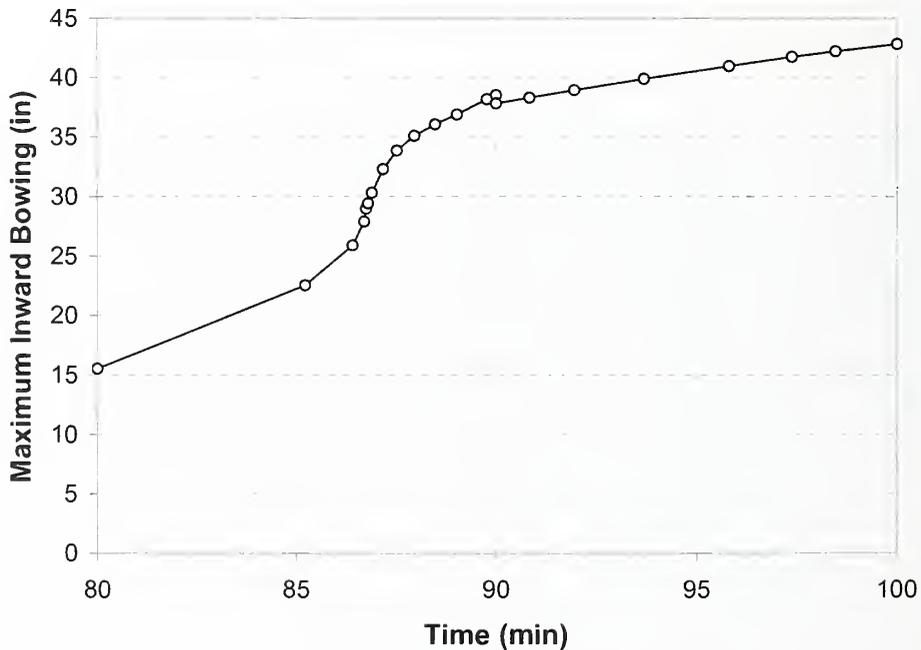
Figure 8–13. Time history of maximum out-of-plane displacement of WTC 1 south wall for Case B with 5 kip pull-in forces.

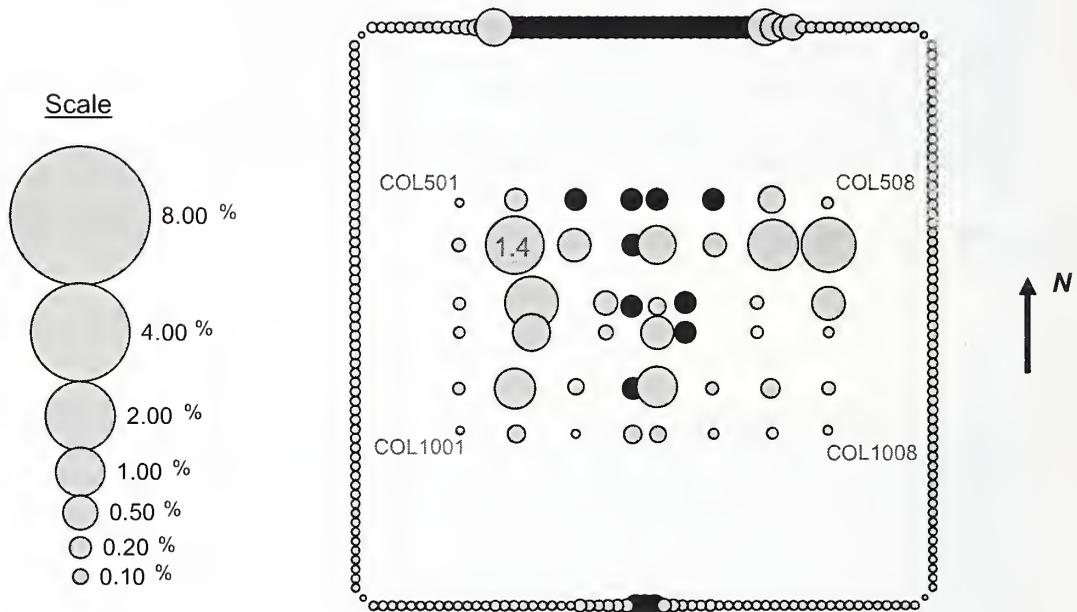
**Figure 8-19. Maximum elastic-plus-plastic-plus-creep strain for columns between Floor 93 and Floor 99 of WTC 1 at 10 min for Case B (strain values are in percent).**

highly damaged columns experienced plastic strains. Plastic strain of the core increased for the first 40 min, and then remained almost constant to 100 min. Plastic strain of the south exterior columns increased in almost all the bowed columns from 40 min to 100 min. However, creep strain was found to be far greater than plastic strain, especially in the core. At 40 min, 22 of 47 core columns had creep strain larger than 1.0 percent. After 40 min, creep strain in core columns on the south side had increased. The maximum elastic-plus-plastic-plus-creep strain at 100 min was 7.3 percent in Column 1006. As temperature increased on the south exterior wall in the later stages of the fire, creep strain also increased in about 20 columns on the south face. The maximum elastic-plus-plastic-plus-creep strain in the south exterior columns reached 2.9 percent.

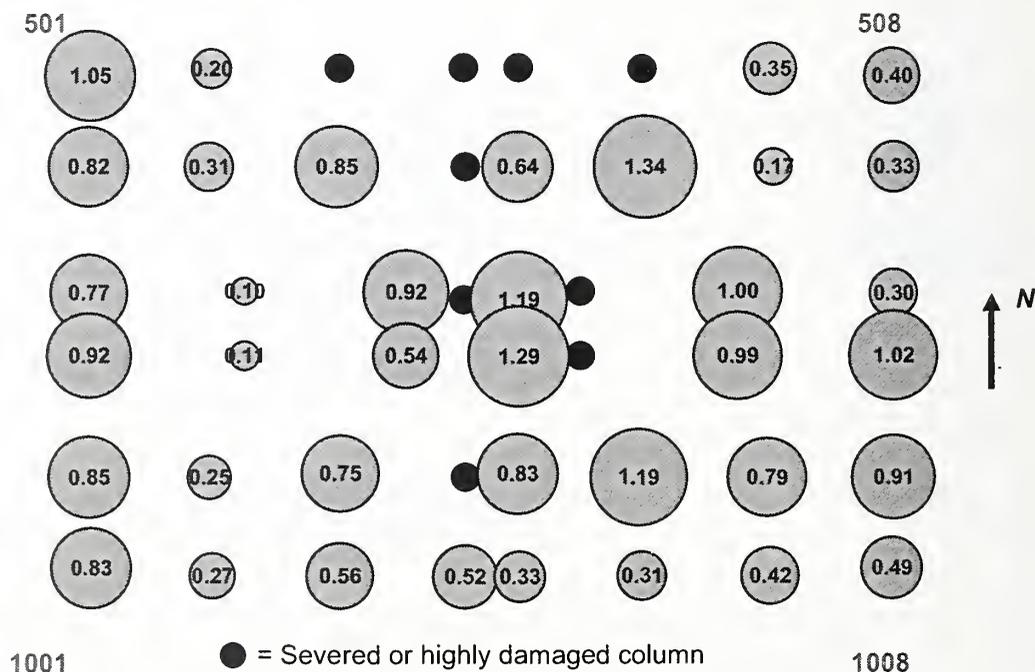
Figure 8–22. Maximum demand-to-capacity ratio for axial force in core columns between Floor 93 and Floor 99 of WTC 1 at 80 min for Case B conditions.

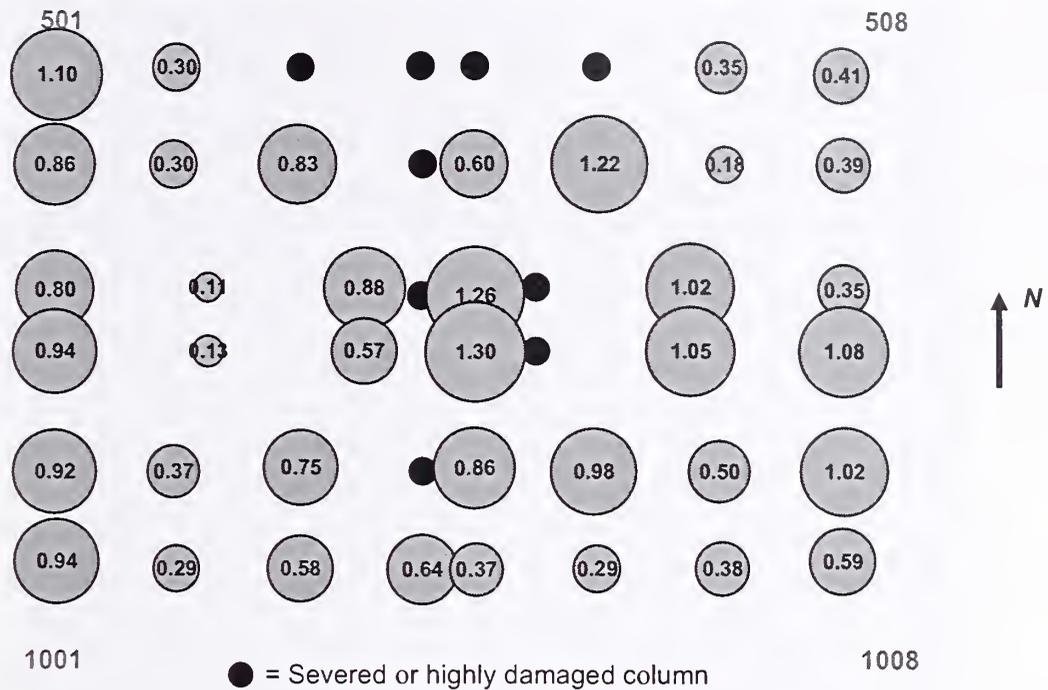
Figure 8–23. Maximum demand-to-capacity ratio for axial force in core columns between Floor 93 and Floor 99 of WTC 1 at 100 min for Case B with 5 kip pull-in forces.

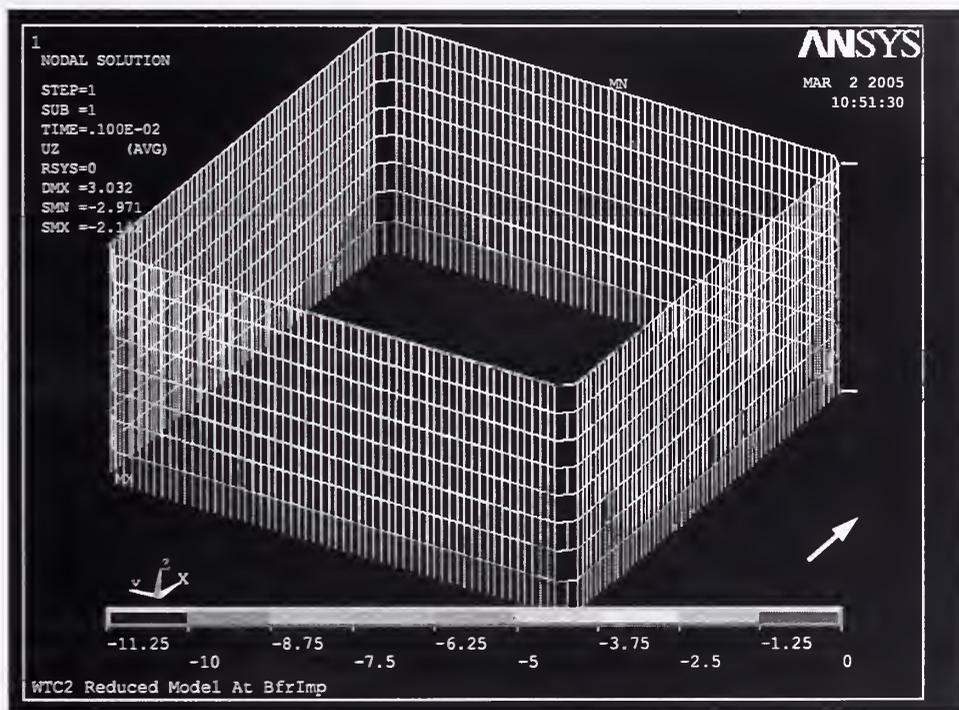
Figure 8–26. Vertical displacement before impact of WTC 2 exterior wall for Case D.

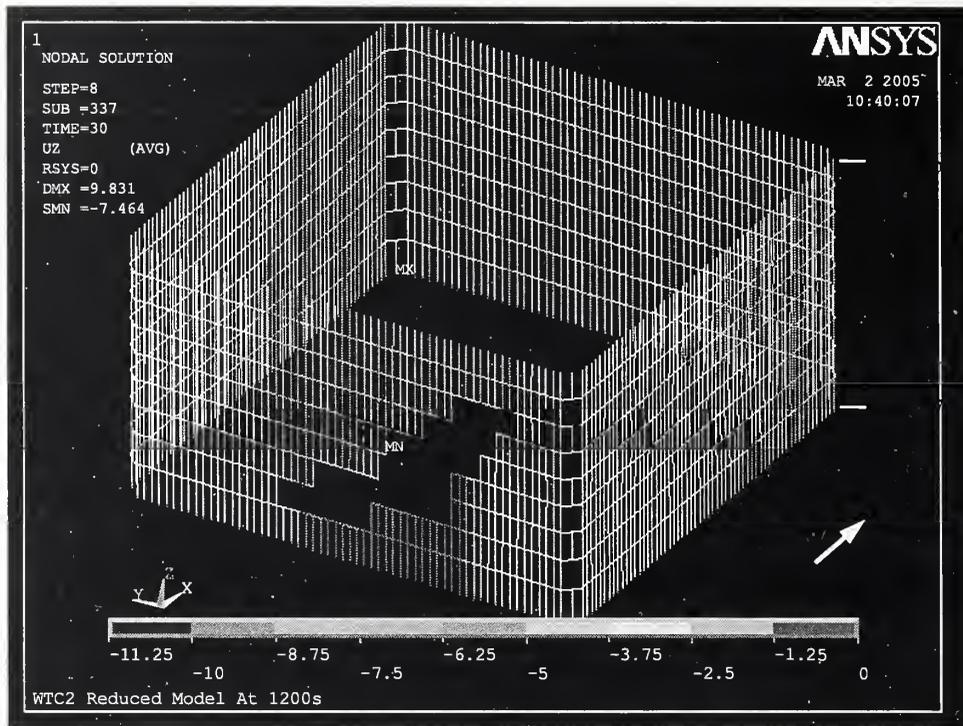
Figure 8–34. Vertical displacement of exterior wall of WTC 2 at 20 min for Case D.

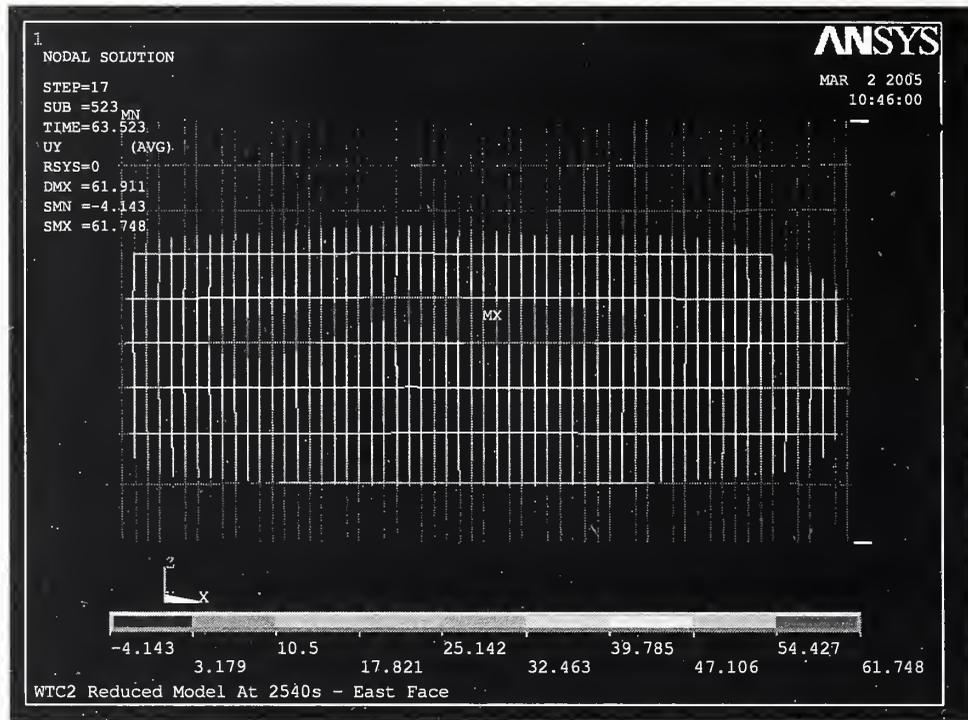
Figure 8–39. Out-of-plane displacement of the east wall of WTC 2 at 43 min for Case D.

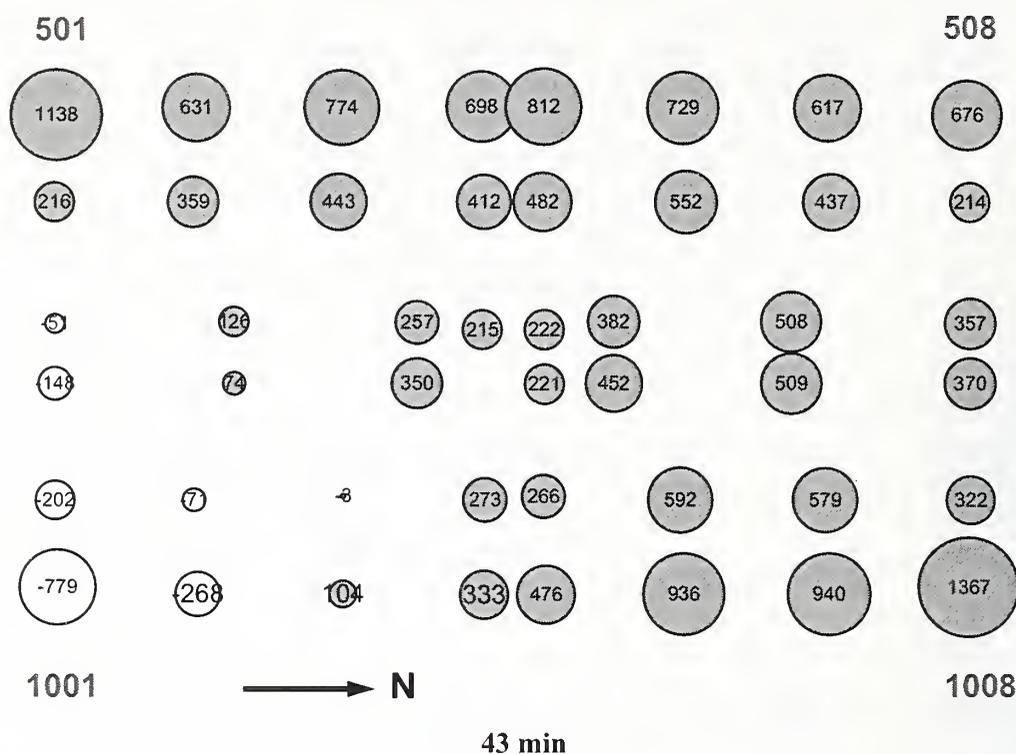
**Figure 8–56. Axial force in core columns (kip) at Floor 105 (at hat truss level) of WTC 2 for Case D conditions (compression is positive).**

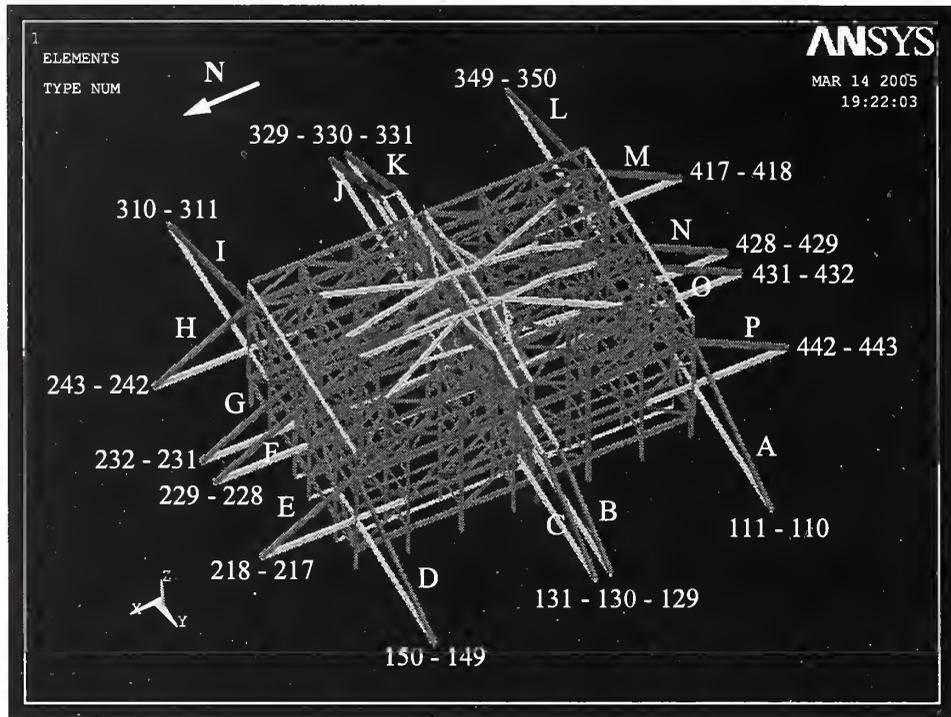
Figure 8-58. Location and IDs of outriggers and supporting columns

In the global analyses, splice failures were not included in the super-element, which remained elastic throughout the analysis. However, based upon the analyses discussed below, it was concluded that the inclusion of splice failures would not have significantly affected the load redistribution in the global analysis. The core floors would have redistributed the loads in the failed columns to adjacent core columns, as occurred for columns with failed splice connections in the impact area. The adjacent columns would have then transferred the loads to the hat truss.

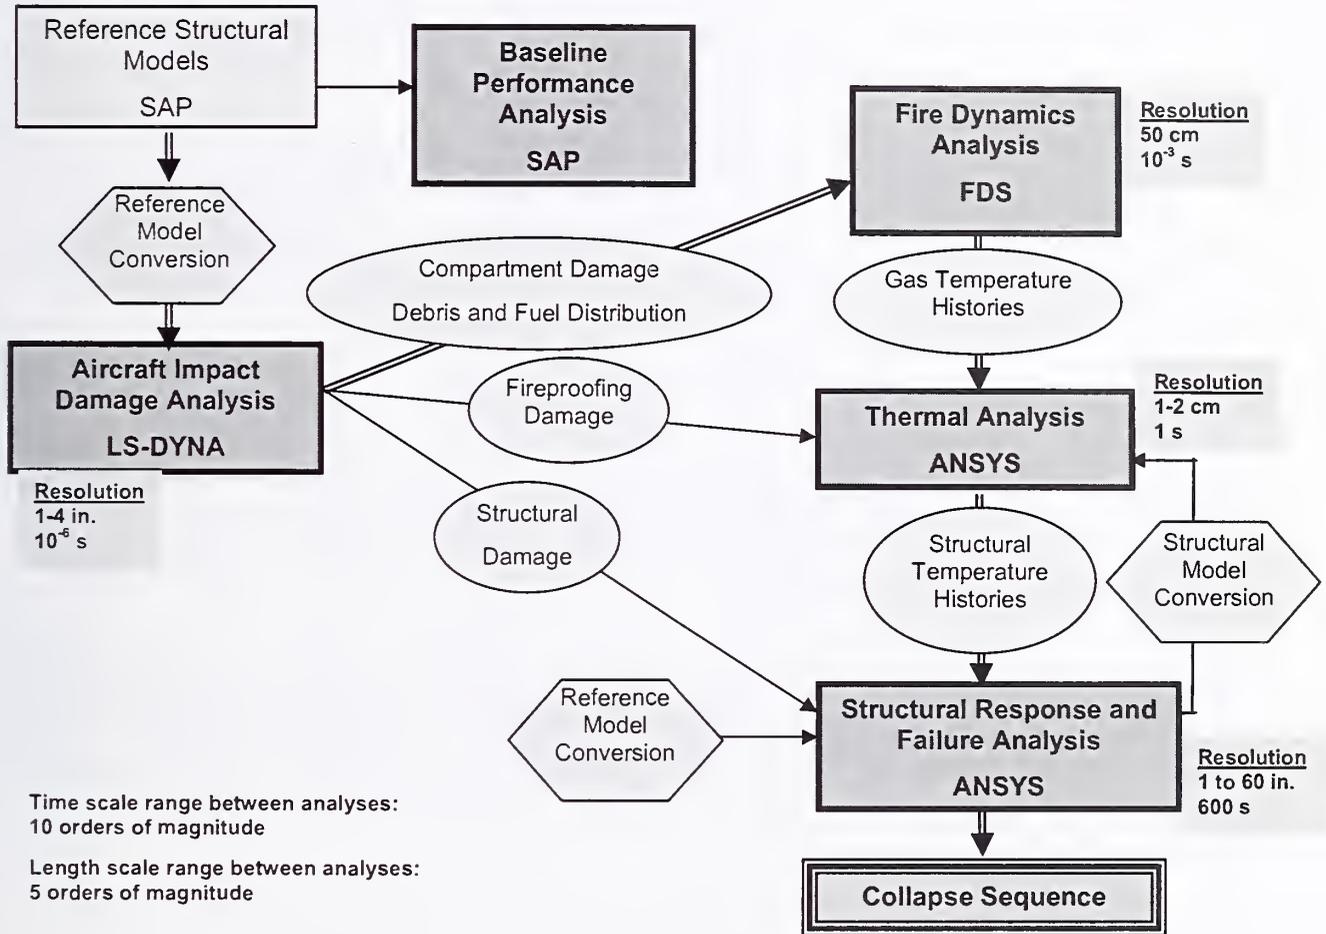
Figure 9-1. Critical analysis inter-dependencies.

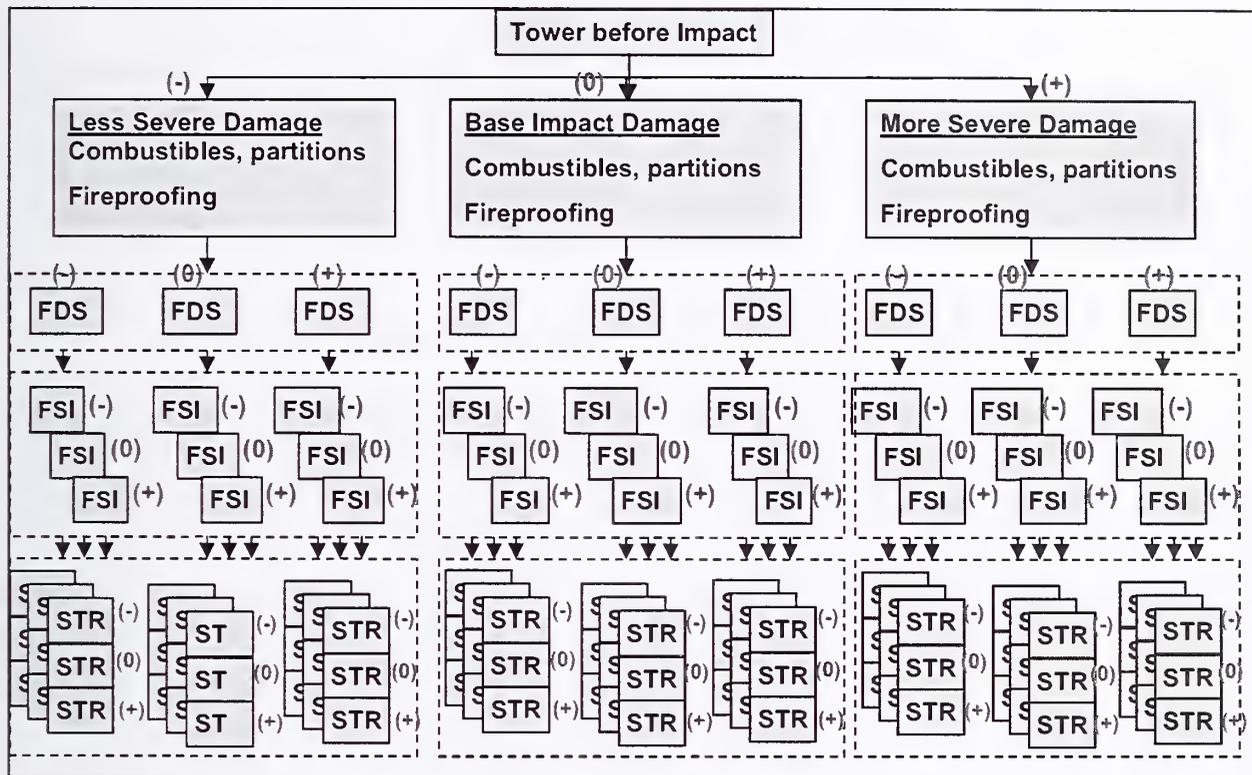
Figure 9-2. Full analysis tree for influential parameter effects.

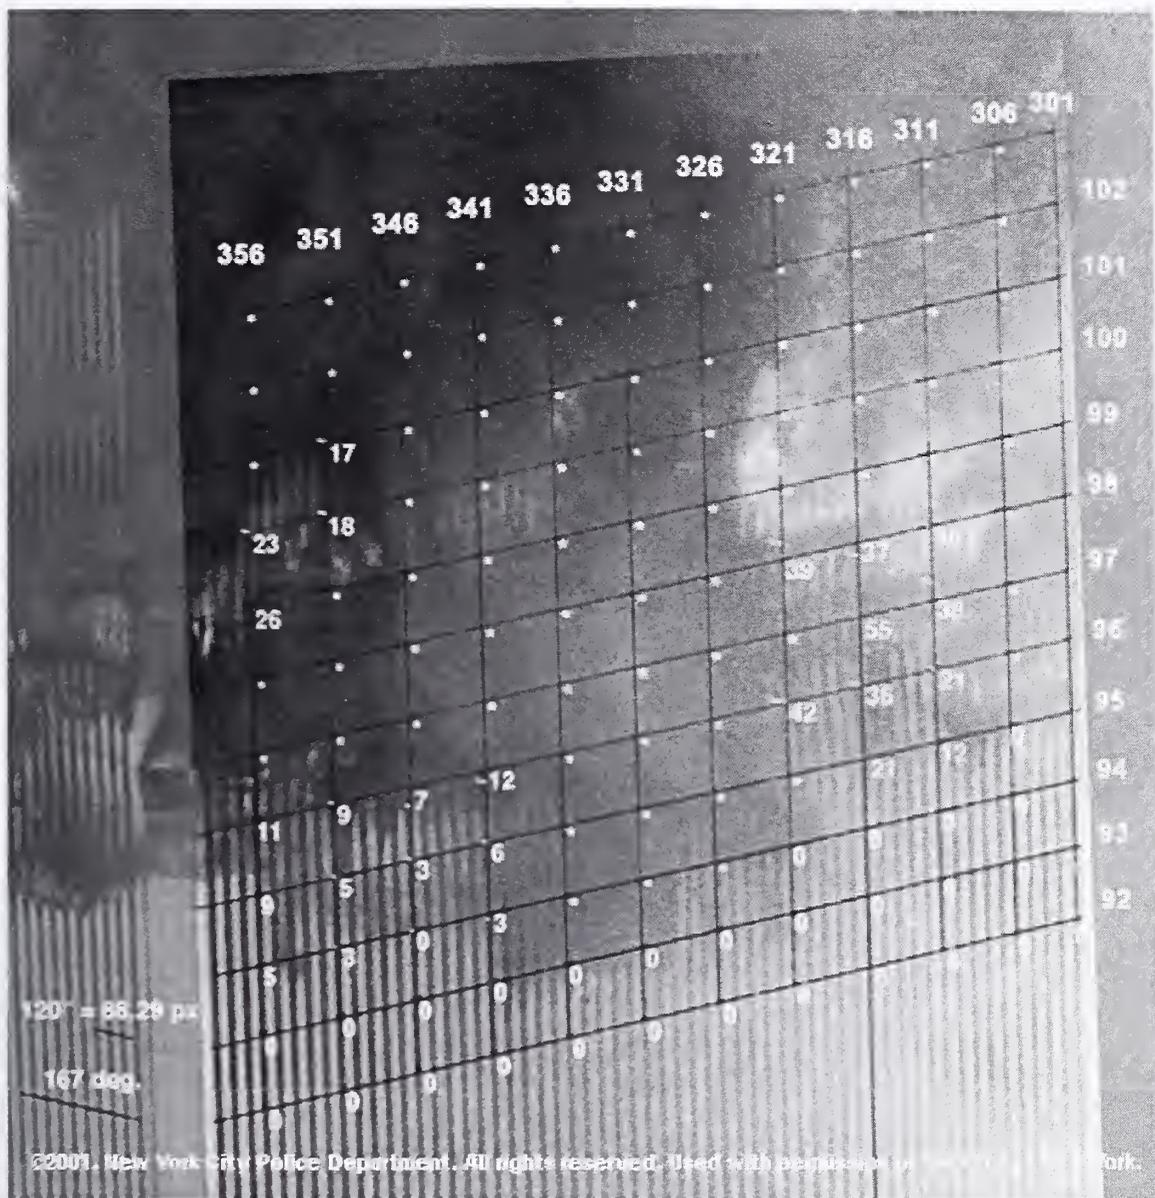
Figure 9-11. Inward bowing of the WTC 1 south wall of WTC 1 at 10:23 a.m.

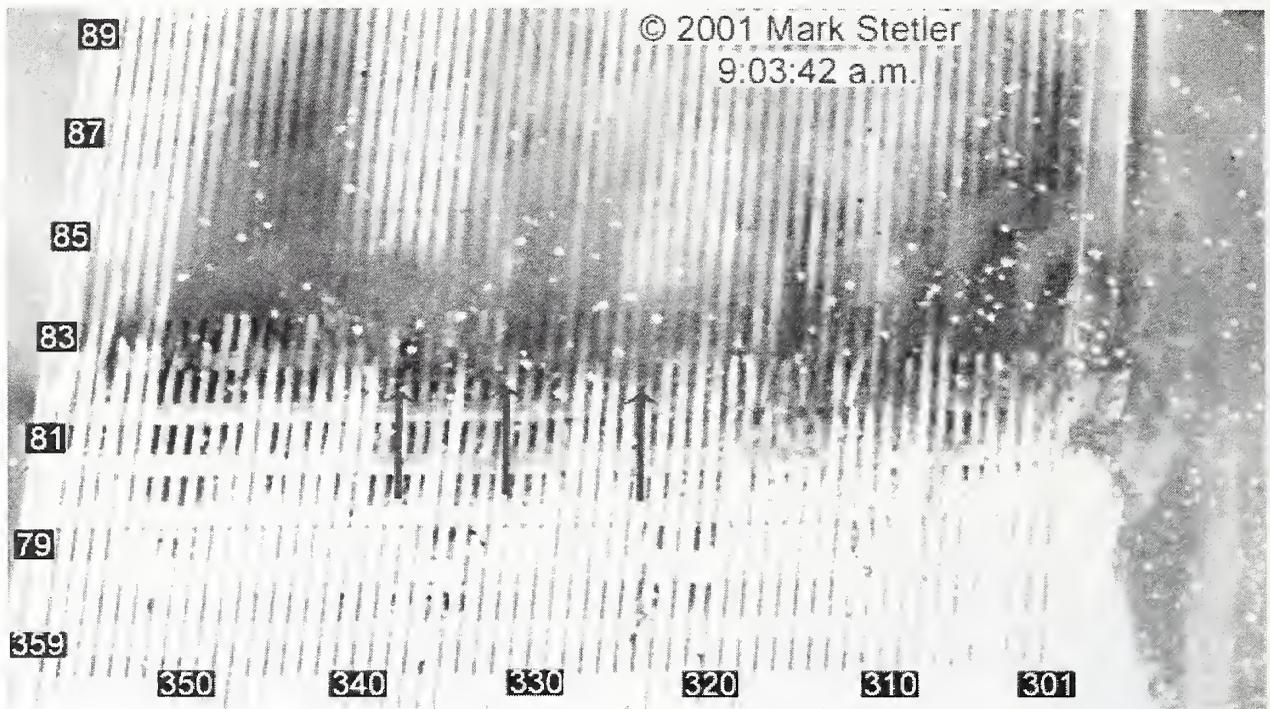
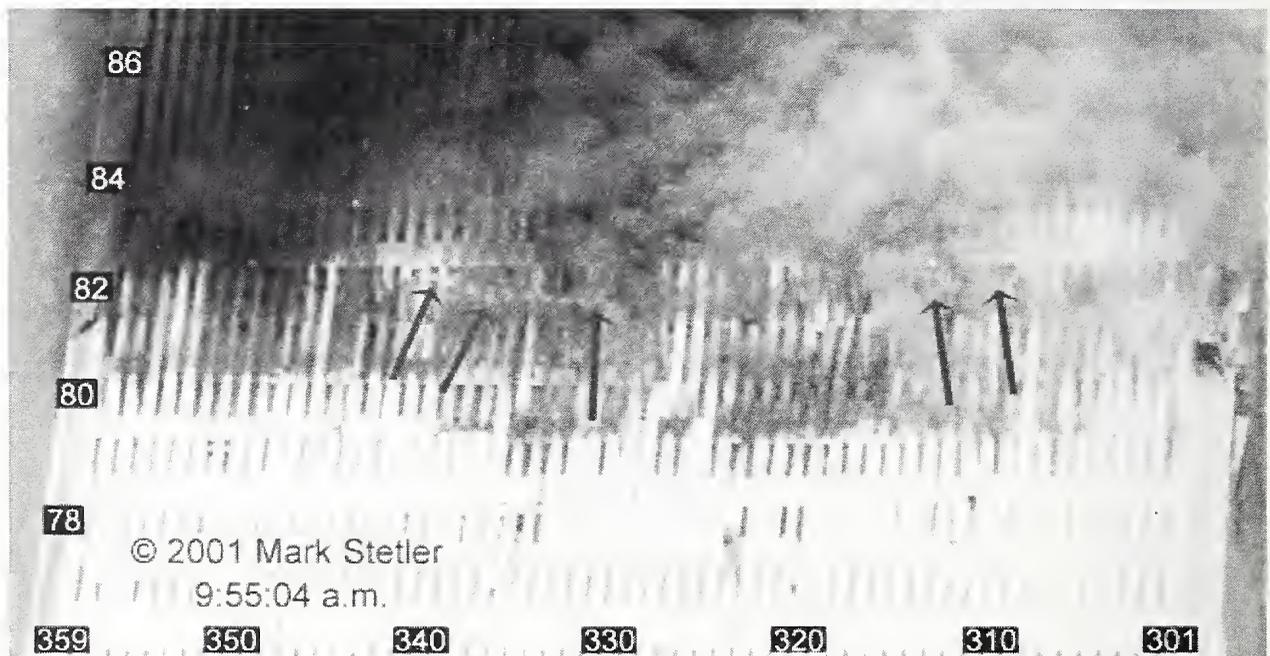
After impact damage

Damage a few minutes before collapse

Figure 9–16. Floor sagging observed on the east wall of WTC 2 at different stages.
