NIST NCSTAR 1-6

Federal Building and Fire Safety Investigation of  
the World Trade Center Disaster

# Structural Fire Response and Probable Collapse Sequence of the World Trade Center Towers

(Chapter 7- Appendix B)

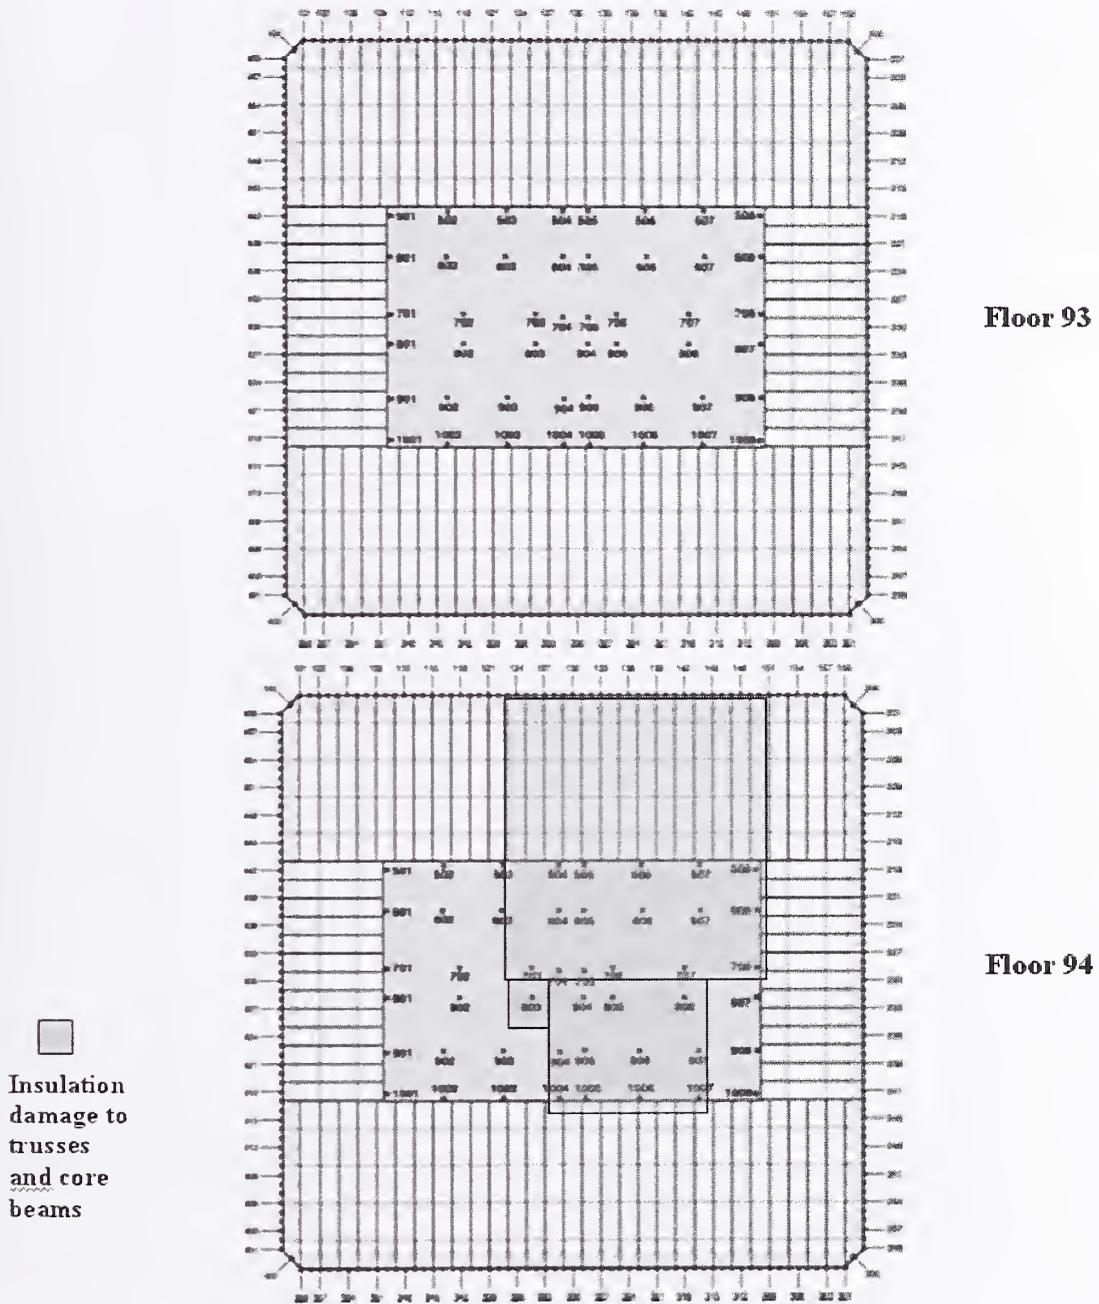
Figure A-1. WTC 1 Case A<sub>i</sub> aircraft impact damage to Structural Floor 93 and 94.

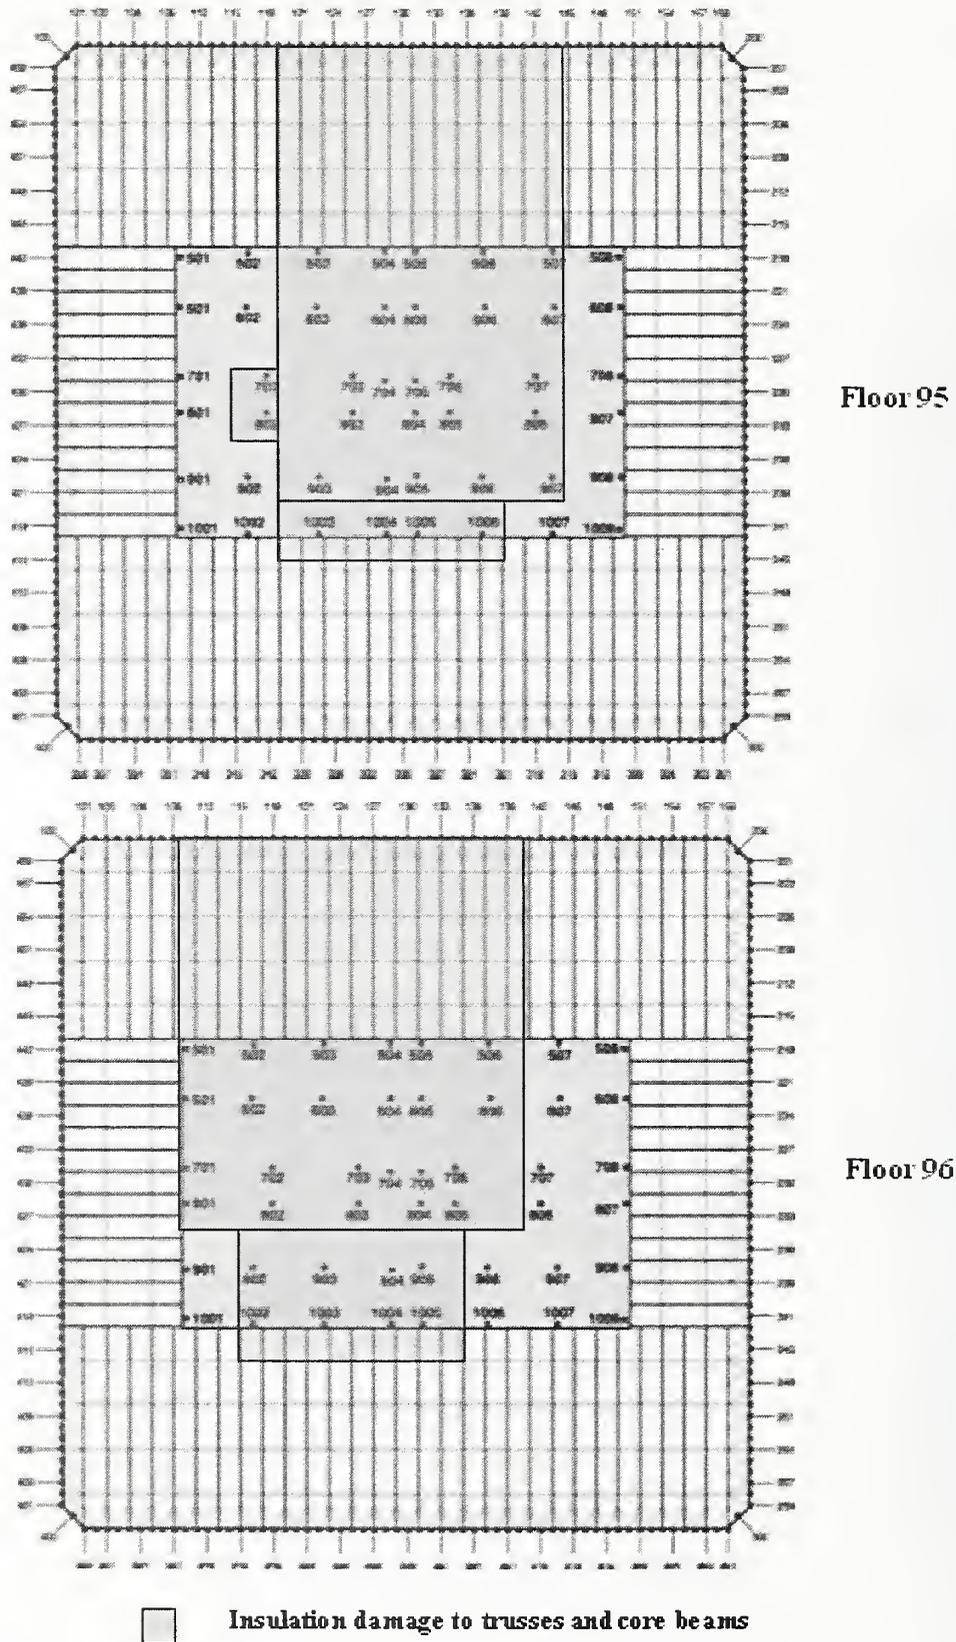
Figure A-2. WTC 1 Case A<sub>1</sub> aircraft impact damage to Structural Floors 95 and 96.

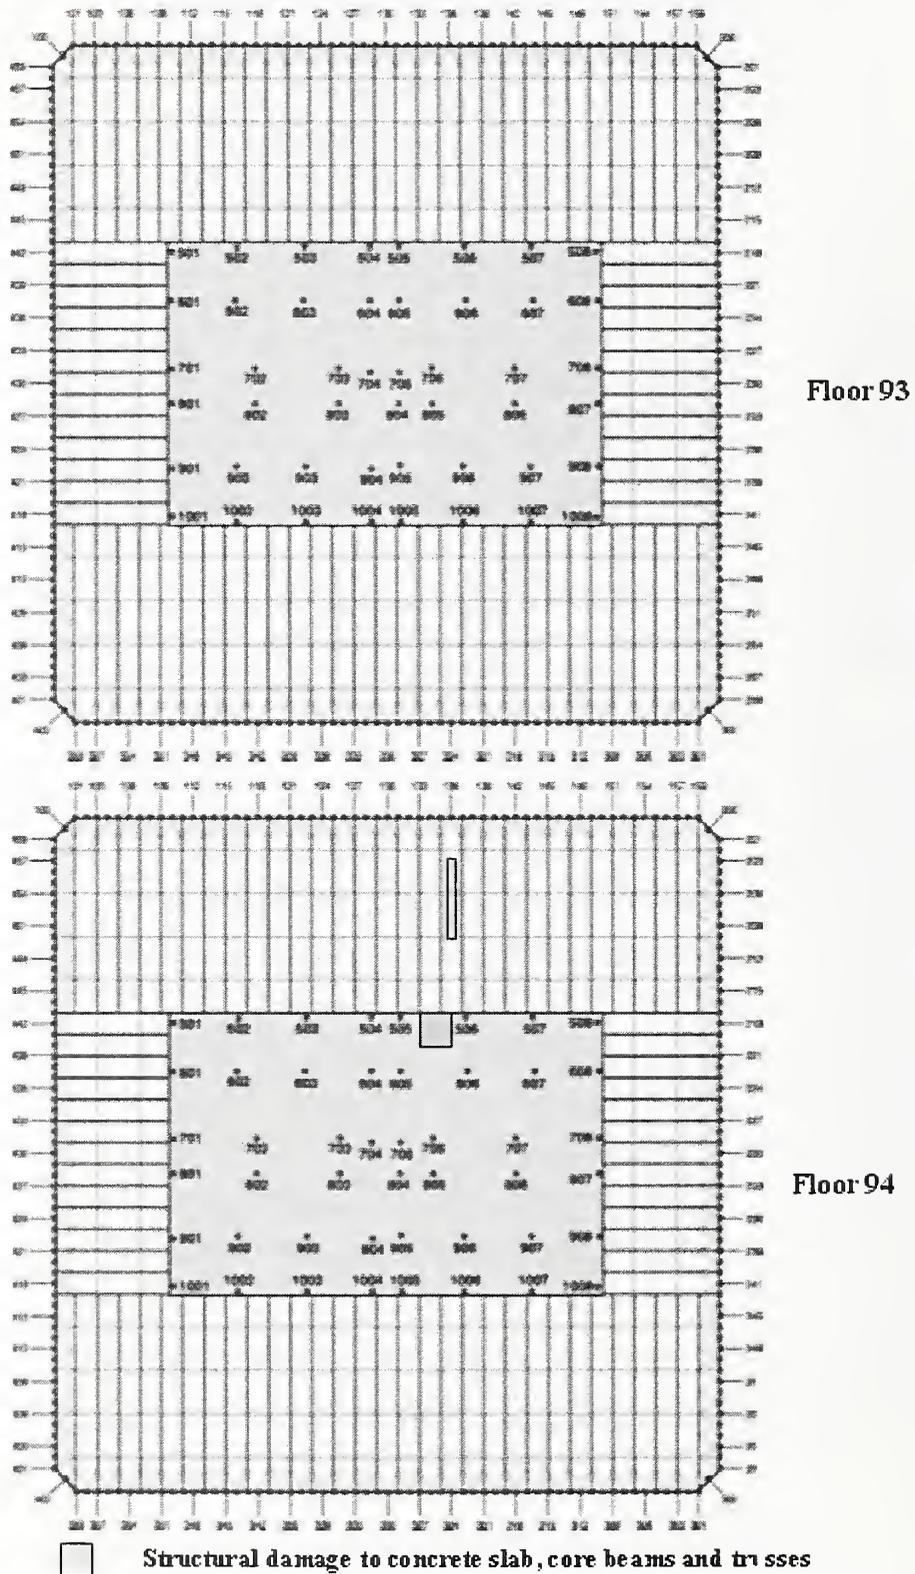
Figure A-4. WTC 1 Case A<sub>1</sub> aircraft impact damage to Structural Floor 93 and 94.

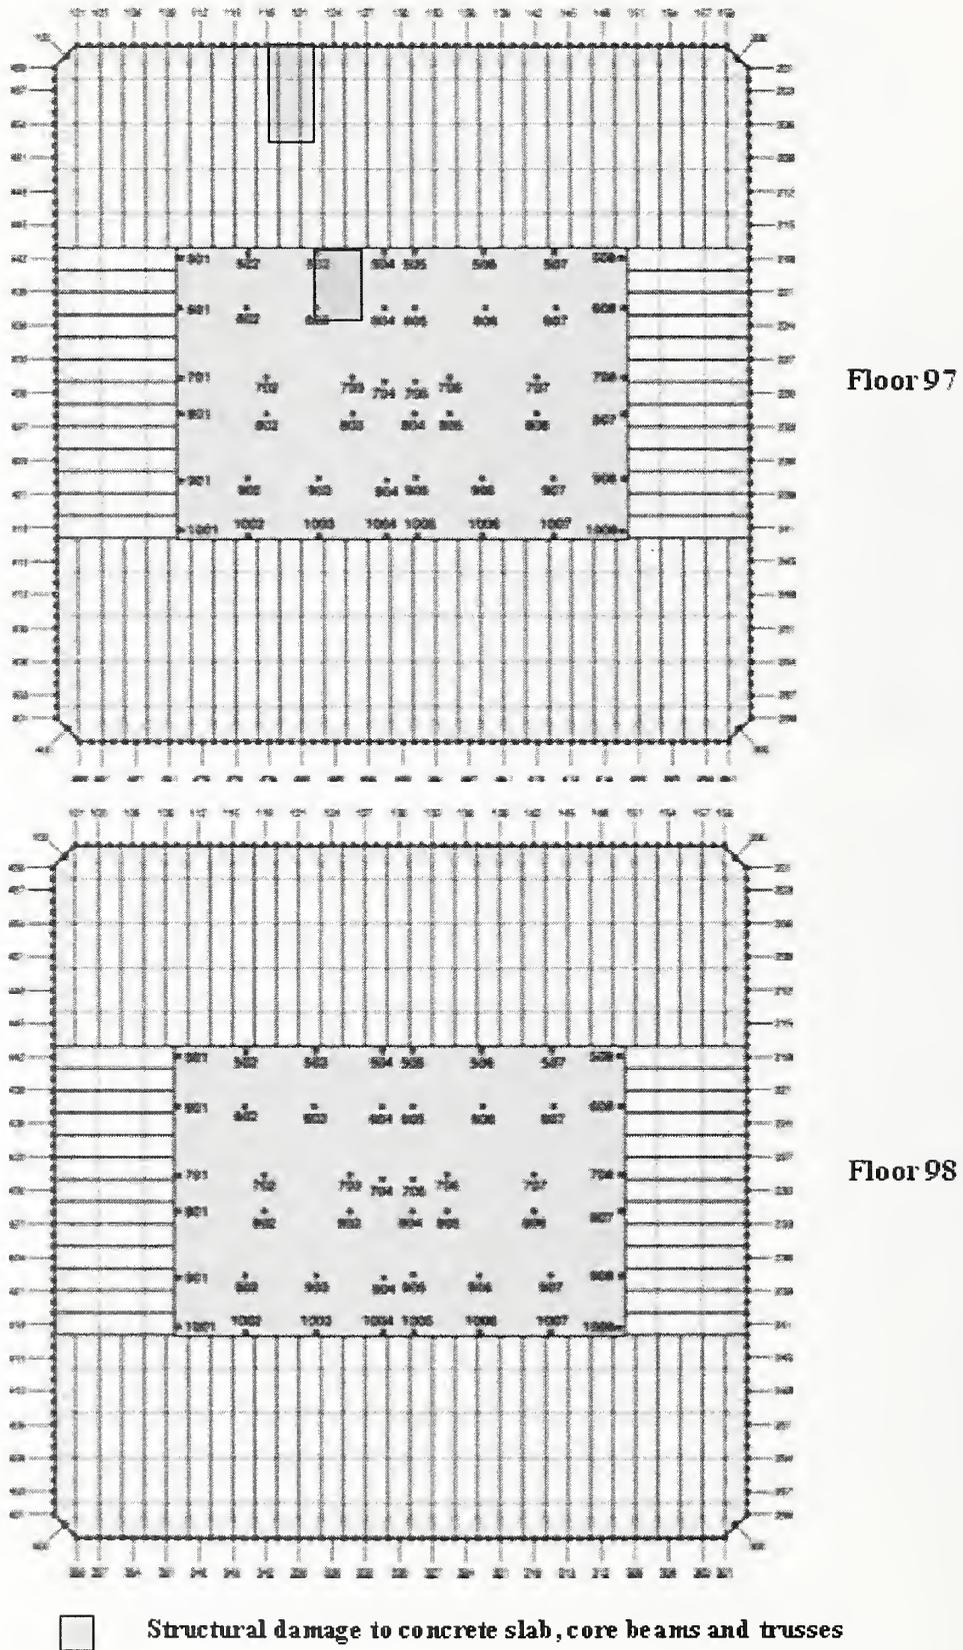
Figure A-6. WTC 1 Case A; aircraft impact damage to Structural Floors 97 and 98.

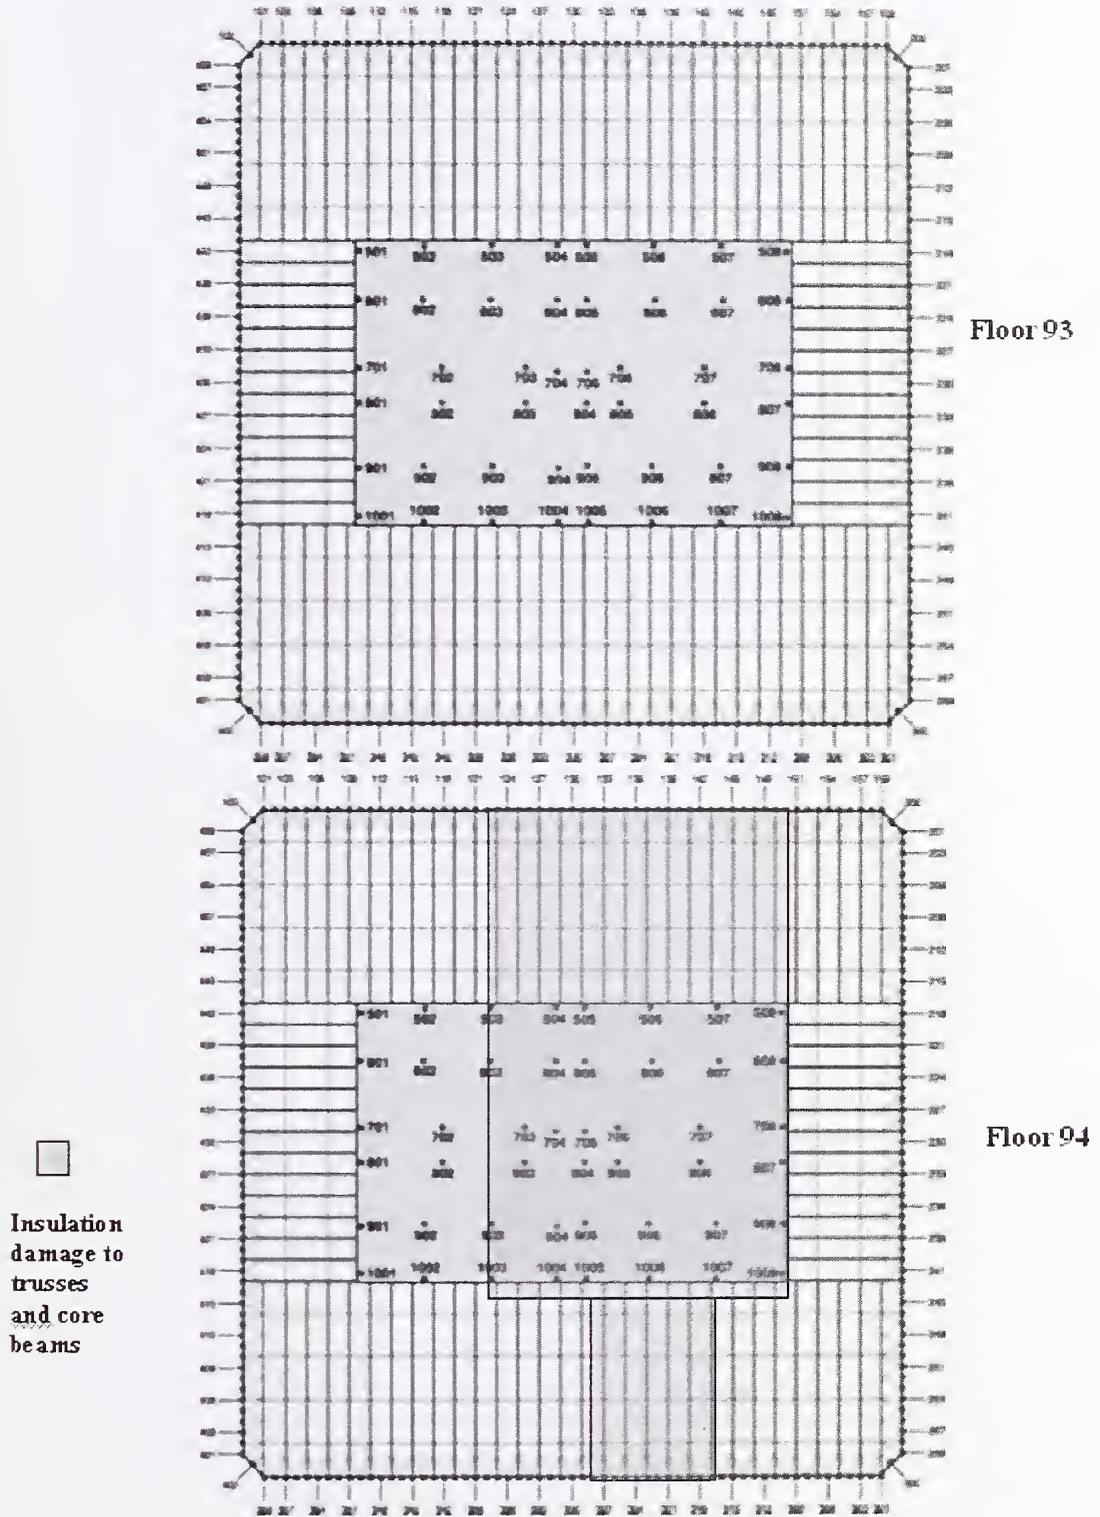
Figure A-7. WTC 1 Case B<sub>1</sub> aircraft impact damage to Structural Floor 93 and 94.

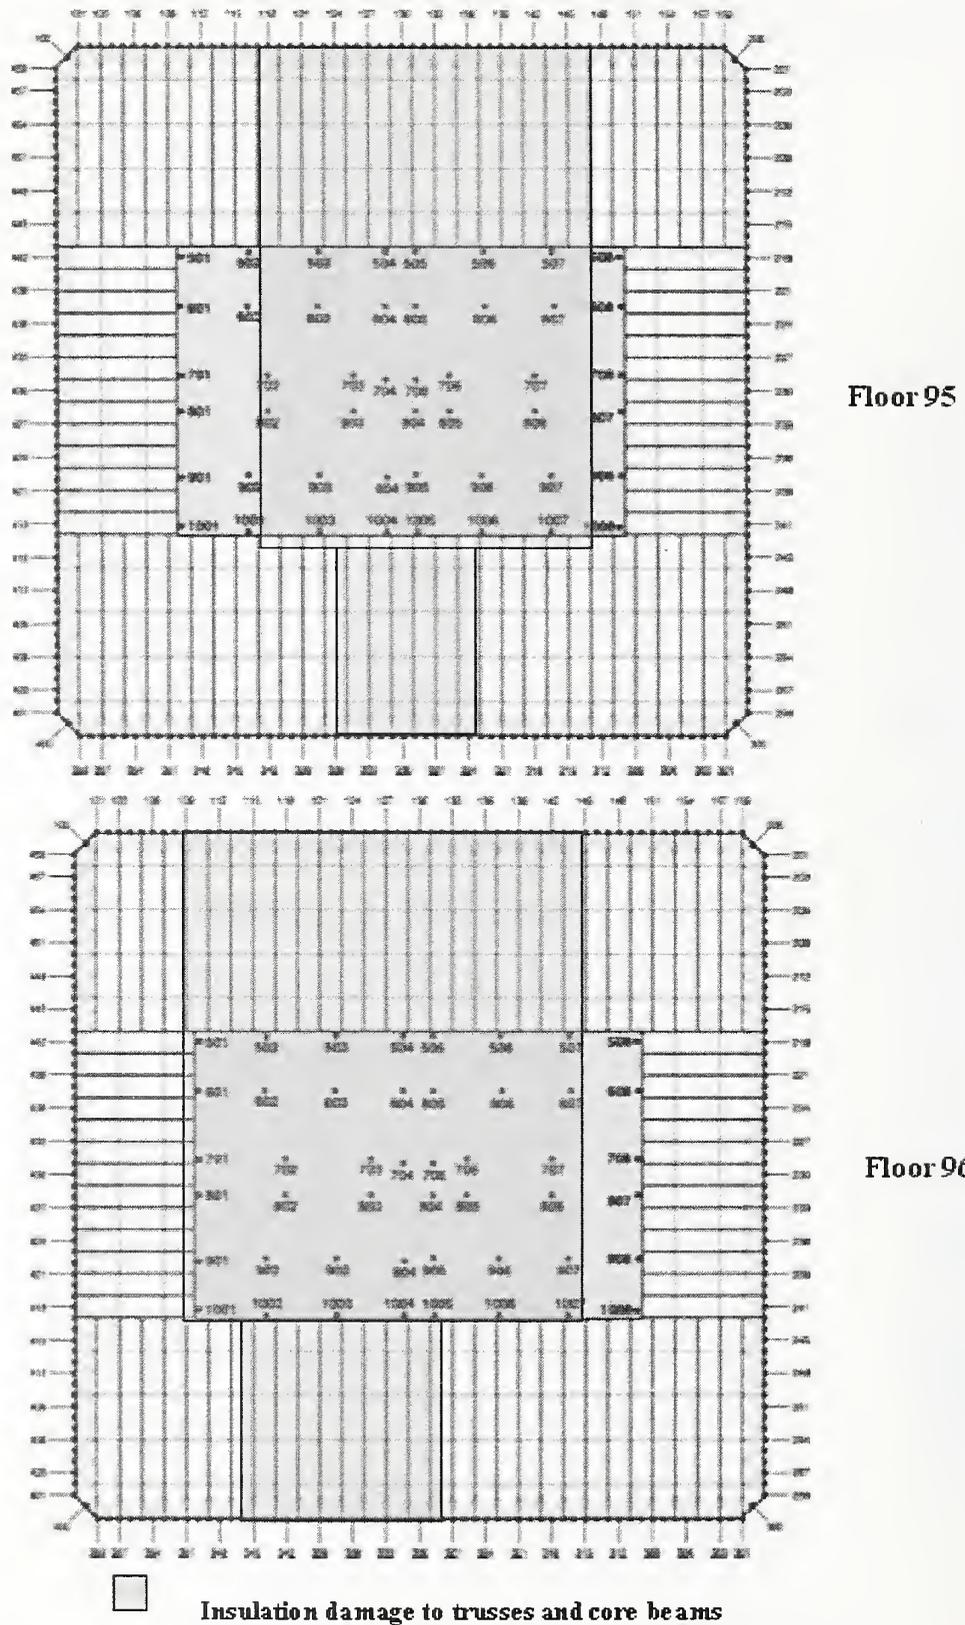
Figure A-8. WTC 1 Case B<sub>1</sub> aircraft impact damage to Structural Floors 95 and 96.

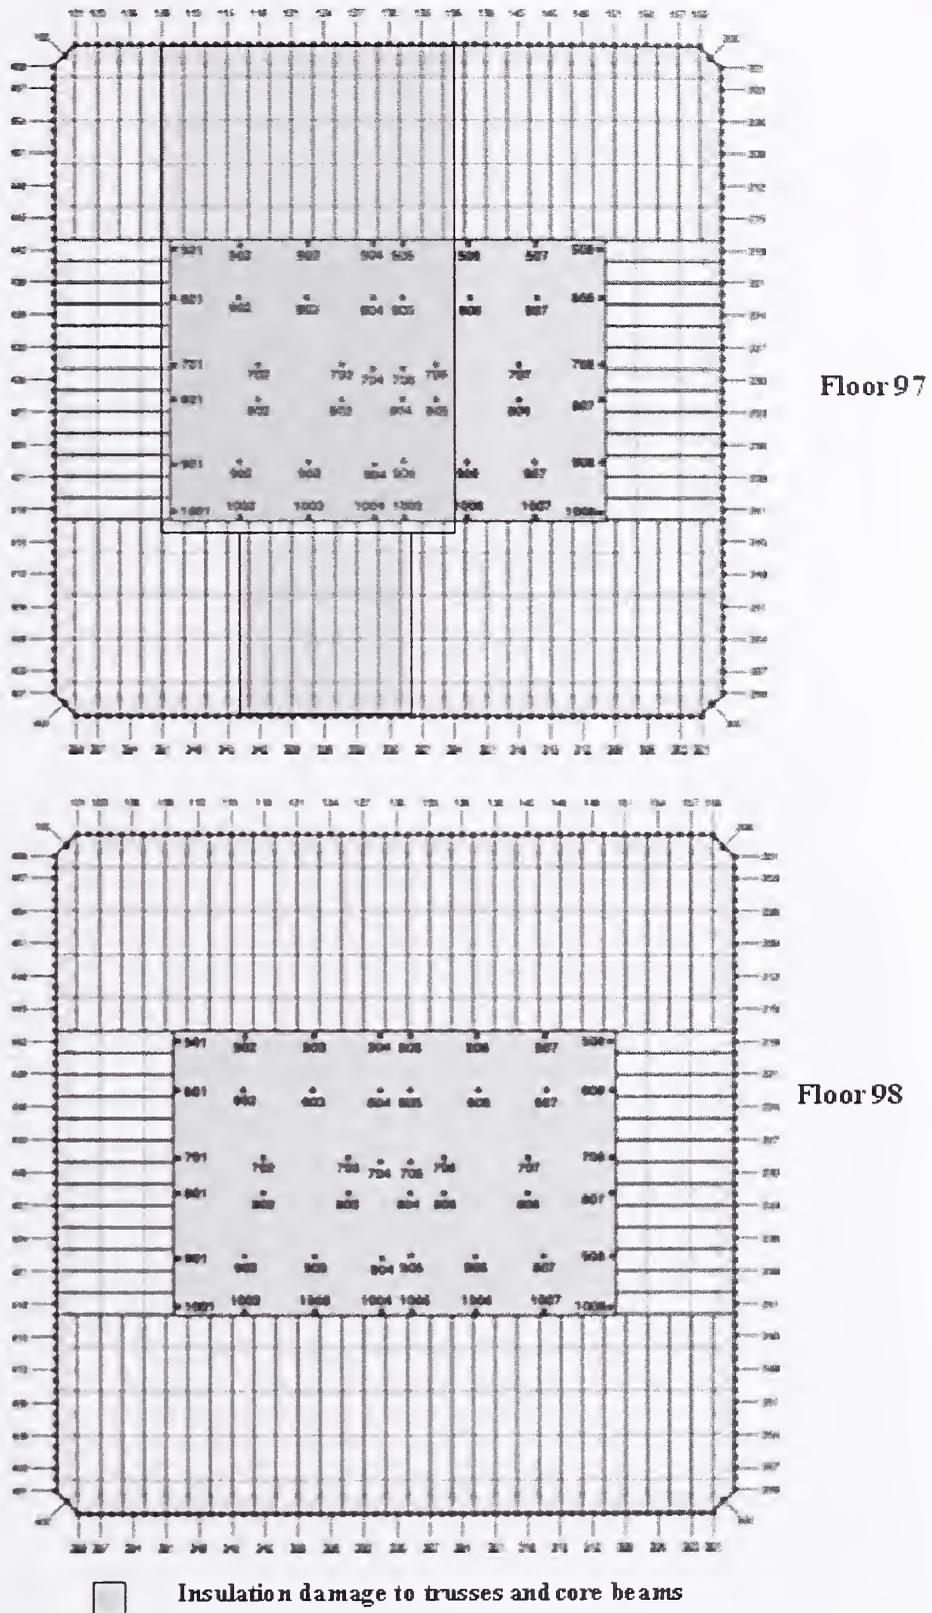
Figure A-9. WTC 1 Case B; aircraft impact damage to Structural Floors 97 and 98.

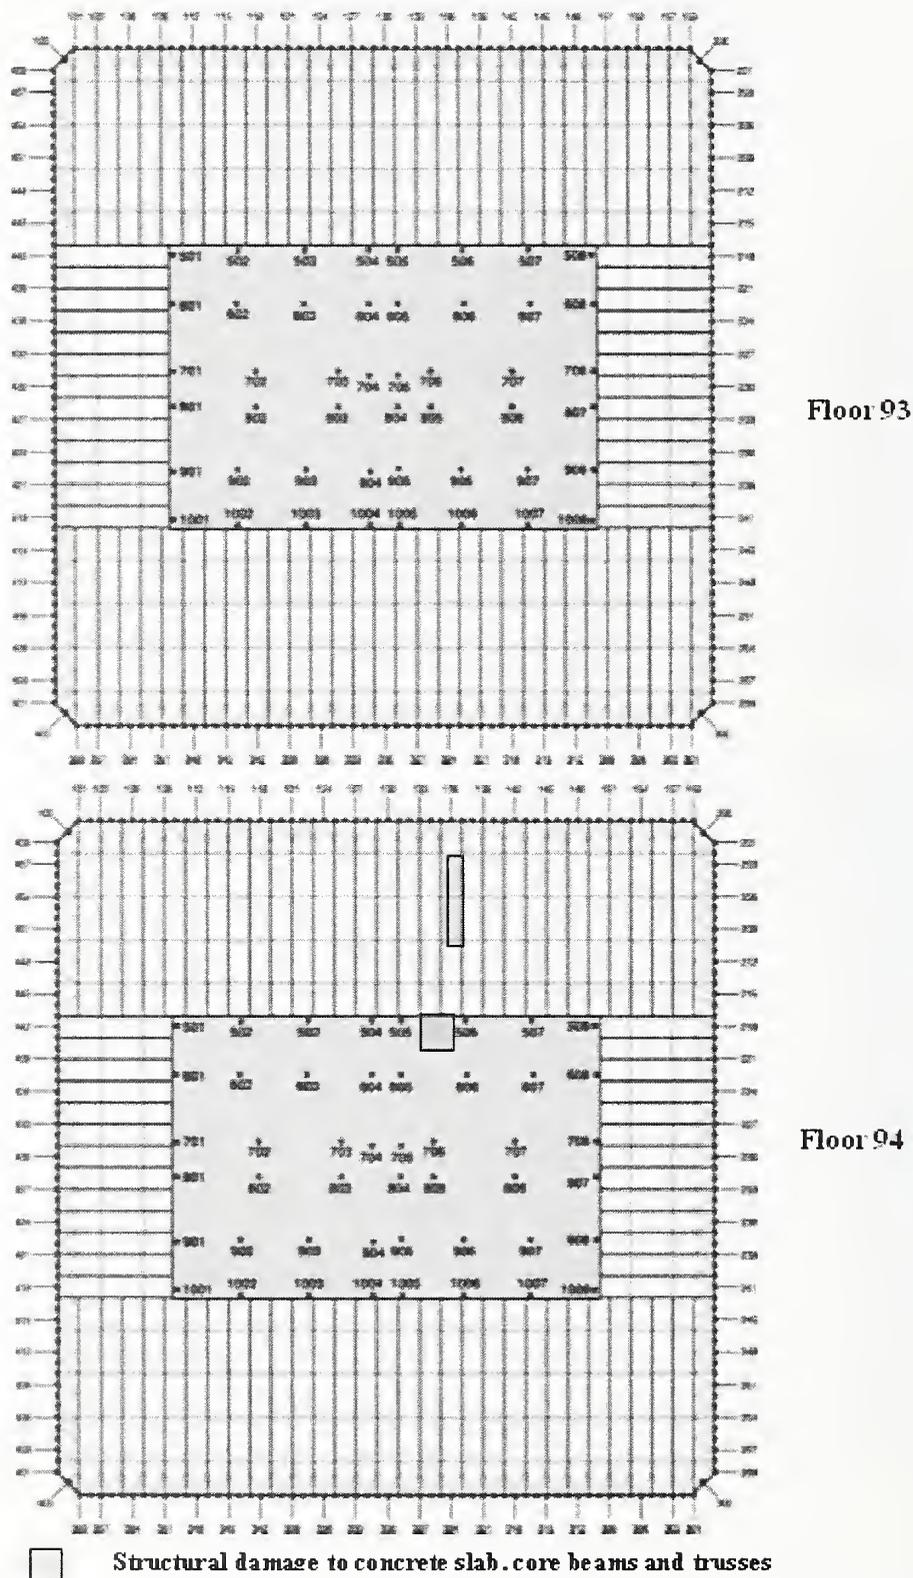
Figure A-10. WTC 1 Case B<sub>1</sub> aircraft impact damage to Structural Floor 93 and 94.

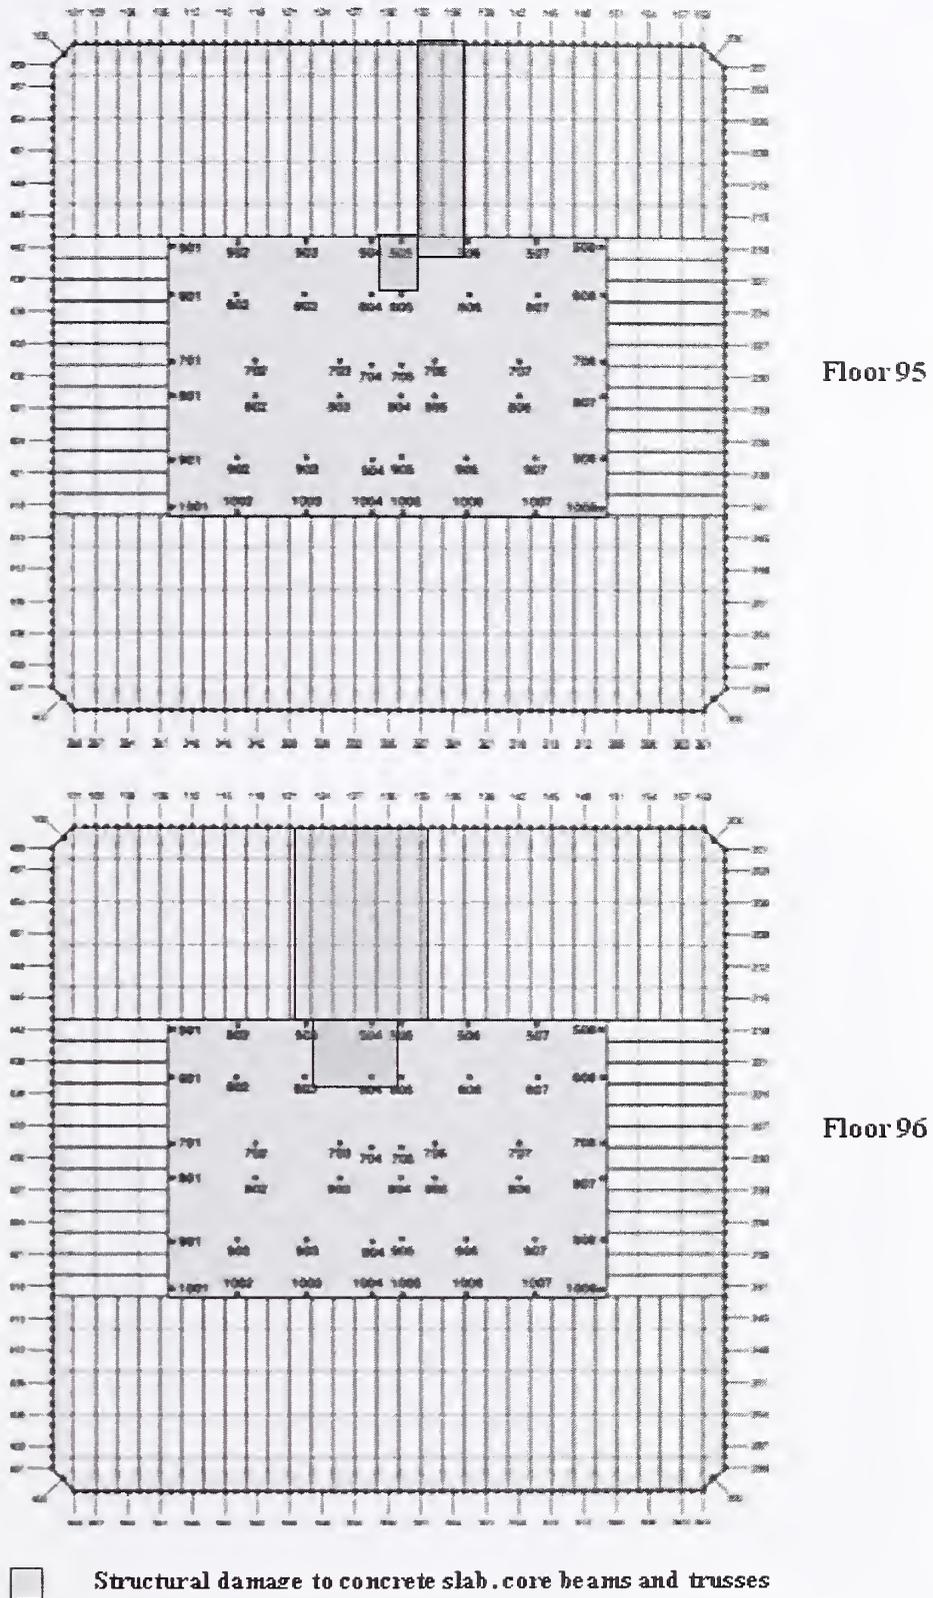
Figure A-11. WTC 1 Case B<sub>i</sub> aircraft impact damage to Structural Floors 95 and 96.

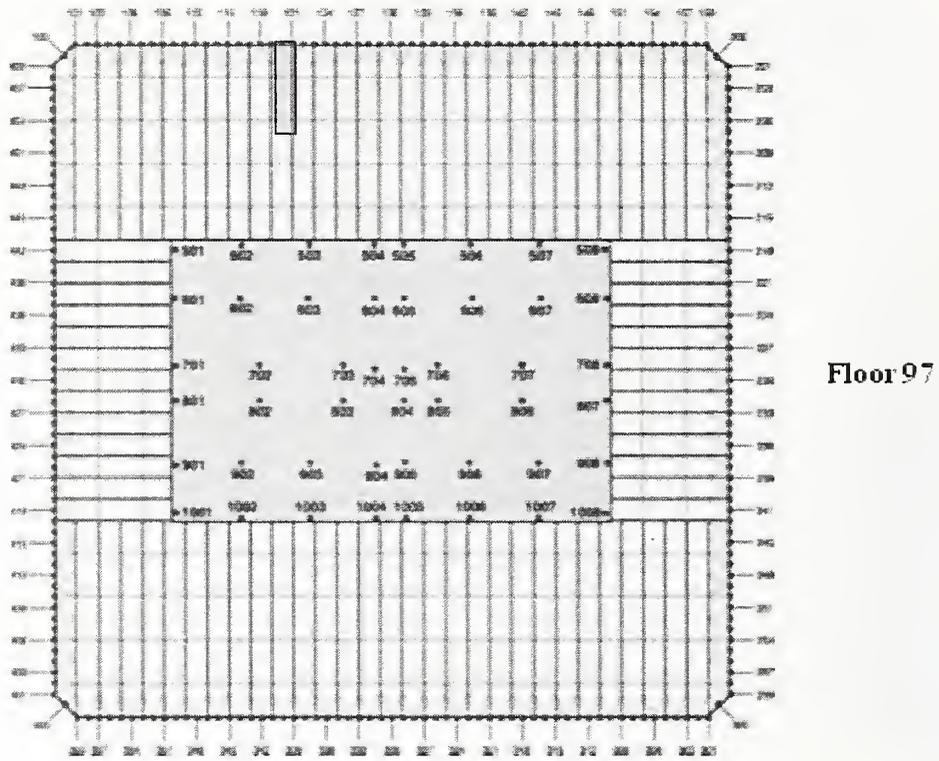
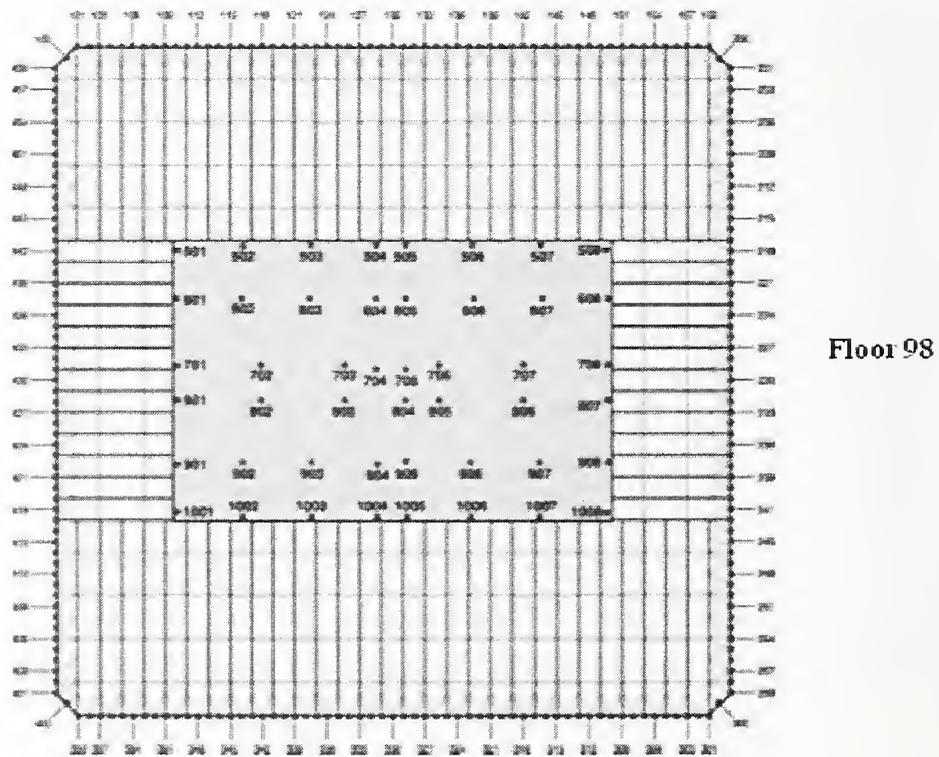
Structural damage to concrete slab, core beams and trusses

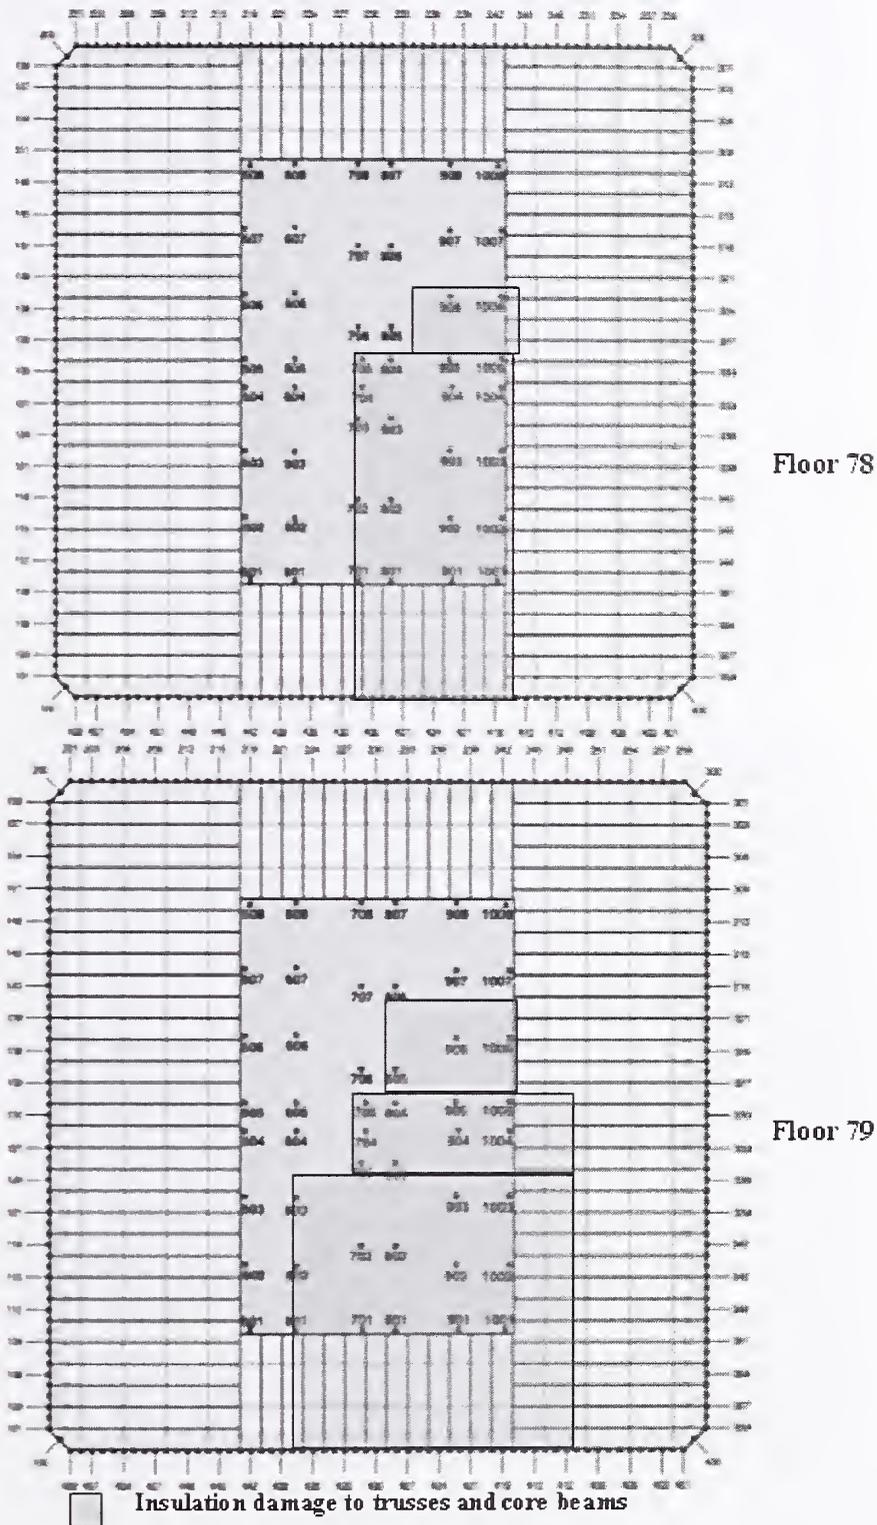
Figure A-13. WTC 2 Case C<sub>1</sub> aircraft impact damage to Structural Floors 78 and 79.

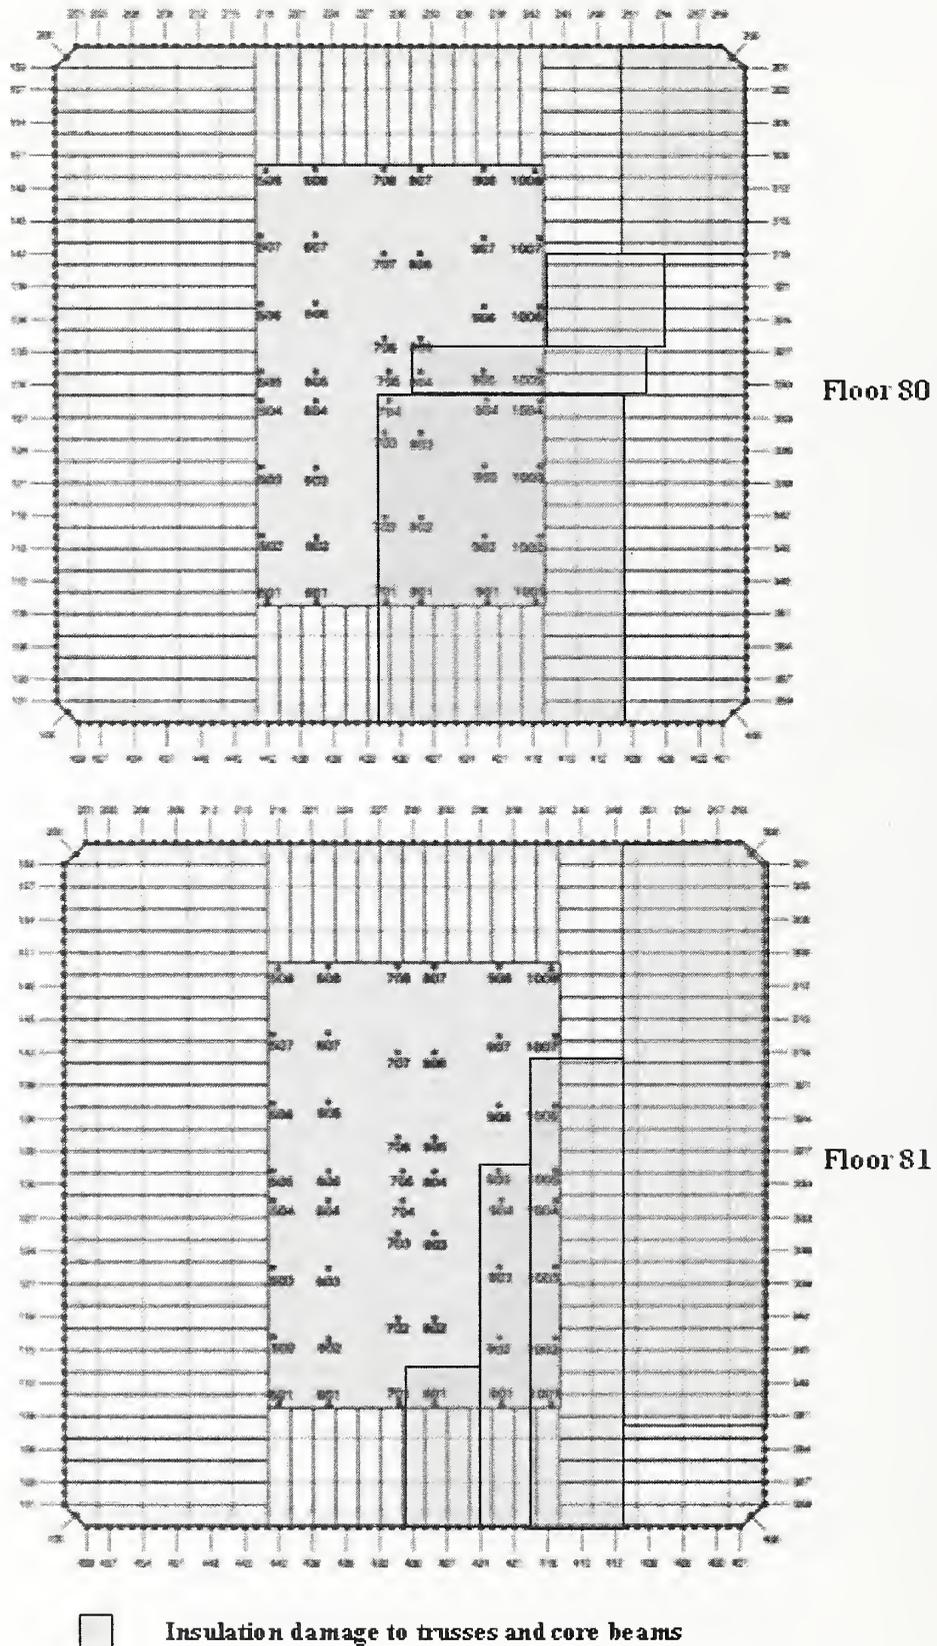
Figure A-14. WTC 2 Case C; aircraft impact damage to Structural Floors 80 and 81.

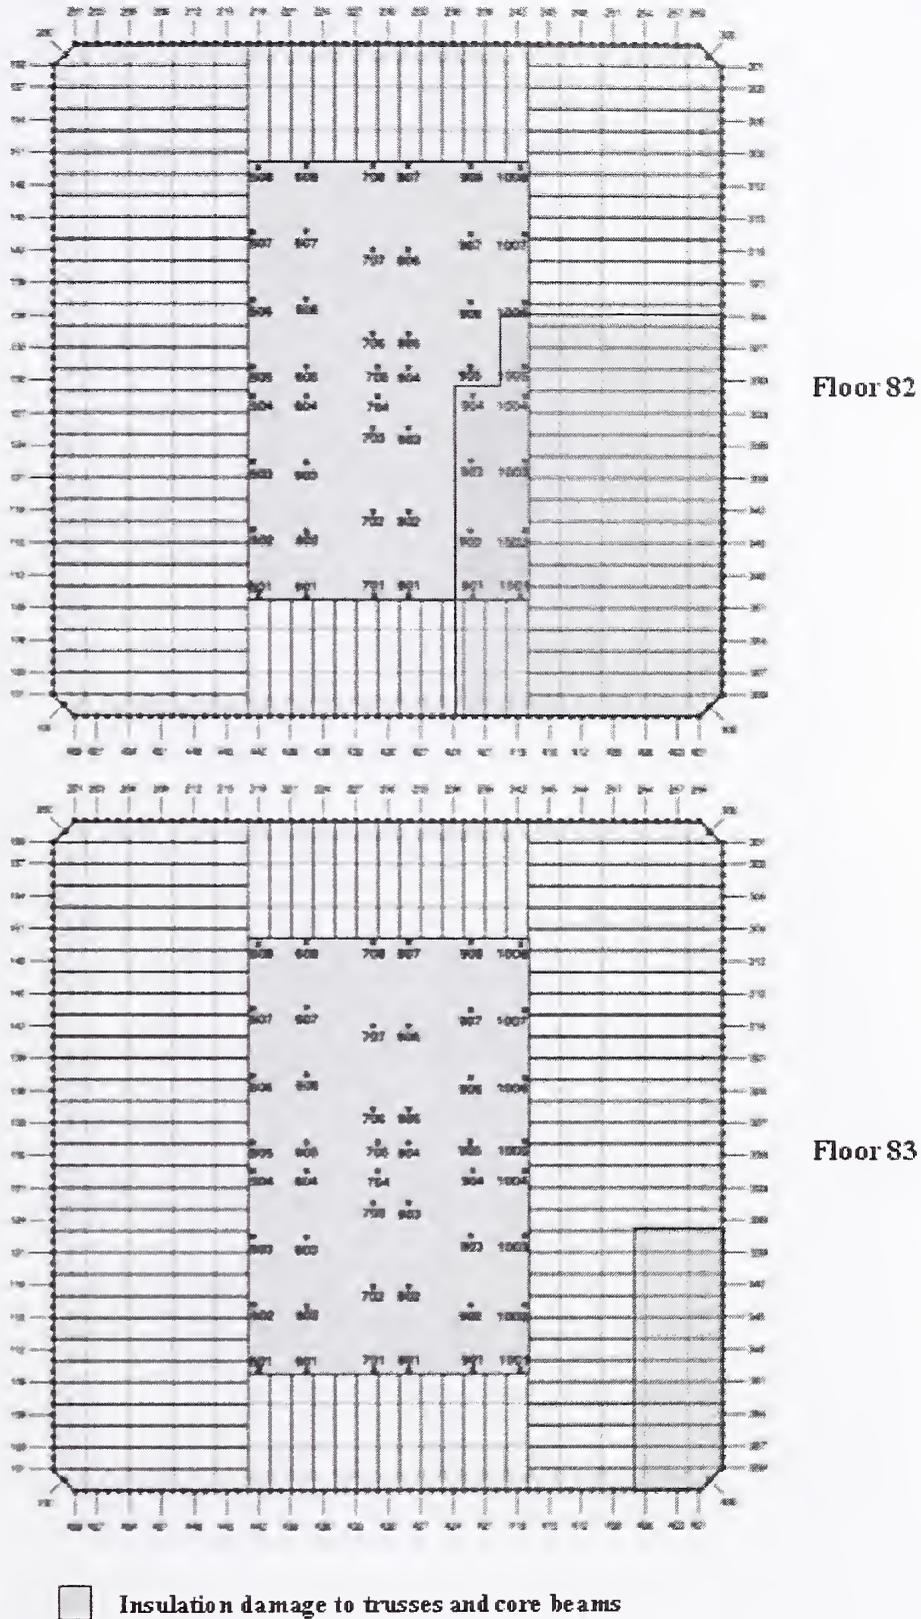
Figure A-15. WTC 2 Case C<sub>i</sub> aircraft impact damage to Structural Floors 82 and 83.

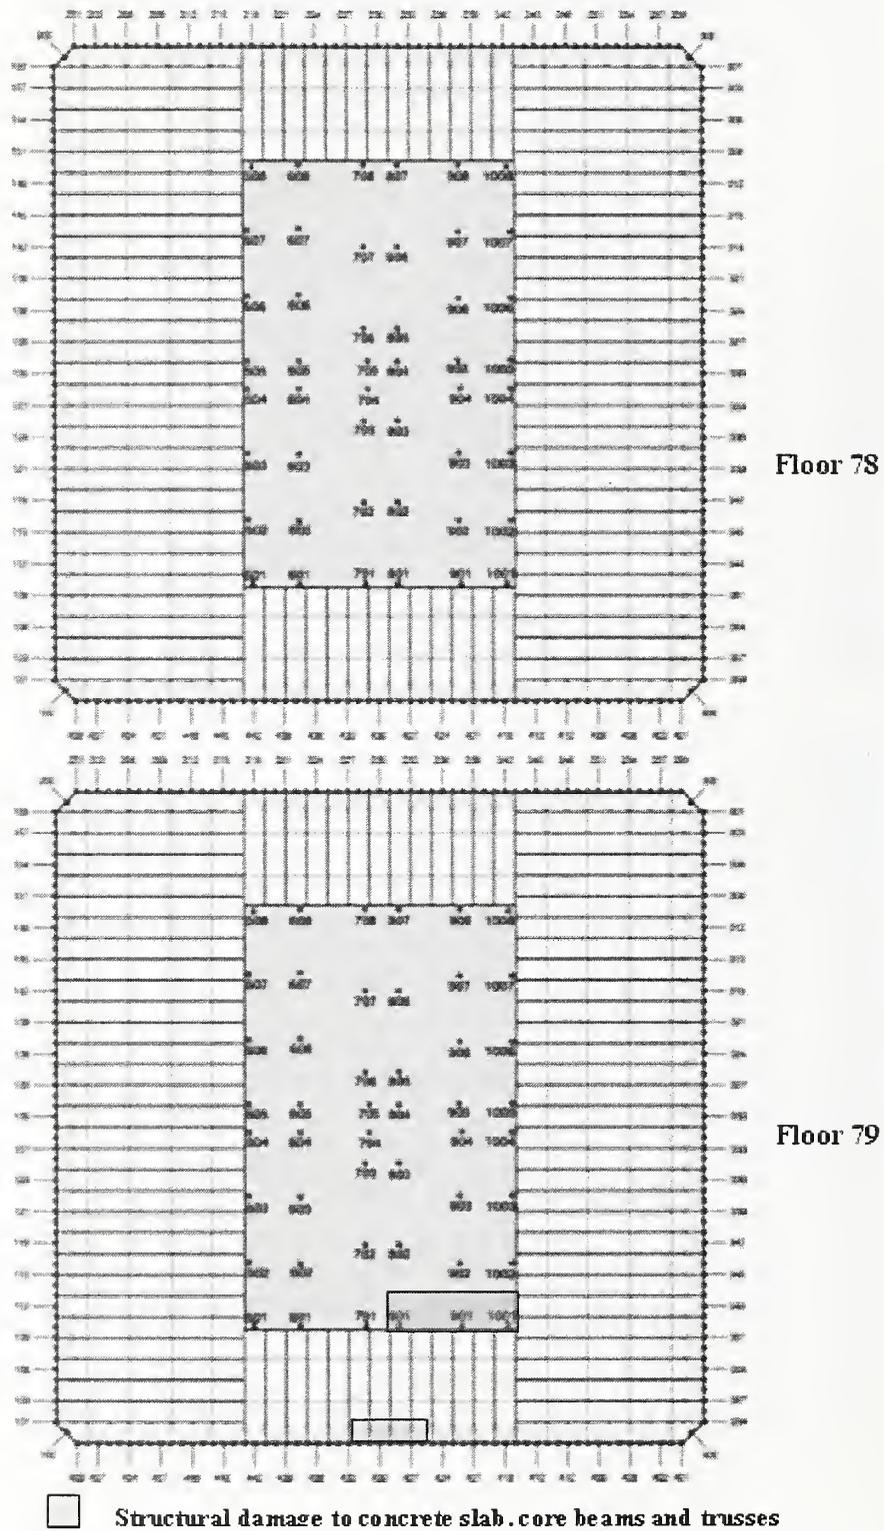
Figure A-16. WTC 2 Case C<sub>1</sub> aircraft impact damage to Structural Floors 78 and 79.

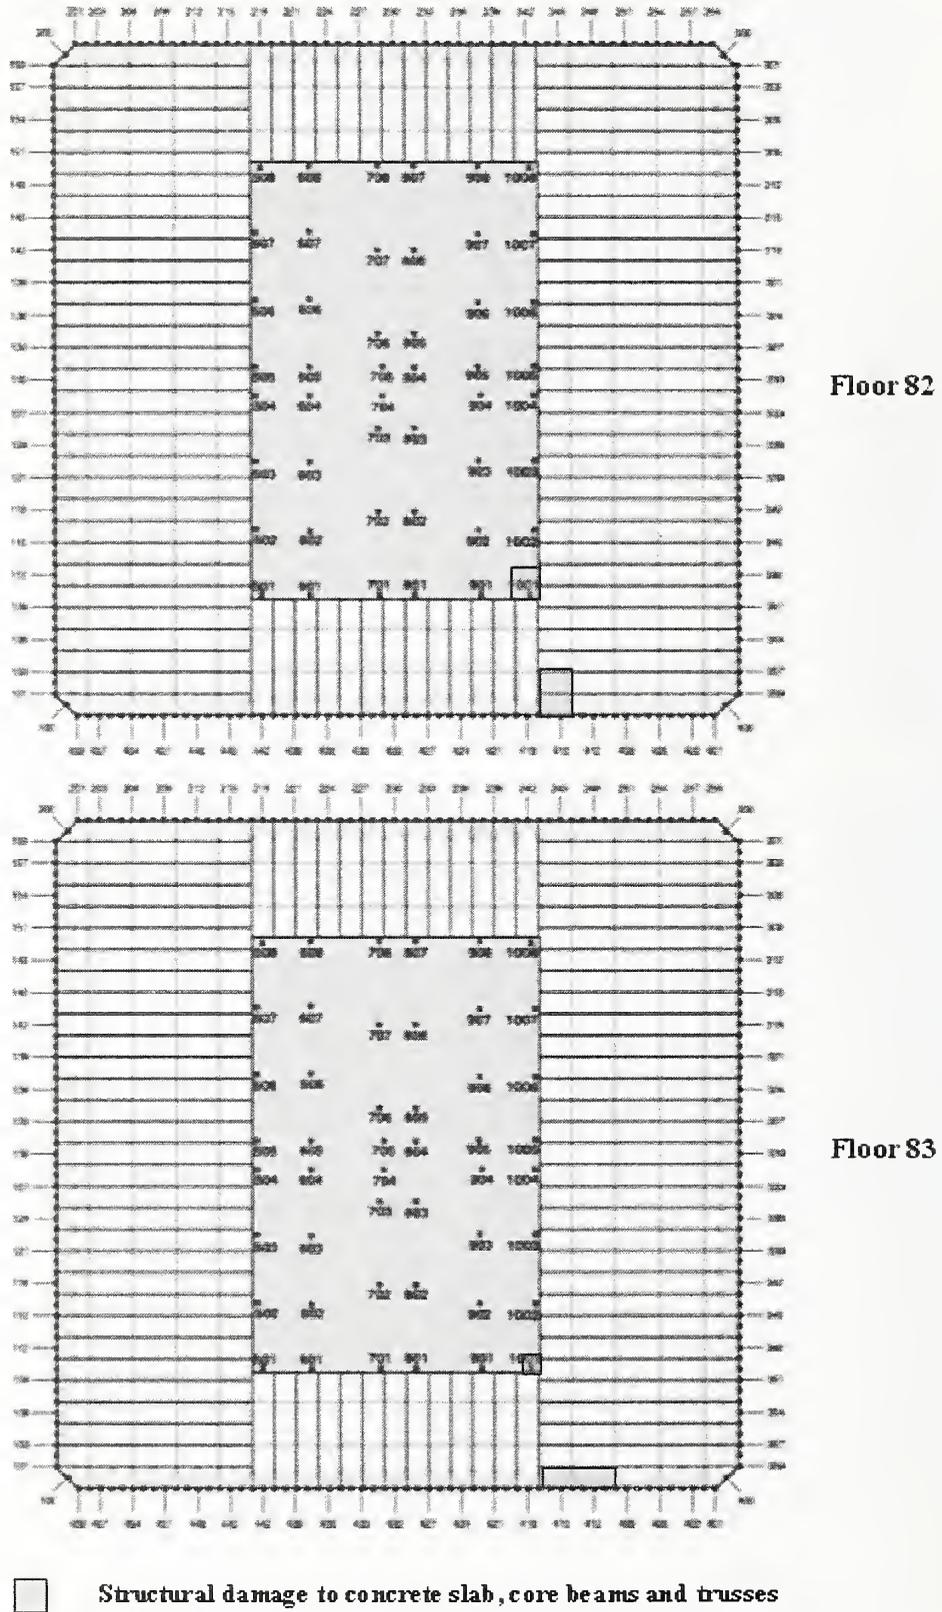
Figure A-18. WTC 2 Case C; aircraft impact damage to Structural Floors 82 and 83.
