NIST NCSTAR 1-6

Federal Building and Fire Safety Investigation of  
the World Trade Center Disaster

# Structural Fire Response and Probable Collapse Sequence of the World Trade Center Towers

(Chapter 7- Appendix B)

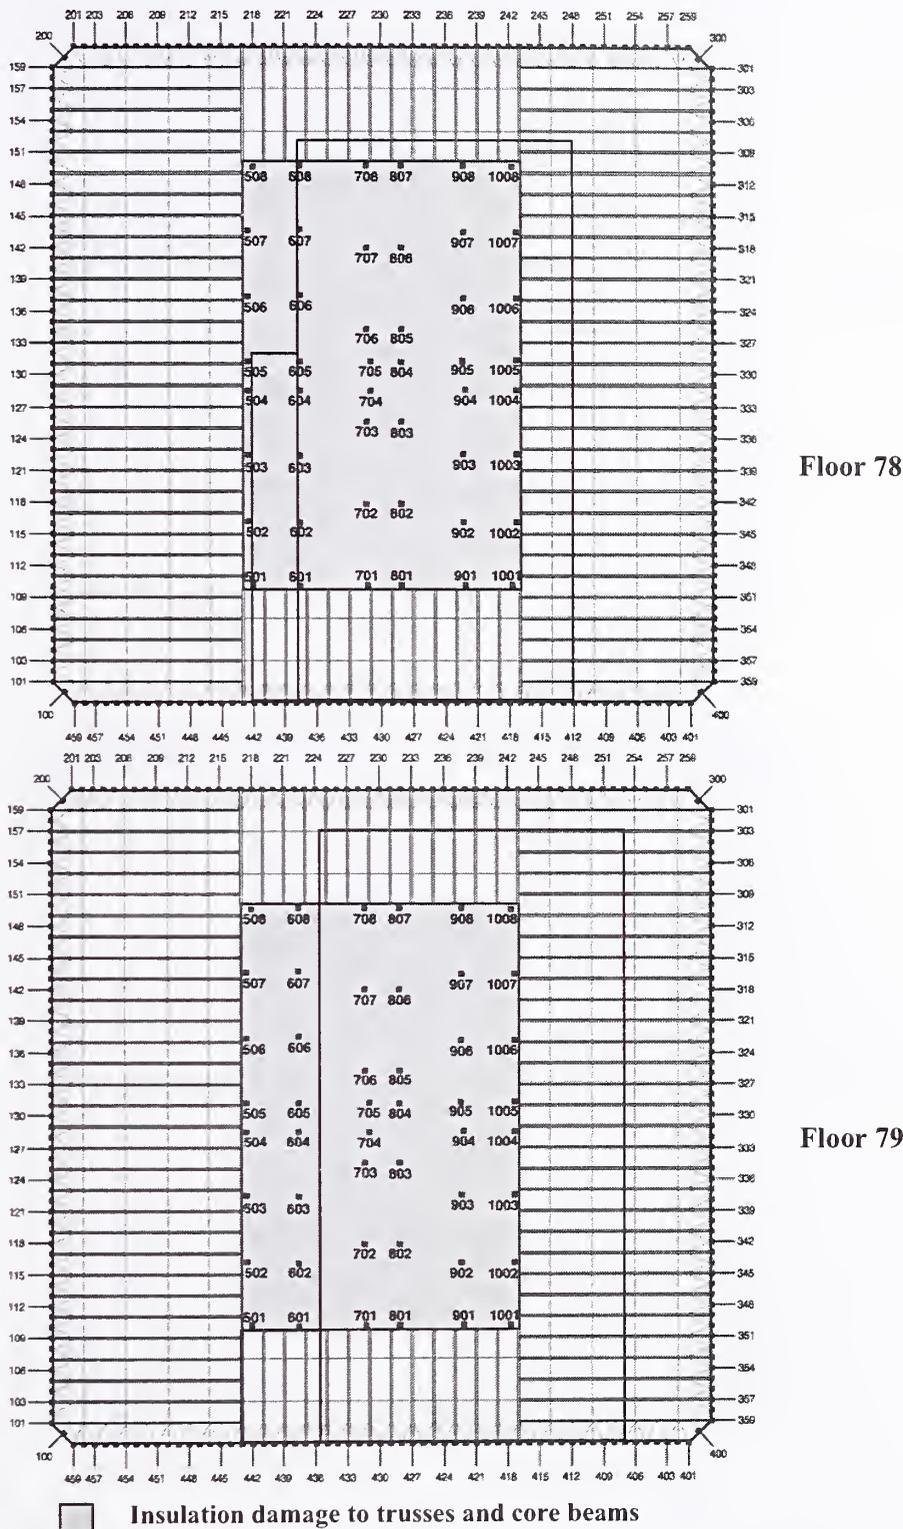
Figure A-19. WTC 2 Case D<sub>1</sub> aircraft impact damage to Structural Floors 78 and 79.

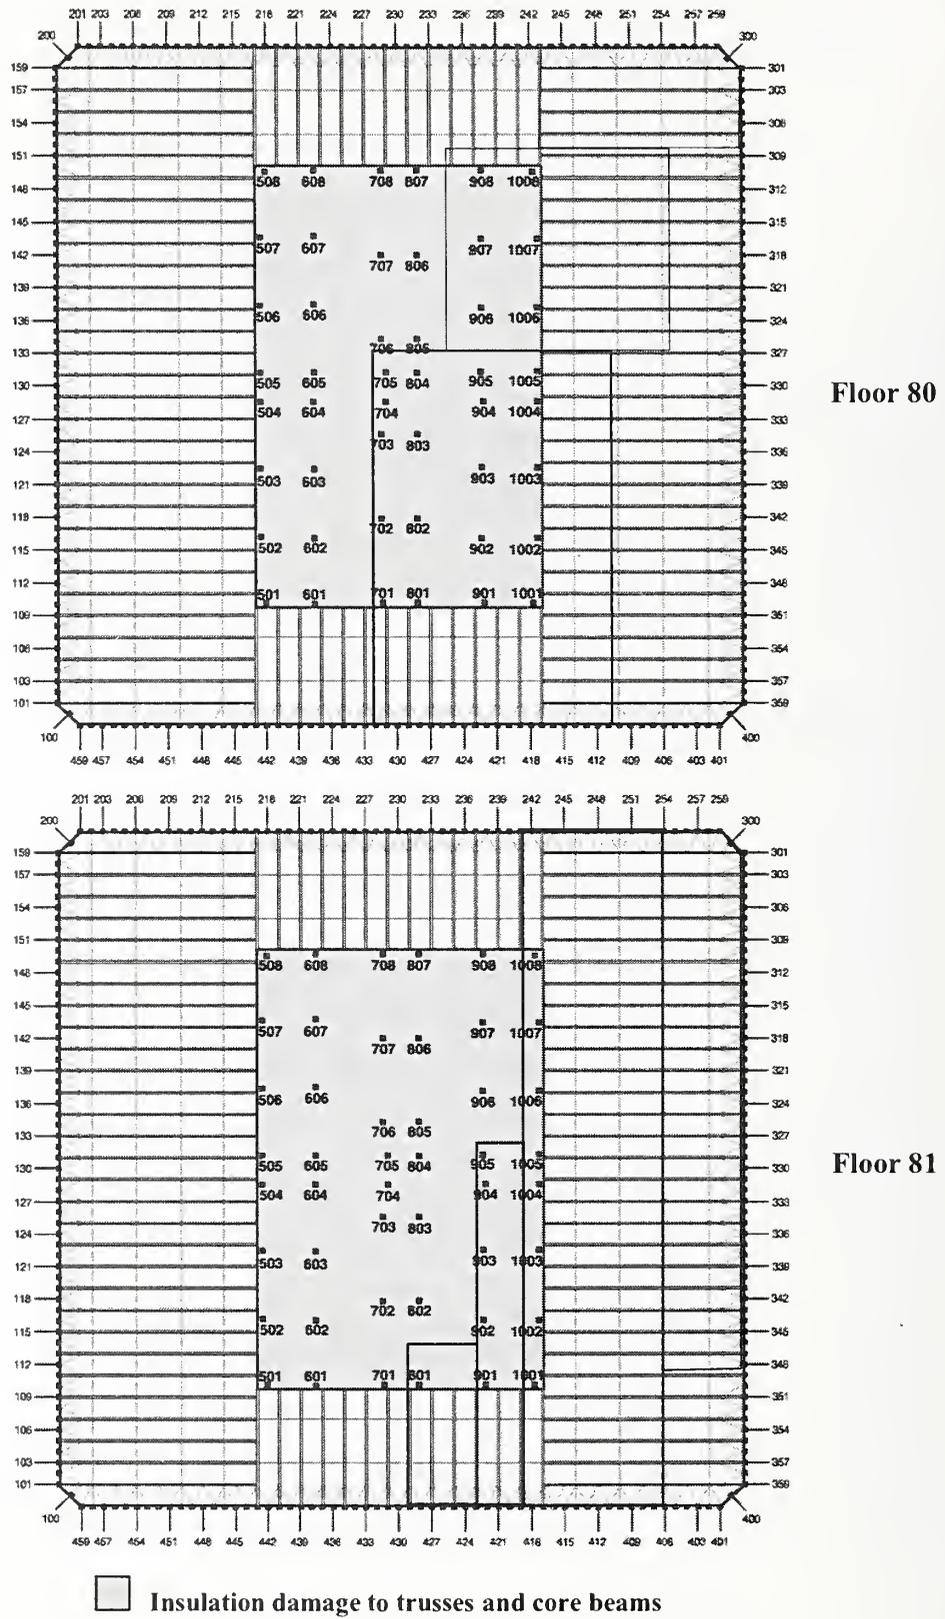
Figure A-20. WTC 2 Case D; aircraft impact damage to Structural Floors 80 and 81.

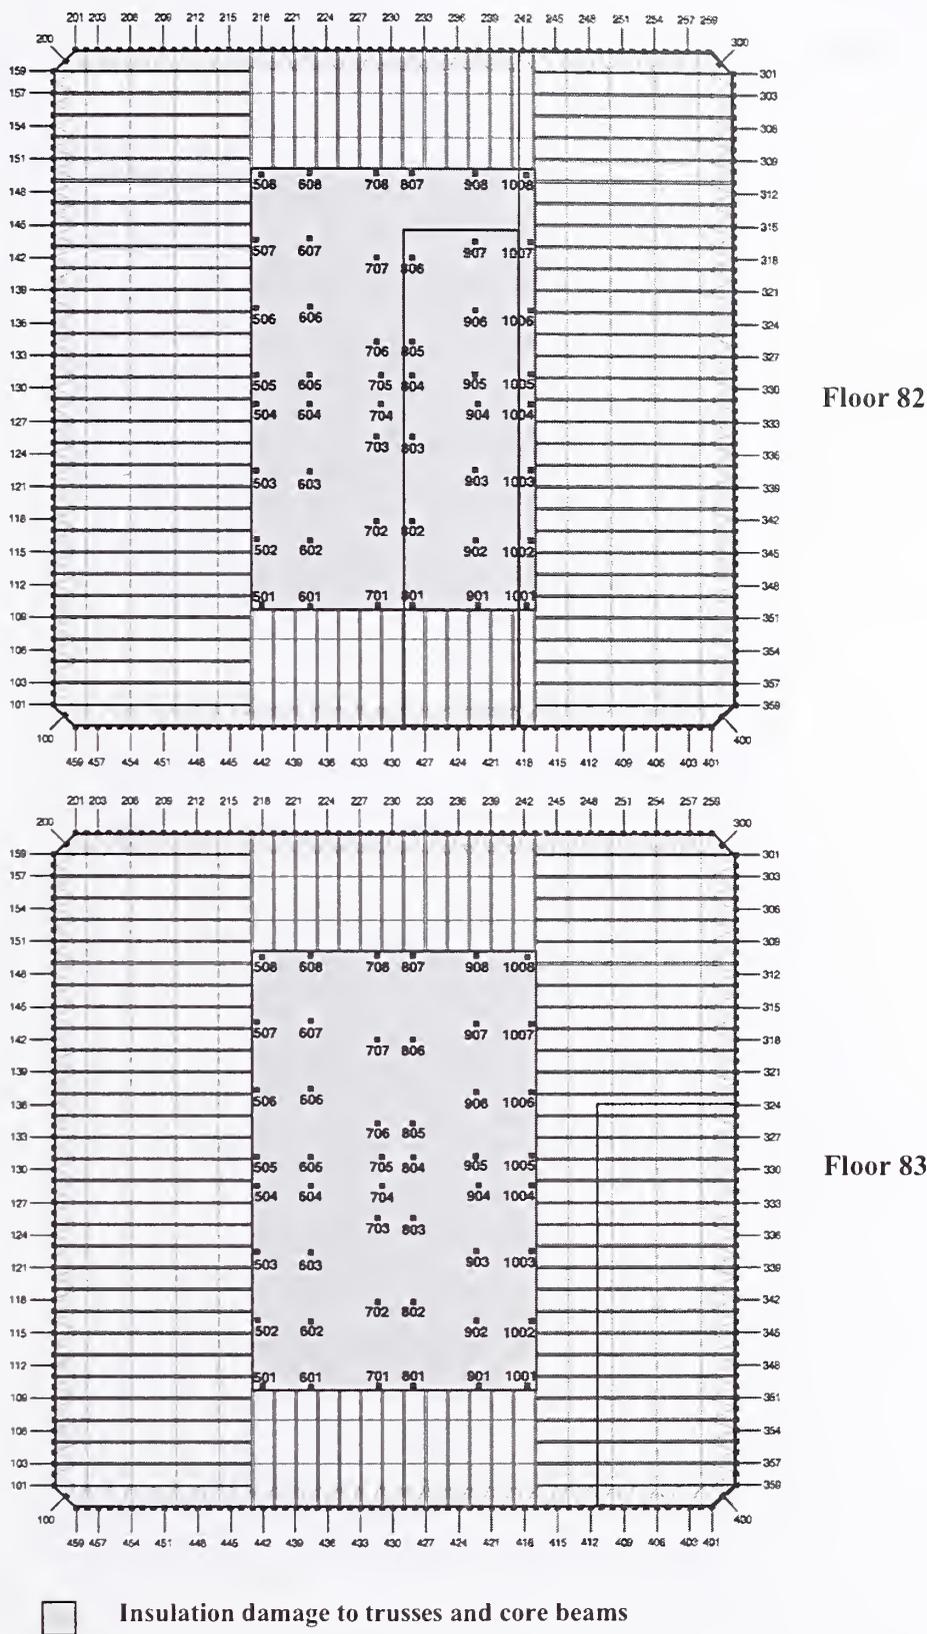
Figure A-21. WTC 2 Case D; aircraft impact damage to Structural Floors 82 and 83.

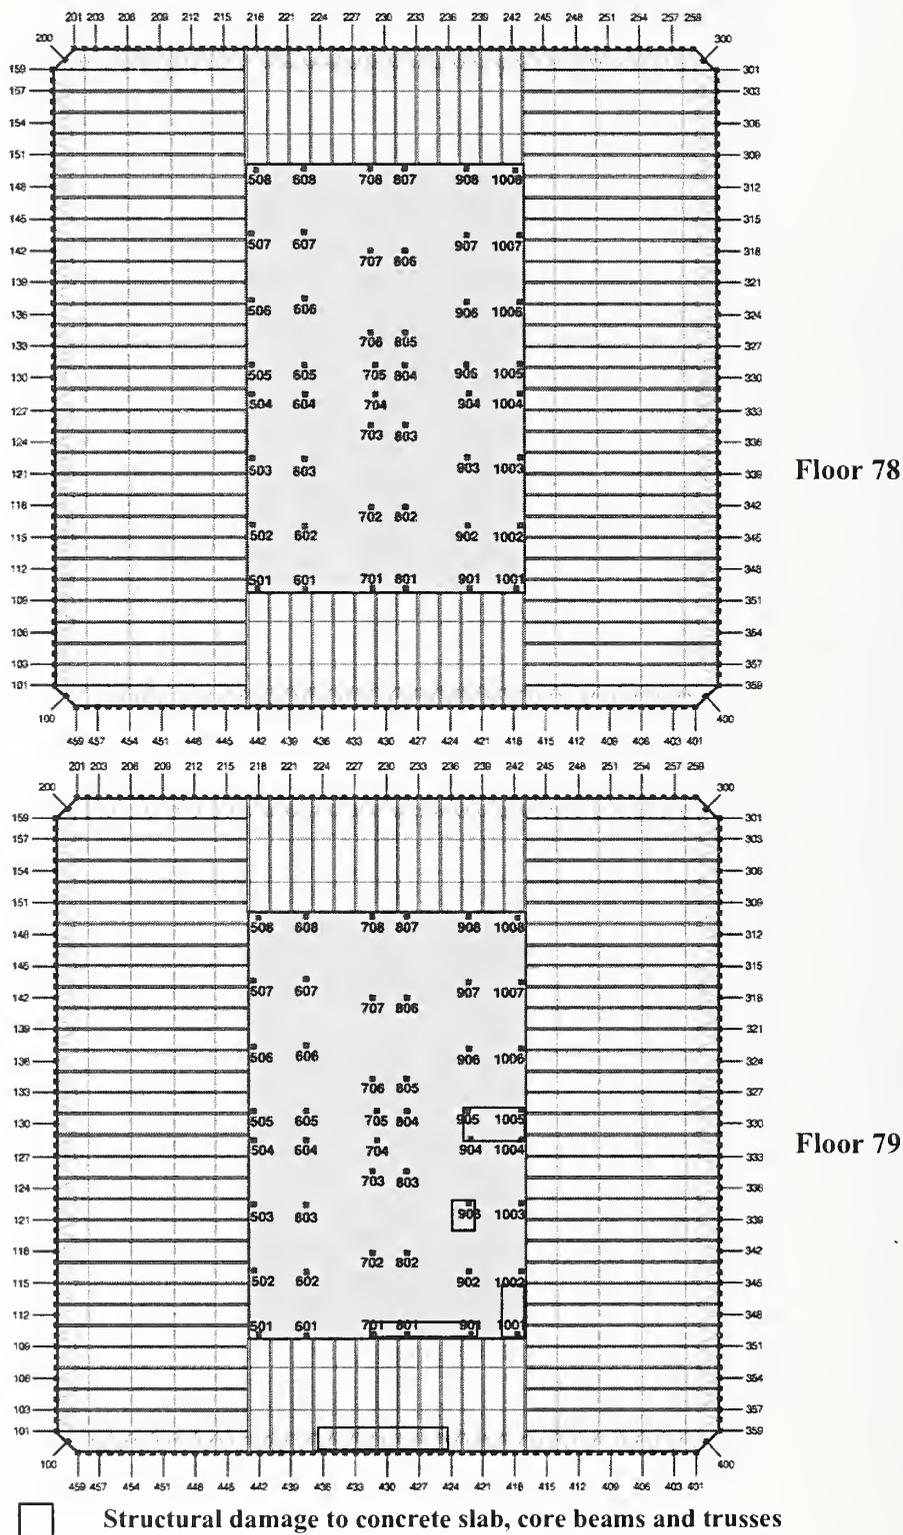
Figure A-22. WTC 2 Case D<sub>1</sub> aircraft impact damage to Structural Floors 78 and 79.

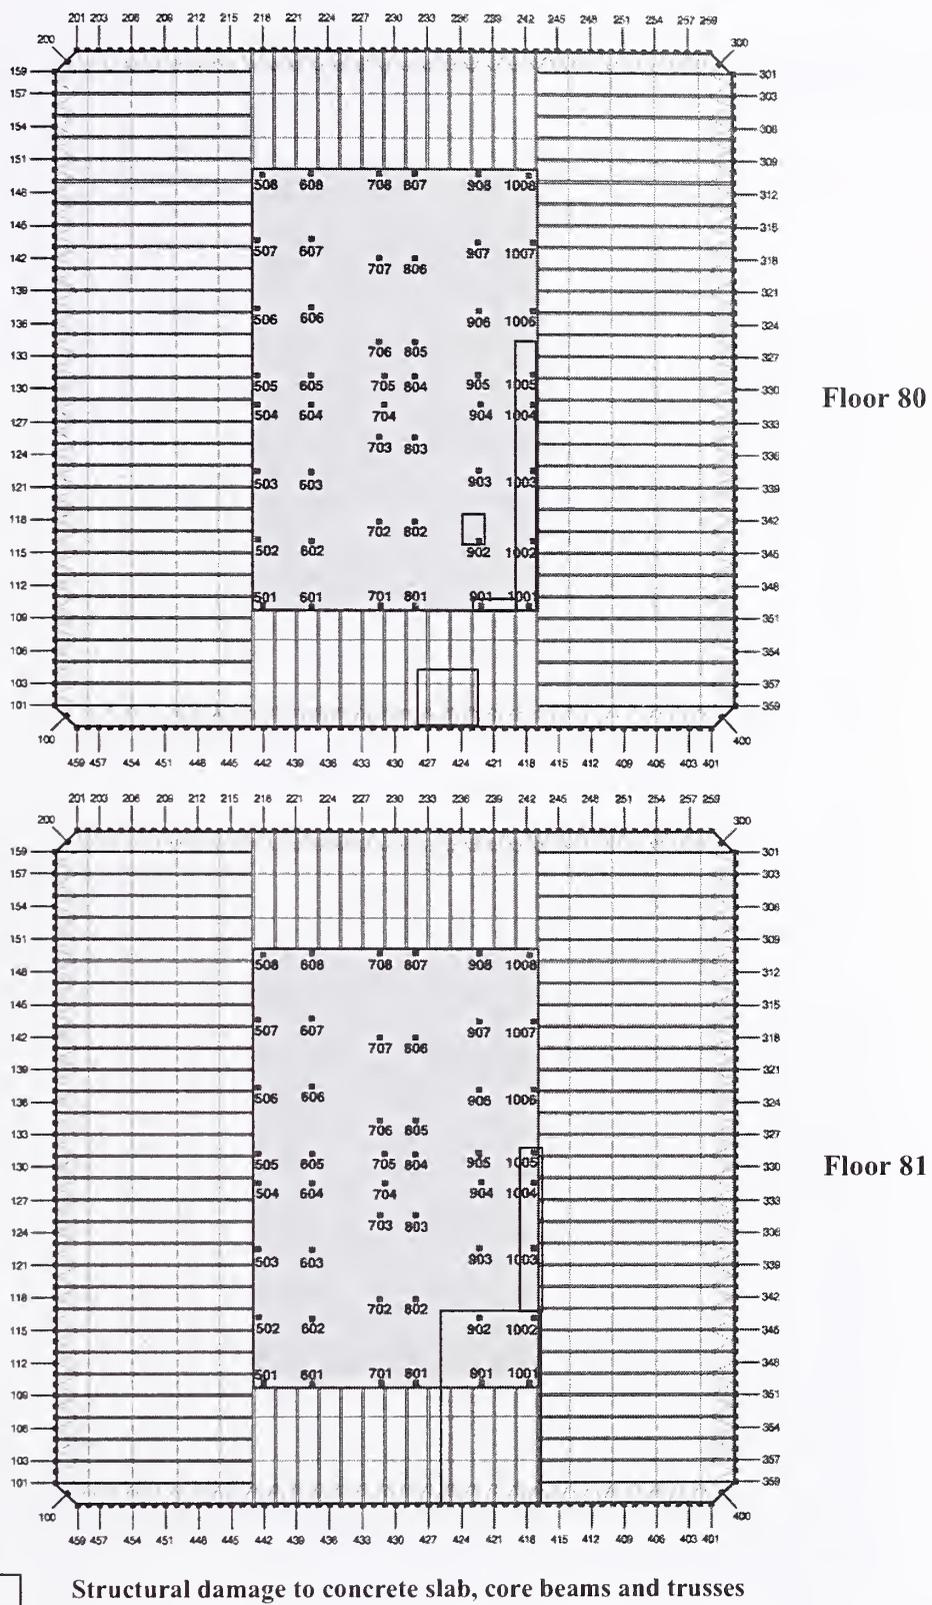
Figure A-23. WTC 2 Case D; aircraft impact damage to Structural Floors 80 and 81.

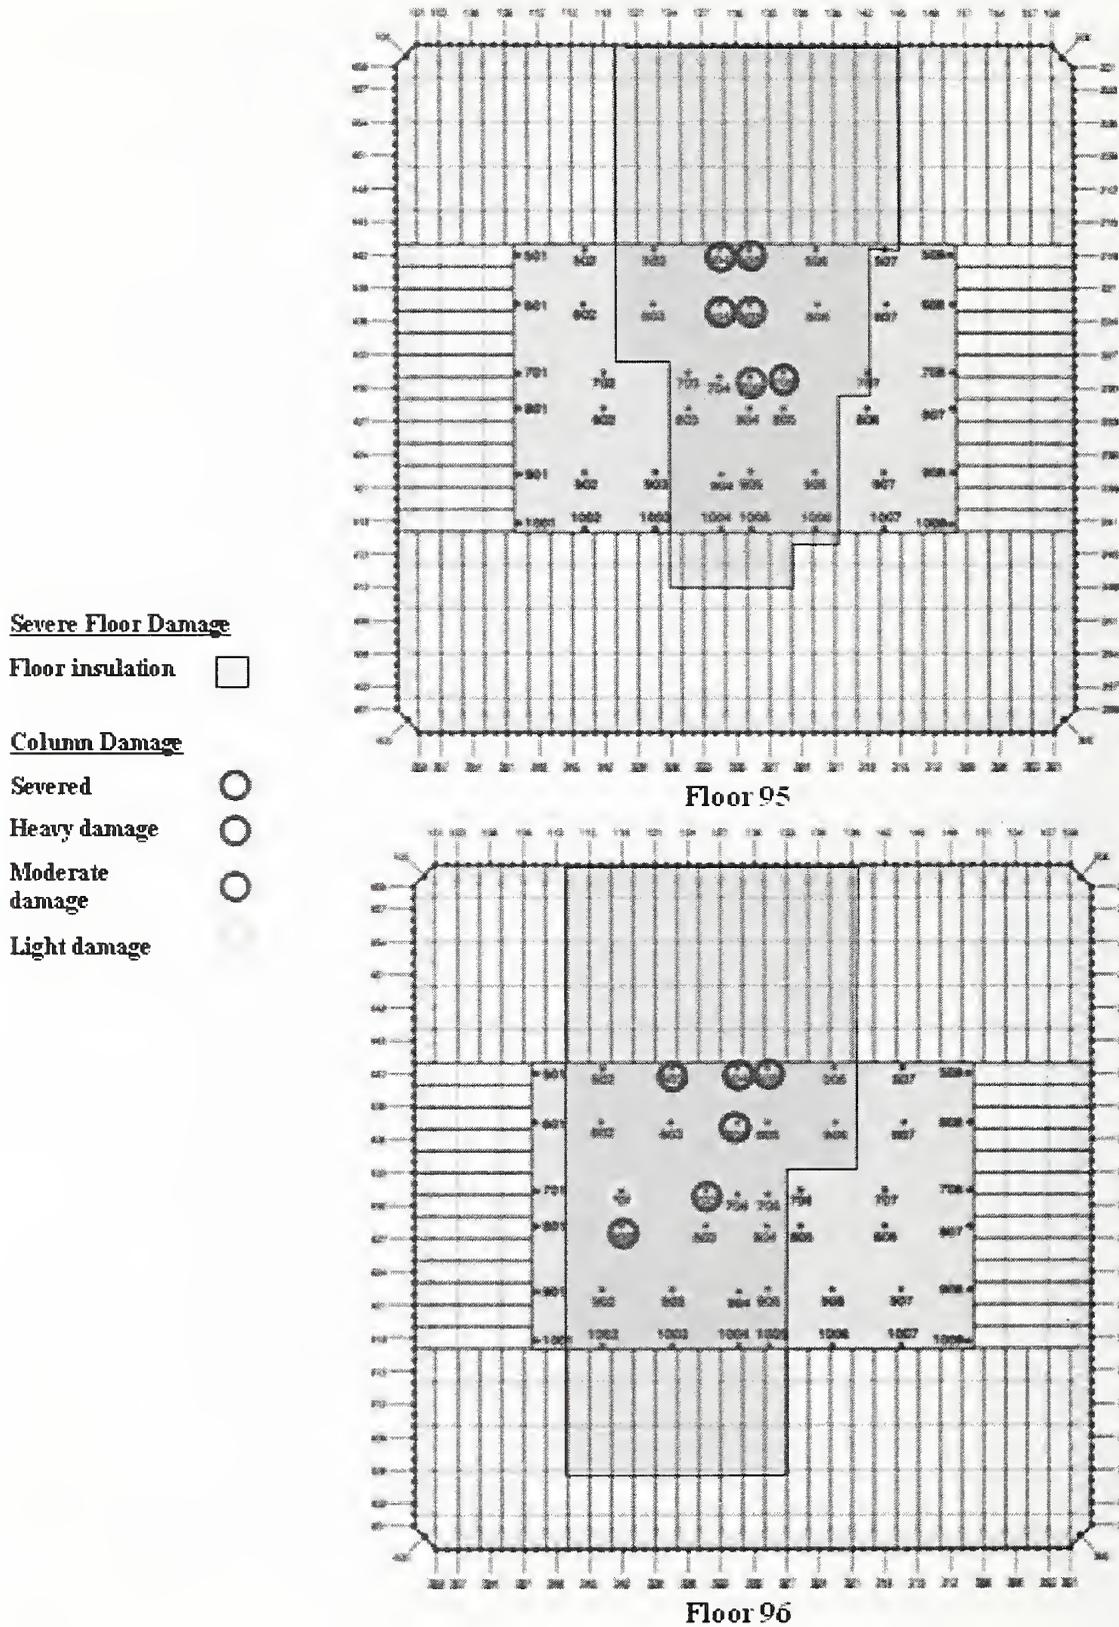
Figure B-2. WTC 1 Case A aircraft impact damage to Occupancy Floors 95 and 96.

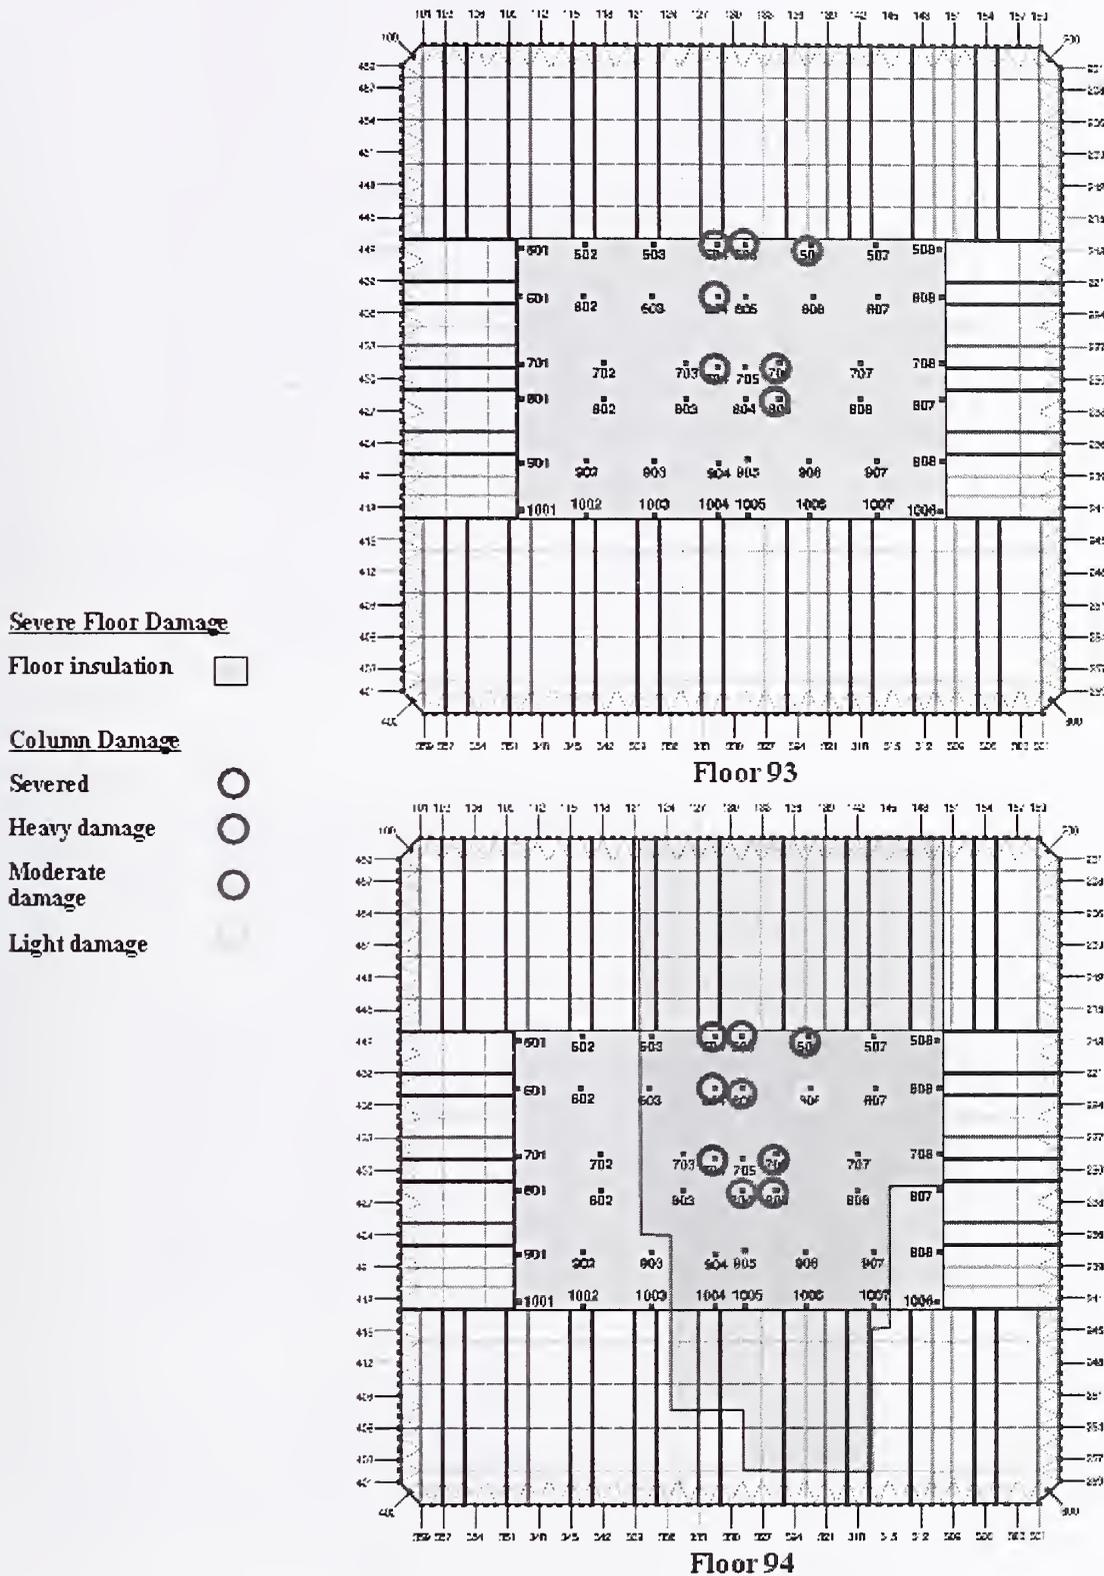
Figure B-7. WTC 1 Case B aircraft impact damage to Occupancy Floors 93 and 94.

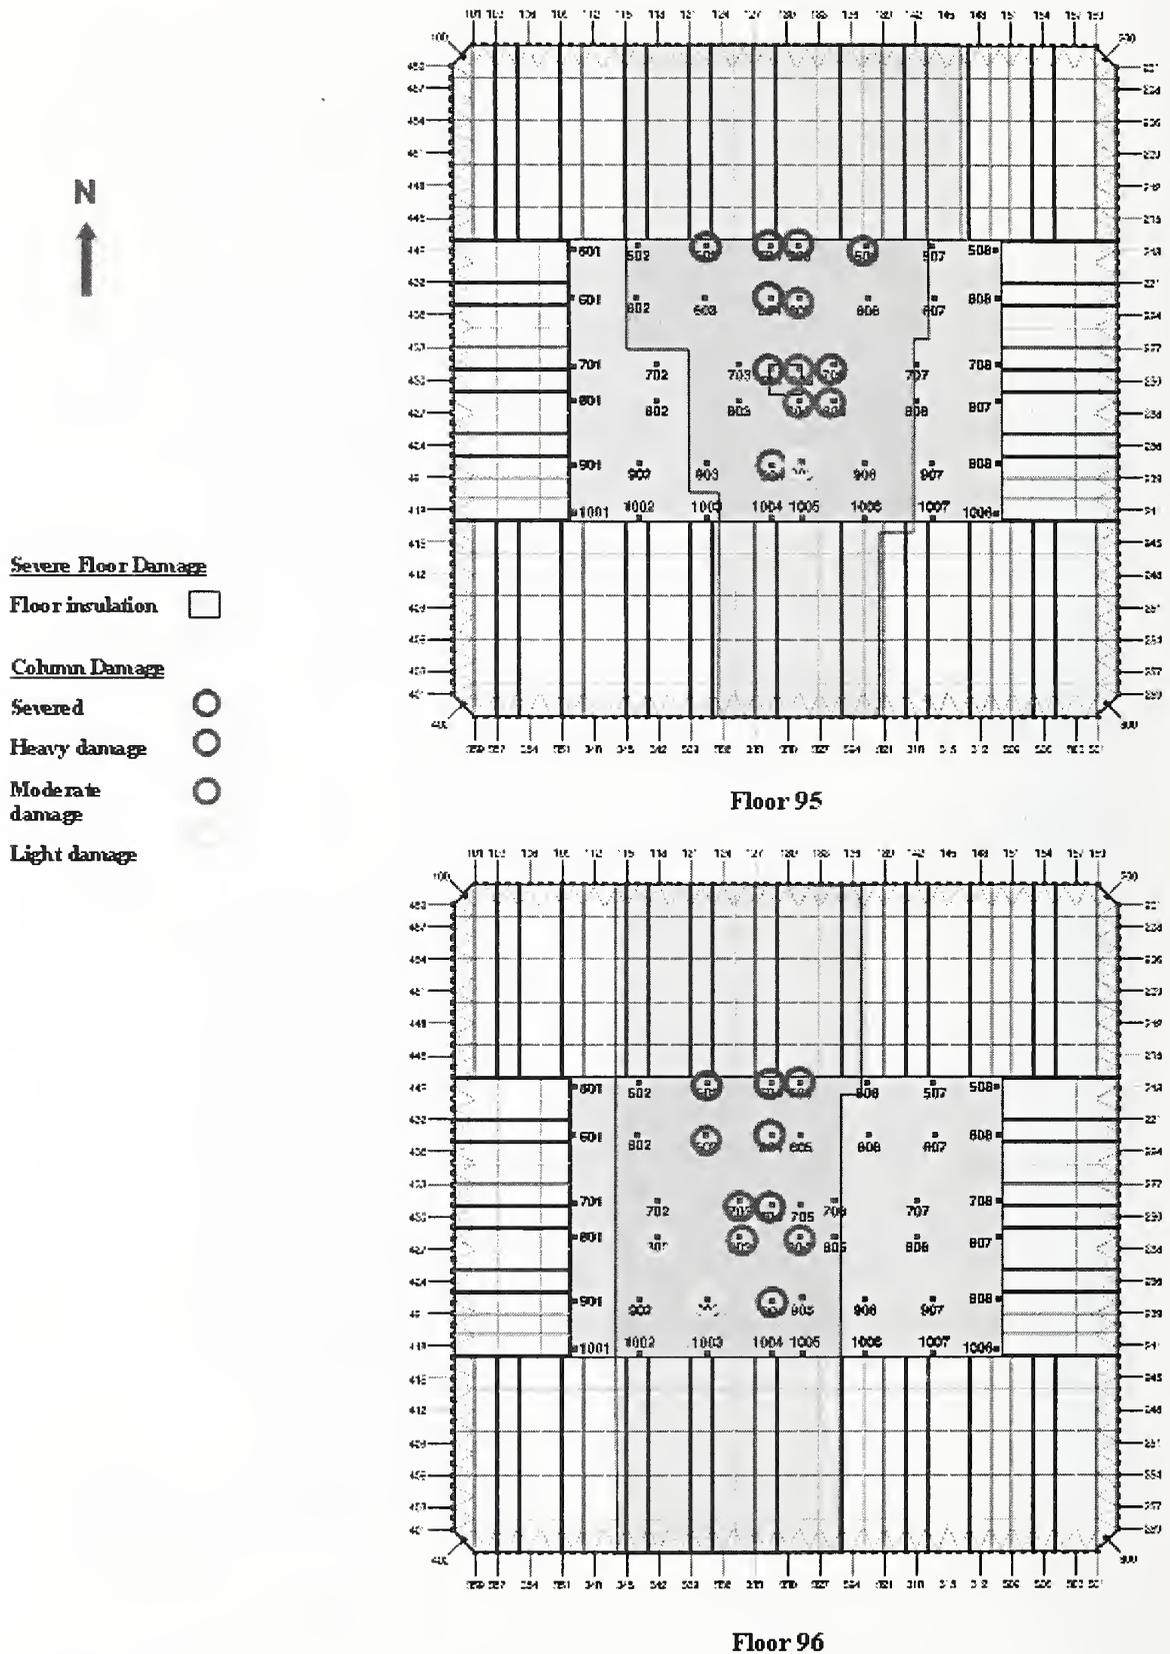
Figure B-8. WTC 1 Case B aircraft impact damage to Occupancy Floors 95 and 96.

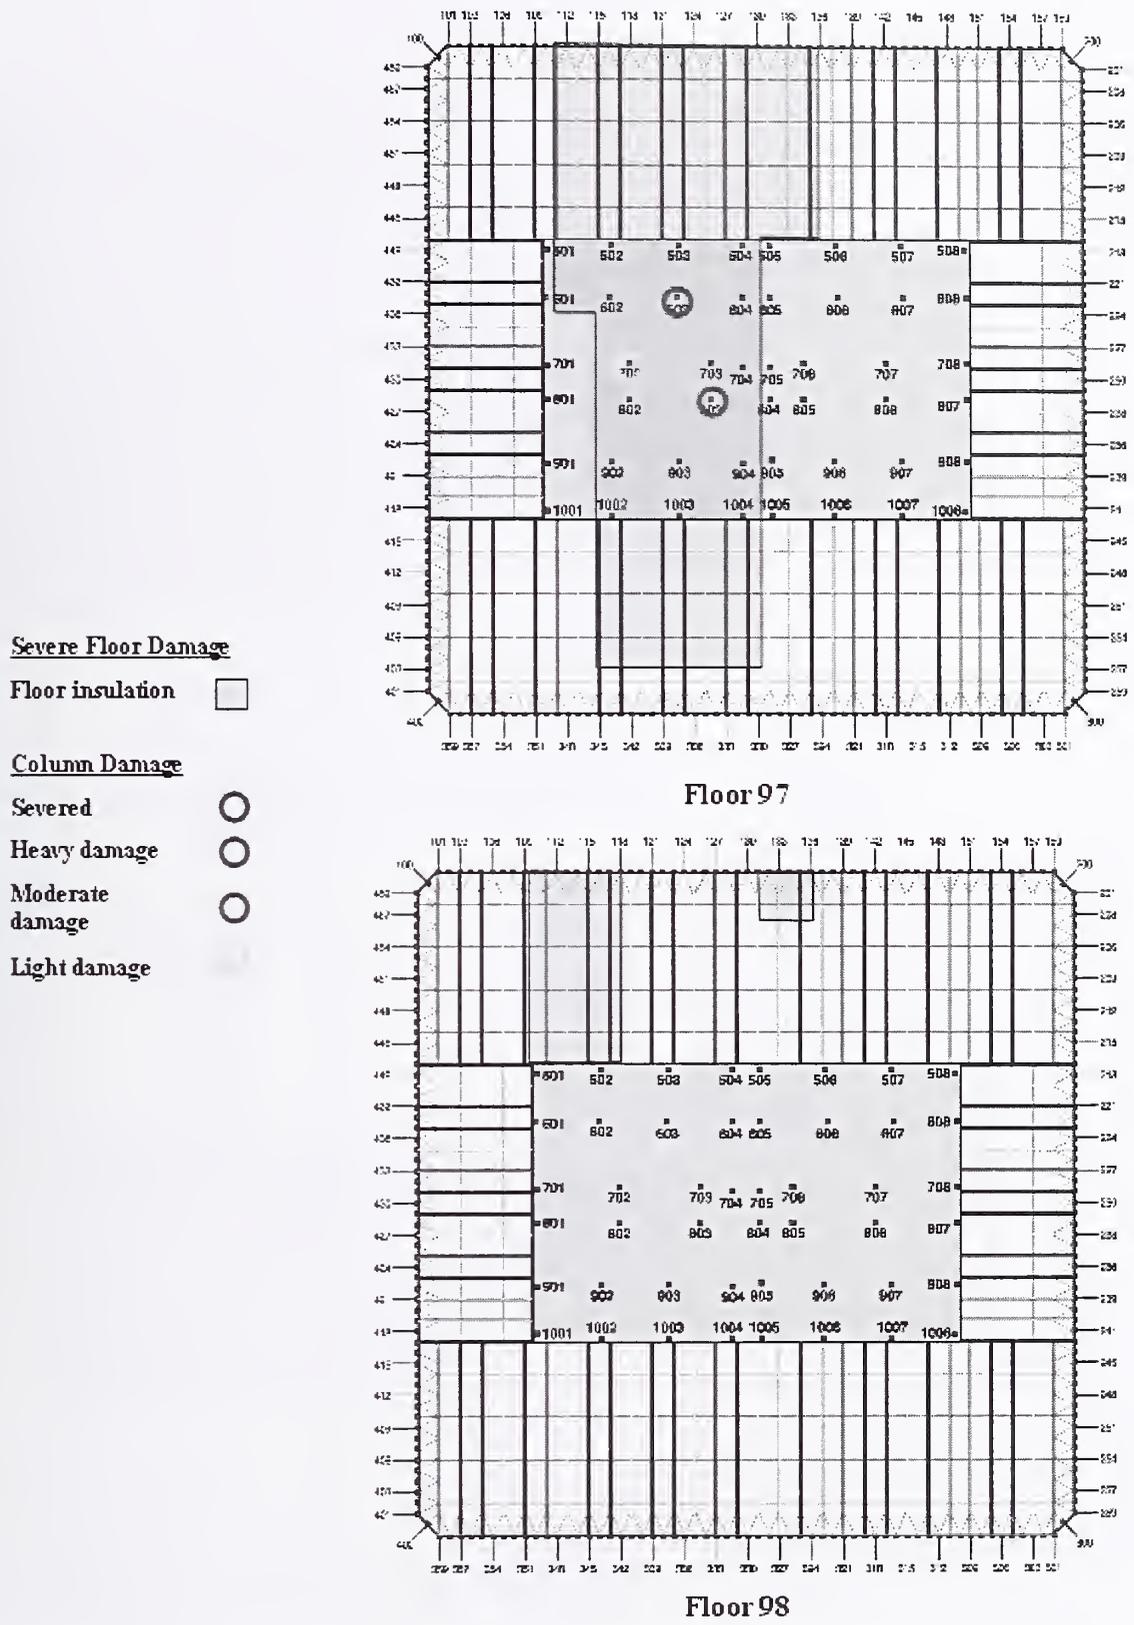
Figure B-9. WTC 1 Case B aircraft impact damage to Occupancy Floors 97 and 98.

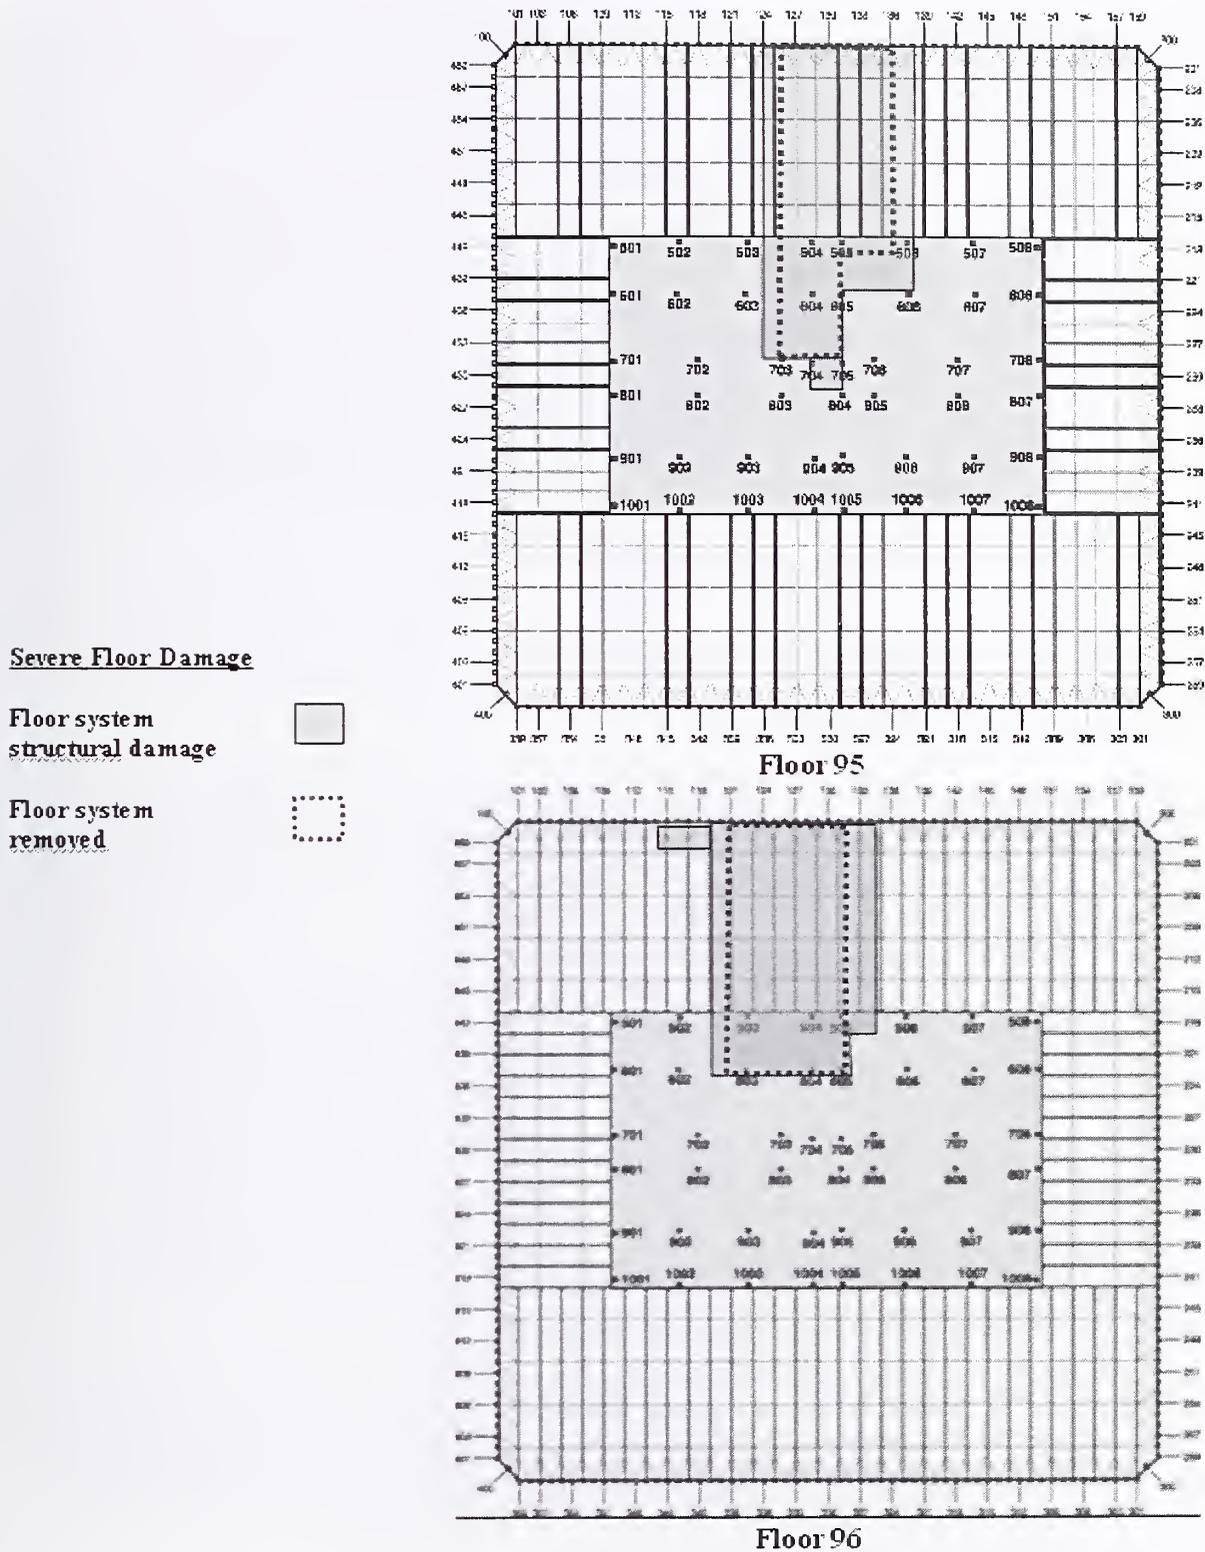
Figure B-11. WTC 1 Case B aircraft impact damage to Structural Floors 95 and 96.

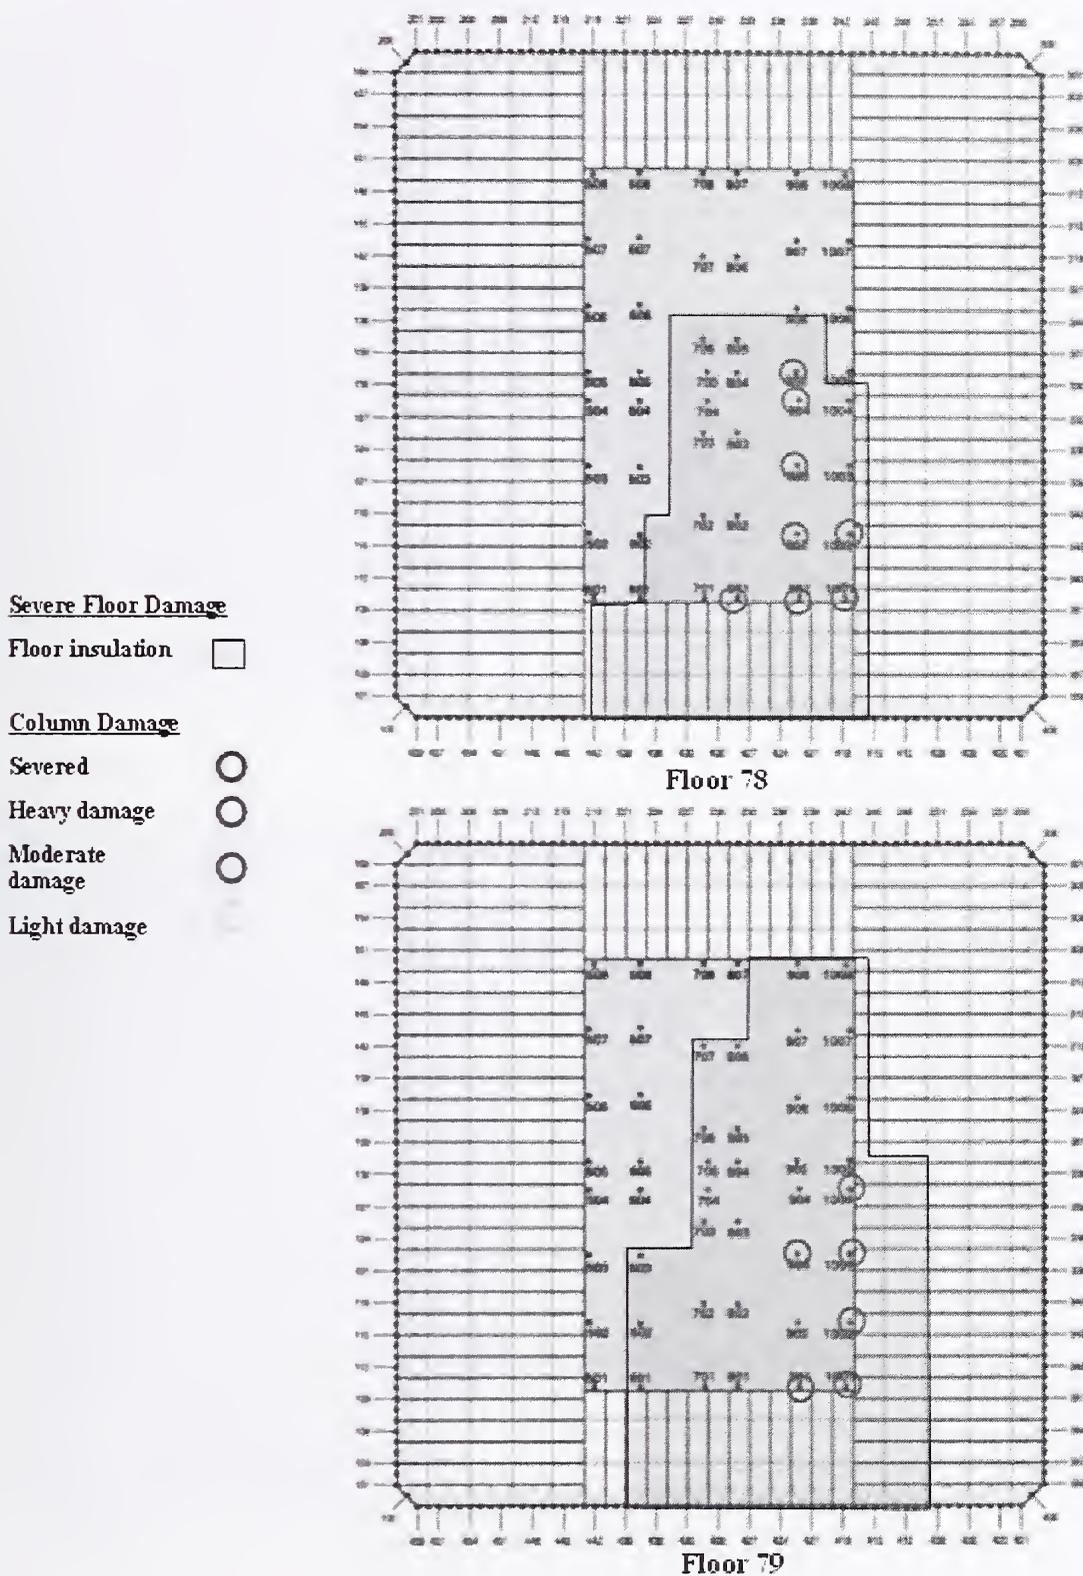
Figure B-13. WTC 2 Case C aircraft impact damage to Occupancy Floors 78 and 79.

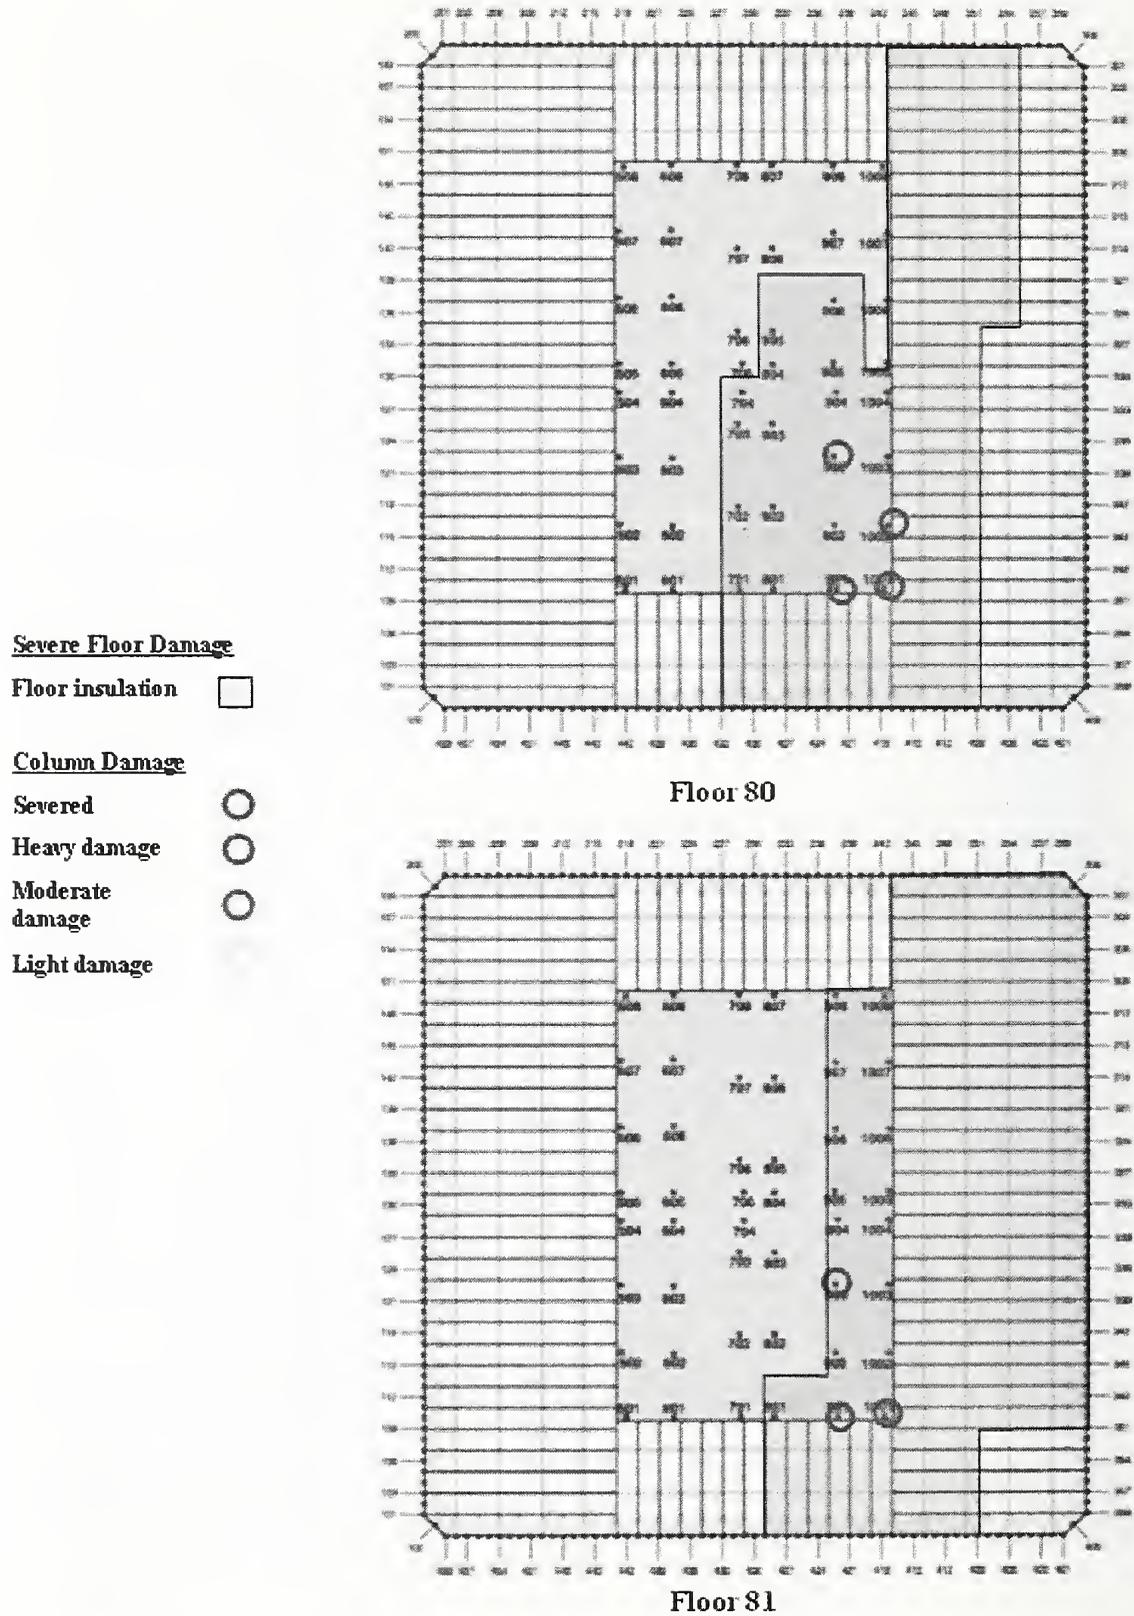
Figure B-14. WTC 2 Case C aircraft impact damage to Occupancy Floors 80 and 81.

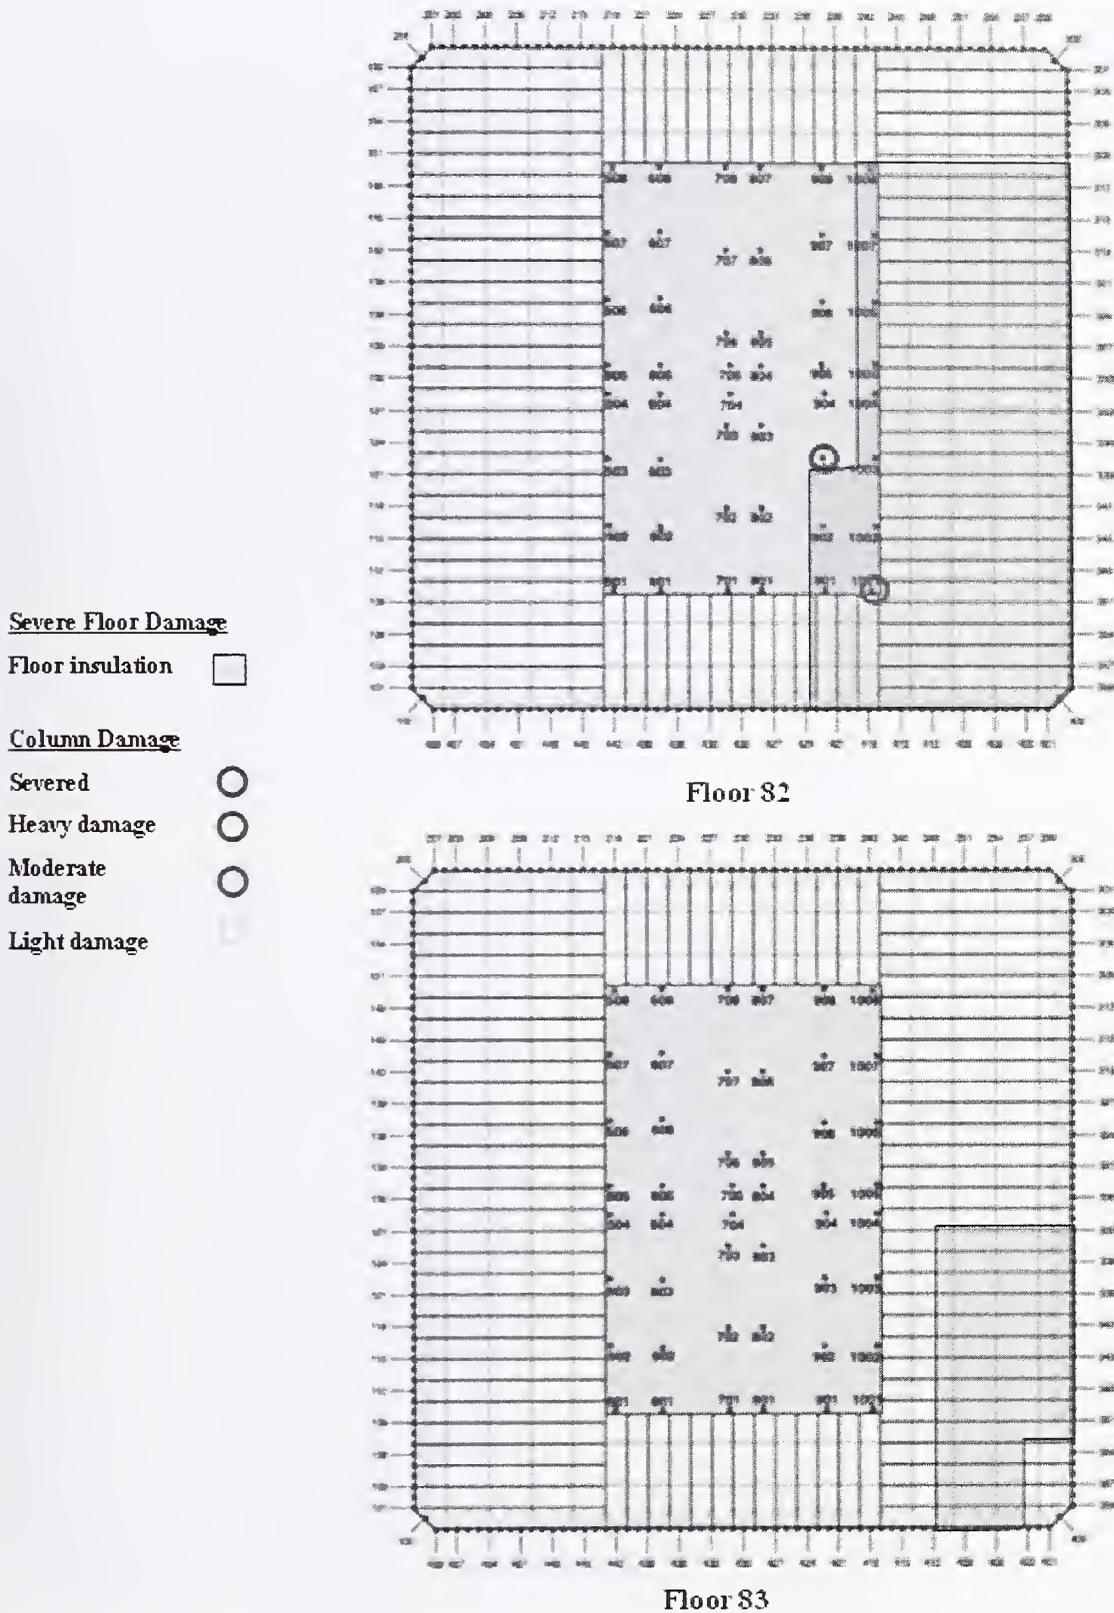
Figure B-15. WTC 2 Case C aircraft impact damage to Occupancy Floors 82 and 83.
