NIST NCSTAR 1-6

Federal Building and Fire Safety Investigation of  
the World Trade Center Disaster

# Structural Fire Response and Probable Collapse Sequence of the World Trade Center Towers

(Chapter 7- Appendix B)

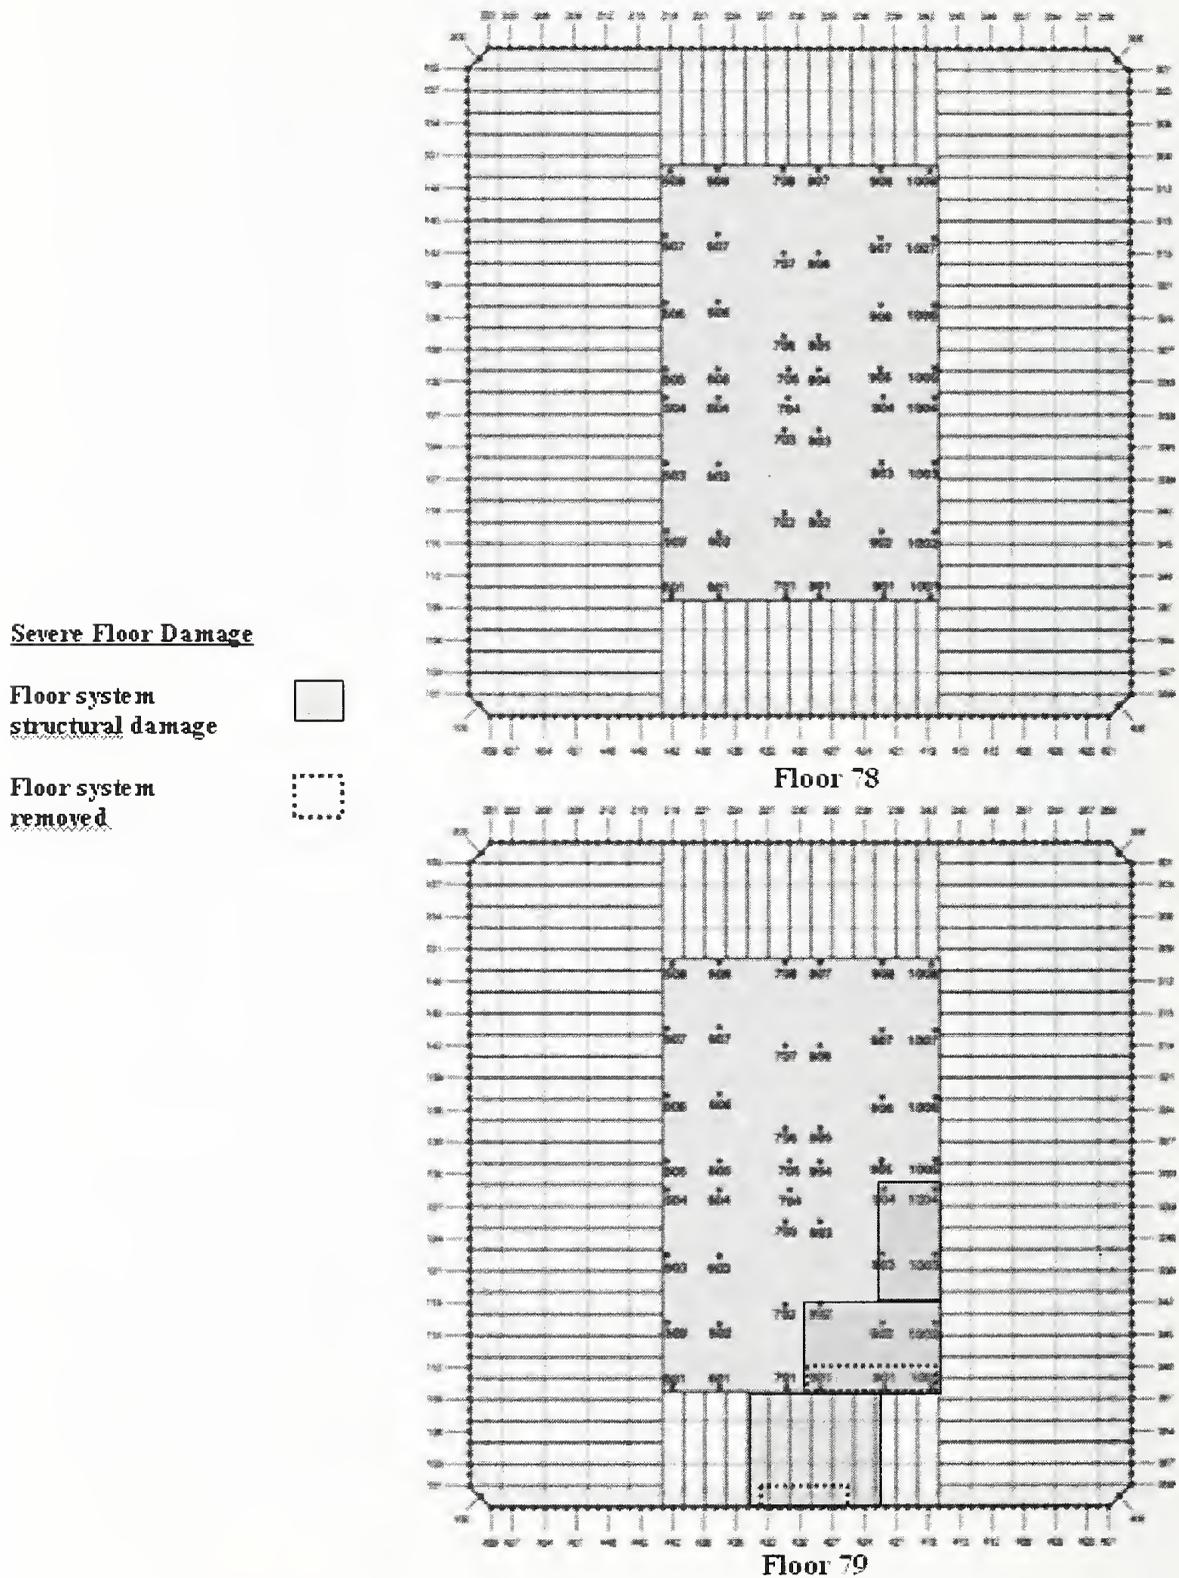
Figure B-16. WTC 2 Case C aircraft impact damage to Structural Floors 78 and 79.

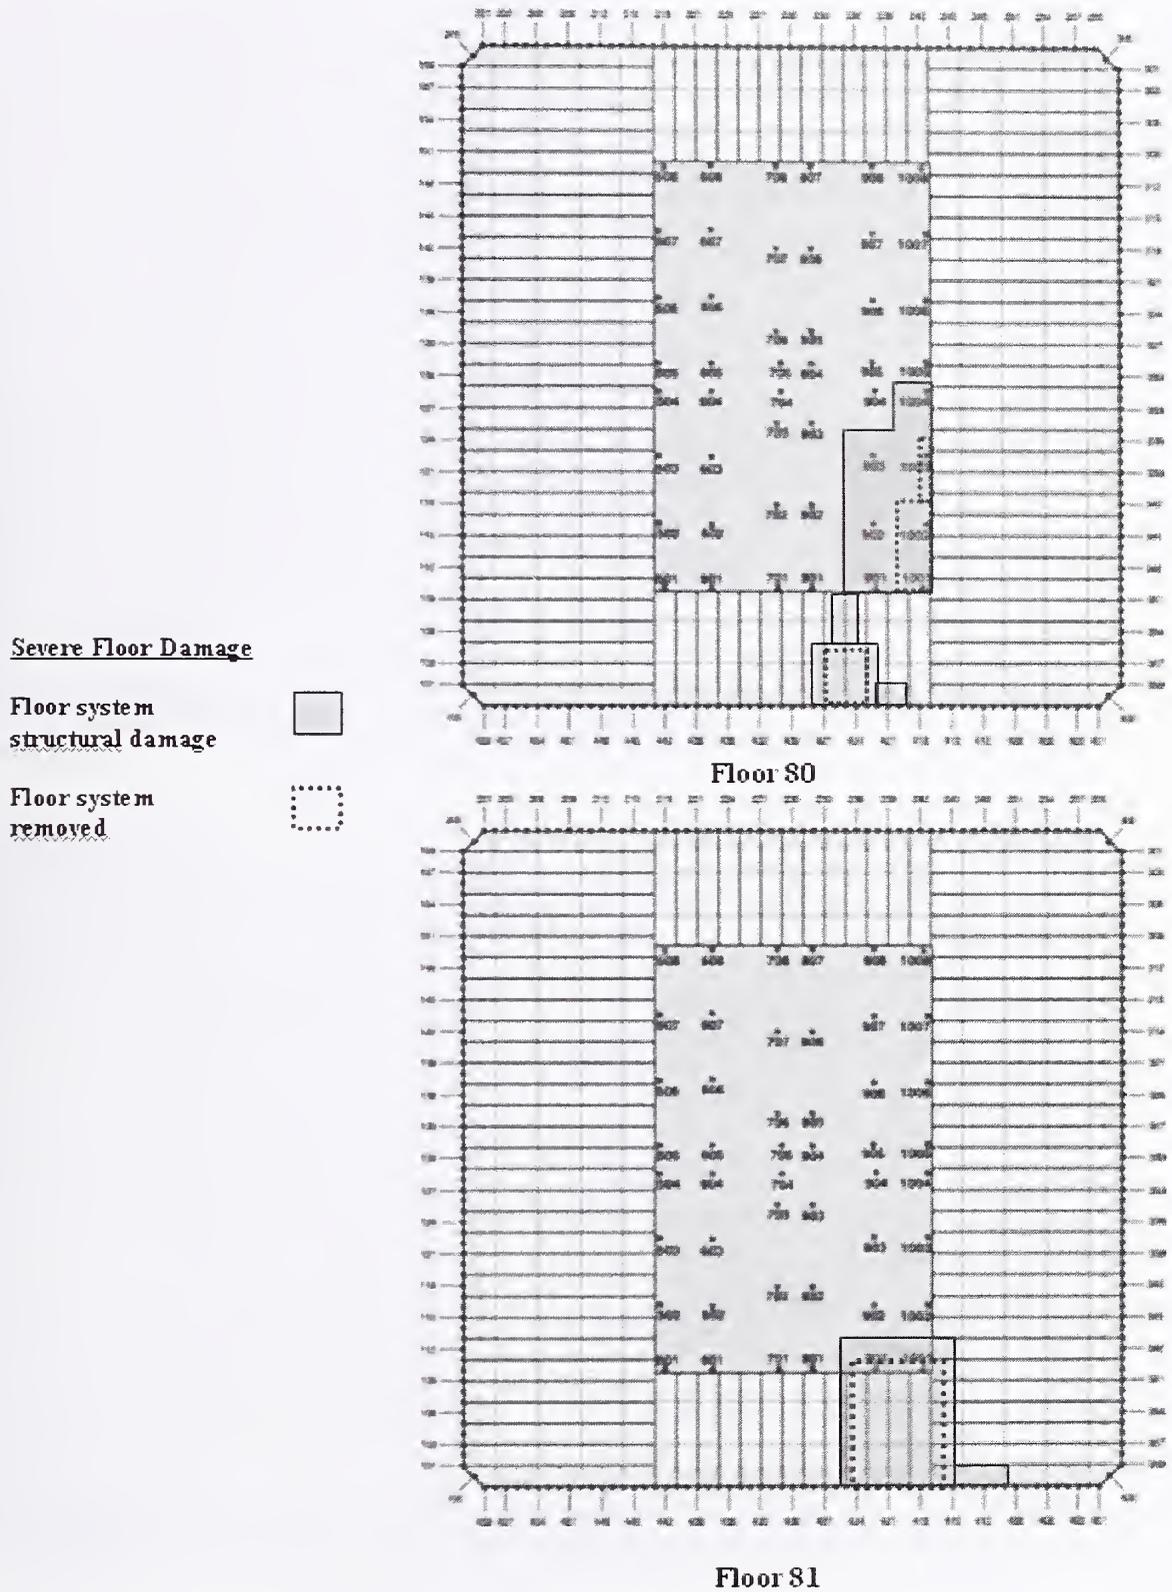
Figure B-17. WTC 2 Case C aircraft impact damage to Structural Floors 80 and 81.

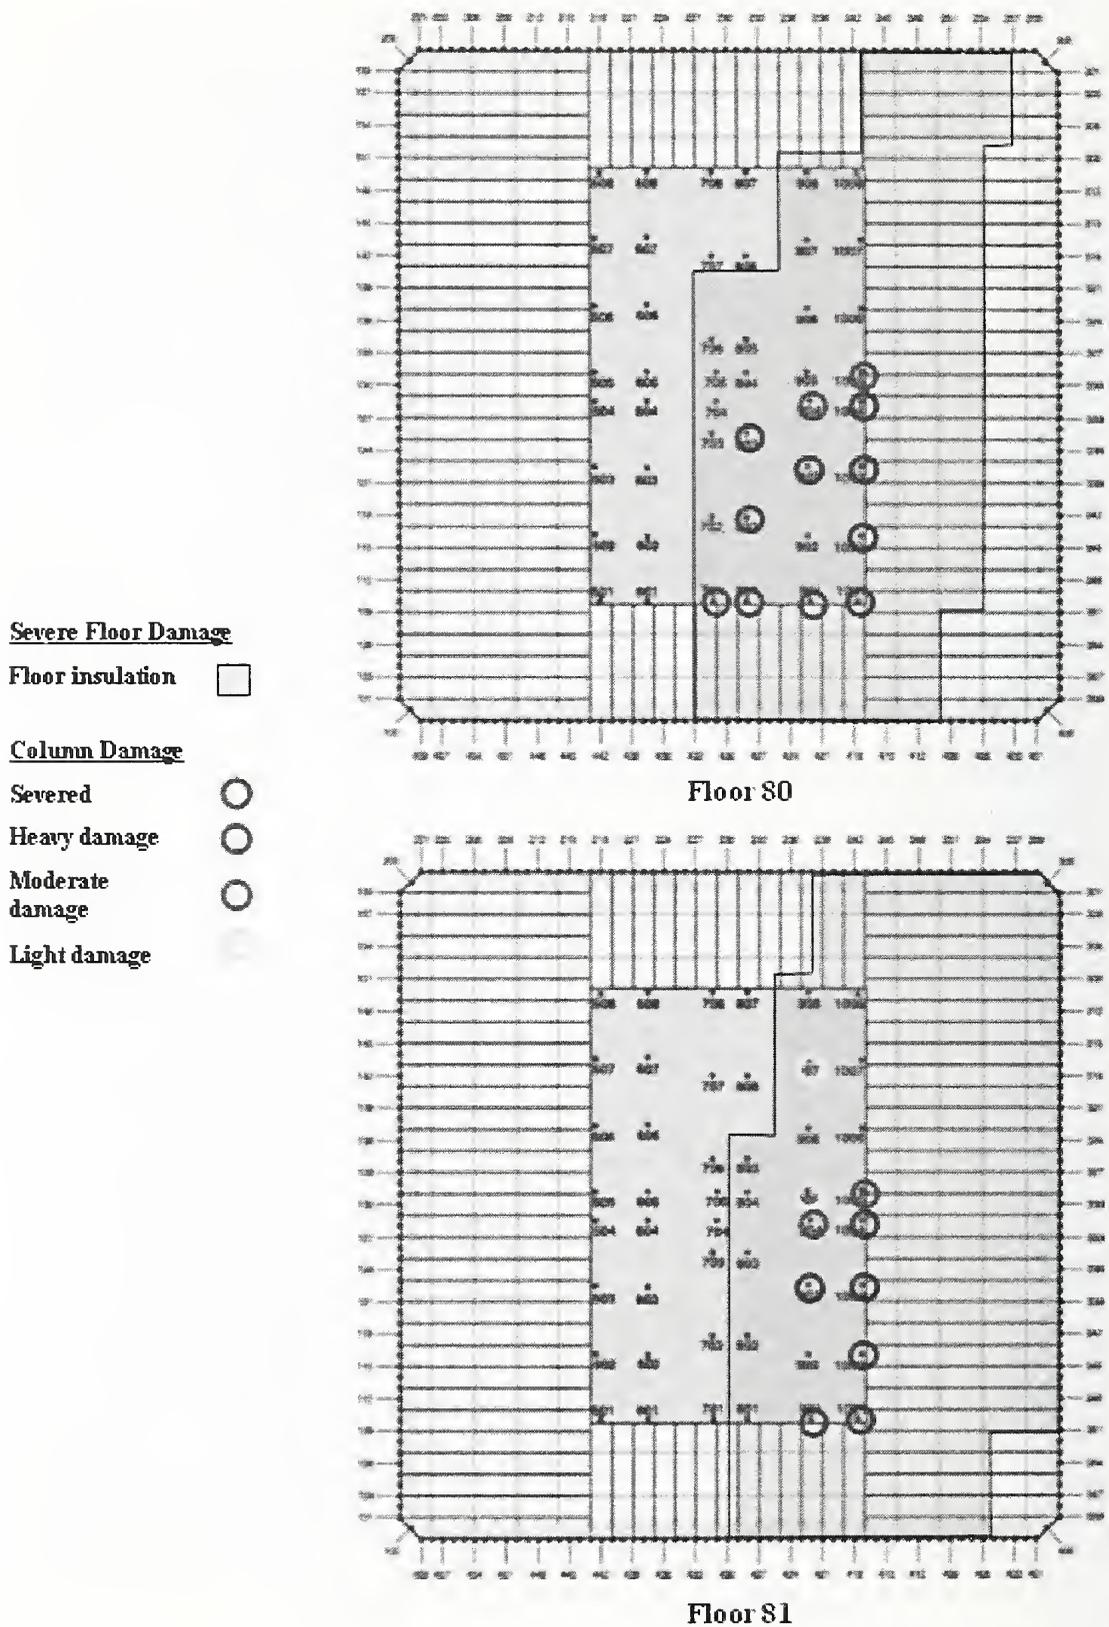
Figure B-20. WTC 2 Case D aircraft impact damage to Occupancy Floors 80 and 81.

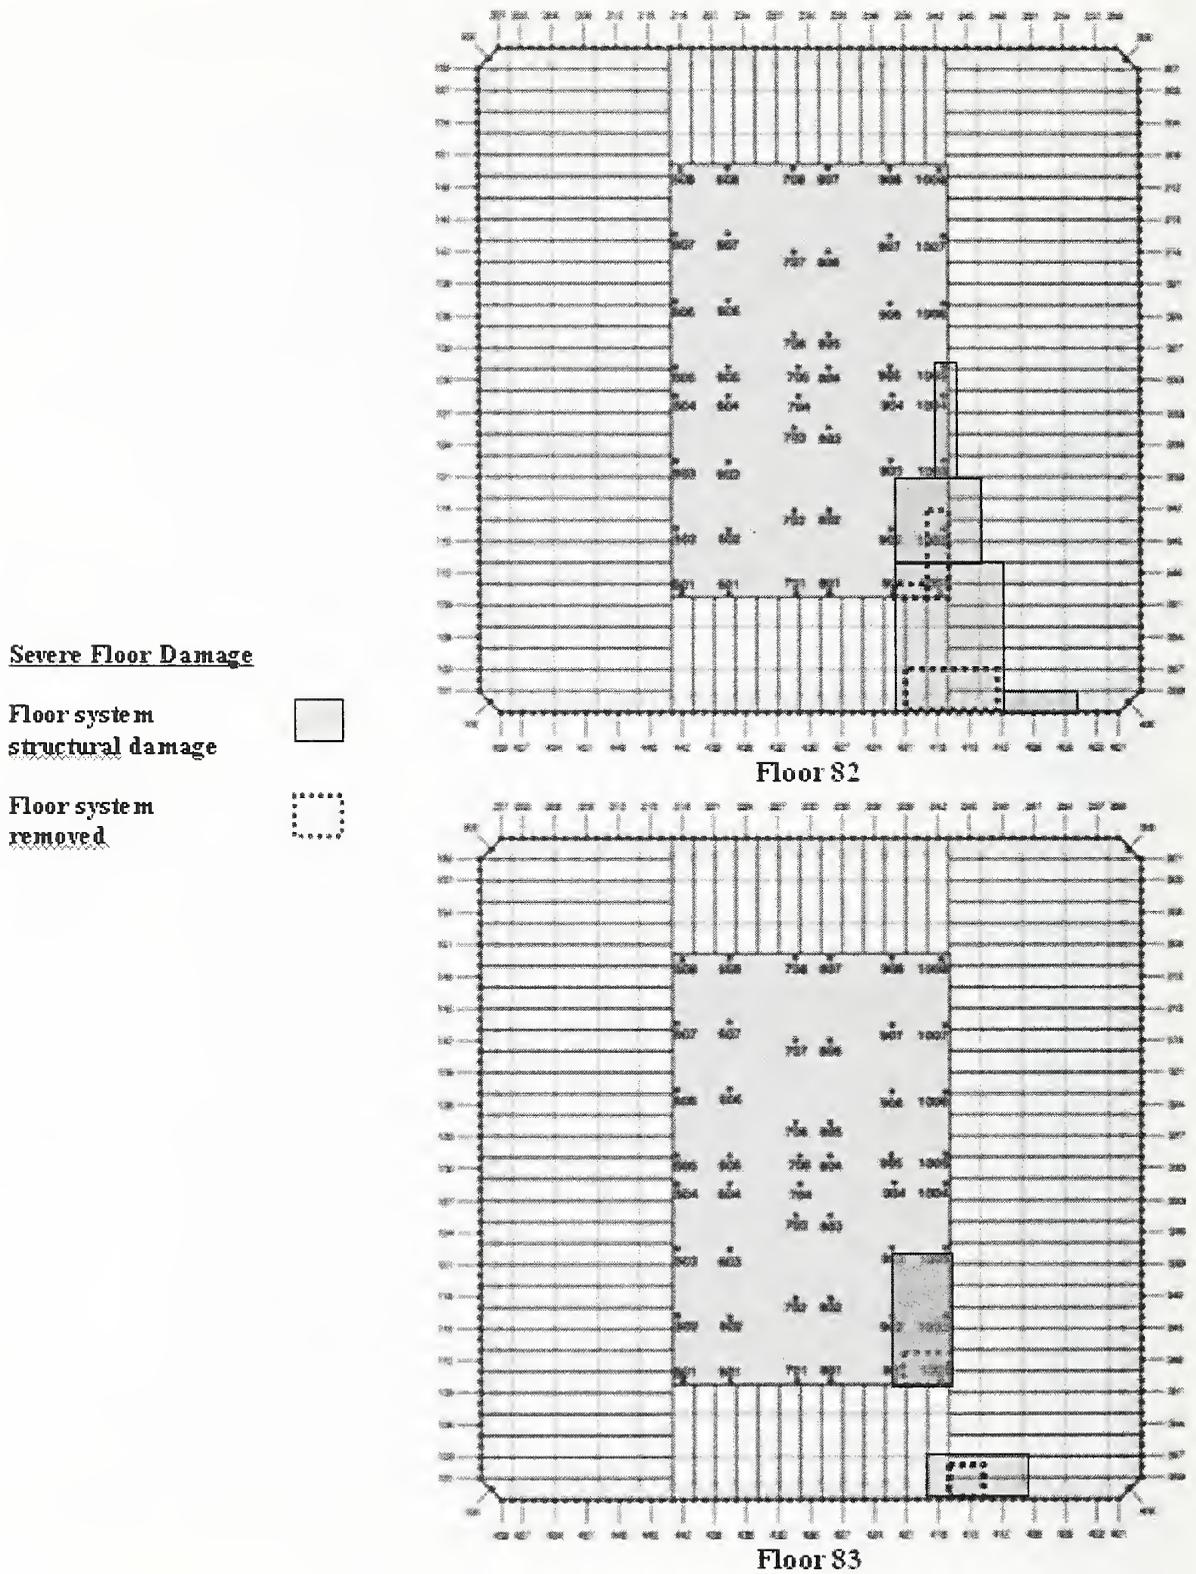
Figure B-24. WTC 2 Case D aircraft impact damage to Structural Floors 82 and 83.
