NATIONAL BUREAU OF STANDARDS REPORT

TRANSIENT VIBRATION TESTS ON WOOD-JOIST FLOORS

June 30, 1970

By
H. S. Lew and L. J. Davis

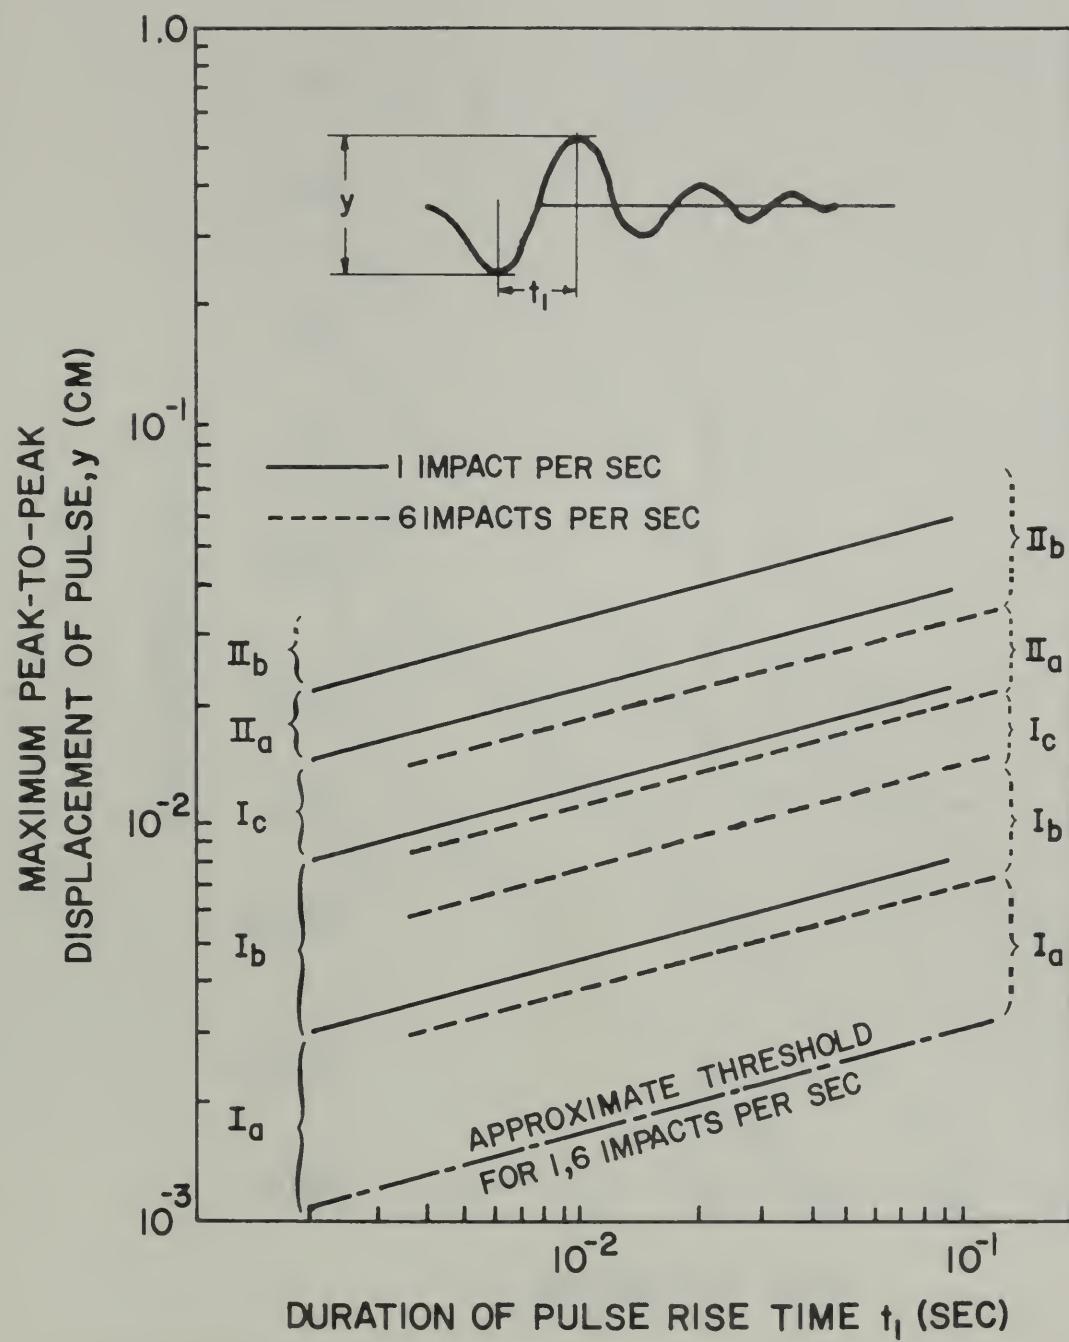
- I_a : THRESHOLD OF PERCEPTION
- I_b : EASY PERCEPTION
- I_c : STRONG PERCEPTION, ANNOYING
- II_a : VERY UNPLEASANT, POTENTIAL DANGER FOR LONG EXPOSURES
- II_b : EXTREMELY UNPLEASANT, DEFINITELY DANGEROUS

FIGURE I TOLERANCE OF HUMANS SUBJECTED TO REPEATED IMPACT
(DUE TO REIHER AND MEISTER, REF. 4)

Reiher and Meister studied the effect of repeated impact vibrations. Subjective tests were conducted under repeated impact pulses at the rate of from one impact every ten seconds to six impacts per one second. It was found that the human response to impact vibration is a function of: (1) the frequency of impact; (2) the maximum peak-to-peak displacement of the initial cycle; and (3) the rise time (half period of the initial cycle). The results of impact rates of one and six per second are given in figure 1.

In figure 18 the test results are plotted on Reiher and Meister's human response curves for one impact per second. As in the previous figure, the test results are grouped by the cross hatched region. It is seen that all test results lie well above the uppermost zone, II_b, indicating that the 75 ft-lb impact would not only induce unpleasant vibration but also would endanger the occupant.

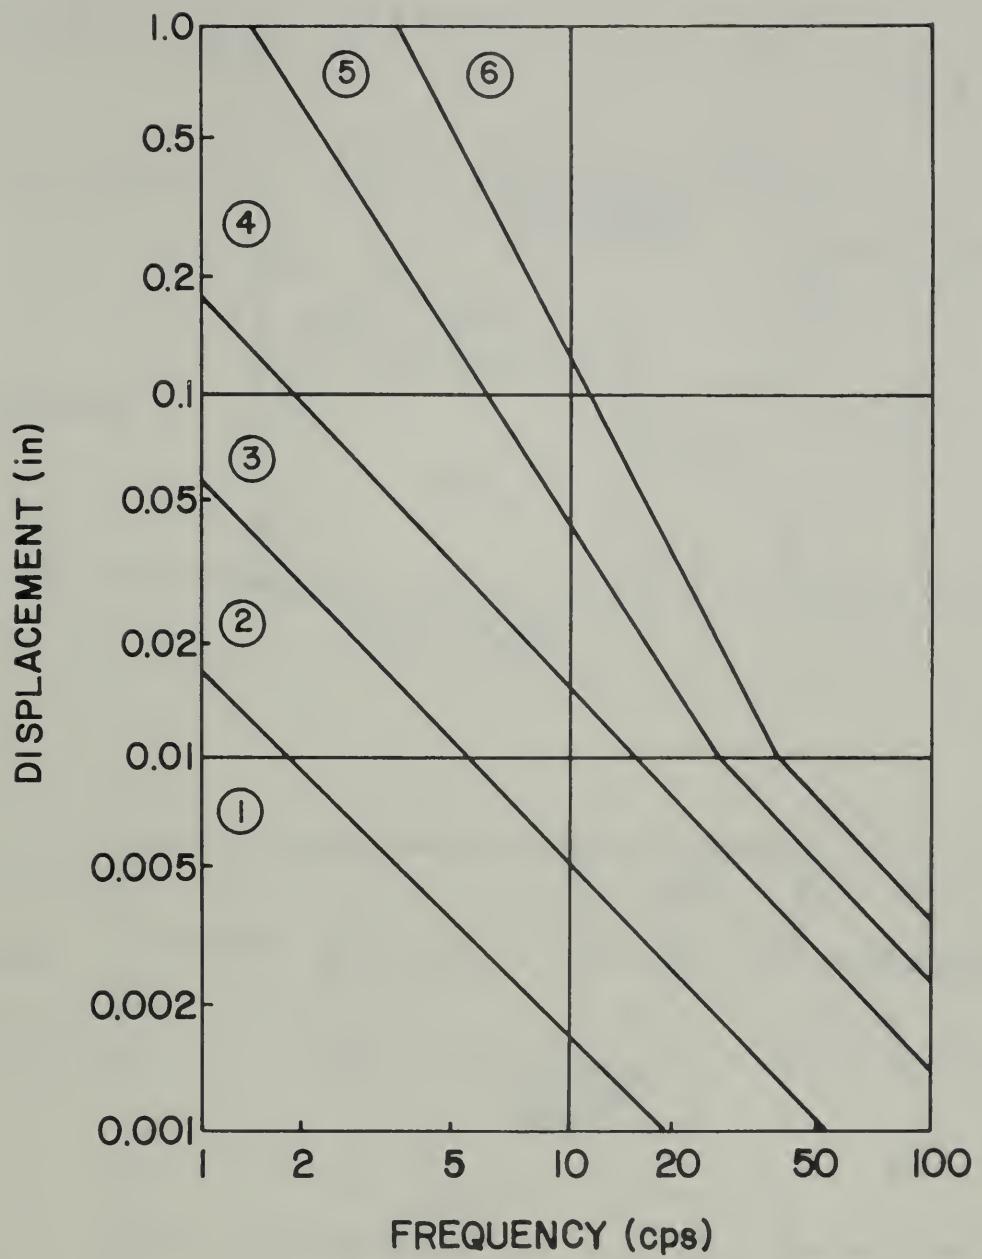
ZONE 1 : NOT PERCEPABLE
ZONE 2 : SLIGHTLY PERCEPABLE
ZONE 3 : DISTINCTLY PERCEPABLE
ZONE 4 : STRONGLY PERCEPABLE
ZONE 5 : DISTURBING
ZONE 6 : VERY DISTURBING, INJURIOUS

FIGURE 2 GRAPH OF REDUCED HUMAN RESPONSE
(DUE TO REIHER AND MEISTER, REF. 3 AND MODIFIED
BY LENZEN, REF. 2)

out in the Lenzen report that if the floor was damped to a small amplitude prior to five cycles of vibration, only the initial impact was sensed. If, however, the vibration persisted for more than 12 complete cycles, the subjects responded to the vibration as if it were a steady-state vibration. It was suggested that for vibration caused by a single impact the human response curve obtained by Reiher and Meister (3) could be used with the amplitude scale increased by a factor of 10. The selection of this factor of 10 by Lenzen appears to have been arbitrary and the curve so corrected is shown in figure 2.

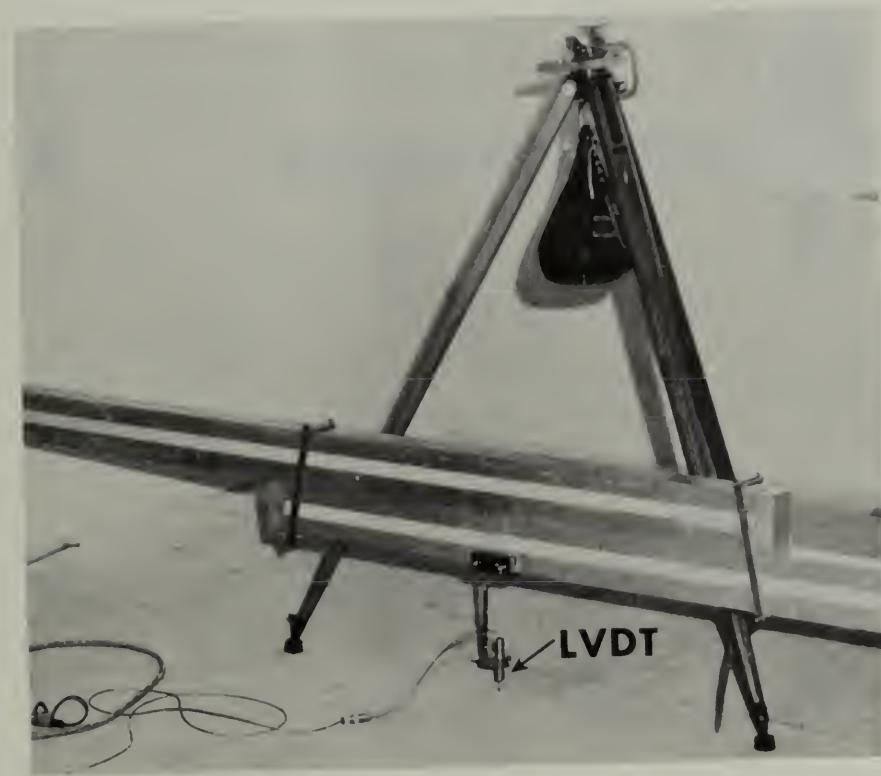
FIGURE 7 PHOTOGRAPH OF TYPICAL TEST SETUP

The test setup is shown in figure 7. It consisted of a weighted bag, a bag-release device mounted on a tripod, and a linear variable differential transformer (LVDT) for deflection measurement.

Filled with sand and lead shot to a weight of 25 lb, the bag was suspended 3 ft above the floor surface. This test setup produced an impact energy of 75 ft-lb, which was sufficient to induce measurable vibratory motion of the floors found in residential structures. This level of impact energy is also considered to be approximately the amount of the energy induced by a 150-lb person moving rapidly across a floor.

The LVDT had a gage length of ± 1.0 in and was calibrated to read increments of ± 0.0001 in. The LVDT was attached to a beam of adjustable-length which was positioned to span between two opposite walls. Both the

loading device and the LVDT were placed as close to the center of the room as possible. The plunger of the LVDT was secured to the floor surface to eliminate rebound. The output of the LVDT was recorded by a recording oscillograph equipped with a 600-cps-response galvanometer.

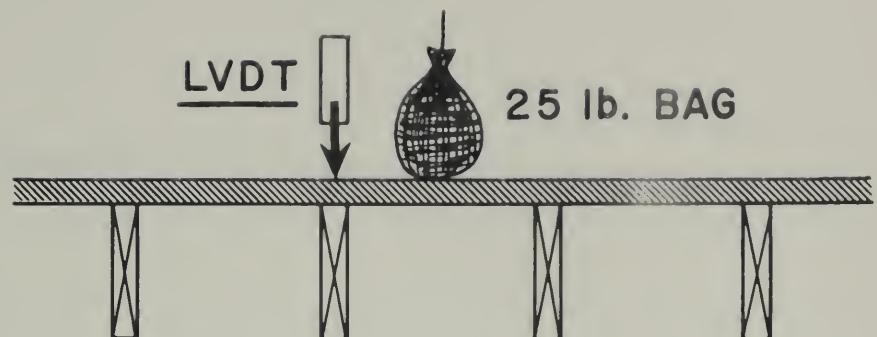
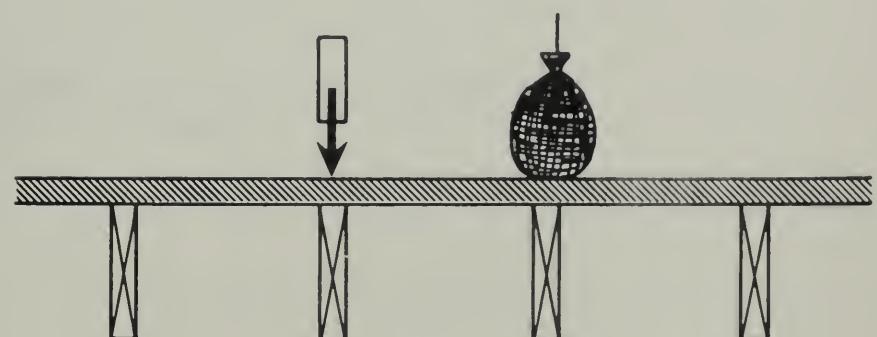
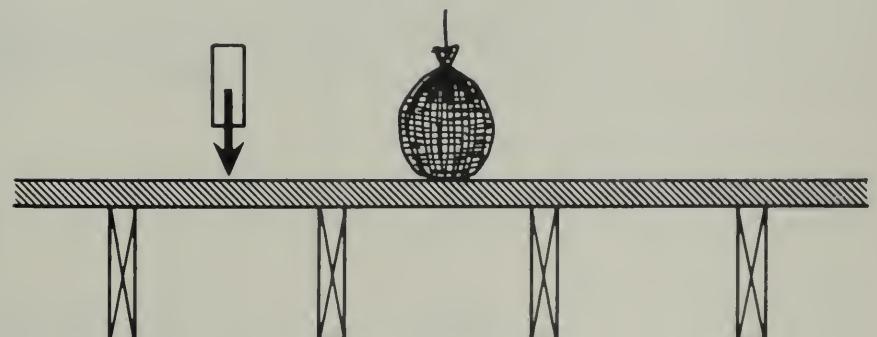
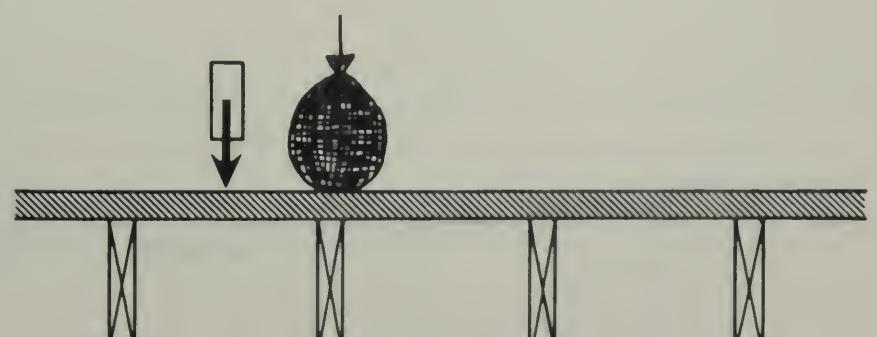
FIG. 8 TEST SETUP AND SEQUENCE

Each floor was tested under four different arrangements as shown in figure 8, the arrangements differing from one another in both the location of the LVDT and the impact point with respect to the joist location.

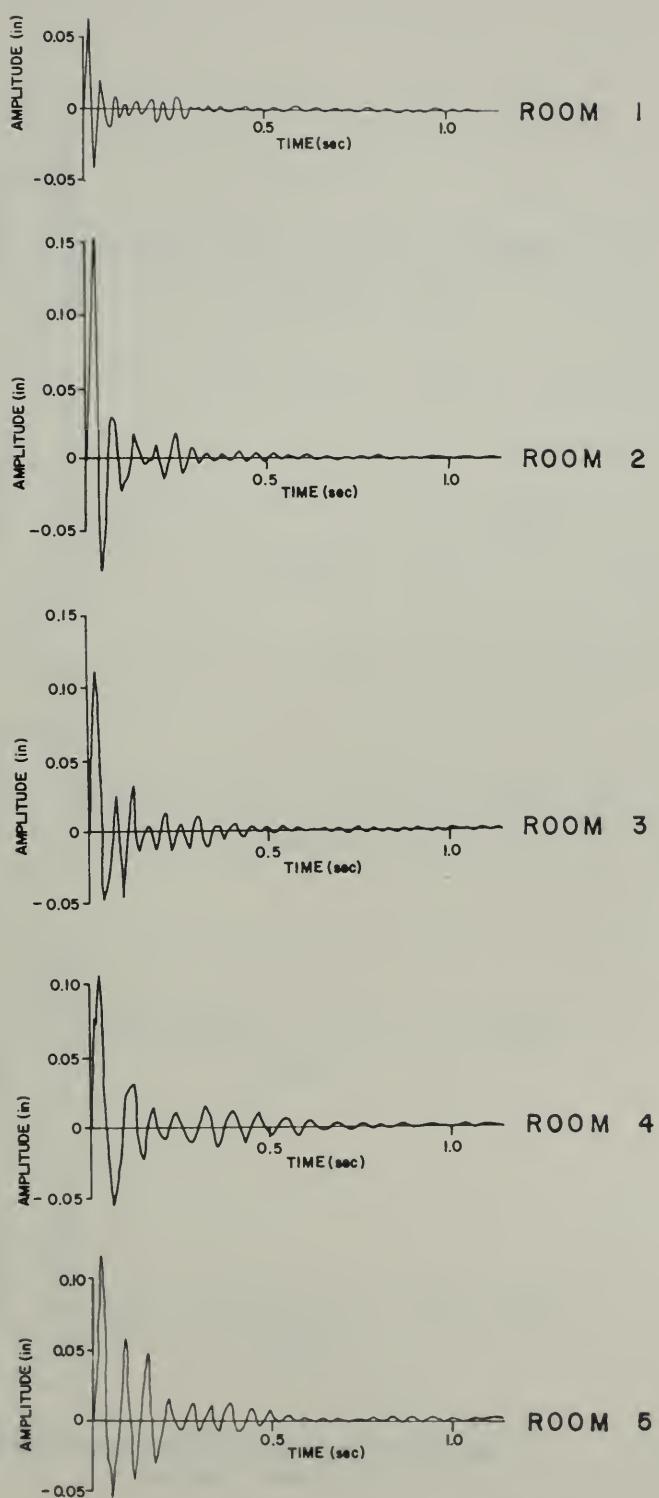
FIGURE 9 DEFLECTION TRACES OF HOUSE NO. 1
UNFURNISHED - TEST SETUP A.

Response to the impact loading for each floor is given in tables 2 through 8. The numerical values listed in the tables are obtained from the deflection traces which are shown in figures 9 through 15 for test setup A.

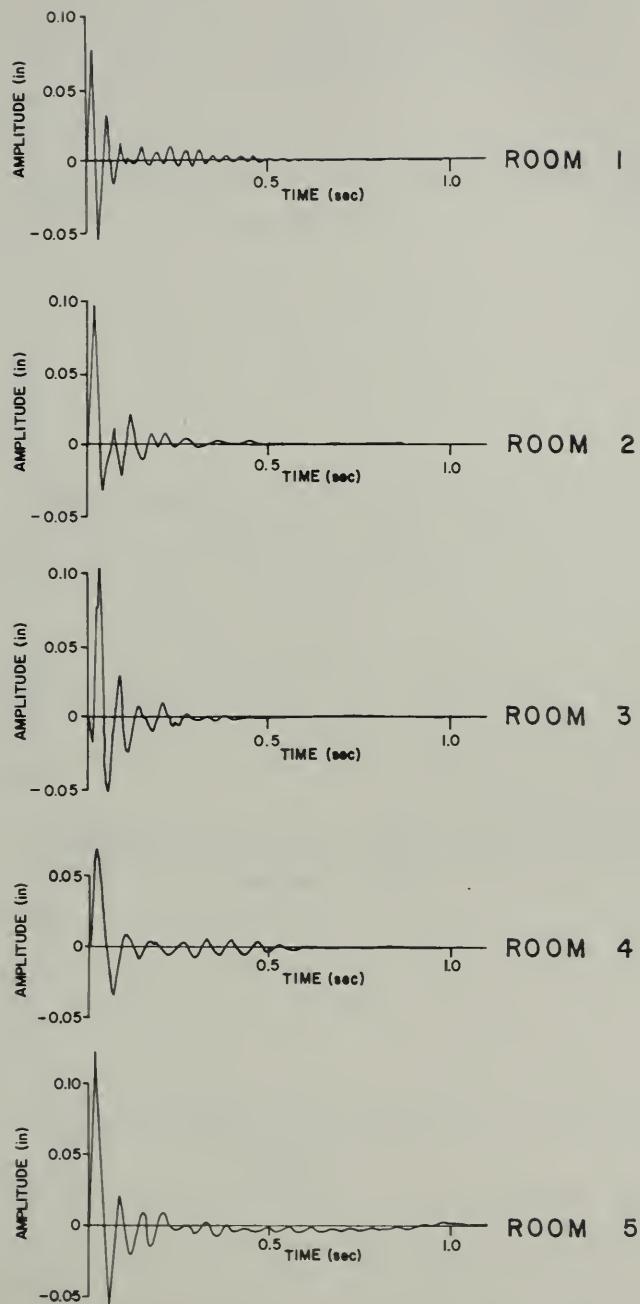
**FIGURE 10 DEFLECTION TRACES OF HOUSE NO. 1
FURNISHED - TEST SETUP A.**

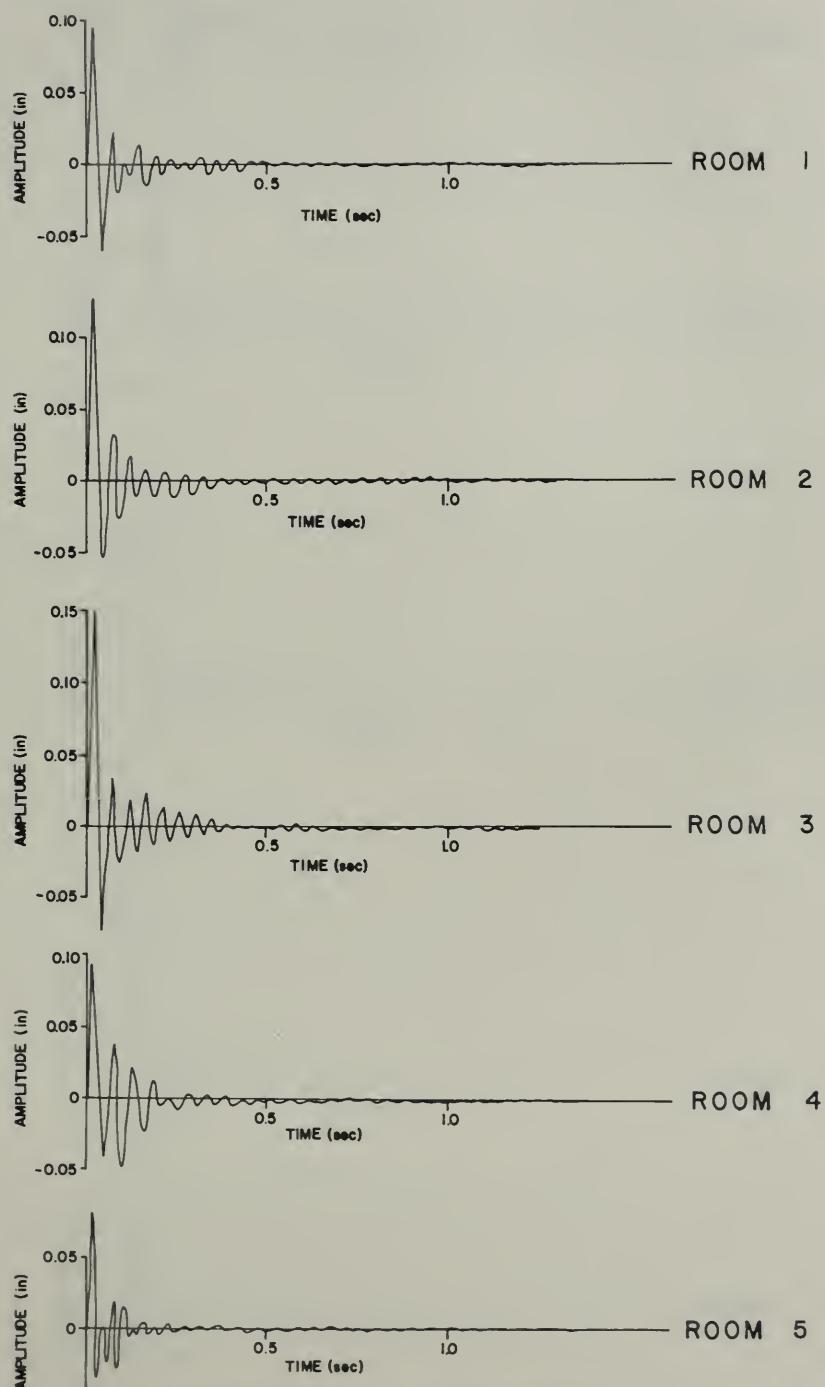
**FIGURE 11 DEFLECTION TRACES OF HOUSE NO. 2
UNFURNISHED - TEST SETUP A.**

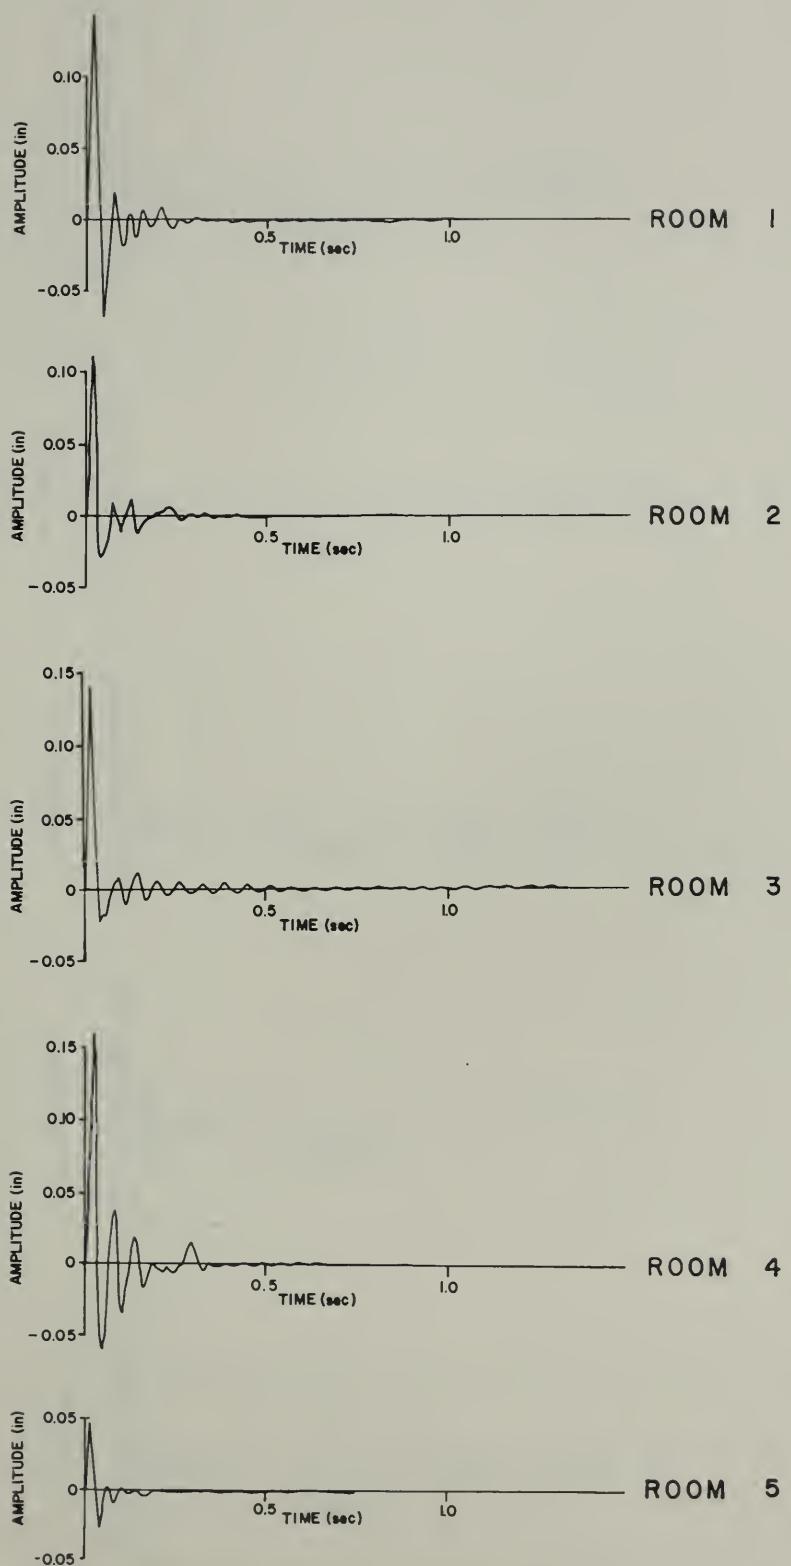
**FIGURE 12 DEFLECTION TRACES OF HOUSE NO. 2
FURNISHED - TEST SETUP A.**

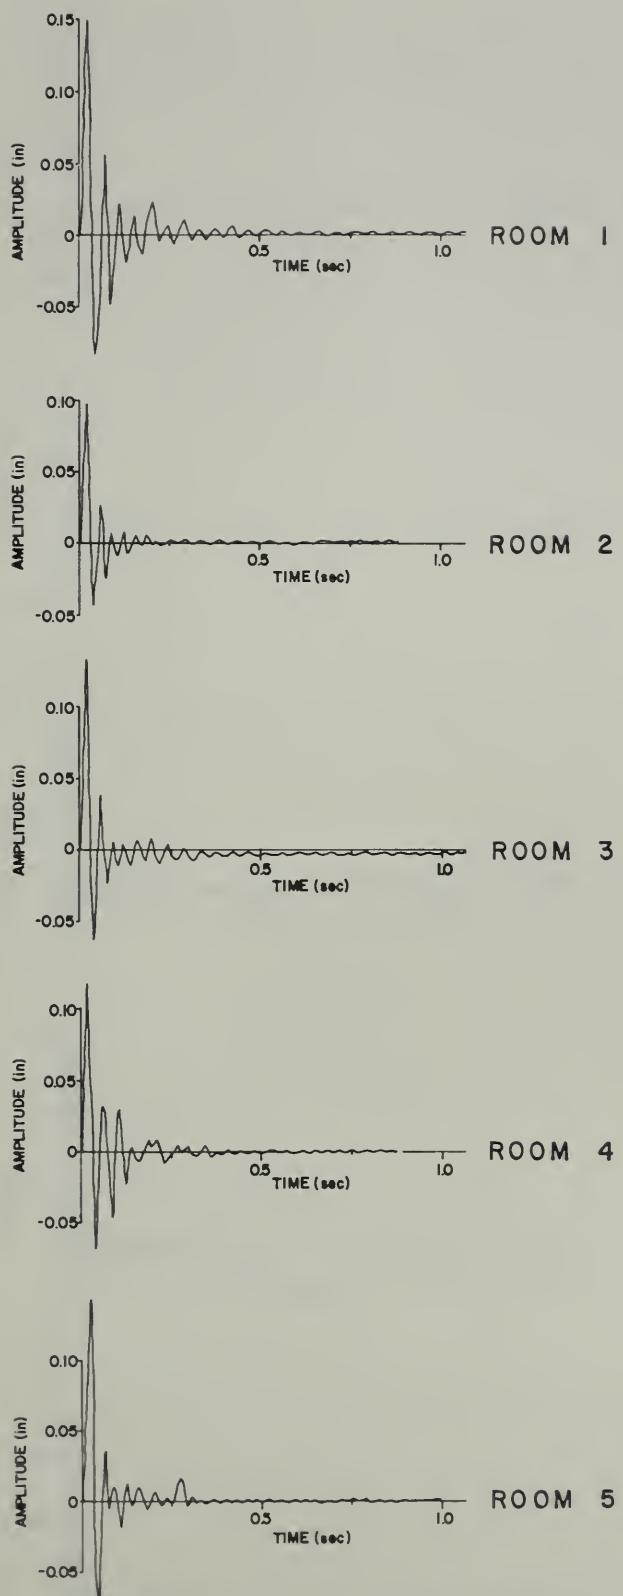
FIGURE 13 DEFLECTION TRACES OF HOUSE NO. 3
UNFURNISHED - TEST SETUP A.

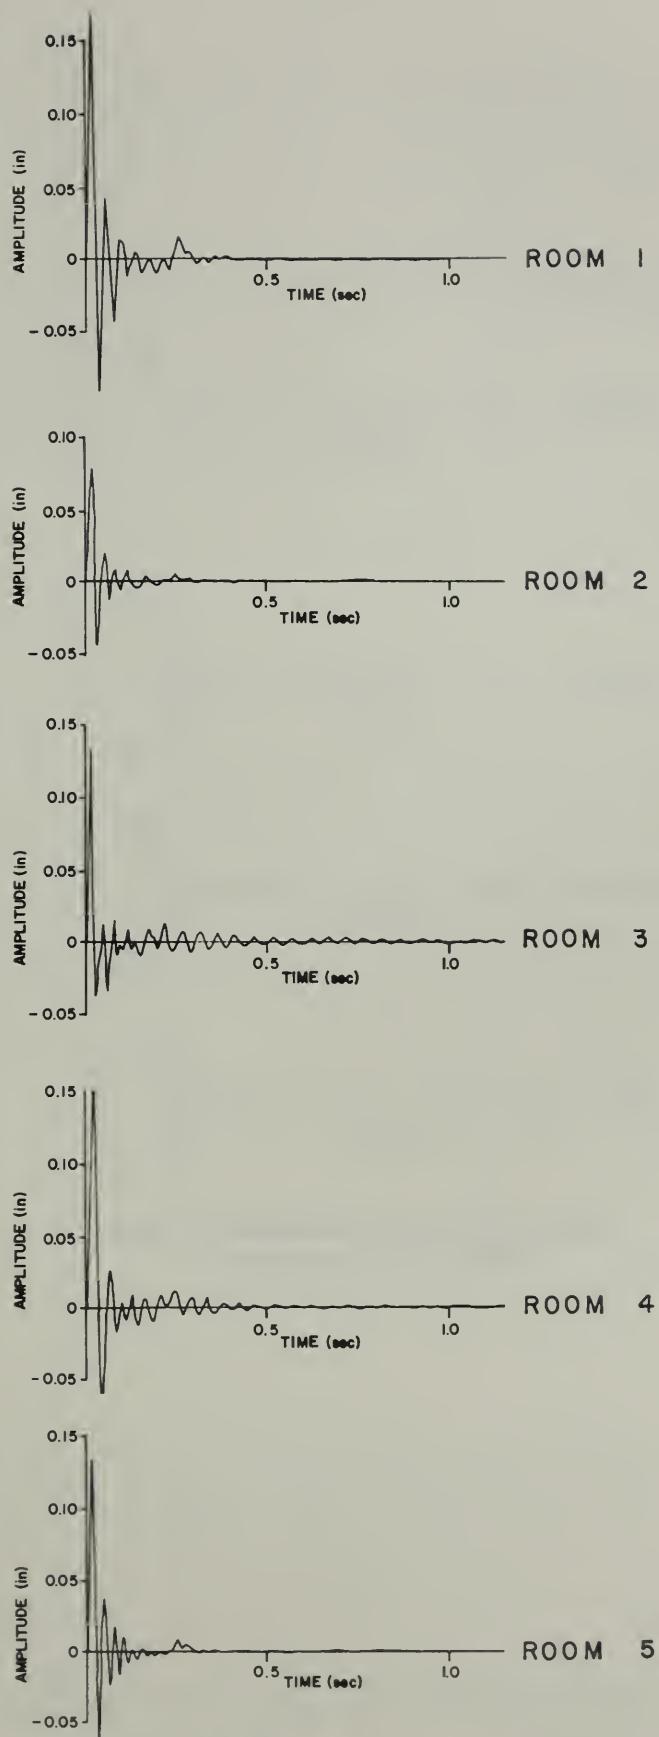
**FIGURE 14 DEFLECTION TRACES OF HOUSE NO. 3
FURNISHED - TEST SETUP A.**

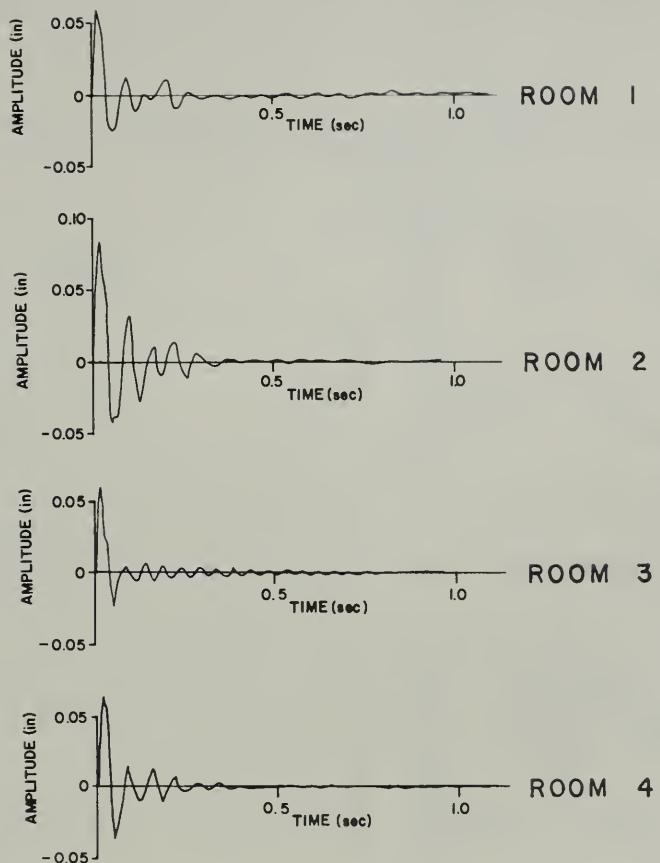
FIGURE 15 DEFLECTION TRACES OF APARTMENT
UNFURNISHED - TEST SETUP A.

When all of these three types of finish are compared with the floor which had lightweight concrete, the latter floor showed a greater damping than the other three. Figure 15 shows the response of the floors which had the lightweight concrete. It is seen that most of the vibration damped out within 5 cycles.

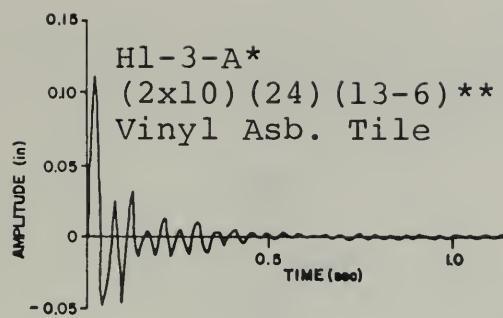
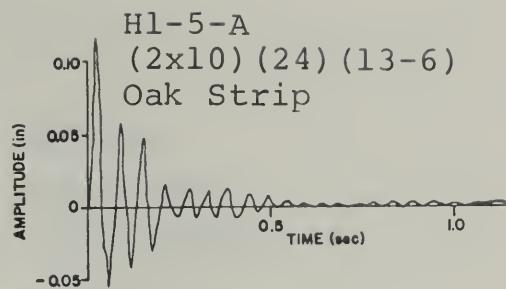
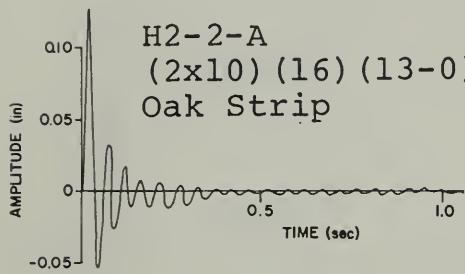
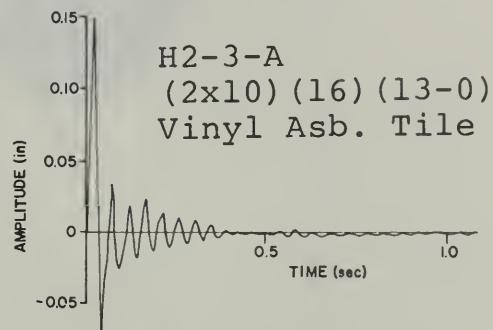
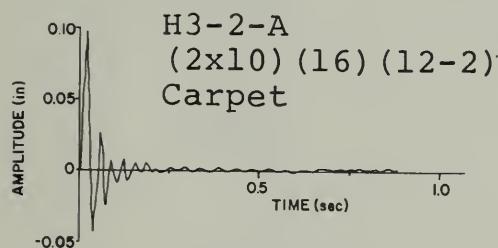
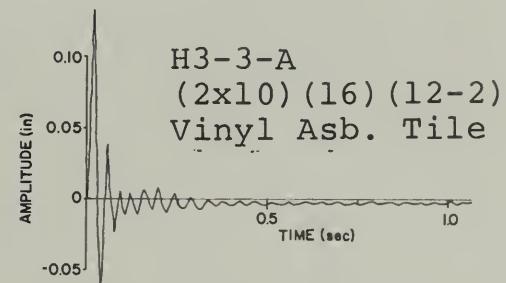
(a) Vinyl Asbestos Tile vs. Oak Strip

(b) Vinyl Asbestos Tile vs. Oak Strip

(c) Vinyl Asbestos Tile vs. Carpet

FIGURE 16 COMPARISON OF FLOOR RESPONSES AS AFFECTED BY FLOOR FINISH

A comparison was made of the response of floors of unfurnished houses in figure 16 using the corresponding

tabulated data given in tables 2, 4 and 6. This reveals that while no significant difference in the initial impact deflection was observed between the floors finished with oak strip and vinyl asbestos tiles, respectively, a substantial difference in the initial deflection was observed between the floors covered with vinyl asbestos tiles and those finished with carpet. For otherwise similar floors, the initial deflection of the carpeted floors (H3-2) was between 27 and 52 percent less than that of the floors finished with vinyl asbestos tiles (H3-3). Of the three finishes, namely oak strip, vinyl asbestos tile and carpets, the carpet provided somewhat greater damping than the other two.

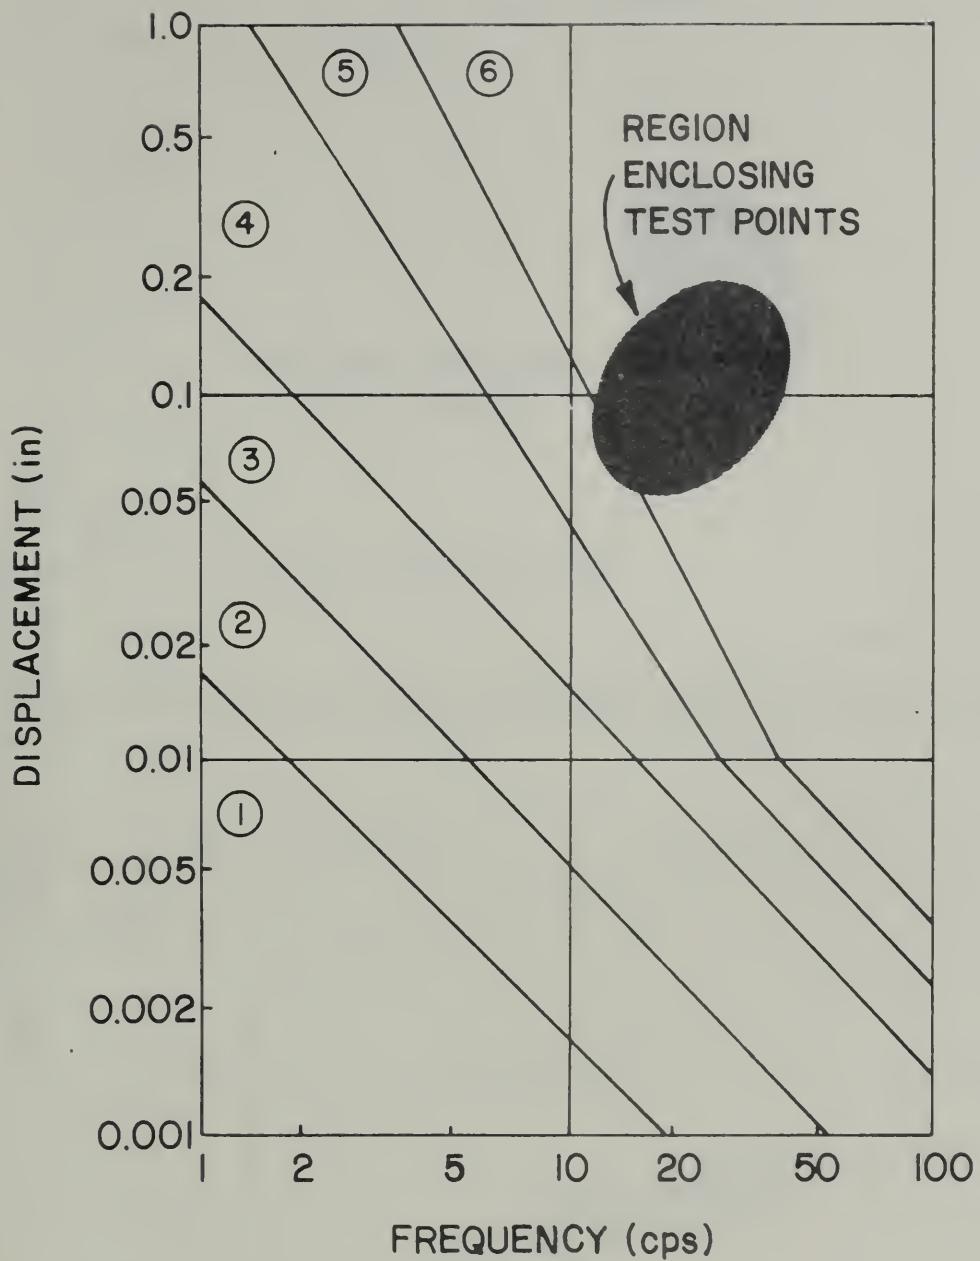
ZONE 1 : NOT PERCEPTIBLE
 ZONE 2 : SLIGHTLY PERCEPTIBLE
 ZONE 3 : DISTINCTLY PERCEPTIBLE
 ZONE 4 : STRONGLY PERCEPTIBLE
 ZONE 5 : DISTURBING
 ZONE 6 : VERY DISTURBING, INJURIOUS

FIGURE 17 GRAPH OF REDUCED HUMAN RESPONSE
 (DUE TO REIHER AND MEISTER, REF. 3 AND MODIFIED
 BY LENZEN, REF. 2)

The test results are plotted on the human response curves for transient vibration as suggested by Lenzen in figure 17. Because the test points are clustered in a small area, the region which encompasses all the test points is cross hatched. The test data indicated that most floors

tested fall in Zone 5 and 6 with most of the test points in Zone 6, suggesting that for an impact of 75 ft-lb the floor response would greatly disturb and be injurious to the occupant.

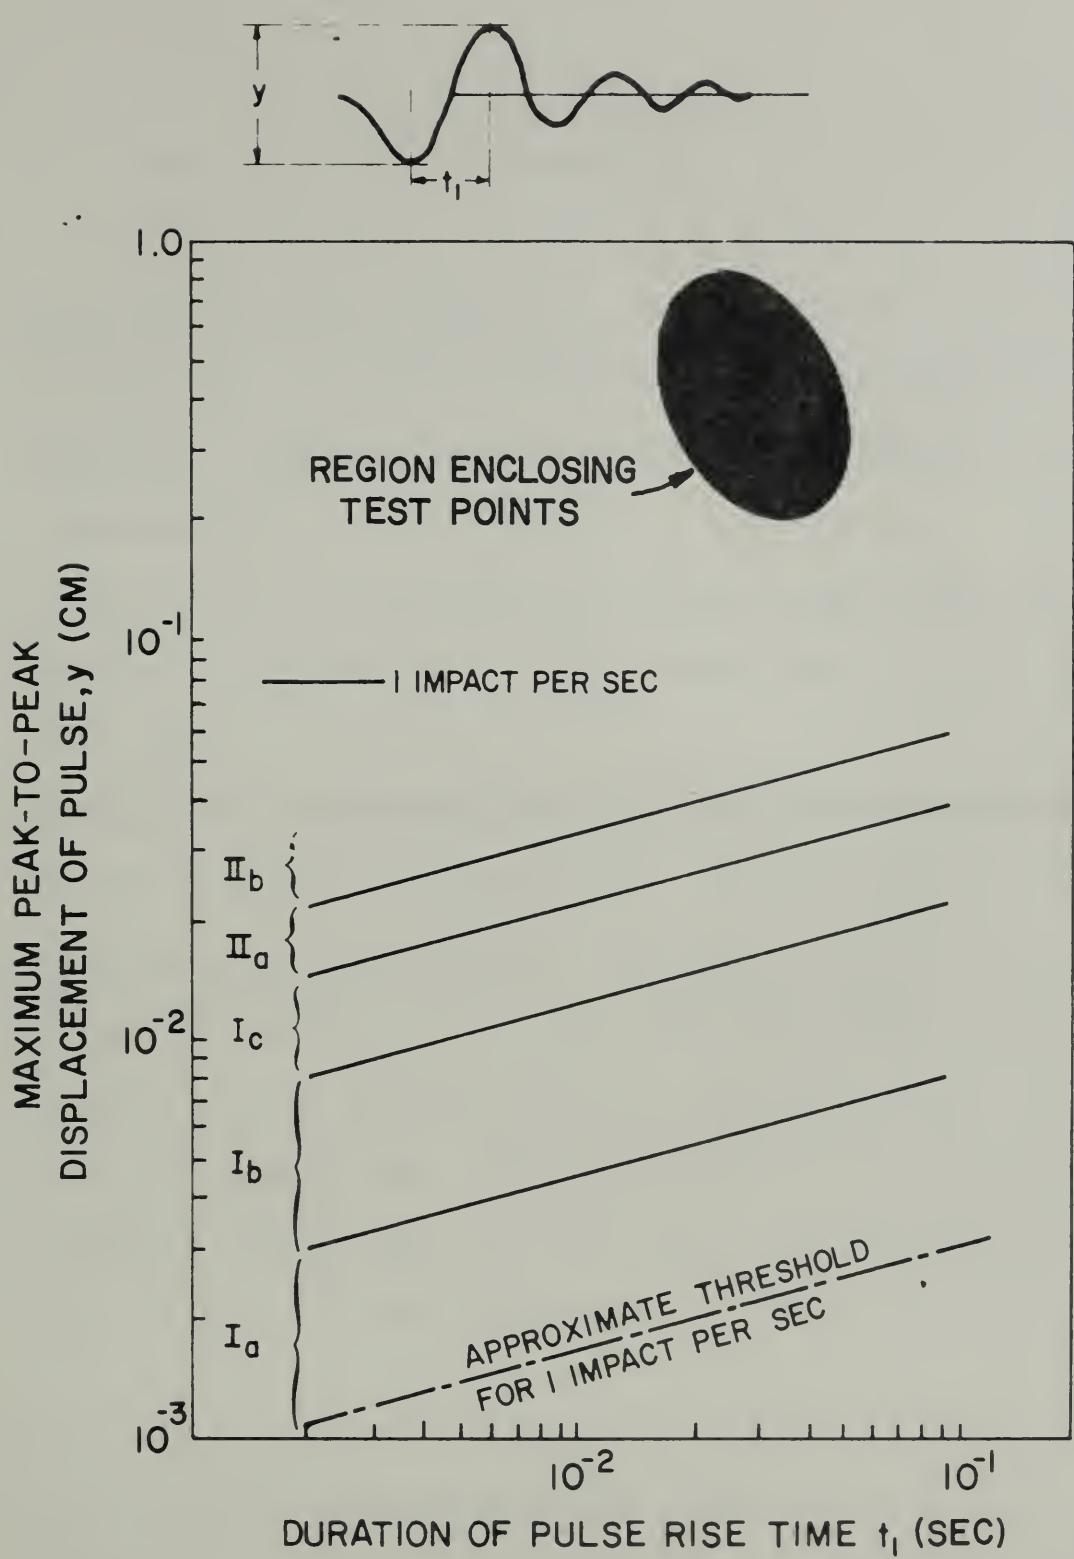
I_a : THRESHOLD OF PERCEPTION

I_b : EASY PERCEPTION
