FIRE ENDURANCE TEST OF A STEEL FLOOR CONSTRUCTION FOR SINGLE FAMILY HOUSING

As a part of the evaluation of Operation BREAKTHROUGH housing systems, a standard fire test performed in accordance with the requirements of procedure ASTM E119-69 was conducted on December 17, 1970, at the National Bureau of Standards on a steel floor system.

Time of failure was 8 minutes:45 seconds. The initial mode of failure was by flame-through of the floor assembly which was then followed by structural failure.

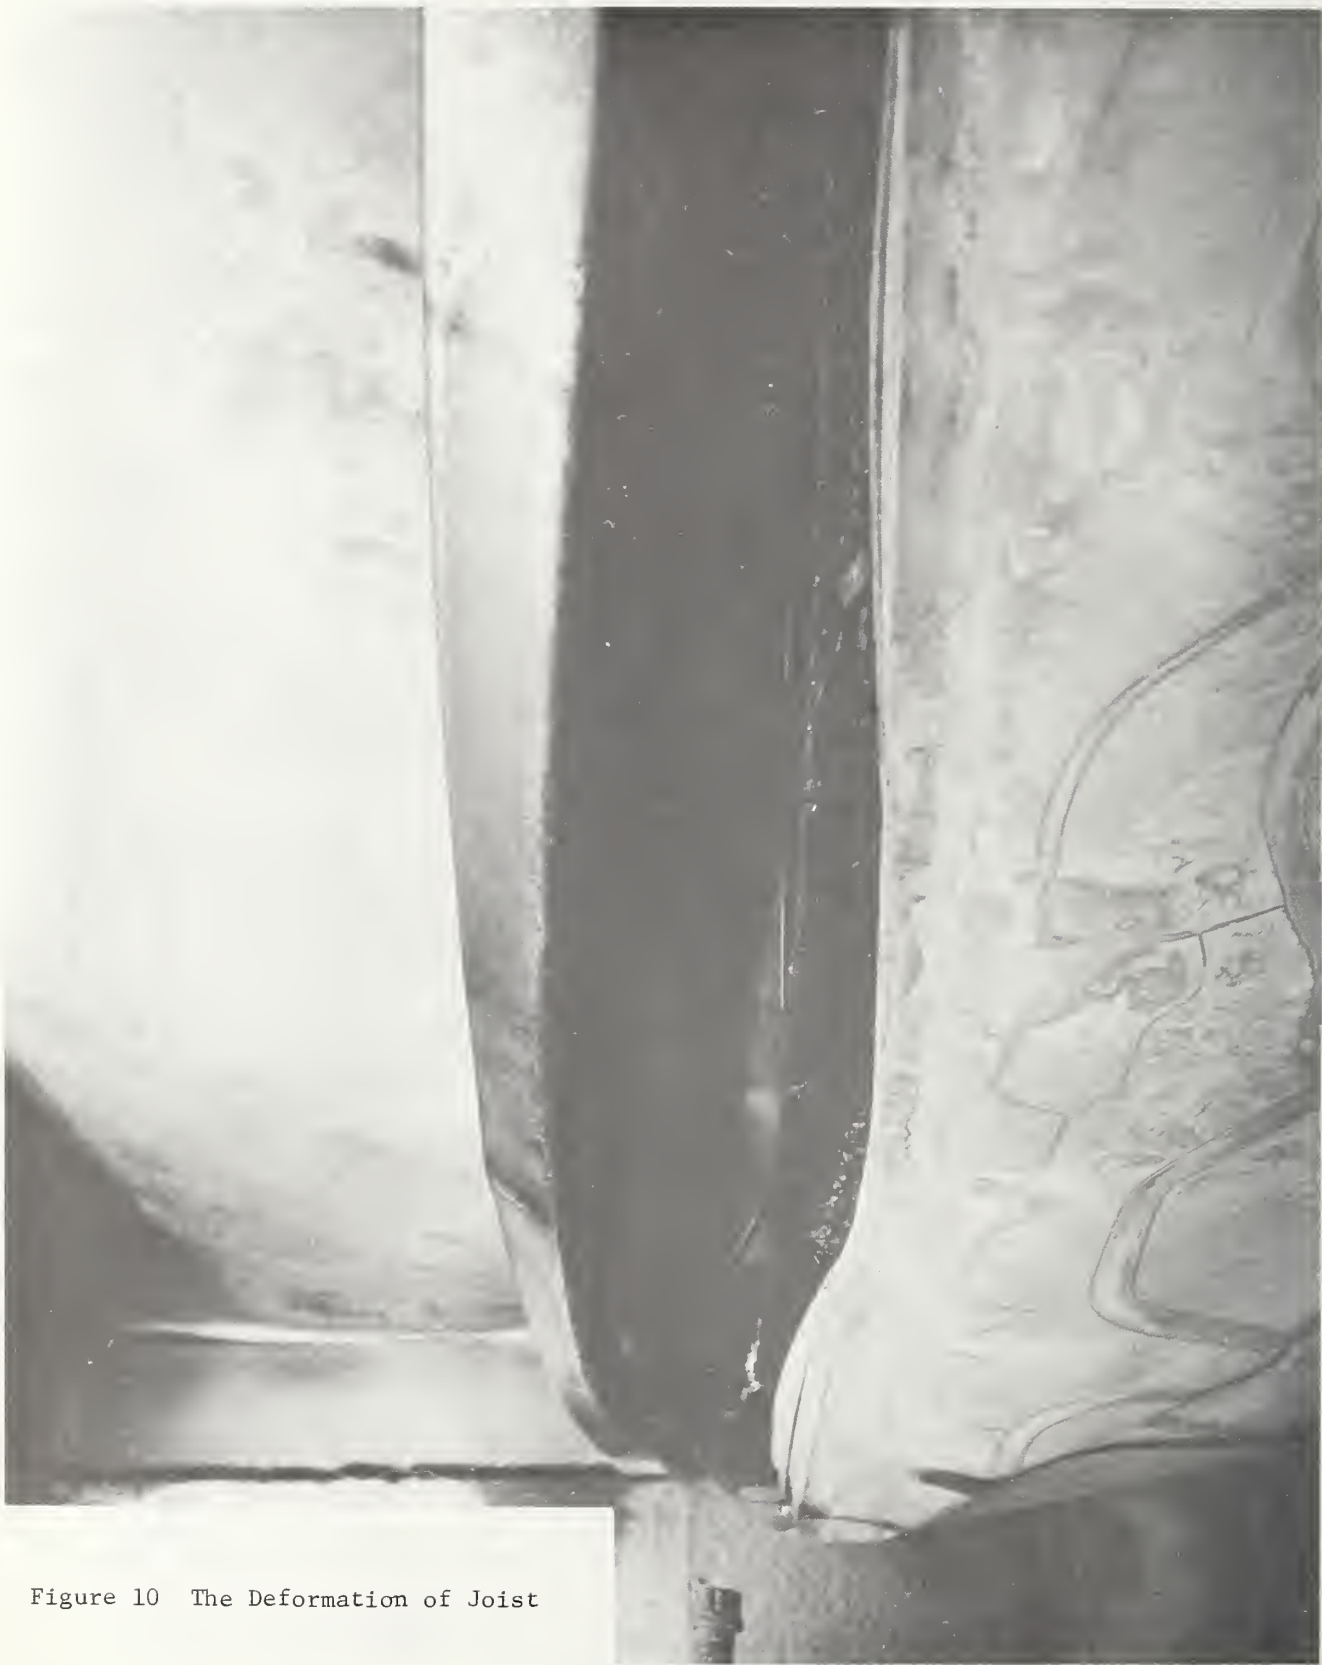
Figure 10 The Deformation of Joist

Figs. 10 and 11 show closeups of the deformations at a joint. Because the C-shaped joists are unsymmetrical, unless restrained, their mode of failure is in torsion bending with the open side down.

It is probable that the deflection and torsion bending

of the C-beam was the main cause of test failure since this initiated the structural failure, opening the gap at the joints thereby permitting flame-through at the joints.
