NATIONAL BUREAU OF STANDARDS REPORT

10 567

INTERIM PROGRESS REPORT OF RESEARCH ACTIVITY TRUCK TIRE NOISE INVESTIGATION

Office of Noise Abatement
Department of Transportation
Washington, D. C. 20590

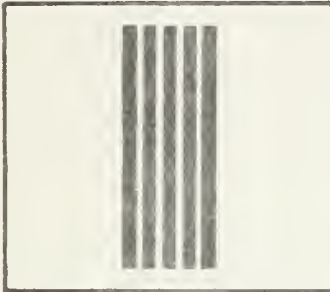
NEUTRAL RIB
RIB - A

Figure 7. Test tire tread designs. These exact tread patterns represent 70-80% of the total truck tire population in use on the road today.

- Rib-A. This neutral rib pattern is similar to the SAE or ASTM[42] test tire and has circumferential tread only. It was felt that due to the total absence of any sipes or cross-bars this tire would provide a lower bound on truck tire noise levels.
- Rib-B. This premium tire has ribbed, multi-siped, rounded shoulders. This tire represents a type often found on over-the-road semi-trailer applications.
- Rib-C. This is a ribbed pattern with a limited number of sipes and rounded shoulders with no sipes. It is a lower priced tire typically used for urban and suburban applications, e.g., delivery and dump trucks.

A detailed discussion of the selected test tires follows with the tread patterns shown in Figure 7. The footprints show the tread element patterns of the nine test tires in a new state under dynamic conditions with a loading of 4430 pounds on the tire.

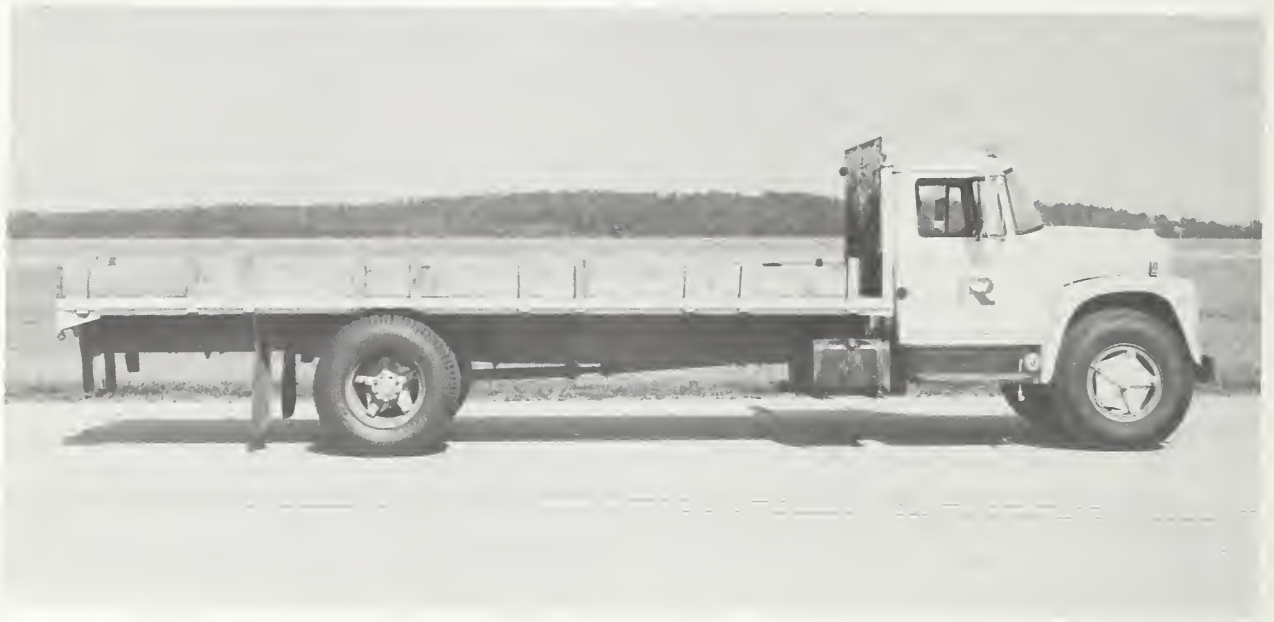
Figure 8. An International Model #1890 chassis equipped with a 20-foot stake body served as the single-chassis test vehicle.

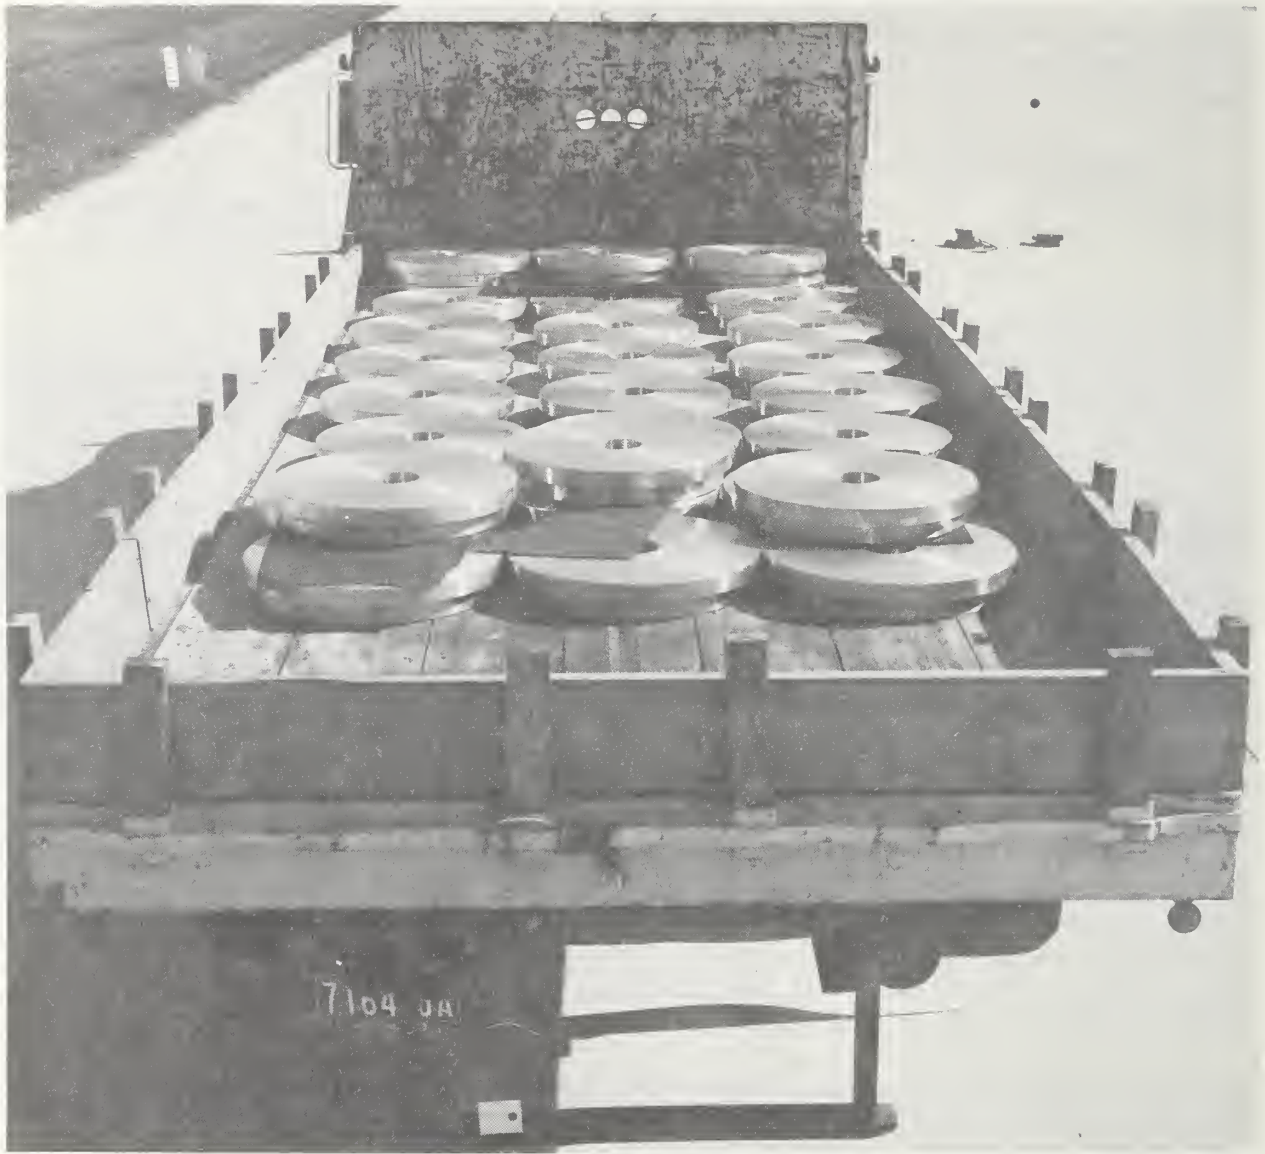
Figure 9. A view of the test vehicle body showing the placement of the thirty 500 pound weights used to provide maximum tire loading.

One truck was operated in the unloaded condition, while the other carried 15,000 pounds of load. Figure 9 shows the loading arrangement. Thirty 500 pound weights were distributed to develop maximum loading on all tires. Both the loaded and unloaded single-chassis test vehicles were weighed at a scale in the State of Virginia near the Wallops Station test site resulting in the following weight breakdown:

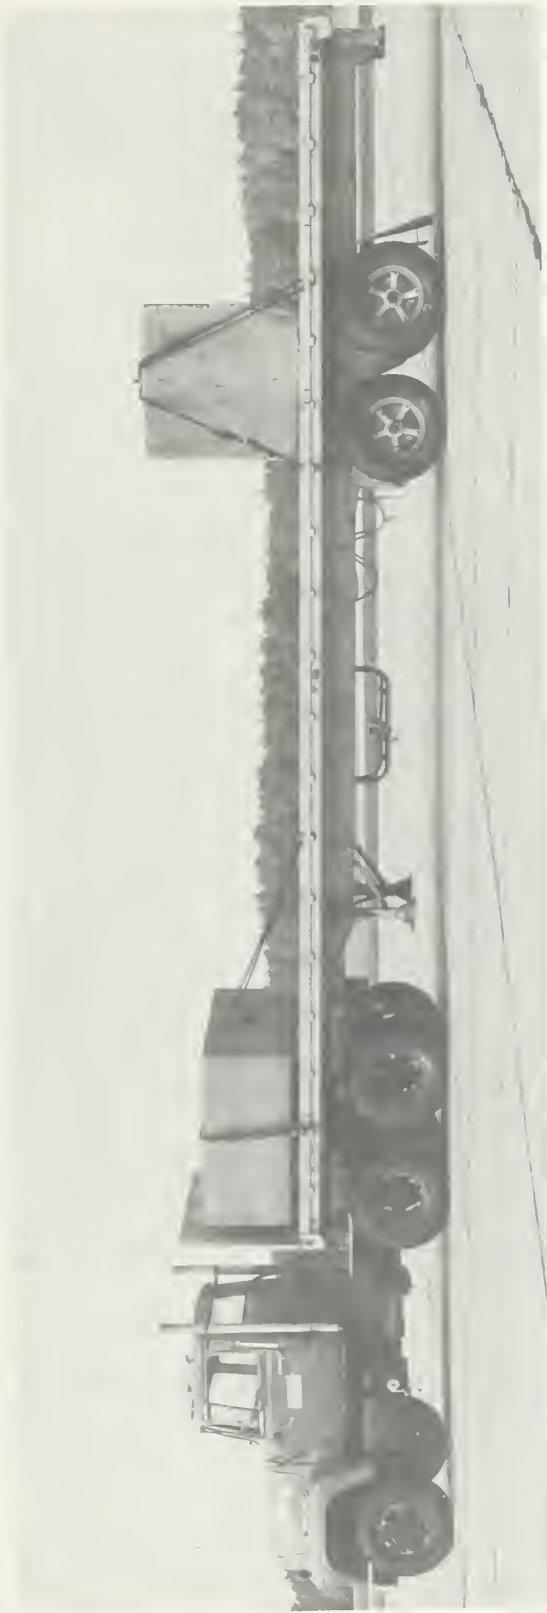
Figure 10. Shown is the tractor-trailer test vehicle in its fully loaded condition. The combination unit possessed a gross vehicle weight of 65,080 pounds.

Following Tire and Rim Association recommendations, the tractor-trailer tires were all inflated to an air pressure of 50 pounds per square inch.

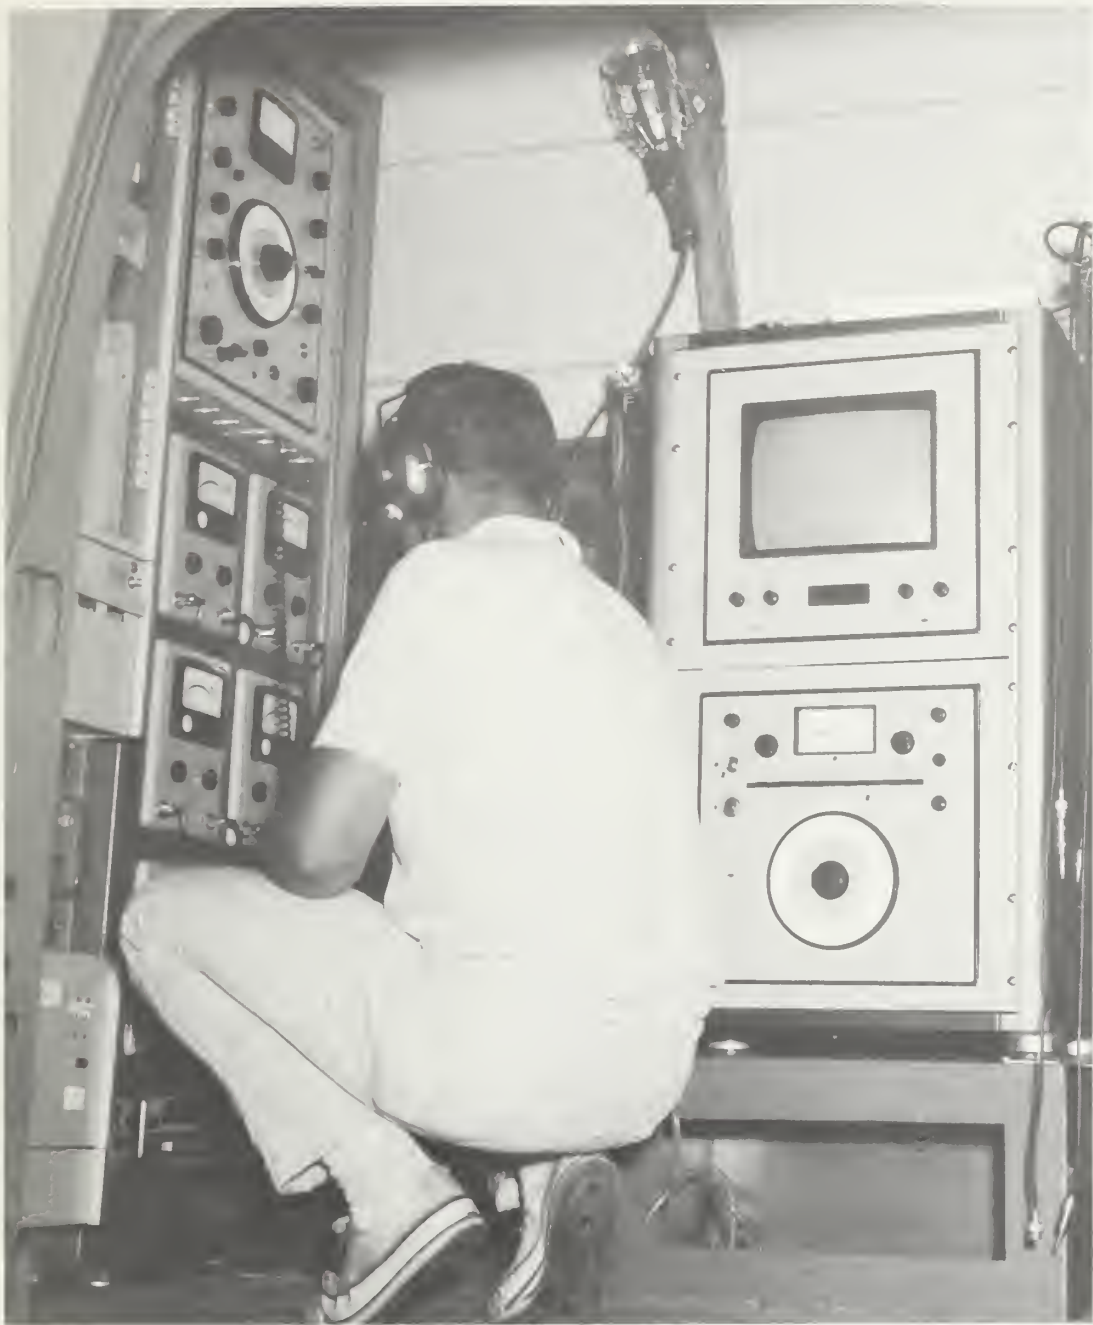
Figure 14. The interior of the mobile instrumentation van showing the instrument mounting arrangement. The operator is adjusting the gain of the signal conditioners to insure optimum signal-to-noise ratio.

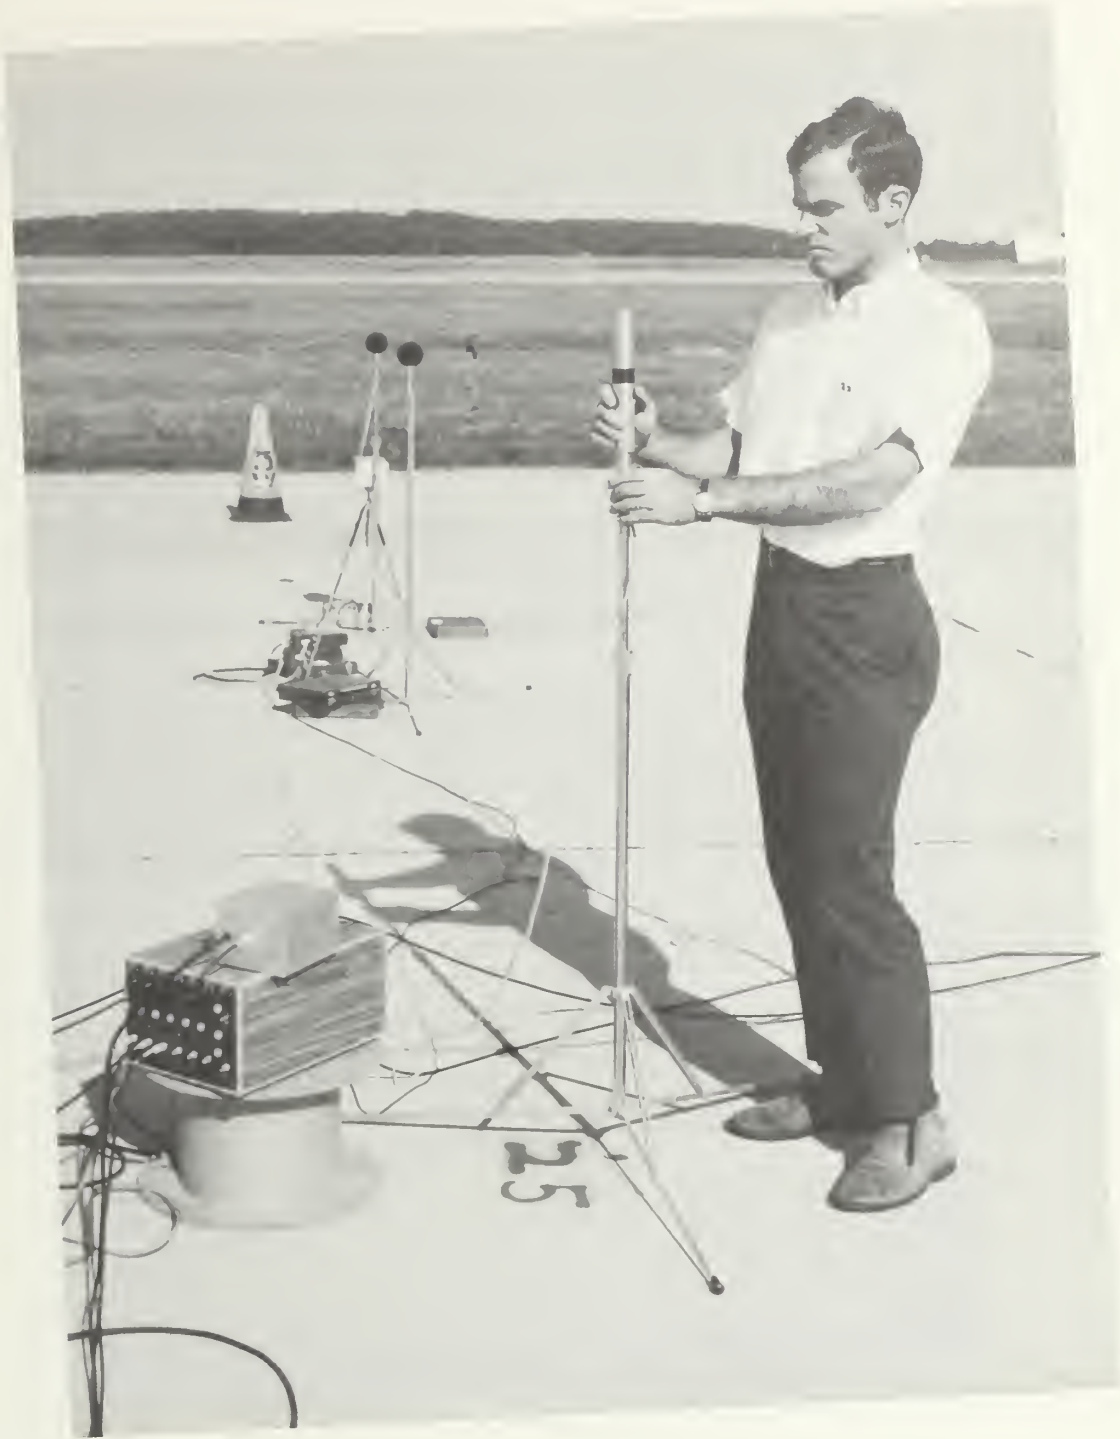
Figure 16. The pistonphone, which delivers a 124 dB sound pressure level at 250 Hz, is shown being coupled to the microphone for the one-point calibration.

Calibration and system checkout were performed in two steps. The pistonphone produced a 124 dB sound pressure level (re $20 \mu\text{N/m}^2$) at a frequency of 250 Hz. This single point calibration was used for system calibration in the field. Figure 16 shows a pistonphone calibration being performed on one of the microphones. The system checkout also involved running a frequency response on the system. To perform this checkout, the microphone cartridge was removed and replaced with an adapter which allowed the sine-random signal generator to be coupled into the system. The sine-random generator was capable of producing wide band "pink noise" which is white noise passed through a network which weights at -3 dB per octave. When a display unit, such as a real-time analyzer was coupled to the output terminals of the tape recorder, a flat frequency response (constant energy per octave of bandwidth) could be observed. In general, a lack of low frequency response would be indicative of overloading of an amplifier and a lack of high frequency response would be indicative of an amplifier failure. This operation also established the integrity of all connecting cables. During actual testing, the real-time analyzer was used to provide some data with which to judge the progress of the testing prior to the later reduction and analysis of the data on the computer.

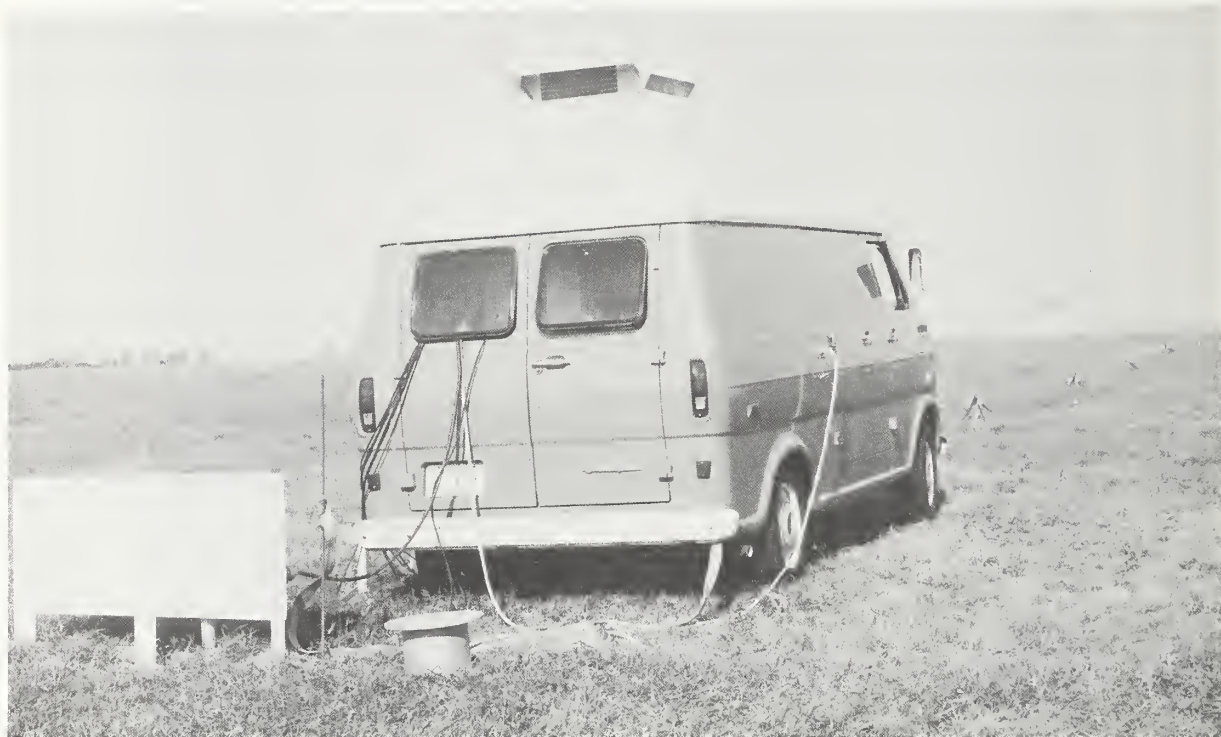
Figure 18. The mobile instrumentation van is shown in its field location. The wires strung on stakes in front of the truck are the signal wires between the microphone array and the recording facility within the van.

The real-time analyzer in its mounted configuration is shown in Figure 17. The instrumentation van in its field configuration is shown in Figure 18. Brief descriptions of the instruments are contained in Appendix C. Reference to the schematics provides an understanding of the contribution of each instrument to the overall system.

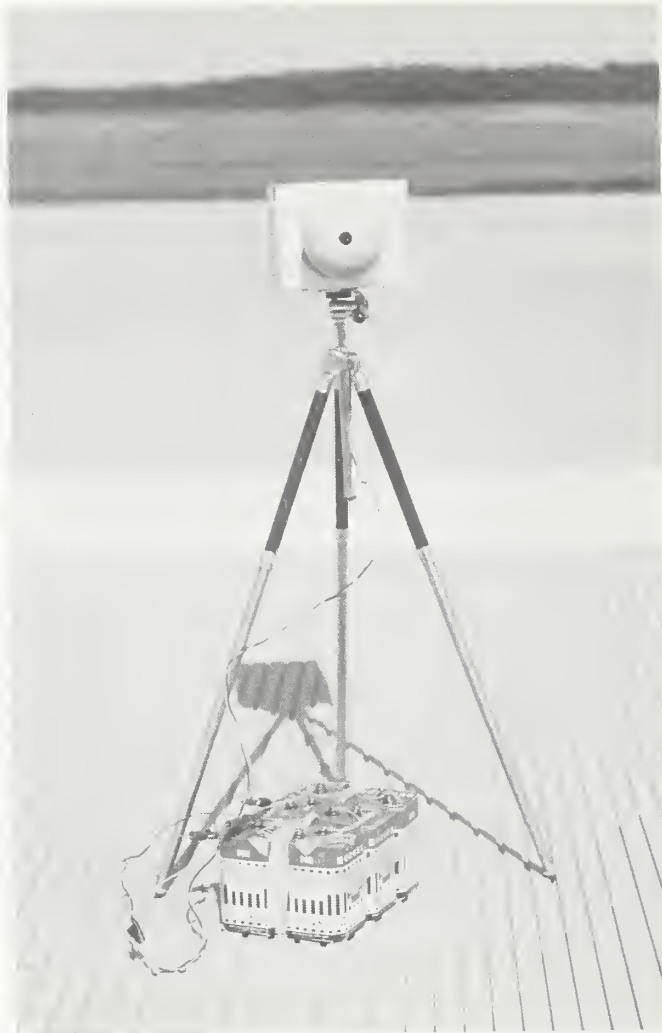
Figure 20. A closeup of the photosensor shows the ± 18 volt battery pack and the tripod-mounted photodetector. The minibox contains the electronics while the integrating sphere houses the photodetector.

A battery-operated photosensor system for the determination of truck velocity and position with time during each run was designed and is shown in Figure 20. A light source on the truck activated the photosensor and an appropriate signal was recorded on the direct channel of the tape recorder. The first sensor the truck passed was interfaced with the analog tape system so that activation of this sensor remotely started the tape transport and record electronics. This sensor was appropriately located so that when the truck passed the second sensor, the tape system was up to speed and data were taken. The final photosensor commanded the tape system to stop. Appendix E contains a detailed technical discussion of the photosensor, start-stop circuitry, and line amplifiers as well as schematics or block diagrams for each.

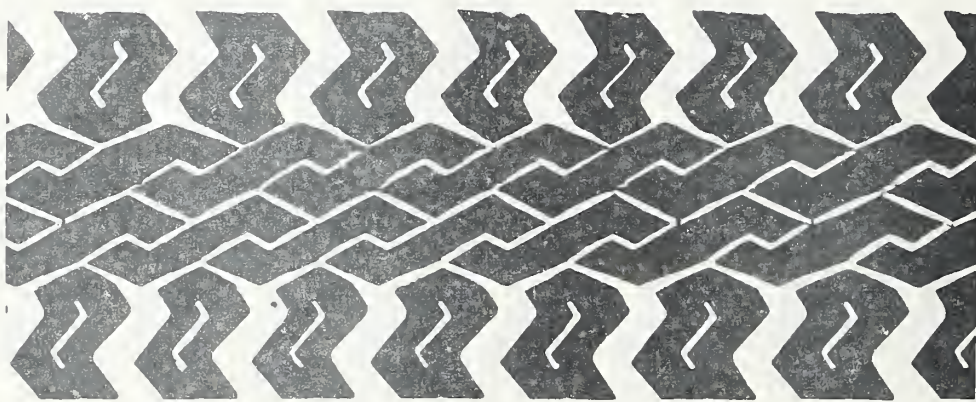
Figure A-27. Peak A-weighted sound levels versus microphone distance and speed for an unloaded single chassis vehicle running on a concrete surface. The truck was equipped with new neutral rib tires on the steering axle and dual, new, cross-bar-F tires on the drive axle.

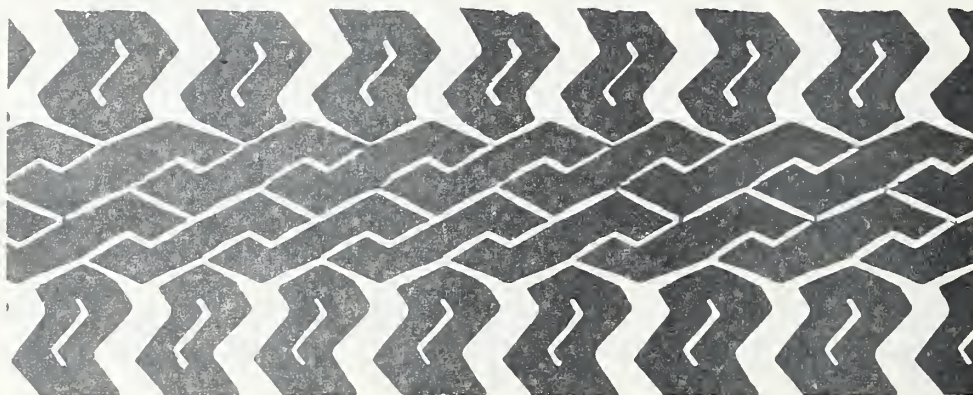
Figure A-31. Peak A-weighted sound levels versus microphone distance and speed for a loaded single chassis vehicle running on an asphalt surface. The truck was equipped with new neutral rib tires on the steering axle and dual, new, cross-bar-F tires on the drive axle.

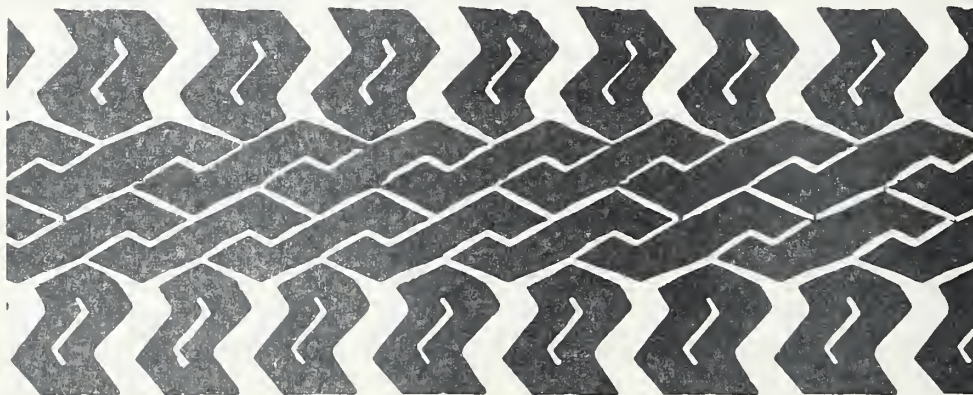
Figure A-33. Peak A-weighted sound levels versus microphone distance and speed for an unloaded single chassis vehicle running on an asphalt surface. The truck was equipped with new neutral rib tires on the steering axle and dual, new, cross-bar-F tires on the drive axle.

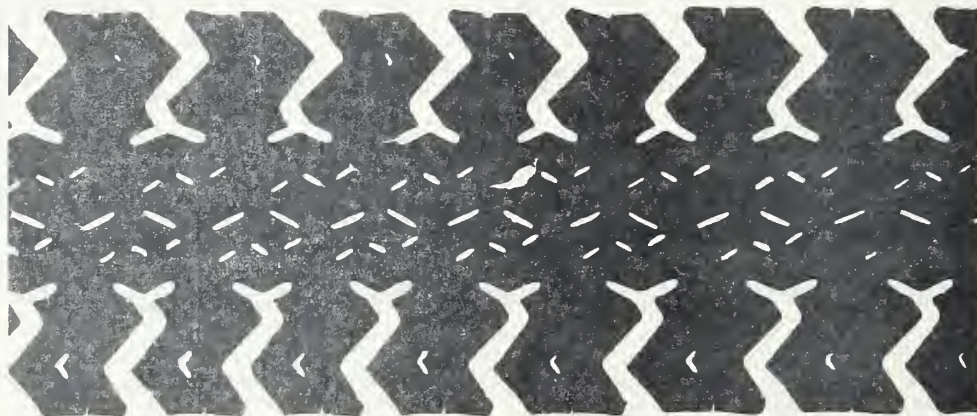
Figure A-34. Peak A-weighted sound levels versus microphone distance and speed for an unloaded single chassis vehicle running on an asphalt surface. The truck was equipped with new neutral rib tires on the steering axle and dual, half-worn, cross-bar-F tires on the drive axle.
