**FIRE TESTS OF COLUMNS ENCASED IN  
PUMICE-AGGREGATE CONCRETE**

N. D. Mitchell  
and  
A. F. Robertson

1002-43-1029

October 2, 1952

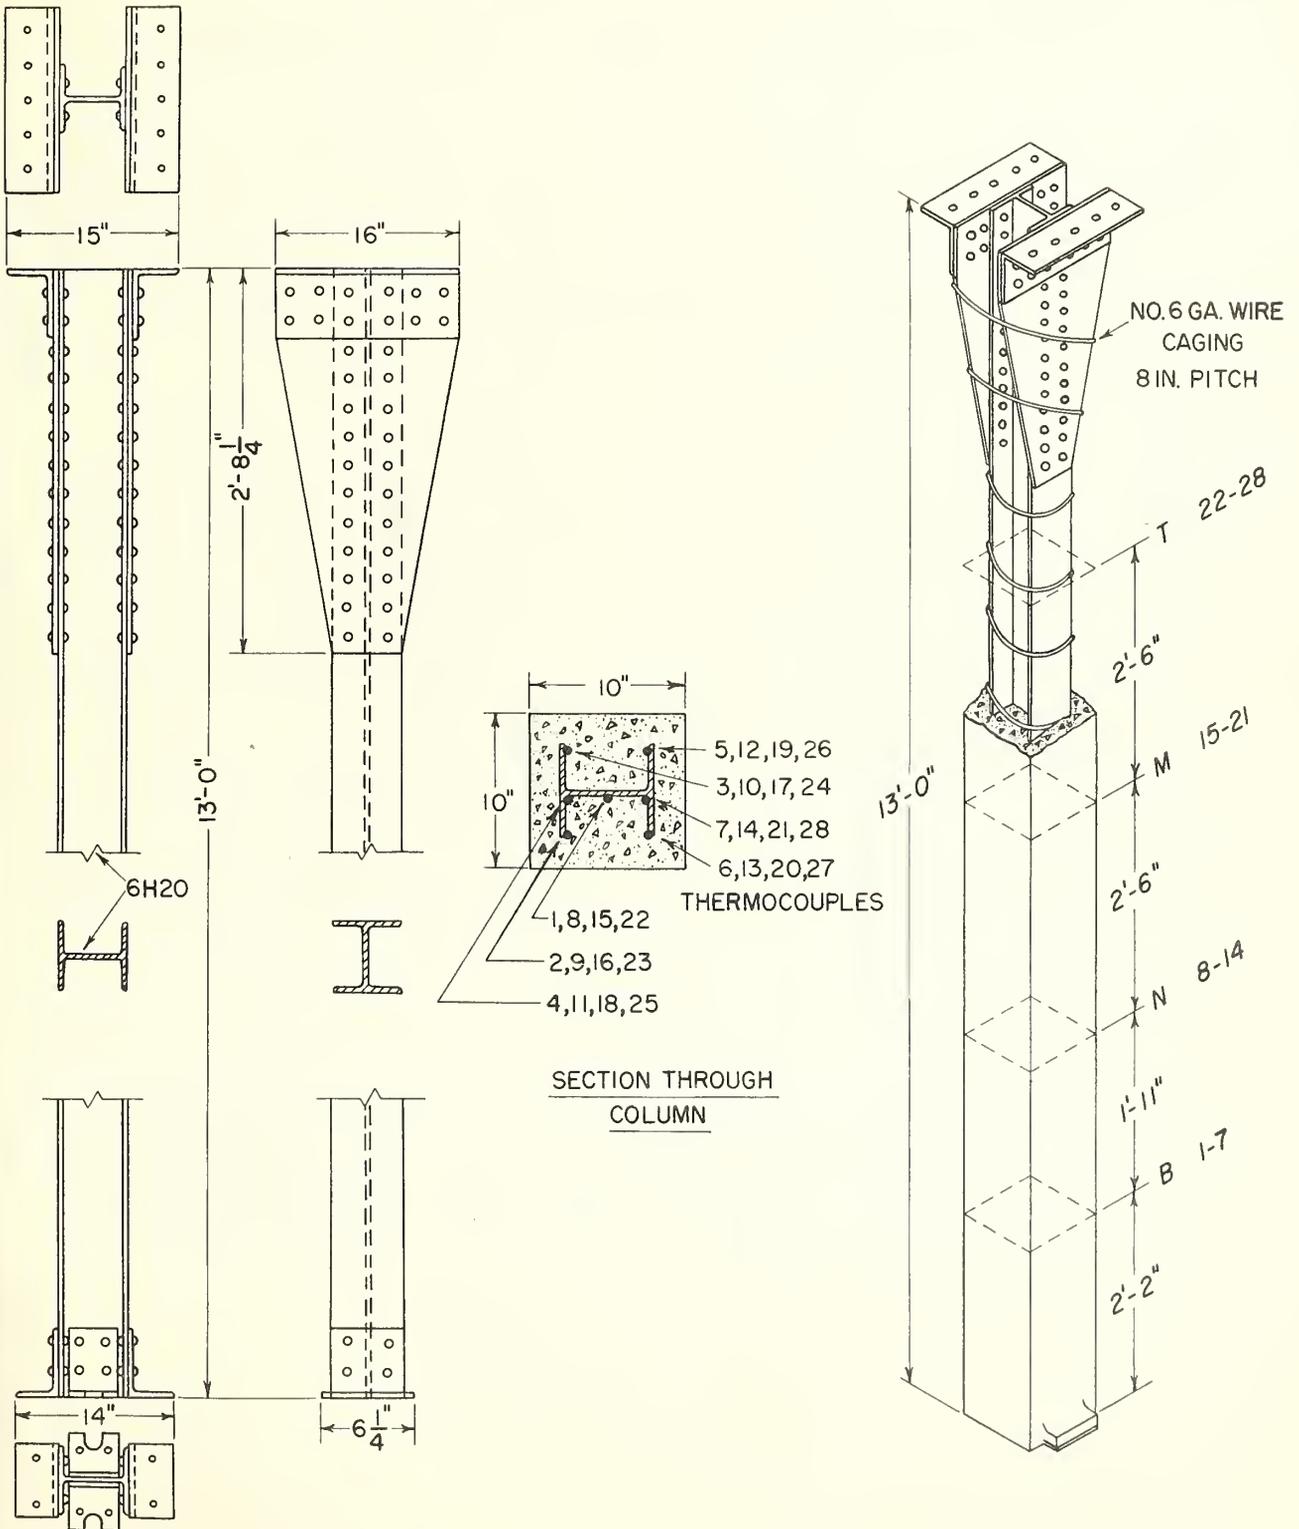
FIG. I. TESTS 267,270,271. CONSTRUCTION DETAILS OF STEEL COLUMNS. FP2983

The columns were prepared for covering with concrete by mounting thermocouples and winding a 6-ga wire (0.192 in. diam) spirally around the column on 8-in. pitch as shown in figure 1. The wire spiral had about 1-in. clearance at the center of the column flanges, leaving a 7/8-in. clearance between the wire and the outside of the concrete covering. Each turn of the wire was tack-welded at one of the four points where it came in contact with the column edges.

The method of fastening the column head gave substantially effective restraint against bending of the upper 32 1/4-in. The upper end of the 10-ft 3 3/4-in. length can be considered as fixed, figures 1 and 2.

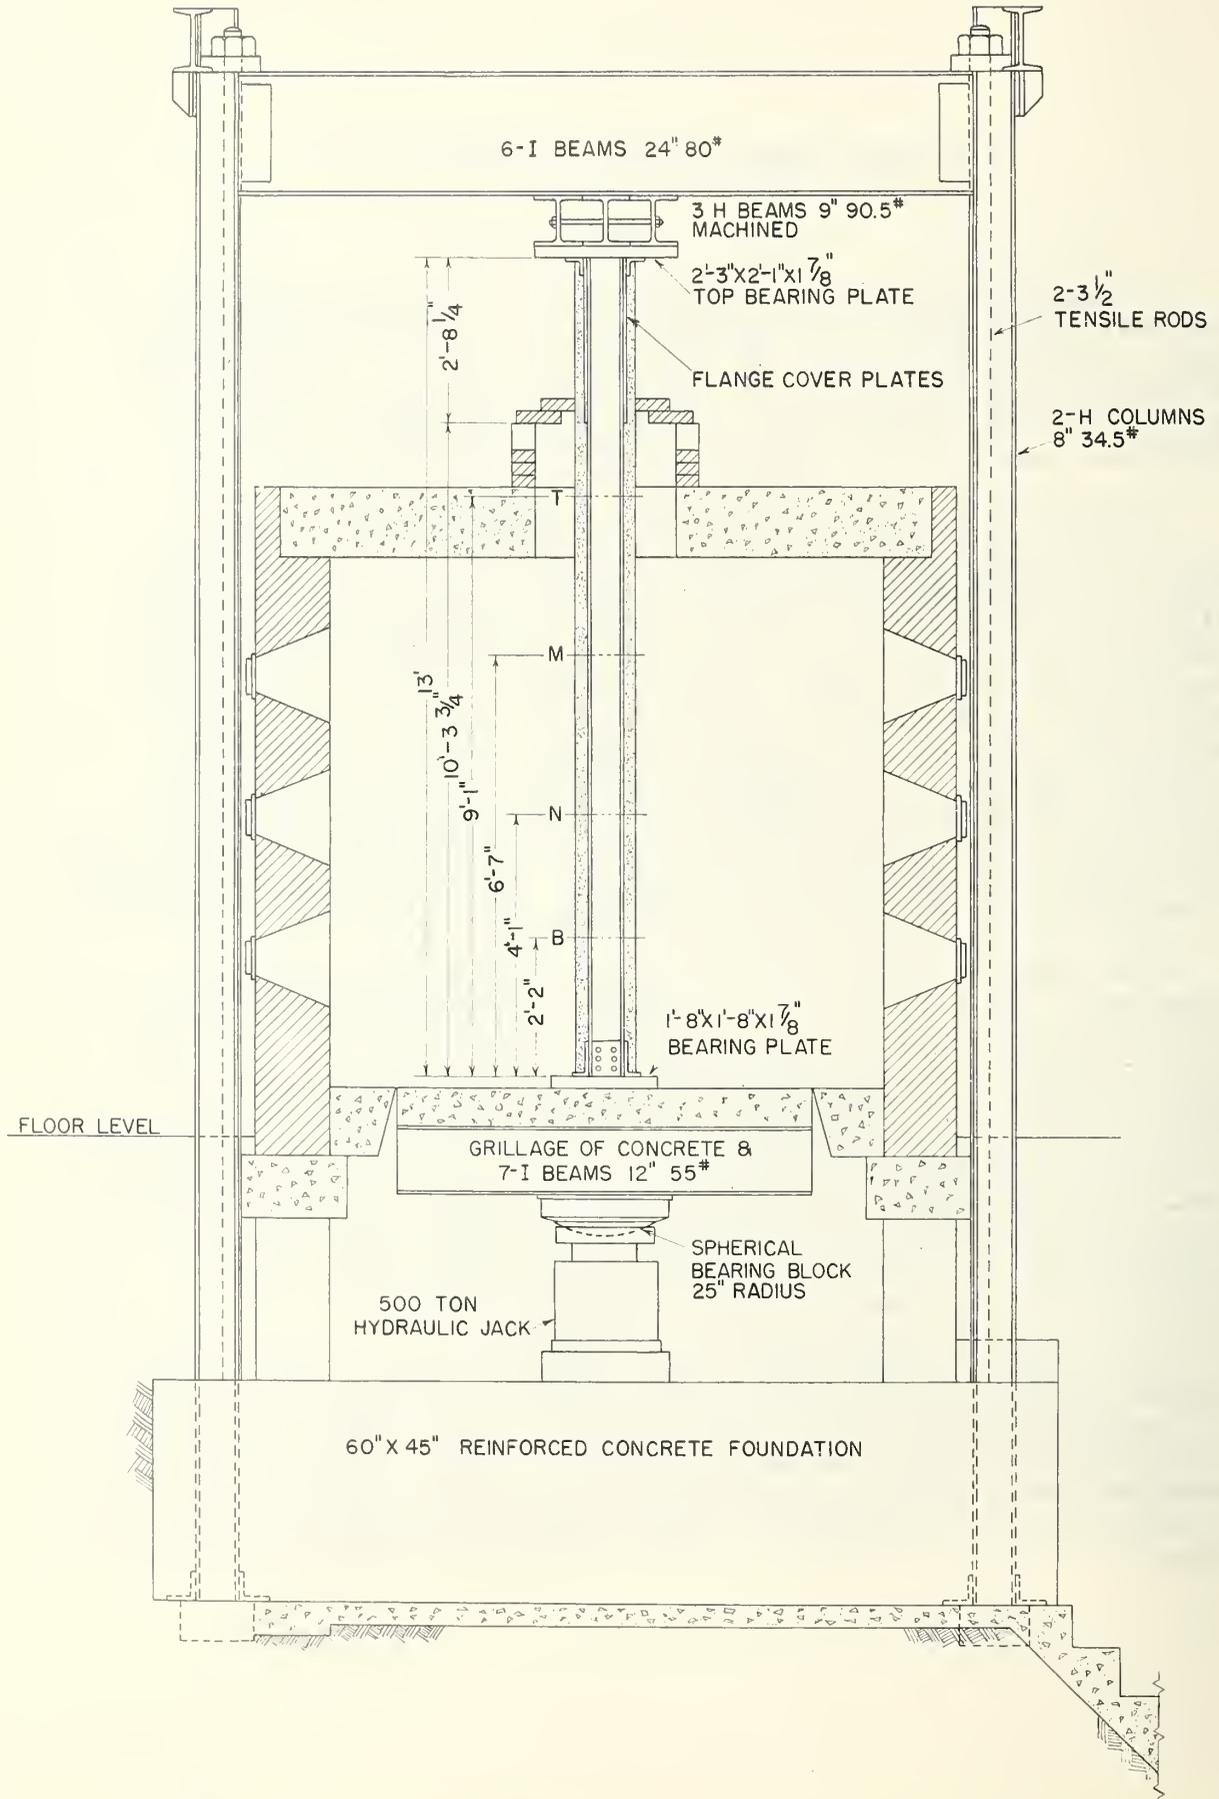
FIG. 2. TESTS 267, 270, 271. FURNACE AND LOADING EQUIPMENT WITH TYPICAL COLUMN IN PLACE. FP2983

A gas-fired furnace was used for testing the columns. Load was applied to the columns by means of a hydraulic jack under the furnace floor. It was maintained by a pump which supplied oil to the jack at constant pressure. The movable section of the floor of the furnace was supported on a spherical bearing block resting on the jack piston.

Temperatures in the furnace combustion space were measured by 12 thermocouples protected by iron tubes. These tubes projected from the furnace walls and roof. The temperatures at 28 points in the steel column were measured by thermocouples made from No. 24 ga duplex chromel-alumel wire. The wires were protected with an insulation of woven glass impregnated with silicone varnish. The ends of the pair of wires were twisted and welded together and the resulting junction inserted to a depth of about 1/8-in. in a hole in the steel column and secured therein by swaging the steel around the hole. The junctions were arranged with seven thermocouples at each of the four levels of the column as indicated by positions B, N, M and T, in figure 2.

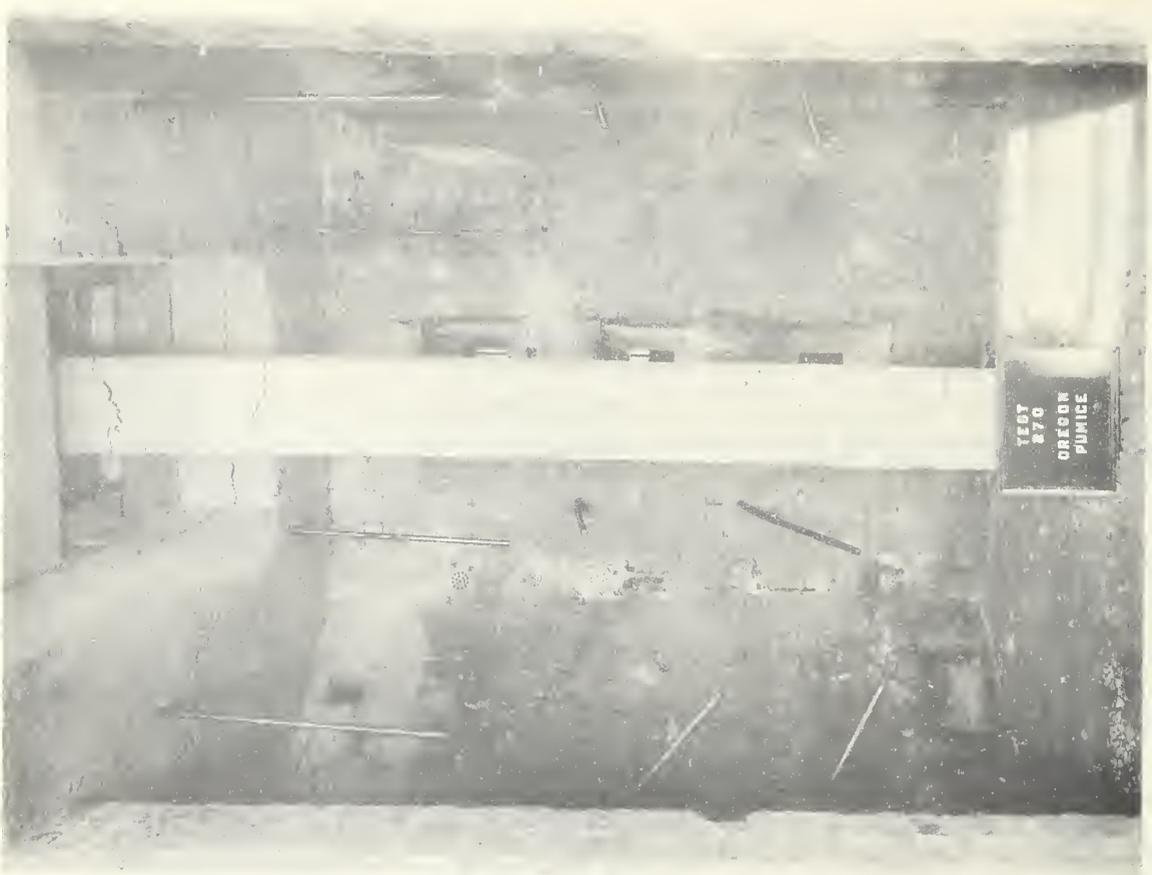
Fig. 4--Column after test.

Although shrinkage cracks developed in the concrete encasements, they remained in place even after load failure of the columns. These cracks are evident in the photographs of the tested columns, figures 3 and 4. None of the cracks in the concrete exceeded  $3/8$ -in. and most of them were less than  $1/8$  in.-wide. The test results on the individual columns are presented in the first section of table 3 and the following test logs.

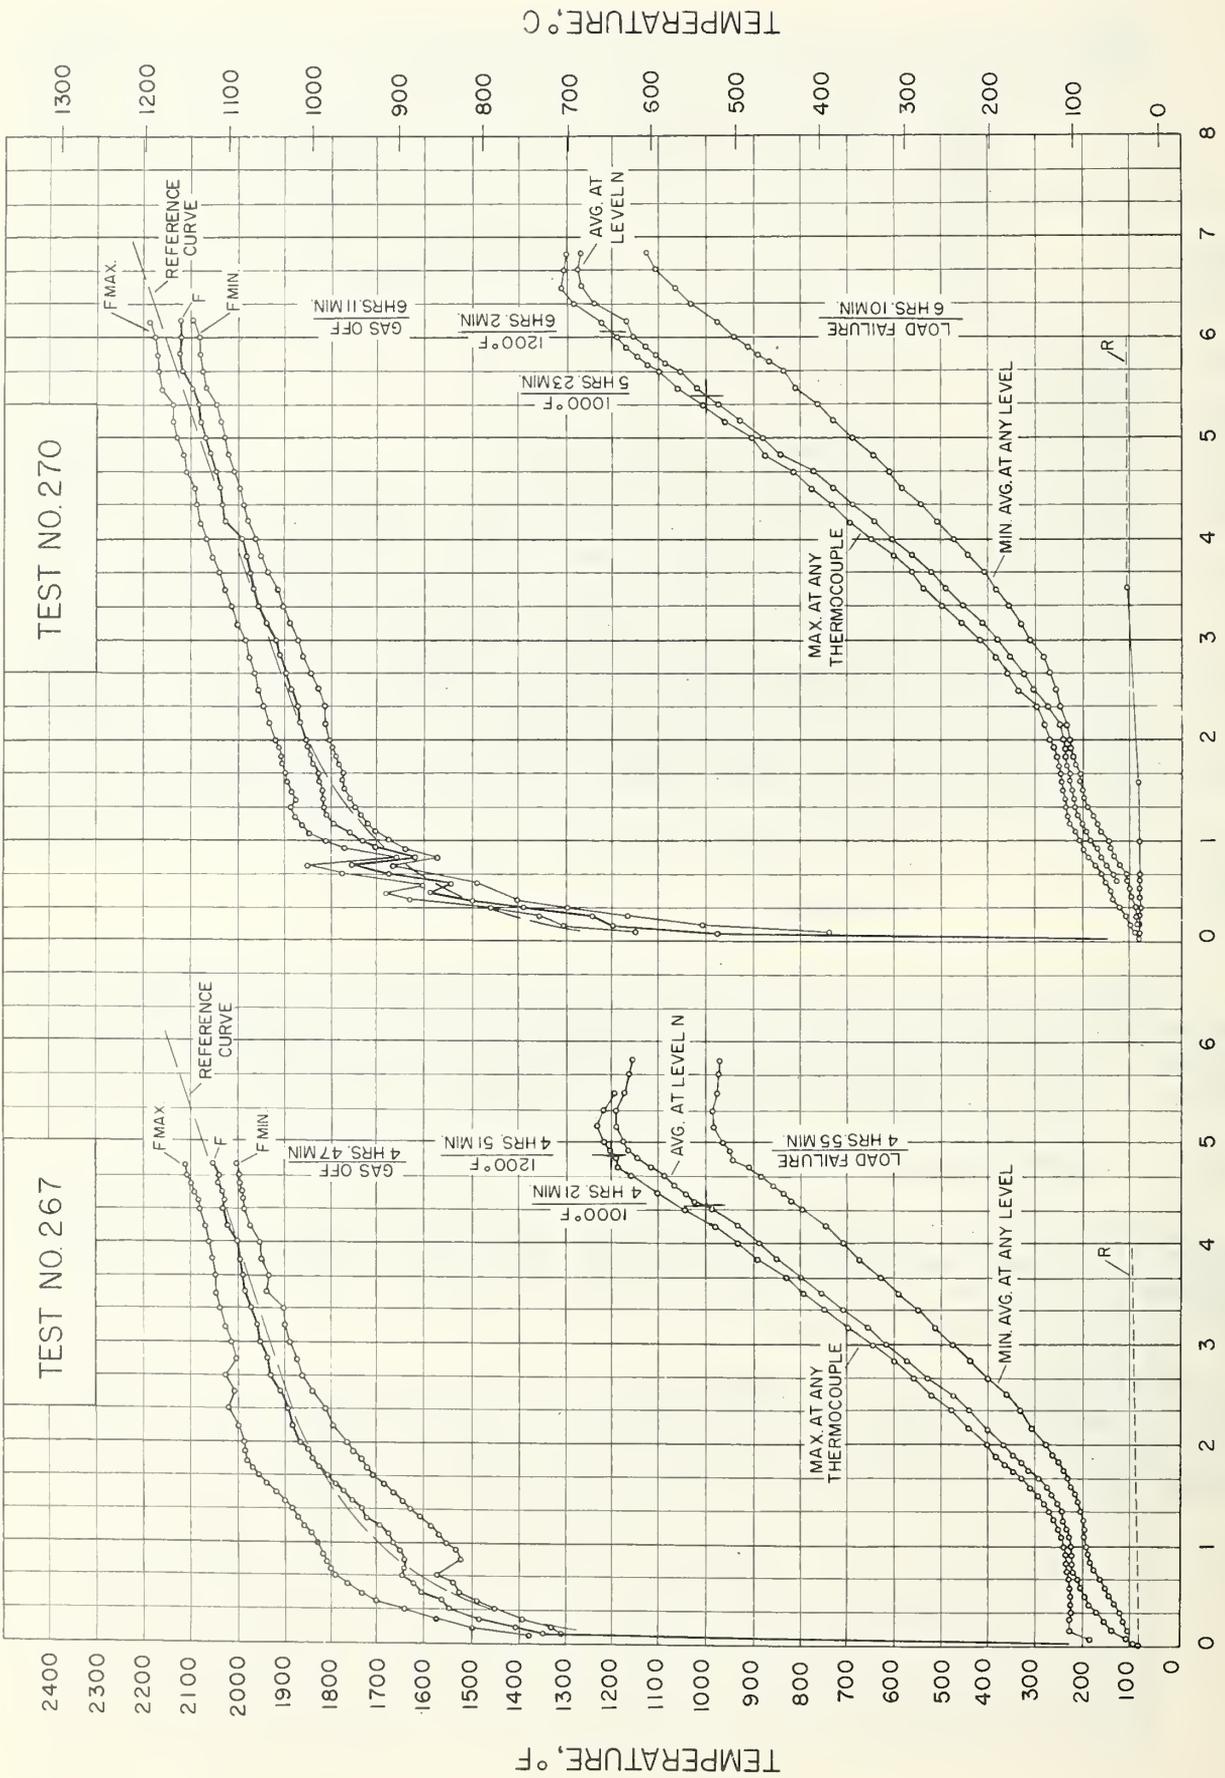
FIG. 5. TESTS 267 AND 270. TEMPERATURES DEVELOPED IN COLUMNS AND CONCRETE ENCASEMENTS MADE WITH PUMICE AGGREGATES FROM NEW MEXICO AND OREGON. FP2983

Furnace and column temperatures are shown in figure 5. Temperatures of the steel column are plotted as (a) the highest at any level (b) the minimum average at any level and (c) the average at level N.

The rapid rise of temperature of the steel to 212°F (100°C) within 10 min at level B was probably caused by a fault in the concrete covering. It may, however, have been caused by the separation of a thermocouple from the steel.

The average temperature at level N reached 1000°F at 4 hr 21 min and thus represents the limit as defined by an average temperature at one level. The temperature of 1200°F at one thermocouple was reached after 4 hr 51 min fire exposure. The fire exposure during the test, as represented by the area under the curve of average temperatures, was 101 percent of that under the standard reference curve.

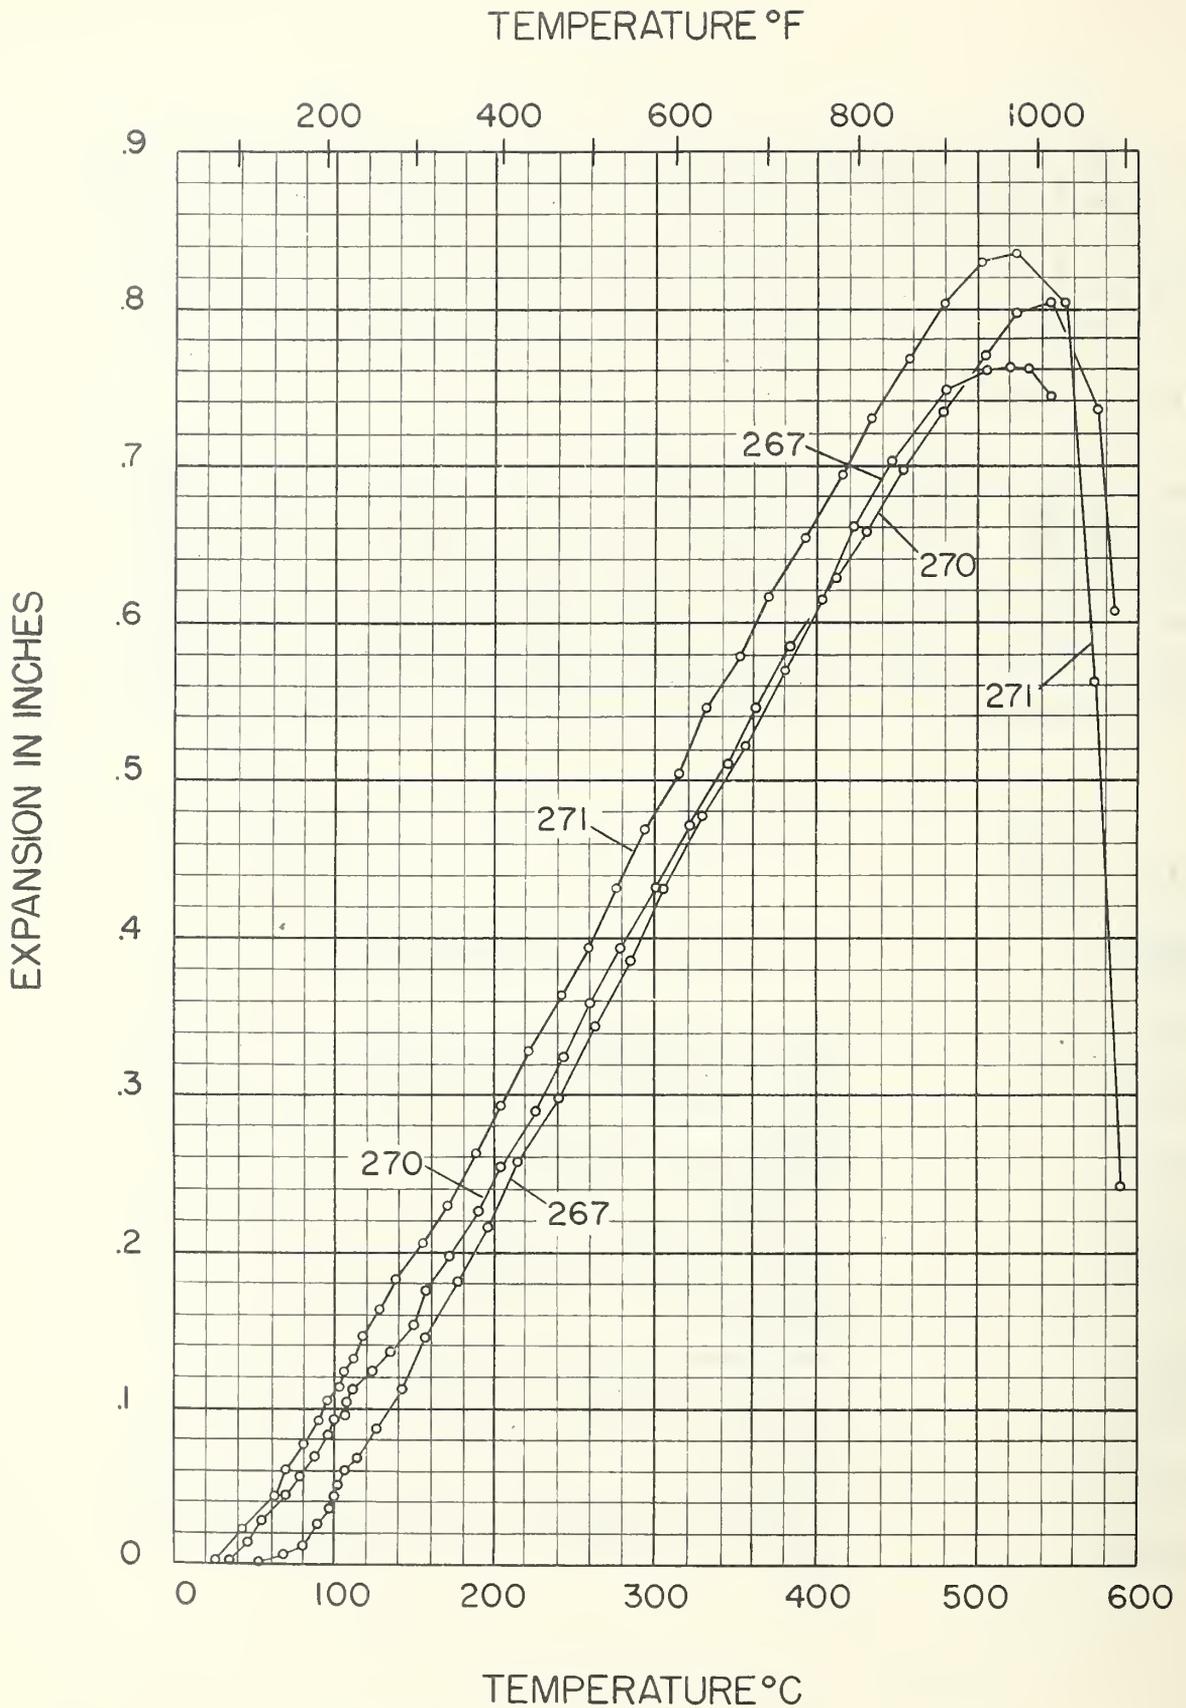
FIG. 6. TESTS 267, 270, 271. EXPANSION OF LOADED COLUMNS WITH INCREASING TEMPERATURES. FP2983

The changes in column length are shown in figure 6. The column reached its maximum length in expansion after 4 hr 35 min of fire exposure. The load was removed after 4 hr 45 min fire exposure at which time the column length had been reduced by about 0.1-in. Through inadvertence, the test was terminated at this time, estimated as about 10 min before the usual limit of yield of 0.6-in. in compression would have occurred; therefore the time of failure of this column under load is recorded as 4 hr 55 min.

Data on the expansion of the column along its length are presented in figure 6. The column reached its maximum expansion in length after 5 hr 50 min fire exposure. The load was removed after 6 hr 10 min of exposure, at which time the column length had been reduced by 0.6 in., marking its failure under load.

Longitudinal expansion data for the column are presented in figure 6. The column reached its maximum length after 5 hr 30 min fire exposure. A total contraction of about 0.6-in. had taken place at 5 hr 55 min, marking failure of the column under load, whereupon the load was removed.

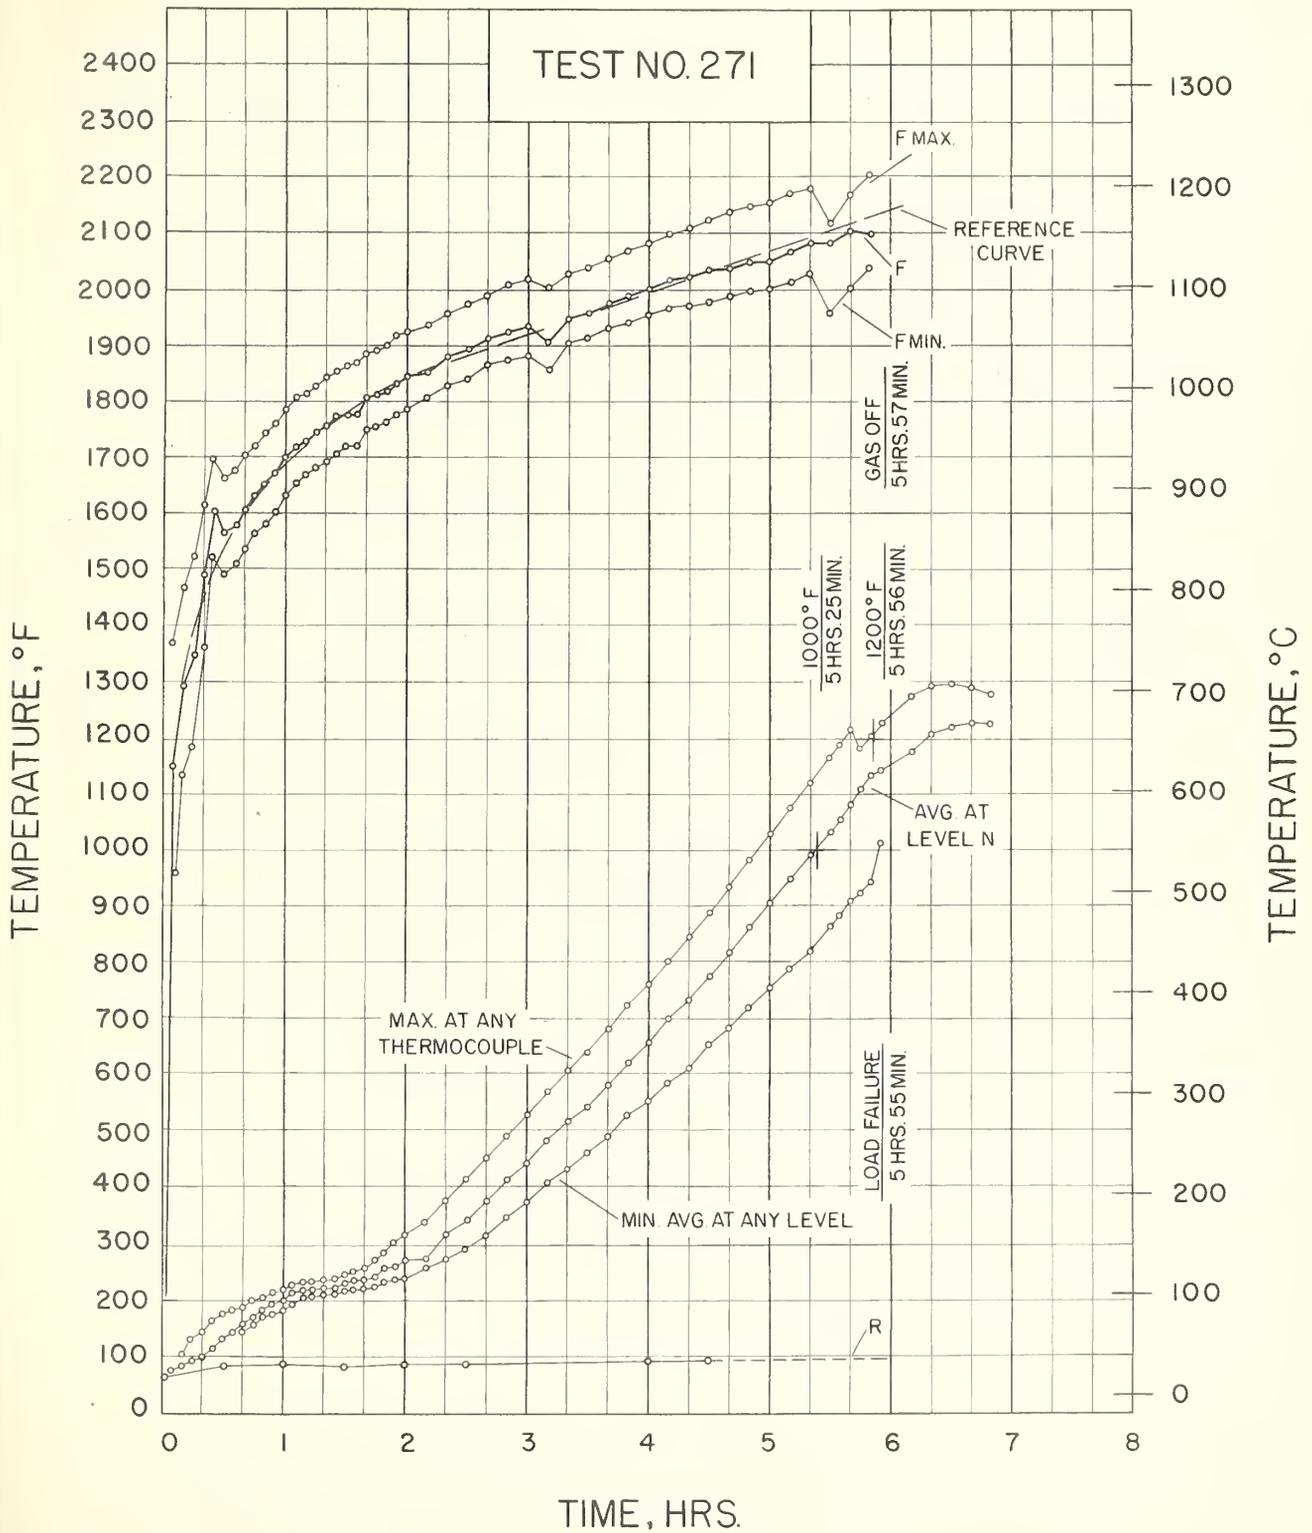
FIG. 7. TEST 271. TEMPERATURES DEVELOPED IN COLUMN AND CONCRETE ENCASUREMENT MADE WITH PUMICE AGGREGATE FROM CALIFORNIA. FP2983

Temperature data for this test are presented in figure 7. The average temperature of 1000°F occurred at level B after 5 hr 25 min fire exposure. A maximum of 1200°F occurred

at level N after 5 hr 56 min fire exposure. Thus these both represent column fire resistance periods as limited by temperature of the steel in accordance with the alternate method of test.

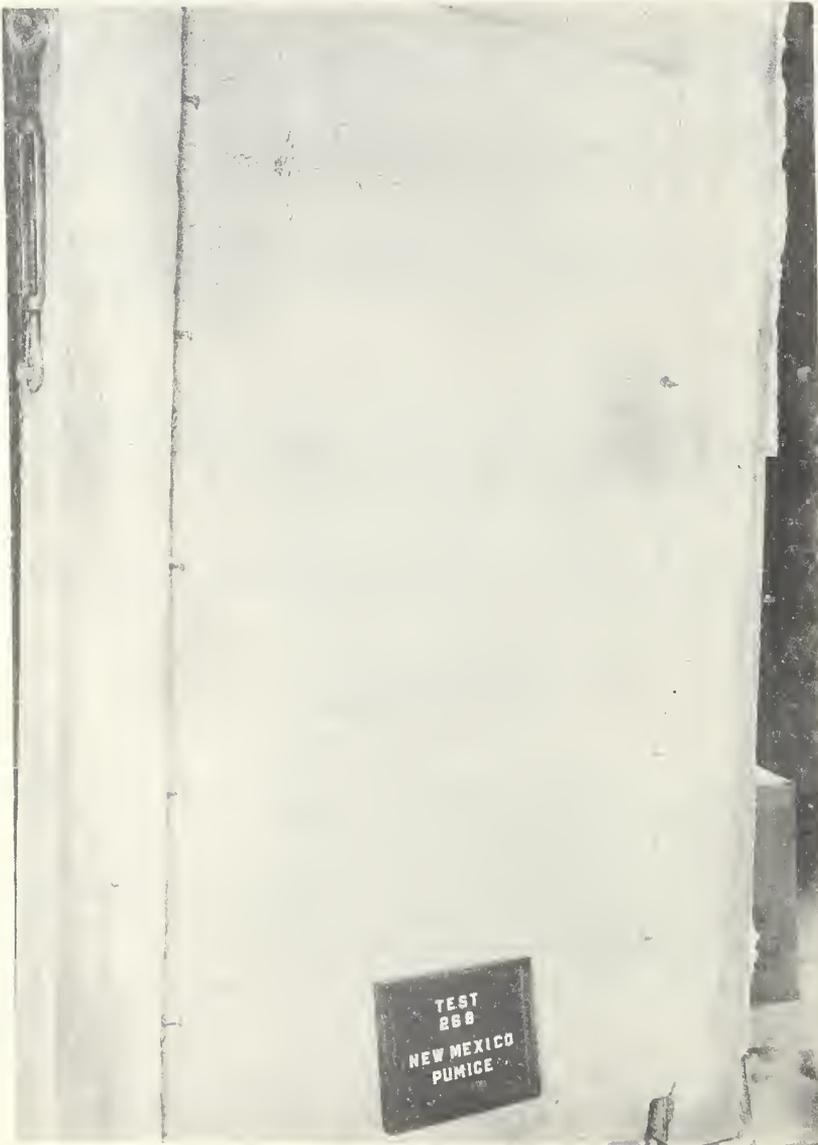
Fig. 8--Fire-exposed surface after test.

the panel likewise straightened out leaving almost no sign of cracks on the unexposed surface. Figure 8 shows the fine network of cracks on the fire-exposed surface after the test.
