NATIONAL BUREAU OF STANDARDS REPORT

Visual Landing Aids
Field Service Operation

Progress Report
For the Period
December 1, 1952 to November 30, 1953

Prepared By
C. A. Douglas
J. W. Simeroth
J. E. Davis
Photometry and Colorimetry Section
Optics and Metrology Division

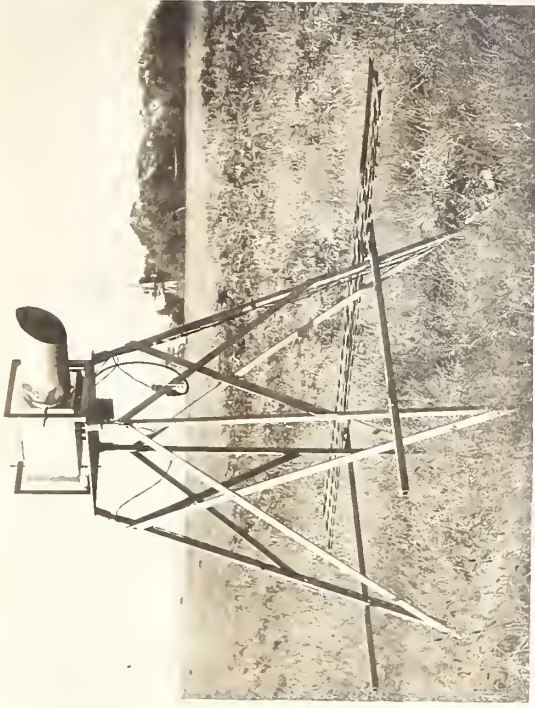
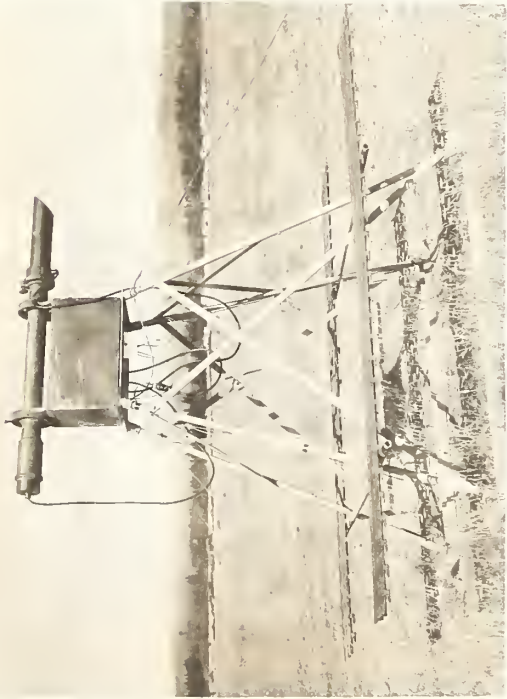
FIG. 3 EXAMPLES OF TRANSMISSOMETER INSTALLATIONS

PROJECTOR

RECEIVER

INDICATORS

Transmissometers in the approach zone and touchdown zone had been installed for operational use under the jurisdiction of the Civil Aeronautics Administration. Arrangements were made to transfer jurisdiction of these instruments to the Field Operation. In addition, one transmissometer from the Naval Air Test Center and one transmissometer and a number of spare components from the NBS laboratory in Washington were shipped to the field location. These instruments are now installed, as indicated on figure 2. These instruments provide adequate measurements of atmospheric transmission throughout the area in which visibility observations are made. Use was made of permanent and portable transmissometer stands already at the airport in making these installations. Details of some of these installations are shown in figure 3. The indicators were installed in the laboratory space in the Operations Building. Two additional automatic sensitivity controls were constructed so that the sensitivity range of all indicators can be controlled automatically. Signal lines between the field units were obtained by using existing cable runs where possible and installing lines where necessary.
