## FIRE TEST OF PRECAST, REINFORCED CONCRETE ROOF SLABS

for the  
Bureau of Yards and Docks  
Department of the Navy

Test Report No. TG10218-23:FP3272  
Fire Test 325

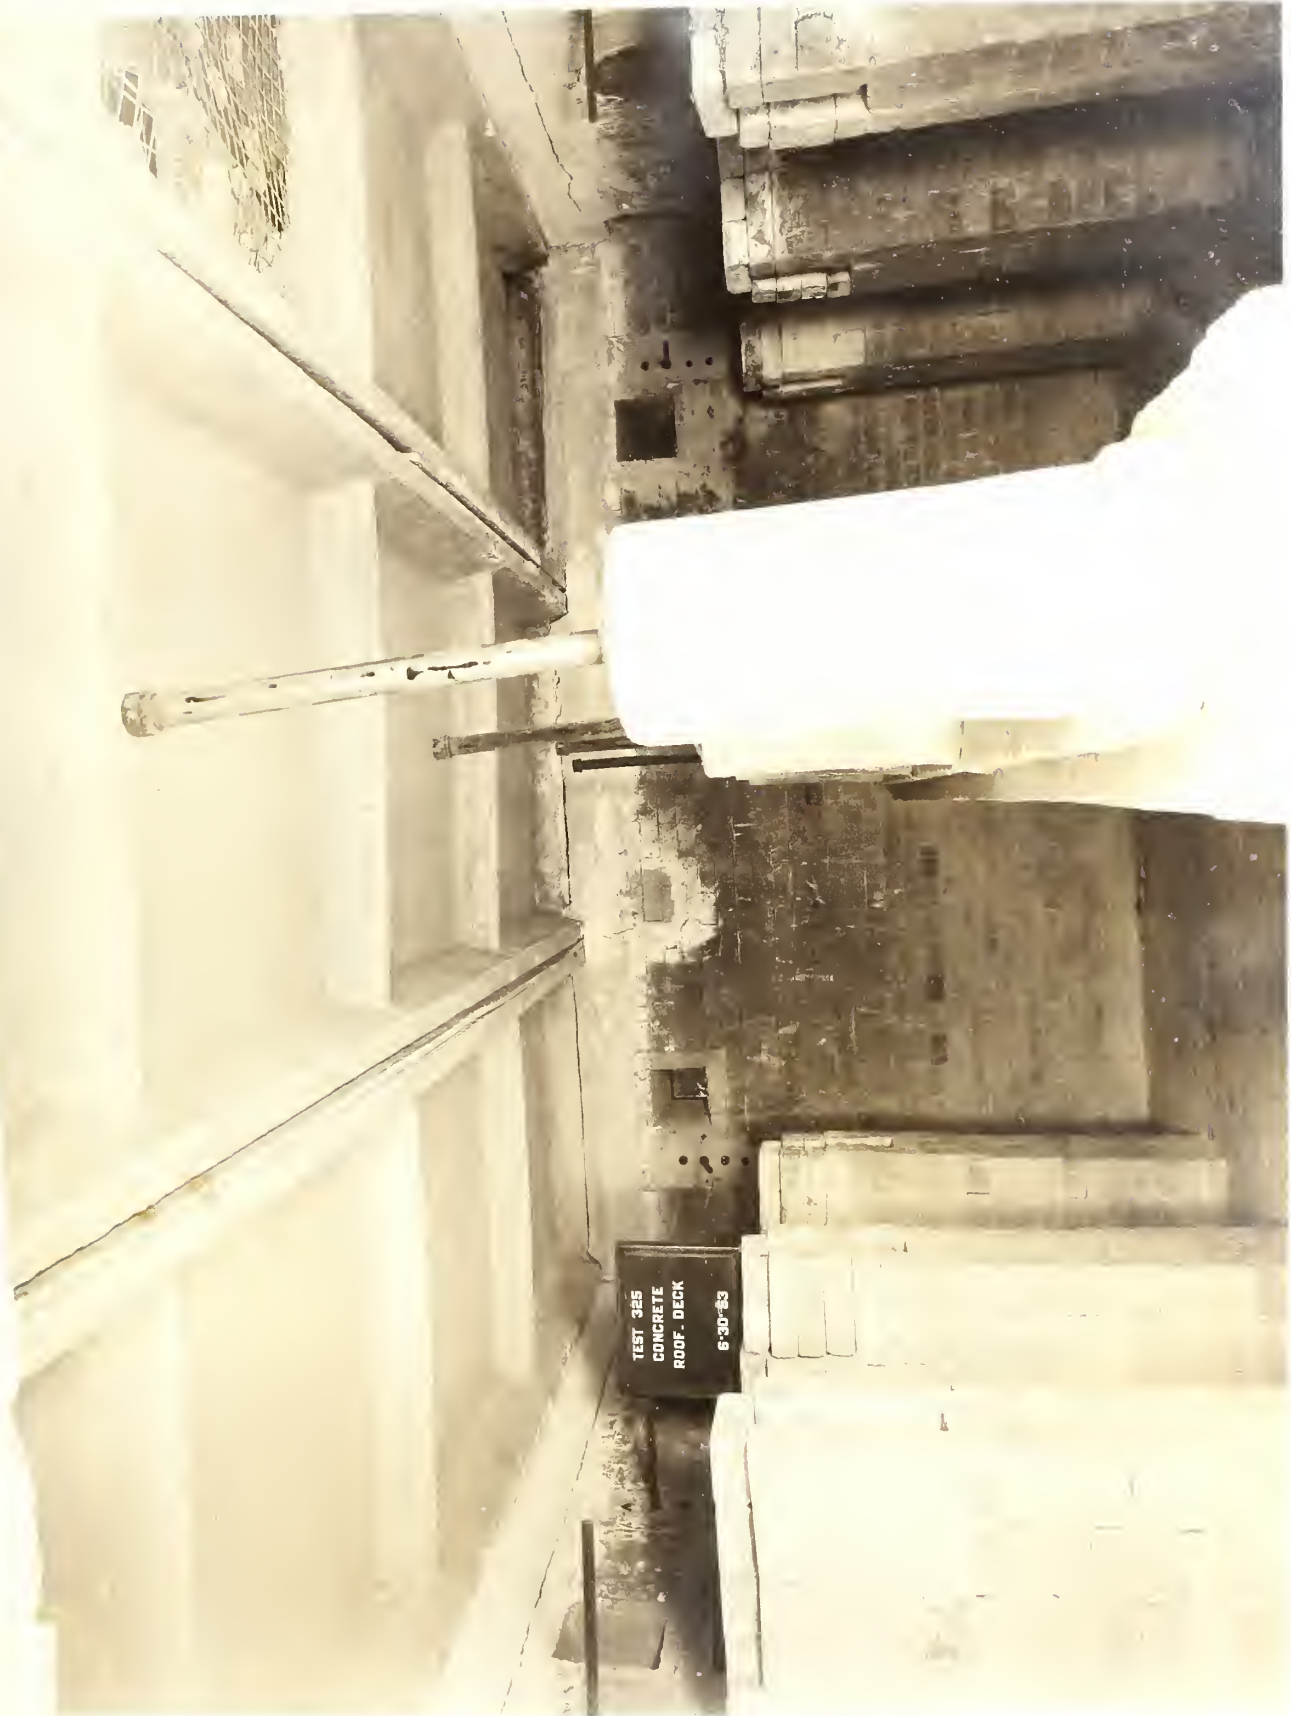
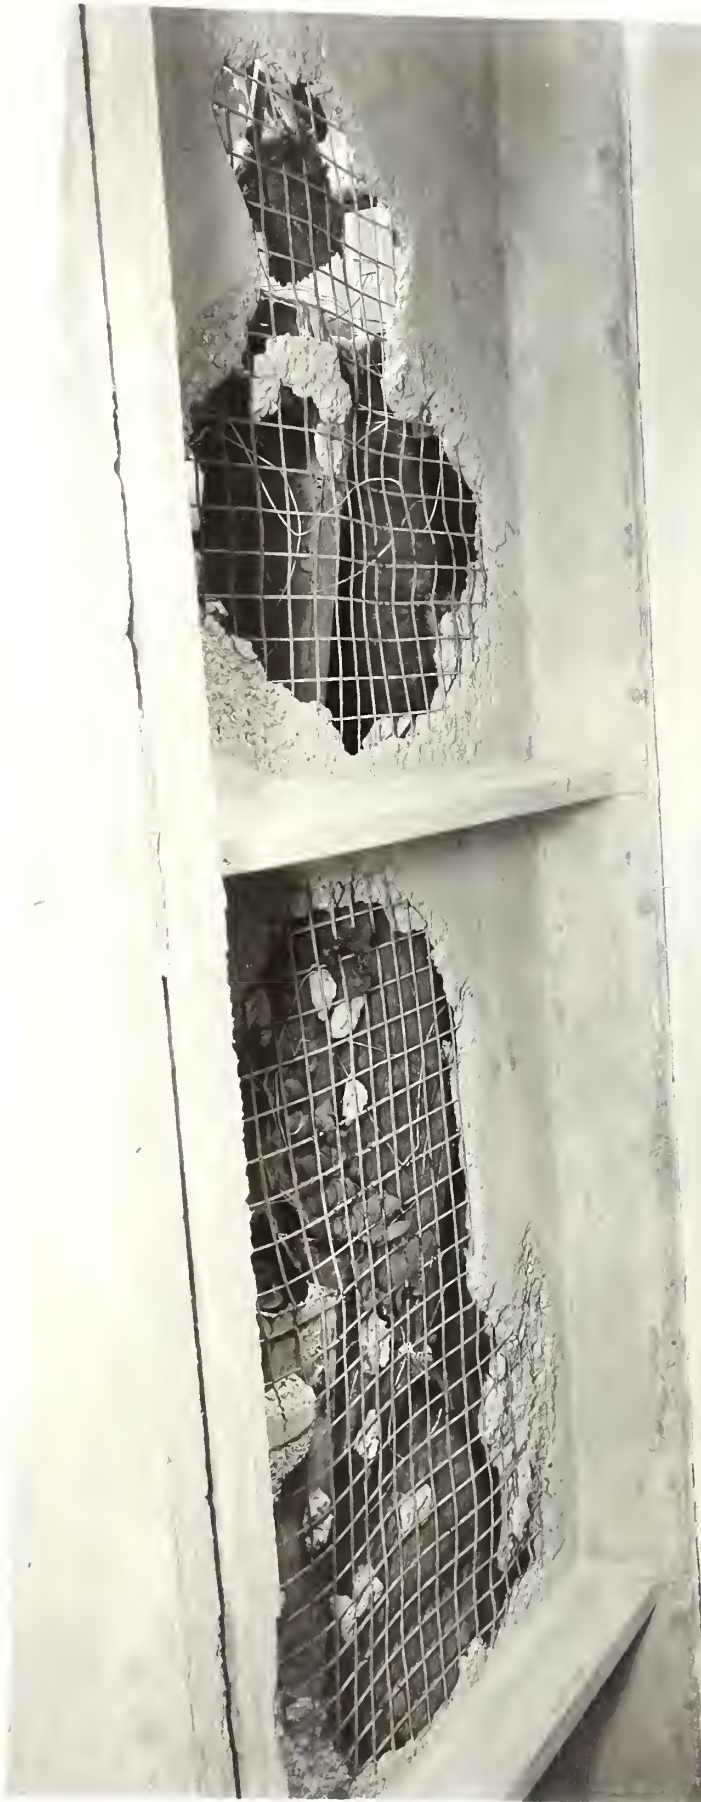
TEST 325  
CONCRETE  
ROOF DECK  
6-30-53

During the fire test, transverse cracks were observed at 7 min in the top surface along the transverse centerlines of the center and East panels and the North quarter point of the center panel; 9 min, moisture on top surface from above cracks; 10 min, diagonal crack across top surface in Southwest corner; 10½ min, full 1½ in. thickness of concrete spalled explosively from over half of bay South of center of East panel; 15 min, concrete spalled through about 1/3 of area of South bay of East panel, explosively; 27 min, channel webs and possibly transverse ribs sagging between flanges; 30 min, spall 2 to 4 in. long at bottom of West flange of East panel, near center of span; 47 min, transverse ribs sagged ¼ to ½ in.; 1 hr, slight sag in longitudinal flanges, up to 1 in. sag in web; 1 hr 2½ min, gas off, test ended.

The apparatus by which measurements of the deflections of the panels were to have been made was disarranged by the explosive spalling at 10½ min and accurate measurements were not possible thereafter. The fire exposure severity for the full duration was 93.0 percent of standard. The average temperature as measured on the unexposed surface of the panels had risen the limiting 250 degrees F (139 degrees C) above the initial average by about 10 min and the maximum temperature as measured at any one point had risen the limiting 325 degrees F (161 degrees C) above its initial temperature at the same time. The average temperature, as measured on the ¾ in. reinforcing bars, reached 1000°F at 1 hr and the maximum at any one point reached 1200°F at 50 min. Plots of the various temperatures measured are given in figure 2. The condition of the specimen after test is shown in figures 3 and 4.

The results of this test indicate a fire endurance limit of about 10 min for the particular specimen tested.
