THE FIRE RESISTANCE OF PRESTRESSED CONCRETE BEAMS

June 1, 1954

## THE FIRE RESISTANCE OF PRESTRESSED CONCRETE BEAMS

Bureau of Yards and Docks  
Department of the Navy  
Project Order No. 61705

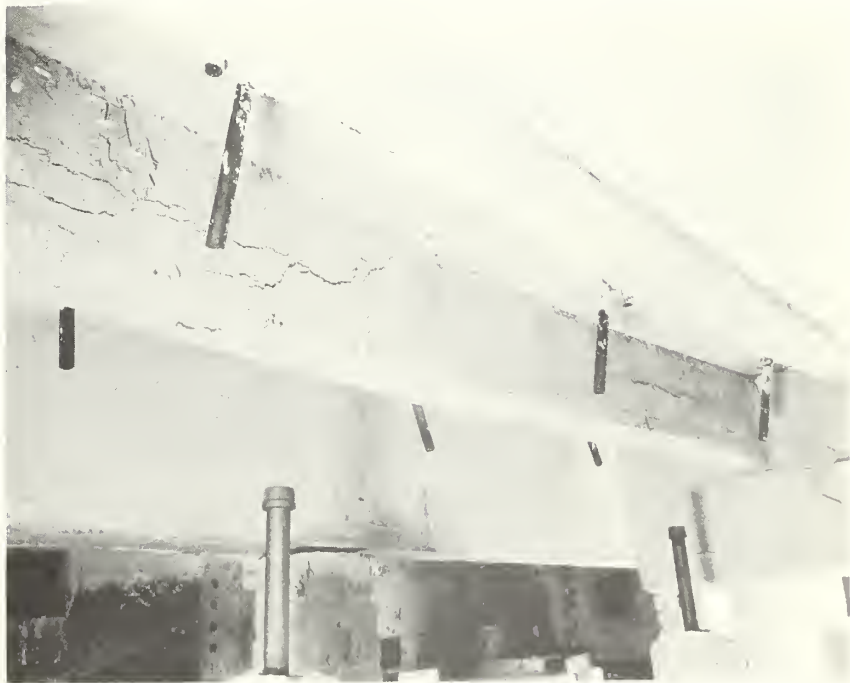
FIG. 7 A:1/2:0 BEAM AFTER FIRE TEST 331 AND RELOADING TEST

The day after the test, the beam had recovered some of the deflection and a reloading test was made. The beam failed under a load of 10.4 long tons, almost the same as the test load. Following the reloading test, when the specimen was broken up, it was found that all of the wires in the prestressed cable were unbroken but the steel-constantan junctions were rusty, possibly accounting for the observed variations in cable temperatures. The conditions of the beam after the fire test and after the reloading test are shown in figures 6 and 7.

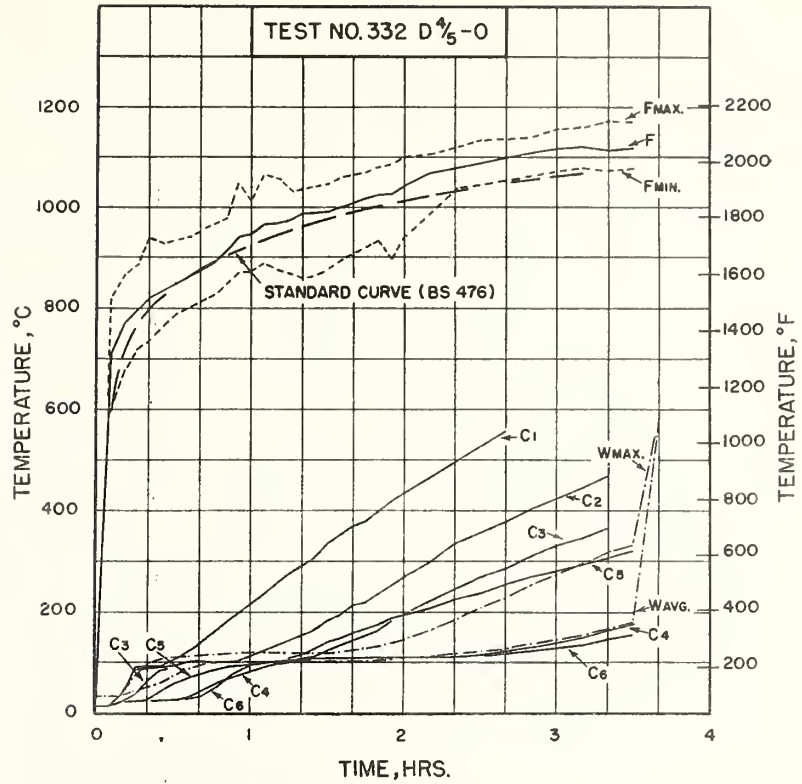
FIG. 8 TEMPERATURES OBSERVED DURING TEST 332. TEST STOPPED BEFORE ALL 3 HR. 40 MIN. TEMPERATURE OBSERVATIONS COMPLETED

The furnace control was fairly good, the average temperature having been near or slightly above the Standard curve throughout the test. The temperatures at the various locations in the beam rose to about 212° F (100°C) and leveled off for periods ranging from 10 min to 1 hr 10 min before continuing upward, apparently indicating time required to eliminate moisture. The cable temperatures behaved in a similar manner but remained near 212° F about 1 3/4 hr. The temperature curves are shown in figure 8.

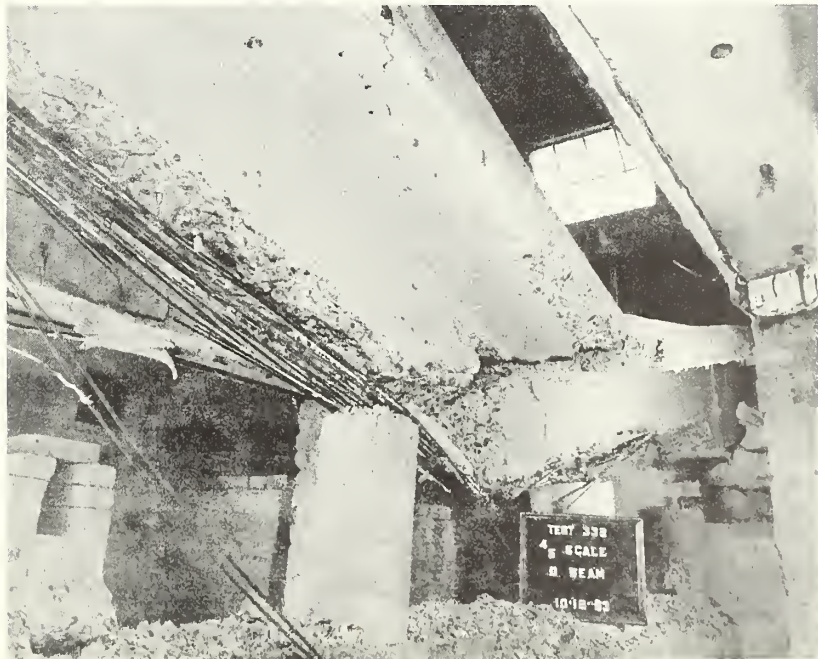
FIG. 9, D<sup>4</sup>/<sub>5</sub>-0 BEAM AFTER FIRE TEST 332, SHOWING BREAKS IN SLAB, BEAM, AND CABLE, THE LATTER GROUPED IN TWO LOCATIONS.

After the test, the beam and slab were found to have broken in the middle, and the bottom concrete had broken off to expose the prestressed wires from haunch to haunch. The breaks in the broken wires were not all in one location but were divided into two locations, as shown in figure 9. All the wires were broken.

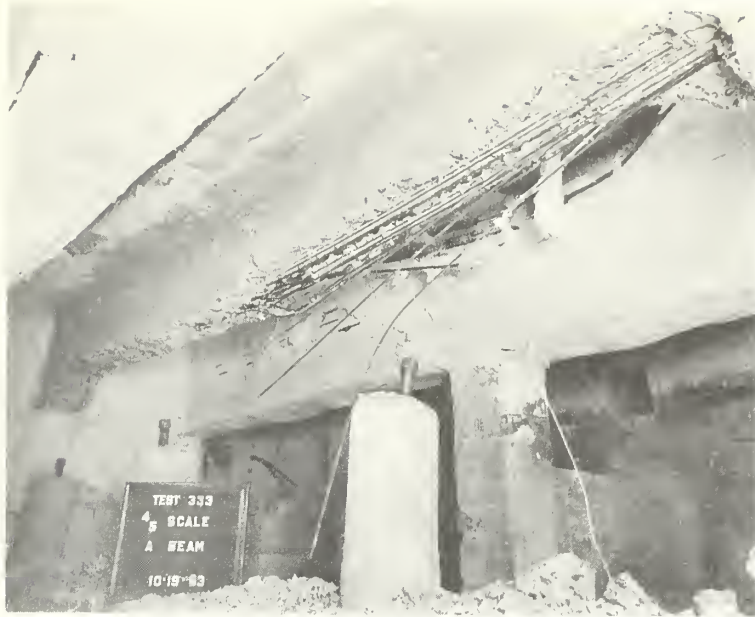
FIG. 12 A:4/5-0 BEAM AFTER FIRE TEST 333

On the day following the test the beam had recovered partially from the maximum deflection and the beam and slab were cracked in several locations. They were cracked through or broken at center span. Concrete had fallen from the bottom to expose the lower side of the grouted cable duct over the north half including most of the haunch, and to expose much of the cable in the south, again including most of the haunch. Fifteen of the 24 wires in the cable were broken. Their locations are shown in figure 11. The condition of the beam is shown in figure 12.

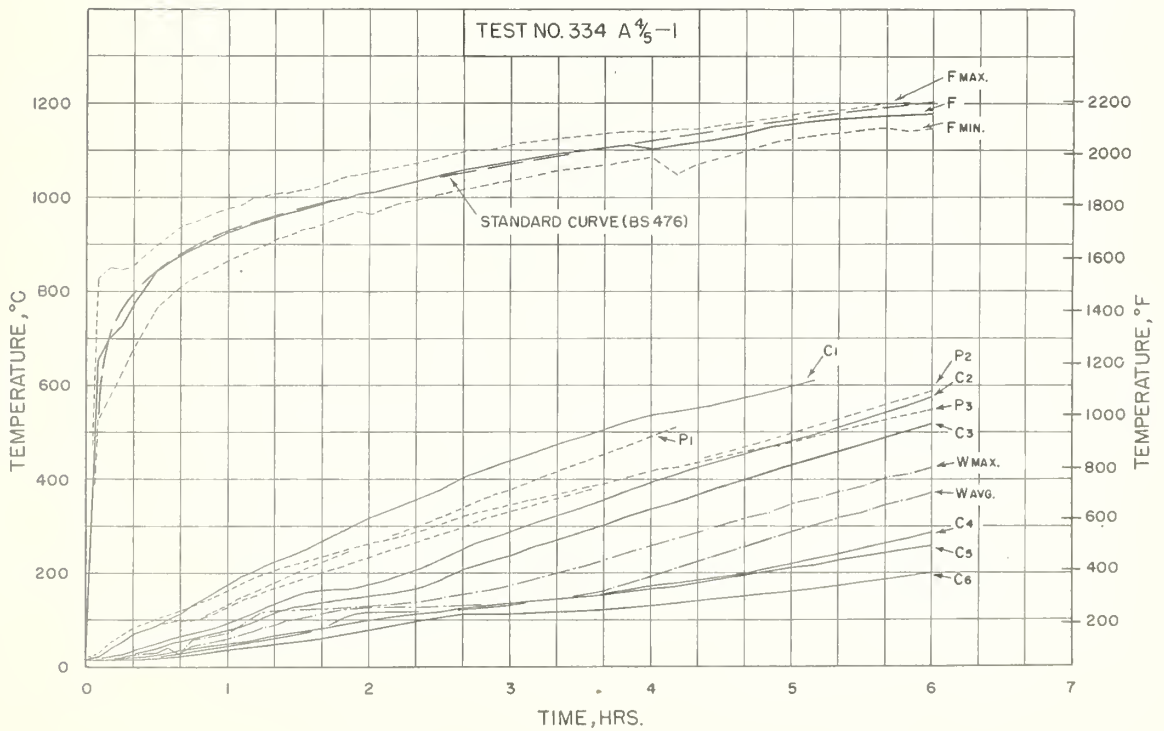
FIG. 13 TEMPERATURES OBSERVED DURING FIRE TEST 334

The furnace control was good, the average temperatures being a little low only near the end of the test, and the temperatures in the beam and cable rose gradually and smoothly throughout the test, as shown in figure 13. Thermocouple P<sub>1</sub> became inoperative at about 4 1/4 hr and P<sub>4</sub> had been found to be inoperative in a pre-test check.

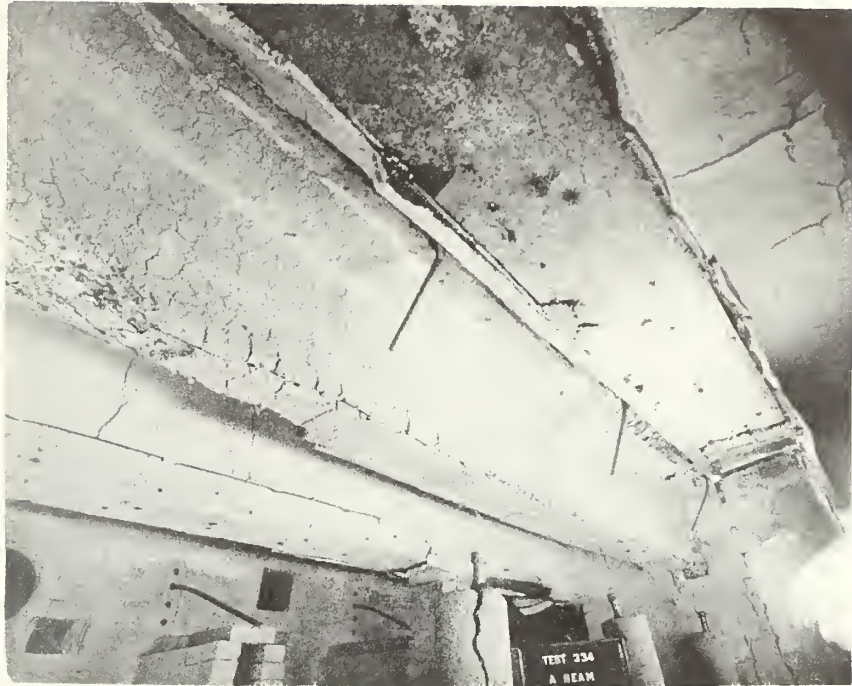
FIG. 14 A:4/5:1 BEAM AFTER FIRE TEST 334

Upon being unloaded and cooling over the weekend, the beam recovered about one-third of the total deflection. The vermiculite concrete slabs were thoroughly cracked and the joints between had opened. The beam had spalled at each end and the slab in the north half on the east side, as shown in figure 14. The spalling had involved, or been caused by, splitting of the aggregate rather than loss of bond between aggregate and cement. This is shown in figure 15. The beam was subjected to a reloading test and failed under a load of about 65,180 lb (29.1 long tons), exclusive of the weight of the beam and slab. The beam and slab broke at the worst of the spall in the slab, about 2 ft north of center, exposing the cable from that location to the north end of the exposed length, as shown in figure 16. After the reloading test it was found that none of the prestressed wires was broken.

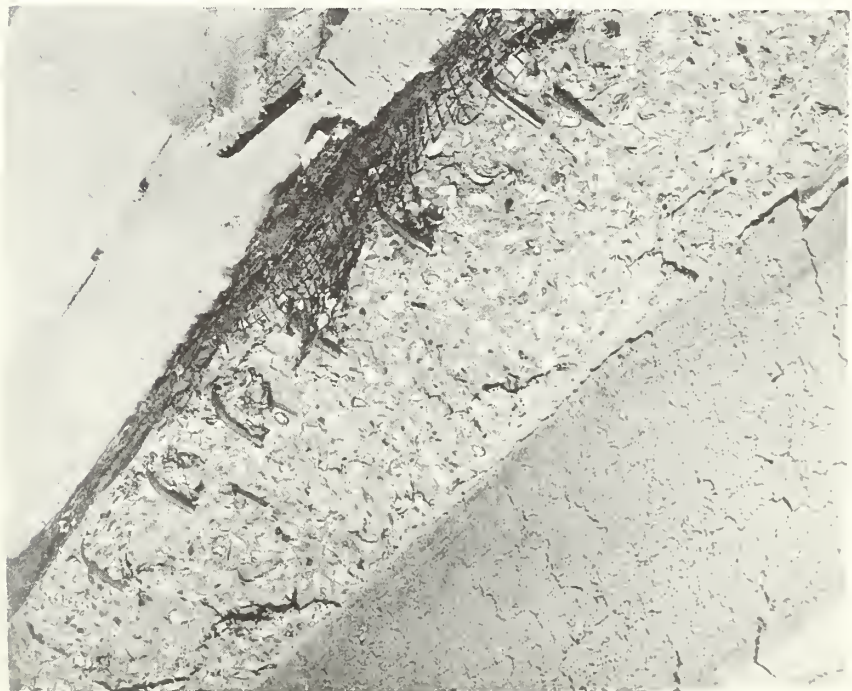
FIG. 15 REPRESENTATIVE SPALLED AREA (SLAB) FROM TEST OF A:  $\frac{4}{5}$ :1 BEAM

The only violent spalling observed in this series of tests occurred in the two tests of beams with insulation of 1-in. reinforced vermiculite concrete. Each of these beams spalled explosively along the haunches and ends of the central section. Spalling near one end occurred in two of the four British tests of A-type beams with 1 in. of vermiculite concrete insulation but did not occur in any other tests, either with greater thicknesses of the same type of insulation or with no insulation. The spalling might have

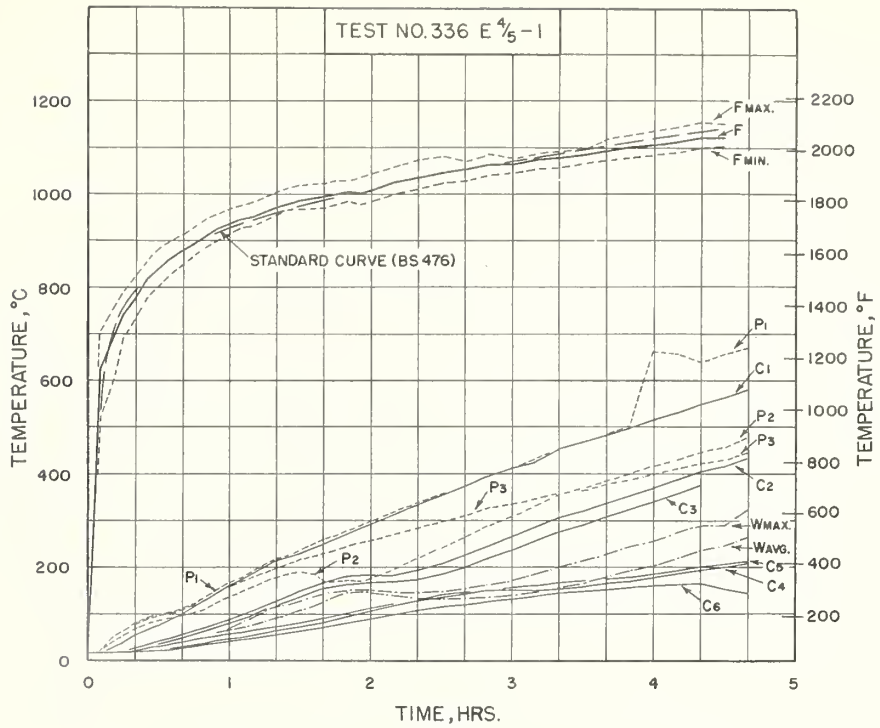
FIG. 18 TEMPERATURES OBSERVED DURING TEST 336

The furnace control was good, the average temperature having been very near that specified by the Standard Time-Temperature Curve throughout the test. The temperatures in the concrete and cable rose smoothly and gradually, except that indicated by thermocouple P1 which jumped at about 4 hr, as shown in figure 18.

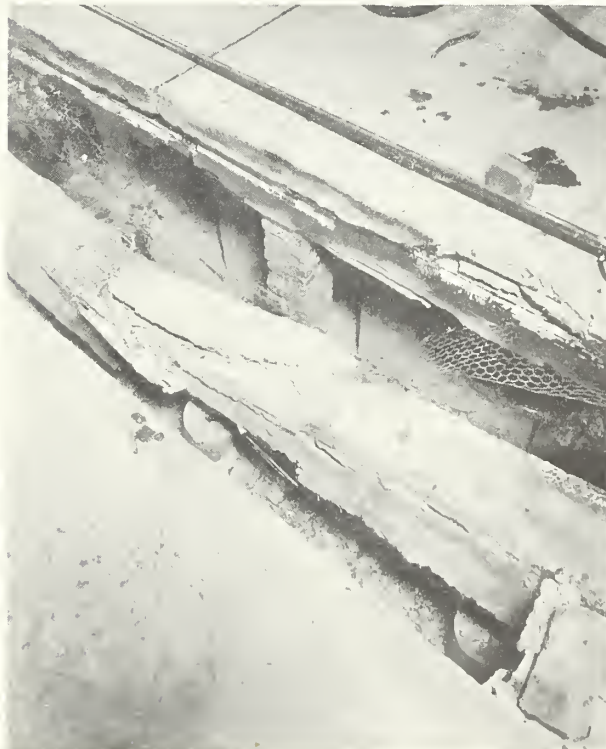
FIG. 19 E  $\frac{4}{5}$ -1 BEAM FROM ABOVE AFTER FIRE TEST 336 SHOWING SHEAR FAILURE AT TOP

After test, the beam was found to have broken at the center of the span and a considerable amount of concrete was off the north half, exposing the cable. Twelve of the 24 wires in the cable were broken, the breaks having been about 4 ft north of where the beam broke. A large piece of concrete had sheared off the top, as shown in figure 19. The spalled areas showed shearing of the aggregate, as in the test of the A:4/5:1 beam.

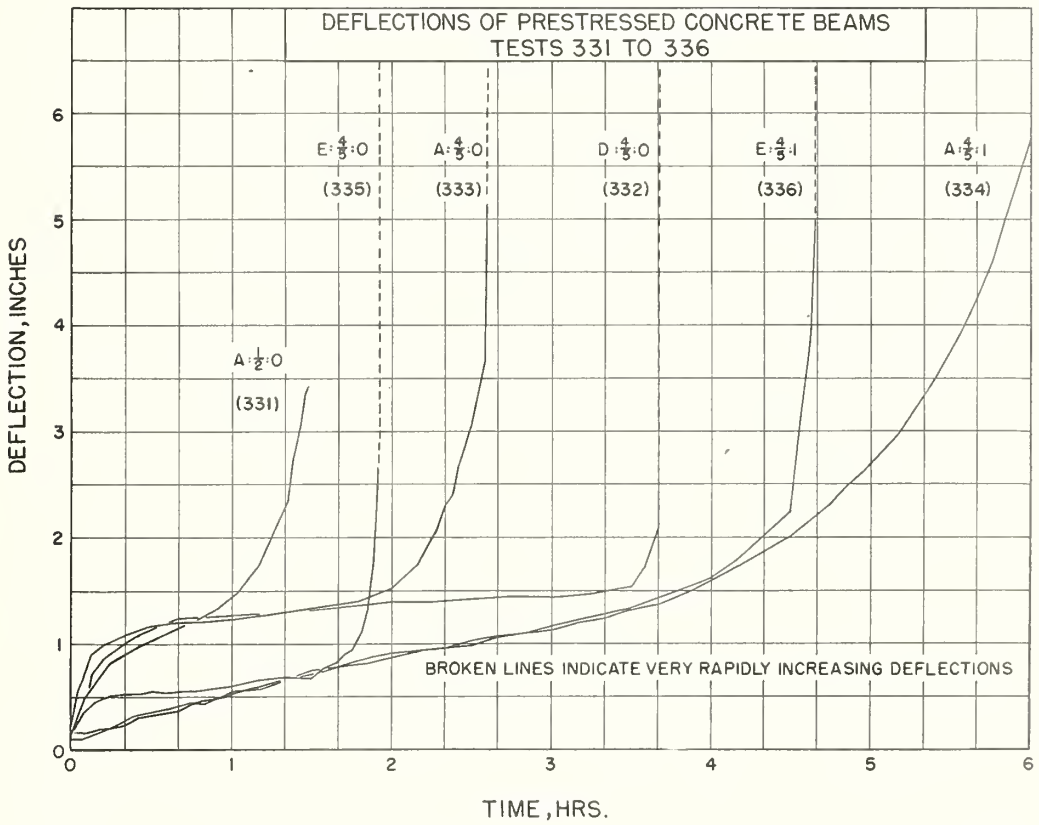
FIG. 20 DEFLECTIONS AT CENTERS OF BEAMS OBSERVED DURING TESTS, ALL DEFLECTIONS DOWNWARD
