PROGRESS REPORT ON ENGINE AIR
CLEANING

Carl W. Coblenz

PROGRESS REPORT ON ENGINE AIR CLEANERS

(Inspection of Two Helicopter Engines)

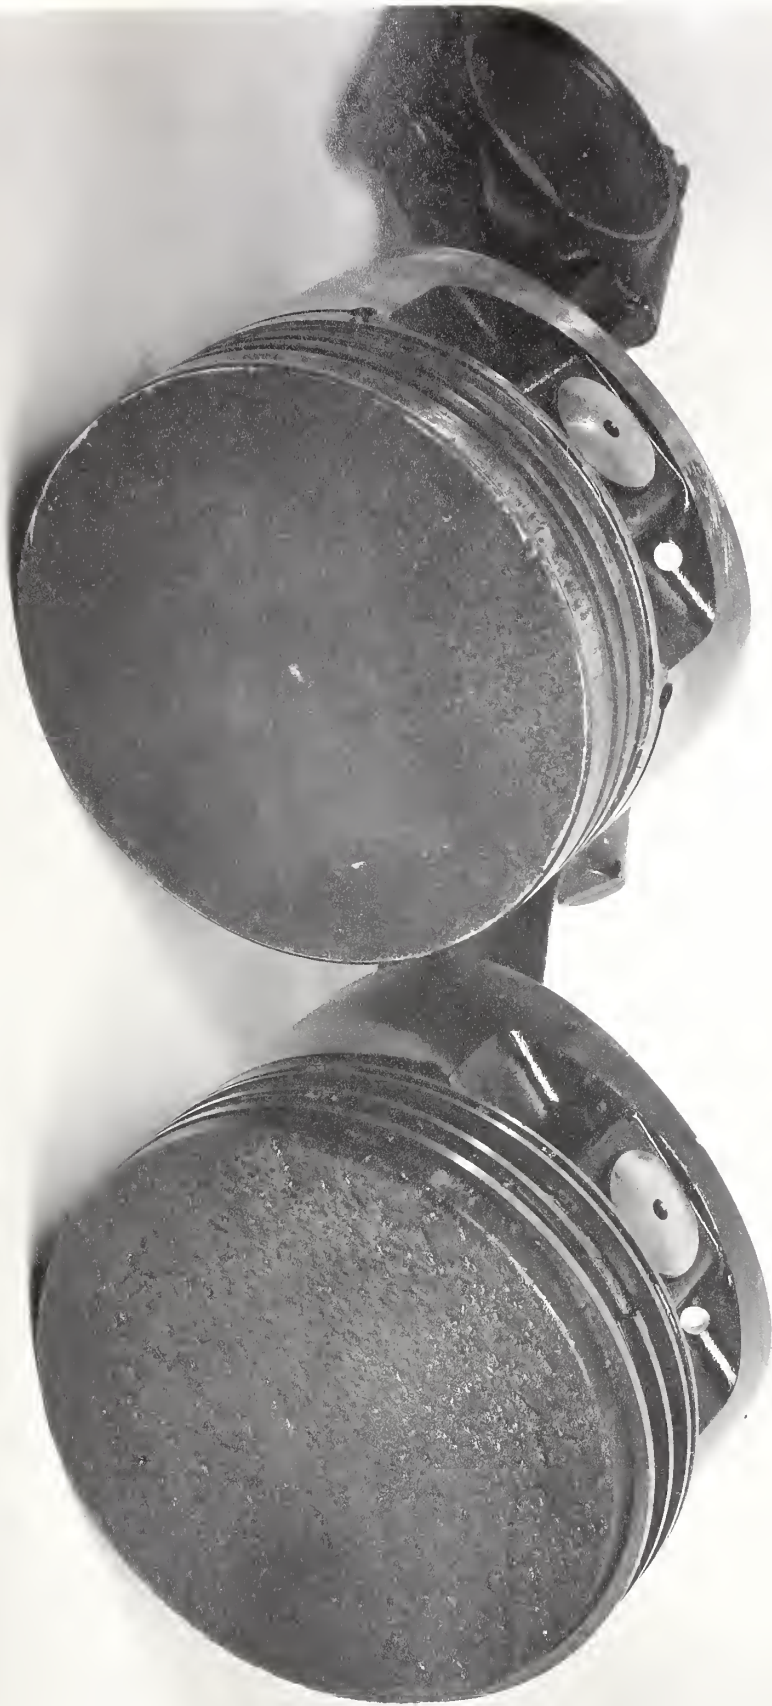
The cylinders and pistons of the engine were disassembled and cleaned with varsol. No marks of extensive wear were noticed on any part and the extent of wear appeared similar on all cylinders and pistons. Figure 1 shows a photograph of two pistons with connecting rods. The right hand piston was only washed and appears as it was removed from the cylinder whereas on the left hand piston the rings were taken off and the walls scraped free of carbon so that the score marks above the first compression ring are clearly visible. These score marks indicate that dust particles of considerable size had reached the cylinders through the air induction system. The piston skirts appeared smooth and showed no score marks.

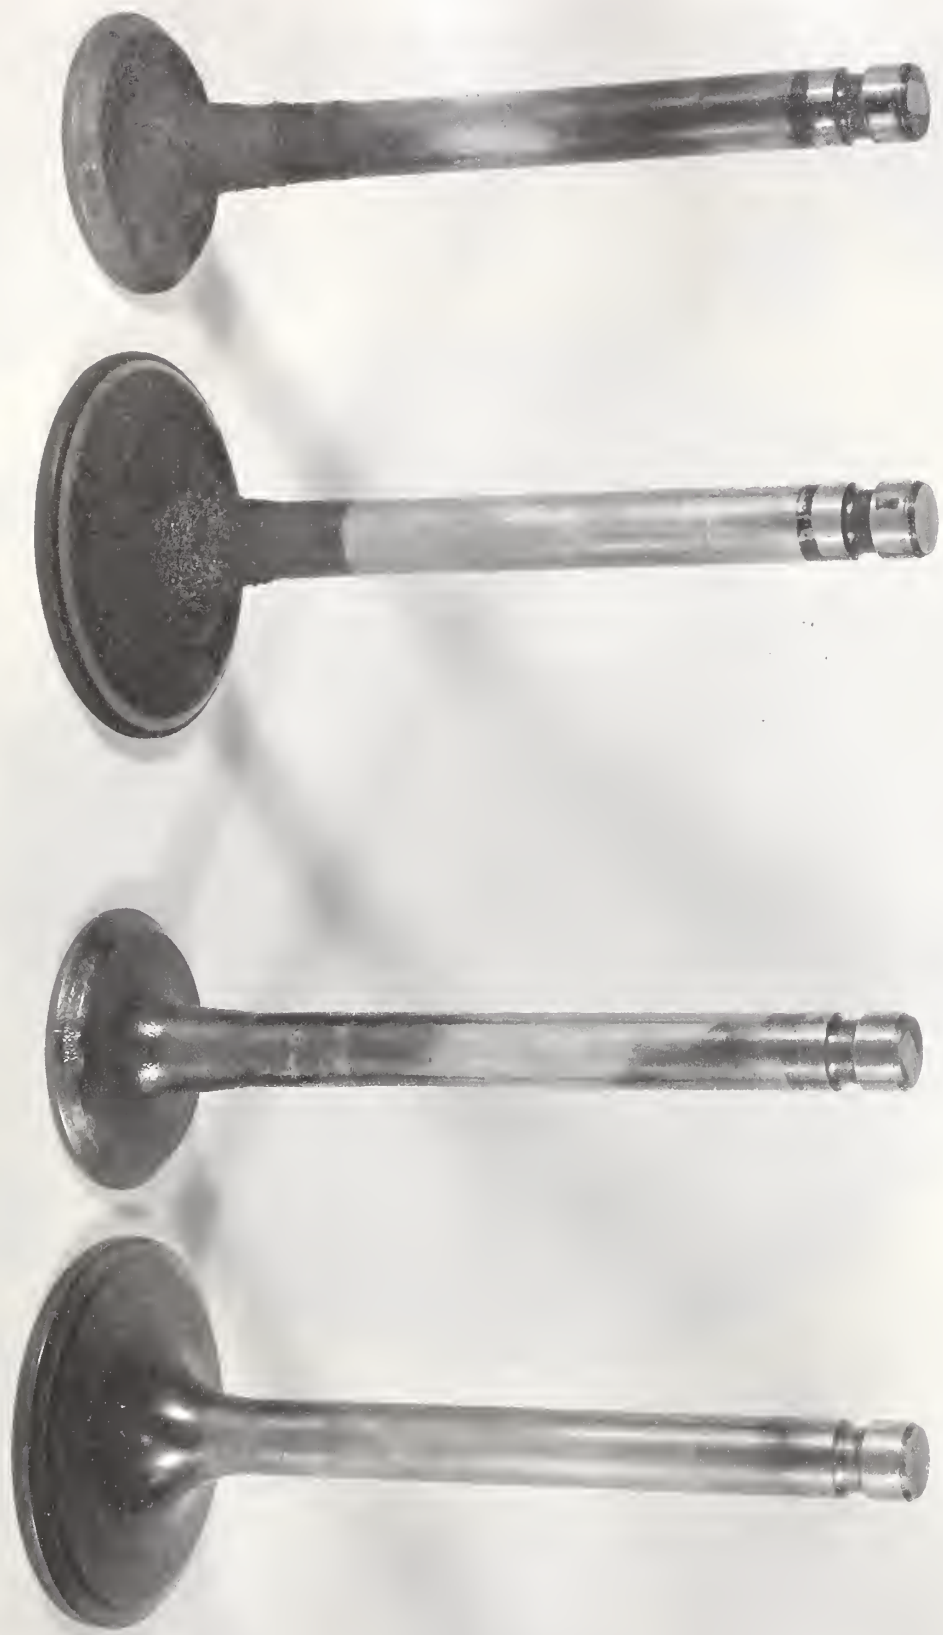
24899 2

Figure 2 shows a photograph of two pairs of valves, the left pair as it was removed from the cylinder and the right hand pair with the carbon brushed off. The valve lip of the cleaned exhaust valve was badly pitted but there was no wear noticeable on the valve stems.

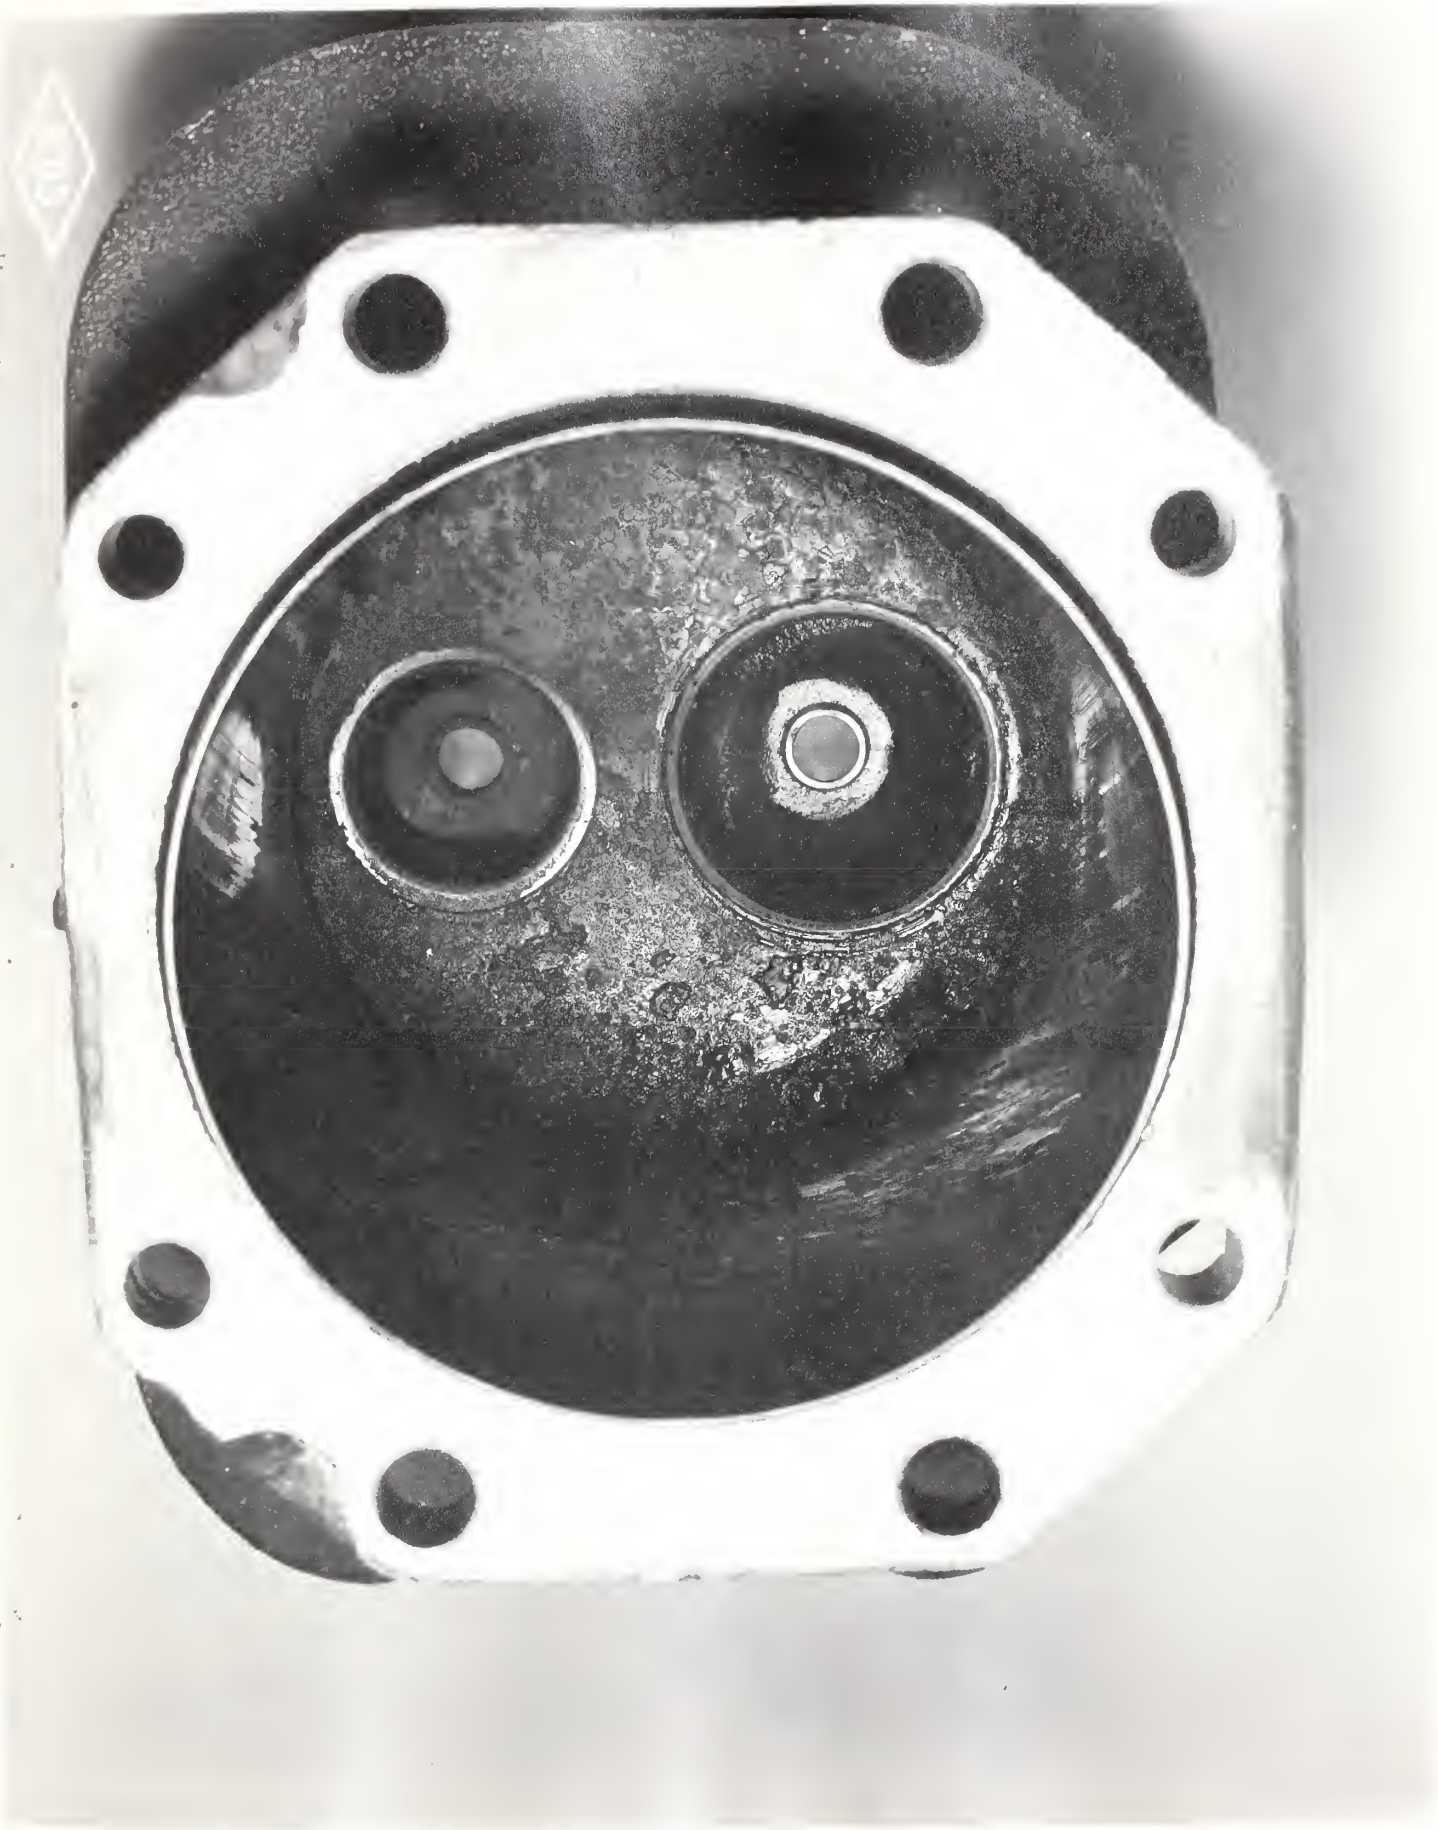
IG. 3

All cylinders appeared in a good condition as indicated in the photograph of cylinder #2 in figure 3. There were no

visible score marks as on the pistons. The seats of the intake valves showed very little or no pitting at all, whereas all the exhaust valve seats were more or less pitted.

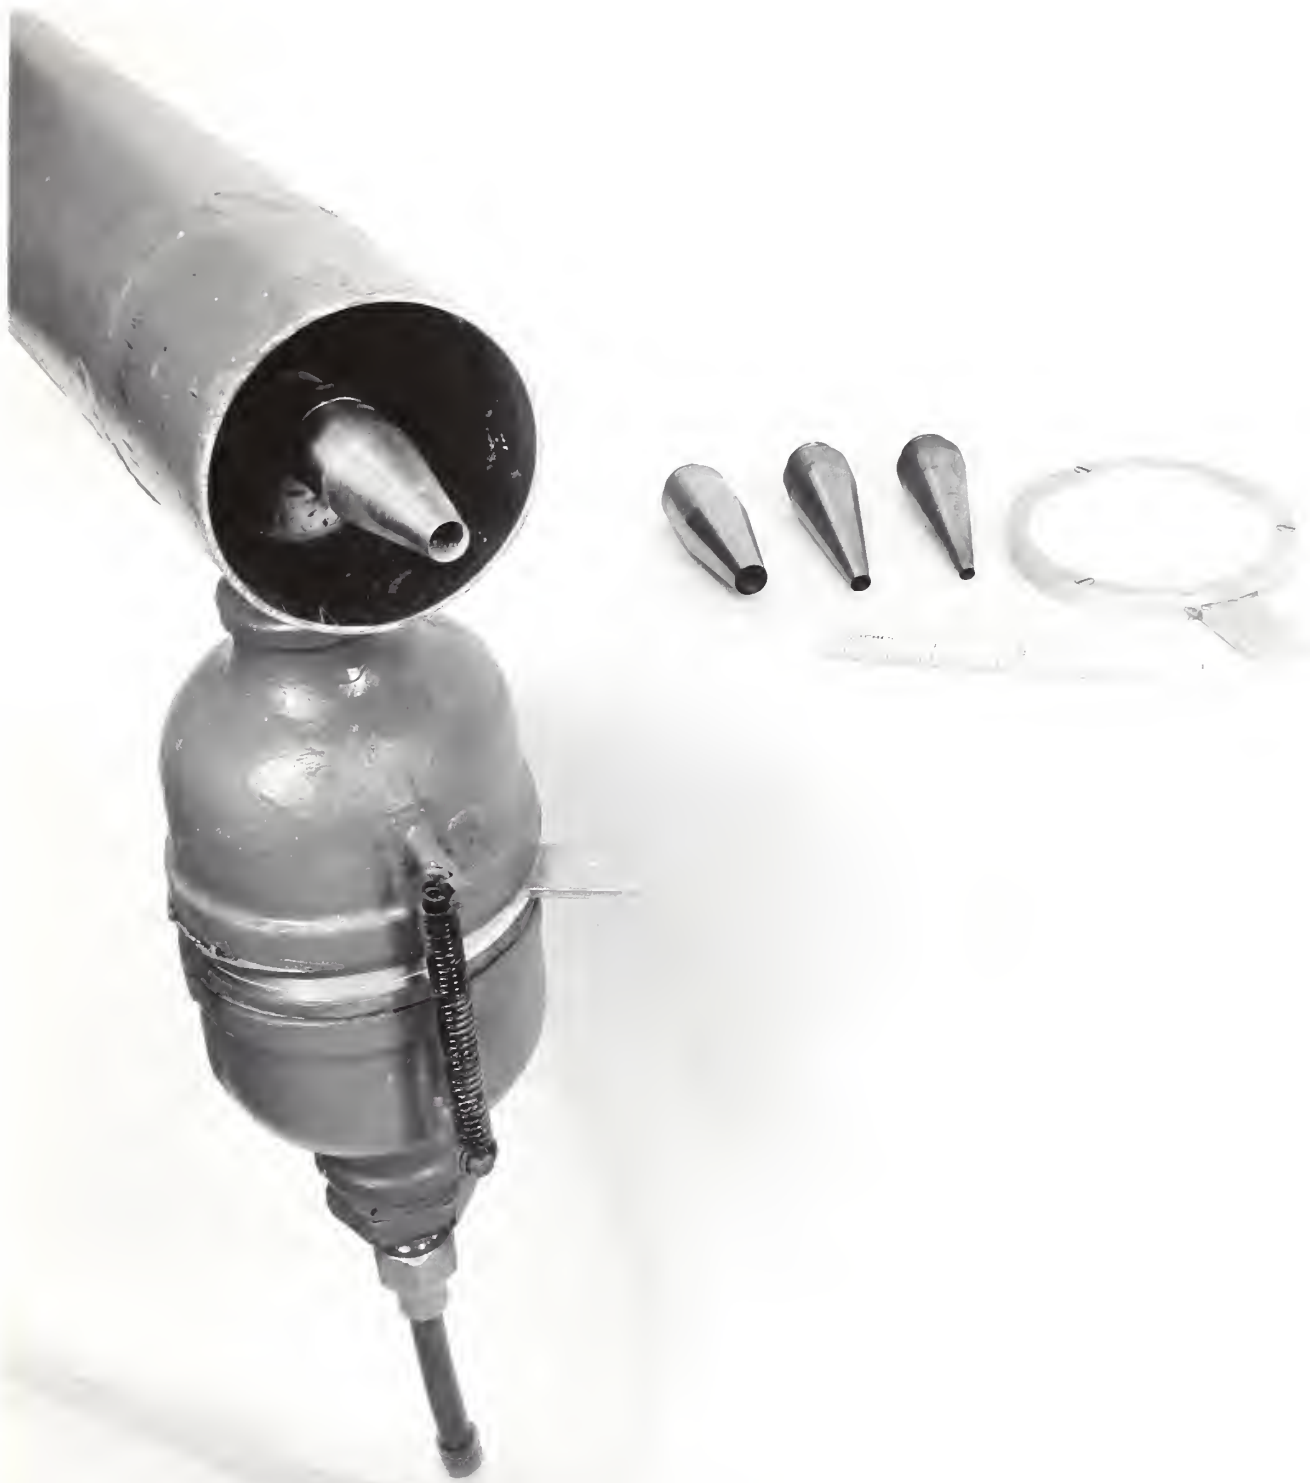
FIG. 7

Four feet from the filter the air sampling device is installed as shown in Figure 7. Exchangeable nozzles from 1/4 inch to 13/32 inch diameter permit the drawing of sampling air isokinetically over a wide range of air velocities in the duct at a flow rate of between 1 cfm and 2 cfm. The maximum

flow rate of the sampling air is determined by the limited tensile strength of the absolute filter a 0.3 micron glass fibre paper which is clamped in a 3 inch holder and will retain 100% of all dust particles above 0.3 micron size. The sampling paper holder is clamped between two pipe bell caps and air is drawn through it by special vacuum pumps. The samplers are weighted before and after each test to the nearest 0.1 milligram.

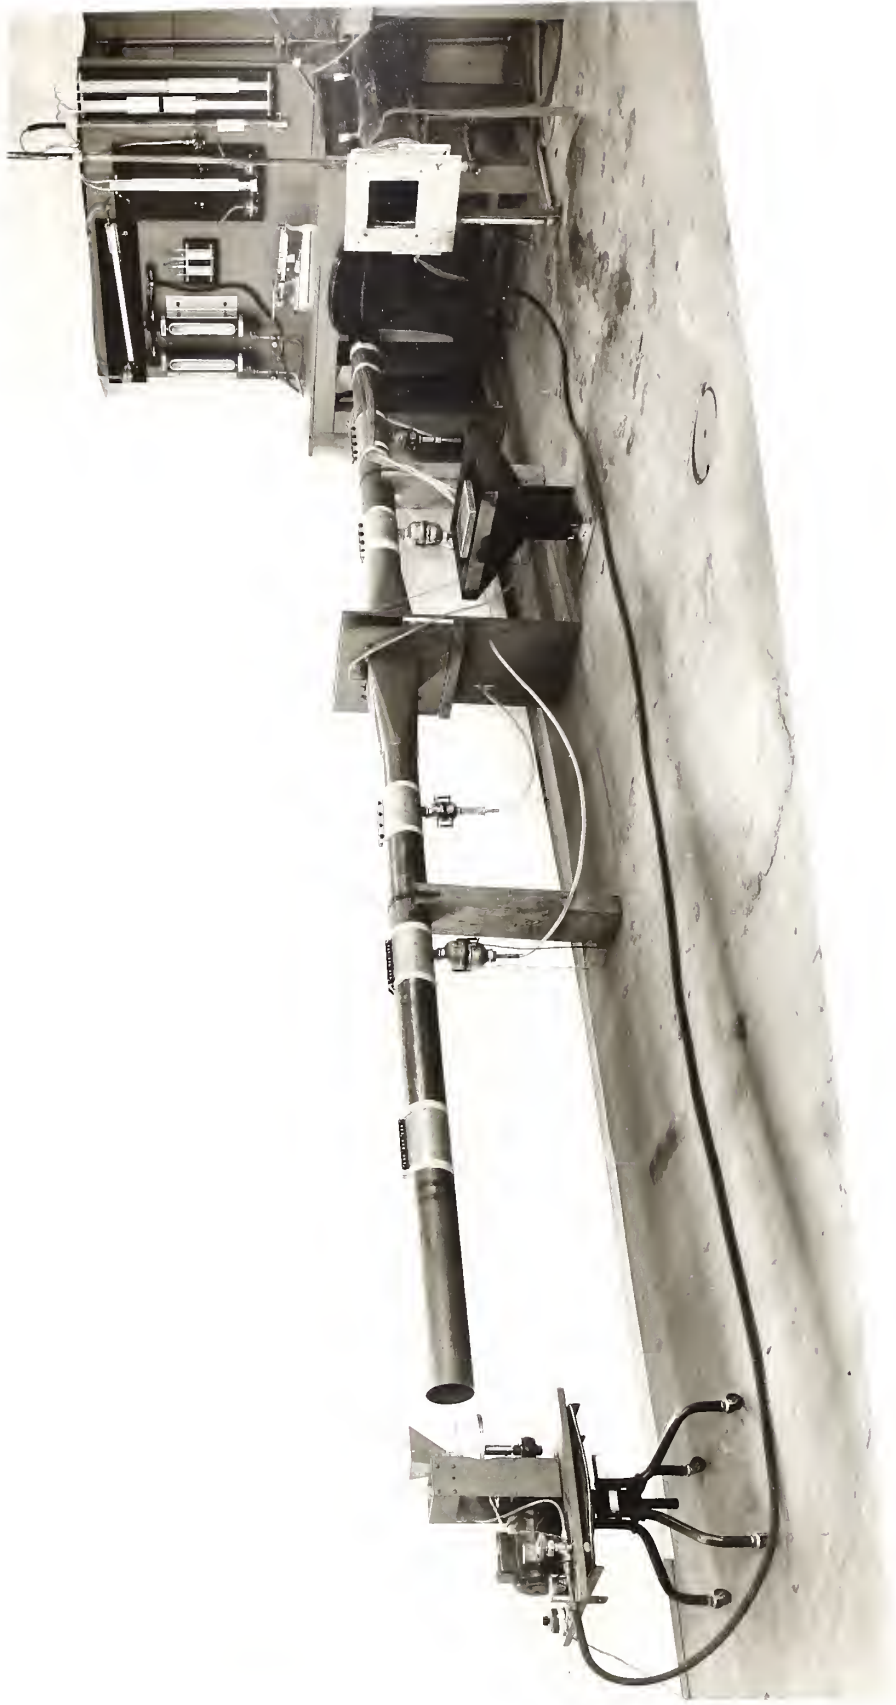
FIG. 9

Figure 9 shows a photograph of the entire test duct with the test panel in the background. The adapter for holding the filters is in the middle of the duct and below it on the floor is shown an inverted funnel used for oiling and draining four filters at one time. Figure 10 shows a close-up view of the test panel.

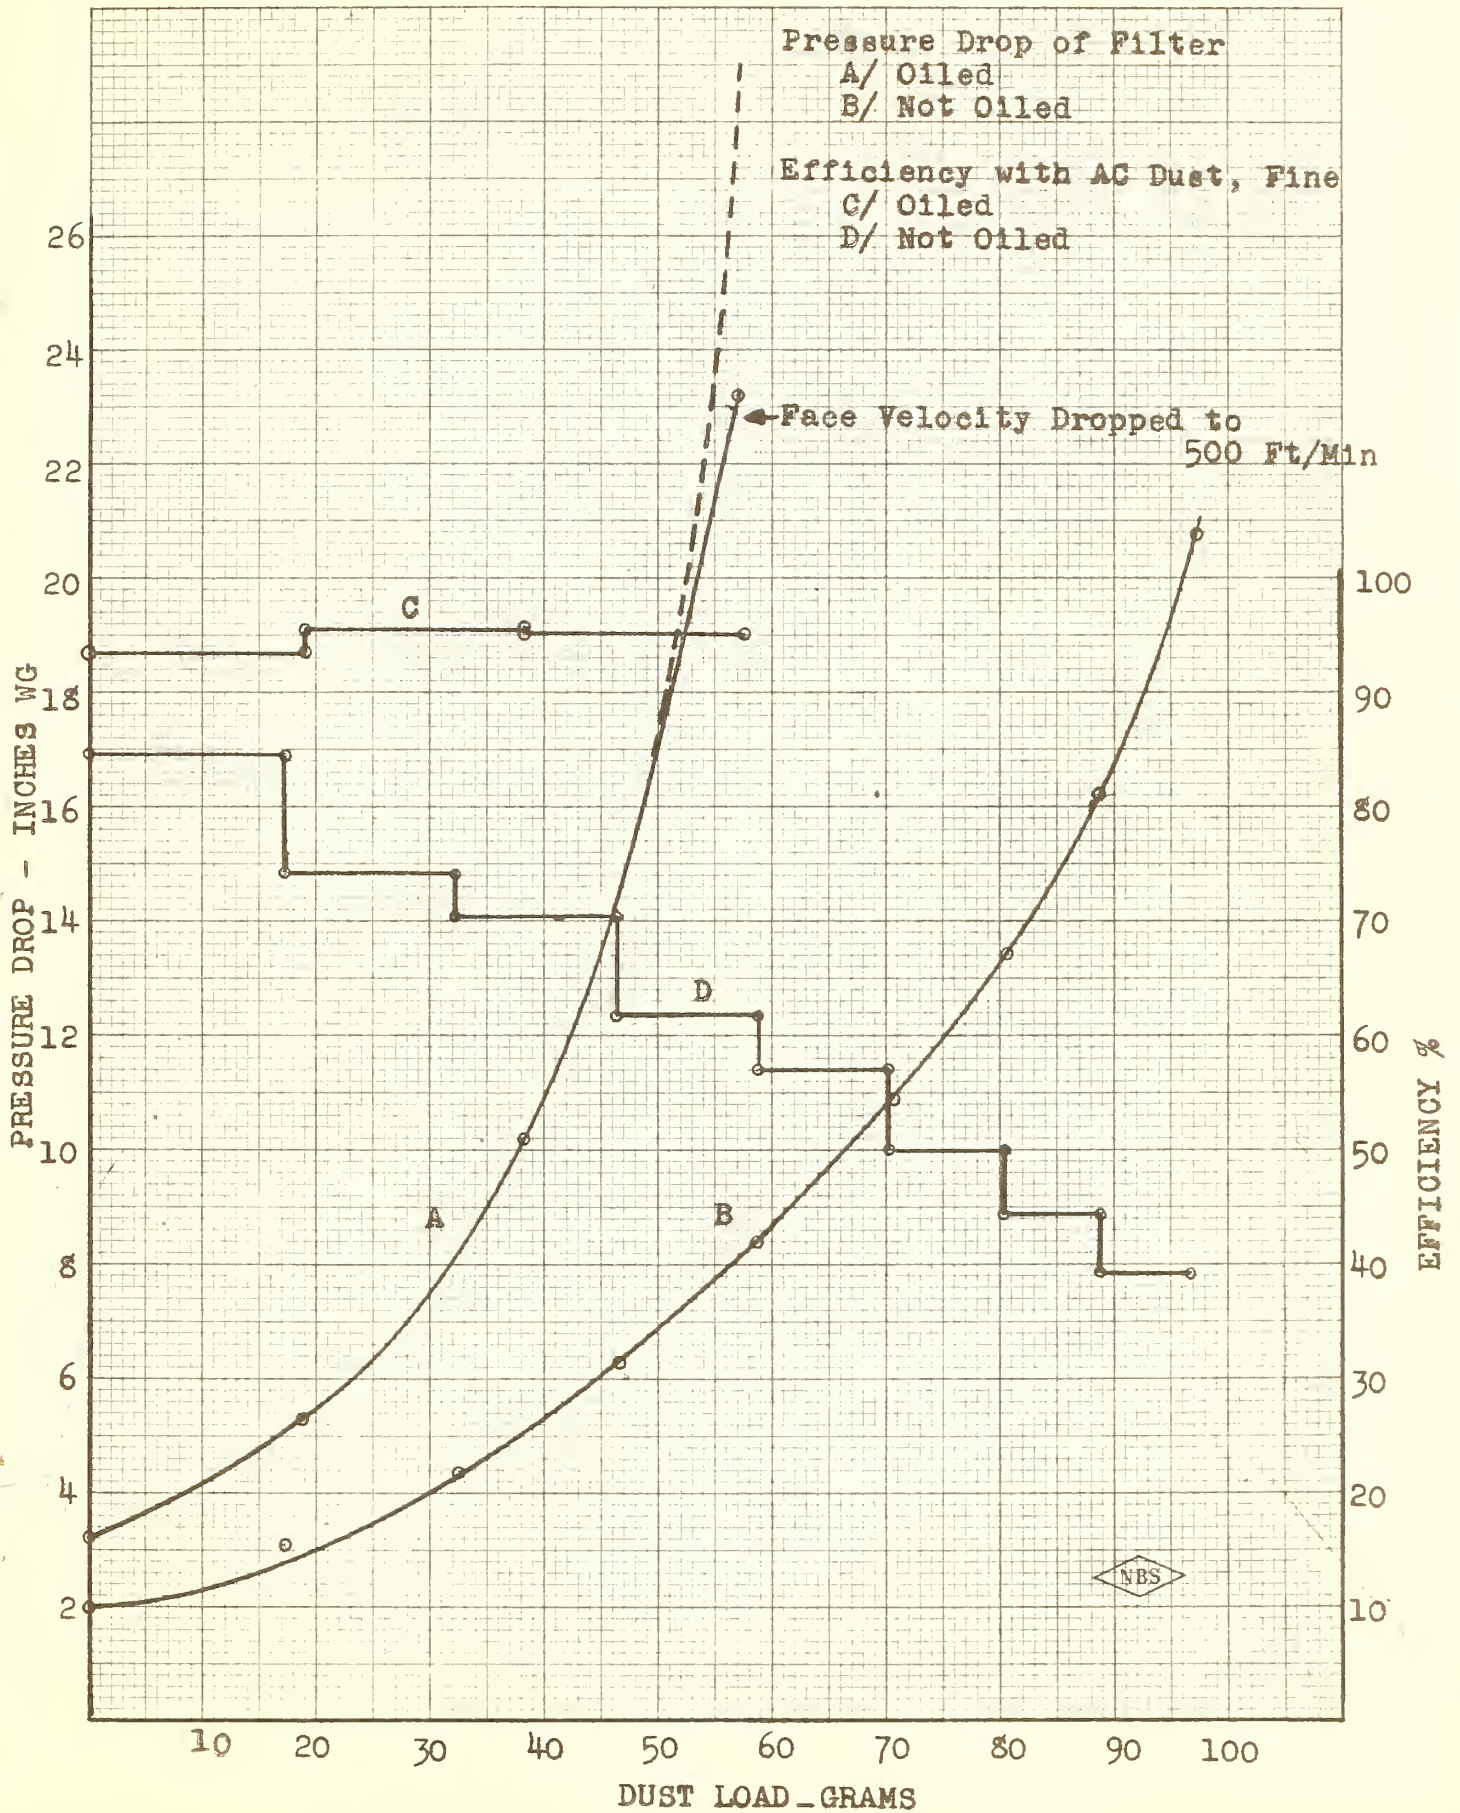
FIG. 11

To determine the effect of oiling on these kinds of filters the two new filters were loaded up to capacity with A. C. Spark Plug dust fine and the efficiency determined by weighing the filter after 20g dust had been introduced into the air stream with a dust concentration of approximately 20 mg/cu.ft. The airflow rate was maintained at 305 cfm, except that at the end of the test with the oiled filter the pressure drop across the filter increased to such a value that the exhaust capacity was reduced to 150 cfm. The results of these tests are plotted in figure 11 which shows that the efficiency of the oiled filter remains well above 90% as the filter clogged up for all practical purposes. The pressure drop across the filter measured as 23.2 in W.G. at 150 cfm would have been very much higher if the airflow rate of 305 cfm could have been maintained by the exhaust blower. The not oiled showed an efficiency of 84.7% at the beginning of the test which dropped down to 39.2% the pressure drop at that efficiency had increased to 20.8 in. W.G. and the test was broken off because the efficiency was below any useful value and also the limit of the blower capacity was reached.

In another test with a new oiled filter it was determined that the introduction of 40g of dust increased the pressure drop from 3.2 in. W.G. to 15.6 in. W.G. and the efficiency computed with the sampling method was 96.1%. It was noticed that the

EFFECT of OILING of AIRMAZE AIRCRAFT FILTERS at 1050 Ft/Min F. V.

specification MIL-F-7194 would require the pressure drop of this filter not to exceed 8 in. W.G. after introducing approximately 58g of dust into the air stream; the required filtering efficiency of 90%, however, is well exceeded.
