NATIONAL BUREAU OF STANDARDS REPORT

WEEP HOLES IN CONCRETE MASONRY PANEL WALLS

C. C. Fishburn and Edward J. McCamley, Jr.

March 10, 1955

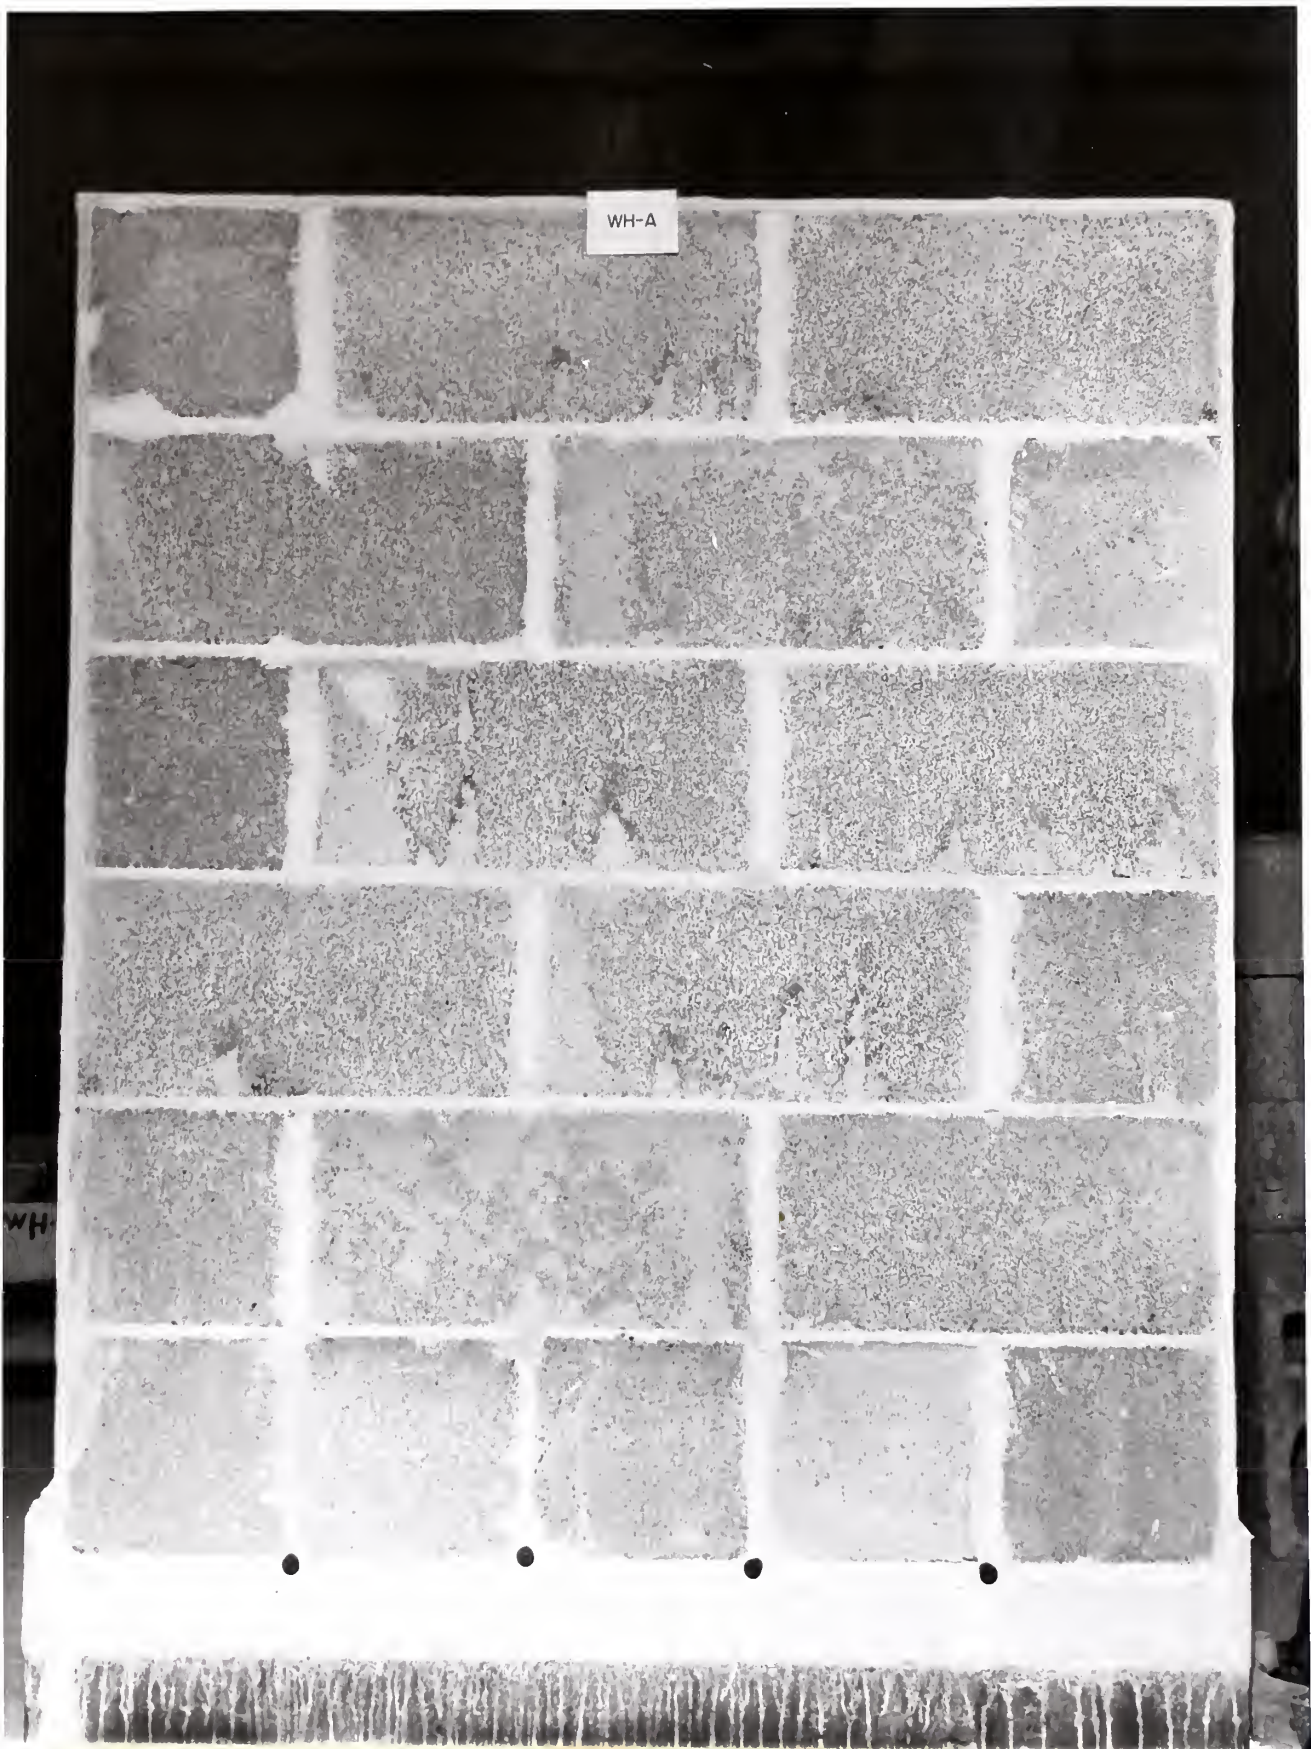
Fig. 2 - Front elevation (exposed face) of wall A, showing weep holes.

Weep holes were placed beneath each vertical joint in the first course (see figure 2). The holes were formed by placing a length of 3/8-in. dia rubber tubing in the mortar bed. One end of the tubing protruded from the wall; the other end was brought up vertically in the wall cells to a height above any mortar droppings. After the walls had been completed and the mortar had hardened, the rubber tubing was withdrawn.

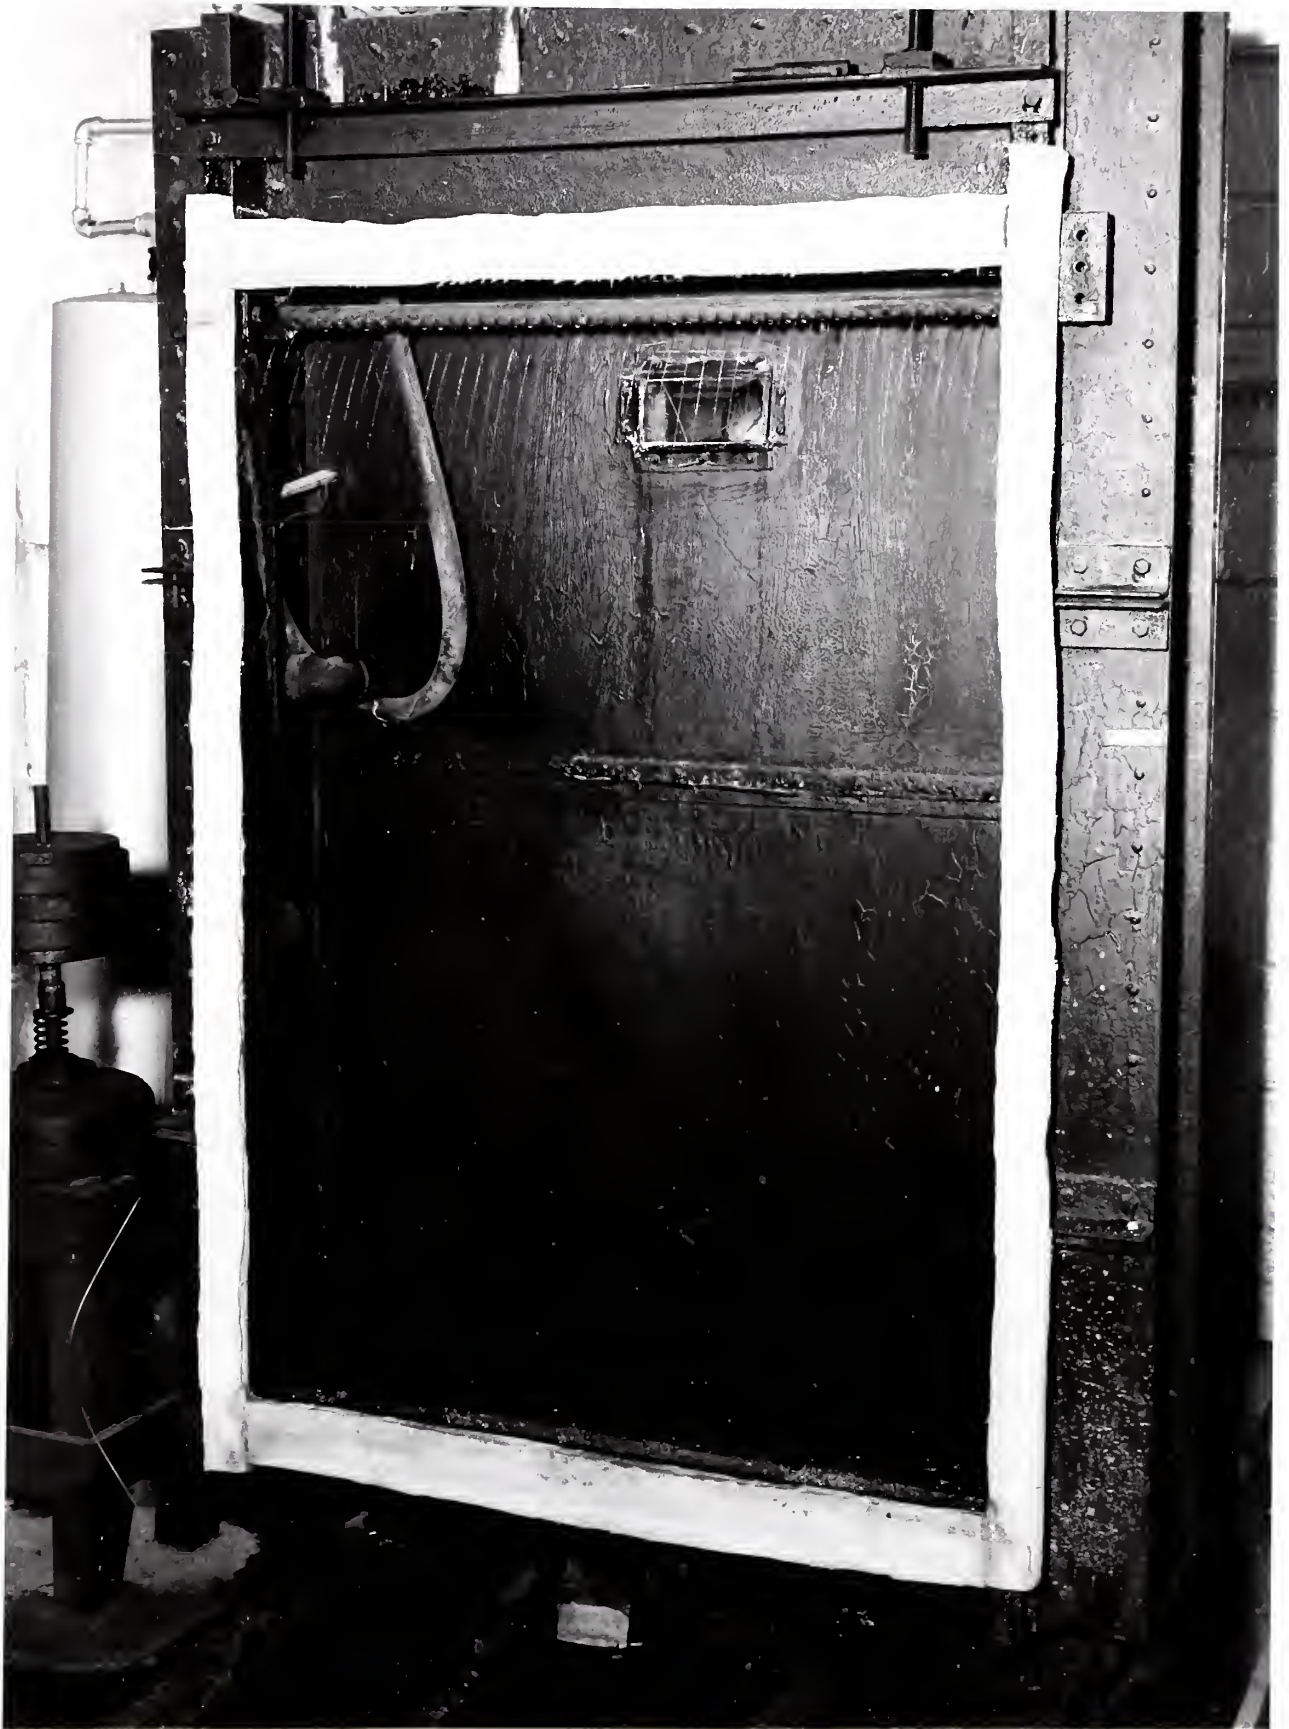
Fig. 3 - Permeability test chamber, showing method of applying water to the wall face.

The test exposures and the test apparatus were similar to those described in NBS Reports BMS82 and BMS95. The exposed face of the test wall formed one side of a pressure chamber. Water at the rate of 40 gal/hr was applied to the top of the wall face from a tube containing a line of small perforations spaced 3/4 in. apart. The test chamber, without the wall, is illustrated in figure 3. The air pressure on the exposed wall face (inside the chamber) was maintained during the test at either 5-, 10- or 15-lb/ft² above atmospheric pressure; these pressures are equivalent to a hydrostatic head of about 1, 2, and 3 in., respectively. A wind velocity of 50 mph may produce a wind pressure of approximately 10 lb/ft². The tests were continued for a minimum of one day. Except for the requirements of a rating of Excellent, the water permeability test ratings of the walls were similar to those described in Report BMS95 and are listed below:

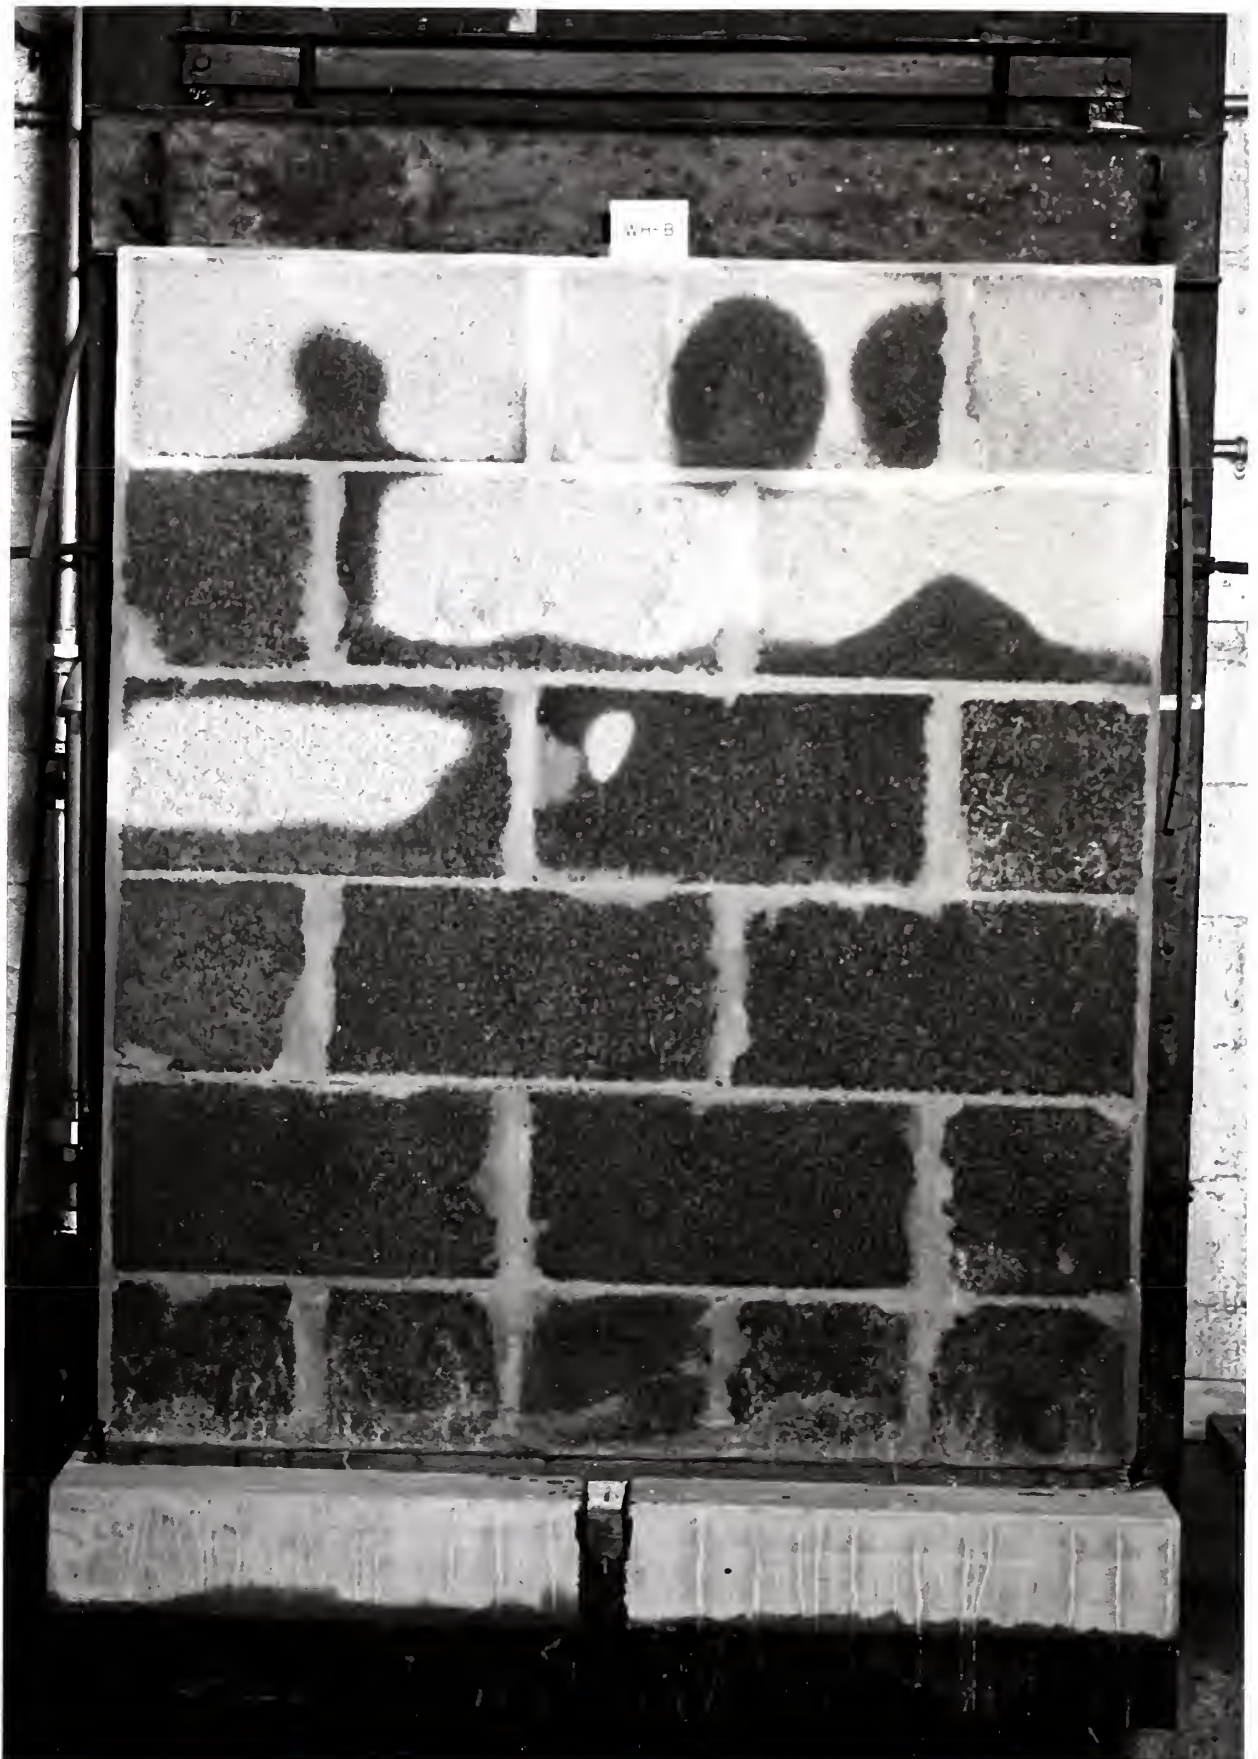
Fig. 4 - Back of wall B after test B-2; exposed face not painted, weep holes open, pressure head of 3-in.

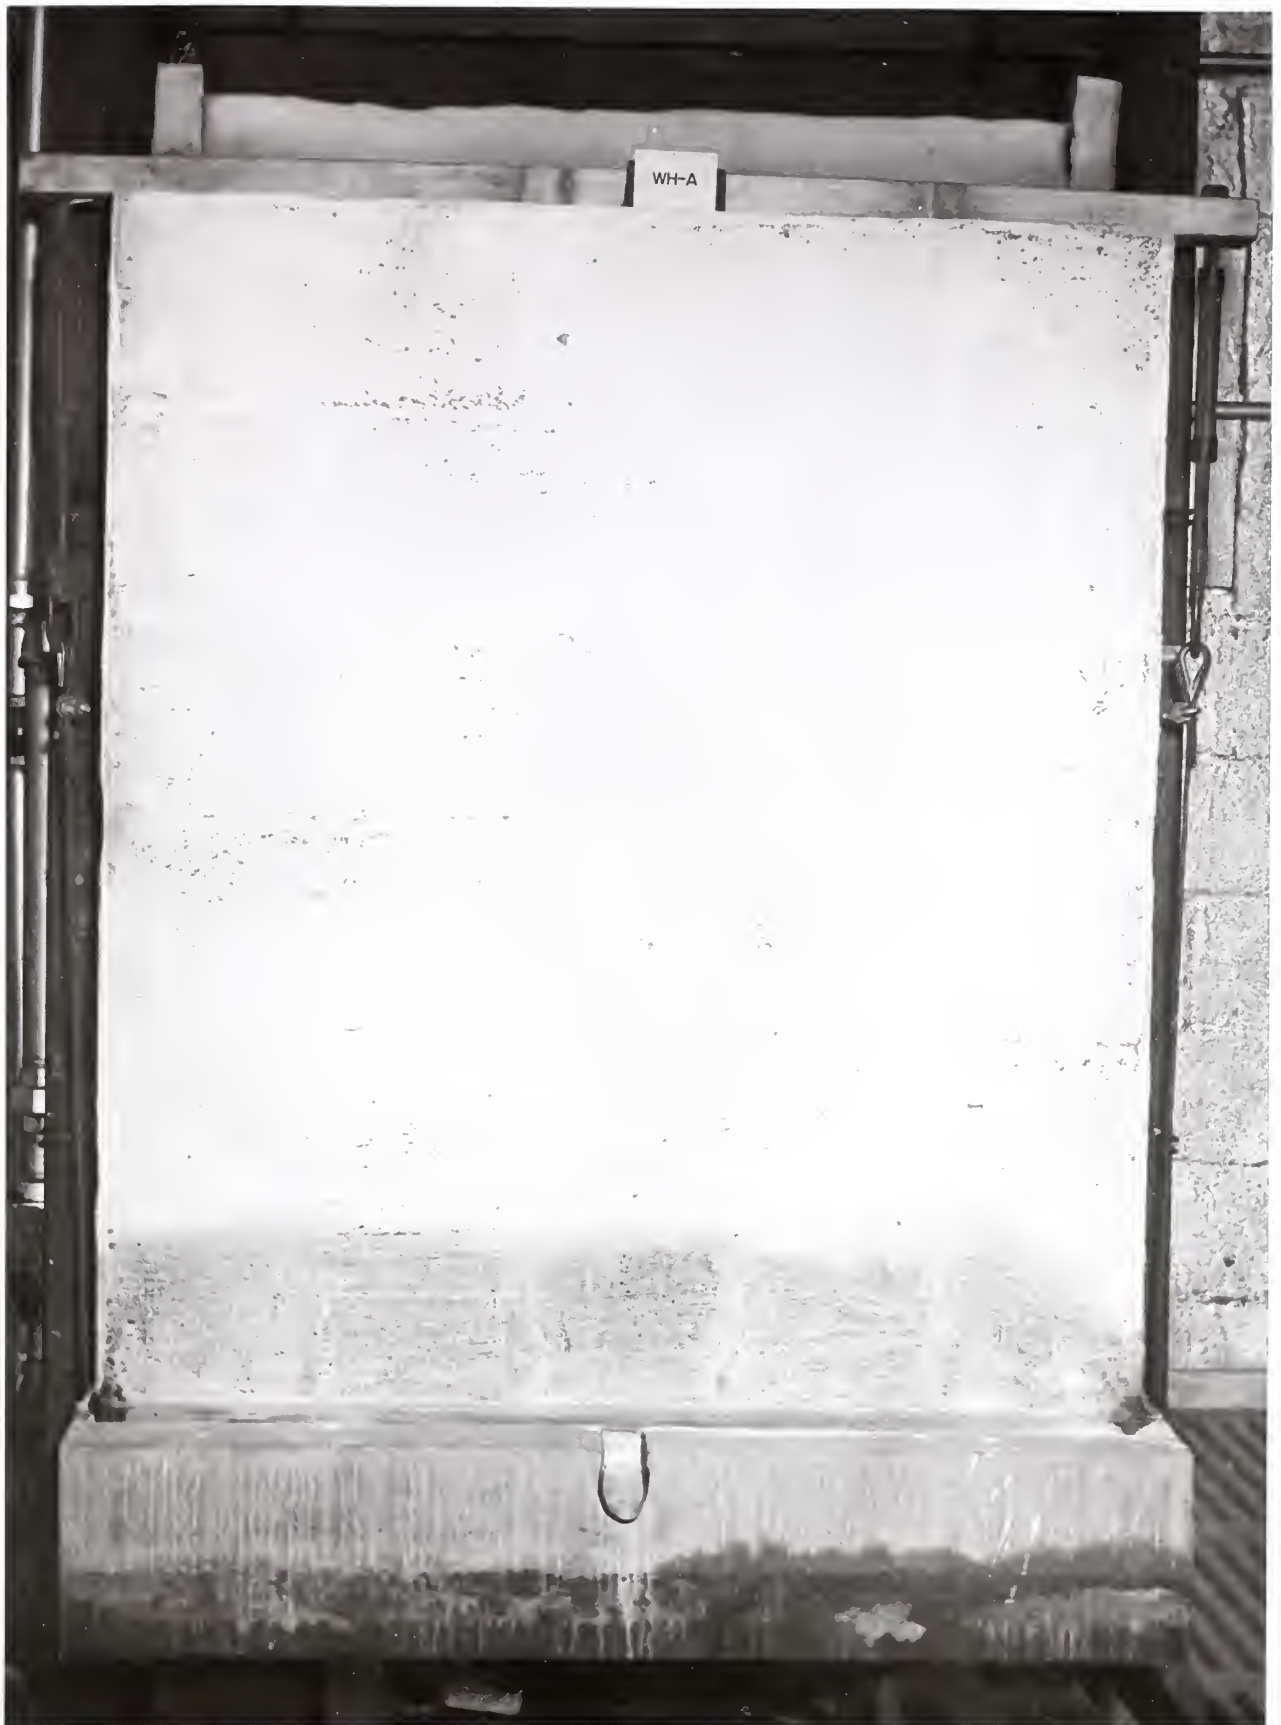
Fig. 5 - Back of wall A after test A-5; face painted, back whitewashed, weep holes open and pressure head of 1-in.

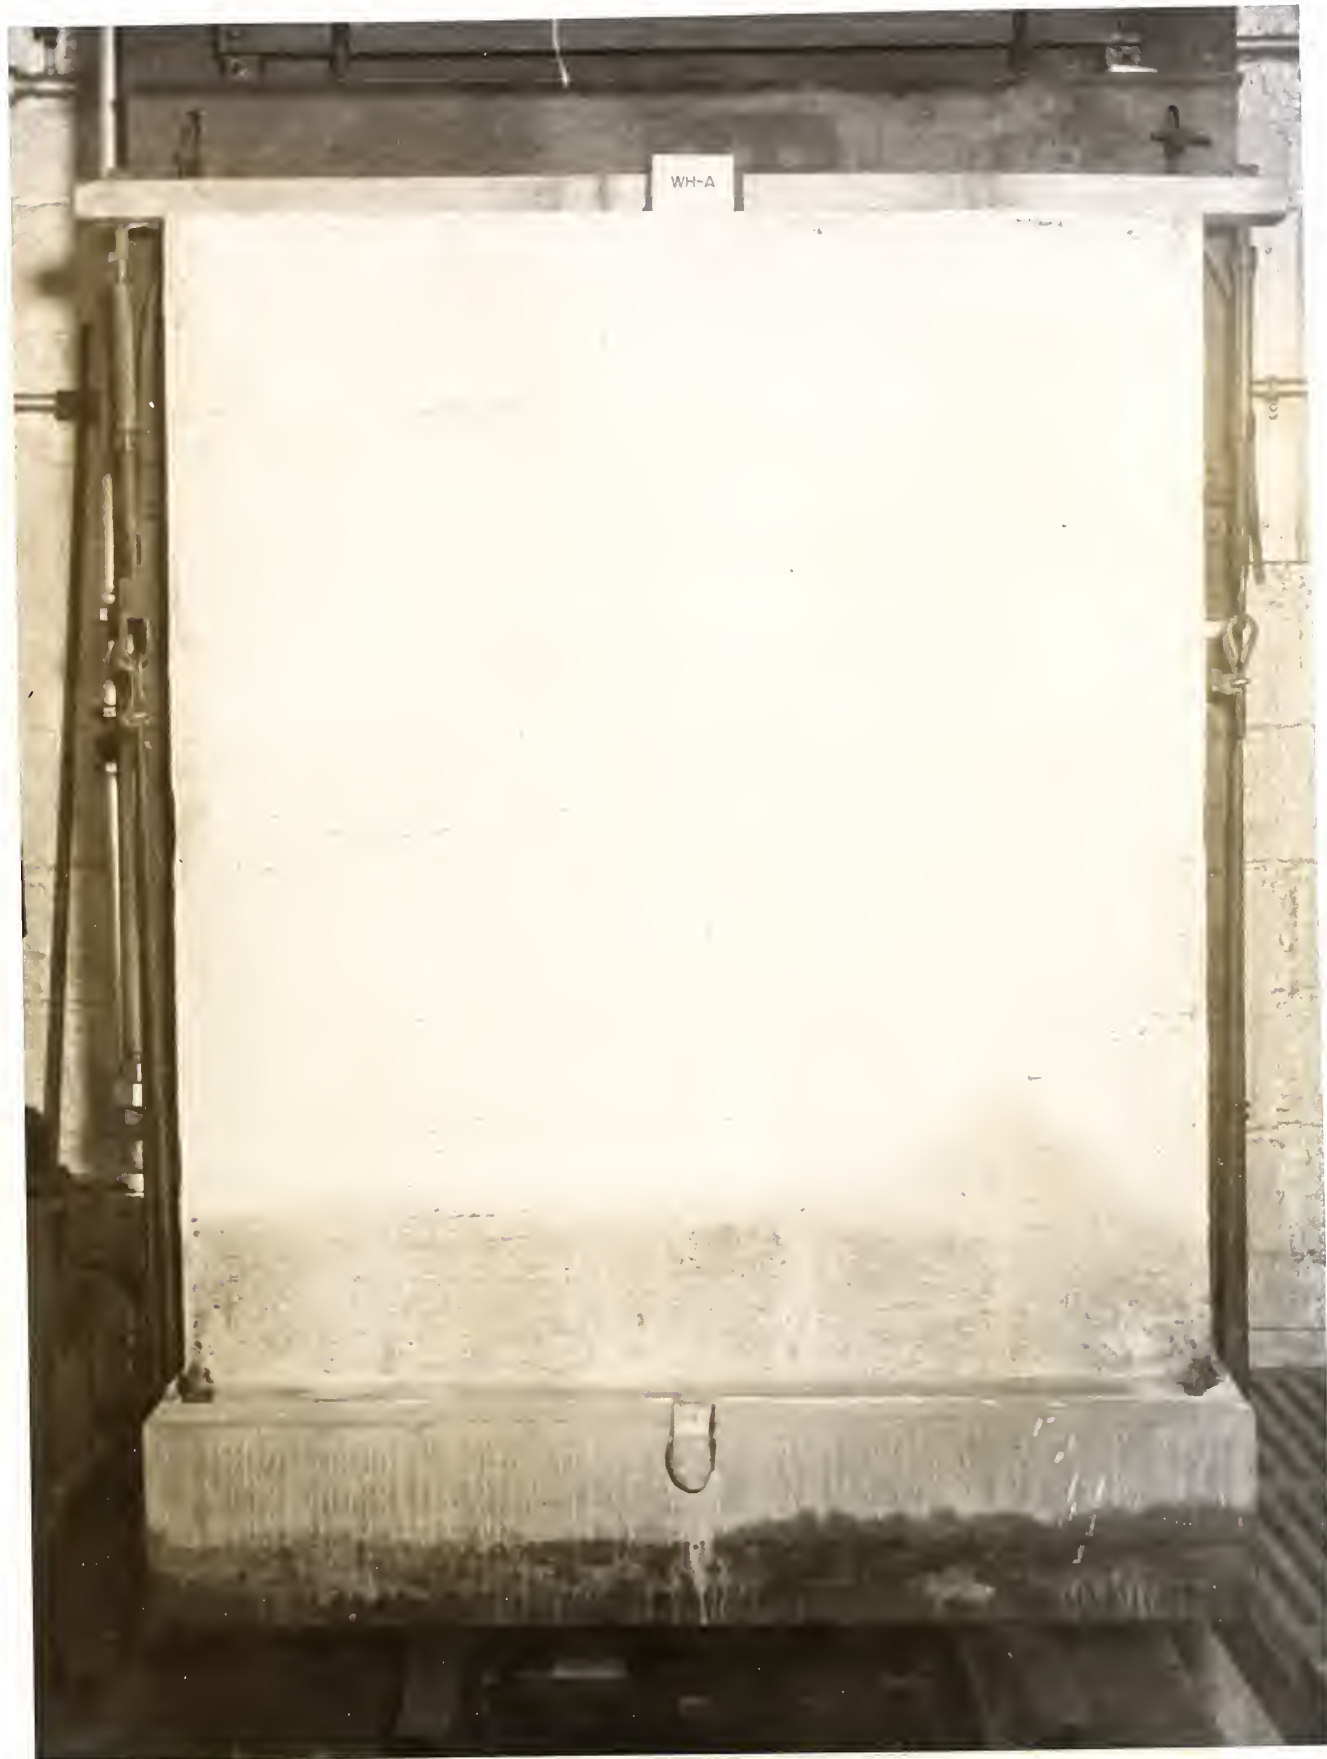
Fig. 6 - Wall A after test A-6; pressure head of 2-in.

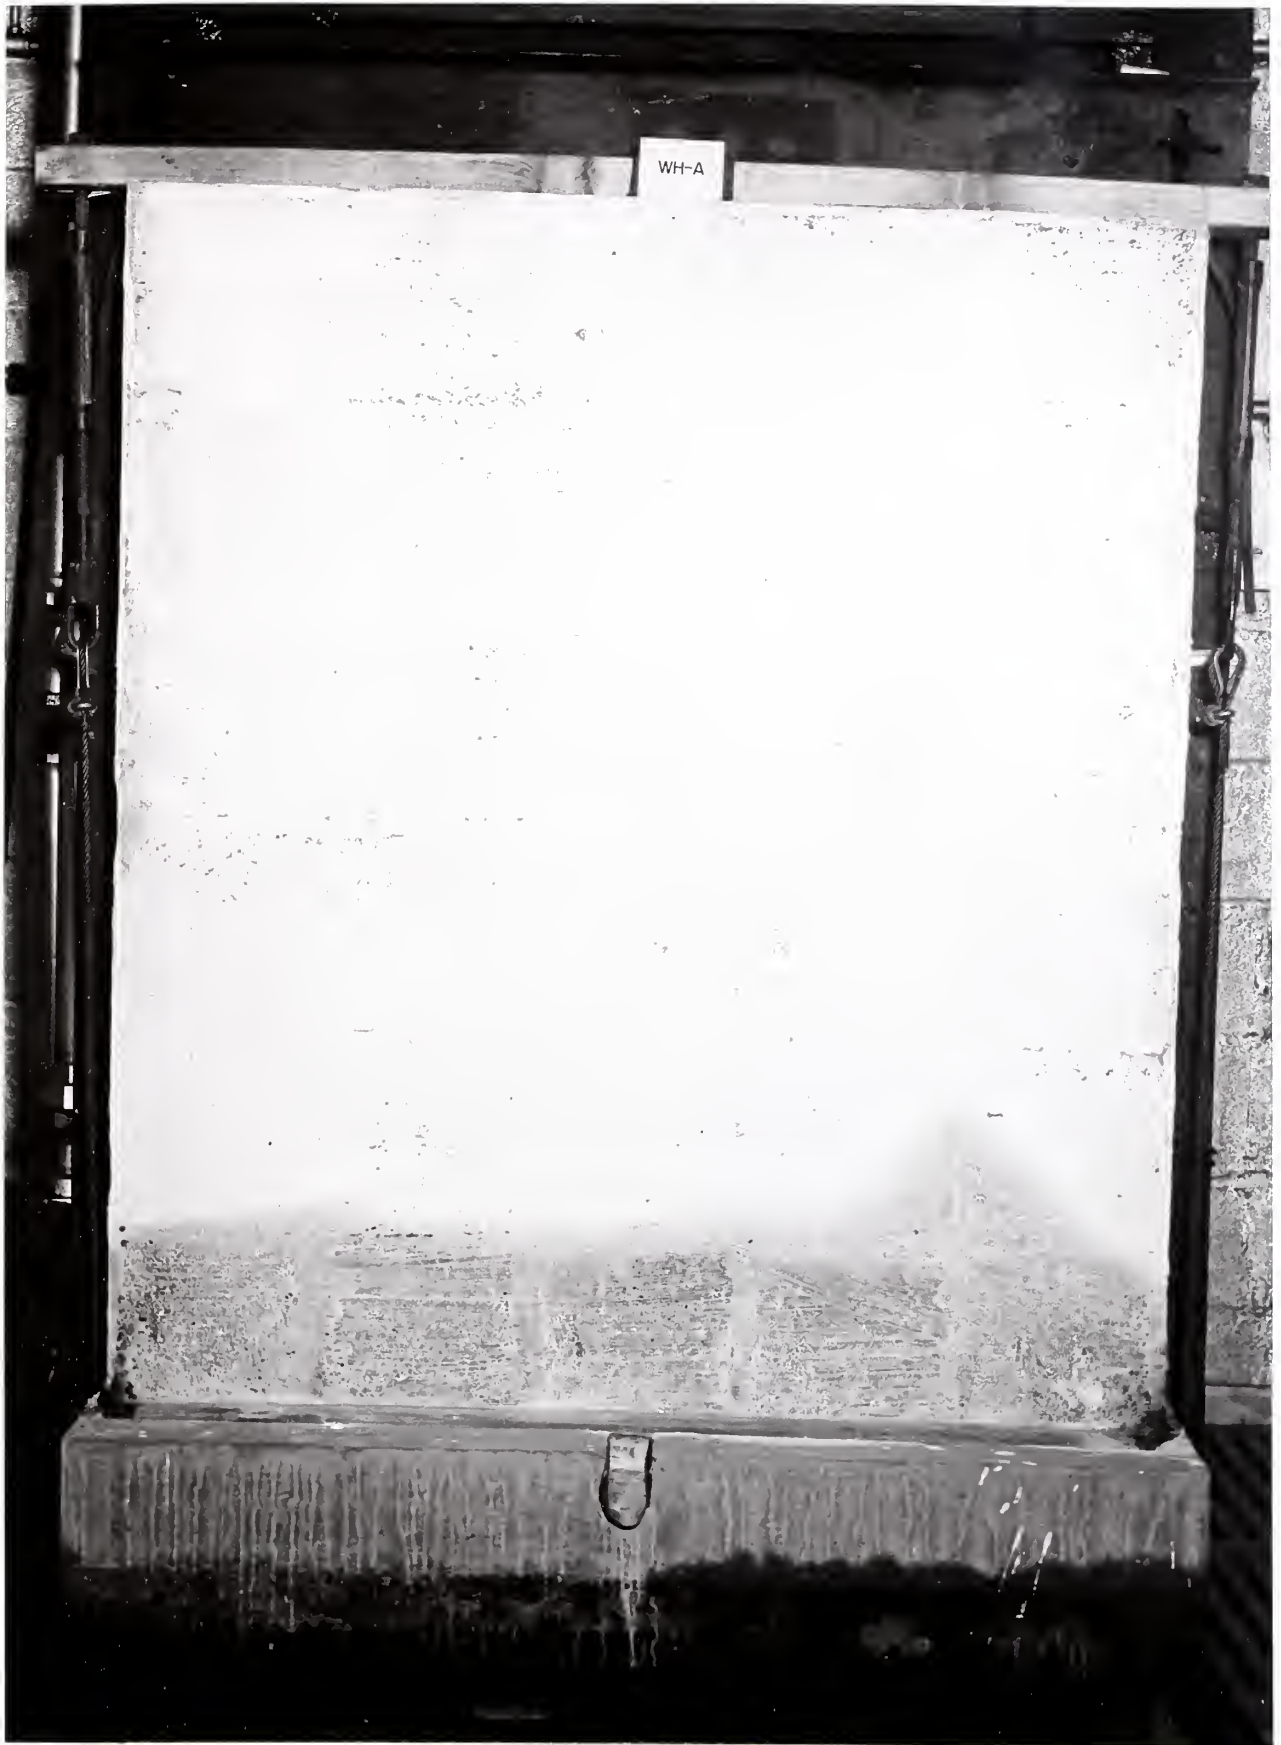
Fig. 7. - Wall A after test A-7, pressure head of 3-in.

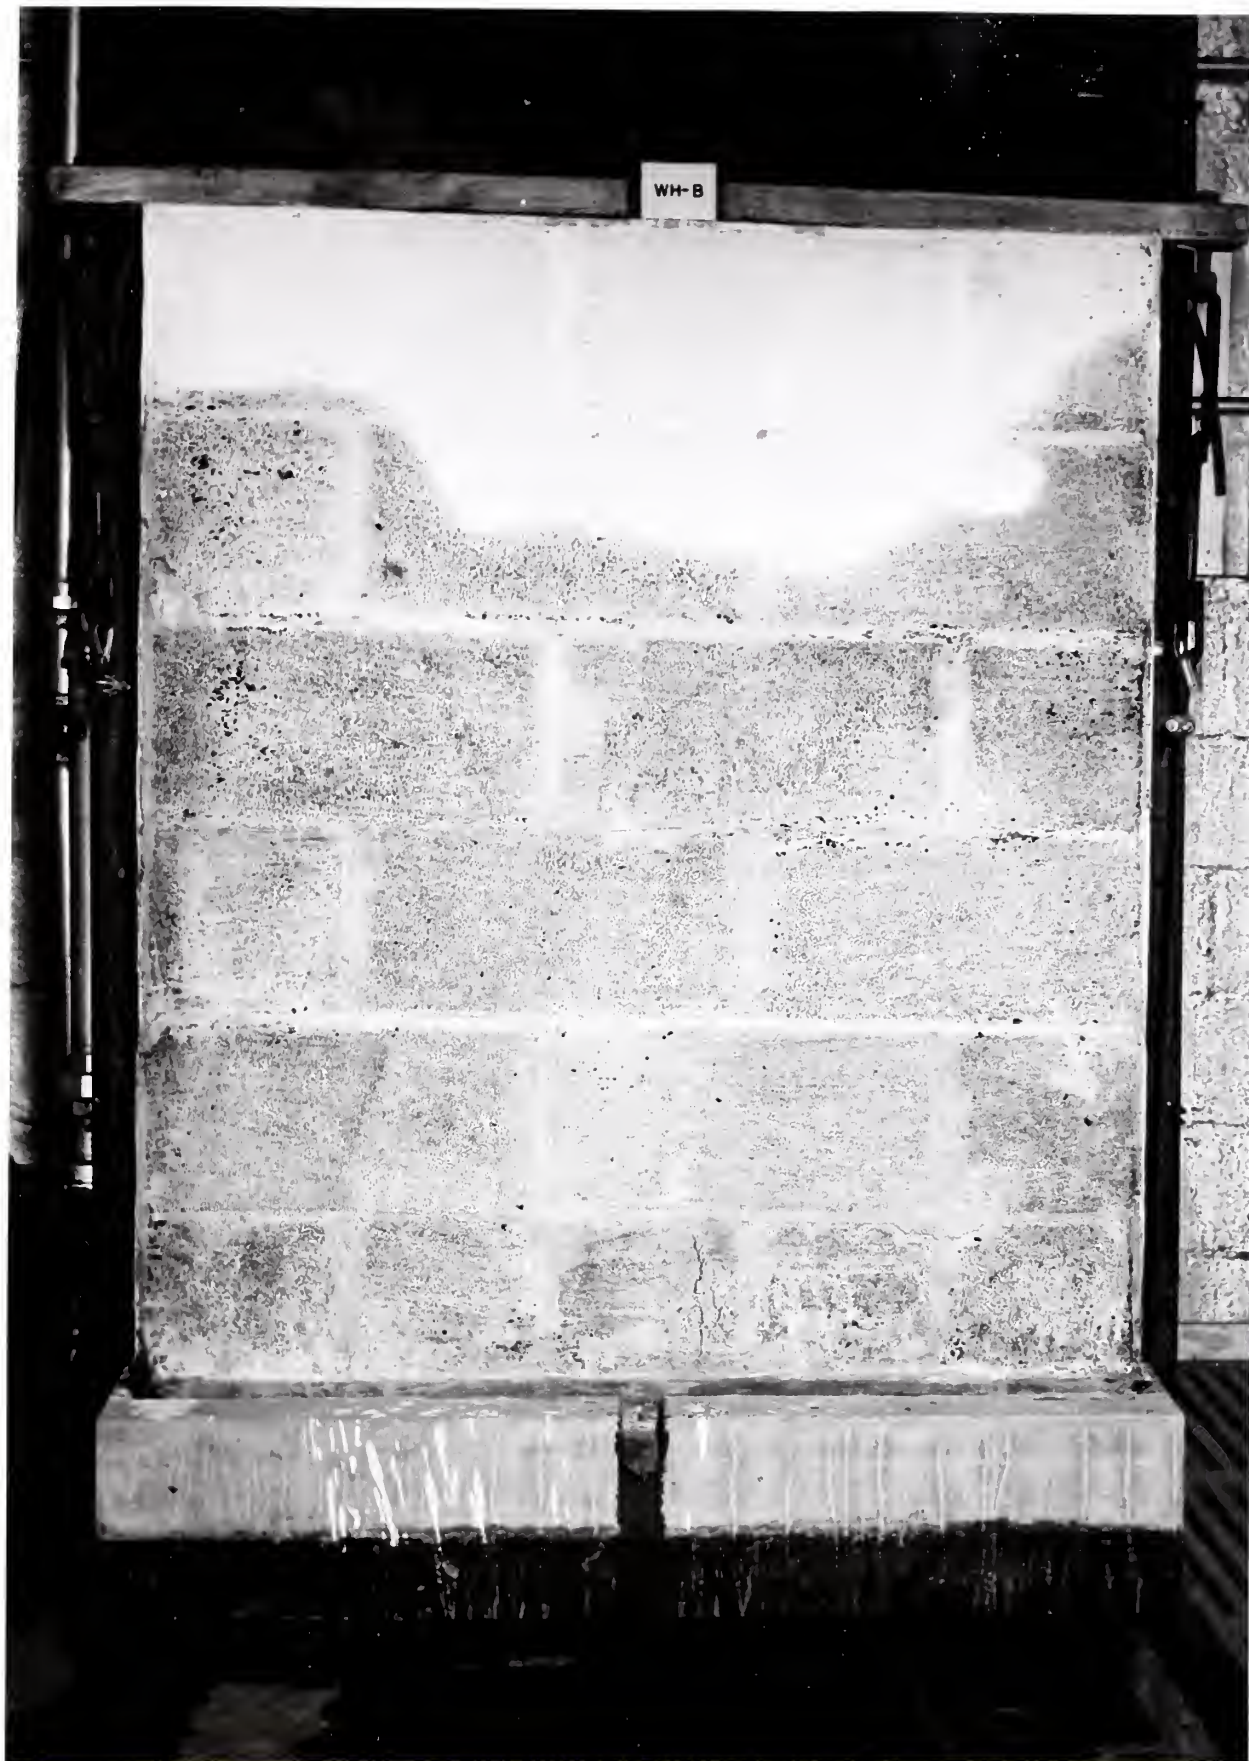
Fig. 8 - Back of wall B after test B-12. Holes drilled in top of exposed face, weep holes open, pressure head of 3-in.
