NATIONAL BUREAU OF STANDARDS REPORT

4396

TESTS OF PRESTRESSED CELLULAR SLABS
(Slab Nos. 1, 2, 3, and 4)

October 28, 1955

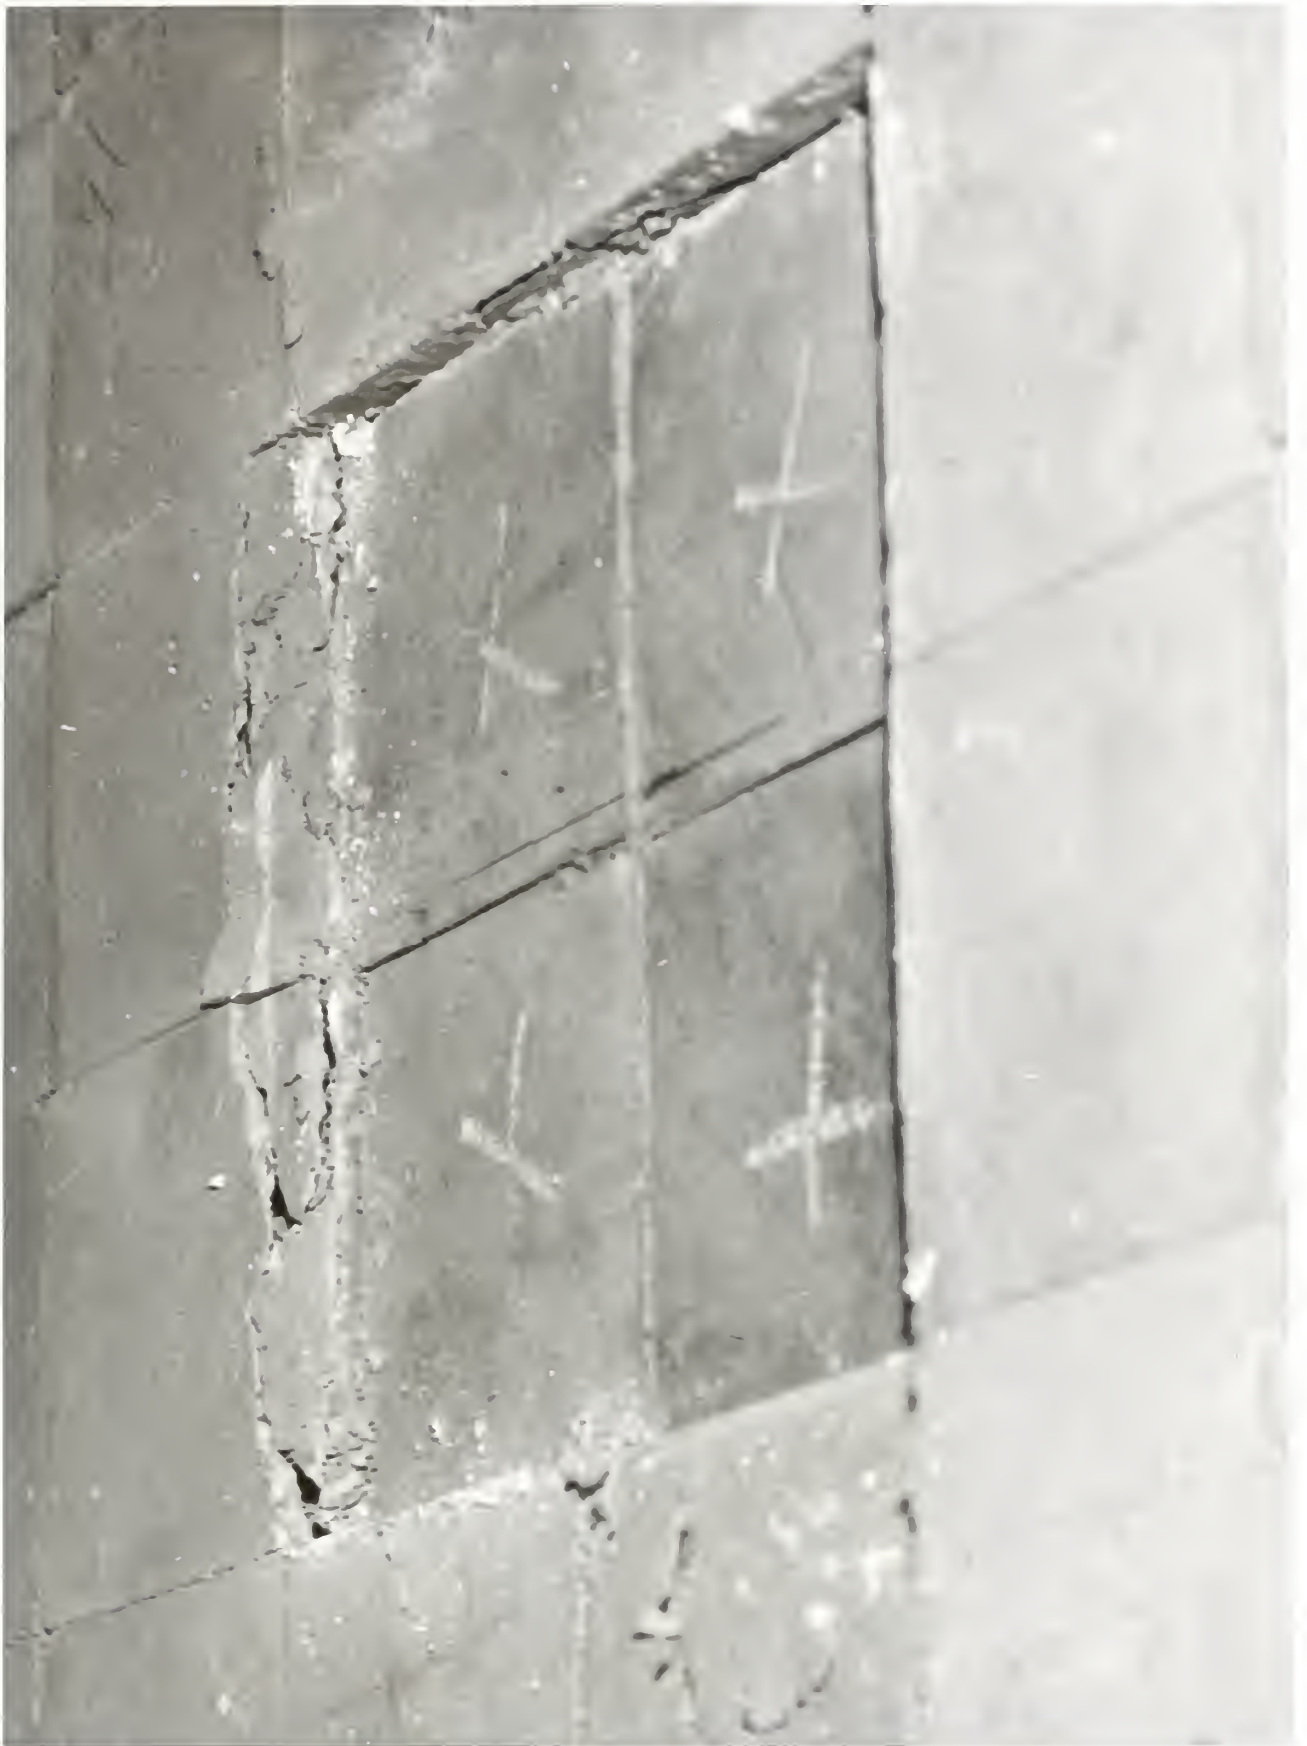
Fig. 8. Top of slab No. 2 after failure.

In Slab No. 2 the four cells directly under the loading block along with two rows of cells surrounding them were pushed down. There was some slipping between cells but the bottom surface formed essentially a convex surface. Cracks were irregular and did not form any definite pattern on the surface. The cells adjacent to the loading block and having a web parallel to its edge developed horizontal cracks near the top shell of the unit; for cells further away from the loading block, the horizontal cracks developed near the bottom shells. Webs of cells perpendicular to the edge of the loading block had diagonal cracks. Cells one foot or more away from the loading block appeared undamaged except for the presence of some horizontal hair cracks in the webs. The top surface of the slab remained intact but the loading block was forced into the slab about $1/4$ inch. (See figures 8 and 9).

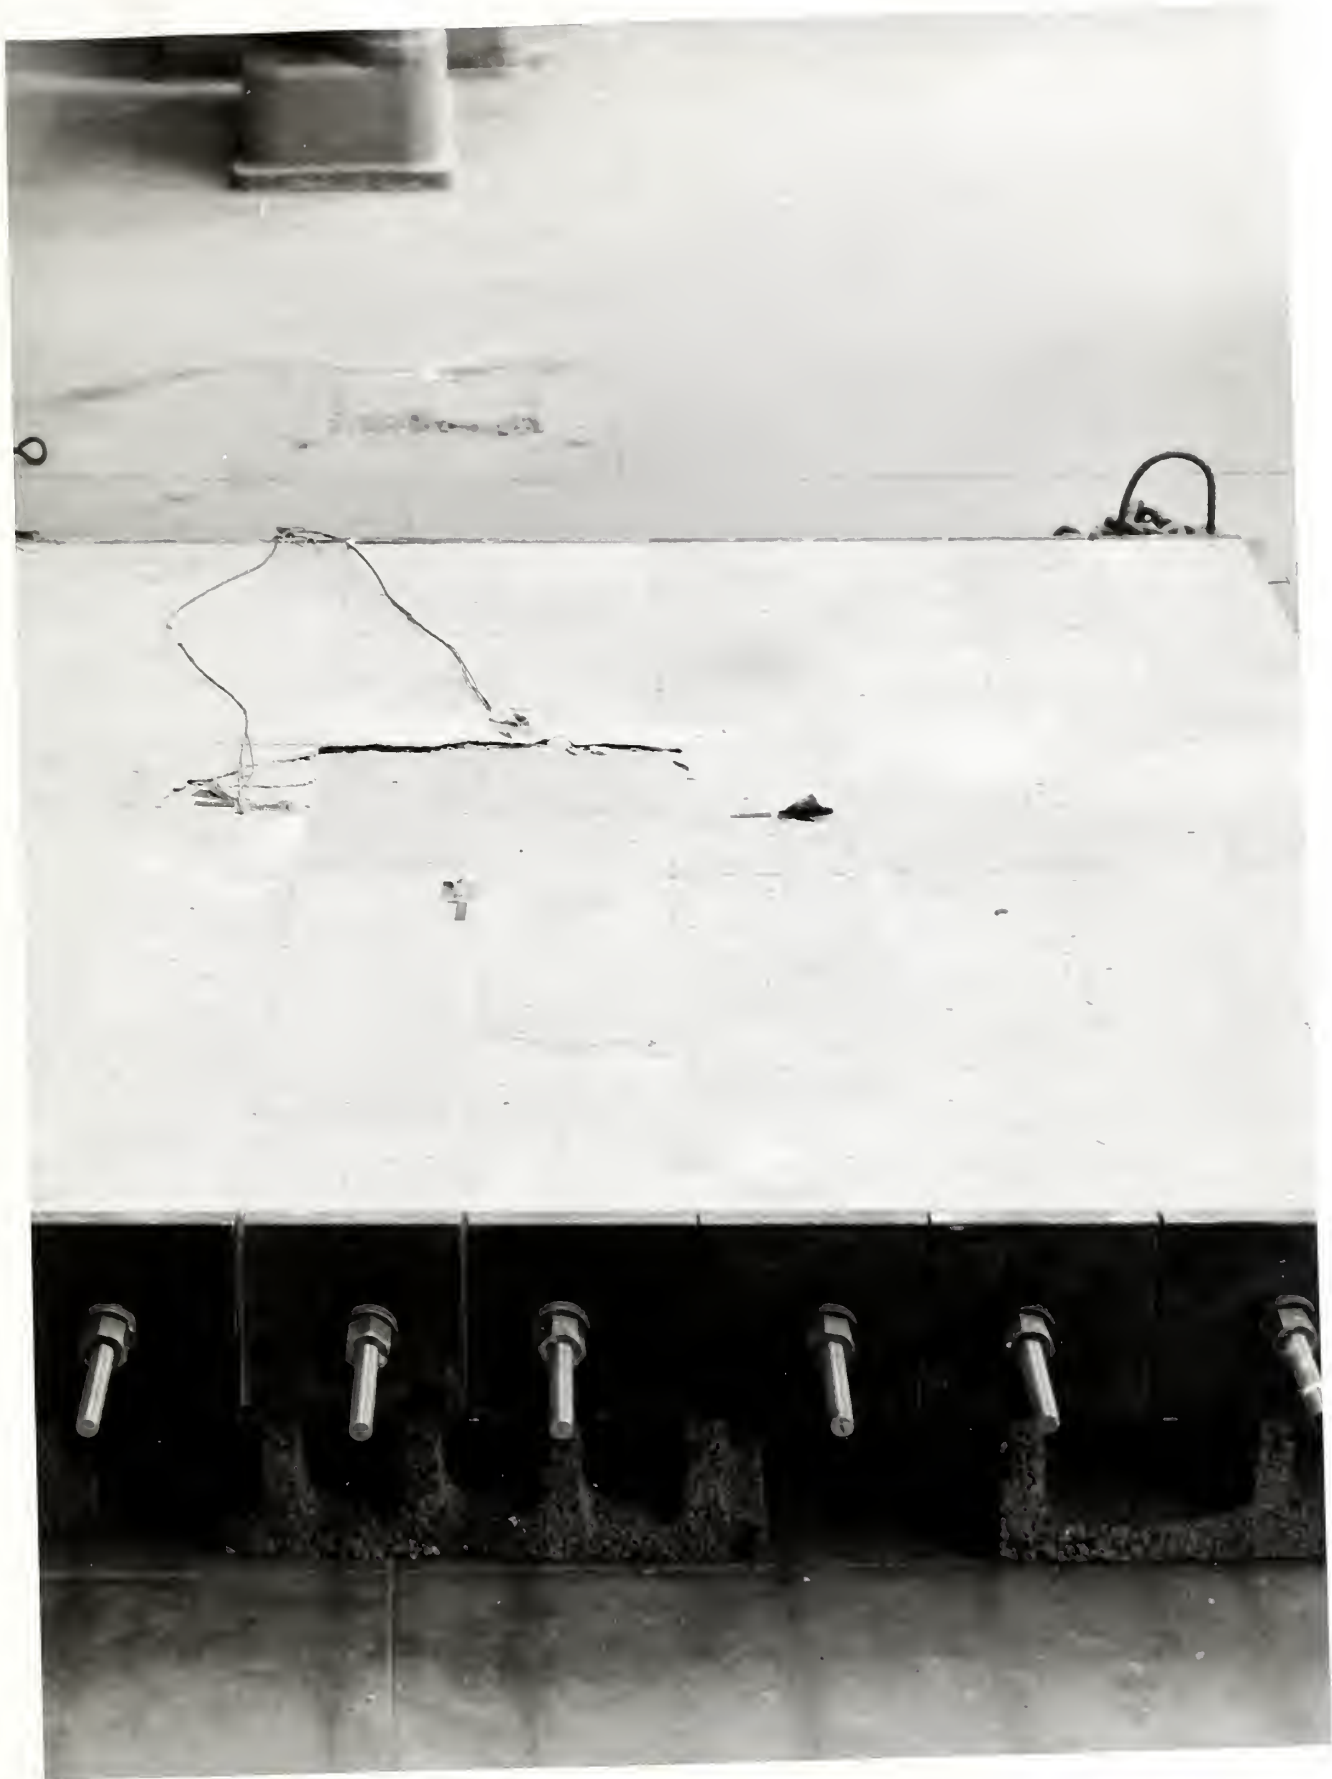
Fig. 11. Circular crack in top of slab No. 3.

In Slabs Nos. 3 and 4 a circular crack approximately 3 ft in diameter appeared at the bottom surface. Figure 10 shows the crack pattern observed in Slab No. 4. As in Slabs Nos. 1 and 2, the loading block was pushed approximately $1/4$ in. into the slab. The top shells of the cells adjacent to the loading block cracked slightly. There was a circular hair crack in the top surface of Slab No. 3 with a diameter of approximately 3 ft. (See figure 11). No similar crack was observed in Slab No. 4. On the other hand, a hair crack approximately $1/4$ in. in diameter was observed in the bottom face of Slab No. 4, but not in Slab No. 3. Cracks in the webs of cells were essentially similar to those in Slab No. 2. Typical diagonal crack patterns in sections of a slab are shown in figures 12 and 13; diagonal cracks in individual units are shown in figure 14.

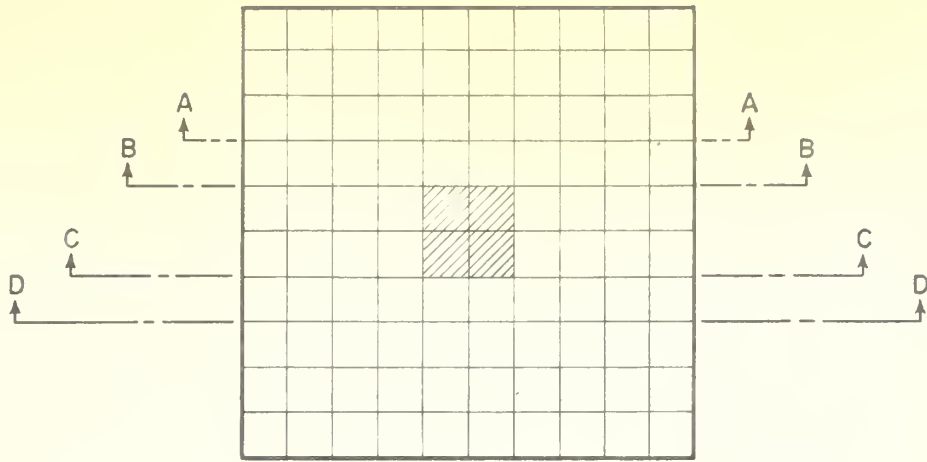
FIGURE 13. CRACK PATTERN IN SECTIONS OF SLAB AT VARIOUS DISTANCES FROM THE LOADED AREA.

From the data given in section 5.1, it is evident that prestressed grouted slabs do not exhibit any sharply defined transition from uncracked to cracked slabs at the point where the initial prestress at the bottom fibers is reduced to zero. There is, rather, a gradual transition as evidenced by both the load-deflection and load-strain relationships in figures 4, 5, and 6. In Slabs Nos. 3 and 4 there was a gradual increase in the center deflection up to a load of about 30,000 lb, or about 85 percent of the load carrying capacity. As the loads approached the maximum values, cracking progressed over the tension face of the slab and deflections increased rapidly. It is probable that at this stage of loading the cracking around the elliptical holes in the cells was extensive. Examination of the cells after test revealed the presence of diagonal tension cracks extending into two or three rows of blocks adjacent to the loading block. This is illustrated in figures 12 and 13.

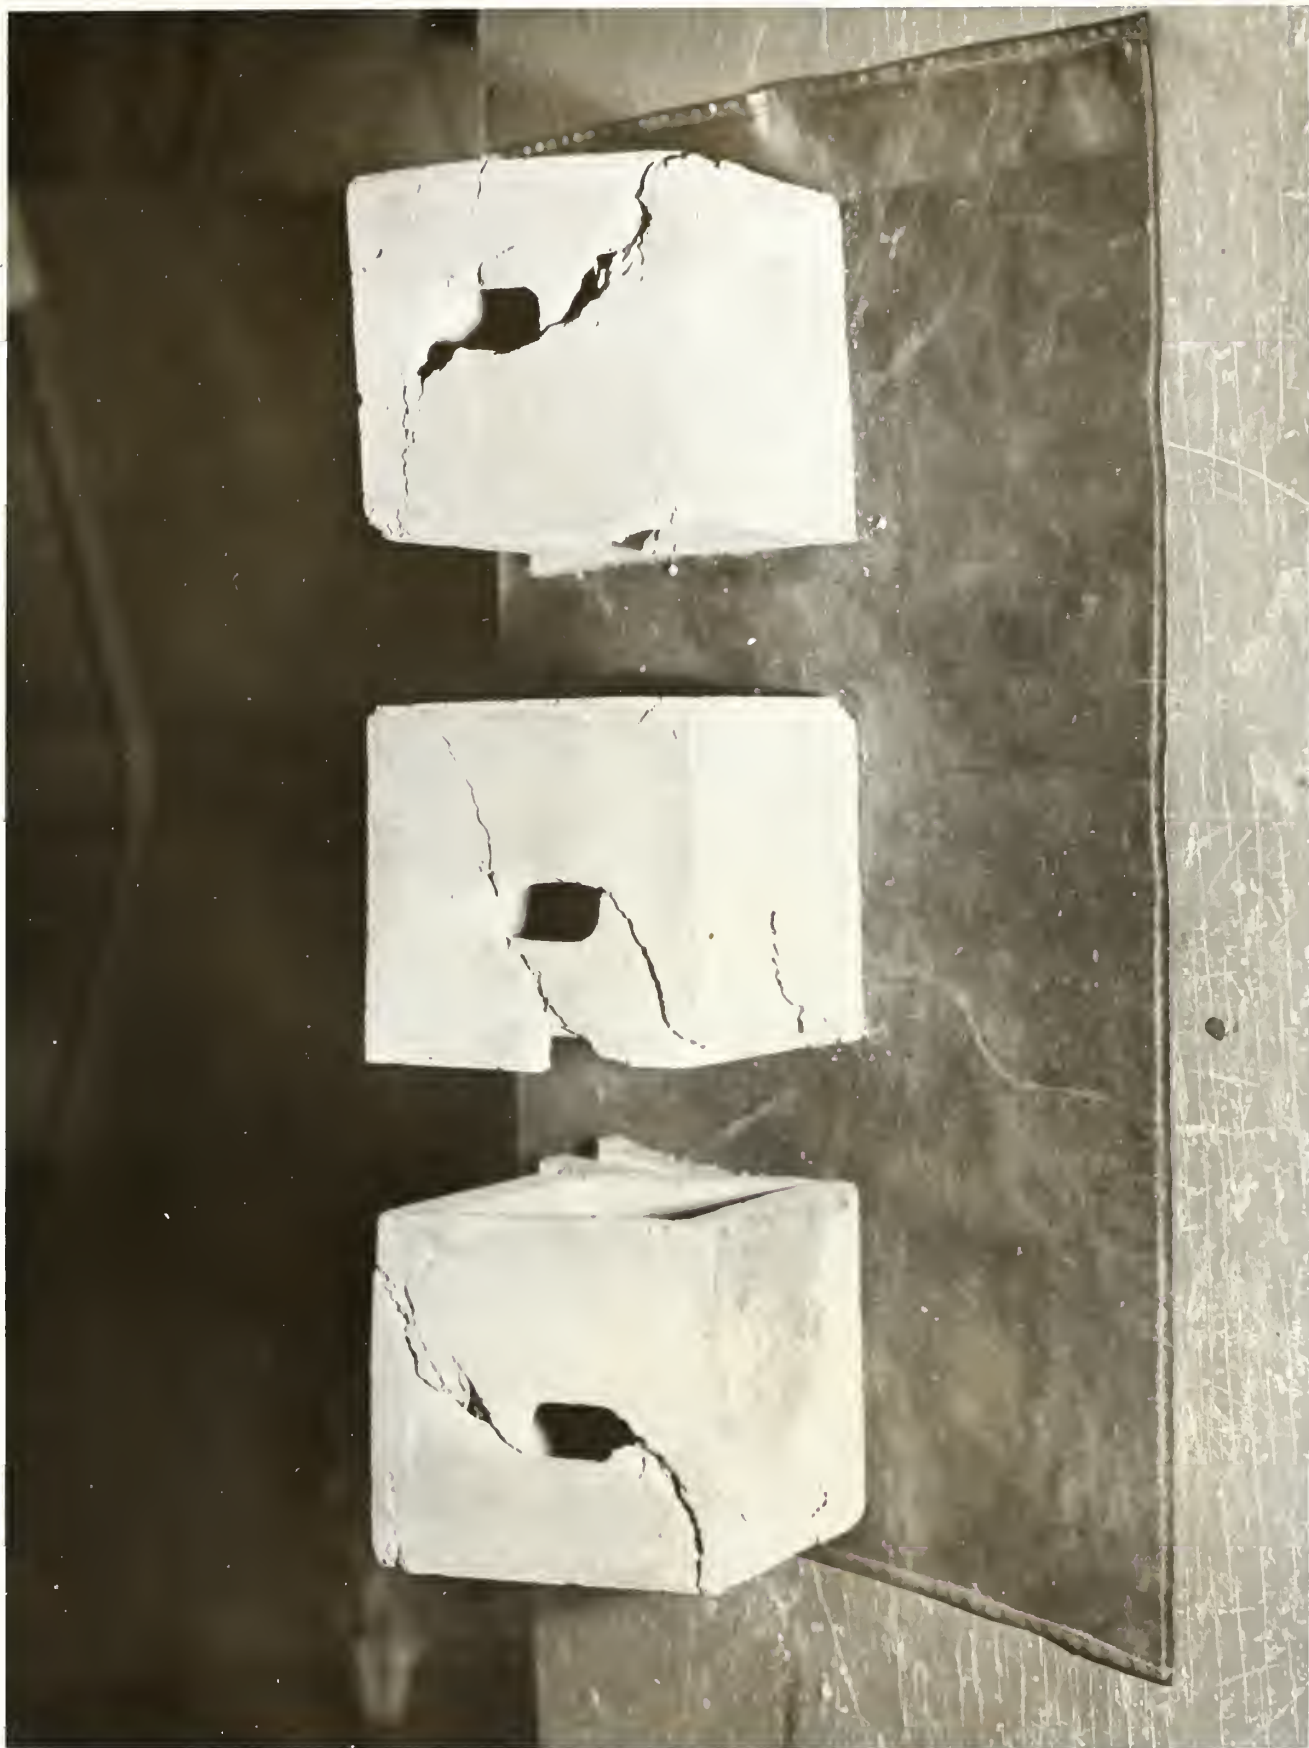
Fig. 14. Diagonal crack pattern in individual units.
