NATIONAL BUREAU OF STANDARDS REPORT

FIRES ENDURANCE TEST
OF
THREE BULKHEAD ASSEMBLIES

ABSTRACT

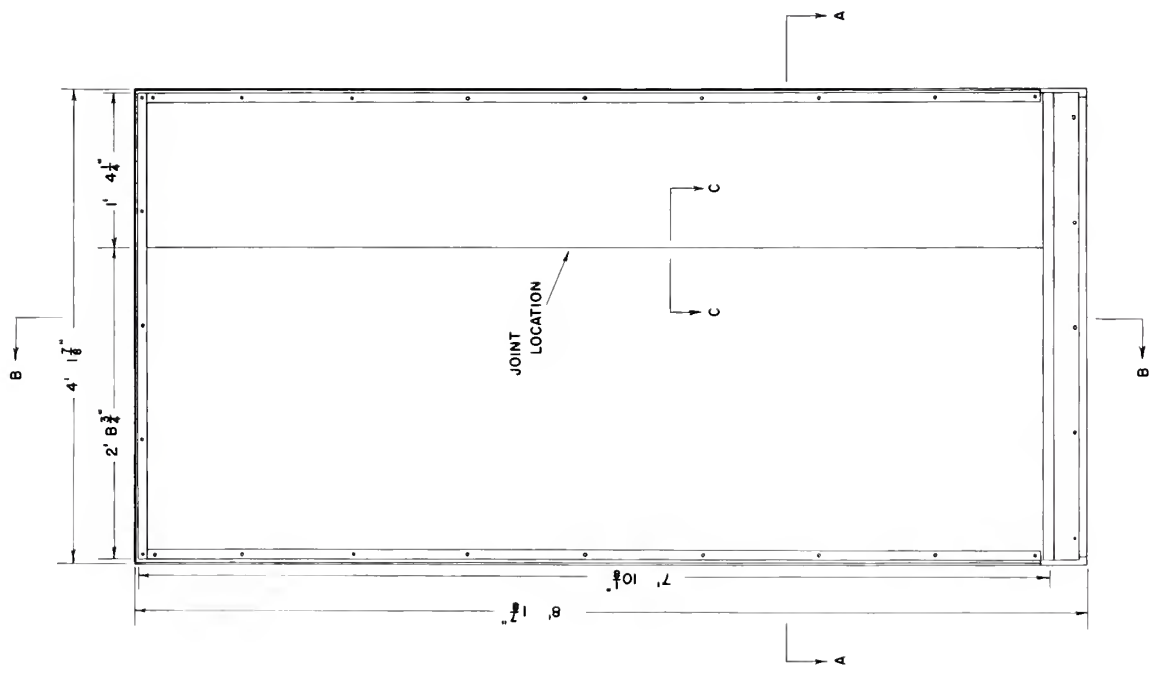
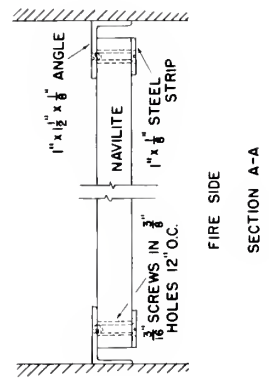
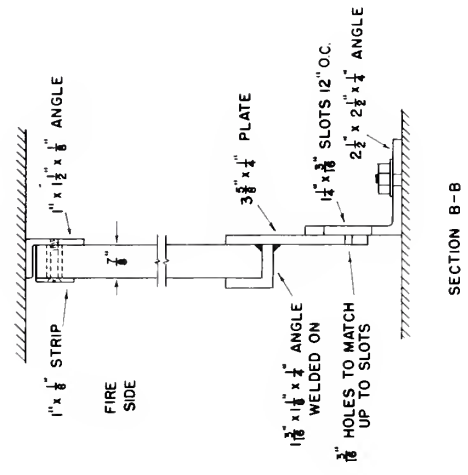
Figure 1. *Identification and characteristics of...*

The three test specimens were alike, except for the details of the vertical joint located in each, consisting of 7/8 in. thick "Navilite" suitably mounted for placement in the furnace test frame. Each bulkhead specimen consisted of two panels of "Navilite", one 7 ft 10-1/8 in. high by 2 ft 8-3/4 in. wide and the other 7 ft 10-1/8 in. high by 1 ft 4-1/4 in. wide, butted together along their height. The Navilite was secured to the test frame as shown in figure 1. The joint for the bulkhead of construction I consisted of a steel spline 0.79 by 0.12 in. by full height that fit into a groove in the butted edges of each Navilite panel. That for the bulkhead of construction II consisted of an iron flat 2.95 in. wide, 0.16 in. thick, and full height secured to each face by 1 in. round head screws at about 1 ft on centers and staggered right and left of the joint. The joint system for the bulkhead of construction III consisted of a 1.75 by 0.12 in. steel strip secured to each face by flat head machine screws through the Navilite. The heads of the screws fit in countersunk holes in the steel strip on the fire exposed face and the threaded ends screwed into tapped holes in the strip on the other face. The screws were about 1 ft on centers and staggered right and left of the joint.

BULKHEAD TEST MOUNTING, FROM FIRE SIDE

SECTION C-C
JOINT DETAILS

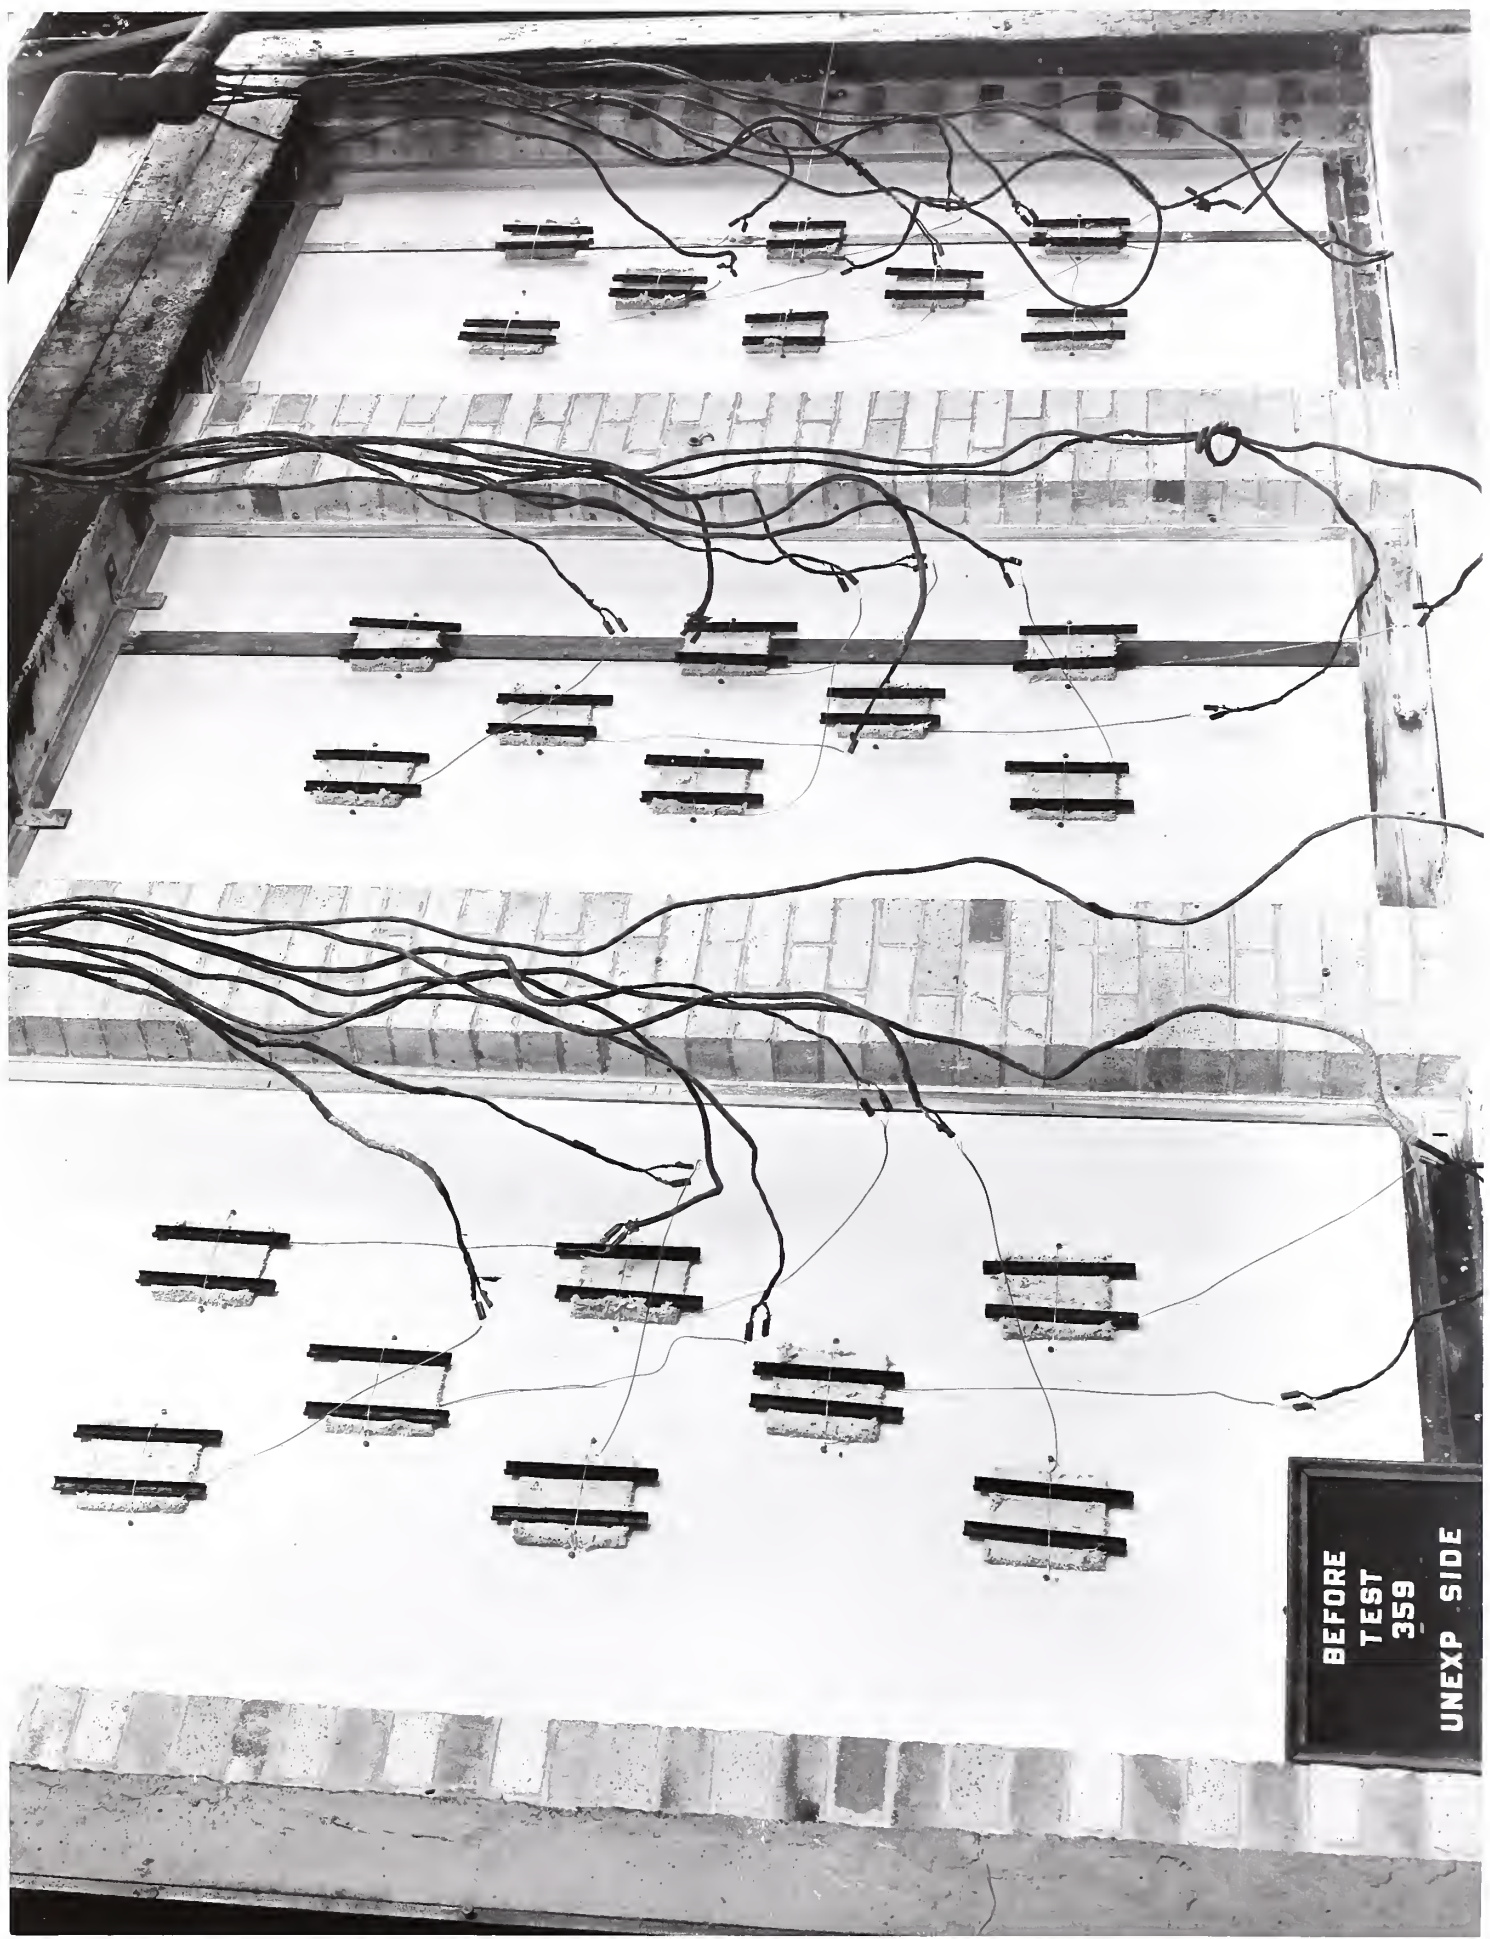
Figure 2. Unexposed surface before test. Construction
I, II, III from left to right. 100 4515
Fig. 23337-4

BEFORE
TEST
359
UNEXP SIDE

The condition of the specimens immediately before the test is shown in Figure 2. In addition to the personnel of the US Fire Protection Section, the following witnessed the test:

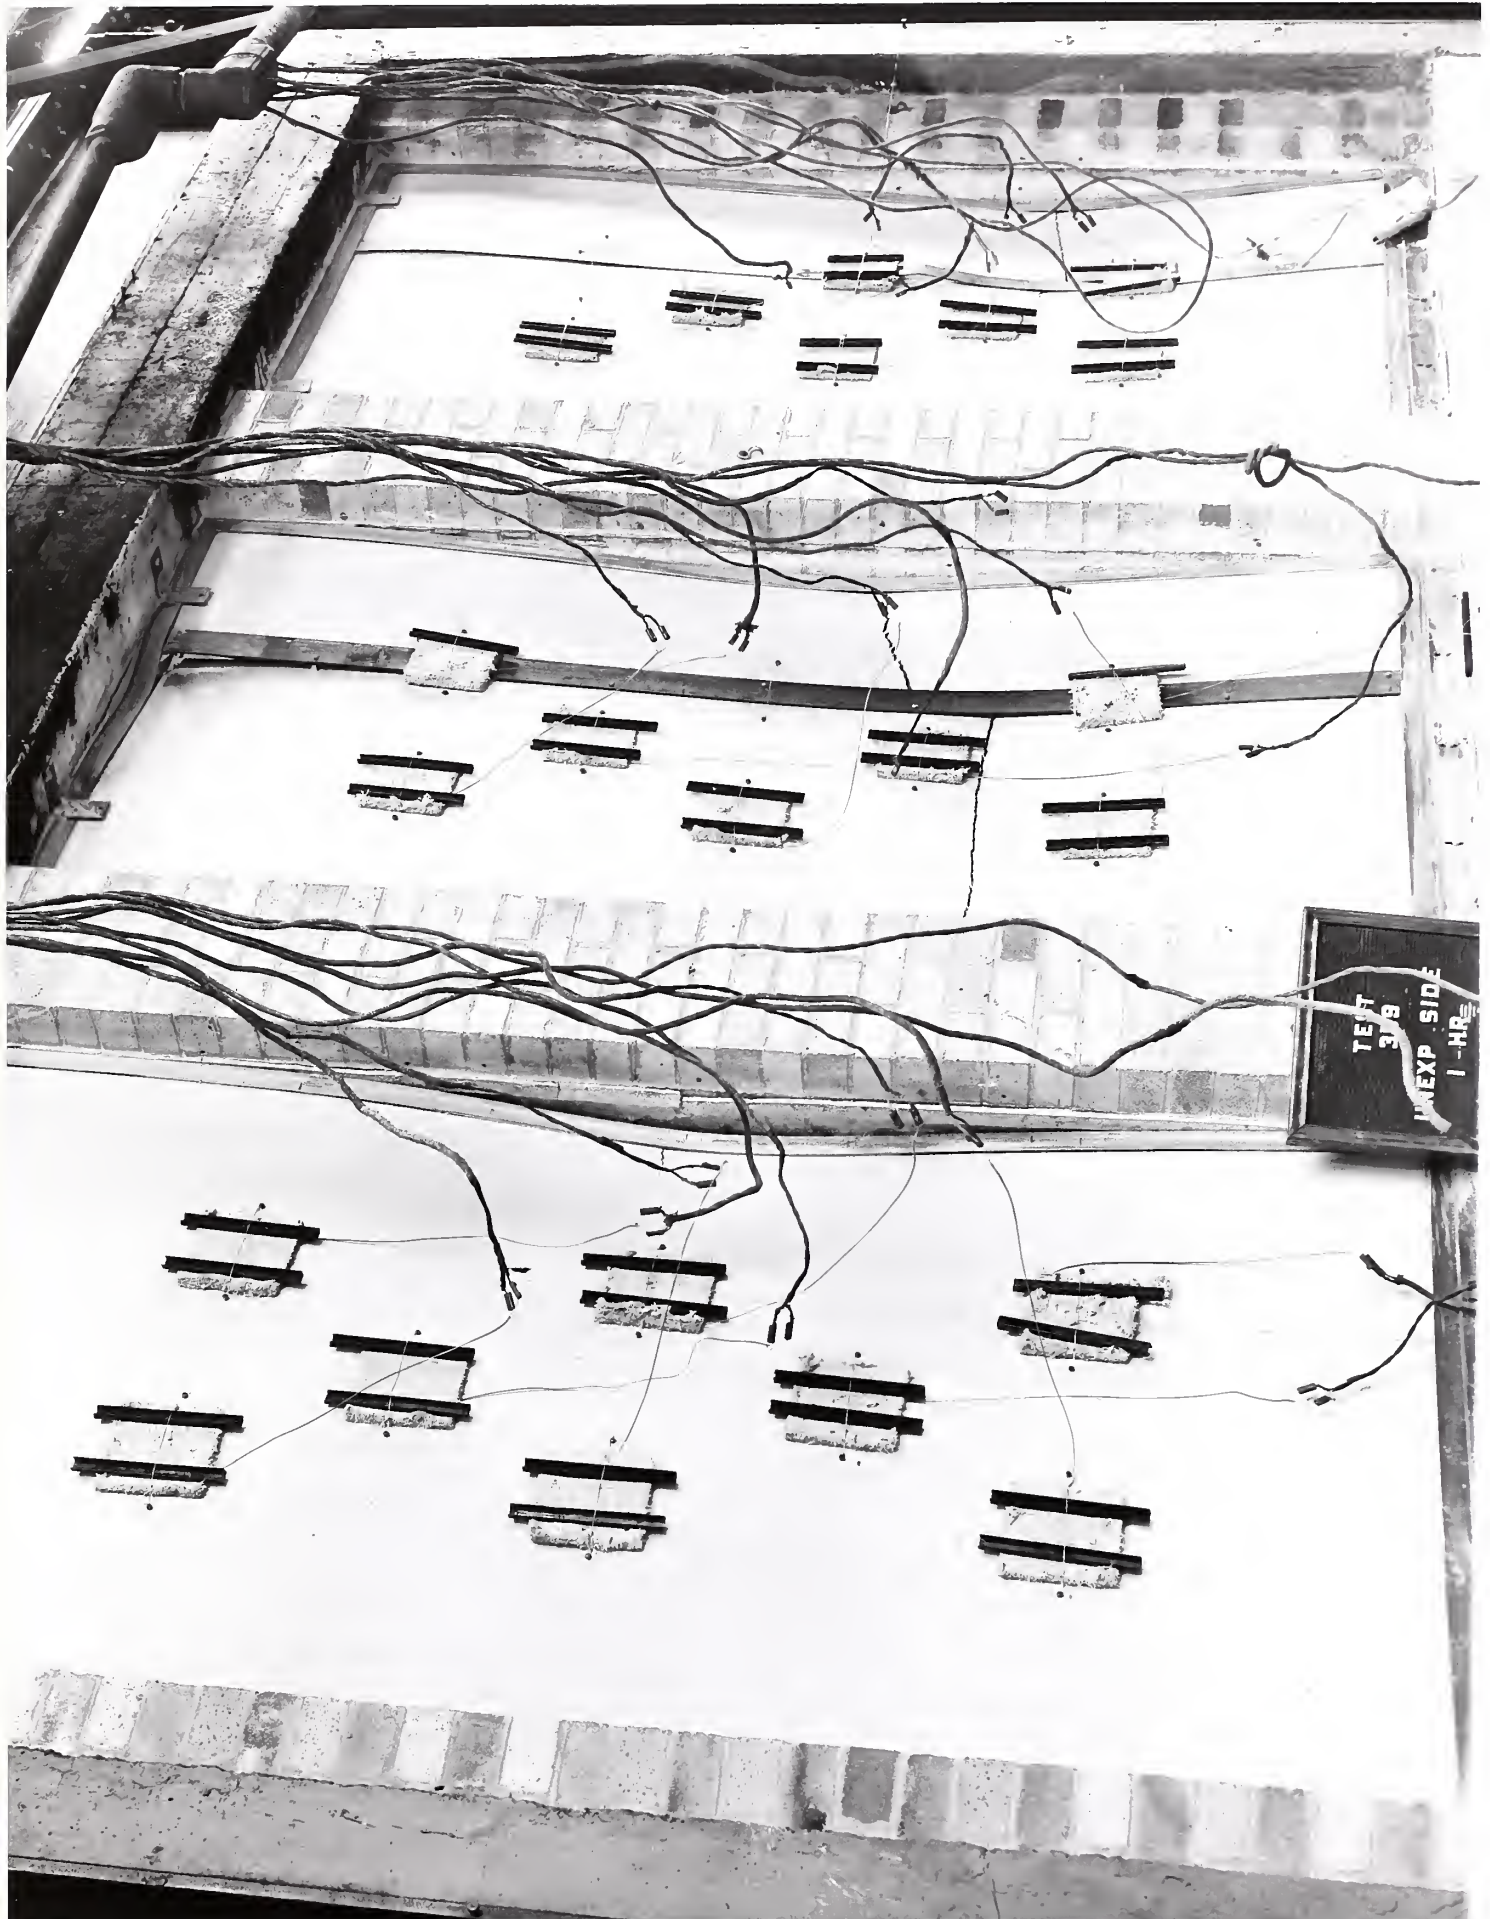
Figure 3. Oxidized surface at end of test. (No 4515
log. 4337-5)

At the end of the test, each bulkhead was bowed toward the furnace fires and had one or more horizontal cracks in the exposed surface. Bulkheads II and III also had significant cracks in the unexposed surface. Cracks in both sections of Bulkhead II and in the narrow section of Bulkhead III extended all the way across the respective sections and completely through the Navilite. The condition of the specimens was not noticeably changed after overnight cooling.

TEST 319
INEXP. SIDE
1-HR.

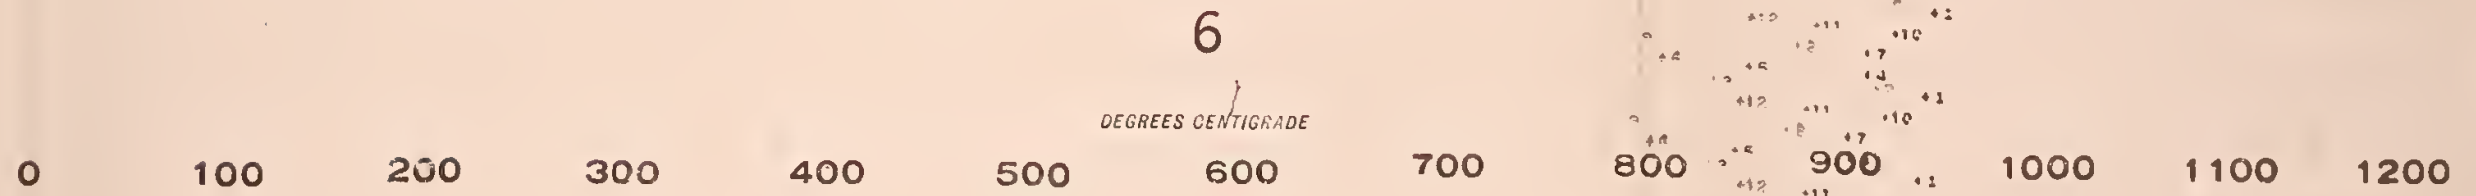
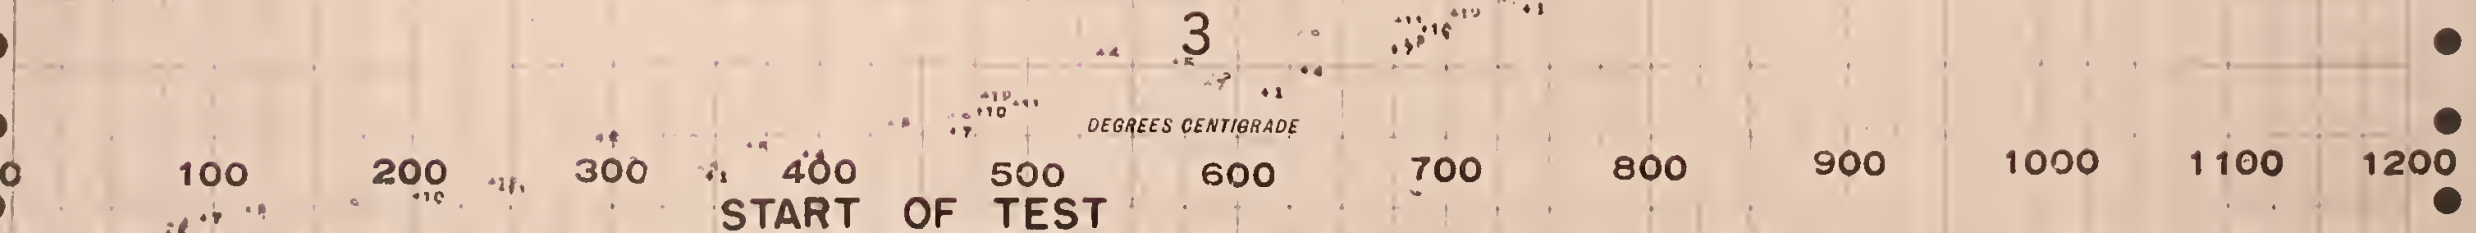
FURNACE TEMPERATURES

The three bulkheads were mounted in a single test frame that had been subdivided for bulkhead tests. Eight thermocouples were placed on the unexposed surface of each bulkhead under 6 by 6 by 0.4 in. felted asbestos pads. Of these eight, three were along the joint and the others on the 2 ft 8-3/4 in. wide panel of Davillite. Eight thermocouples were used on each bulkhead rather than nine so that the data from the three bulkheads could be recorded on two 12 point recording potentiometers. Other than for the number of unexposed surface thermocouples, the test was conducted in compliance with the provisions of Subpart 104.000-3(b) of Specification for Bulkhead Panels for Merchant Vessels. The furnace fires were controlled to produce temperatures as close as feasible to those defined by the standard time-temperature curve of ASTM E119-53, which include 1000°F at 5 min, 1300°F at 10 min, 1550°F at 30 min, and 1700°F at 1 hour.

NAVILITE BULKHEADS

8 IN. = 1 HR

Reproductions of the potentiometer charts, indicating the recorded temperatures in detail, are given at the end of this report.

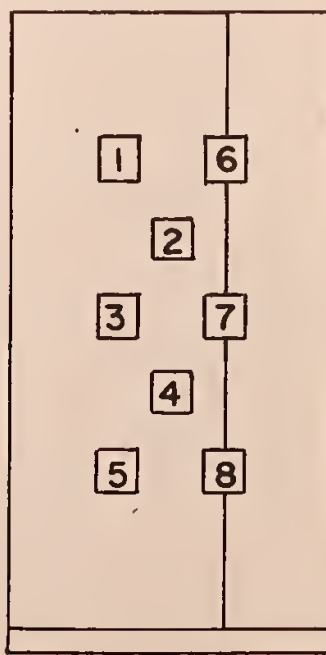
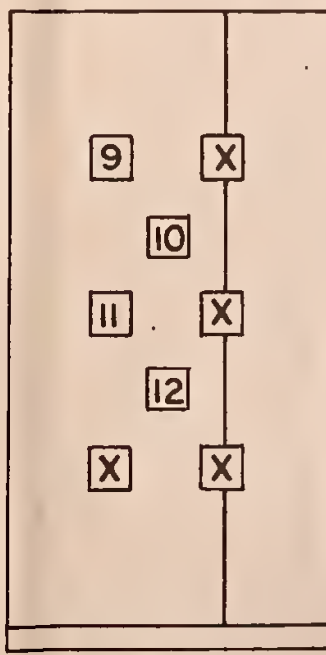
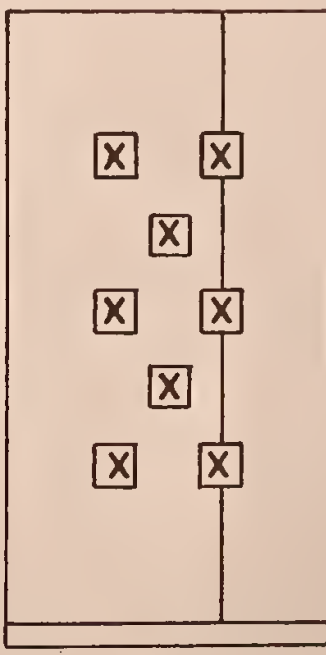
NAVILITE BULKHEADS UNEXPOSED SURFACE TEMPERATURES

The fire exposure severity was 99.0 percent of standard. The temperatures on the unexposed surfaces of the three specimens had risen 250°F above the initial at the times indicated in the following table.

250 Degree F rise	
	Panel	Joint
	min	min
Bulkhead I (spline)		
Average	0:21.1	0:19.6
One point	0:17.4	0:17.4
Bulkhead II (screws)		
Average	0:17.5	0:21.9
One point	0:17.1	0:17.4
Bulkhead III (machine screws)		
Average	0:26.5	0:19.4
One point	0:17.3	0:17.4

UNEXPOSED SURFACE
THERMOCOUPLE LOCATIONS
X: SEE OTHER CHART

I

II

III

8 IN. = 1 HR

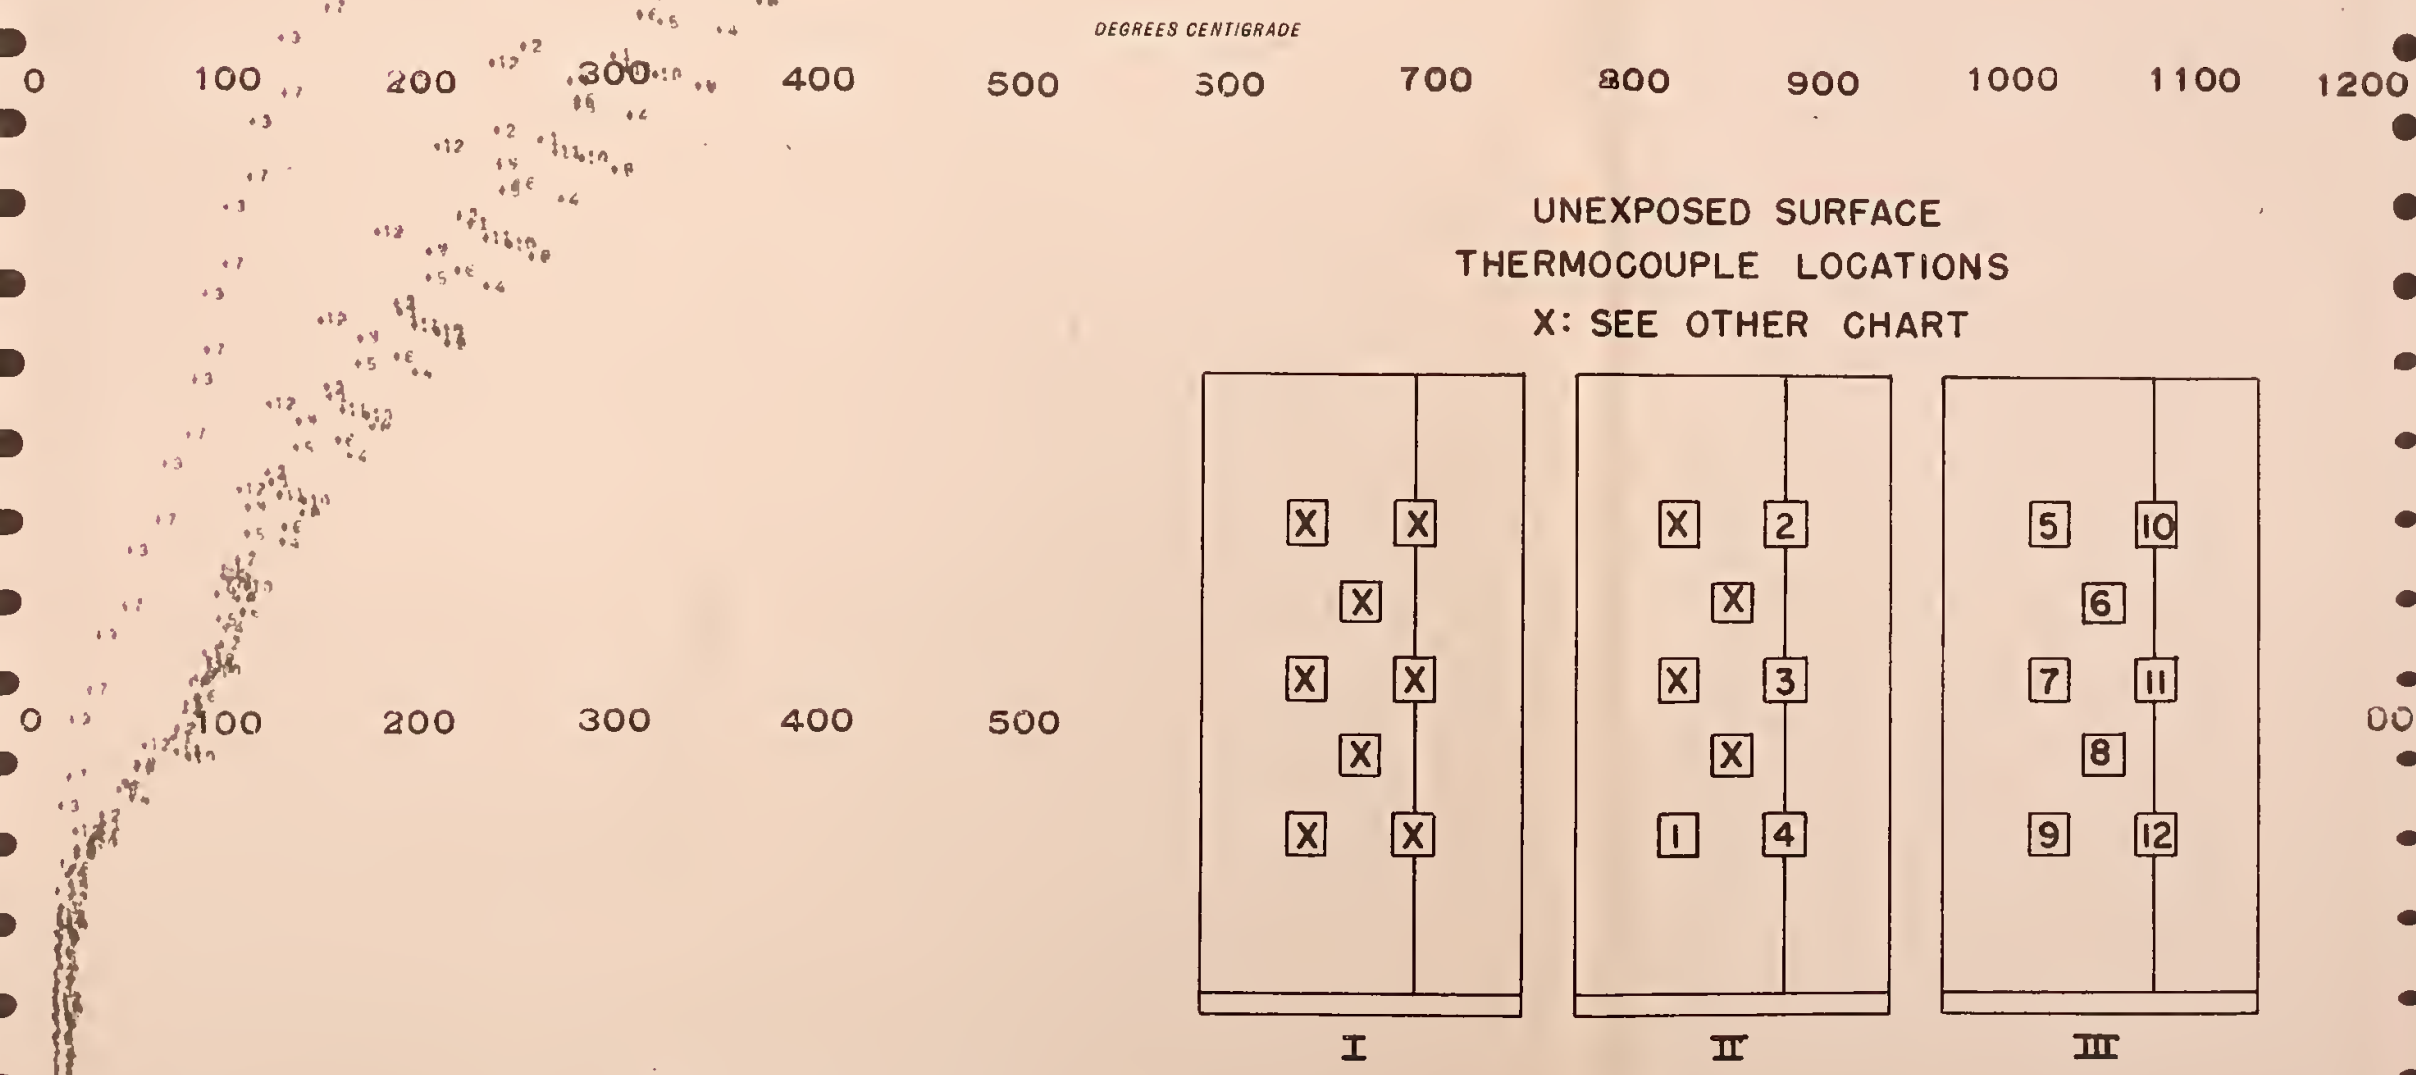
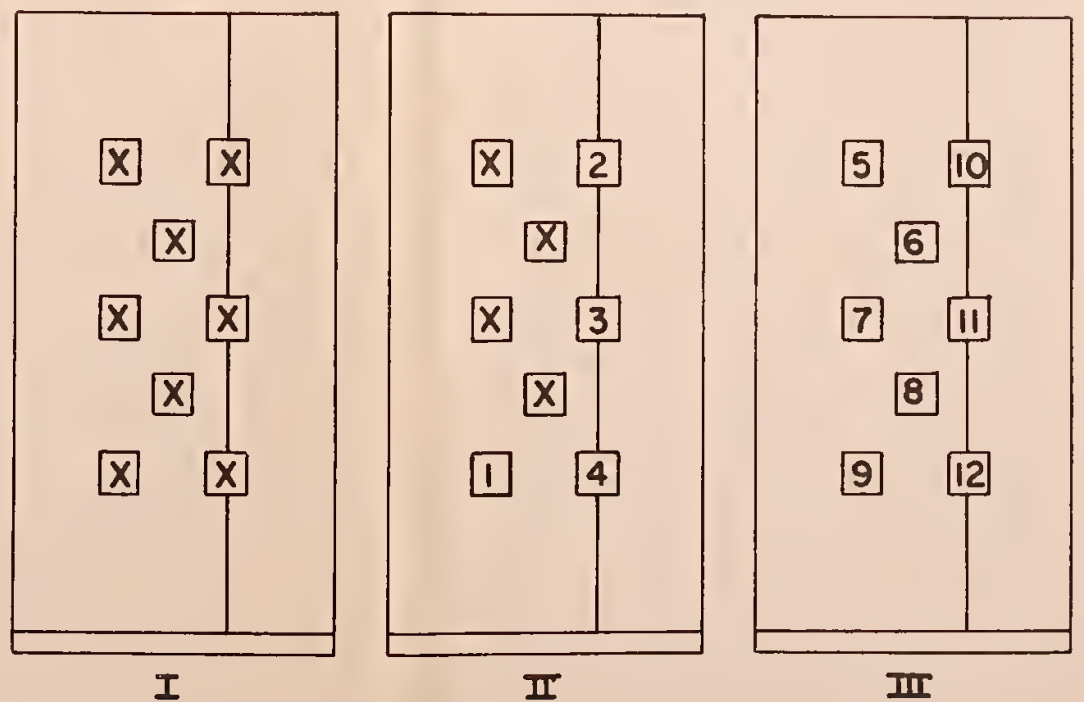
START OF TEST
NAVILITE BULKHEADS UNEXPOSED SURFACE TEMPERATURES 8 IN. = 1 HR

UNEXPOSED SURFACE
THERMOCOUPLE LOCATIONS
X: SEE OTHER CHART
