FIRE TEST
OF
STEEL JOIST ROOF DECK

NBS REPORT
4594

Department of Highways,
District of Columbia Government

REPORT OF FIRE TEST OF STEEL JOIST ROOF DECK
for
Department of Highways, District of
Columbia Government

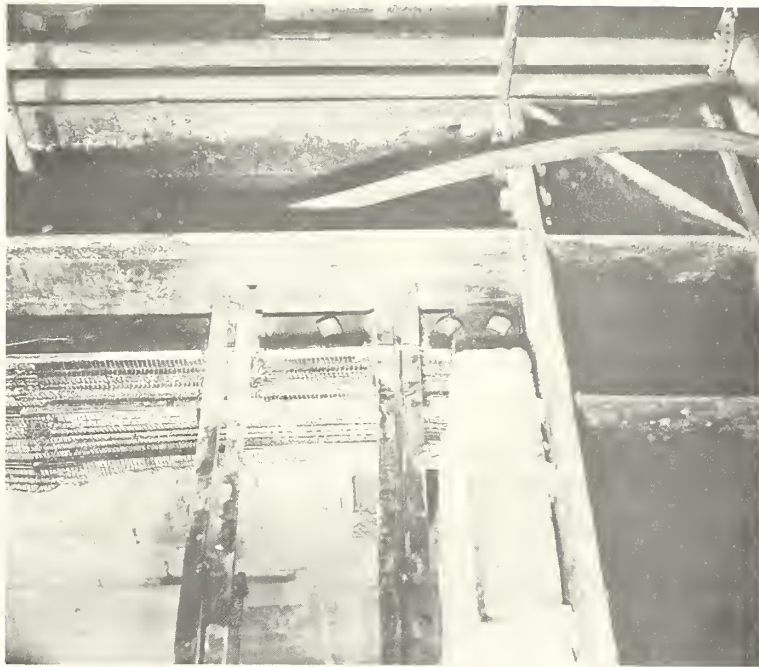
Fig. 1. Corner detail, showing steel plate, bolt heads, spacers, and joists.

For the purpose of providing only moderate axial restraint a 1- by 5-in. steel plate was secured to each 4- by 4-in. bearing angle along each side of the furnace by three bolts near each end. A 1- by 1- by 3-in. piece of steel was placed between the plate and the furnace frame near each end as a spacer.

Figure 1 shows the spacer, plate, and bolt heads. Eight steel joists were placed to span the short dimension of the furnace opening and bear on the steel plates. The joists were placed parallel to the transverse centerline of the furnace opening, and spaced symmetrically therefrom. The spacings between joists on each side of the centerline were 18 in., 36 in., 36 in., and 10 in. No joist was located at the centerline. The joist bearing plates were securely welded along both edges to the 1- by 5-in. plates across the entire 5 in. width. Nine-sixteenths-inch rods were welded transversely to the top and bottom chords of the joists as horizontal bridging.

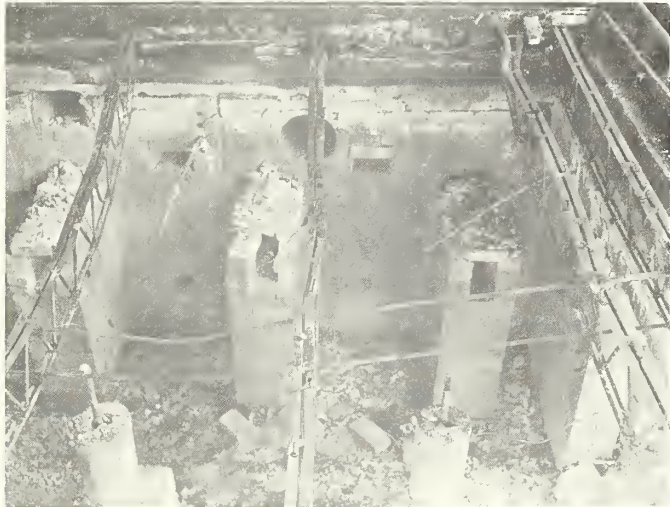
Fig. 5. Condition of joists in South half.

Examination after cooling showed that most of the joists were bent down several inches and some were bent transversely, as shown in figure 4, 5, and 6. Several welds in the joists were broken but all between the joists and the bridging were intact, as were all between the joist bearing plates and the 1- by 5-in. steel plates. The 1- by 5-in. steel plates were bent laterally as much as 2-1/4 in. and bent up as much as 1-1/4 in.

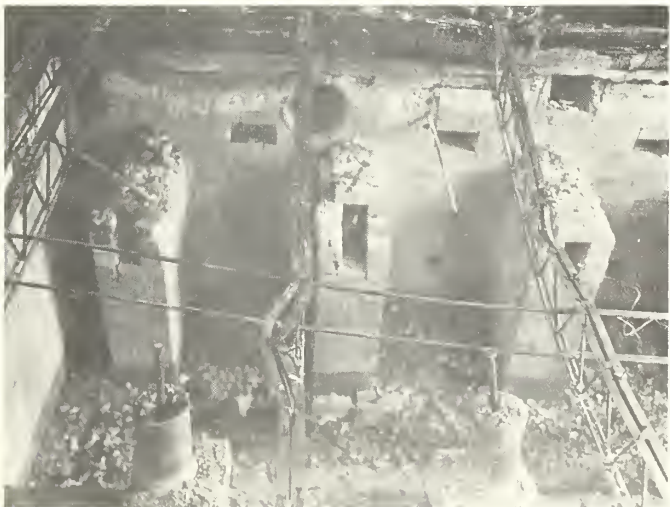
Fig. 6. Condition of joists in North half.
