FIRE TESTS OF PRECAST THIN-SHELL CONCRETE ROOF PANELS

November 5, 1956

4920

Bureau of Yards and Docks  
Department of the Navy

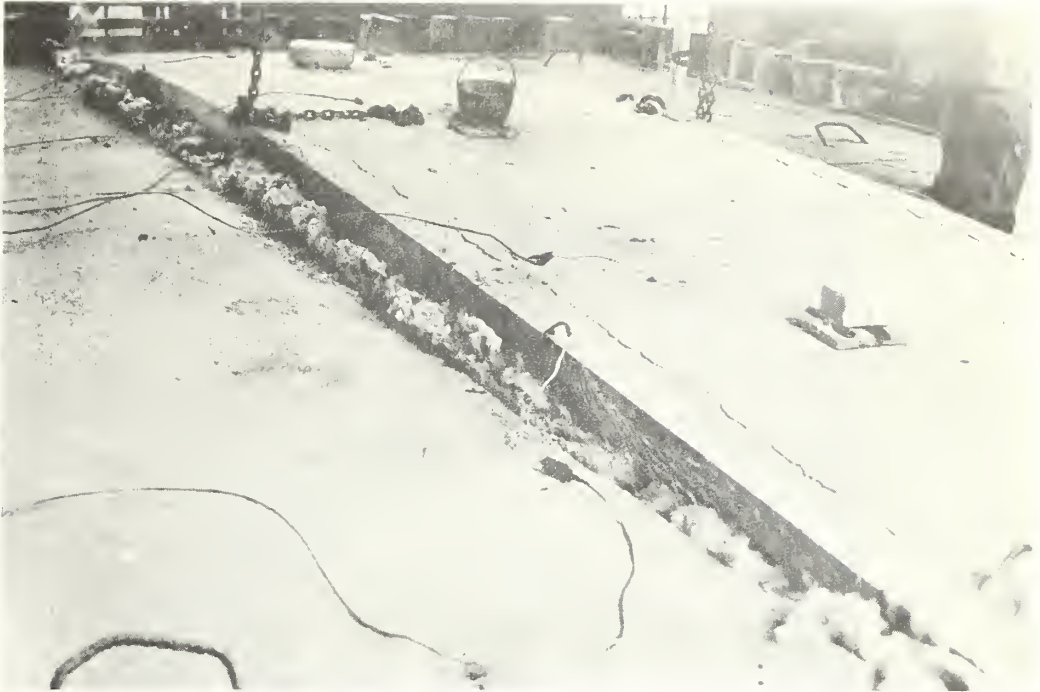
Fig. 5. Arched condition of panel, test 364, tested without applied load.

The deflections of the longitudinal flanges were upwards, initially, reaching individual maxima of 0.7 to about 8 in. An example is shown in figure 5. Except in the very short tests, the deflections decreased from these maxima and, with one additional exception, became downward with respect to the initial position of panel. The additional exception was one test (364) in which the thermal expansion of one of the prestressed bars was sufficient to jam against the furnace frame and hold the panel in an arched position. The downward deflections of the other panels reached values of 8 in. to 2 ft. In many instances these deflections represented the limit of slack in chains attached at mid-span to prevent complete collapse. The thin-shell webs of the panels with intermediate transverse ribs, and the ribs, sagged with respect to the longitudinal flanges. The deformations of the webs of the panels without transverse ribs were less consistent. In some cases they were upwards, in others downwards, and in still others upwards along part of the panels length and downwards along other parts at the same time. In general, the deformations of the webs became downward as the tests progressed.

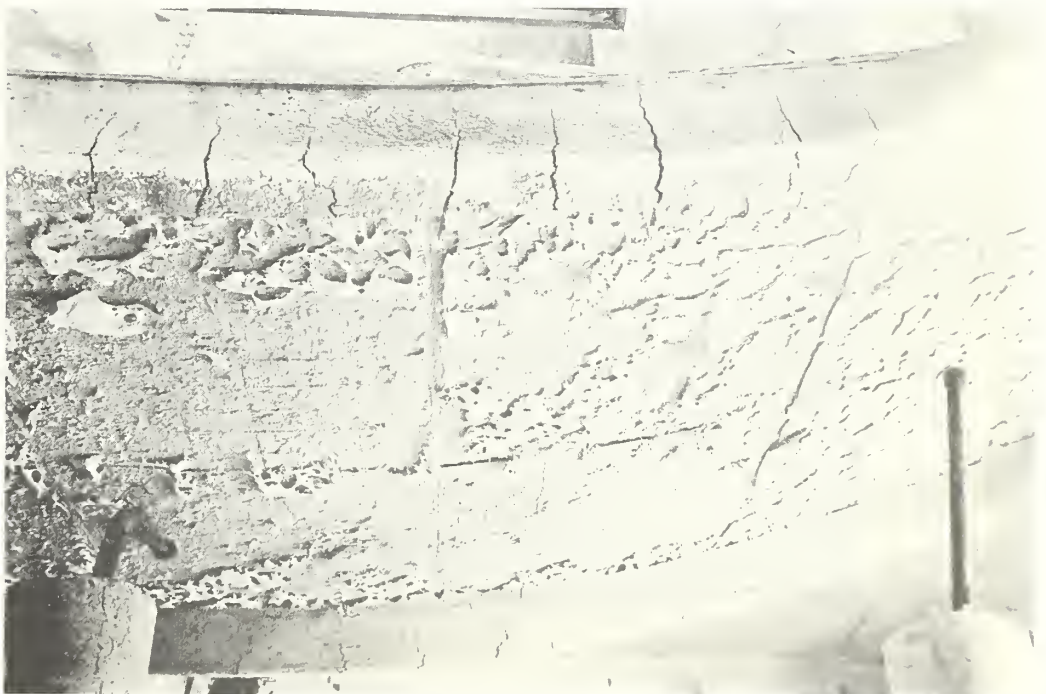
Fig. 6. Exposed surface of specimen having had glass fiber underface, showing remains of same and cracks in concrete.

The glass fiber insulation on the exposed surfaces of two of the panels fused and dropped off in pieces. By the end of an hour of exposure, most of the insulation appeared destroyed as shown in figure 6. The perlite-foam concrete underface did not show any signs of damage other than craze cracks. None of the exposed structural concrete of the panels spalled or sluffed off.

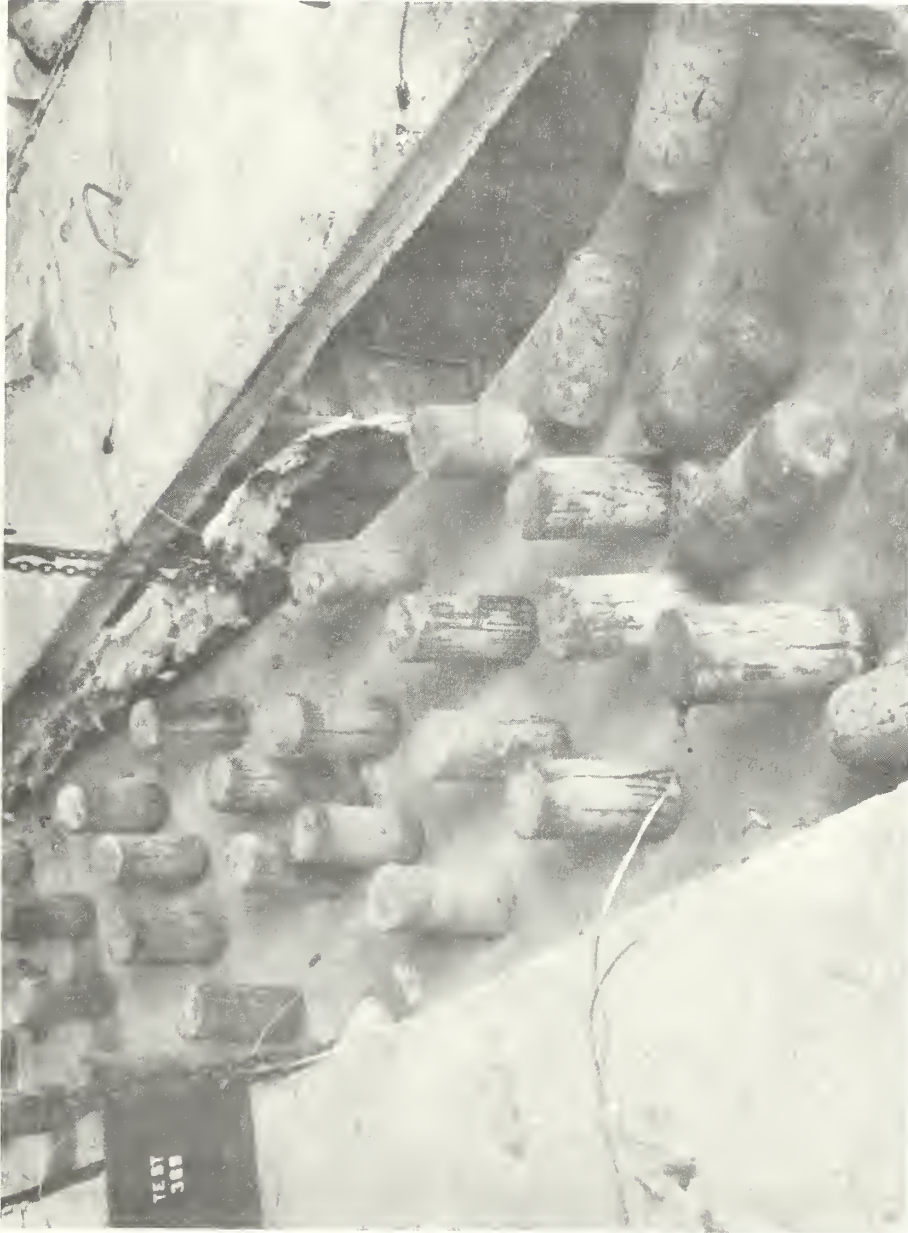
Fig. 7. Panel deflected about 20 in., beyond which further deflection or collapse prevented by chain suspension. Load ( $14 \text{ lb/ft}^2$ ) supplied by 6 in. diameter 12 in. long concrete cylinders.

The deflections of the four panels were in the downward direction throughout and reached values of from 11 to 20 in. by the ends of the tests. The thin shell webs sagged with respect to the longitudinal flanges. The deflections of the panels and sag of the webs were so large that some of the concrete cylinders used as applied load on two panels were toppled over, as shown in figure 7.
