# NATIONAL BUREAU OF STANDARDS REPORT

TESTS OF PRESTRESSED CELLULAR SLABS  
(Slabs Nos. 5, 7, 8, and 9)

Report to  
Bureau of Yards and Docks  
Department of the Navy

December 11, 1956

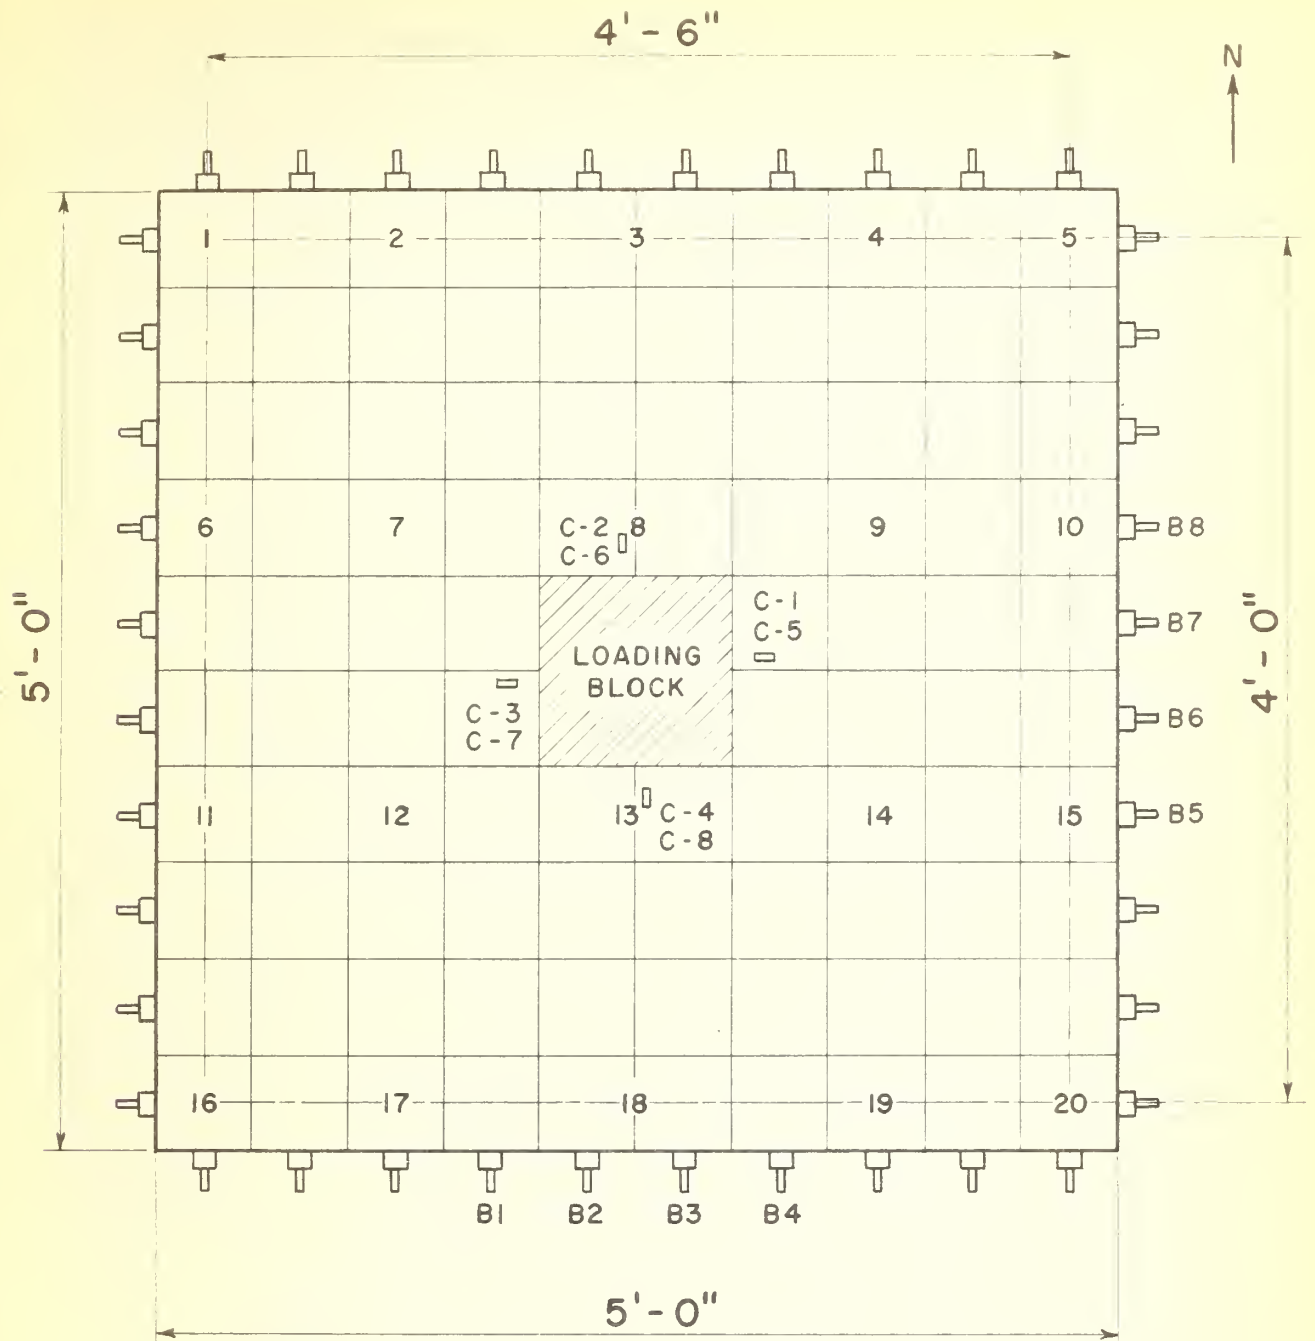
GAGES 1 THROUGH 20 INDICATE DIAL GAGES

B1 THROUGH B8 INDICATE GAGES ON BARS

C1 - C4 INDICATE SR-4 GAGES ON BOTTOM SURFACE OF SLAB

C5 - C8 " " " " TOP " " "

FIGURE 3. LOCATION OF DIAL GAGES AND STRAIN GAGES.

The variation of strain in eight prestressing bars was measured by means of bonded wire strain gages. Each of the eight bars was instrumented with two gages that were connected in series to eliminate the effects of any bending that might take place. Four of these bars ran through the slab in one direction, and the other four were perpendicular to them. The locations of the instrumented bars are shown in figure 3.

Figure 3 also shows the location of eight bonded wire strain gages that were applied to the concrete. Four of these gages were on the top surface of the slab and four were on the bottom.

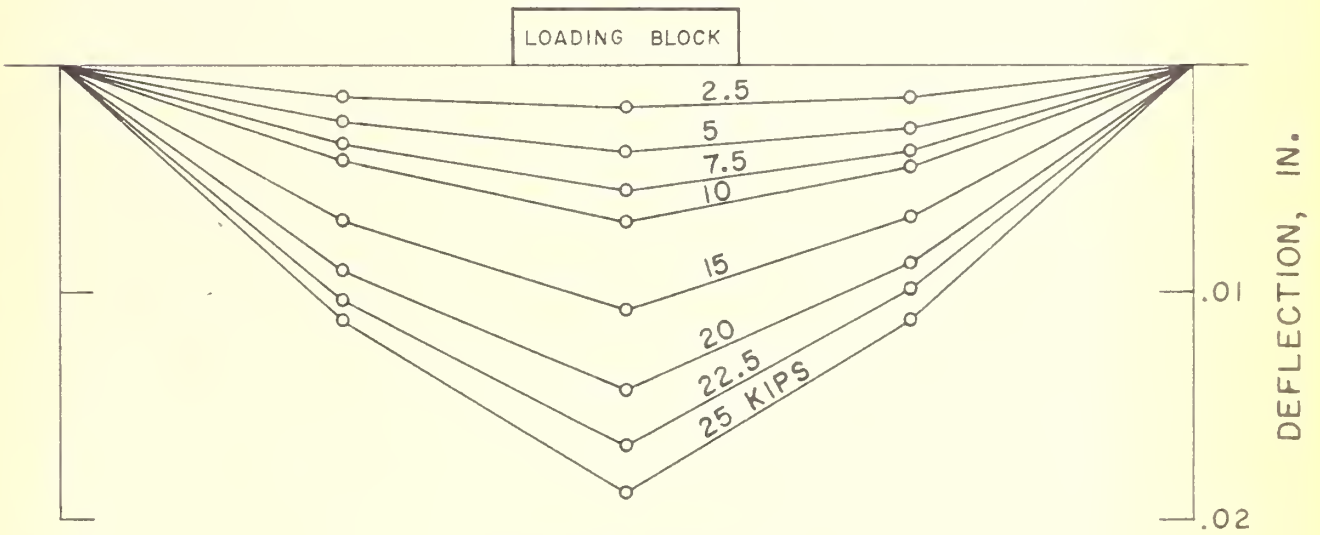
FIGURE 6. DEFLECTION PROFILES FOR SLABS NOS. 5 AND 7.

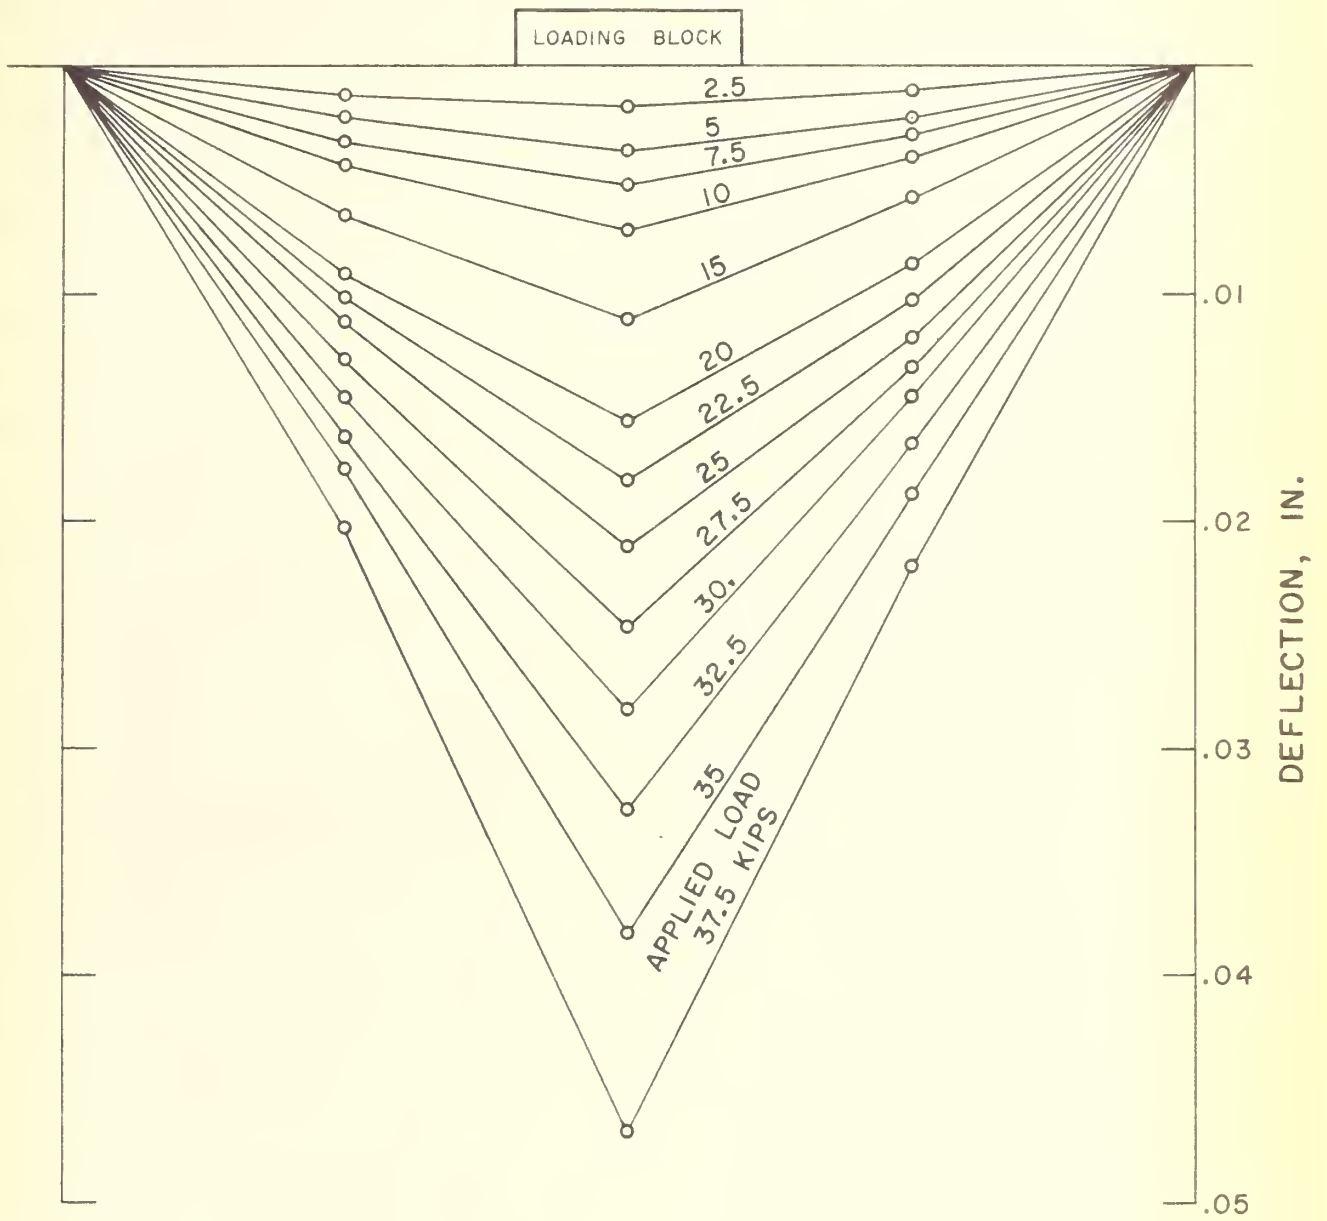
FIGURE 7. DEFLECTION PROFILE FOR SLAB NO. 8.

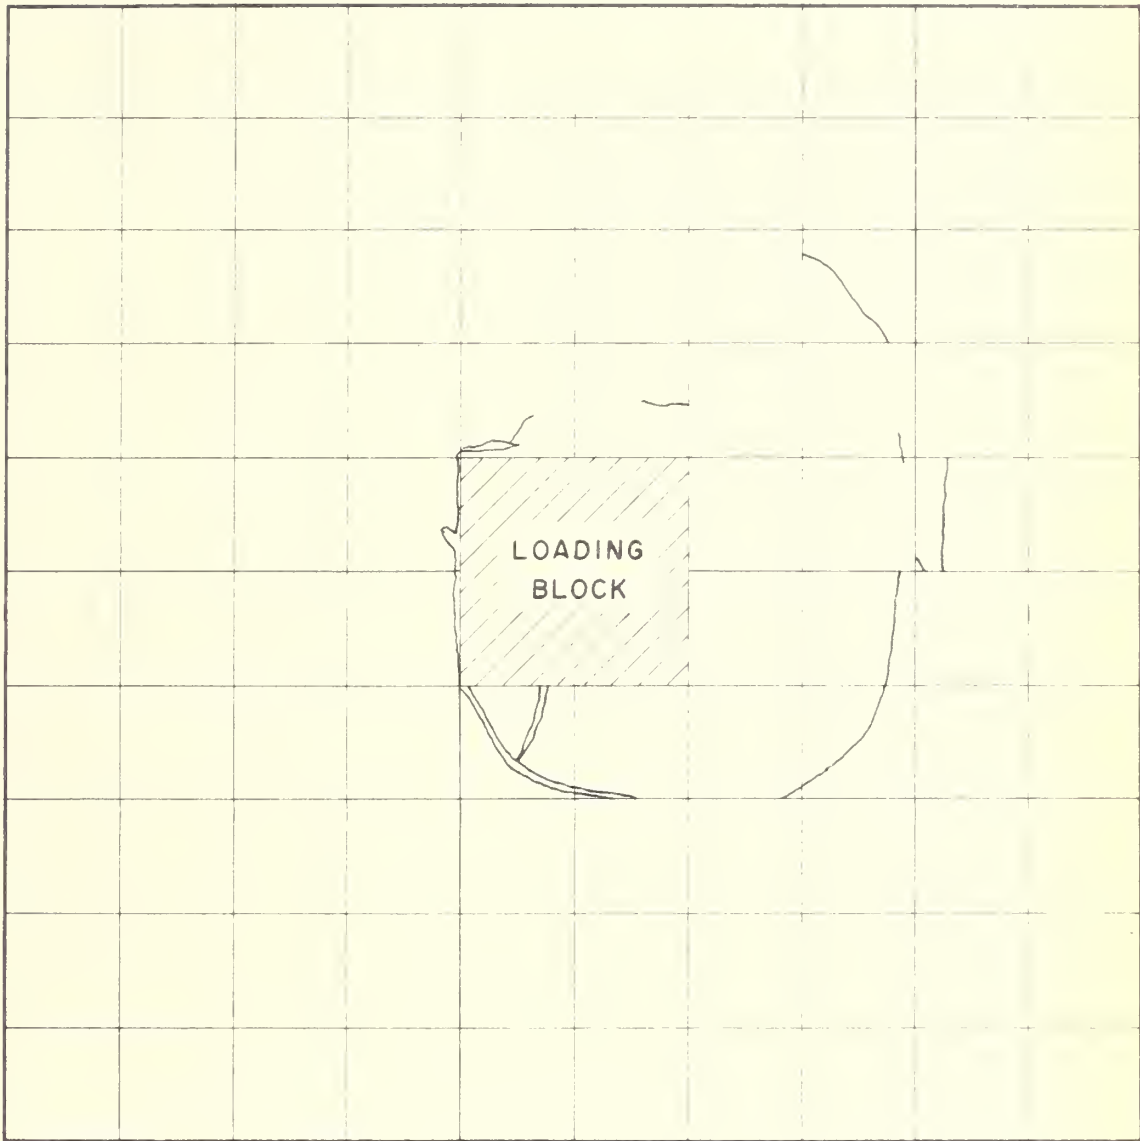
TOP VIEW AFTER FAILURE  
(BOTTOM SURFACE INTACT)

FIGURE 14. VIEW OF TOP SURFACE OF SLAB NO. 5  
AFTER TEST.

Figures 14 through 19 show the crack patterns on the top and bottom surfaces of Slabs Nos. 5, 7, 8, and 9. The cracks in the bottom surface of slab No. 8 were more or less circular arcs that developed some distance from the loading block. This crack pattern very closely resembled that of a similar slab (No. 4) that was illustrated in figure 10 of NBS Report 4396.

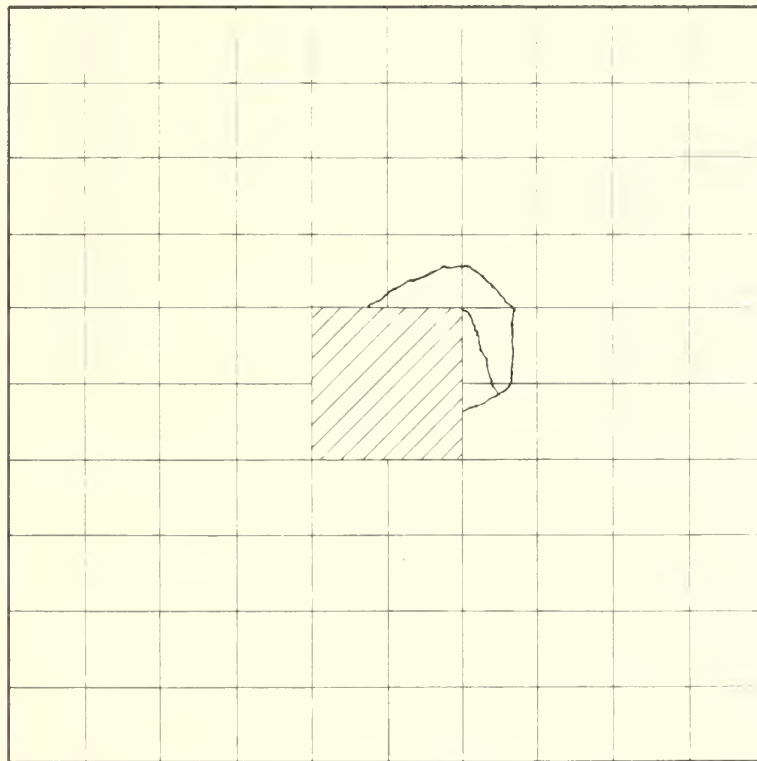
TOP VIEW  
(BOTTOM INTACT)

FIGURE 15. VIEW OF TOP SURFACE OF SLAB NO. 7  
AFTER TEST.

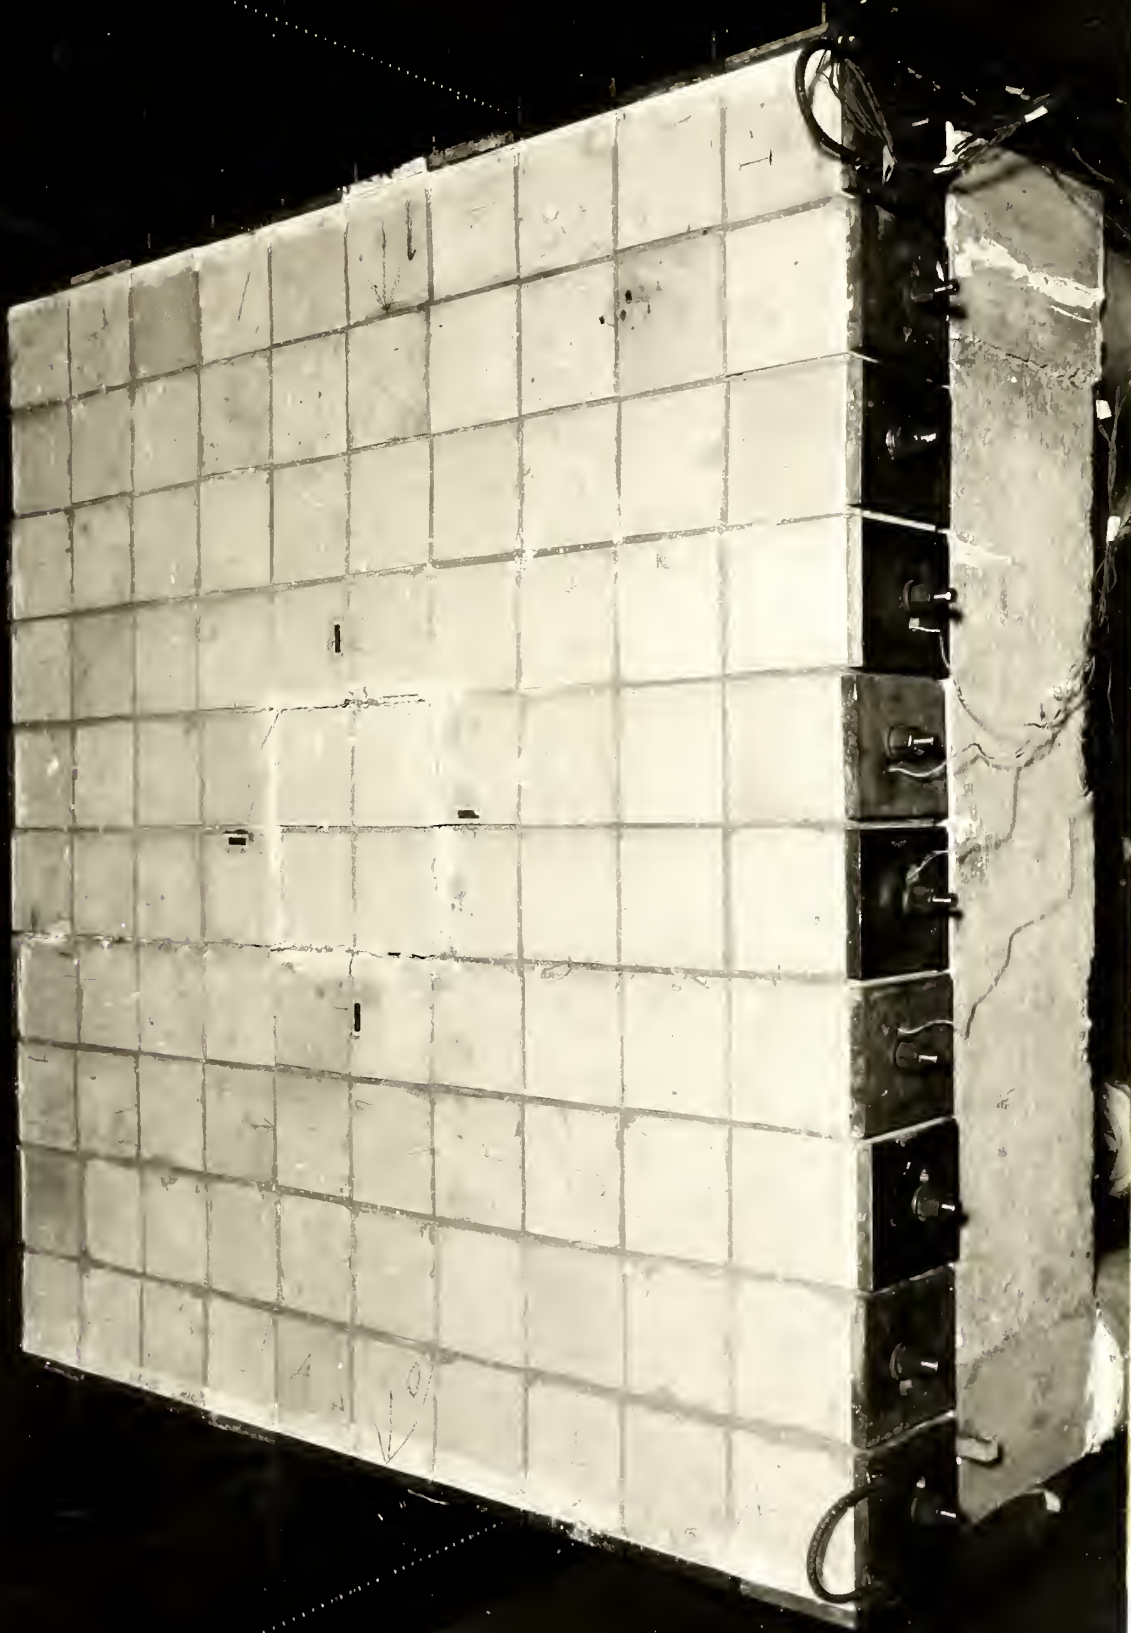
Fig. 18. Top view of Slab No. 9 after test.

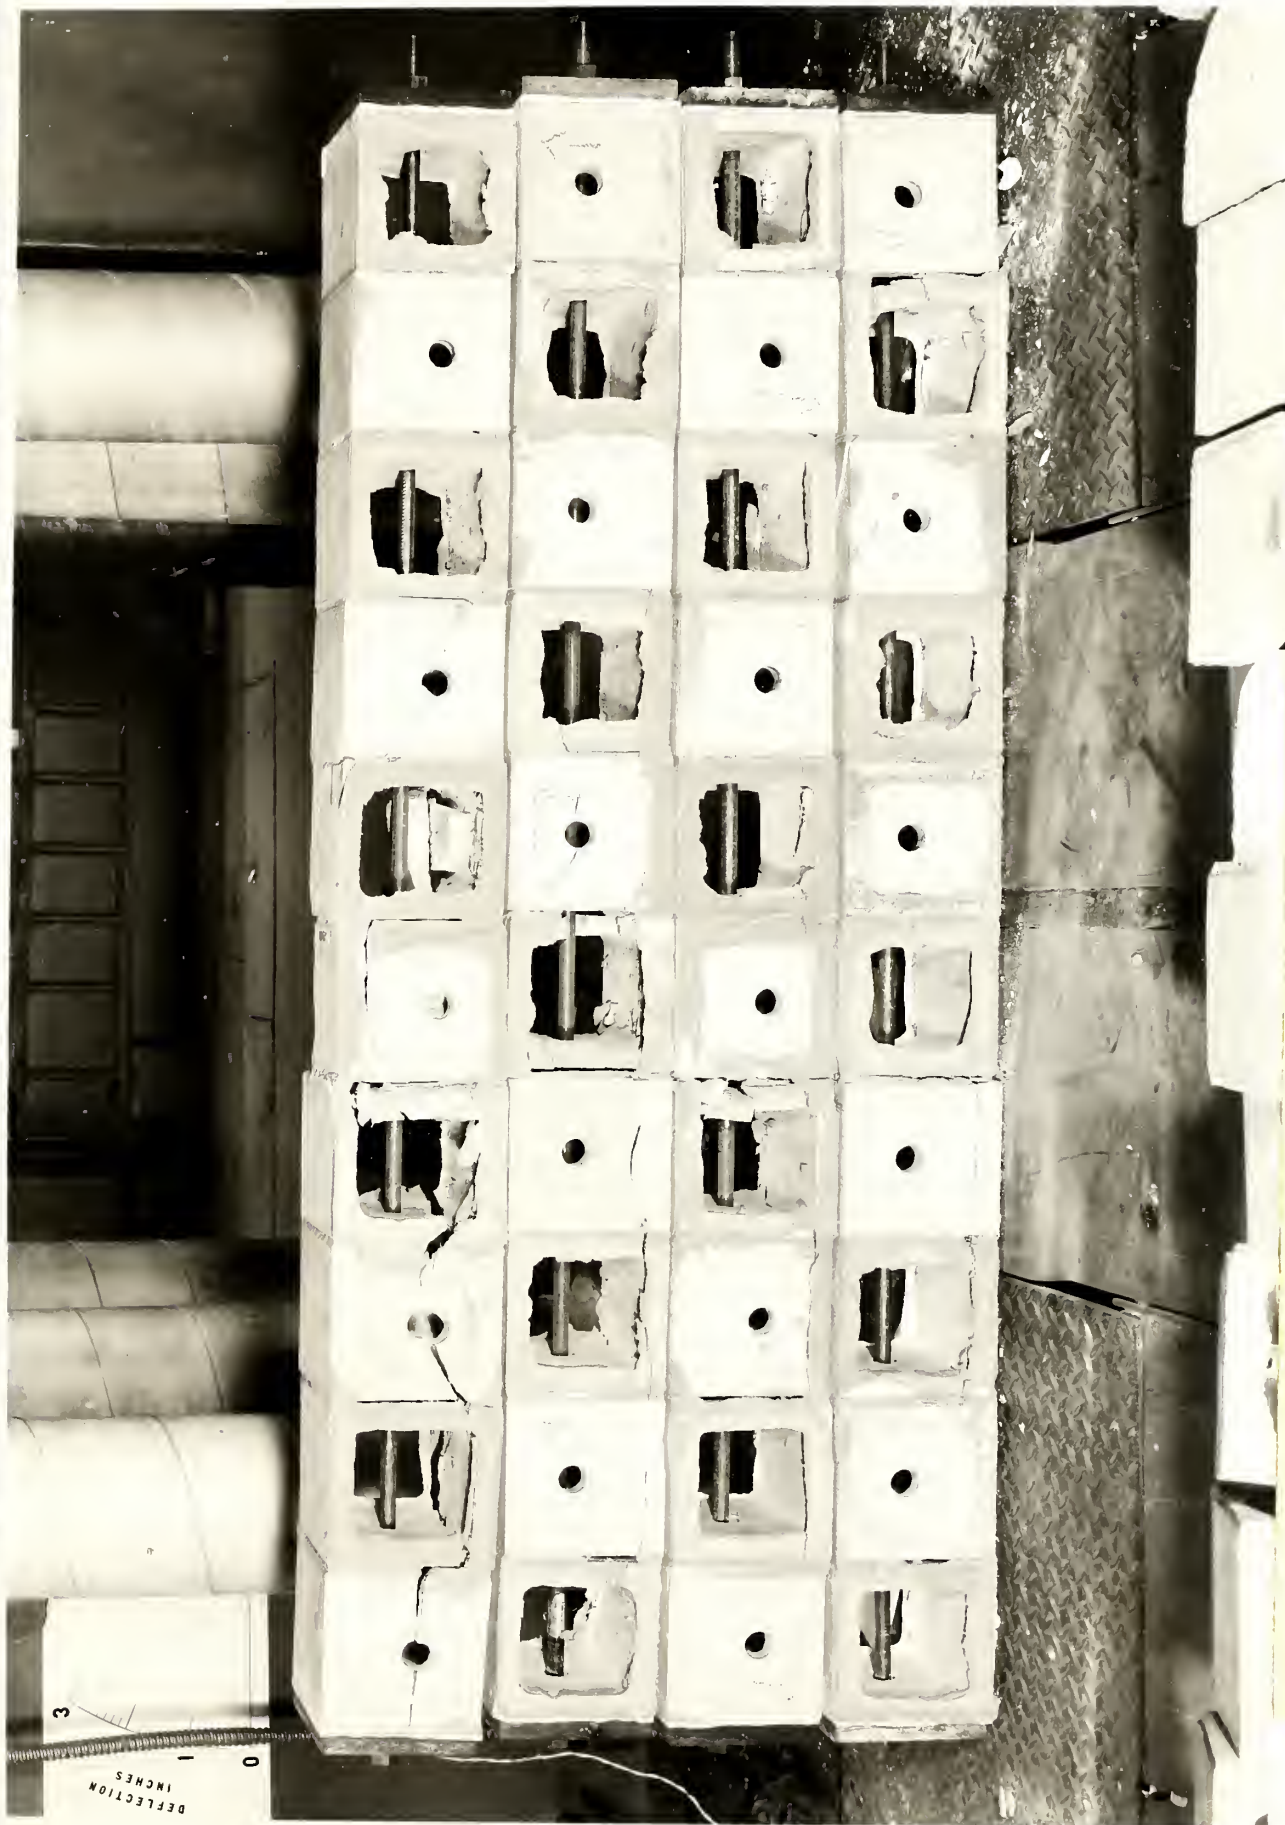
Fig. 25. View of sections through Slab No. 9.

The crack patterns in the webs of the unreinforced blocks along various sections through the slabs as indicated in figure 20 are shown in figures 21 through 25. These cracks were very wide and extensive, and their direction was usually parallel to the shells of the slabs. It is apparent from the crack pattern in the webs of the reinforced blocks shown in figure 25 that the cracks were confined to relatively few blocks, and upon further inspection after the test, the cracks were found to be narrower than those in the unreinforced blocks.

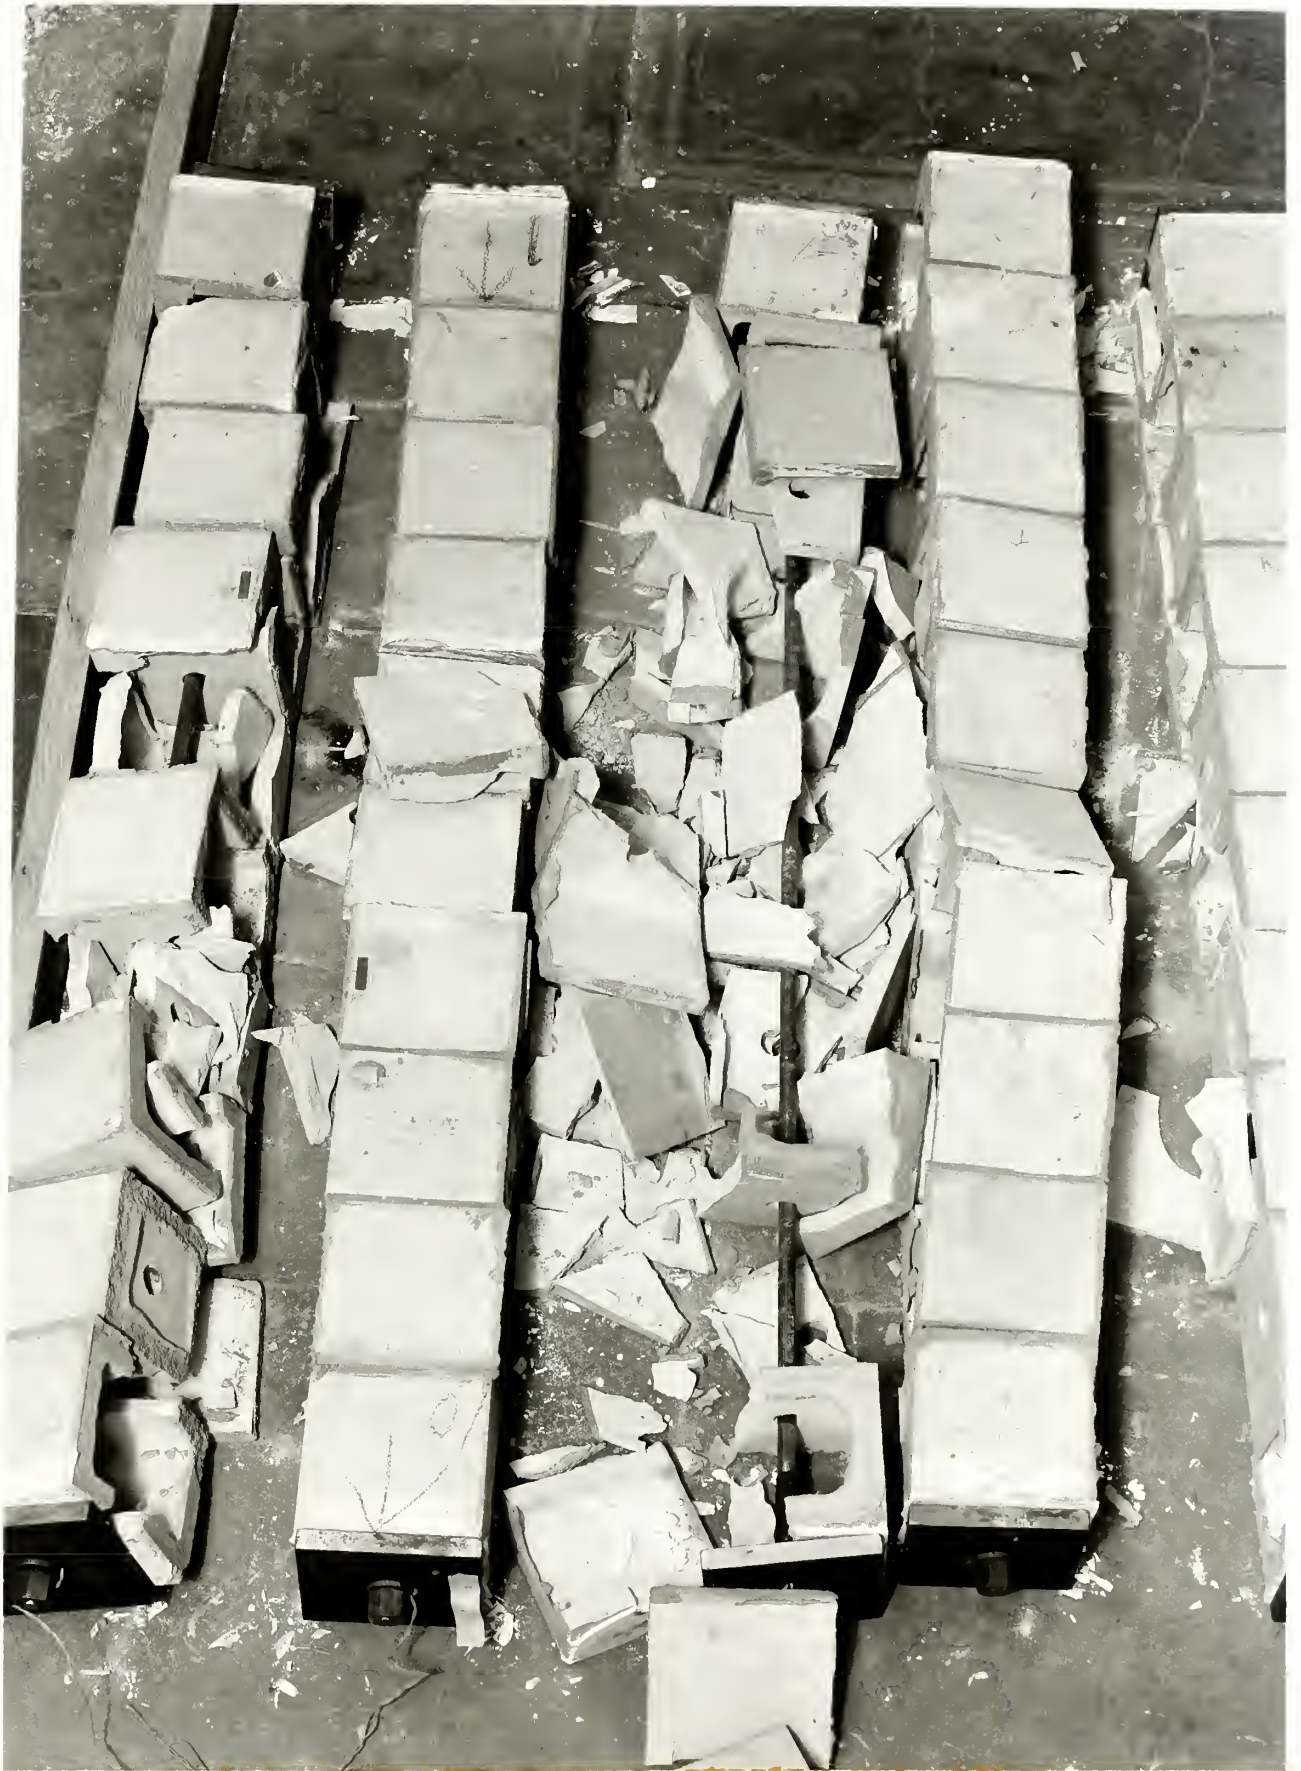
Fig. 26. Bursting effect of prestressing force on structural clay units.

The extensive horizontal cracks in the block having unreinforced webs were attributed to the bursting effect of the prestressing force. This effect was noted in auxiliary tests and reported in the NBS Report No. 4813.
