STRENGTH AND RIGIDITY OF LAP WELDED SPLICES  
IN PRECAST REINFORCED CONCRETE FRAMING MEMBERS

L. F. Skoda, A. F. Kirstein, and D. Watstein

Bureau of Yards and Docks  
Department of the Navy

January 10, 1958

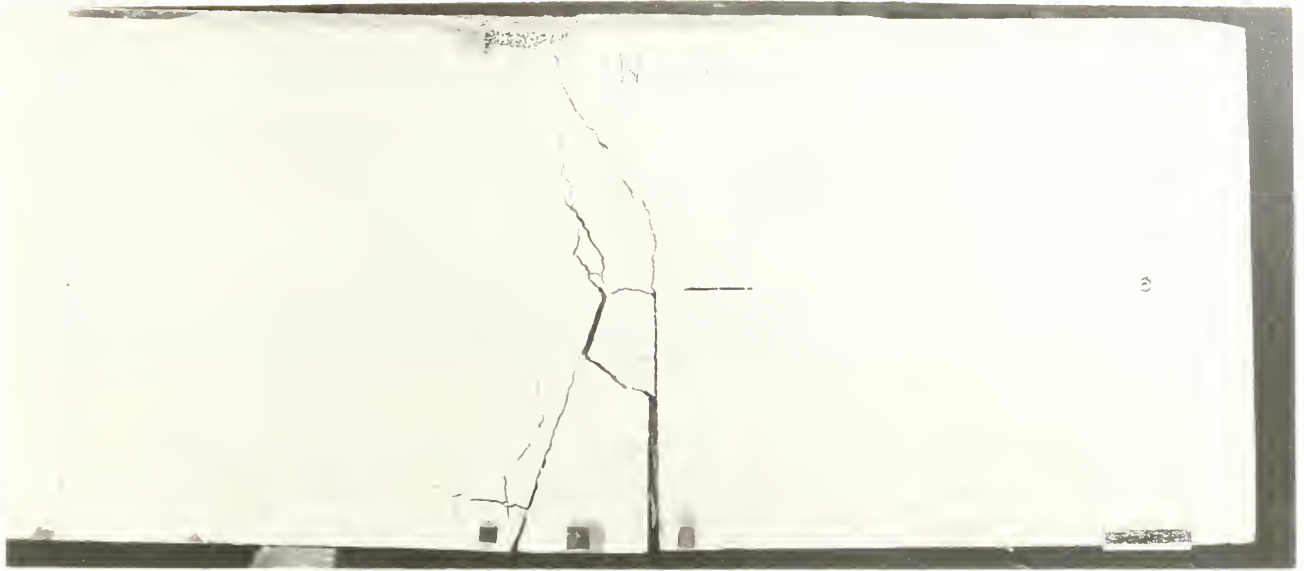
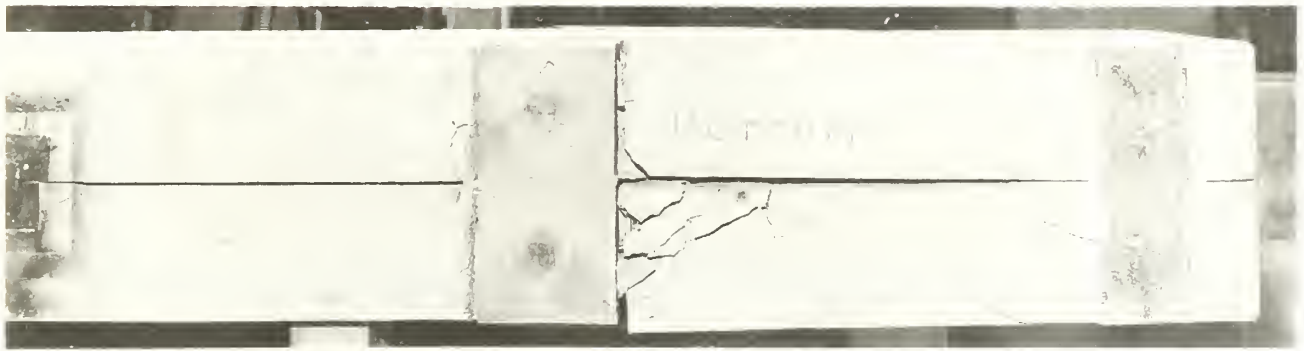
FIG. 4 VIEW OF FAILURE, GIRDER NO. 1 NORTHWEST & BOTTOM.

The primary cause of failure in the flexural tests of the girders appeared to be yielding of the tensile reinforcement in the splices. This is indicated by the views of the girders after test in figures 3 through 10 and by the load-strain relationship for girders 3 and 4 shown in figure 11. The views of all girders tested show wide cracks at the straight boundary of the grout pocket. These cracks were sufficiently wide in most of the specimens to reduce the compressive zone of the concrete to a depth which permitted shear failure to occur as a secondary mode of failure.

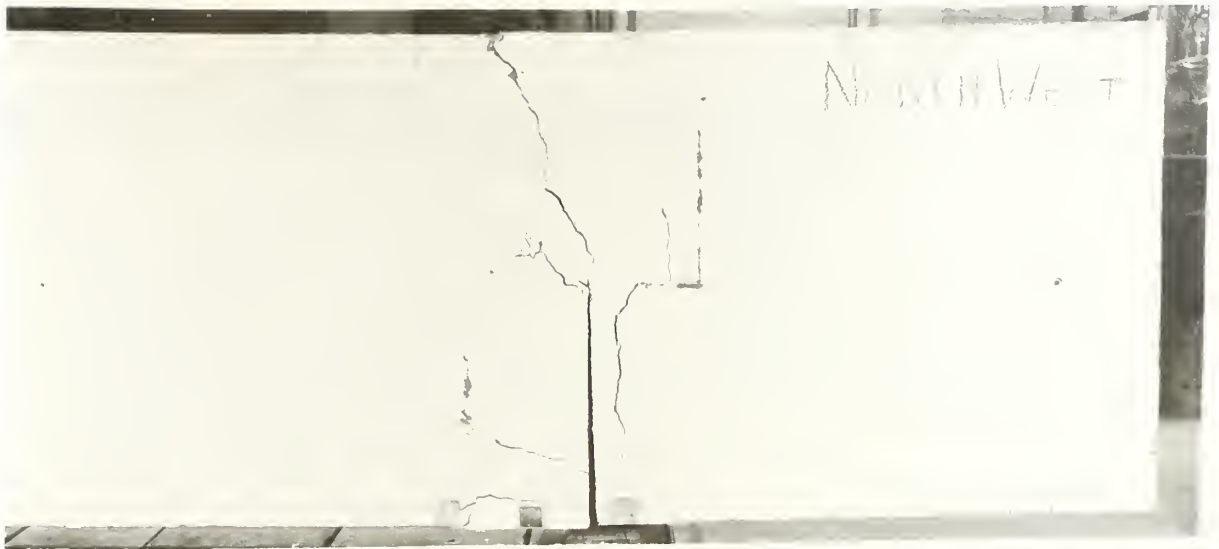
FIG. 6 VIEW OF FAILURE, GIRDER NO. 2 NORTHWEST & BOTTOM.

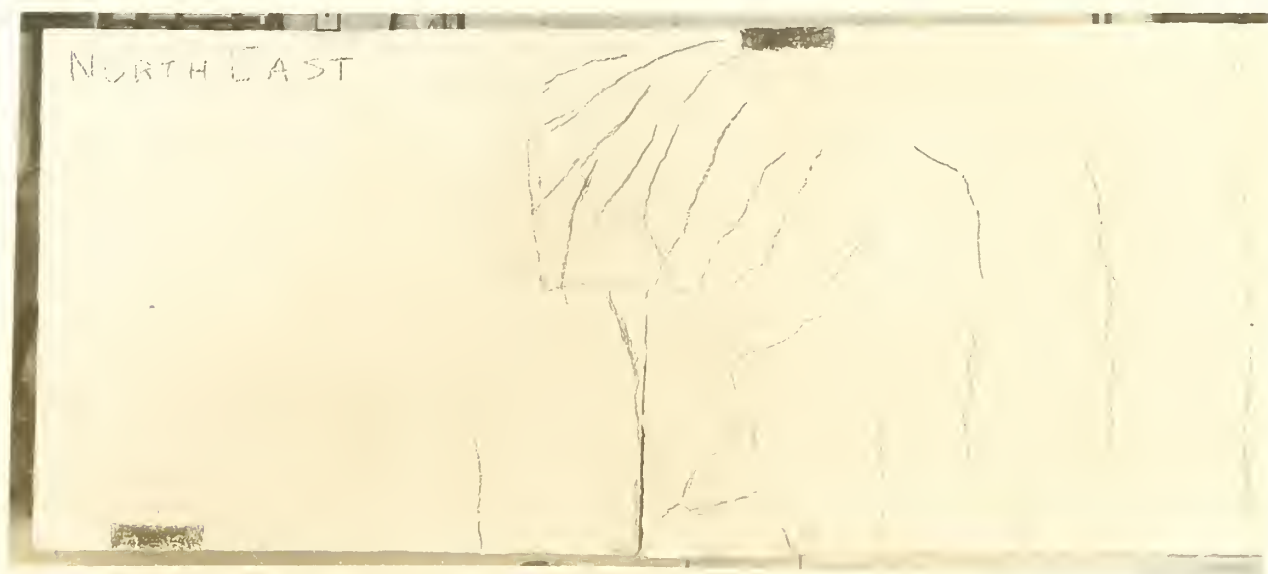
FIG. 7 VIEW OF FAILURE, GIRDER NO. 3 NORTHEAST & TOP.

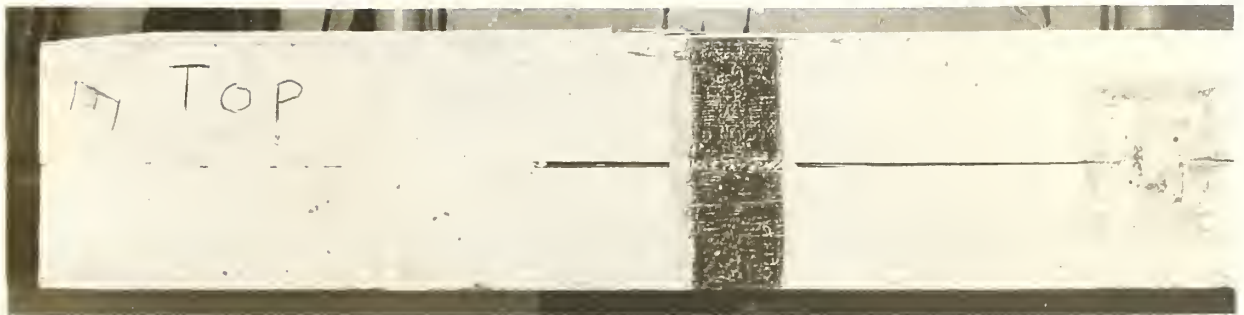
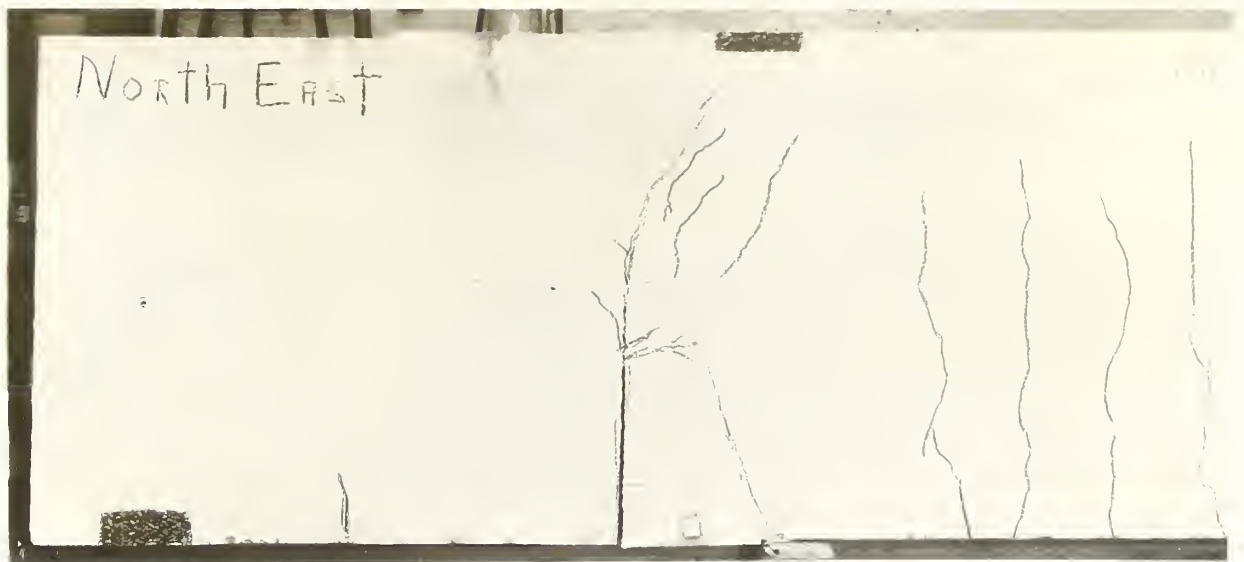
FIG. 9 VIEW OF FAILURE, GIRDER NO. 4 NORTHEAST & TOP.
