NATIONAL BUREAU OF STANDARDS REPORT

FIRE TEST OF STEEL DECK FLOOR SYSTEM AND BEAM

5375

Department of the Air Force
(AFCIE-ES)

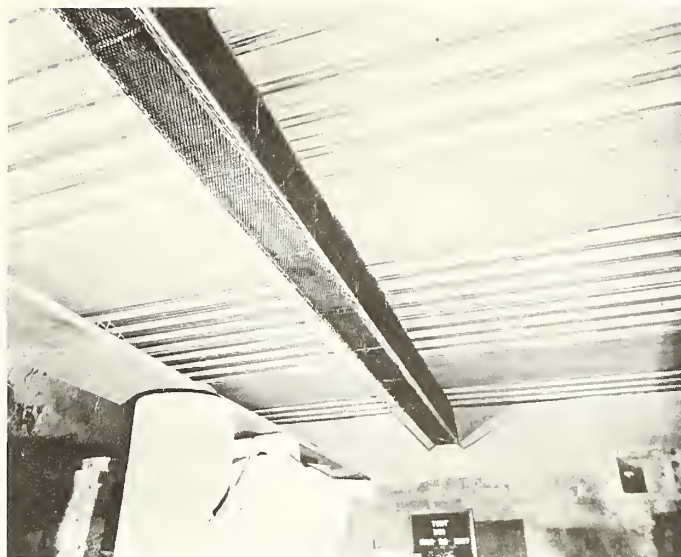
Figure 2. Undersurface of deck units; and beam encased in metal lath with corner beads in place.

Sheets of flat diamond mesh 3.4 lb/yd^2 expanded metal lath were bent to form long channel-shaped pieces of such size that they boxed the beam and fit against the wire hangers. The lath was tied to the hangers by 18 gage lathers' tie wire. Corner beads, consisting of a formed sheet metal nose and woven wire legs, were tied to the metal lath along the two bottom edges of the beam protection. The corner beads were positioned to provide grounds for not less than $1\frac{1}{2}$ in. of plaster, as measured from the face of the metal lath, on the soffit and up both sides of the beam.

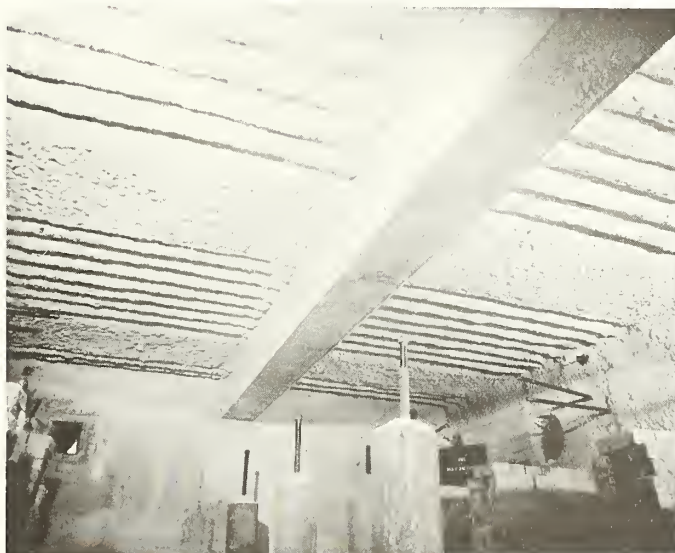
Figure 3. Undersurface of specimen just before fire exposure.

Shrinkage of the acoustical plastic, as each application dried, produced numerous cracks over the surface. In most instances the subsequent applications covered the existing cracks satisfactorily. Between the third and final applications, cracks in and parallel to the flutes were patched by trowelling considerable added material into the flutes. This was followed by application of the final thin texture coat. The combination of spraying and trowelling resulted in a surface with flutes of curved or V-shape rather than nearly rectangular cross-section.

The day before and the day of the fire test, a series of measurements were made of the thickness of acoustical plastic by probing with fine wires. Measurements were made of the thickness beneath the flat plates of the cellular units and beneath the flutes and between the flutes of the other units. The maximum, minimum, and average under the cellular units were 1 11/16 in., 1 1/16 in., and about 1 7/16 in. respectively; under the flutes 1 3/4 in., 1 in., and about 1 3/8 in. respectively; and between the flutes 2 9/16 in., 1 1/16 in., and about 1 5/8 in., respectively. The overall average of these measurements was about 1 7/16 in. (1.46 in. actually).

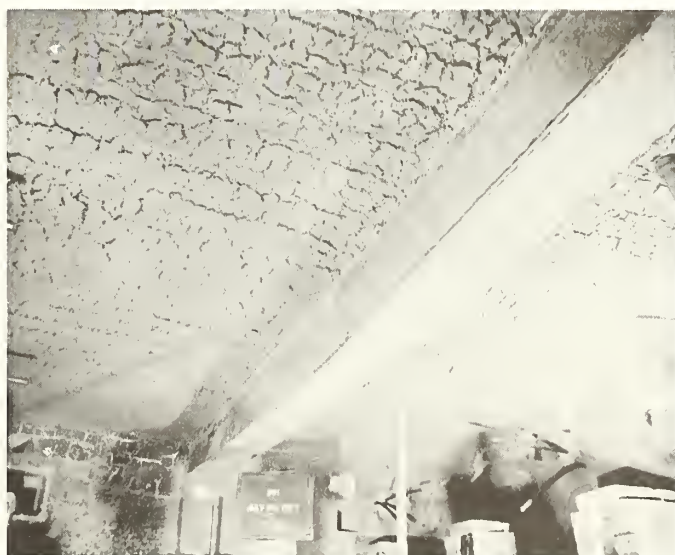
Figure 4. Undersurface of specimen the day after fire exposure.

After the test, and cooling, the only significant cracks in the beam cover were those across the soffit and up each side at the center of the beam. The plaster was a light brown color, somewhat darker than before the fire exposure. Measurements were made of the thickness of the fire exposed plaster, from the face of the metal lath. The soffit varied from $1\ 3/8$ to $1\ 7/8$ in. and averaged $1\ 1/2$ in.; the West side varied from $1\ 9/16$ to 2 in. and averaged $1\ 3/4$ in.; the East side varied from $1\ 1/2$ to $2\ 5/16$ in. and averaged $1\ 13/16$ in. One section of the East side was $1\ 5/8$ in. thick at the bottom and $2\ 5/16$ in. about 2 in. from the top. The beam had a permanent deflection of 5 in. at its center. The acoustical plastic was covered with craze cracks and fissures, some $1/2$ to 1 in. wide and deep. The original surface was a slightly darker brown than the beam. However, the base application material that showed in the cracks and fissures was a very dark brown and fairly shiny.

The concrete fill had hairline cracks across the four corners plus two $1/16$ in. wide East-to-West cracks, one about 5 ft from the North end and the other the same distance from the South end. The former was about 10 ft long, the latter about 3 ft long. The concrete was still in close contact with the steel deck units and the joints between units were closed.
