# NATIONAL BUREAU OF STANDARDS REPORT

6389

PERFORMANCE TESTS OF PROTECTED METALS,  
SERIES 1959, COLOR PROTECTED METALS

April 30, 1959

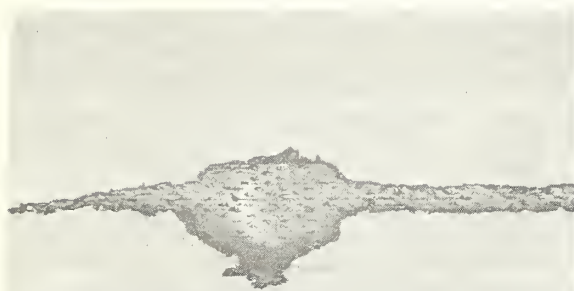
I-4 (FRONT)  
5.0 SQ. IN.

FIGURE 5. COLOR STEELBESTOS, FRONT, -30°F, 5.0 SQ. IN.

The damage that occurred to Color Steelbestos was slight to moderate. As expected, the effect of the impact was more severe at -30°F. than at 0°F., both on the exposure and the reverse sides of the specimens. Figures 5, 6, 7 and 8 indicate typical failures that occurred with this product at both 0°F. and -30°F. In every case the loss of adhesion occurred between the felt and the metal core.

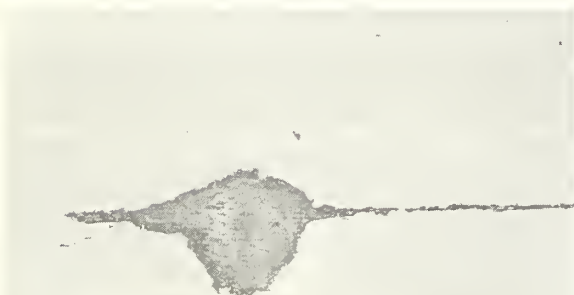
I-1 (FRONT)  
2.9 SQ. IN.

FIGURE 7. COLOR STEELBESTOS, FRONT, 0°F, 2.9 SQ. IN.

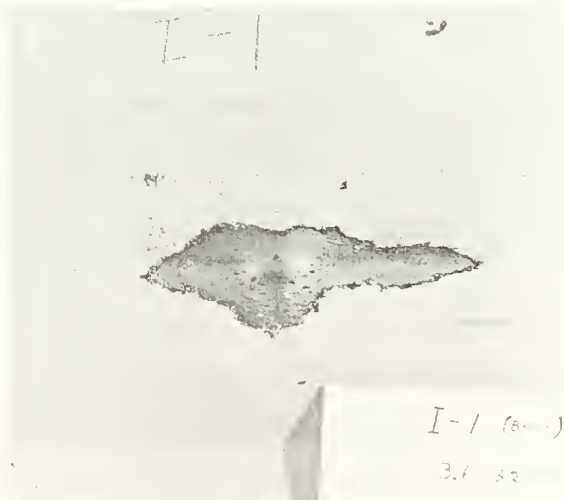
I-1 (BACK)  
3.6 SQ. IN.

FIGURE 8. COLOR STEELBESTOS, BACK, 0°F, 3.6 SQ. IN.

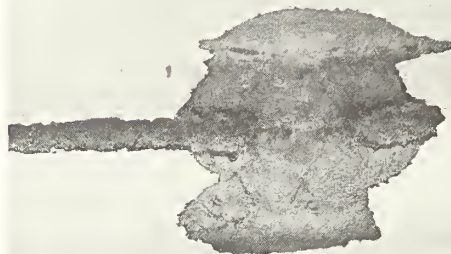
PLASTEEL #7  
ZB FRONT  
-30°F

FIGURE 12. COLOR PLASTEEL, ZB, FRONT, -30°F, 12.7 SQ. IN.

The damage that occurred to this material was classed as moderate to severe. The type and extent of the damage that occurred is shown in Figures 10, 12 and 14. As expected, the most severe failures occurred at -30°F and on the specimens which were coated both sides.

Cracking of the coating and actual shatter on an area of about one square inch was observed in the vicinity of the point of impact.

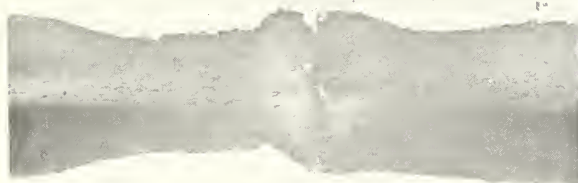
PLASTEEL #2-4  
REGULAR BACK  
-30°F

FIGURE 13. COLOR PLASTEEL, REGULAR, BACK, -30°F, 24.0 SQ. IN.

This material was rated as poor because of the severe loss of adhesion and of the actual cracking and shatter that occurred on all specimens at both 0°F. and -30°F. The types of failures that were observed were similar to those described for the CP-400 type, but to a greater extent as shown in Figures 9, 11 and 13.
