A Field Evaluation of the Relative Brightnesses of Eight Types of Runway Marking Materials

NBS REPORT

October 1959

6549

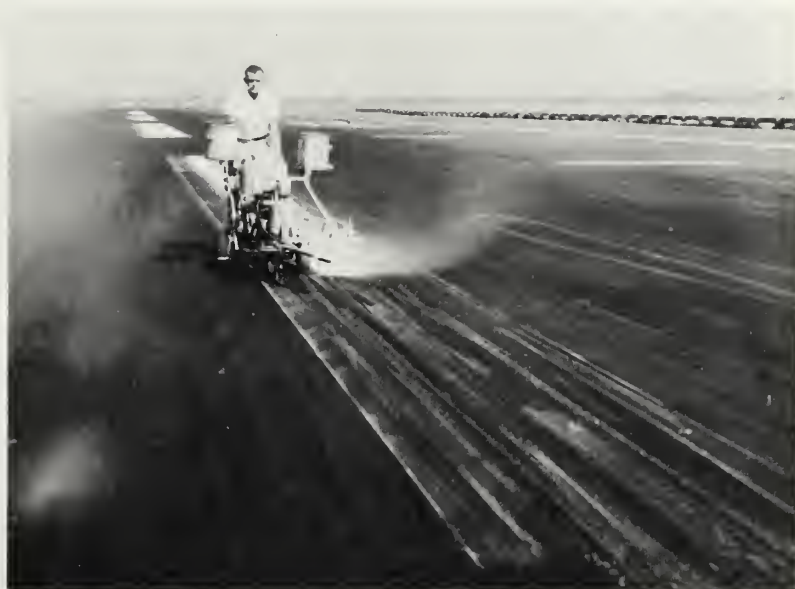
REPAINTING THE CENTERSTRIPES DURING THE SECOND INSTALLATION
(Chalkline around perimeter of stripe was used as guide while painting)

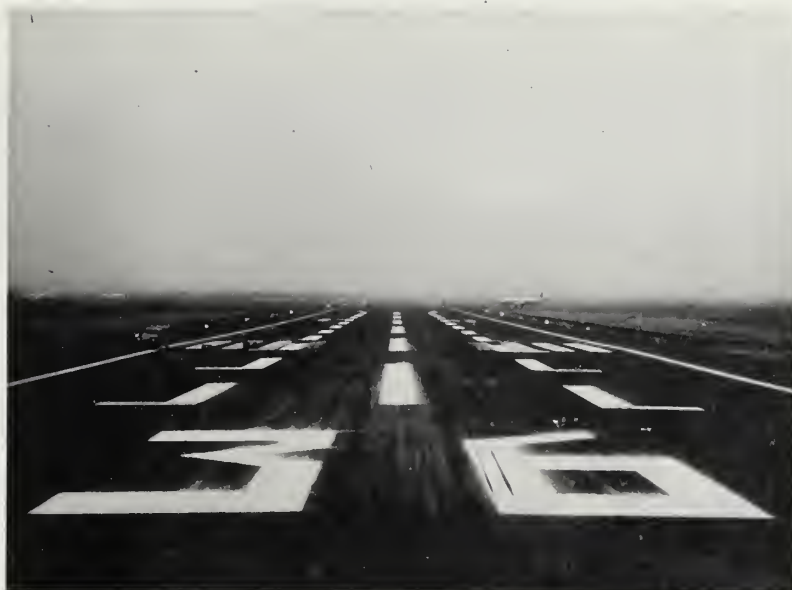
THE COMPLETED SECOND INSTALLATION

None of the material that was added in this second installation was considered test material, and none of it was subsequently evaluated. A photograph of the additional markings immediately after their installation is shown in figure 3.

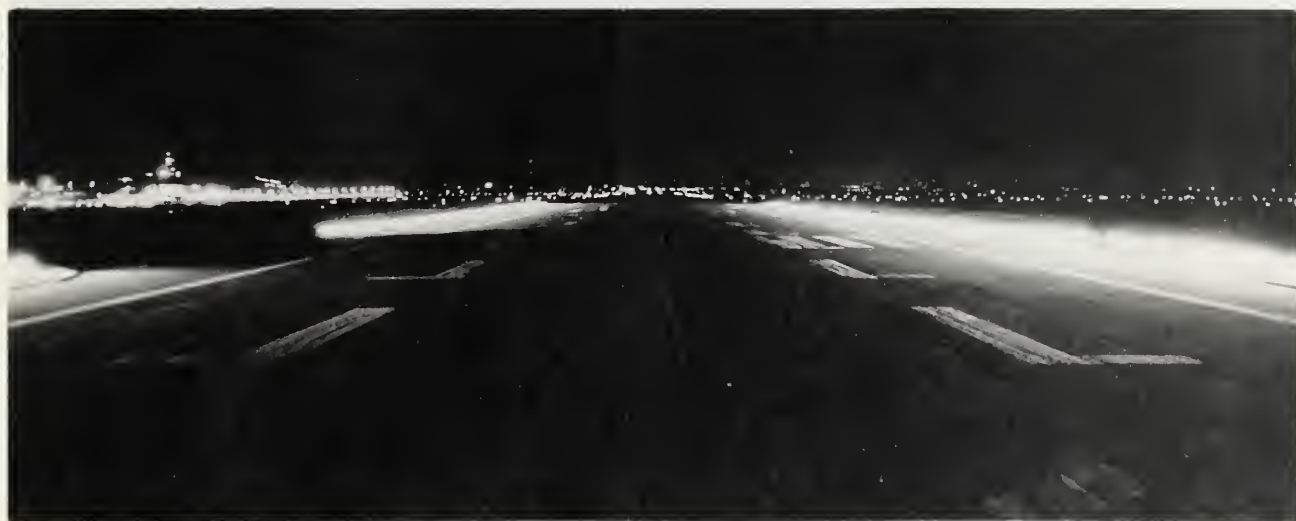
COMPOSITE PHOTOGRAPH OF TEST INSTALLATION
ILLUMINATED BY FLOODLIGHTS

Photographs of each bar, wet and dry, illuminated by the centrally located lights, are shown in figure 5. Bars L5 and L11 were not measured wet because of the low brightness when dry. One photograph with floodlighting only is shown in figure 4.

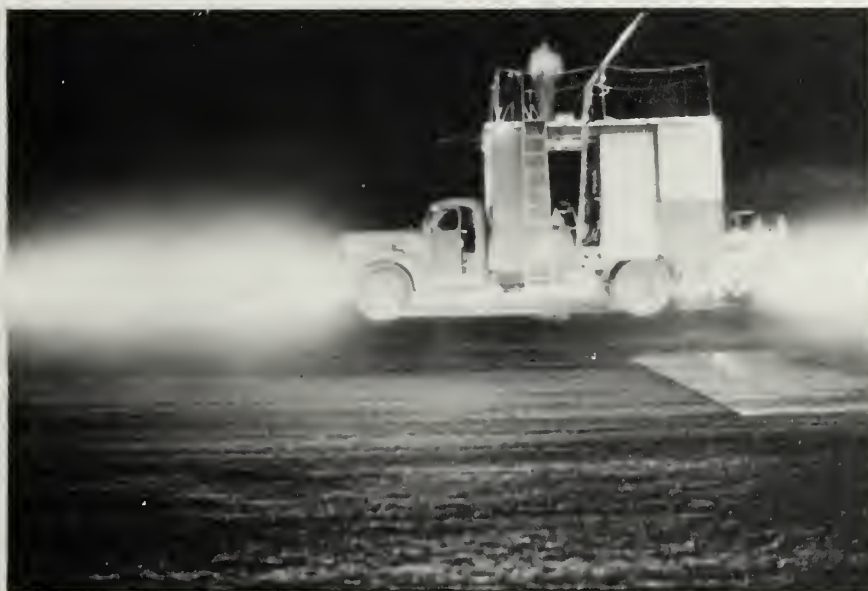
PHOTOGRAPH OF TRUCK SHOWING ROUGHNESS OF ASPHALT RUNWAY SURFACE

Cemented plastic sidebar is at right

When this test runway was resealed, crushed rock had been applied with the seal coat and the rock had not been rolled flat. This left, in addition to the pits and holes between aggregate, the peaks of the crushed rock projecting above the gross plane of the runway. Rather than dilute the paint for better penetration, it was decided to use two coats of paint for materials A and F, each coat being applied at the specified rate of 100 square feet per gallon. For material A, paint with beads, the drop-in beads were dispensed with the second coat only.
