NATIONAL BUREAU OF STANDARDS REPORT

Test of the Mobilization Structure
Under Sustained Uniformly Distributed Load

L. F. Skoda

November 27, 1961

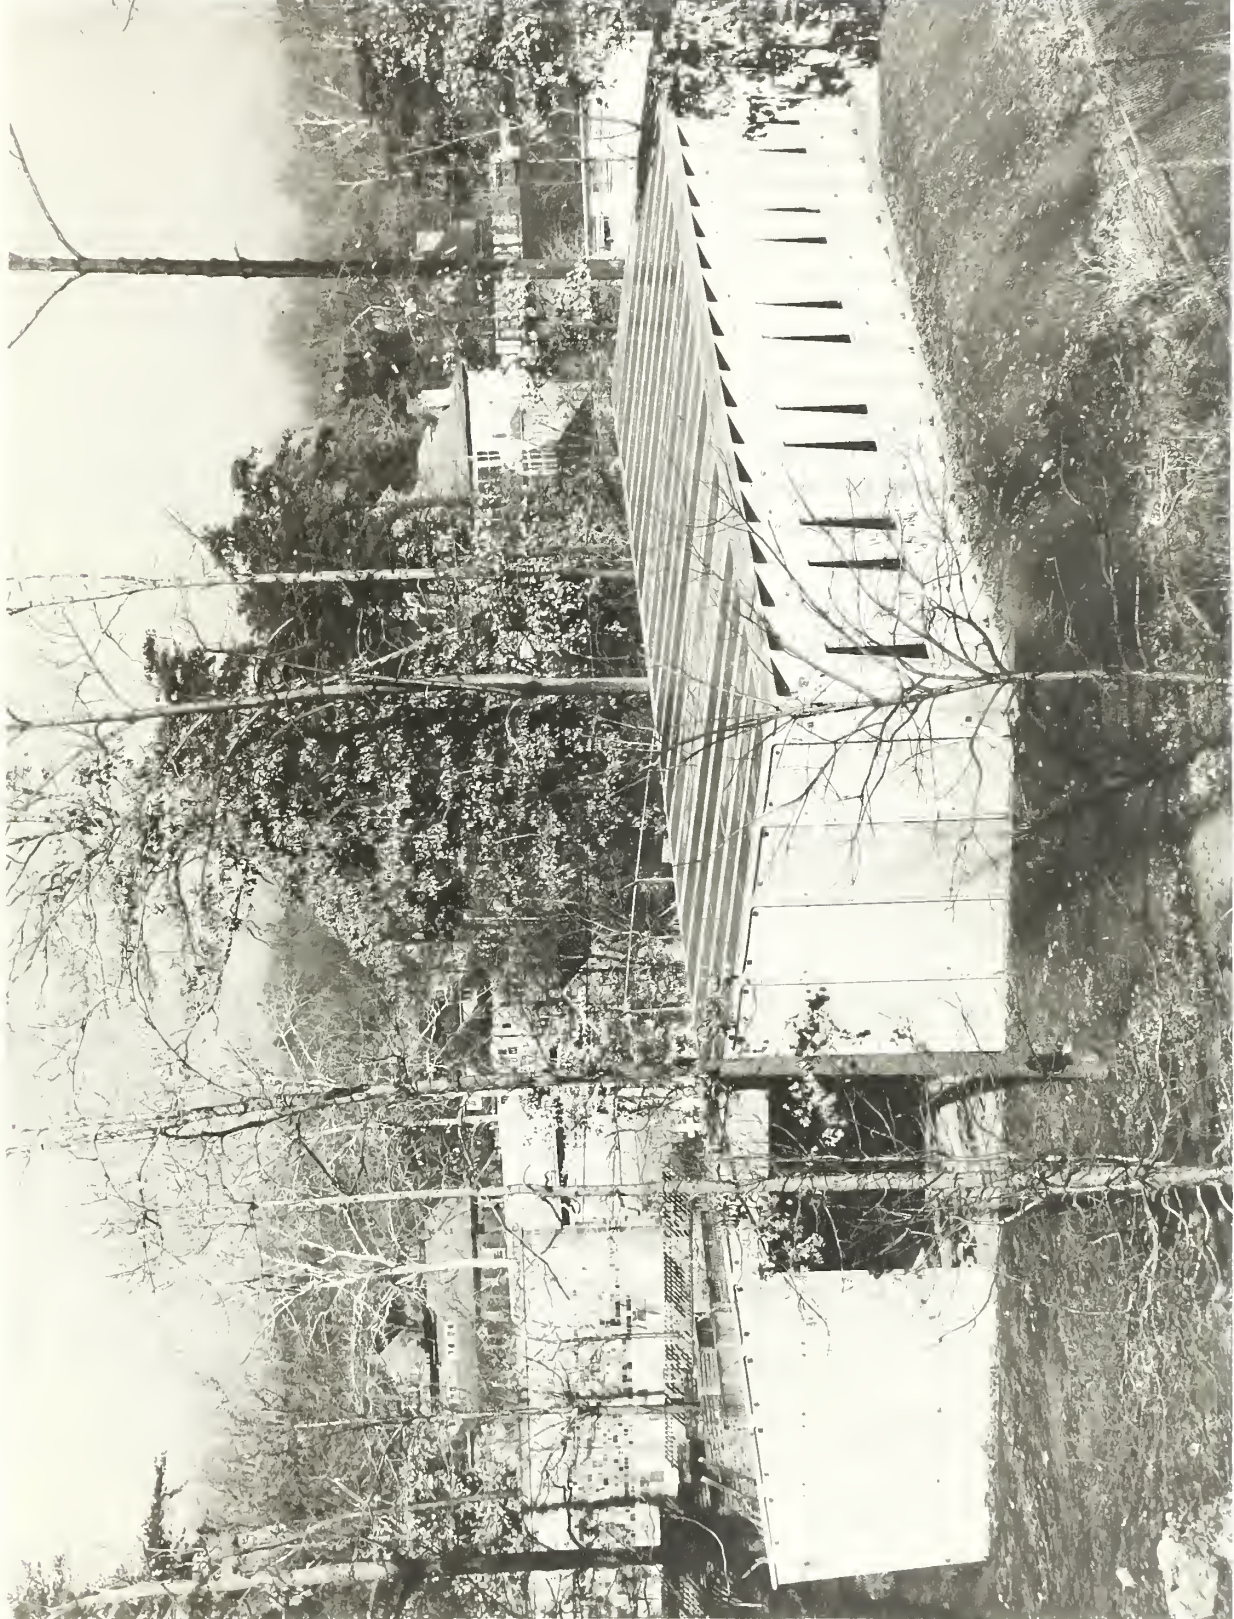
FIG. 1. MOBILIZATION STRUCTURE

The "Mobilization Structure" illustrated in figure 1 is a precast thin-shell concrete building composed of 20 bents, each bent being 4-ft wide and spanning 44 ft. The bents are made up of two side wall and two roof panels that are essentially channel shaped in cross section. Fabrication of the building elements and erection of the structure were accomplished on the basis of a competitive bid contract.

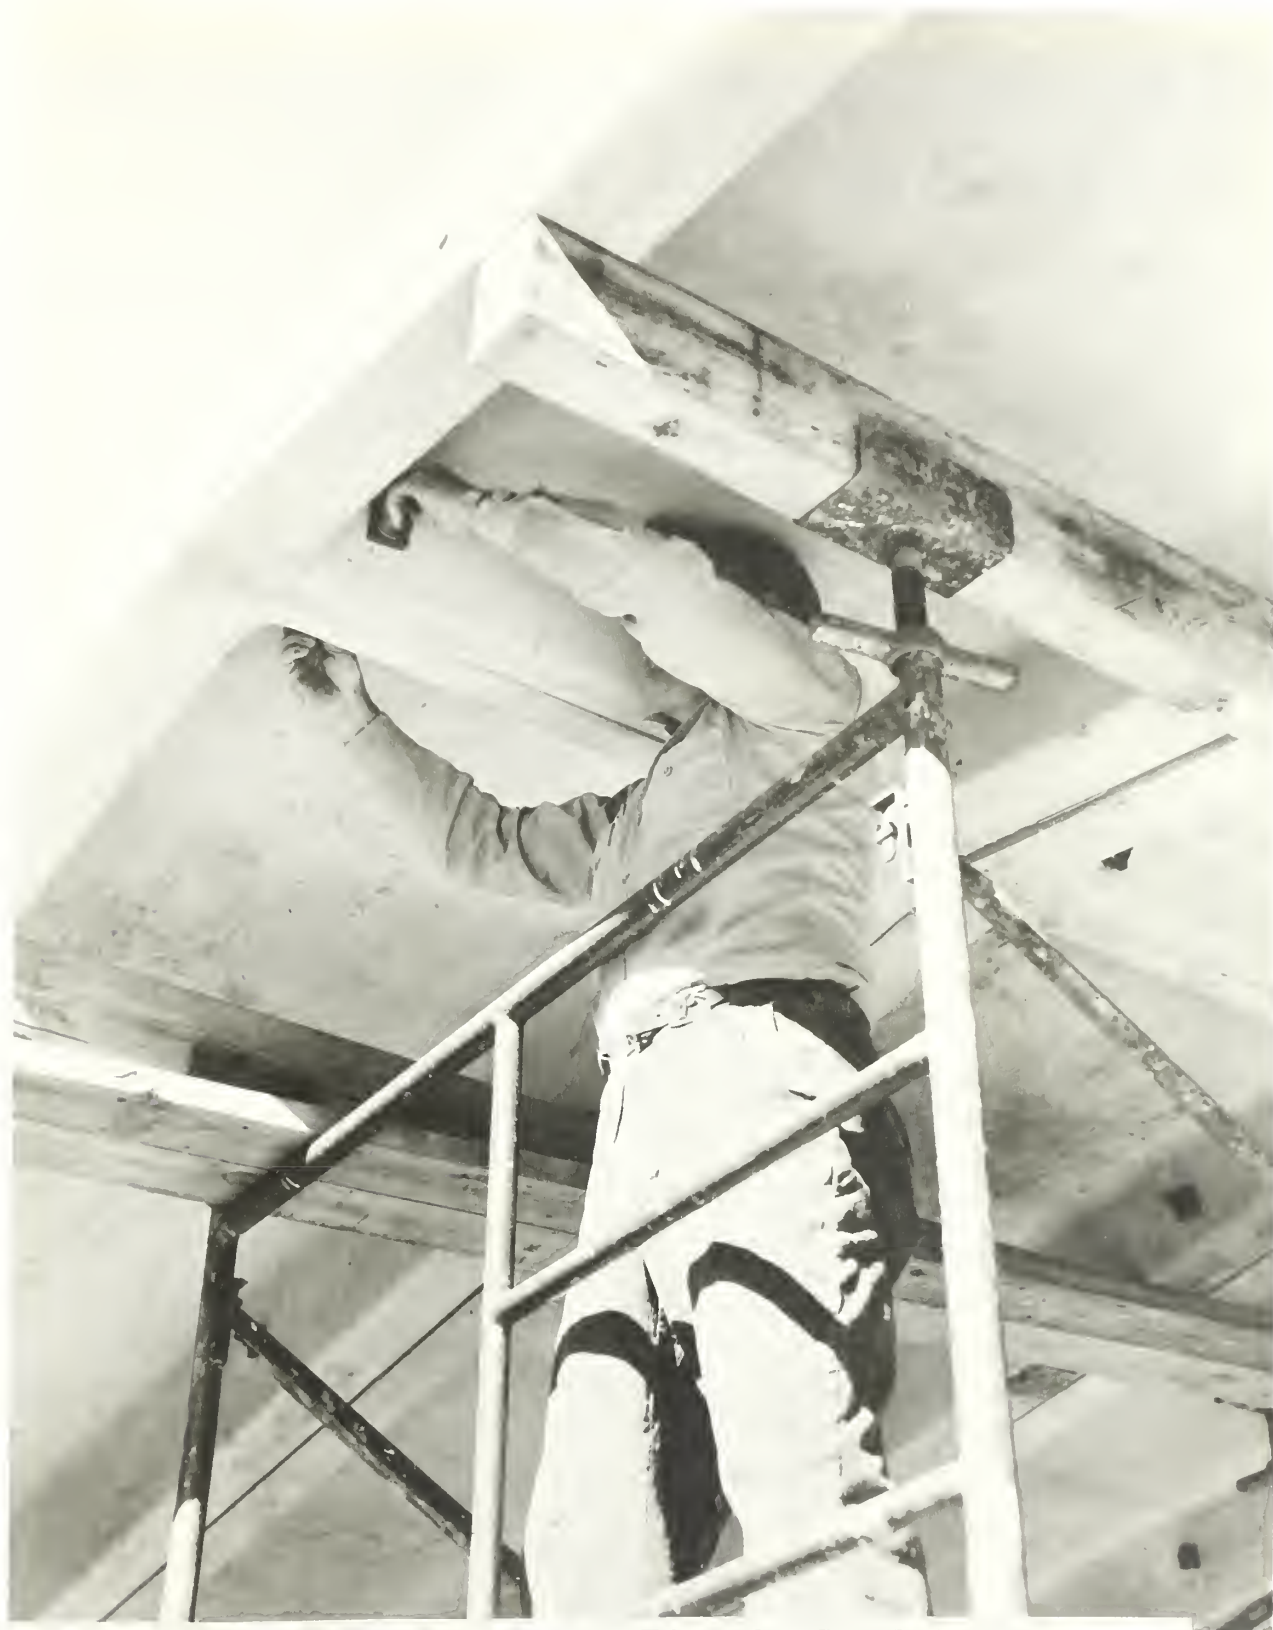
FIG. 4. BOLTING ROOF PANELS TOGETHER AT RIDGE JOINT

The panels were fastened to one another by a system of bolted and welded connections. Inserts had been cast into the wall panels and footings that enabled a welded connection to be made between each wall panel and the footing. The knee joint (wall-roof connection) was made with lap welded splices of metal plates that were attached to the main reinforcing of each wall and roof panel prior to casting. The roof panels comprising each bent were joined together at the crown with two 3/4 in. D bolts that passed through transverse ribs located at the crown ends of the roof panels. Each bent was connected to the previous bent with a number of 3/4 in. D bolts. These bolts passed through pipe sleeves that were precast into the longitudinal legs of all panels. Closure of the structure was accomplished with end wall panels that were bolted to the first and last bents. Views of wall and roof panels, and joints between them are shown in figures 1 through 6.

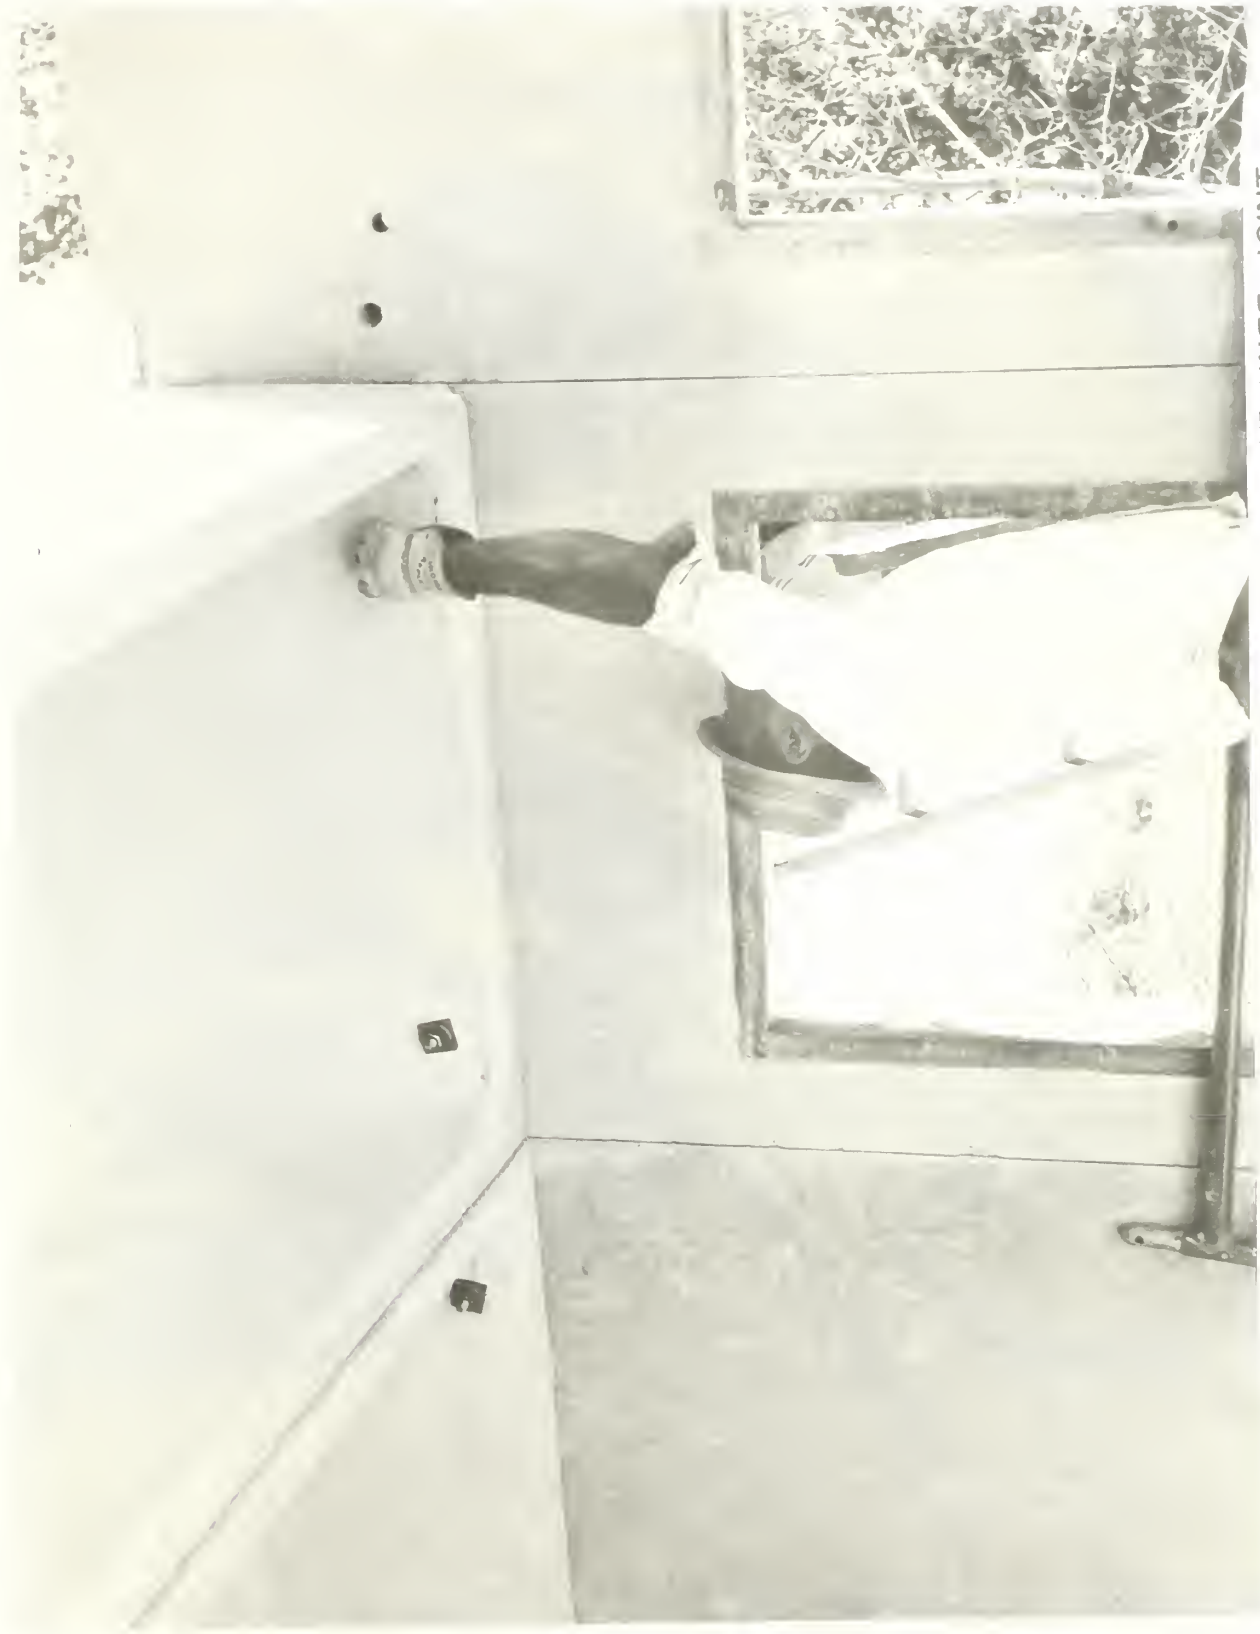
FIG. 5. BOLTING ROOF TO SIDE WALL PANELS AT KNEE JOINT

Another problem brought about by the use of the bolt system is that each bolt exposed to weathering is a source of water leakage during rainy weather. The bolts at the knee joints in particular exhibited a tendency to permit the passage of water. The reason for this is that water running off the roof follows the contour of the upper wall section and passes through the bolt holes. The same problem is evident at the bolted connections between wall panels but with less severity than was observed at the knee joints. The elimination of exposed bolts would, of course, be the ideal solution to the problem and future design considerations should be directed towards this end.

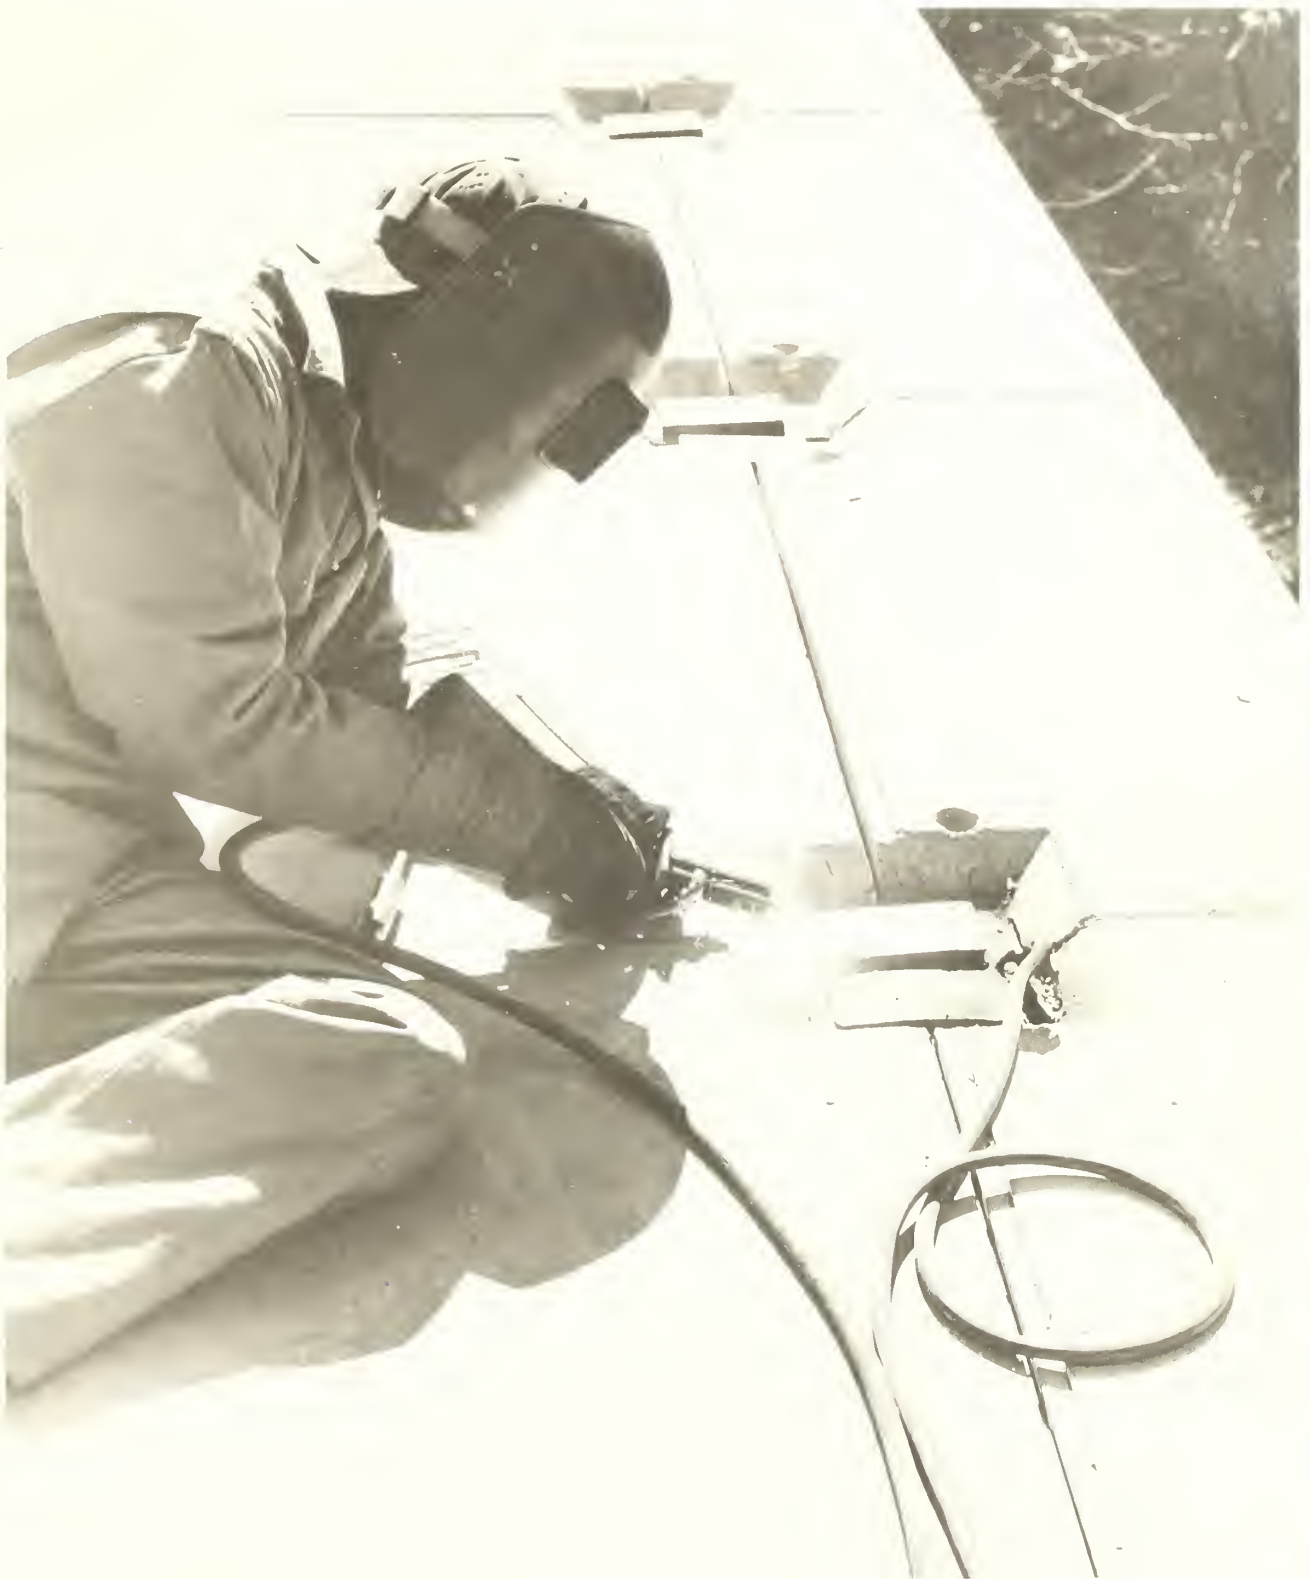
FIG. 6. WELDING ROOF TO SIDE WALL PANELS AT KNEE JOINT
