## THE APPLICATION OF X-RAY PROJECTION MICROSCOPY TO ROOFING ASPHALT SYSTEMS

August 10, 1962

7589

Research Associate  
Asphalt Roofing Industry Bureau

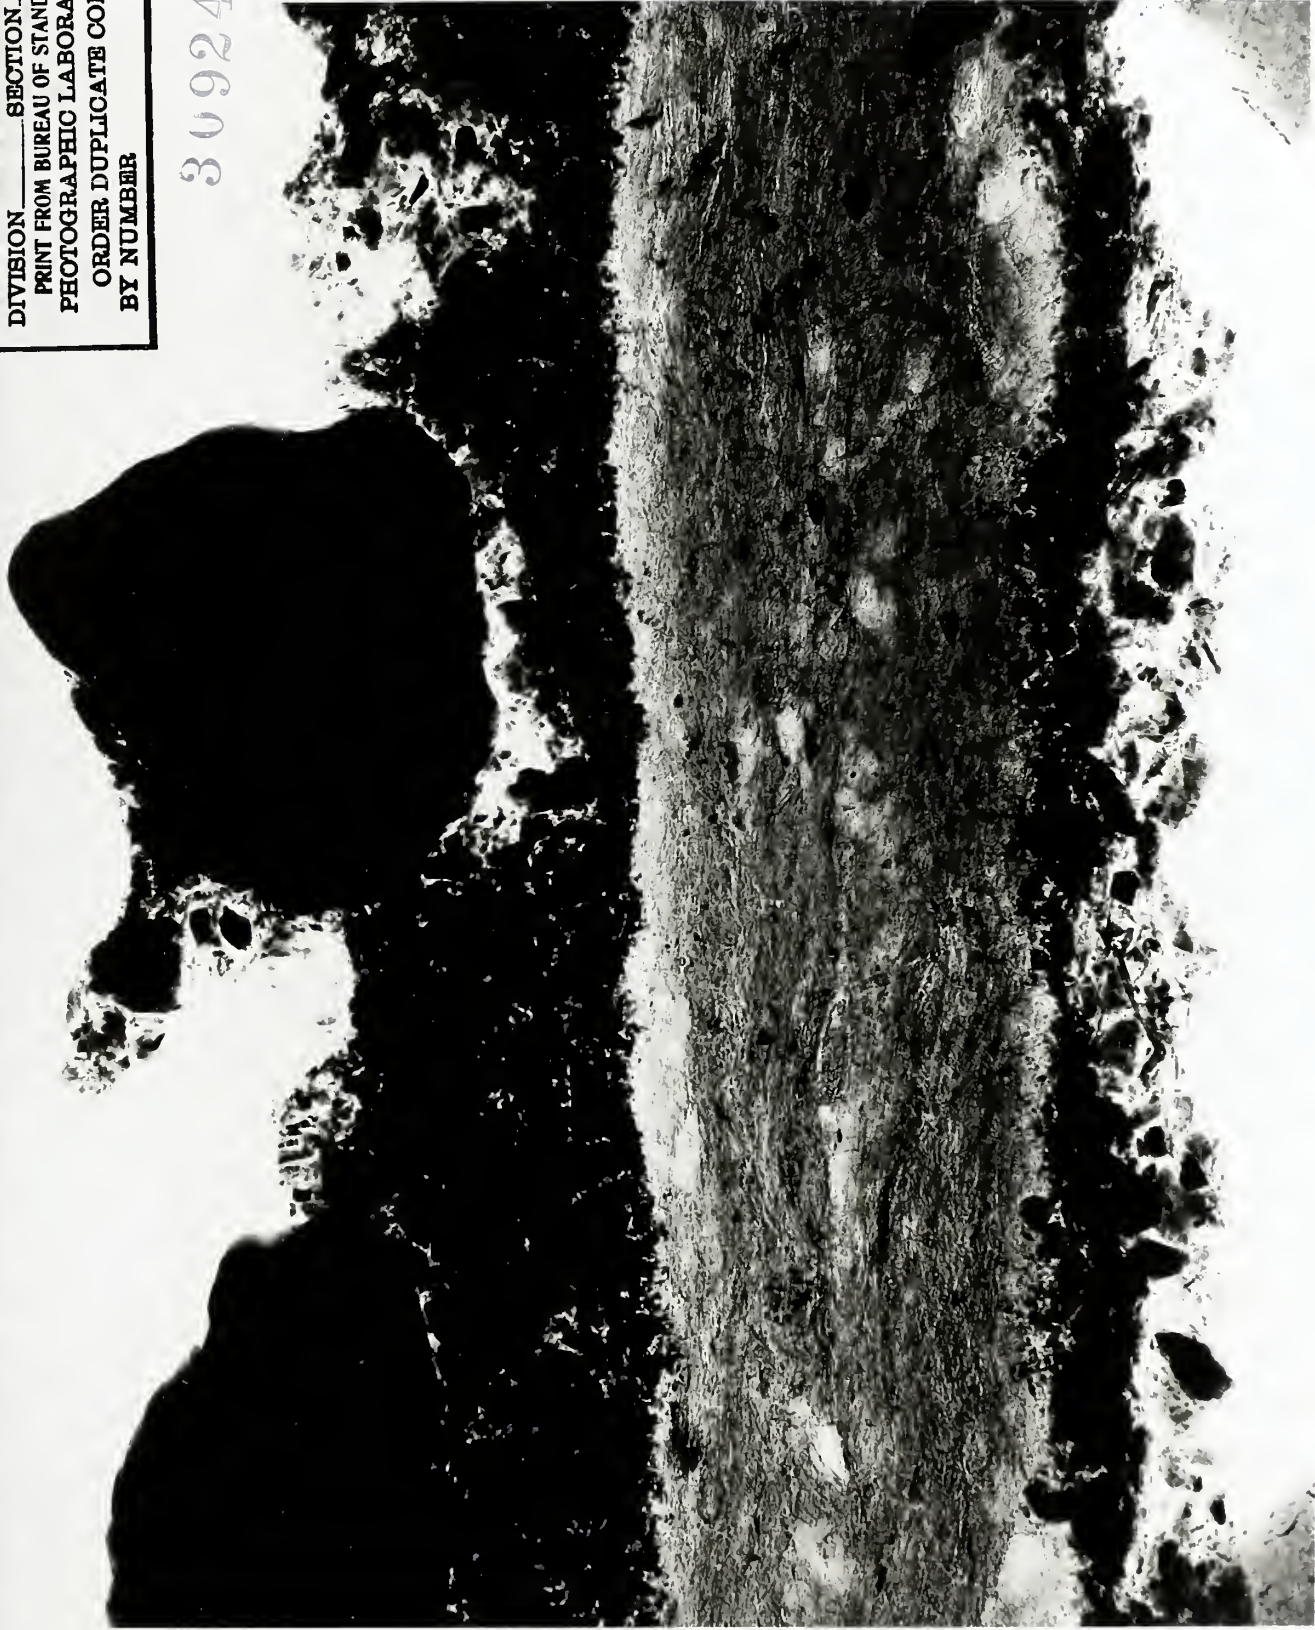
Figure 5 - Random Sample of 215-pound Uniform-Thickness Asphalt Shingle - Magnification 70X

This sample of a commercial asphalt strip shingle may not be typical, but it demonstrates vividly the value of the x-ray microscope for observing latent failures in roofing products. The mechanical embedment of the granules is quite evident. There is no contact (let alone adhesion) of coating and granules in large areas of their interface.

Some coating has been brought on to the exposed surface of the granule in the center of the photograph, possibly by rotation of the granule during embedment. A thin spot in the coating exists just to the right of this granule.

Regions in the saturated felt show significantly lower density than others. If these areas are less dense because of lower saturant, it would appear that the interfaces between coating and felt have become depleted in saturant. The saturant could have fluxed with the coating or could have been driven back into the felt. Small isolated areas in the body of the felt seem to be lacking saturant as well.

The variation in thickness of back-coating and back surfacing is quite apparent.

FIGURE 5. A COMMERCIAL, UNEXPOSED UNIFORM-THICKNESS ASPHALT SHINGLE - 70X

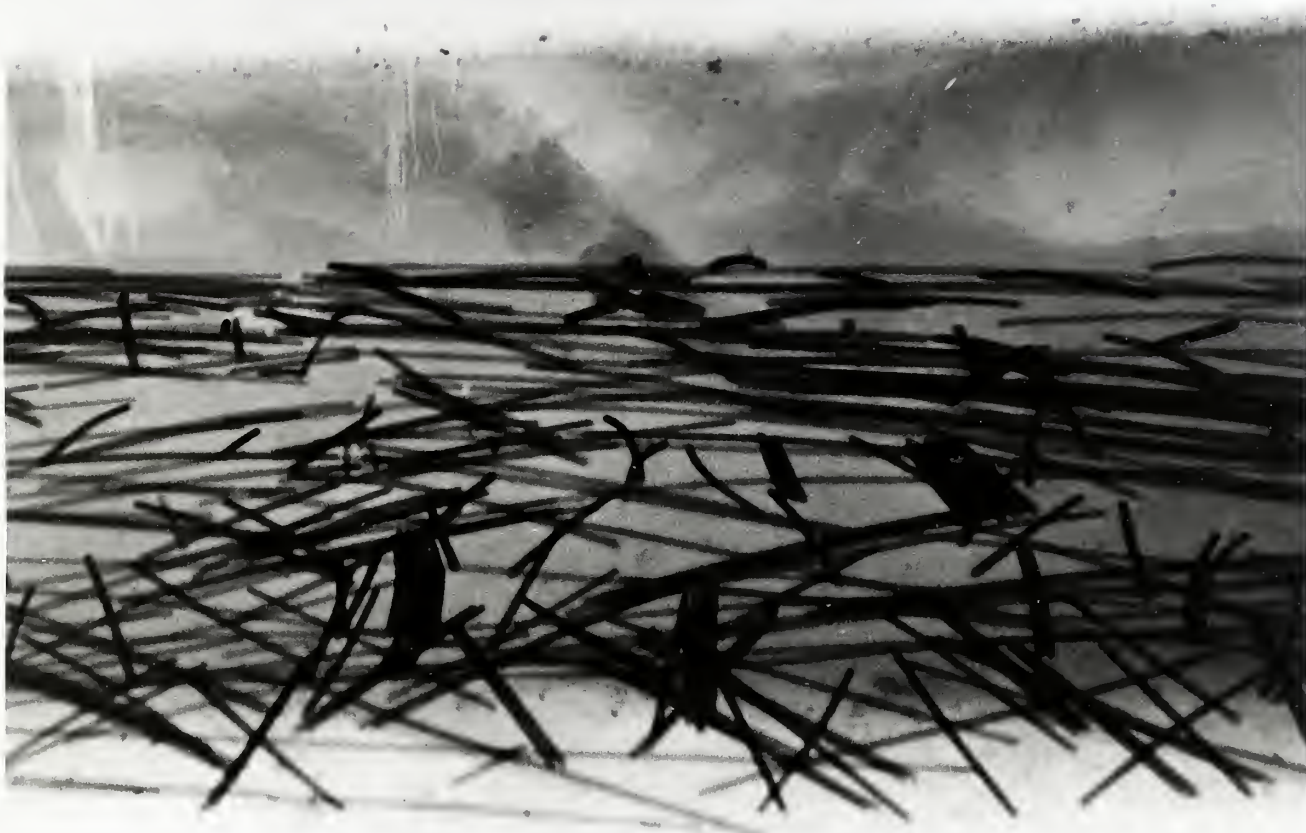
Figure 7 - Peace River Glass Mat with Kansas Asphalt. Thickness - 42 mils. Exposed 600 hrs to 51-9C cycle. Magnification - 110X

The glass mat occupies the lower two-thirds of the total thickness of this film. The mat is quite open and the individual fibers are surrounded by asphalt. The asphalt surface shows some signs of weathering; it is less dense than the interior and seems to have a fuzzy texture. The mottled appearance of the asphalt is difficult to explain, but is not untypical. Many asphalt specimens, before exposure, appear like this one.

FIGURE 7. AN ASPHALT FILM CONTAINING A PEACE RIVER  
GLASS MAT AFTER 600 HOURS IN THE WEATHER-  
OMETER - 110X

The stratification occurring during weathering is quite apparent in this picture. The glass mat, which is of the same weight as the one in Figure 7, tends to be concentrated in the lowest part of the asphalt film. Some debris is clearly seen in the asphalt.

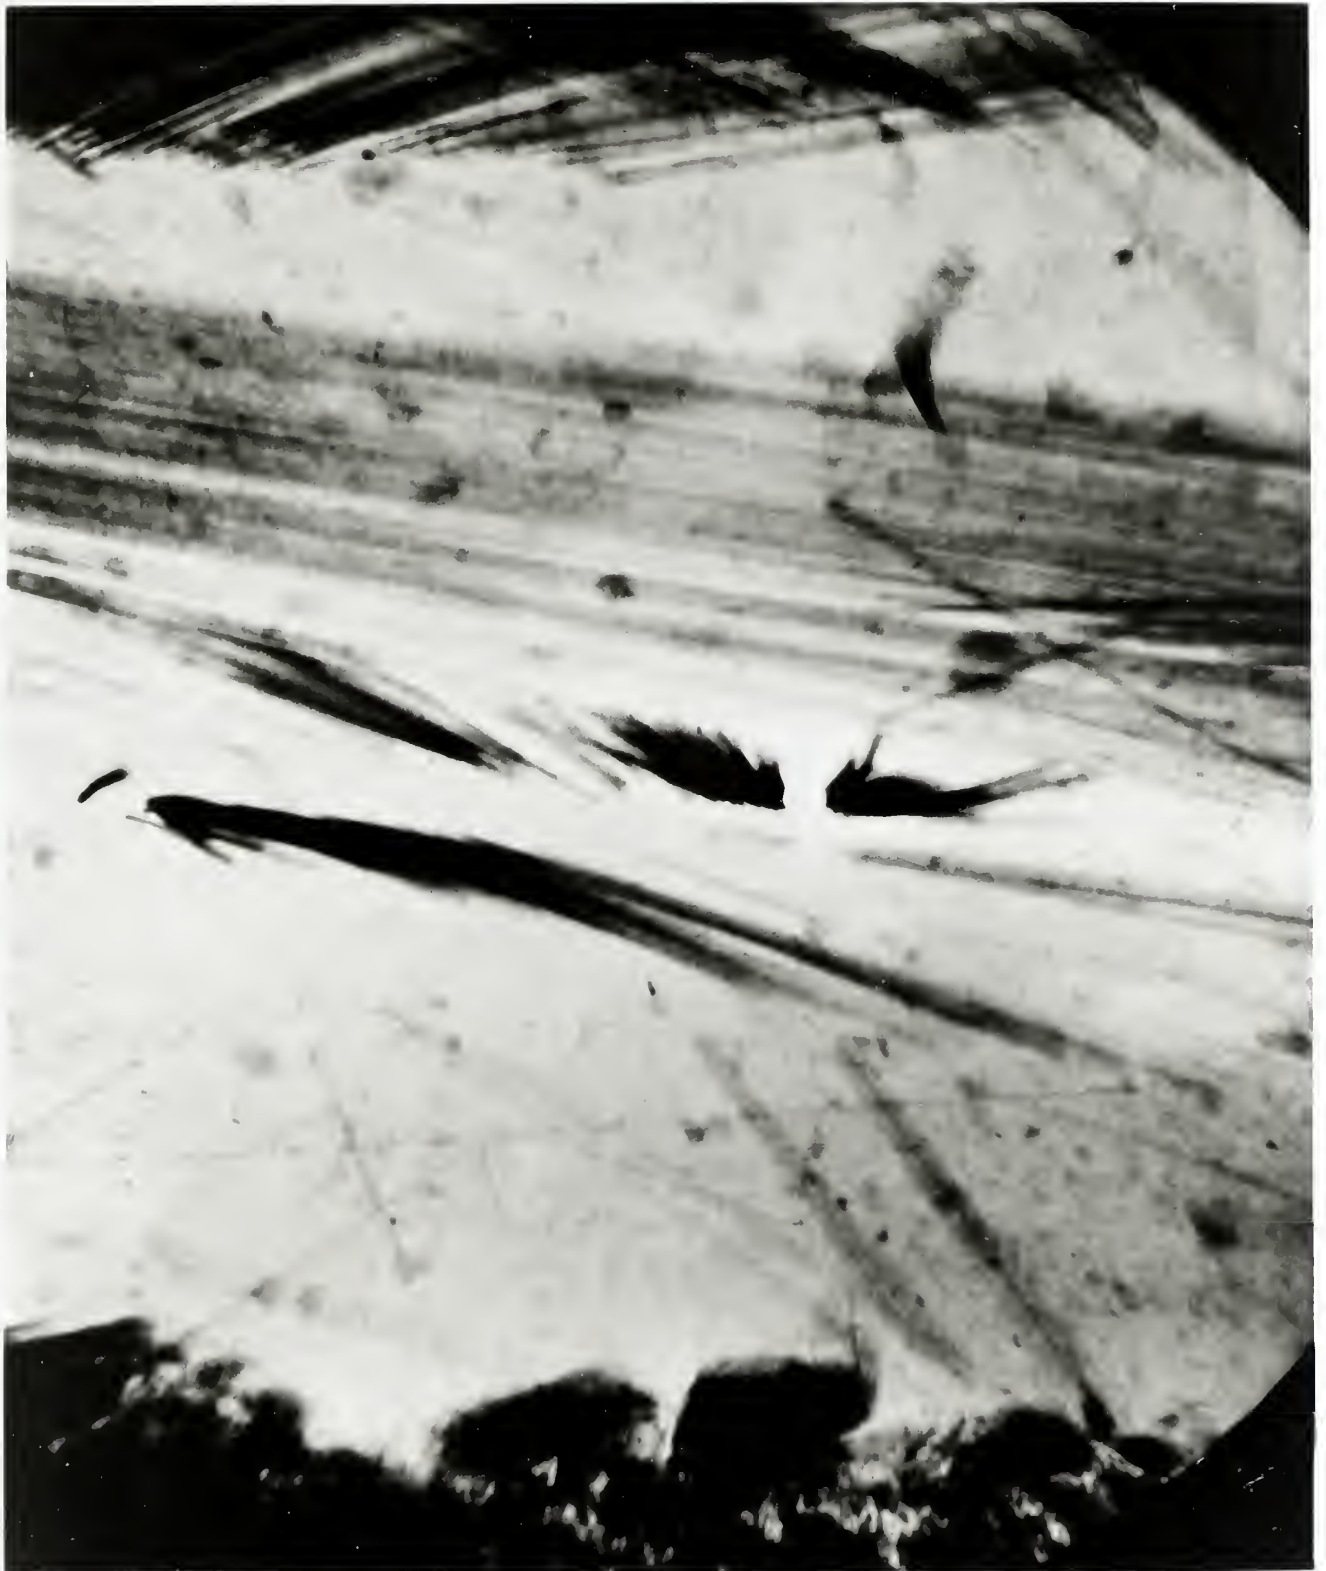
Figure 9 - Monoform Roofing - Clay Emulsion Reinforced with Chopped Glass Fibers on a Coated Sheet - Magnification Not Determined.

The mineral matter in the coating on the saturated felt is visible at the bottom of the picture. The random and irregular distribution of the glass fibers, as individuals and in clusters, throughout the clay emulsion residue is quite apparent. Clay particles are also quite apparent.

FIGURE 9. GLASS FIBER REINFORCED CLAY EMULSION ON A COATED BASE SHEET
