NATIONAL BUREAU OF STANDARDS REPORT

QUARTERLY STATUS REPORT FOR THE
QUARTER ENDING APRIL 30, 1966 ON

INVESTIGATION OF THE DIRECTIONAL EFFECTS
IN THE STRESS CORROSION OF ALUMINUM ALLOYS

QUARTERLY STATUS REPORT FOR THE QUARTER ENDING 4/30/66

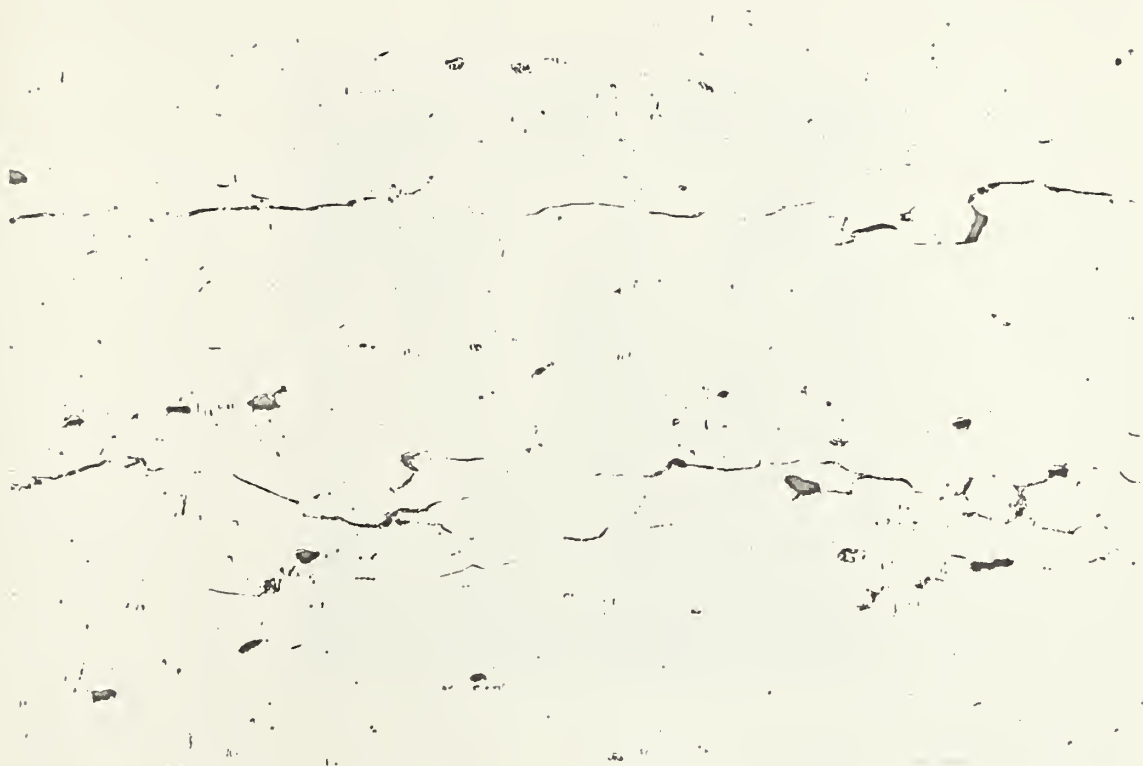
Photomicrograph of a 2219-T87 aluminum alloy short transverse tensile specimen prior to testing. Photomicrograph was taken at the same level as indicated by fractures in Figure 1. Unetched X 100

During machining of short transverse specimens from the 2219-T87 plate, three were broken. We attributed this to poor machining technique. However, two notched tensile specimens from a nearby area broke in tensile test not at the notch, but in a region having 9/4 the area at the root of the notch and at a stress computed to be 6100 psi. The location of these fractures was at approximately the same depth below the surface of the plate as those in the specimens broken during machining as shown with a macroetched cross-section of the plate in Figure 1. Adjacent short transverse specimens, one of which was sectioned longitudinally for metallographic examination, were radiographed and showed some indication of voids or inclusions. Figure 2 is a photomicrograph of the longitudinally sectioned specimen in the unetched condition. The macroconstituents are to be determined with the aid of the electron microprobe.

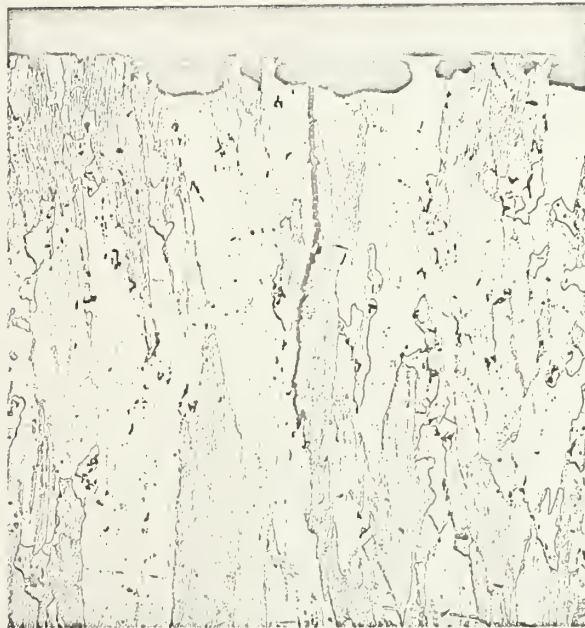
Figure 3

Photomicrograph of a 7075-T651 aluminum alloy short transverse specimen which failed at 75% of its yield strength after 5 minutes in Alcoa H solution. Note the intergranular stress-corrosion cracks which start at the pits. Keller's etch X 100

All tests were made using 75% of the specimen's yield strength. Times to failure for the 7075-T651 alloy were 5 minutes for the short transverse, 5.5 hours for the long transverse and 10.6 hours for the longitudinal specimens. (Preliminary tests - only one specimen tested in each orientation.) Photomicrographs (Figures 3, 4 and 5) were taken of the short transverse specimens and show the typical stress-corrosion cracks observed. The fractured surfaces are being replicated for electron microscopy studies. Work is continuing to determine if the long transverse and longitudinal specimens failed by stress-corrosion.

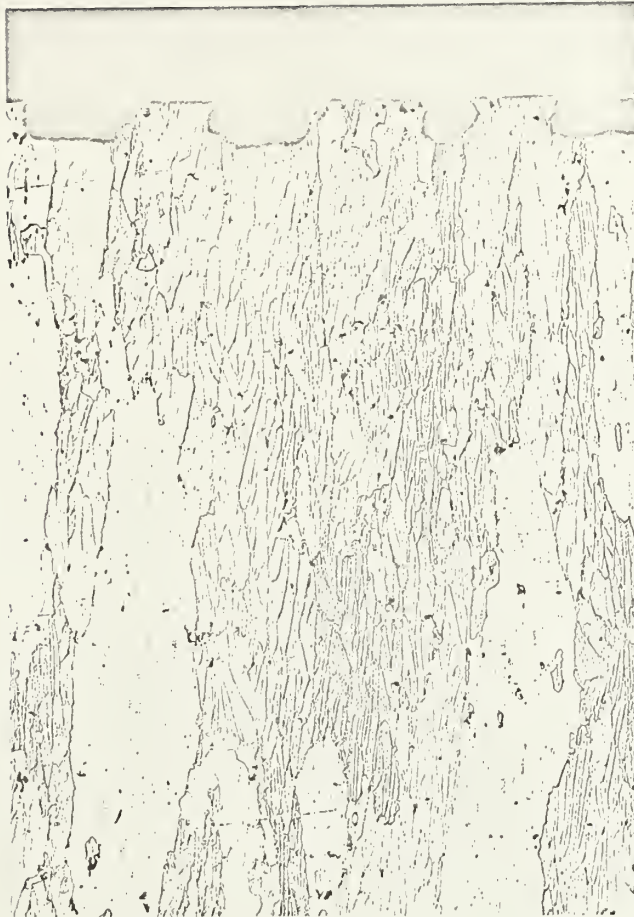
Figure 5

Photomicrograph of a 7075-T651 aluminum alloy short transverse specimen which failed at 75% of its yield strength after 5 minutes in Alcoa H solution. Note the intergranular stress-corrosion cracks which start at the pits. Compare with the unetched condition in Figure 4. Keller's etch X 100
