REPORT OF FIRE TESTS ON TWO SCR BRICK WALL COLUMNS

September 9, 1966

Two brick wall-columns were subjected to fire tests, under applied loads, in cooperation with the Structural Clay Products Research Associateship. The two specimens were nominally identical, except as to age. The first was tested to failure under load, which occurred at 2 hours 54 minutes. The fire exposure in the second test was stopped after 2 hours but the load maintained. The intention was to load the specimen to failure after cooling. However, it collapsed about 1 3/4 hours after the fires were shut off.

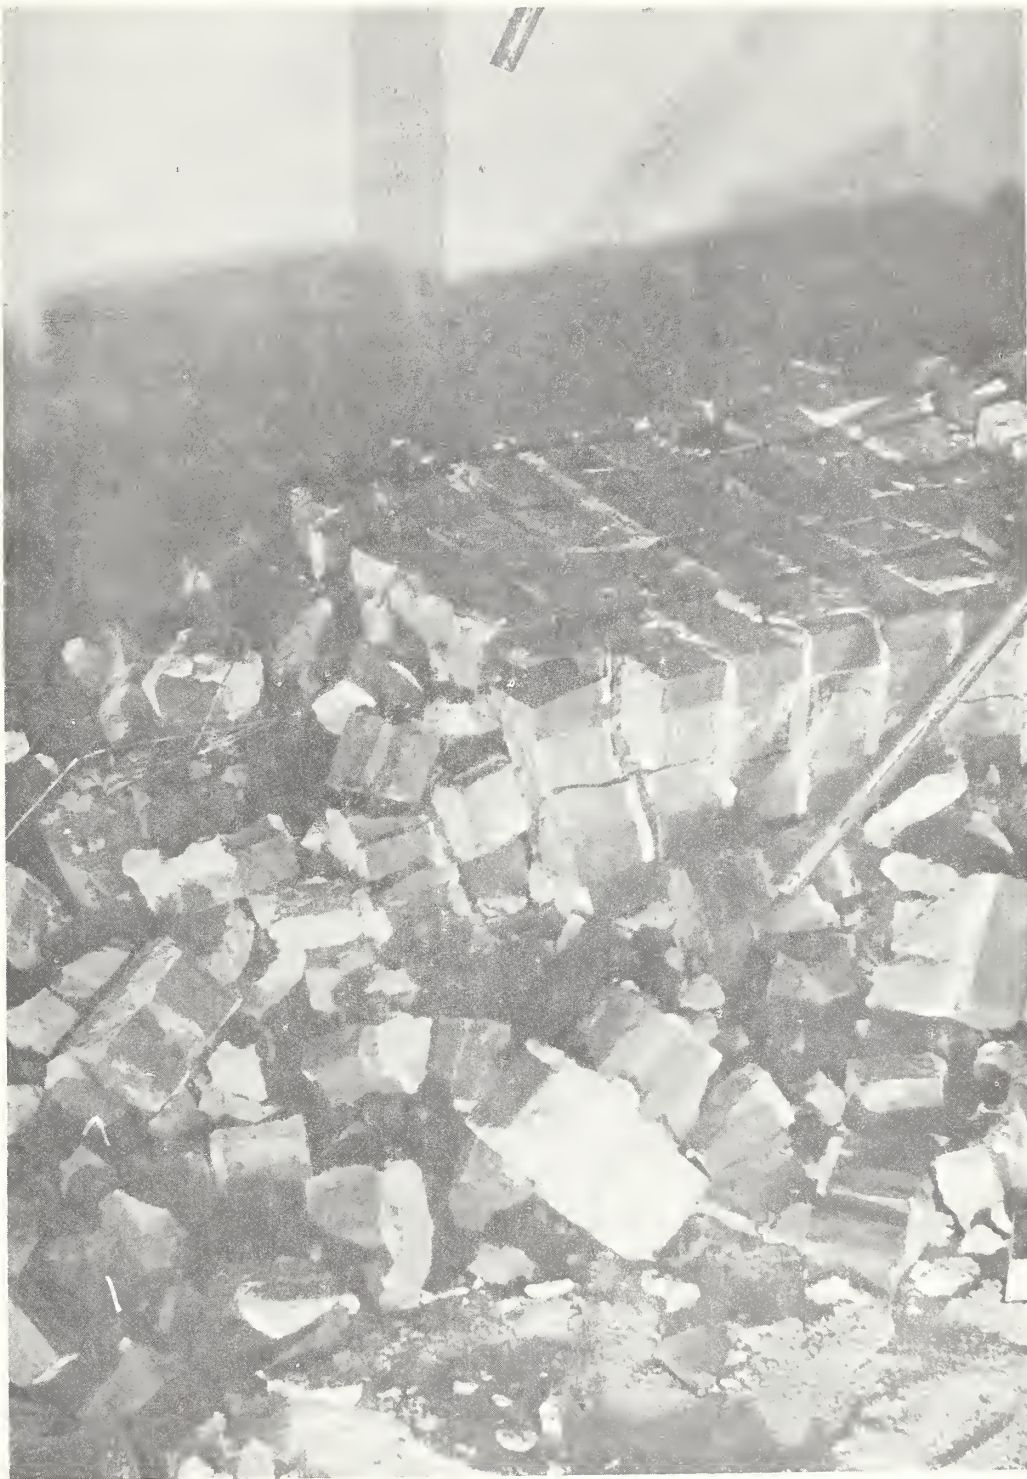
Fig. 6. Column Fragments for Specimen 1.

After the test, the specimen was a somewhat ordered pile of debris. It had folded and laid back on itself, so that about half the remains were neatly aligned. The rest were in a random jumble. The cracks observed during the fire exposure had become complete breaks. The broken bricks are shown in Figure 6.
