SEP 28 1966

NATIONAL BUREAU OF STANDARDS REPORT

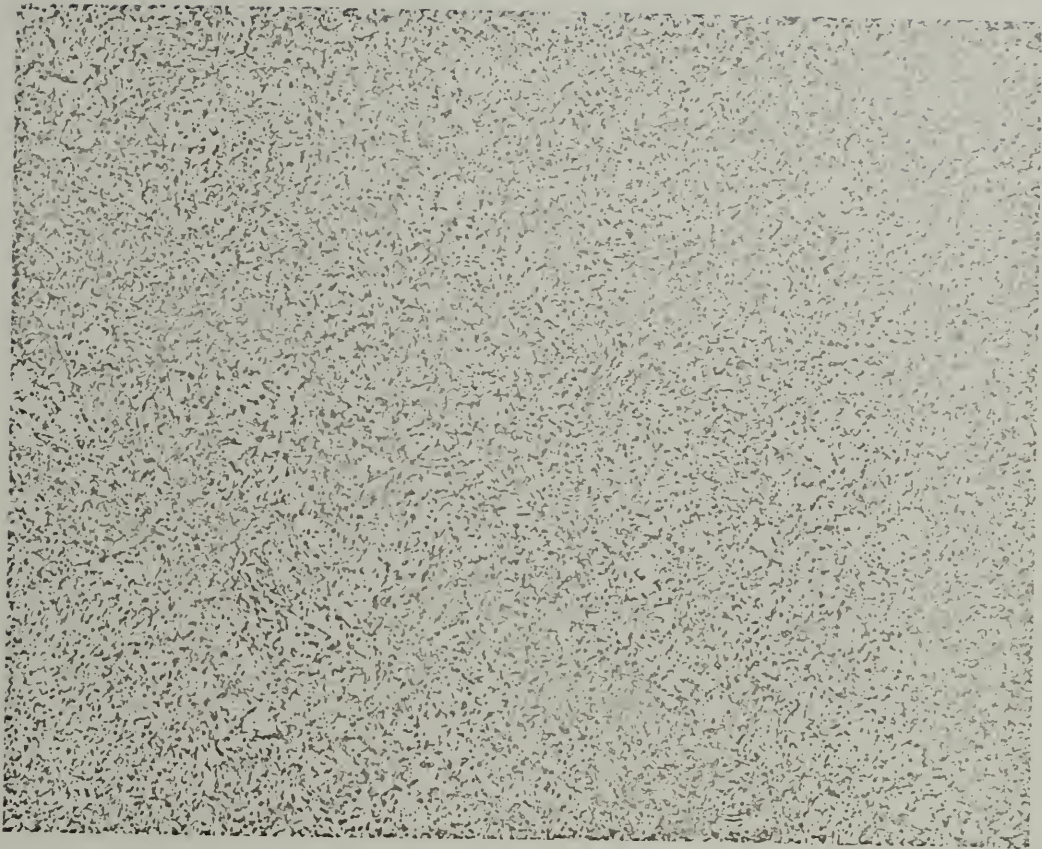
Figure 7. Photomicrograph of a portion of the section of a lot 5 bolt that failed to meet the minimum tensile and hardness requirements for a 180 ksi bolt. Microstructure is tempered martensite with no metallographic evidence of delta ferrite. Etched with Kalling's reagent. X500.

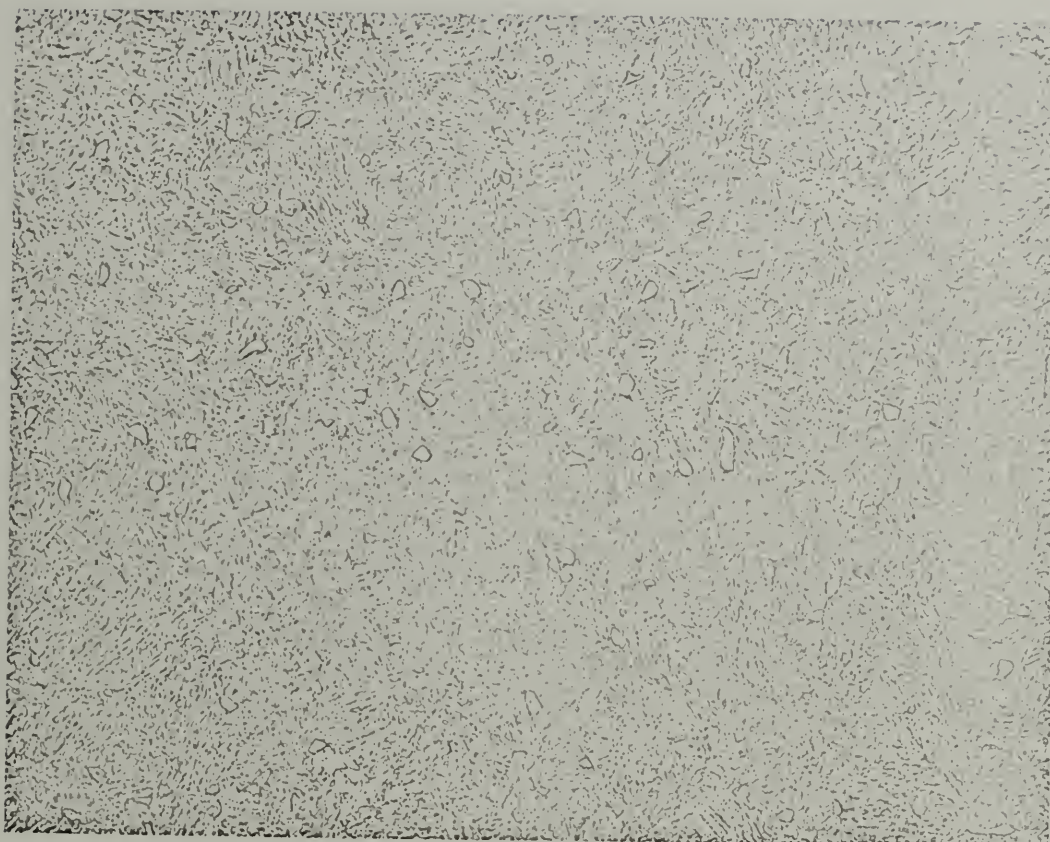
Figure 9. Photomicrograph of typical structure in bolts from lot 6, item 5 and 6. Microstructure is tempered martensite with delta ferrite. Note that some grain growth occurred. Etched with Kalling's reagent. X500.

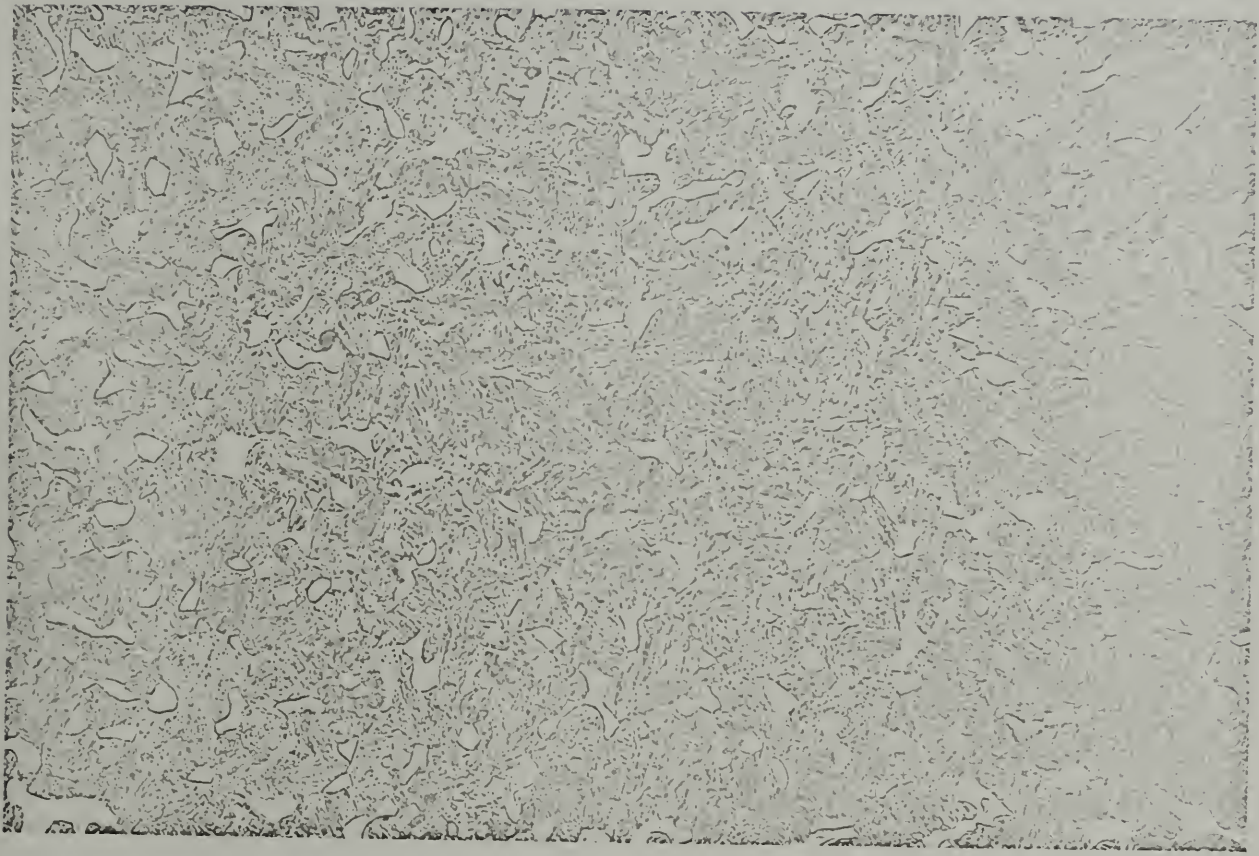
Figure 10. Microstructure in a bolt from lot 8. Note the presence of an abundance of free ferrite in the tempered martensite matrix. Etched with Vilella's reagent. X500.
