NATIONAL BUREAU OF STANDARDS REPORT

ANNUAL REPORT FOR THE PERIOD ENDING DECEMBER 31, 1966 ON

INVESTIGATION OF THE DIRECTIONAL EFFECTS
IN THE STRESS CORROSION OF ALUMINUM ALLOYS

National Aeronautics and Space Administration
George C. Marshall Space Flight Center
Huntsville, Alabama

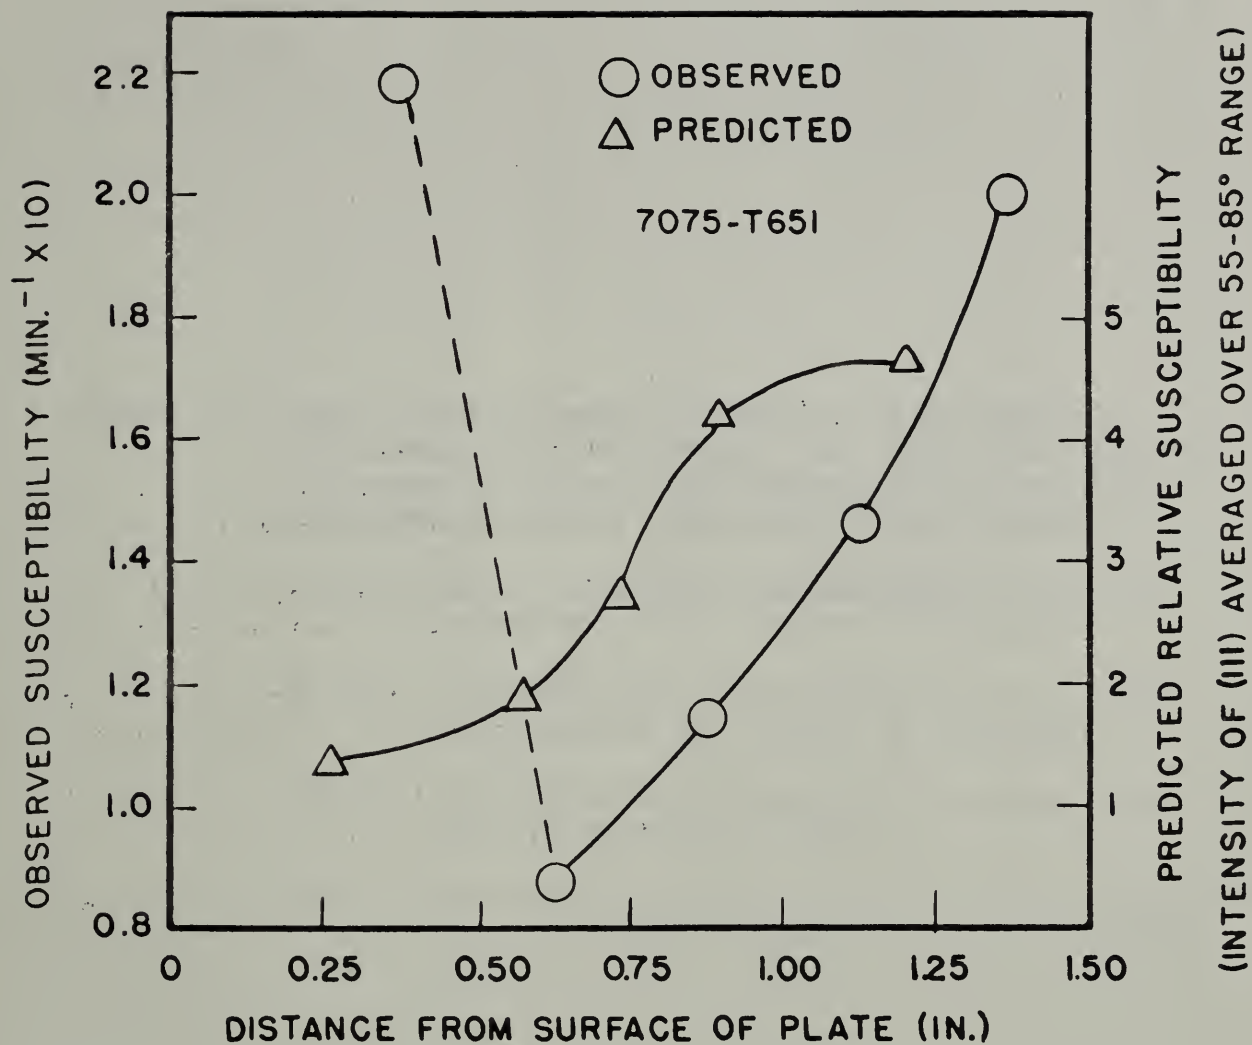
The observed stress corrosion susceptibility and the predicted susceptibility are shown plotted against distance from the surface of a 7075-T651 aluminum alloy plate.

However, on comparing the stress corrosion results with the preferred orientation results, Figure 13, it is seen that the preferred orientation predicts susceptibilities as observed (i.e., more susceptible toward the center) for all but the specimens taken from 3/8" below the surface of the plate. Figure 13 shows observed susceptibility as (endurance time)⁻¹ and predicted relative susceptibility plotted against distance from the surface of the plate. It is expected that the curve for observed susceptibility would be of the same shape as that for predicted susceptibility if more specimens were tested between the 1 1/8" and 1 3/8" levels.

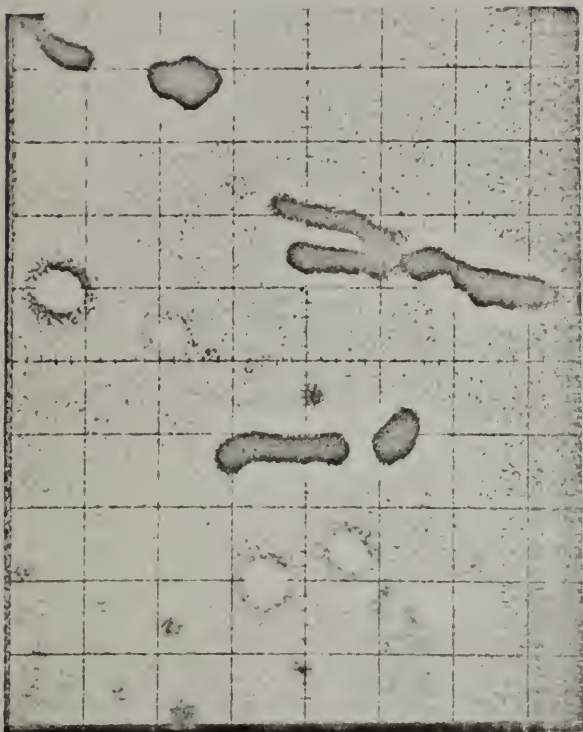
Figure 14. Target current images of areas of 7075 aluminum alloy plate with inclusions. The light areas indicate inclusions of lower atomic number and the dark areas, inclusions of higher atomic number than the matrix.

T73-1S. 7075-T73 material perpendicular to rolling direction, at the surface of the plate.

T6-1S 7075-T651 material perpendicular to rolling direction, at the surface of the plate.

T73-2S 7075-T73 material parallel to rolling direction, at surface of plate.

T6-2S 7075-T651 material parallel to rolling direction, at surface of plate.

The target current images of areas with inclusions are shown in Figure 14 for the specimens near the surface of both the 7075-T6 and -T73 conditions. The light areas indicate inclusions of lower atomic number and the dark indicates inclusion of higher atomic number than the matrix. In Figure 15, the magnesium X-ray images, the light areas are high in magnesium content. These areas correspond to the light particles in Figure 14 and, as determined by other X-ray images, are also high in silicon. It was also determined that the dark inclusions of Figure 9 were low in magnesium and silicon.

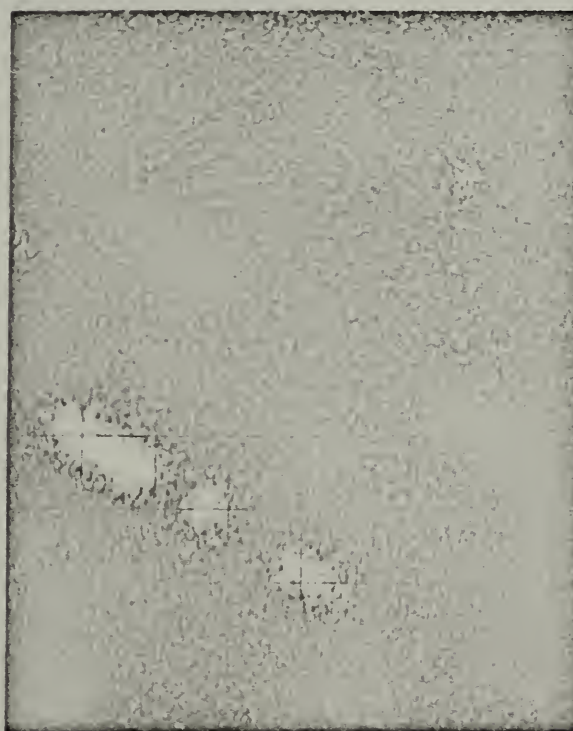
Figure 15. Magnesium X-ray images of areas shown
in Figure 14. Light areas are high in
magnesium.

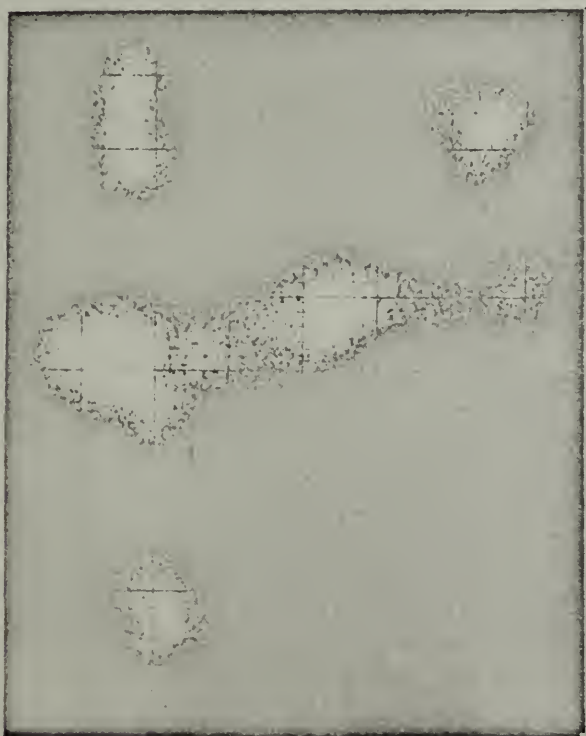
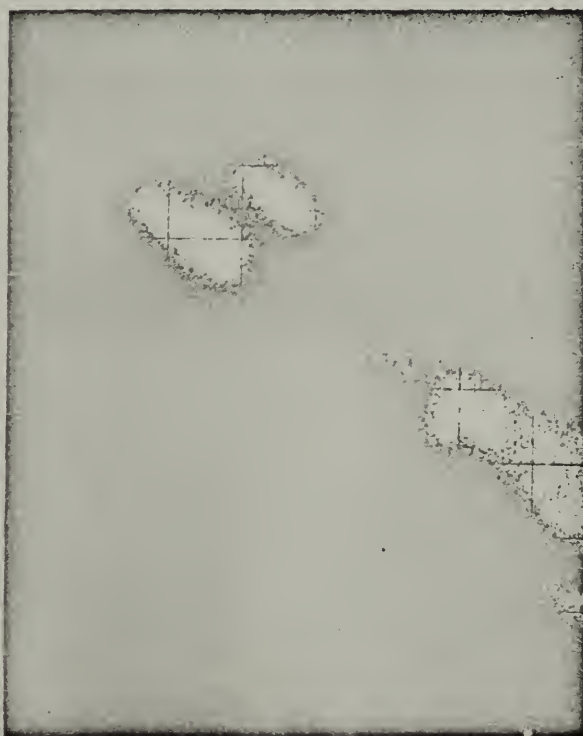
Figure 16. Iron X-ray images of areas shown in

Figure 14. Light areas are high in iron.

Figure 16, the iron X-ray images, shows iron to be highly segregated at the dark particles of Figure 14. Copper and manganese were also segregated at these inclusions. Aluminum and zinc were found to be depleted at all inclusions.
