# NATIONAL BUREAU OF STANDARDS REPORT

## PROGRESS REPORT

August 1, 1966 through April 30, 1967

THE ADHERENCE OF PORCELAIN ENAMEL TO ALUMINUM

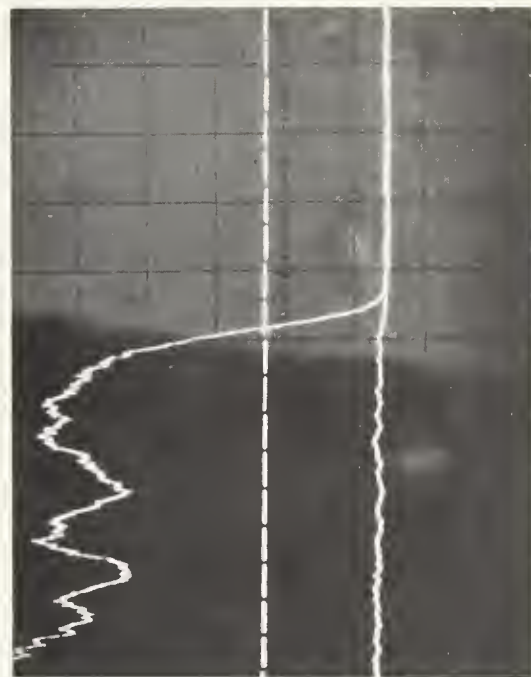
Figure 8. Target Current plus SiK $\alpha$

Cross-section samples were submitted for electron microprobe analysis of the interface. Initially samples of 1100 and 6061 were submitted. Both alloys had been chemically cleaned for seven minutes and then subjected to an R-100<sup>1</sup> bath for ten minutes prior to enameling. The 1100 sample exhibited good spall resistance and the 6061 sample exhibited failure. Both samples were tested using the antimony trichloride spall test. Traces for all the elements contained in the two samples showed no marked difference, so a sample of prefired 5154 alloy was added and traces of the elements aluminum, magnesium, lead and silicon were obtained. Figures 1-4, 5-8, and 9-12 show these traces on the 1100, 6061 and 5154 samples respectively. As a follow-up to this work, samples of 5154 with a seven minute chemical clean, ten minute R-100 pretreatment prior to enameling, and samples of prefired 6061 and 5657 were submitted and traces were obtained for magnesium, copper and chromium. Figures 13-15, 16-18 and 19-21 show these traces on the 5154, 6061 and 5657 samples respectively. The microprobe shows no evidence of aluminum or other elements diffusing from the substrate into the enamel. However, the resolution of the microprobe is not critical enough to indicate diffusion of less than about 3 1/2 microns since the area being analyzed by the probe is approximately 3 1/2 microns in diameter. Concentrations of magnesium are noted at or near the interface of the magnesium bearing alloys except for the sample of 5154 which had been chemically cleaned and treated with R-100 prior to enameling. 5154 is a magnesium alloy whereas 6061 is a magnesium silicide alloy. The fact that magnesium is more soluble in the R-100 bath than magnesium silicide could account for the disappearance of the magnesium peak on the second sample of 5154 as opposed to the peaks being evident on both of the 6061 specimens.

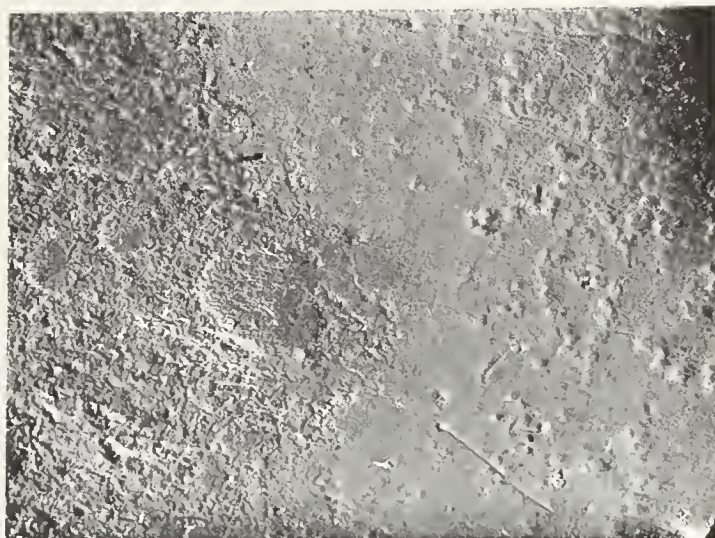
Figure 22.  
Enameled 1100 Alloy  
Not etched 4KX

Another technique used for studying the enamel-aluminum interface was electron microscopy. Palladium-shadowed plastic replicas were taken of the surface of tapered sections of enameled 1100 and 5154. The initial replicas were exploratory and are inconclusive. Nevertheless, several photomicrographs using this technique are shown in Figures 22-25. Figures 22 and 23 are of enameled 1100 at a magnification of 4KX. The angle of taper is approximately 5 degrees from parallel to the interface. This would effectively enlarge any band of diffusion zone approximately 15 times normal thickness. There is no sharp delineation between the enamel and the aluminum in these figures. While this might indicate diffusion, it must be kept in mind that there was no attempt made at selective etching following polishing. This might possibly lead to erroneous conclusions. Figure 24 is a sample of enameled 1100 which was etched with 80% phosphoric acid, 10% nitric acid and 10% water at 90 degrees C for two minutes following polishing. (The dark segments are caused by tearing and subsequent folding of the plastic replica in localized areas.) Figure 25 is enameled 5154 which also has been etched after polishing. The replica is badly torn at the interface area, making interpretation of this micrograph difficult.

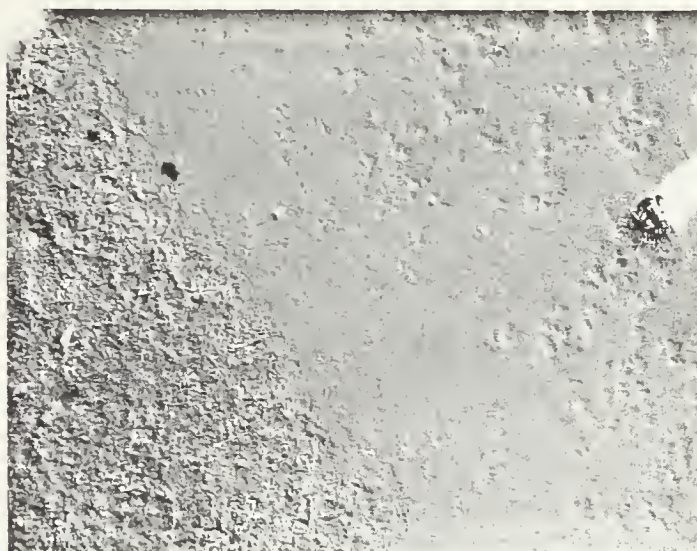
Figure 23  
Enameled 1100 Alloy  
Not etched 4KX

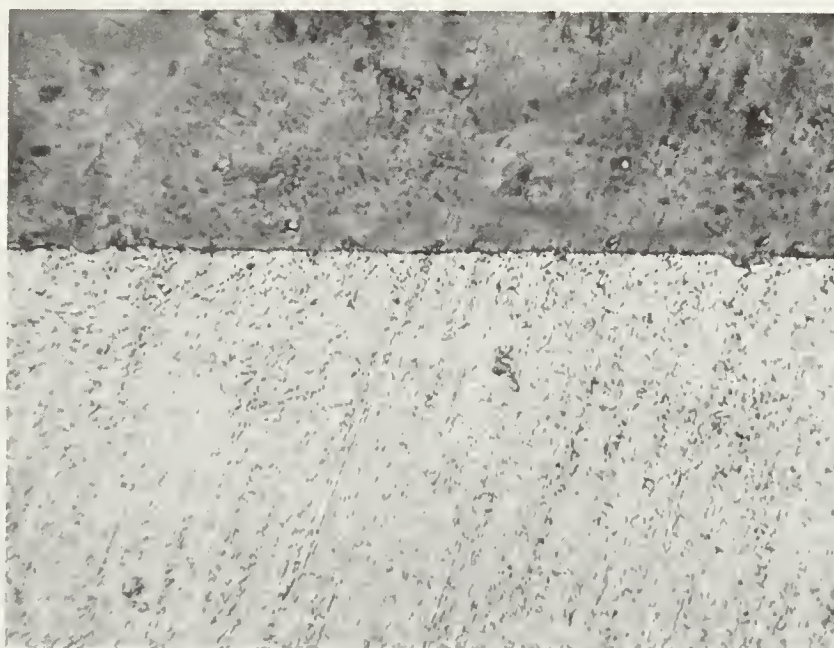
Figure 26. 625X  
Alloy 1100 Chemical clean plus R-100  
90 degree cross section

A number of photomicrographs were taken of various alloys after enameling. Magnifications up to 875X failed to reveal any definitely identifiable zone of reaction in the interface area. In several instances, what appeared to be banded zones at the interface were later concluded to be due to relief occurring during the polishing of the samples. See figures 26 and 27 for examples of light micrographs.
