NATIONAL BUREAU OF STANDARDS REPORT

9543

INTERIM REPORT ON FHA WALL SYSTEM PERFORMANCE
COVERING HEAT, AIR AND MOISTURE PENETRATION AND
RESULTING PHYSICAL DEFLECTION CAUSED BY THE ENVIRONMENT

Thomas K. Faison
and
Henry E. Robinson

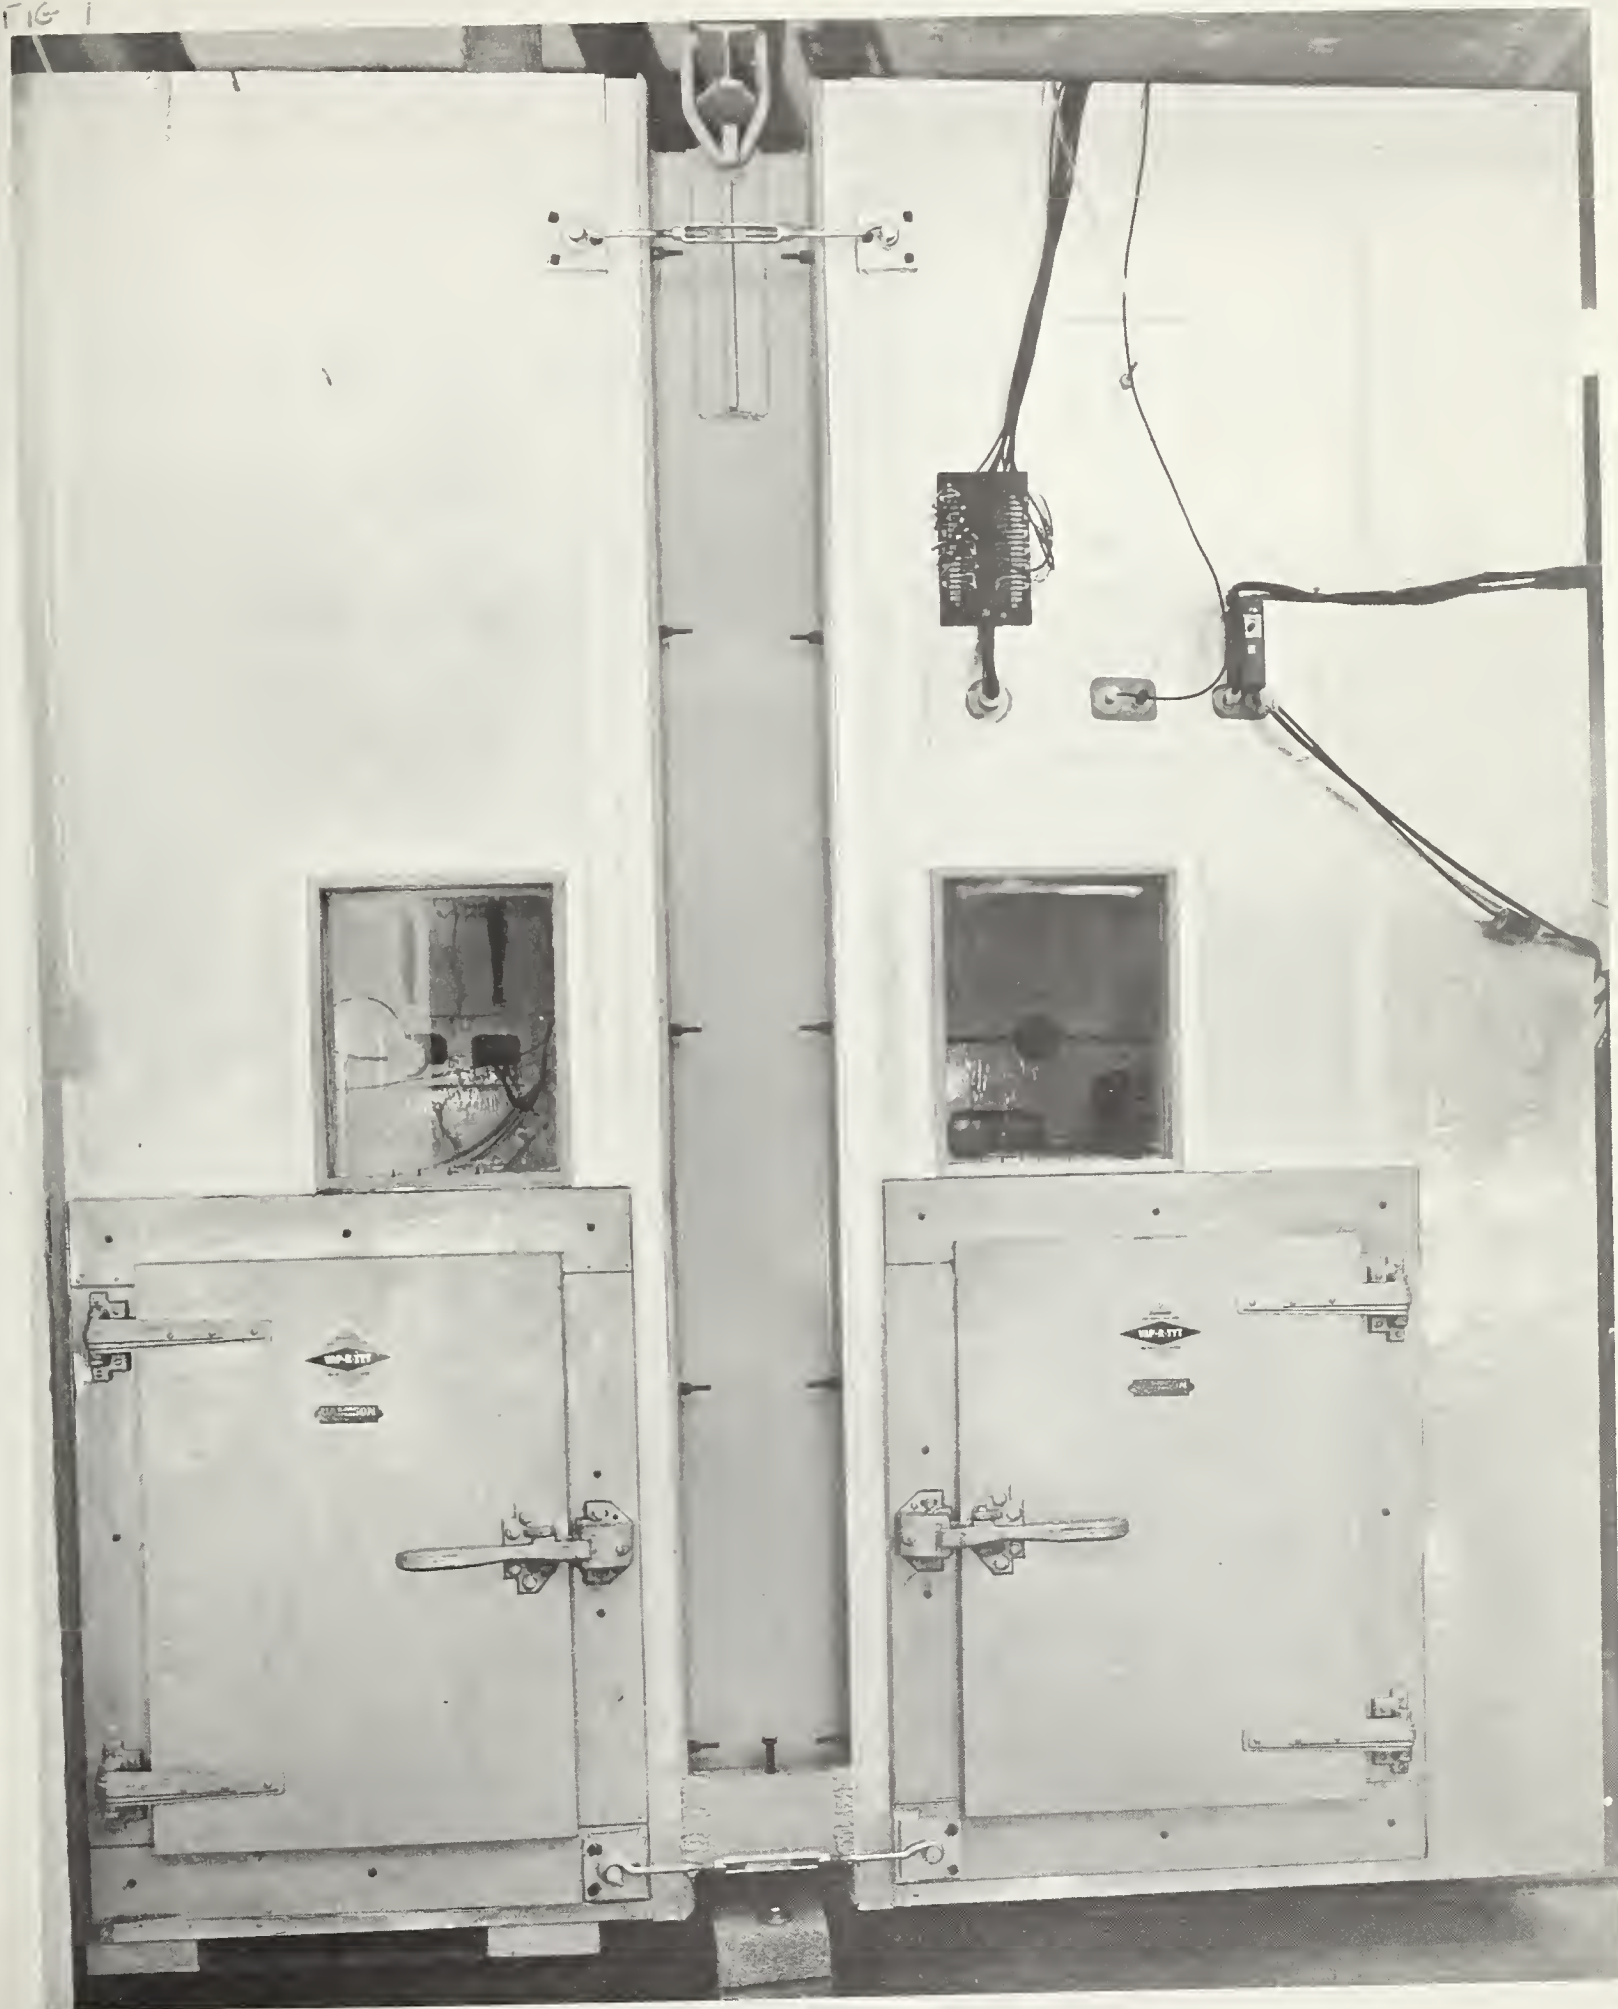
FIG 1

There shall be two environmentally-controlled chambers, open on their facing sides, capable of closing with an air-tight seal against an intermediate steel support frame within which the test wall is constructed. An overall view of the testing apparatus is shown in Figure 1.

1. Overall view of apparatus with the test wall enclosed between the warm and cold chambers.
2. Location of instrumentation within the structure of the wall.
3. Details of construction of the test wall.
4. View of outdoor surface of the test wall.
5. View of indoor surface of the test wall.
6. Air penetration rate through the test wall and apparatus at selected static pressure differences.
7. Relationship between the ratio $Q/\Delta p$ and time of exposure to the environmental conditions.
8. Deflection of the wall at the mid-height during the two periods of exposure.
9. Air penetration rate through the test wall and the apparatus as plotted on log-log coordinates.
10. Accumulation of water at the base of the test wall (exterior surface) after termination of the winter tests.
11. A typical set of temperature and humidity conditions within the wall structure during the winter tests.

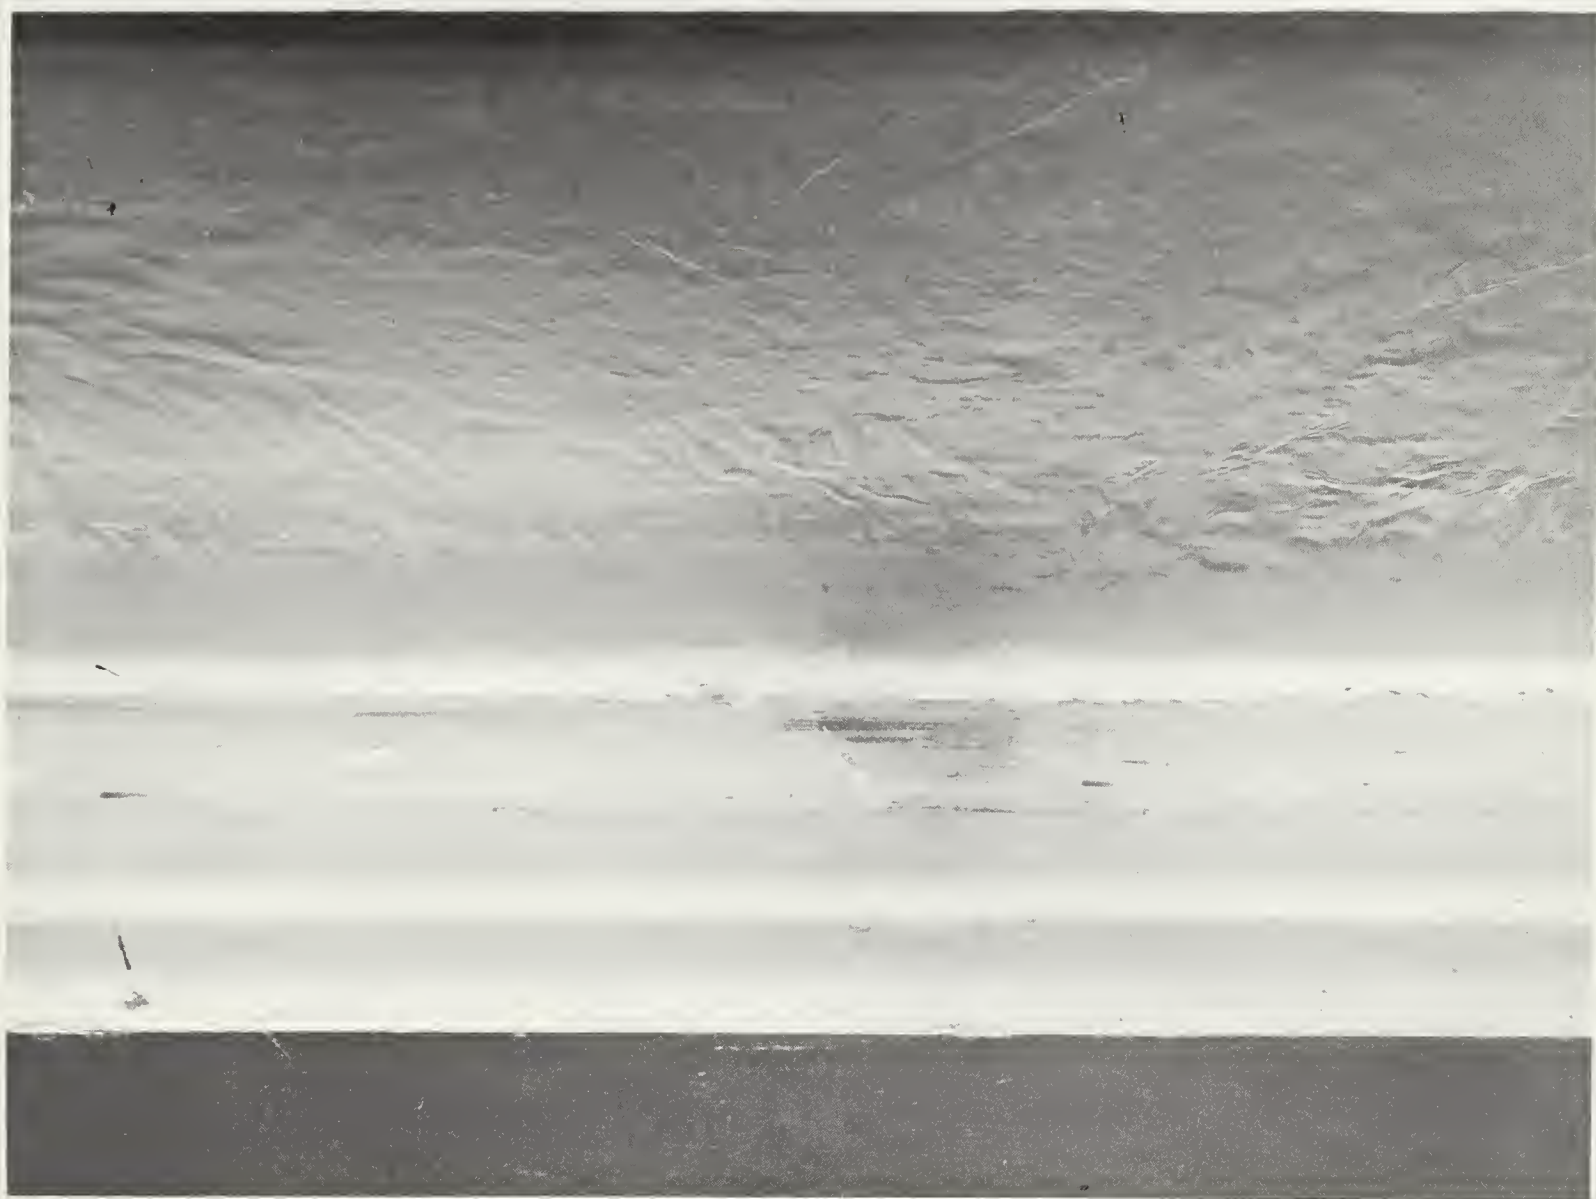
FIG 10

period the wall was allowed to reach an equilibrium temperature between the cold condition of 0 °F and the warm condition of 75 °F. Approximately 12 hours after the termination of the test, the cold chamber was entered and small amounts of water were found to have dripped from the wall to the floor of the chamber. A total amount of approximately 1/2 cup was mopped from the floor at the base of the wall. A small pool of water is shown at the base of the wall in Figure 10.
