NATIONAL BUREAU OF STANDARDS REPORT

DEVELOPMENT, TESTING, AND EVALUATION OF VISUAL LANDING AIDS

Consolidated Progress Report

October 1 to December 31, 1967

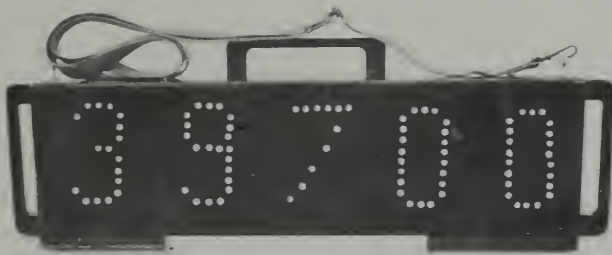
WEIGHT DISPLAY UNIT

Internal, front, and back views of this unit are shown in figure 2.

FRONT VIEW

TYPE 352 LAMPS

OPEN VIEW

BATTERIES D-CELL
(SERIES-PARALLEL)

ON-OFF SWITCH

DIGIT SETTING KNOBS

BACK VIEW

Prior to his being launched, the carrier pilot is informed of the aircraft weight used in determining the thrust setting of the catapult. A method of displaying this weight setting to the pilot has been developed. It consists of a hand-held, self-contained, battery-operated unit that will display to the pilot five four-inch high internally-illuminated digits. The first three digits displayed can be readily changed. (The last two digits are zeros). Thus the catapult setting in hundreds of pounds can be displayed.

The brightness of this unit is low, as the unit is meant for night use only. If a presentation system of this type is desired for daylight use, it would be necessary to power it from an external power source because of the current requirement of the higher intensity required.
