SURFACE PROTECTION OF MARAGING STEEL

QUARTERLY PROGRESS REPORT No. 9

January 1 to March 31, 1968

Picatinny Arsenal Project

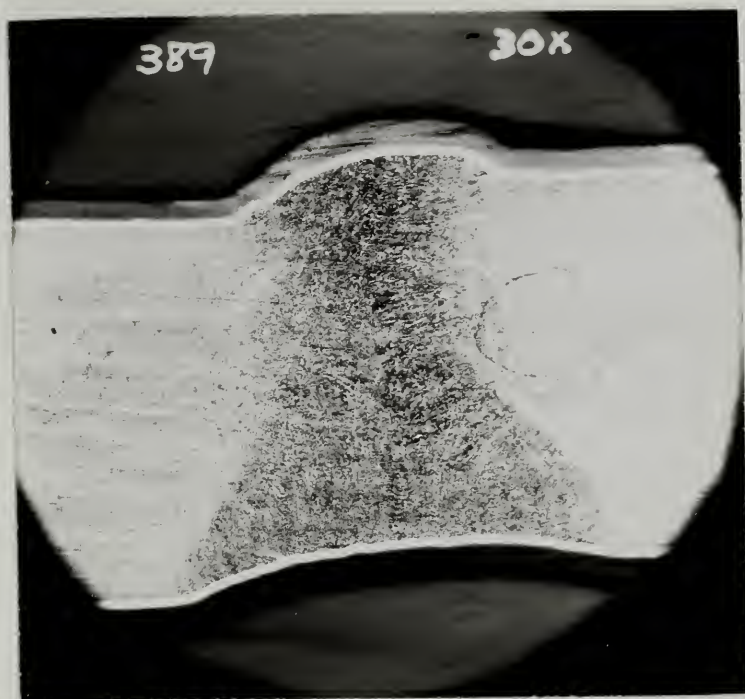
Figure 1. (316-1) Cross-section of nickel on welded Maraging steel after 463 days in contact with MHF-3 fuel at 160°F. Welded area is in center of picture. The nickel coating (horizontal white lines) covered the welded Maraging steel uniformly. No attack of the nickel coating is evident. Copper (darker bands) was plated over the nickel coating for protection during polishing. 30X. Modified Fry's etchant.

Data on corrosion of nickel is contradictory. The specimen in Unit No. 316-1 showed little attack. This was a welded specimen, and no effect of the weld on the coating was seen. On the other hand, the nickel coating in Unit No. 347-Ni was visibly etched where it had been in contact with liquid fuel. Weight loss could not be determined because the outside of the tube was severely corroded from submersion in the water bath. However, the high concentration of salts in the fuel, together with the dark green color of the fuel, are evidence that considerable corrosion of the nickel occurred. This unit (similar to Figure 3, Report No. 1, April 1, 1966) was sealed with end plugs made of aluminum. It is possible that the aluminum in the aluminum-nickel couple had an accelerating effect on the corrosion of the nickel. In Unit No. 316-1 the nickel was in the form of a strip specimen, electrically insulated from the stainless steel bomb by placement in a glass cup liner.

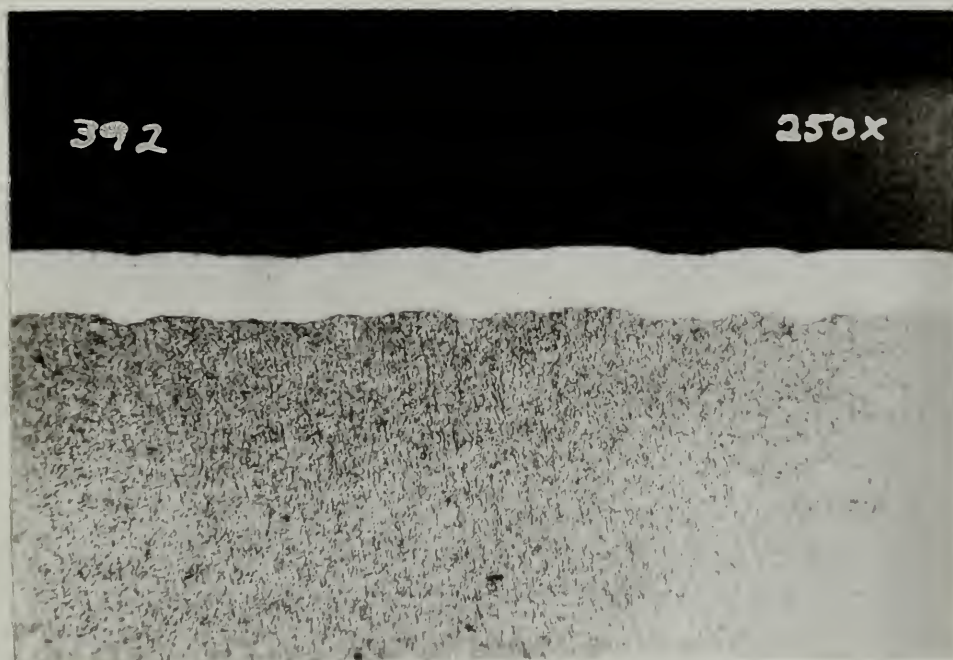
Figure 2. (316-1) Cross-section of nickel-plated Maraging steel after 463 days exposure to MHF-3 fuel at 160°F. Good coverage of rather rough surface of Maraging steel (bottom) is shown. No attack on nickel (white band) surface is evident. Darker band above nickel is polish-protective copper overlay. 250X. Modified Fry's etchant.

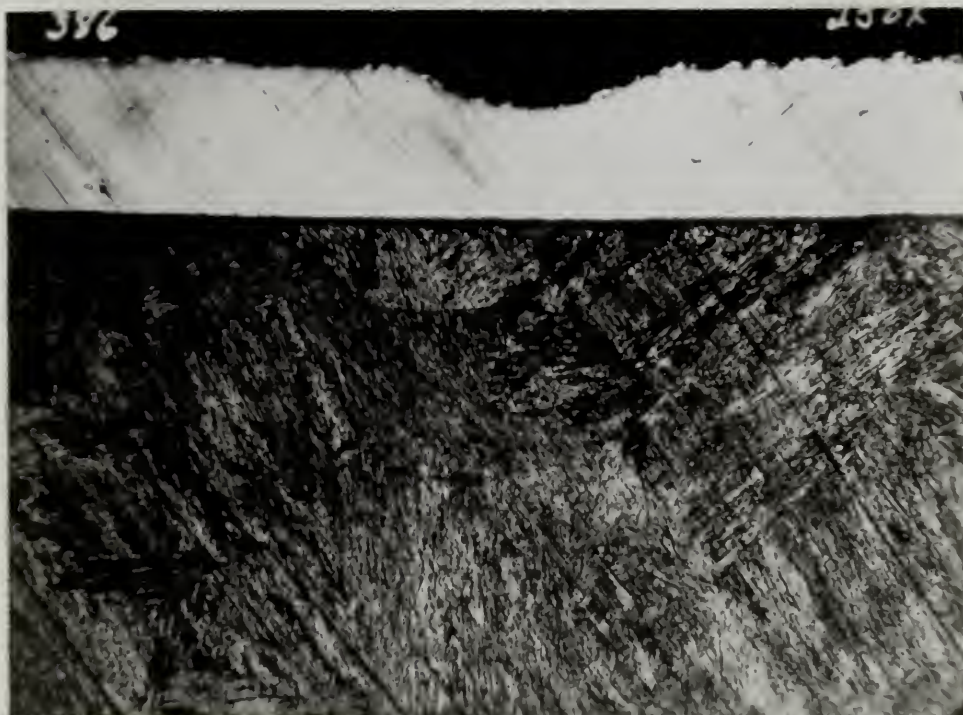
Figure 3. (347-Ni) Cross-section of nickel-plated Maraging steel tube after 456 days in contact with MHF-3 fuel at 160°F. The shallow pit in the nickel coating (light band at top) is of uncertain origin. Slight roughness of surface of nickel believed due to attack of fuel. 250X. Modified Fry's etchant.

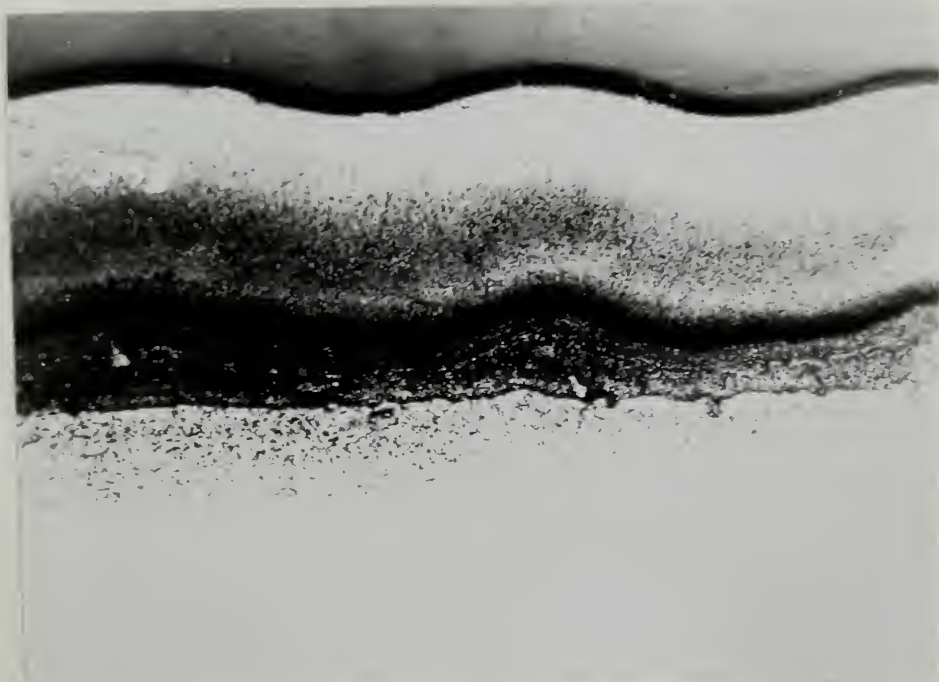
Figure 4. (347-1) Cross-section of lead-plated Maraging steel after 454 days in contact with MHF-3 at 160°F. Identification of bands: Bottom (mostly white zone), Maraging steel; center, lead plate (darker band); top (thick, black-edged band), copper coating applied after sectioning as polishing support. As-plated unevenness of the lead deposit is reflected in the copper coating. Little, if any, attack on the lead is evident. 250X. Modified Fry's etchant.

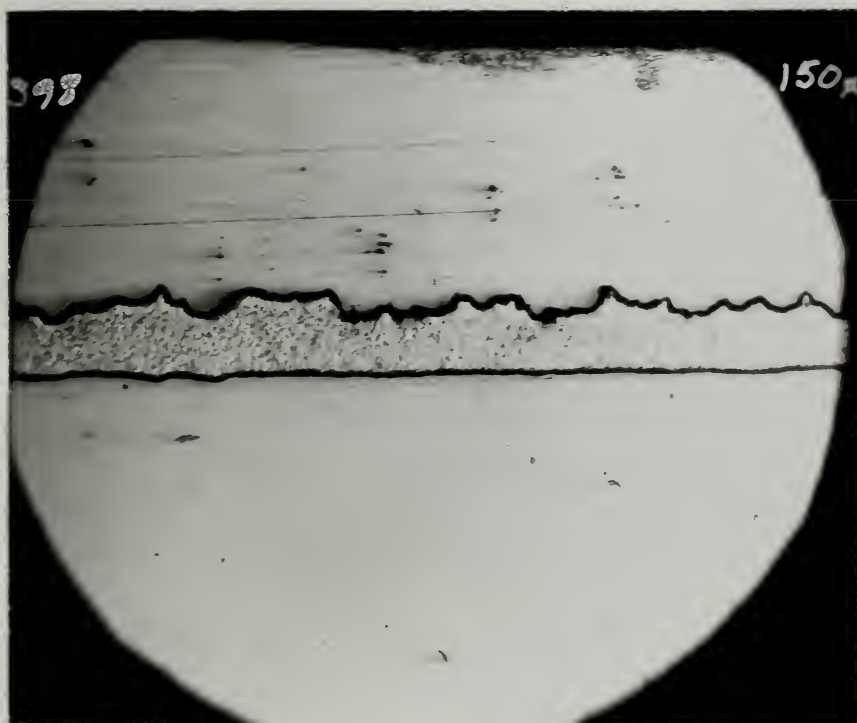
Figure 5. (Hg-3) Cross-section of cadmium plate (band through center of photo) on Maraging steel after 473 days exposure to MHF-3 fuel at 160°F. Irregular etch-corrosion of the surface of the cadmium is evident. The Maraging steel is below and a polish-protective copper deposit above the band of cadmium plate. 150X. Chromic acid etchant.

Zinc was also most severely corroded at room temperature (see preceding report). Cadmium was less corroded at 160°F than at room temperature. Figure 5 shows that it underwent some pitting attack. Weight loss data for cadmium and electroless nickel (Units Hg-3 and Hg-4) are not given because these coatings were partially amalgamated. Accidental amalgamation spoiled a few early tests. This difficulty was eliminated by use of the glass frit shown in Figure 3, Report No. 7, October 1, 1967.

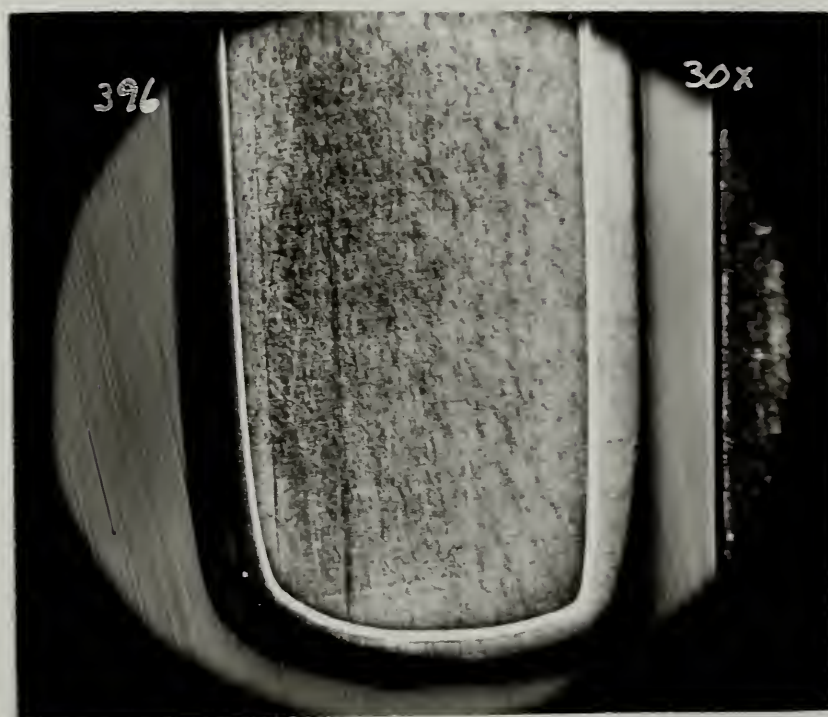
Figure 6. (Hg-4) Cross-section of electroless nickel on Maraging steel after 458 days exposure to MHF-3 fuel at 160°F. Shown are one edge and part of the sides of the specimen with the Maraging steel at the center surrounded by the white band of nickel, and the thick protective copper overlay applied after sectioning. 30X. Modified Fry's etchant.

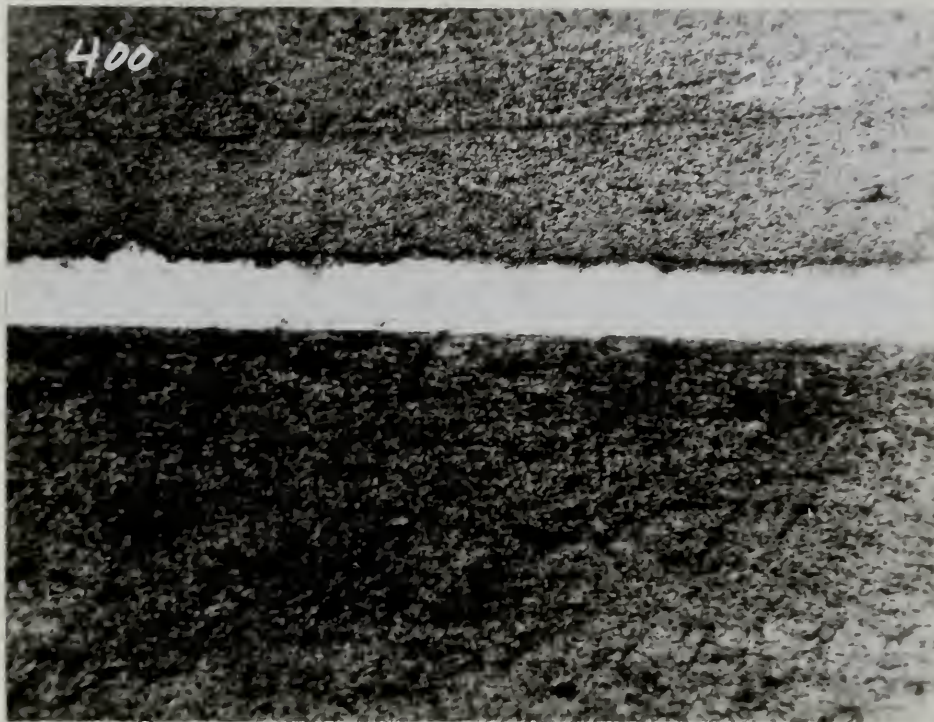
Figure 7. (Hg-4) Cross-section of center of specimen of Maraging steel plated with electroless nickel after 458 days of contact with MHF-3 fuel at 160°F. The nickel (white band at center) shows little evidence of attack. Very slight unevenness at surface of deposit (top) is likely the as-plated condition. 250X. Modified Fry's etchant.

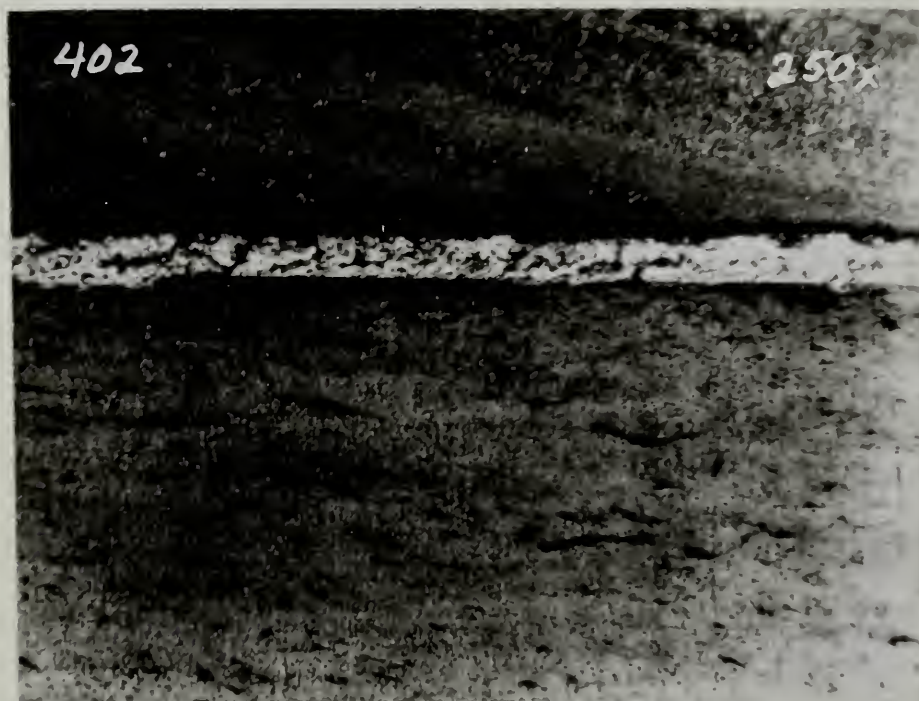
Figure 8. (Hg-5) Cross-section of tungsten deposit on Maraging steel after 358 days in contact with MHF-3 fuel at 160°F. The tungsten is the light band in the center with the Maraging steel below and the copper protective plate above. There was practically no attack of the tungsten. 250X. Modified Fry's etchant.

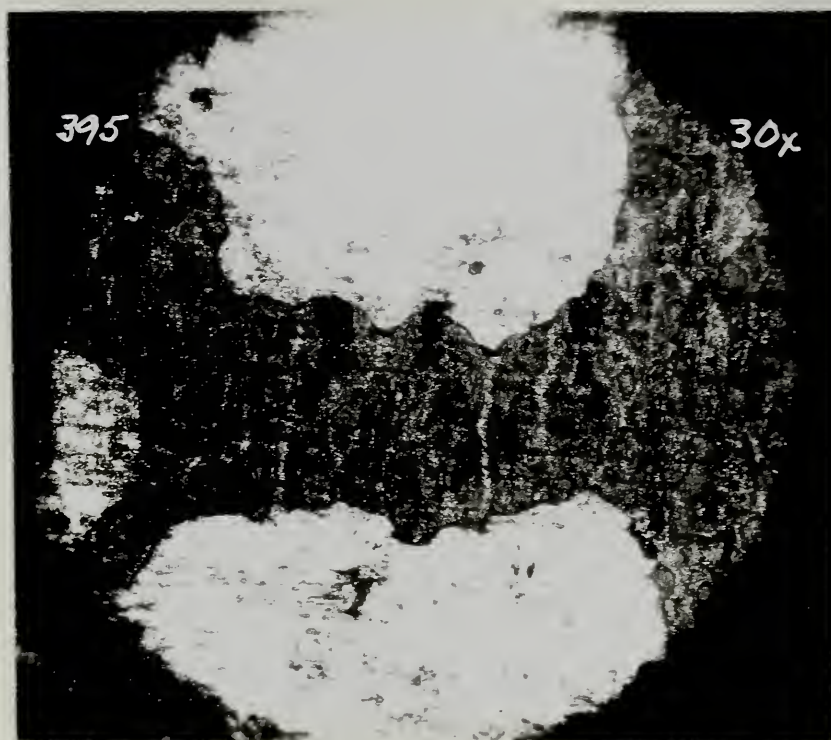
Figure 9. (Hg-7) Surface of zinc-plated Maraging steel after 341 days exposure to MHF-3 fuel at 160°F. This photo shows tightly adherent, dense scale (darker area) partially removed from specimen. All the zinc deposit was affected. 30X. No etch.

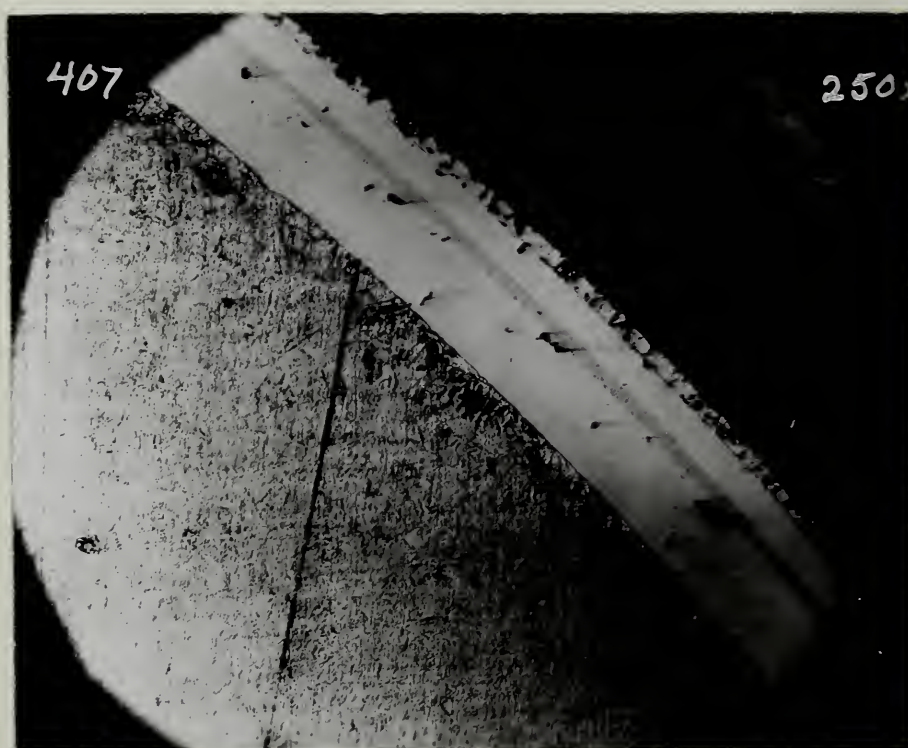
Figure 10. (Hg-8) Cross-section of nickel-tin alloy coating on Maraging steel after 358 days exposure to MHF-3 fuel at 160°F. Banded structure of deposit (lighter diagonal strip) due either to interruption during plating, or to a spontaneous cyclic phenomenon during deposition. Unevenness of surface may be due to chipping of the brittle coating during polishing, rather than to attack by fuel. 250X. Modified Fry's etchant.

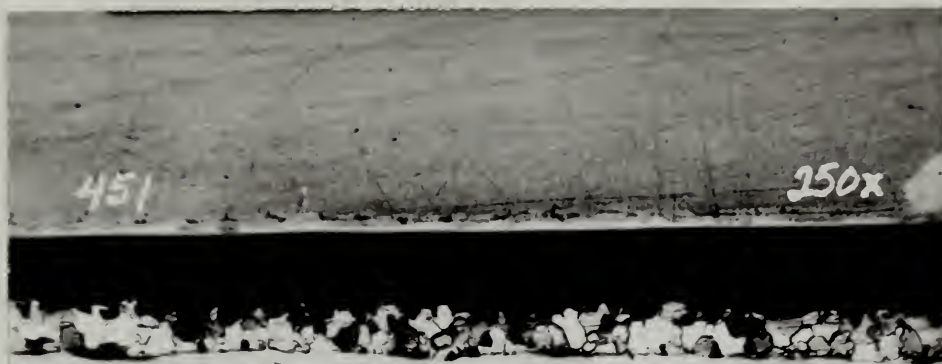
Figure 11. (Hg-11) Cross-section of tin-plated Maraging steel after 432 days exposure to MHF-3 fuel at 160°F. Maraging steel is at bottom of photo with the tin immediately above. Apparent grain structure in deposit appeared without an etch. Roughness of surface of tin coating thought to be as-plated condition. 250X No etch.

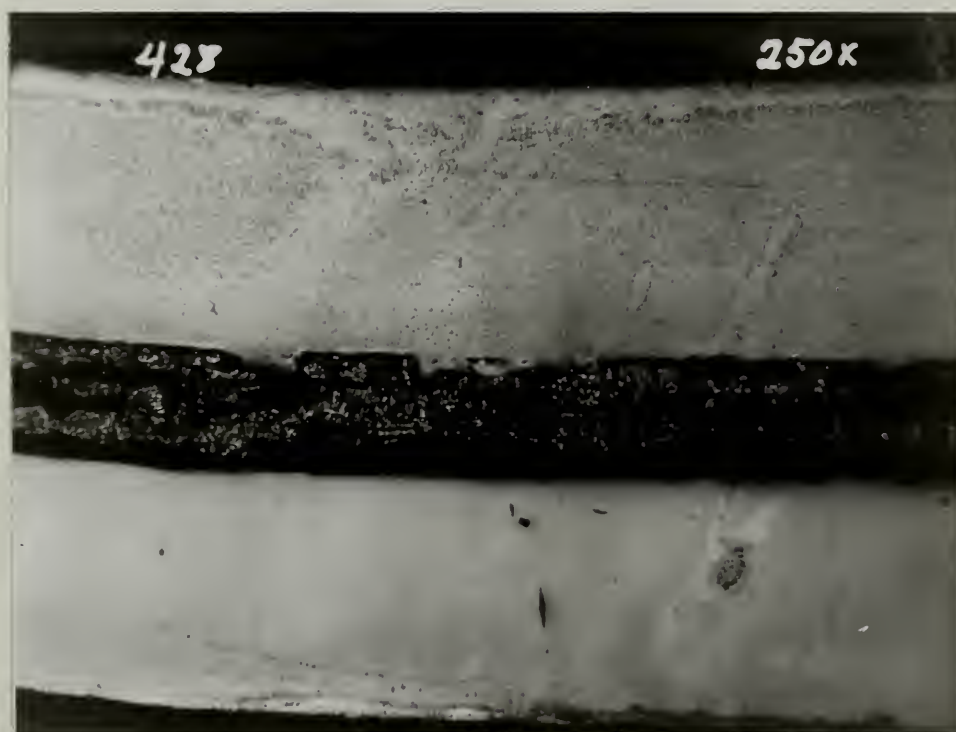
Figure 12. (PA 20) Cross-section of iron foil exposed to MHF-3 fuel for 193 days at 160°F. Iron is dark band at center with polish-protective nickel layers above and below. Evidence of some pitting attack may be seen in upper surface of the iron. 250X. Modified Fry's etchant.

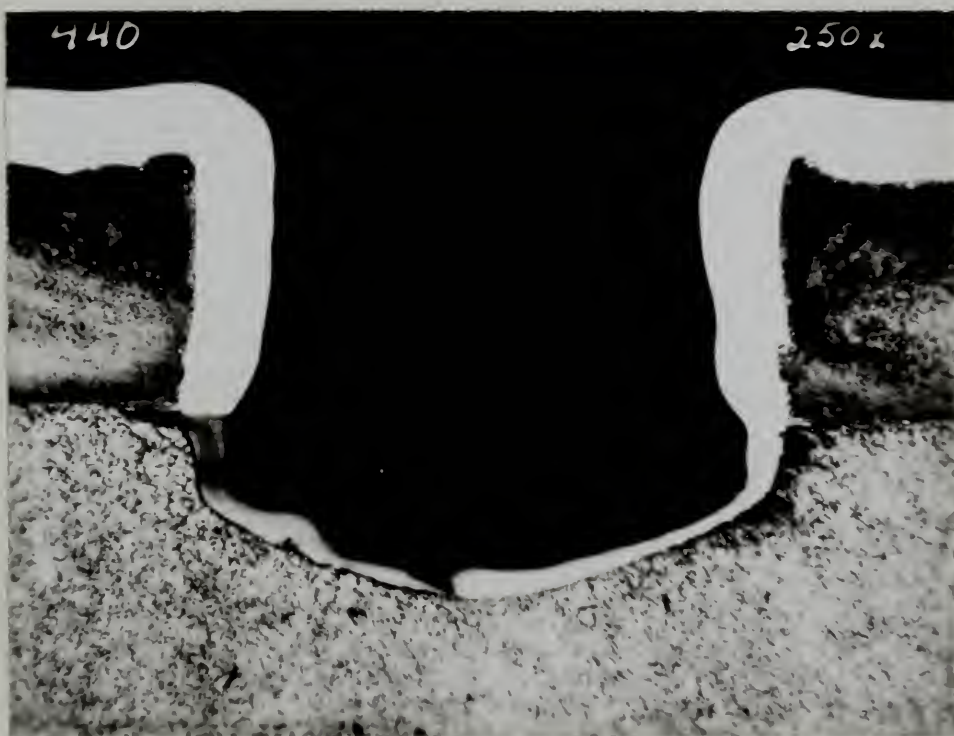
Figure 13. (34-A) Cross-section of silver-plated Maraging steel with artificial pore after 205 days exposure to MHF-3 fuel at 160°F. The layers, top to bottom, are: white nickel polish-protective coating, silver deposit, and Maraging steel. Some undercutting of the silver, which has been filled in with nickel, is evident; otherwise, there is little effect on the exposed Maraging steel. 250X. Modified Fry's etchant.

The silver plates in Units 34A-D (Table 4 and Table 6) were coated with a hard yellow film which was difficult to remove. Cross-sections of the "pores" on these specimens showed some under-cutting of the silver deposit due to dissolving of the underlying Maraging steel close to the interface (Figure 13), but very little attack of the exposed Maraging steel at greater distance from the silver.
