# NATIONAL BUREAU OF STANDARDS REPORT

## FATIGUE FAILURE OF ELECTROFORMED PRINTING PLATES

NBS REPORT  
9923

## Fatigue Failure of Electroformed Printing Plates

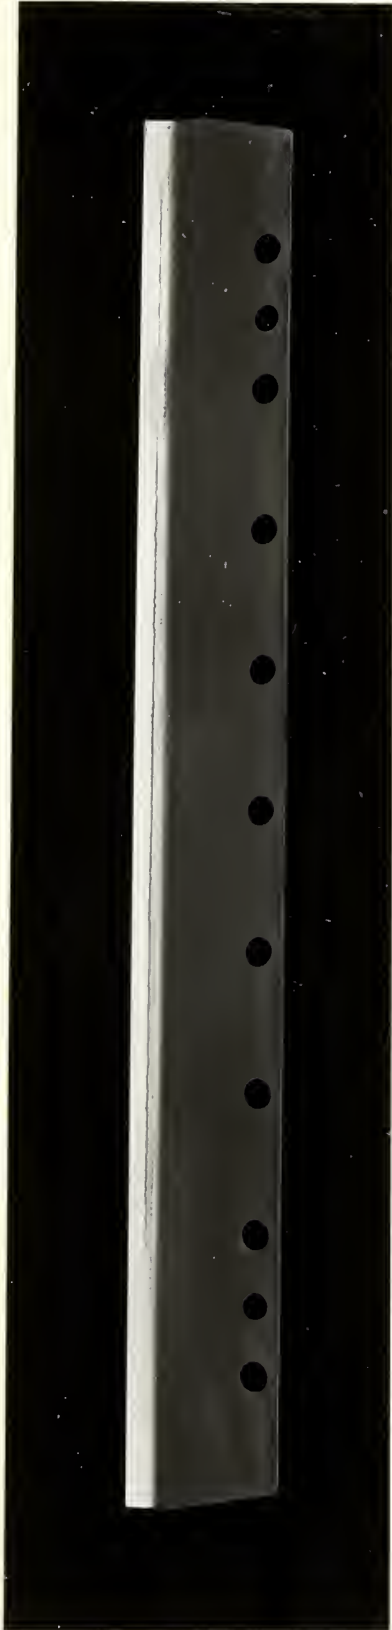
Figure 1. Strip from printing plate No. 40395. The location of the cracks with respect to the plate-bend line is typical of that observed in all of the strips examined.

a. Obverse face. X 1/4

b. Reverse face. X 1/4

All of the strips contained cracks that were adjacent to and parallel to the bend line in plate Vee bends - bends necessary for adaptation of the plates to the press cylinder. The cracks observed varied in length from approximately one inch in one plate to three-fourths of the plate width in others. A typical view of the general location of the cracks with respect to the plate bend line is shown in Figure 1. Strip identifications and pertinent plating and service life data are given in Table 1. The Bureau of Engraving and Printing (BE&P) requested NBS to determine whether cracking could be attributed to detrimental material conditions or to mechanical factors. BE&P also requested that the mechanical properties of the materials be established for their records and possible future reference.
