9946

## STRESS-CORROSION BEHAVIOR OF TI-6AL-4V ALLOY IN A SYNTHETIC SEA WATER ENVIRONMENT

Naval Ship Research and Development Center  
Department of the Navy  
Carderock, Maryland

W. F. Gerhold  
and  
B. Z. Weiss

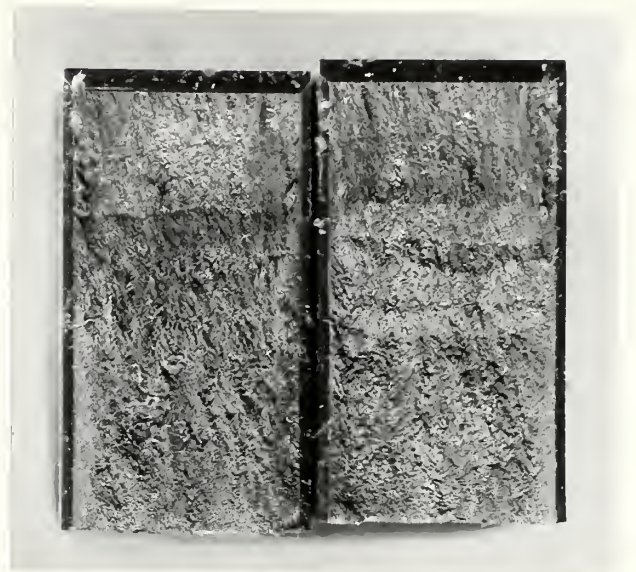
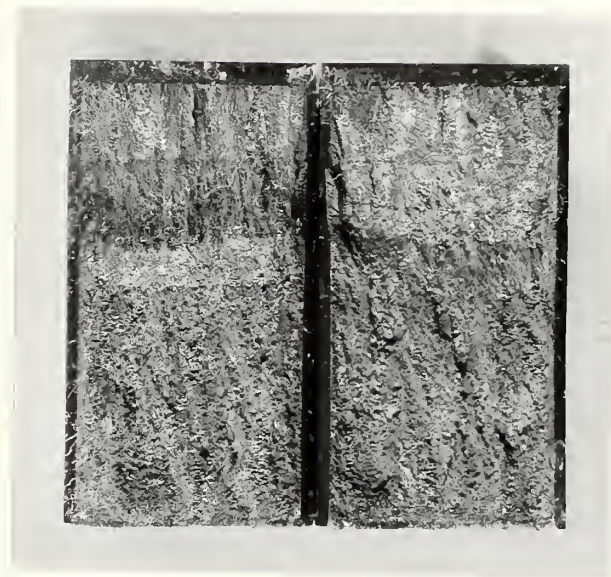
Figure 4. Stress-corrosion test specimens showing typical fractured surfaces. The uniformity of the fatigue cracks (resulting from the pre-cracking process) may be seen in the upper area of each specimen. Each horizontal striation delineates the base of a fatigue crack. The coarser, fibrous areas are those resulting from stress-corrosion and subsequent fast fracture.

the stress apparatus and stressed again at a slightly higher stress intensity. This was repeated until failure occurred or until the depth of the fatigue crack had increased to a value which made the specimen unsuitable for further tests. Figure 4 shows the uniformity of the fatigue cracks initiated by the precracking process and typical fractured surfaces for 3 failed stress-corrosion test specimens.
