NATIONAL BUREAU OF STANDARDS REPORT

**STRUCTURAL PERFORMANCE
OF
A BUILDING SYSTEM**

STRUCTURAL PERFORMANCE OF A BUILDING SYSTEM

Prepared For
Department of Housing and Urban Development

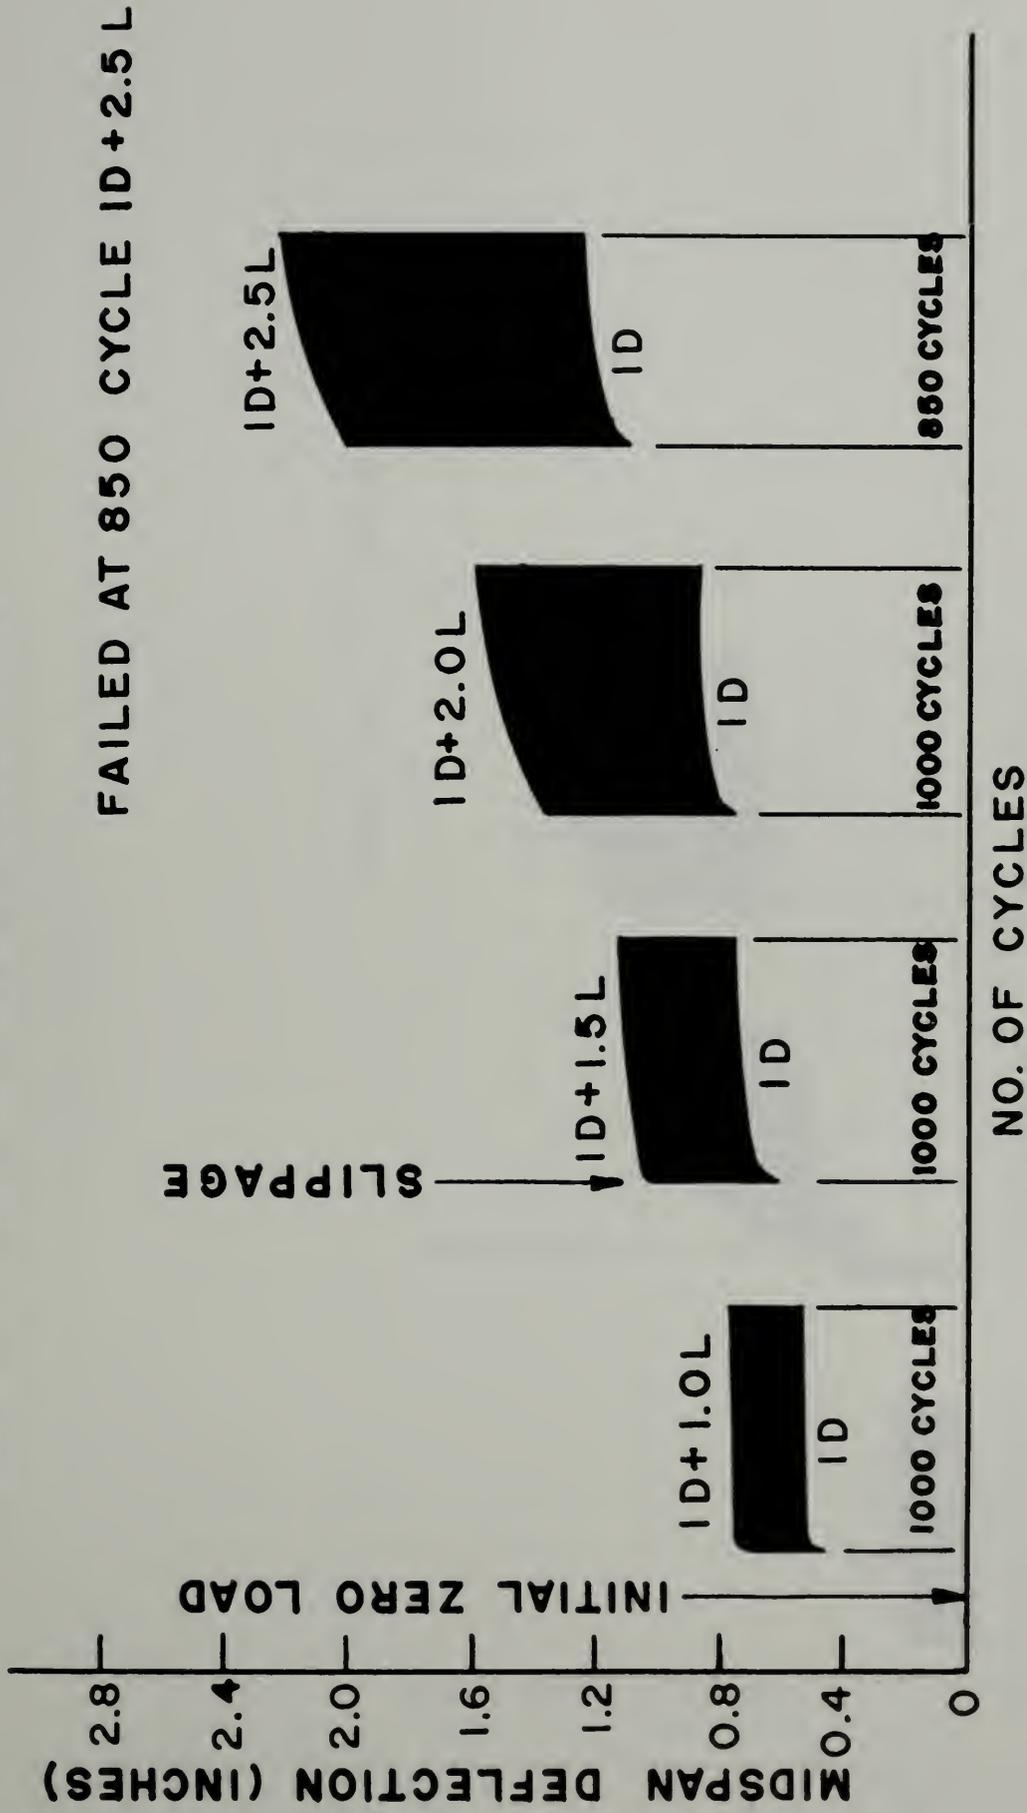
FIGURE 10.26 FATIGUE LOADING, BEAM NO. 9

The results of the test on Beam 9 are shown in Fig. 10.26.

PHOENIX BEAM NO. 9
 STAR INSERTS AT 19"
 PARTIAL BEAM-COLUMN CONNECTION
