NBS SPECIAL PUBLICATION 433

Success by Design: Progress Through Failure Analysis

Proceedings of the 21st Meeting of the
Mechanical Failures Prevention Group,
held at the National Bureau of Standards,
Gaithersburg, Maryland, November 7-8, 1974

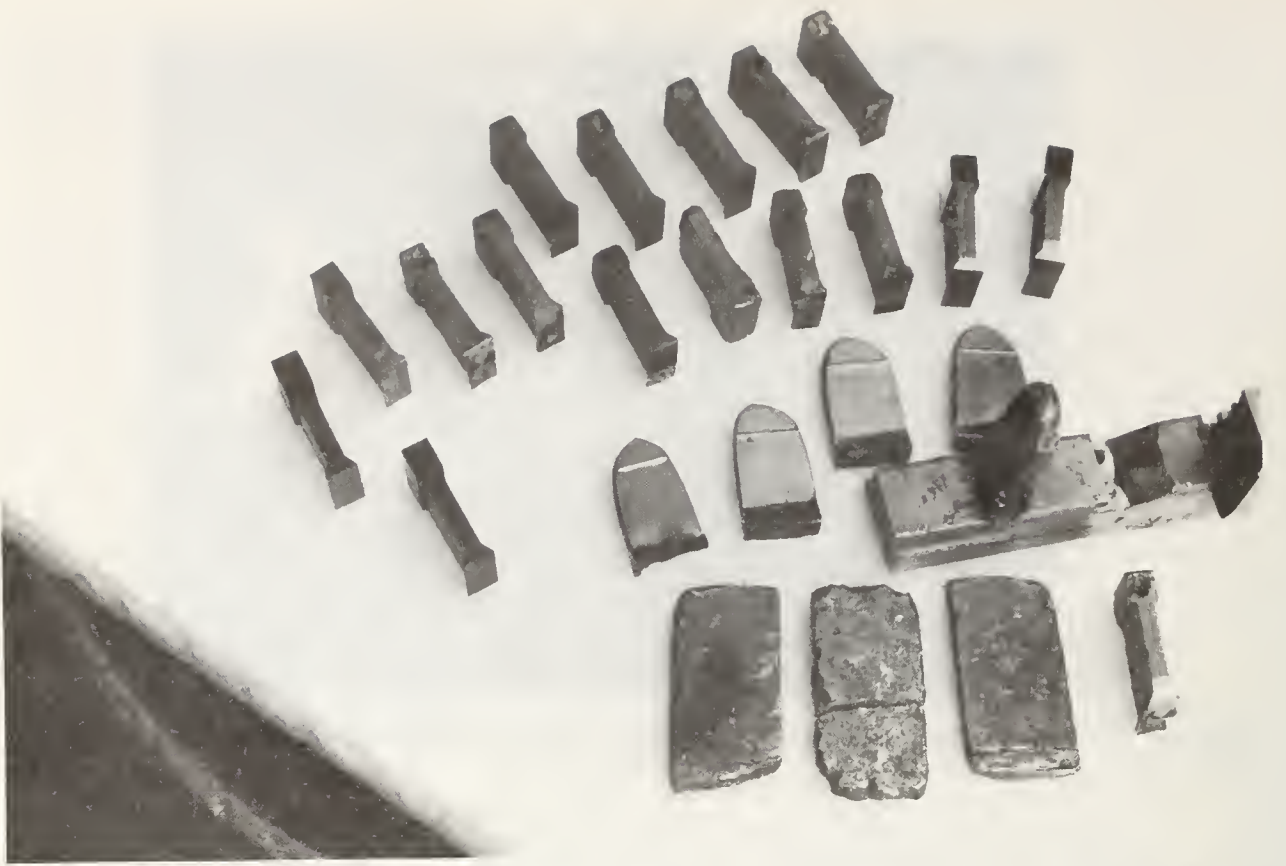
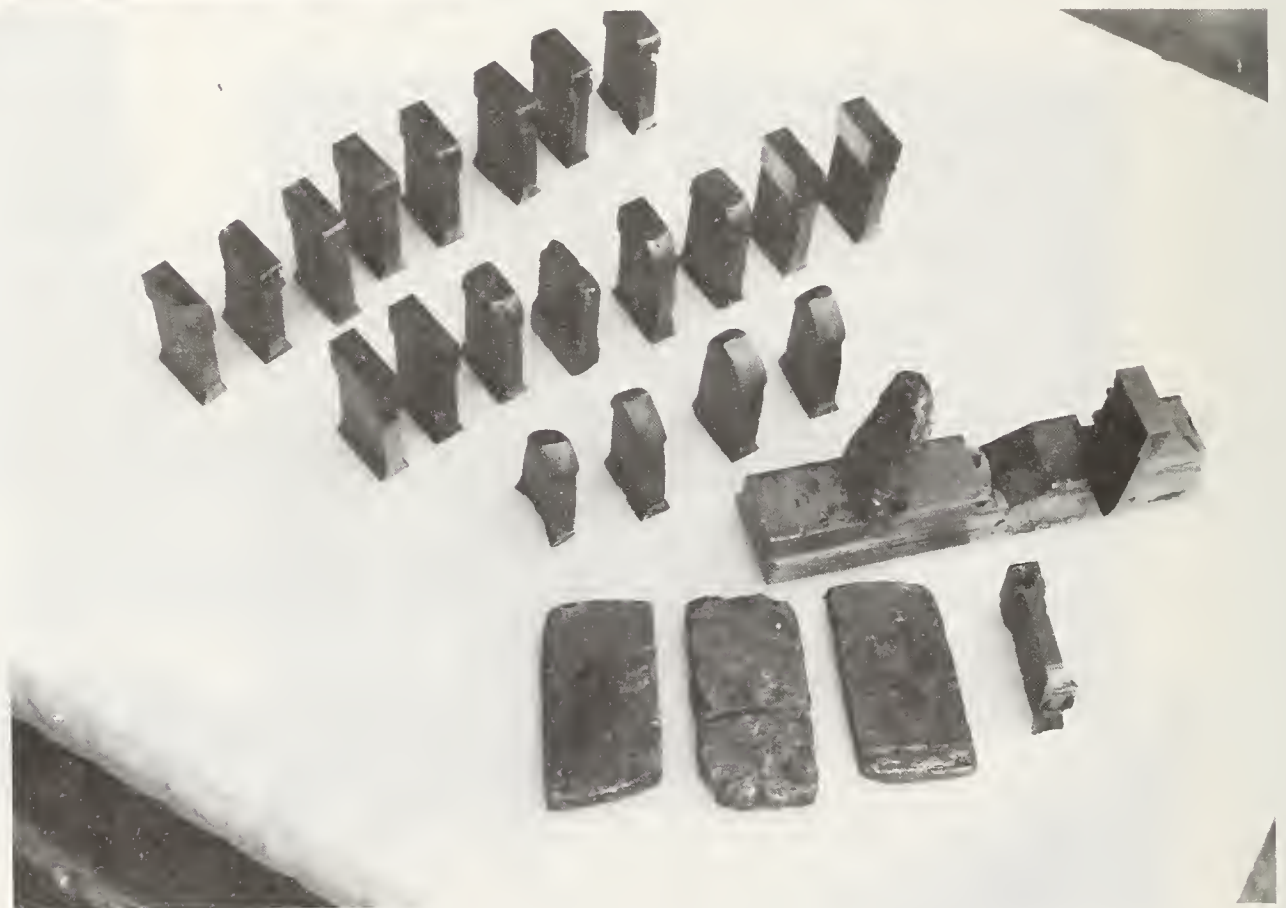
Figures 5 & 6: The different modes of failures of various hammers.

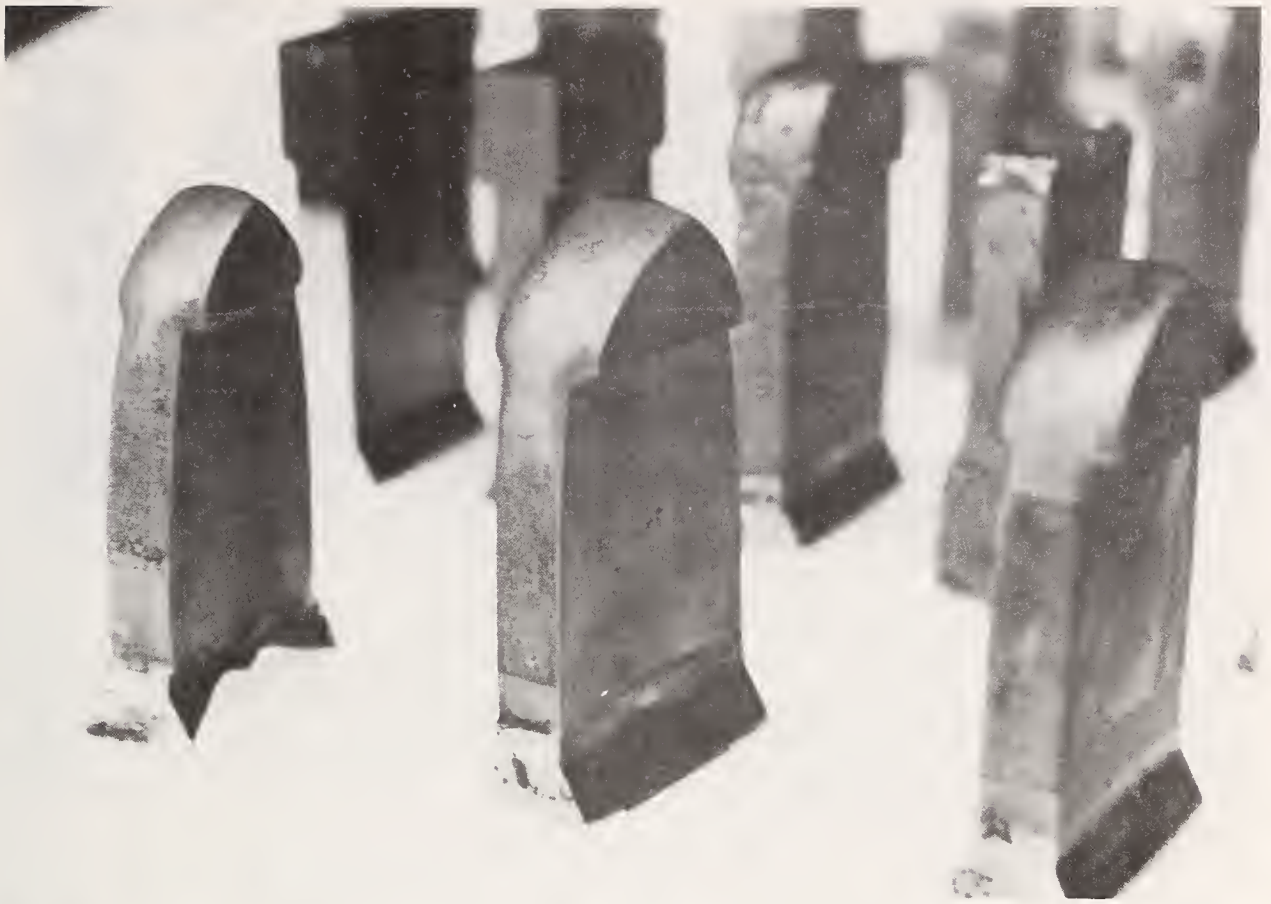
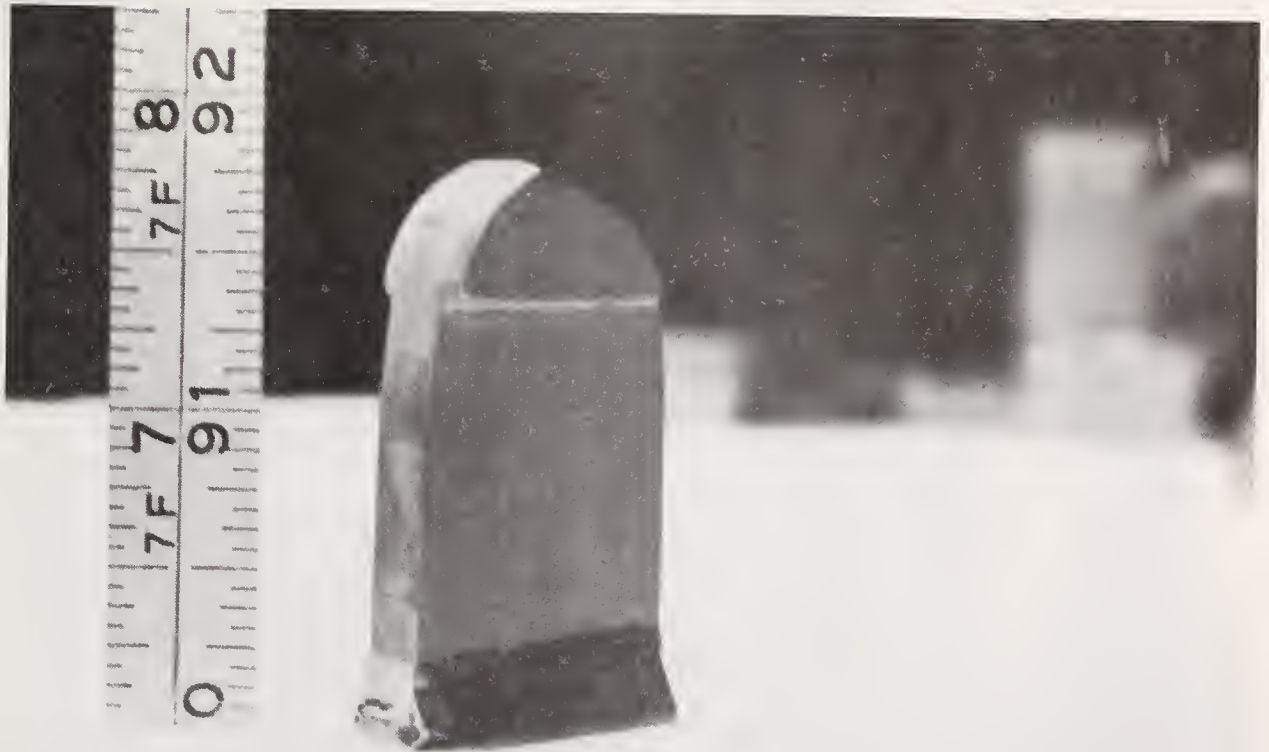
Figures 7 & 8: Complete wearing off on the top part of the hammer.

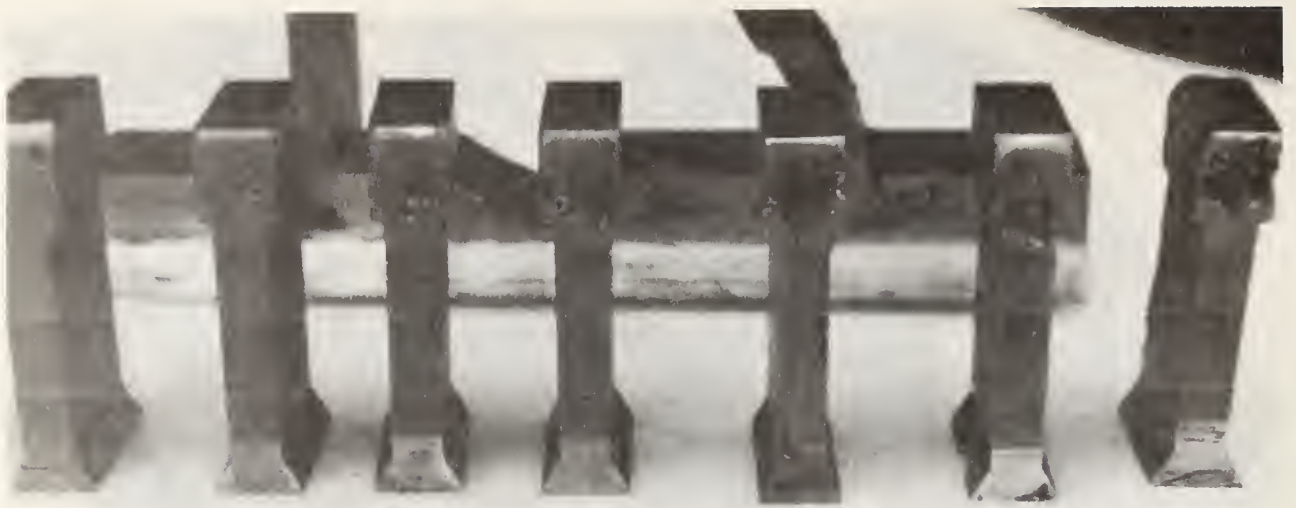
Figures 9&10 : Pitting- Erosion at the top part of the hammer .

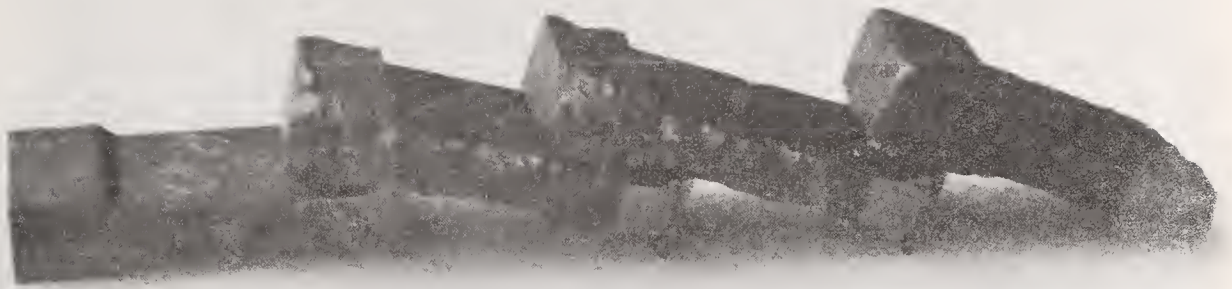
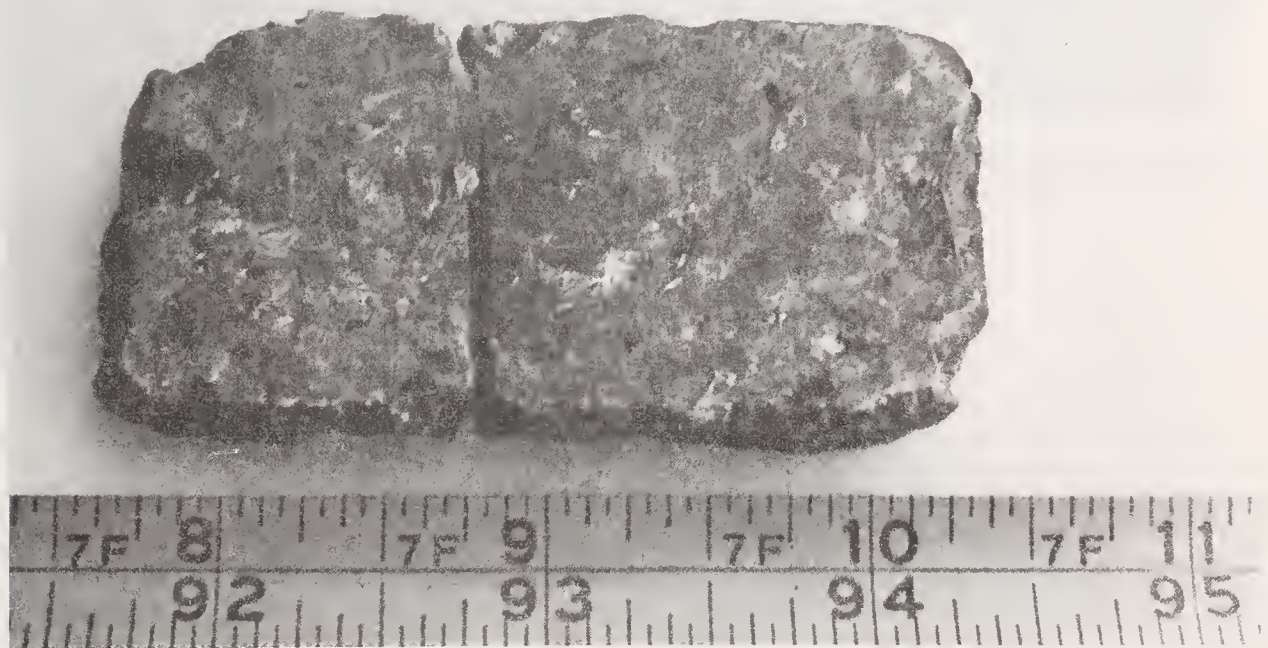
Figures 11&12 : Cracked and Broken Hammers.

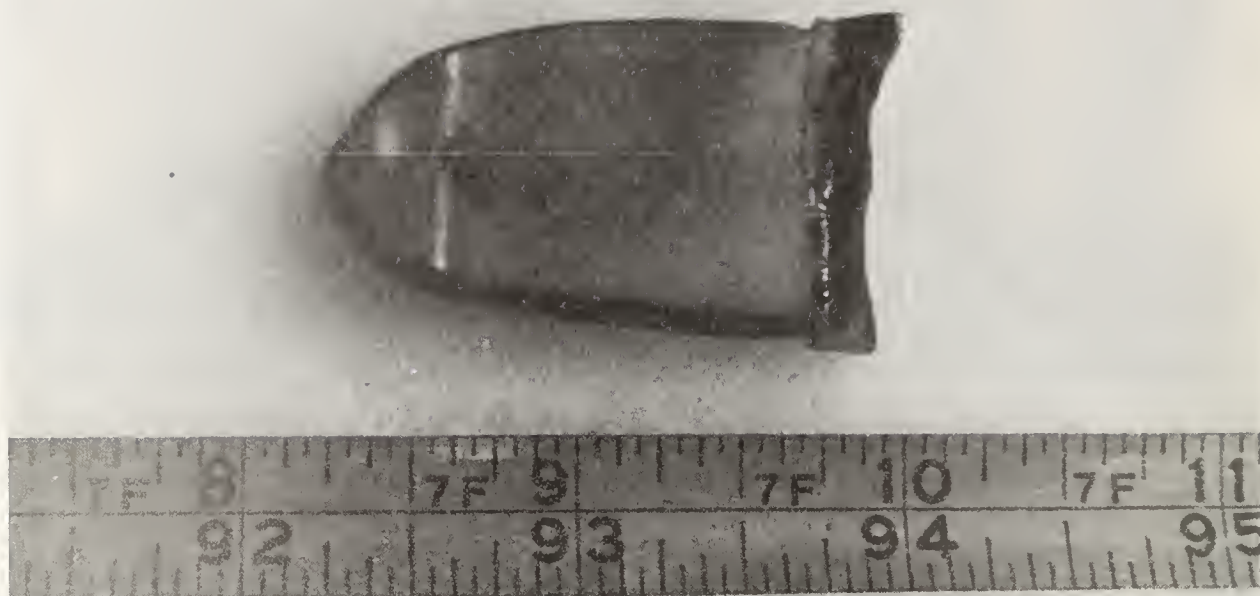
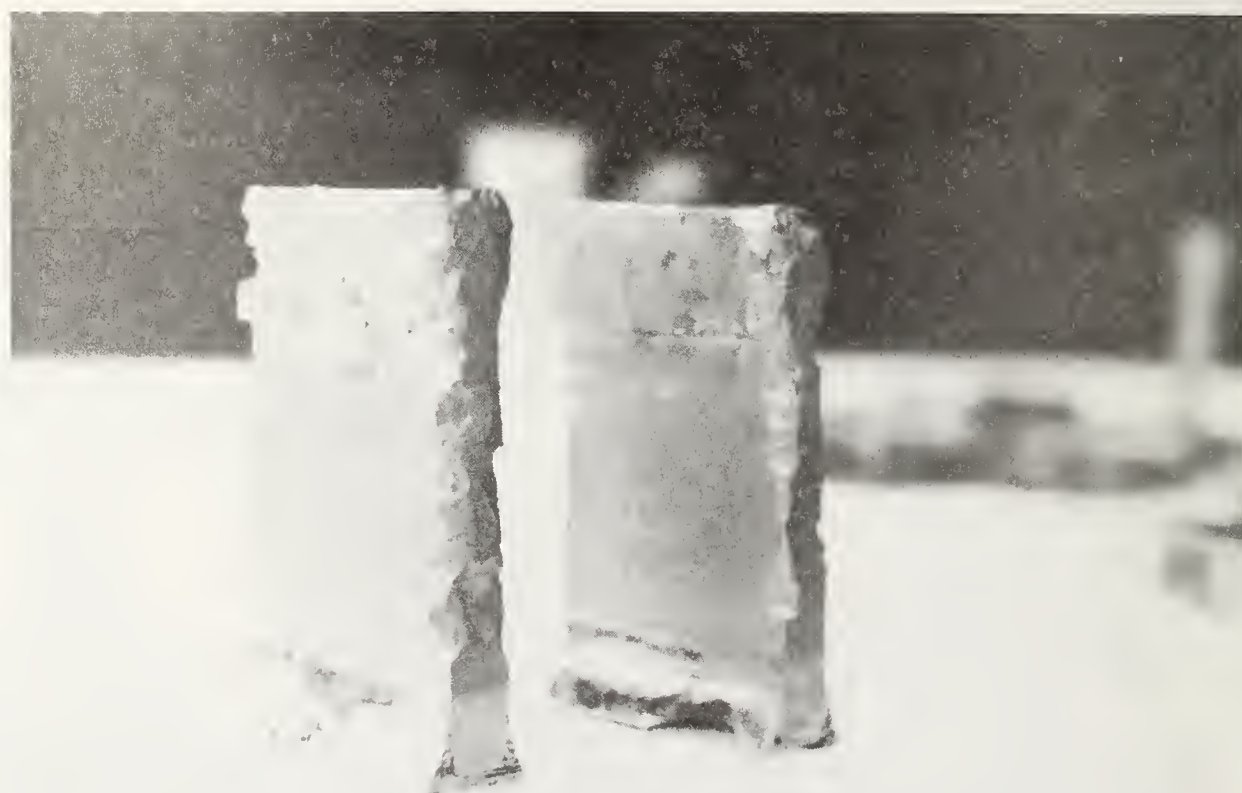
Figures 13&14 : Hammers broken at the base.

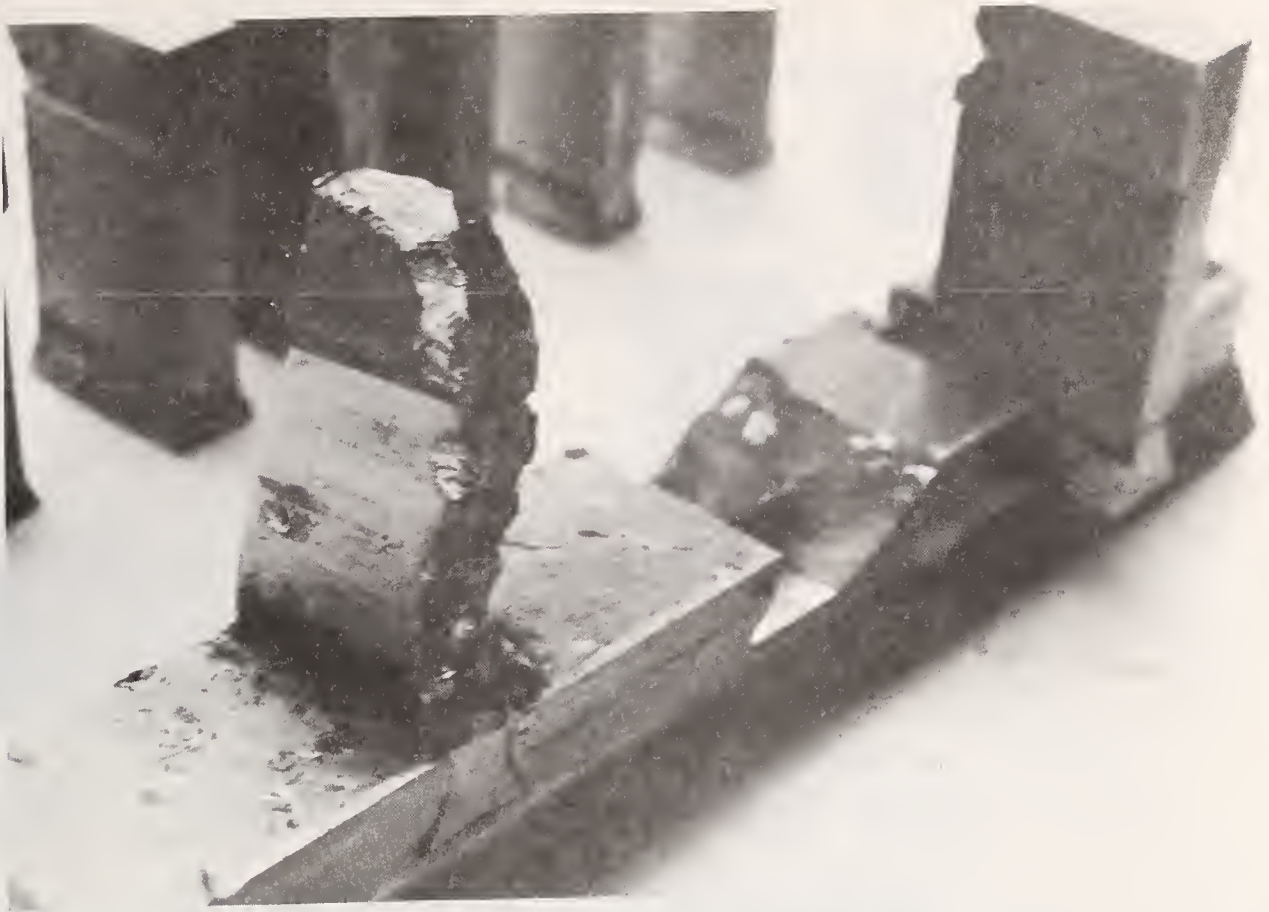
Figure 15 : Damage done to the knife bar and other hammers because of breakage.

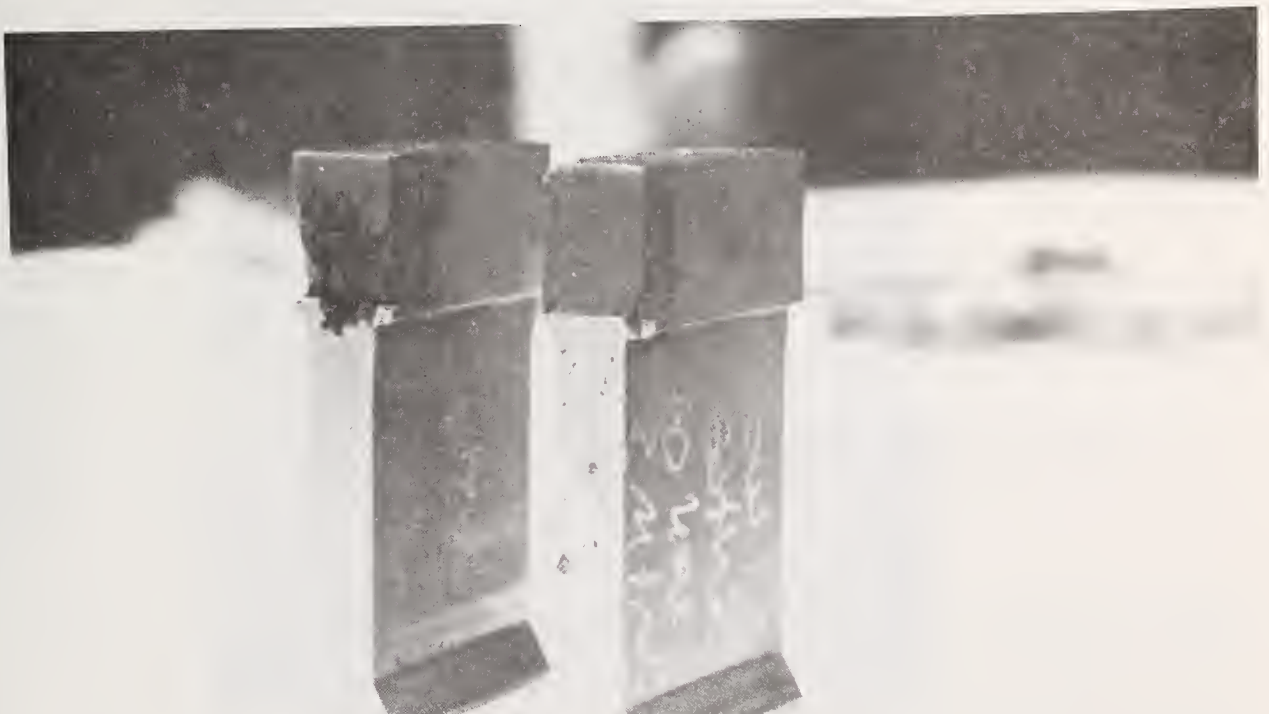
Figure 16 : Failure of the hammers with carbide insert.

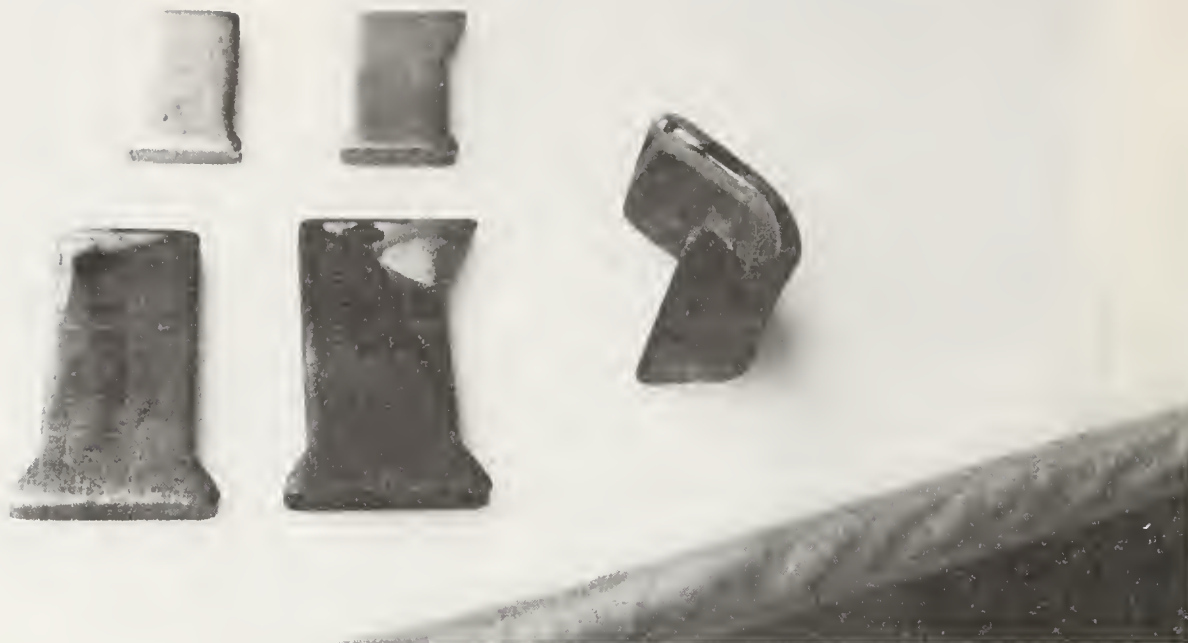
Figure 17 : Stamped Hammers with and without the Stellite hard facing. The bent hammer shows the ductility of stainless 316.
